4 and 5 Peas Hill Cambridge

Building Recording and Archaeological Observations

Cambridge Archaeological Unit
University of Cambridge
December 2007

CAU Report 799

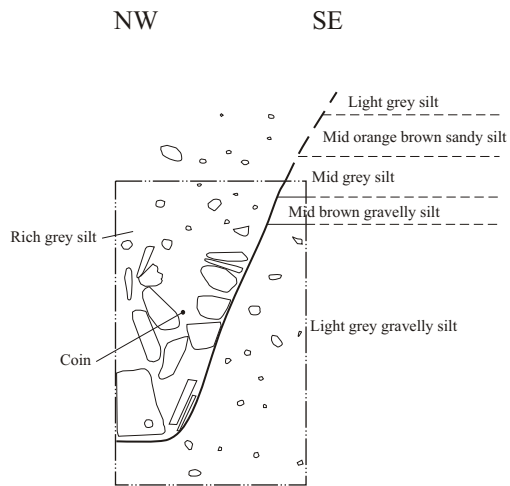
Wall investigation hole V

Side of a pit cut through stratified archaeological levels. A copper alloy coin or jetton recovered from the pit awaits identification. If a jetton it is likely to be 16th century in date.

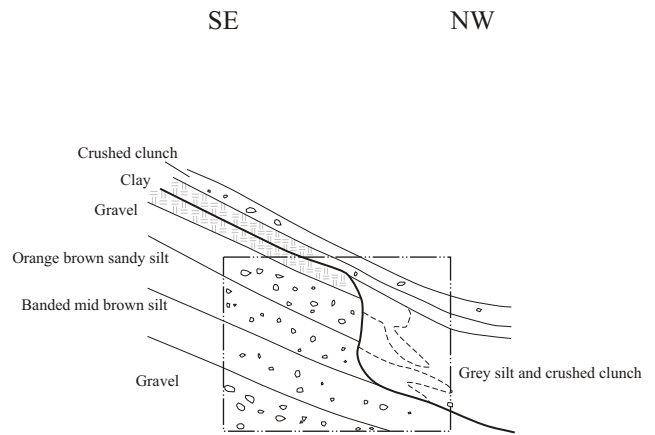
Wall investigation hole VI

A sequence of archaeological layers apparently sloping SE to NW, perhaps tip lines in a larger pit cut into gravel. A smaller cut within contained grey silt and crushed clunch.

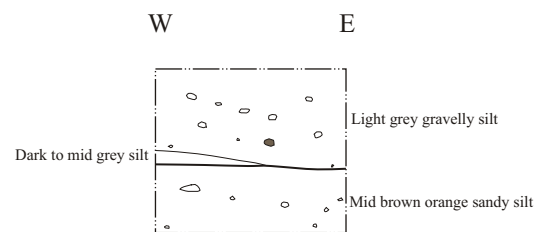
Wall investigation hole VIII

Three layers were evident, but a possible cut may mean the upper two are within a larger feature extending beyond the observable area. A piece of Thetford Ware pottery from above the possible cut is 12th or 13th century in date.

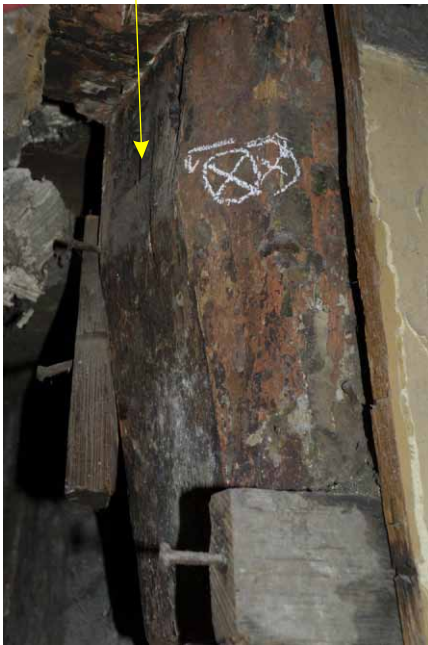
a. Head of jowl post V17

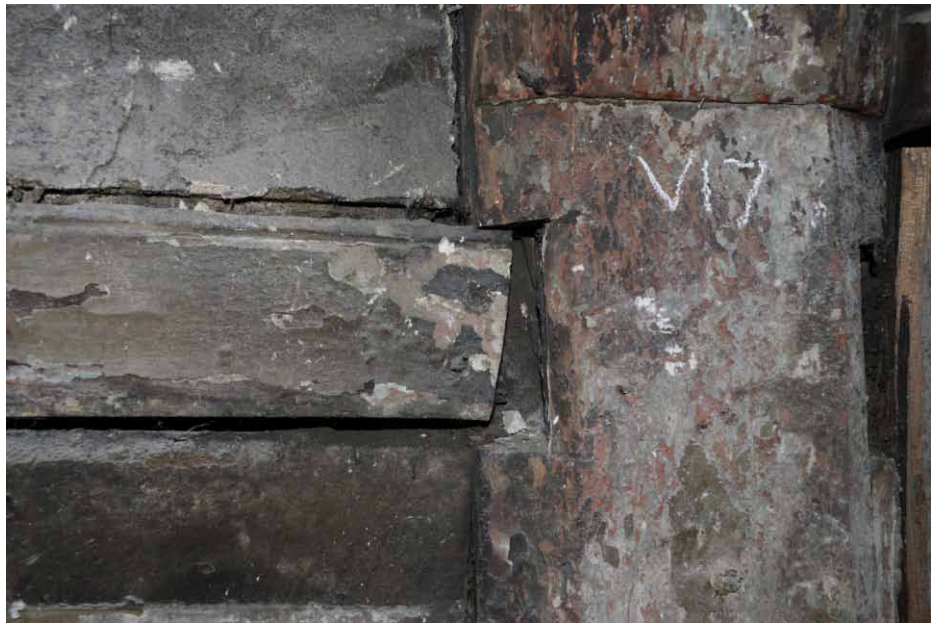
b. Crude fit of H44 in slot in jowl post V17

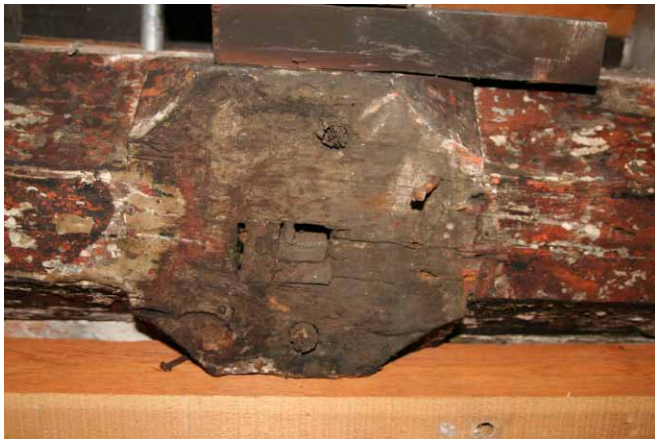
c. H45 showing stopped steps forming a boss with central mortice to hold a samson post (looking up)

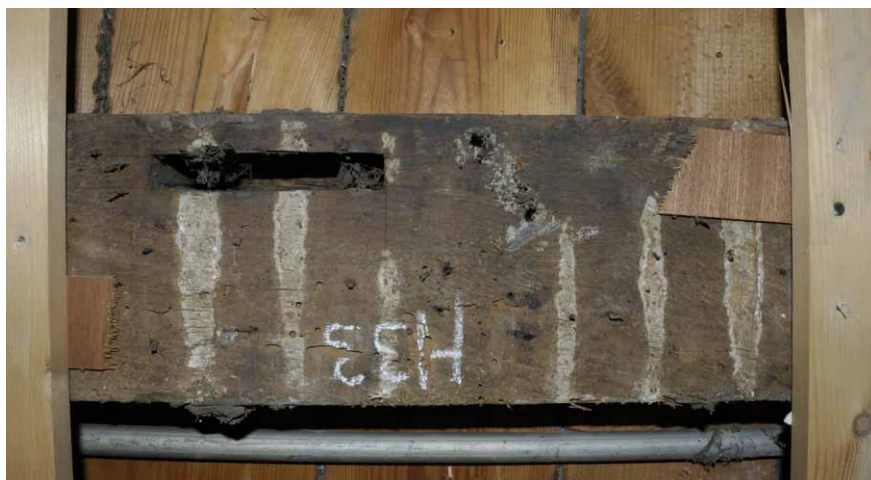
e. Joist H33 showing mortice slot for plank and muntin screen

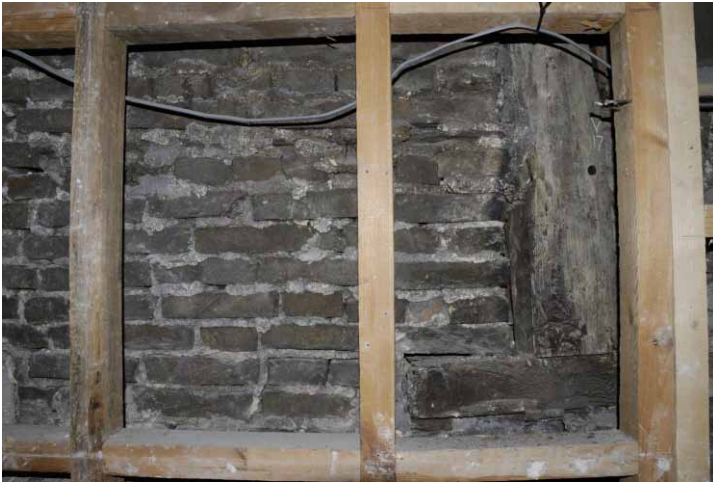
a. Cut-off base of jowl post V17 supported on H47

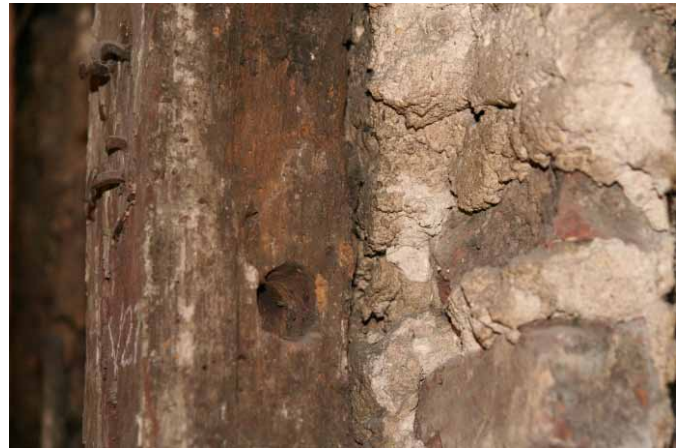
b. Auger hole in V27

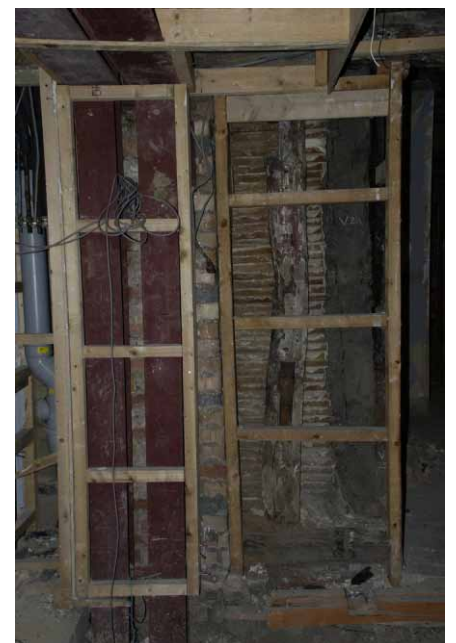
f. Lath and plaster behind V22

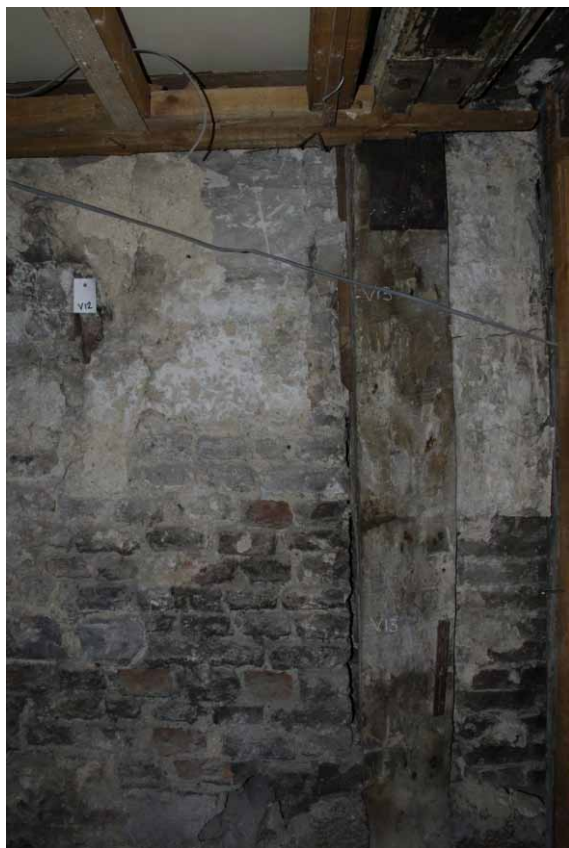
c. Replacement post V13

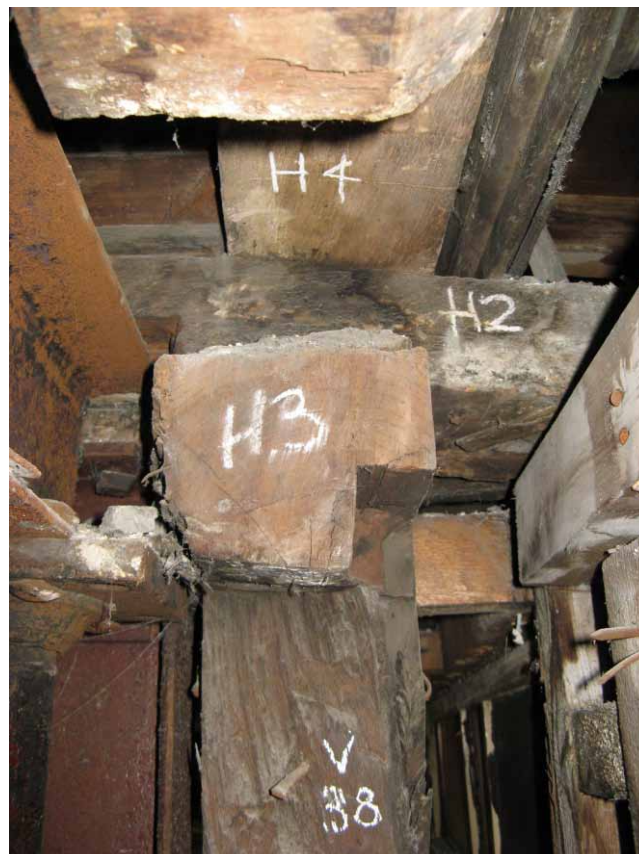
d. Replacement jetty plate H3, jetty joist H5 at top of image, bressumer H4 above

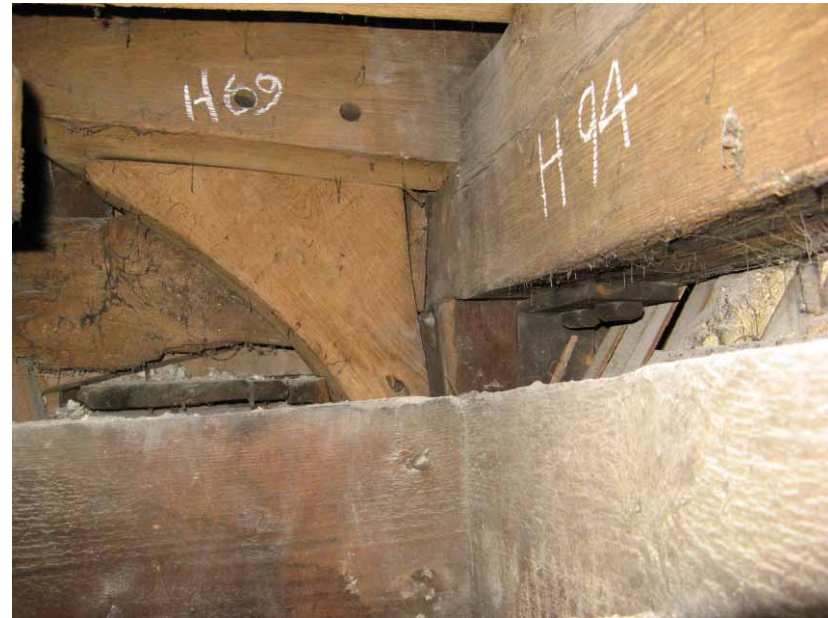
b. Bracket H68, jetty plate H94 and jetty joist H69. Note clean state of timber in images a and b

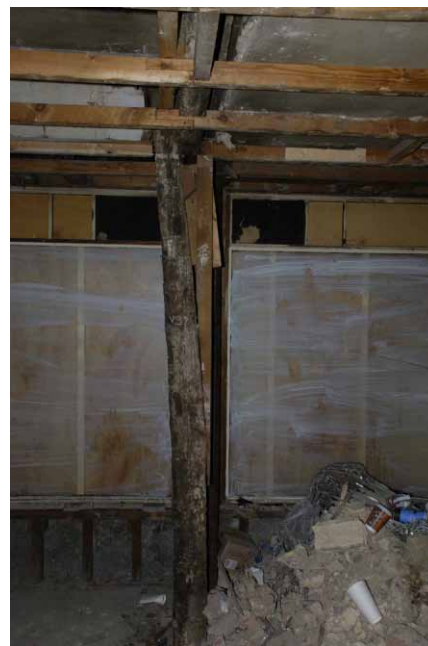
The front part of No. 4 has a jetty front with surviving jetty plate **H94**, supported on a badly cut up post **V37**. This post had a long mortice slot on its north side that originally held a brace. There is, however, no corresponding slot on the underside of the jetty plate **H94**, indicating that these timbers are not contemporary. The jetty consists of jetty plate **H94**, jetty joists **H69**, **H70**, **H71**, **H72**, **H73**, **H74**, **H75**, **H76**, **H77** and **H78** and bressumer **H96**. Between the southernmost joist **H69** and post **V37** is jetty bracket **H68**, the joint between bracket and post being rather poorly made, the bracket of clean cream coloured oak, the post of brown oak. All the jetty timbers are of the cream coloured oak and are very clean in appearance. Other than for some insect damage to the top of the jetty plate and that the west side was dirty, the timbers could have been erected yesterday. The clean state indicates that they were protected in a clean void since they were fitted as exposure to the elements would have changed the colour of the wood within a month. The clean surfaces of the wood were hewn and sawn but not finished, suggesting that they were never intended to be visible. The jetty joists were sawn sections of large trees rather than boxed heart. There was a mortice hole in the jetty plate **H94** below joist **H73** with a sawn off tenon *in situ*. This tenon was broken and not simply a packing piece being used to fill an unused or redundant mortice hole. The tenon was the same cream colour as the other pieces of this structure. The purpose is unknown. Rising from the bressumer two studs (unnumbered) form the timber-framed front of the building. This part of the structure was visible only with difficulty and no measurements were possible. Photographs taken through a small gap revealed a lath and plaster wall in front of, but separate from, the timber frame. A later timber, **H79**, runs in front of **H96**. Touches the nose of **H76** butt ends c. 120mm in front of the nose of **H69**. This is part of the later shop conversion.

d. Post V37

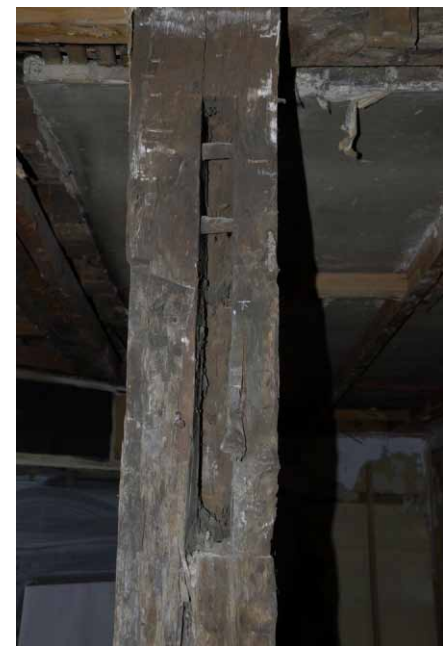
e. Slot for brace on north side of V37

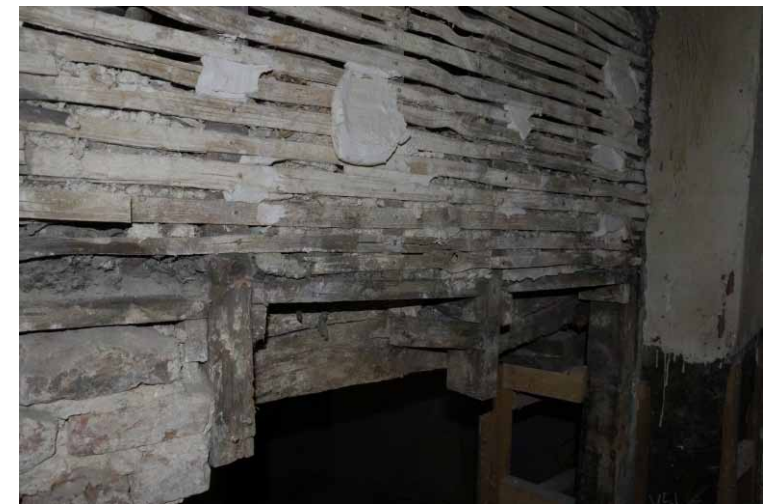
e. Stud of No. 4 wall nailed to frame of No. 5

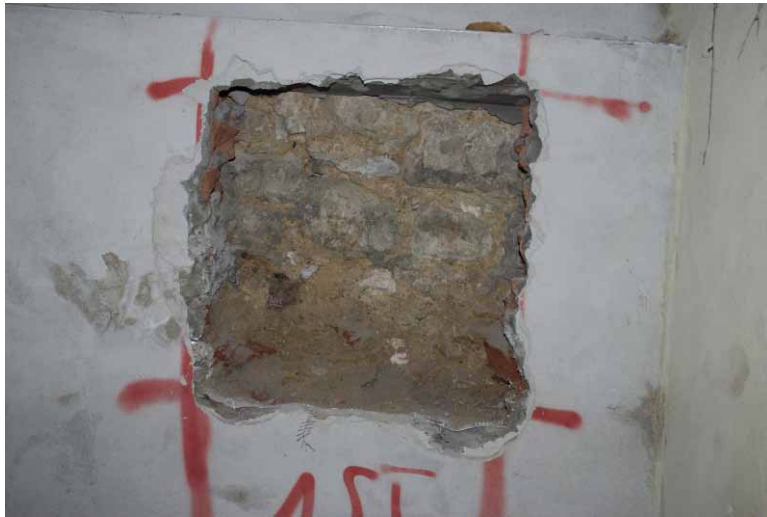
Clunch and mortar wall visible behind modern brick skin.

a. Clunch walling in II below No. 5

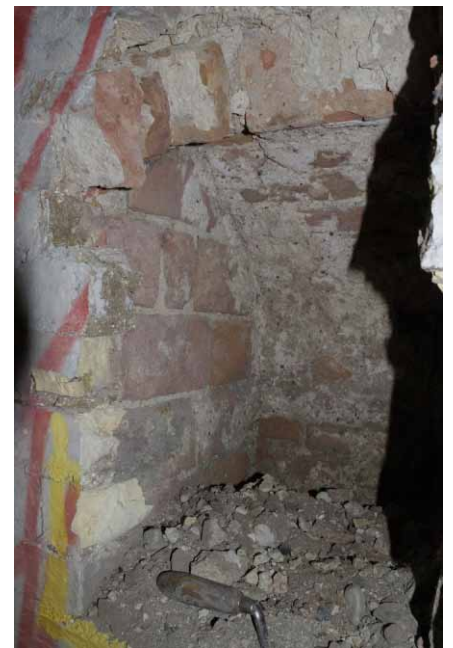
In the rear part of the No. 4 cellar was a curious brick built structure, arching forwards (southwards) into the room. The southern edge was lost in the modern brick cellar wall, but the original structure would have been approximately 0.70m wide based on the angle of the arch. The arched part of the structure was constructed from red brick measuring $2\frac{1}{8} \times 4\frac{1}{2} \times 2\frac{1}{8}$ inches. The west end was blocked with a section of dusky pink bricks measuring $4\frac{3}{4} \times 1\frac{7}{8} \times 9\frac{1}{4}$ inches. Initially though to perhaps be an oven there is no trace of burning on the bricks, at present the purpose is not known.

c. Brick structure
