## **Saint Peter's Church, Stetchworth** **Observations on the roof during internal repairs** **October 2014**

June 2015  
Report No. 1294  
HER No. ECB4504

## **Introduction**

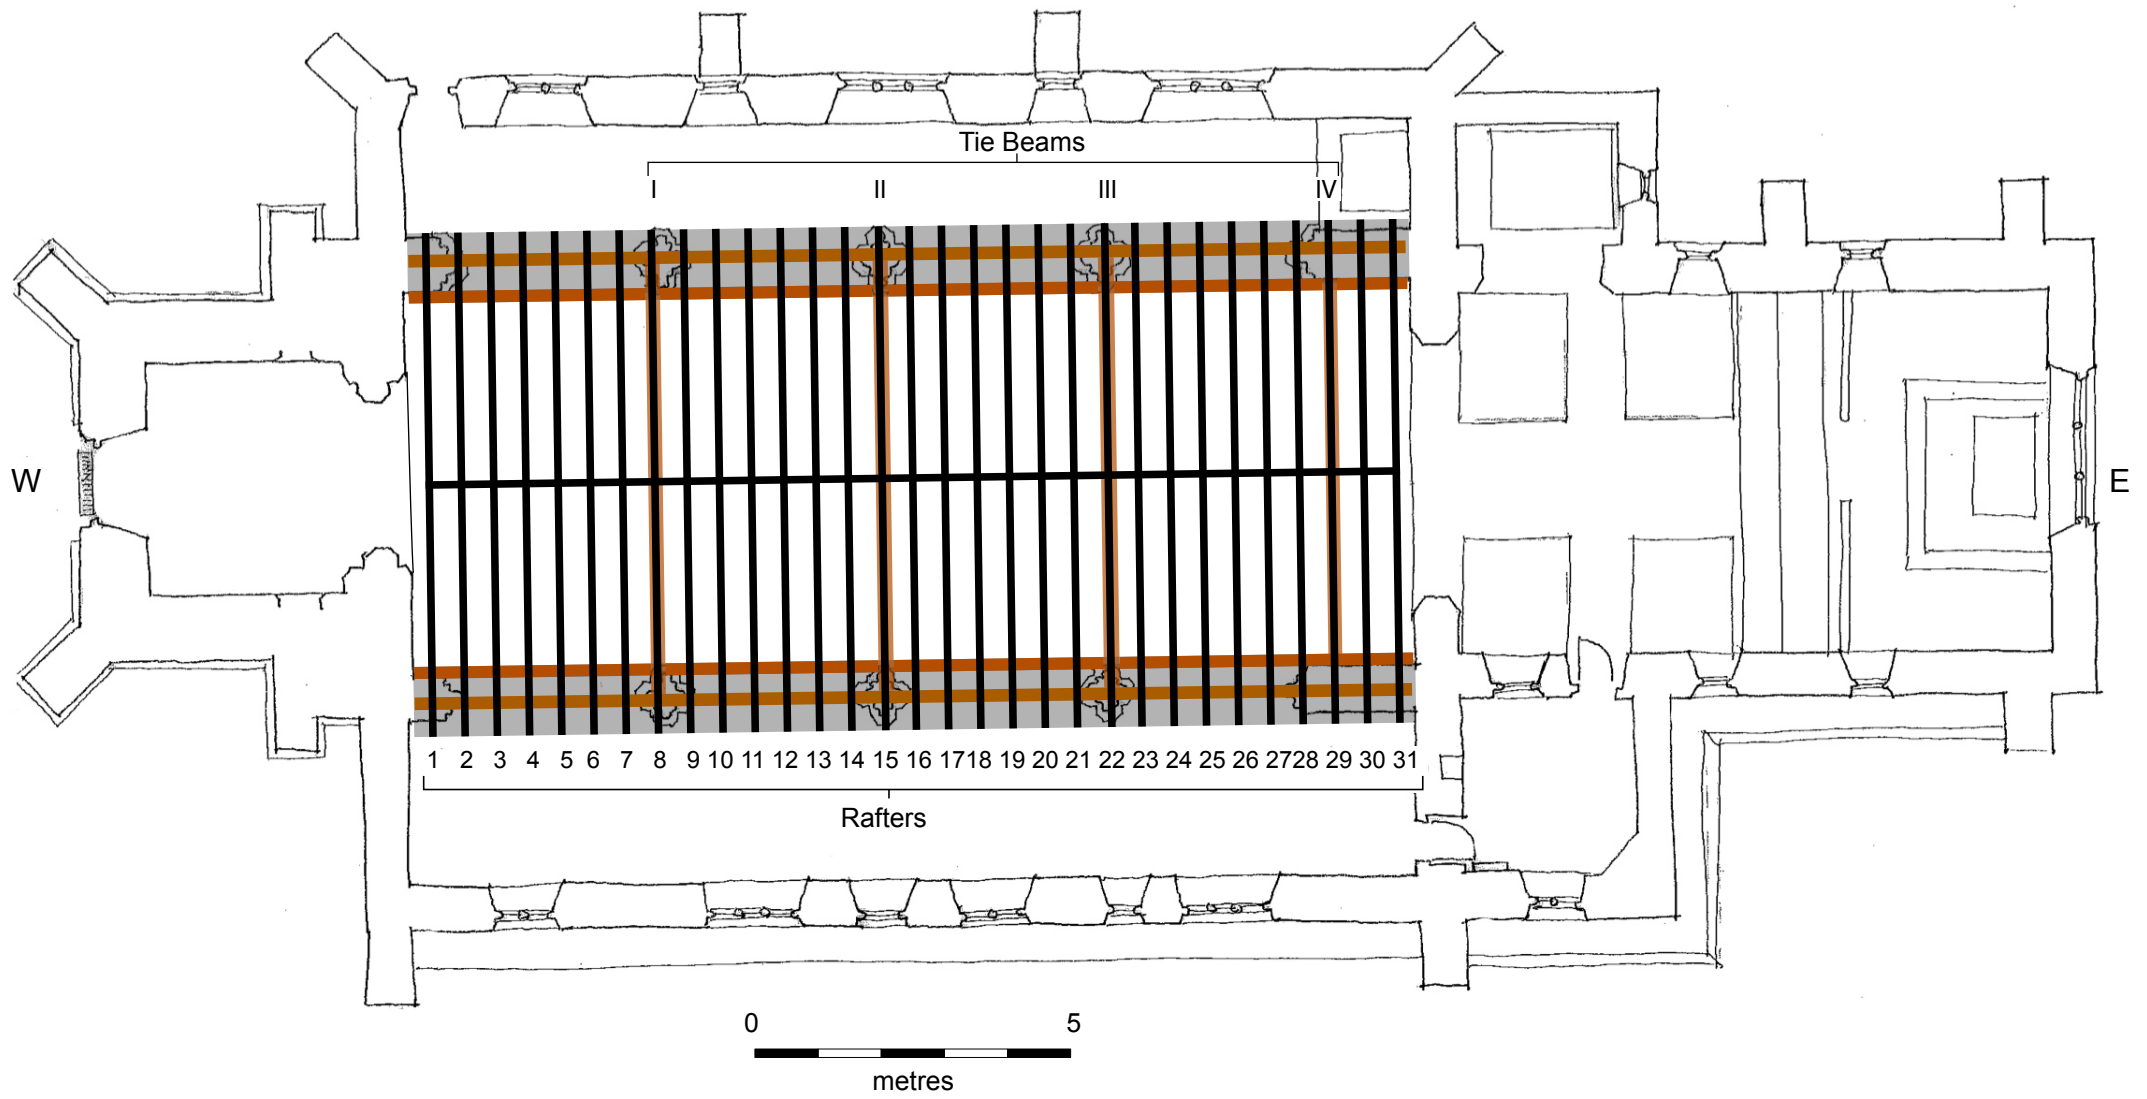
Figure 2: Plan of Existing Roof Structure

For ease of reference the elements of the roof have been numbered from west to east, Tie Beams I – IV, rafters 1 – 31 (figure 2).

There are four tie beams in the roof, located beneath rafters 8, 15, 22 and 29. Tie beams I and II appear largely intact; however III has seen significant damage to its upper face. Tie beam IV, whilst retaining its original lower moulded part has had the top replaced with a saw cut squared timber broadly similar in appearance to the 1894 roof timbers.

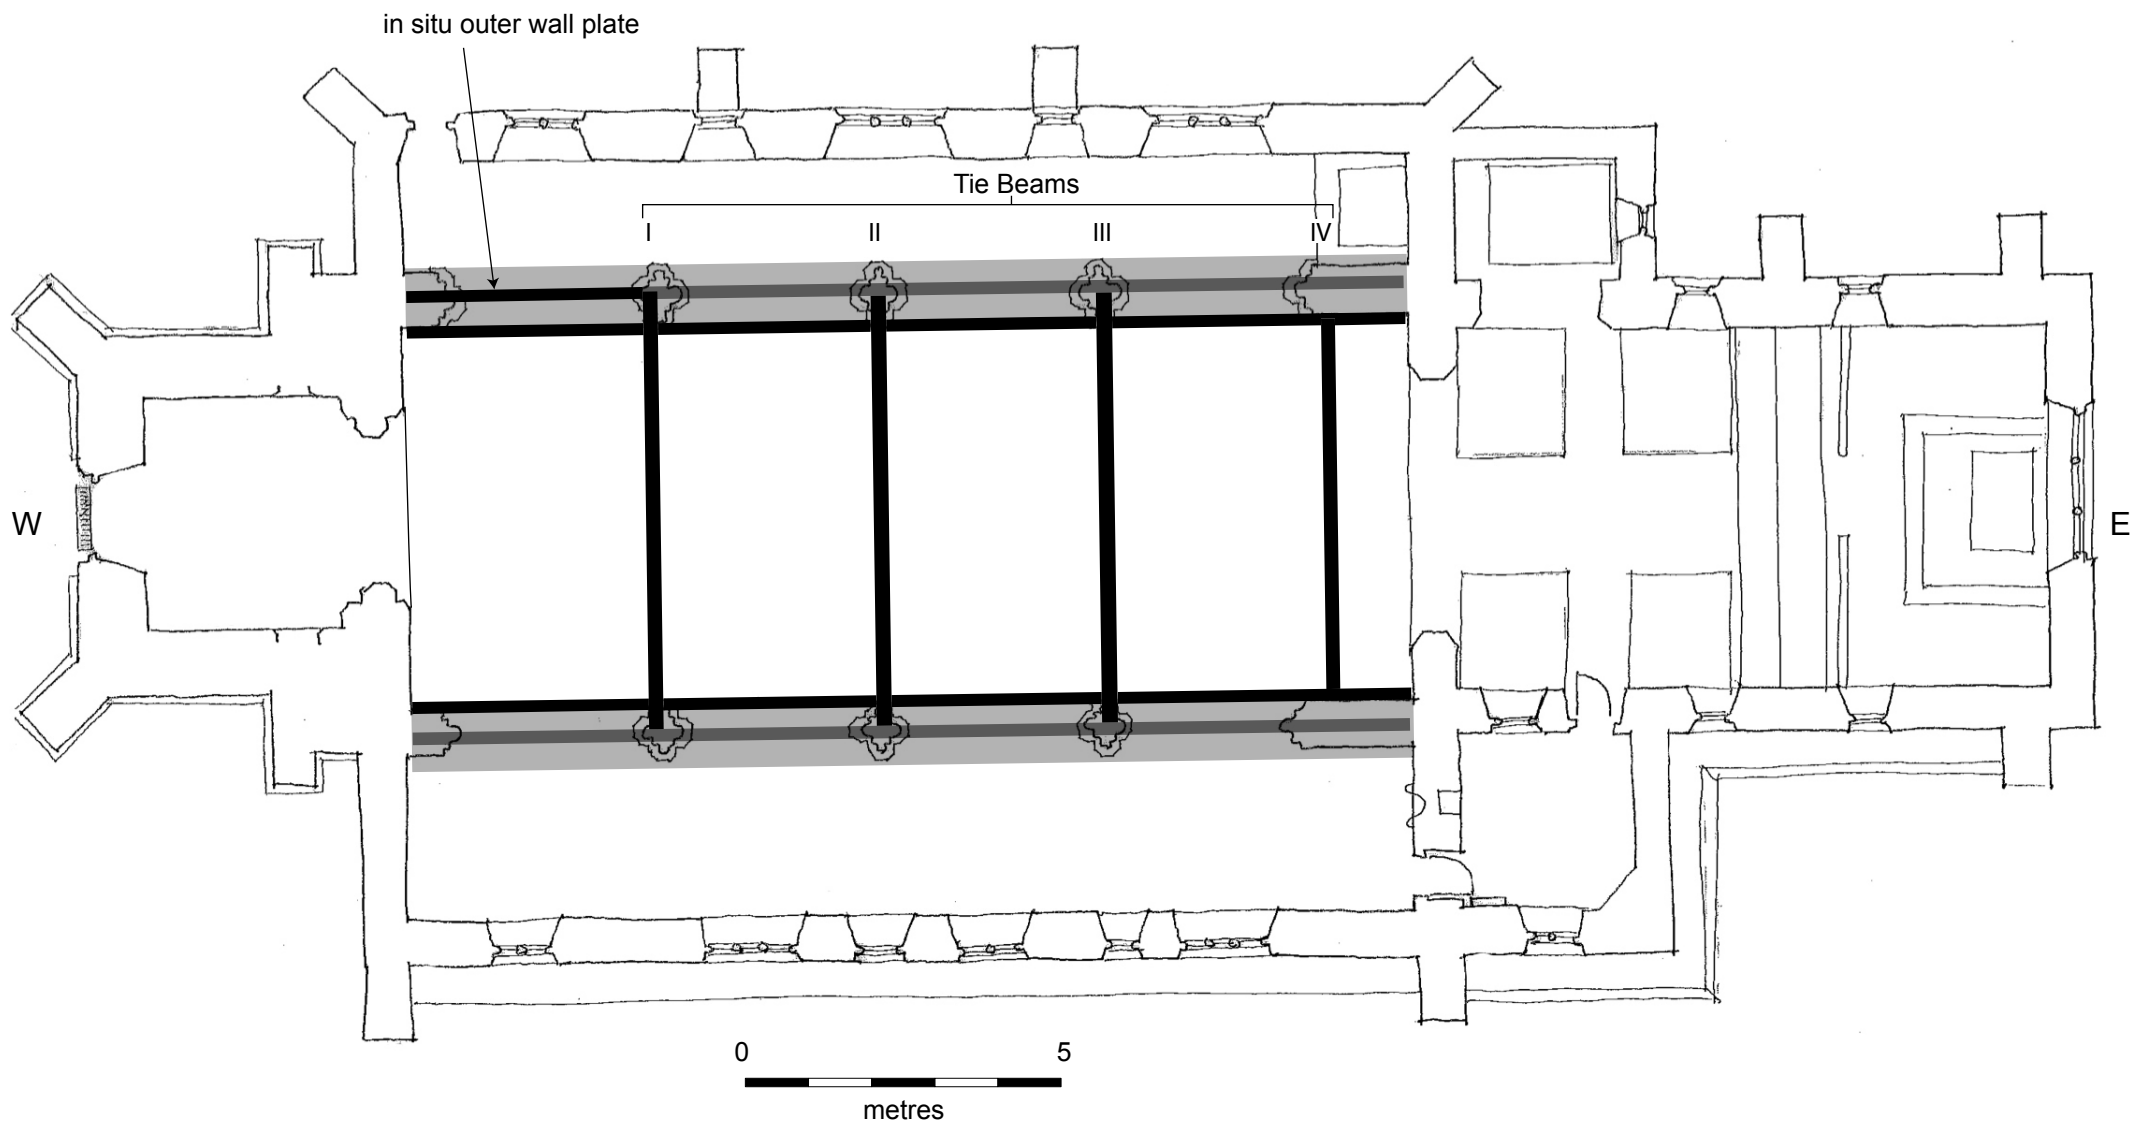
Figure 3: Surviving Elements of Older Roof Structure

Although the main roof structure is late, it incorporates several much older elements. Principal amongst these are all of three and part of one of the four tie beams and their associated wall posts, the inner wall plate and a section of outer wall plate (figure 3).

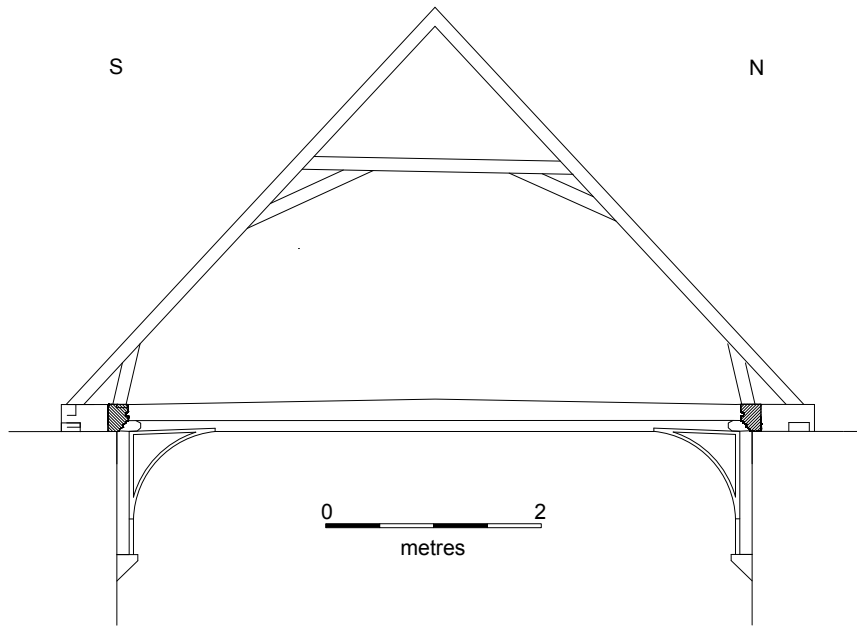
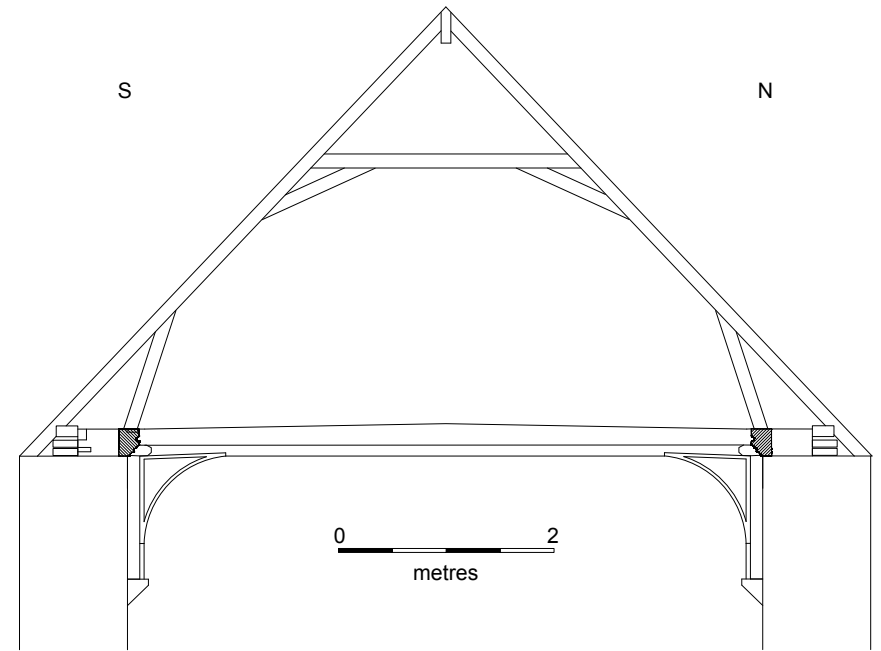
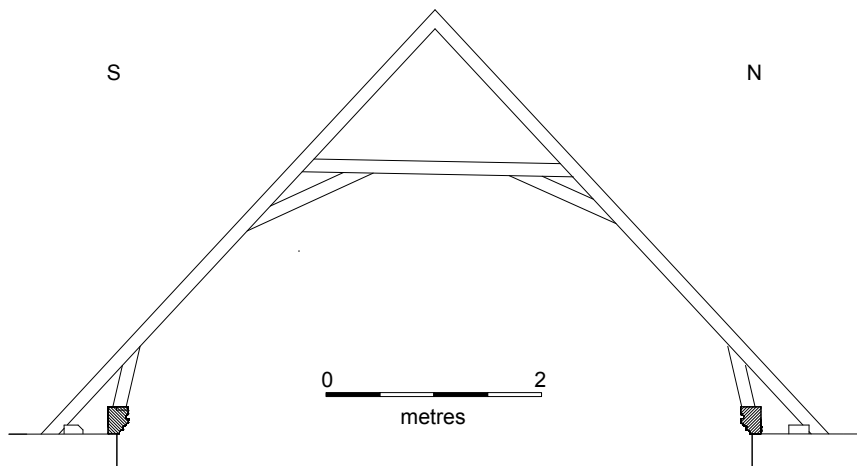
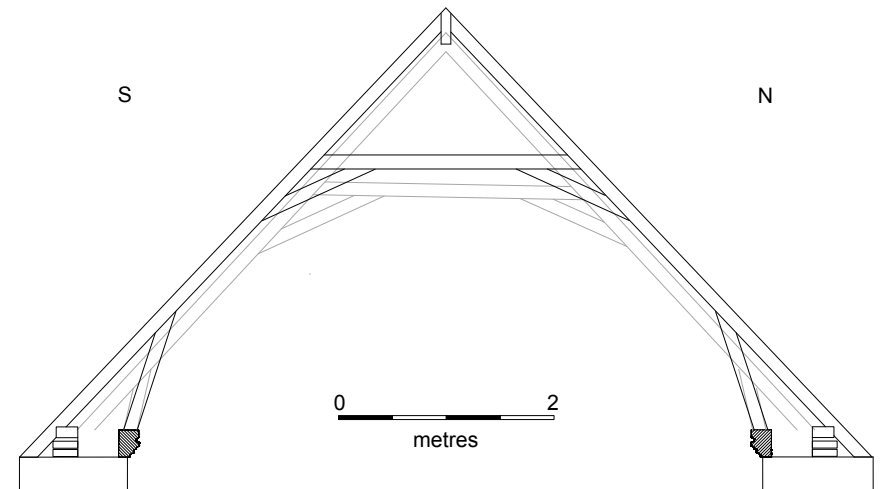
Figure 4: Existing and Reconstructed Roof Structure

The roof structure consists of 31 pairs of trussed common rafters, each pair with a collar and four struts (figure 4). The lower struts rest on an inner wall plate, the ends of the common rafters appear to rest directly on the top of the nave wall (there is no sole plate), but have a birds mouth notch to fit over an outer wall plate consisting of two courses of brick and a wooden plate, set 380 – 450mm from the back of the front one. The timber of the main construction (common rafters, collar and struts) is saw cut and uniformly 120mm wide and belongs to the reported rebuild of 1894.

At each end of the nave, but rather clearer at the west end on the tower wall, are “ghosts” of the line of the earlier roof (figure 11). These both indicate that the earlier roof was pitched just a little lower than the replacement and that the seven-sided tunnel effect sat a little lower on the wall. It proved possible to take measurements of both length and angle on some of these ghosts, which have been used together with information from the other *in situ* timbers to recreate the trusses as shown in figure 4.

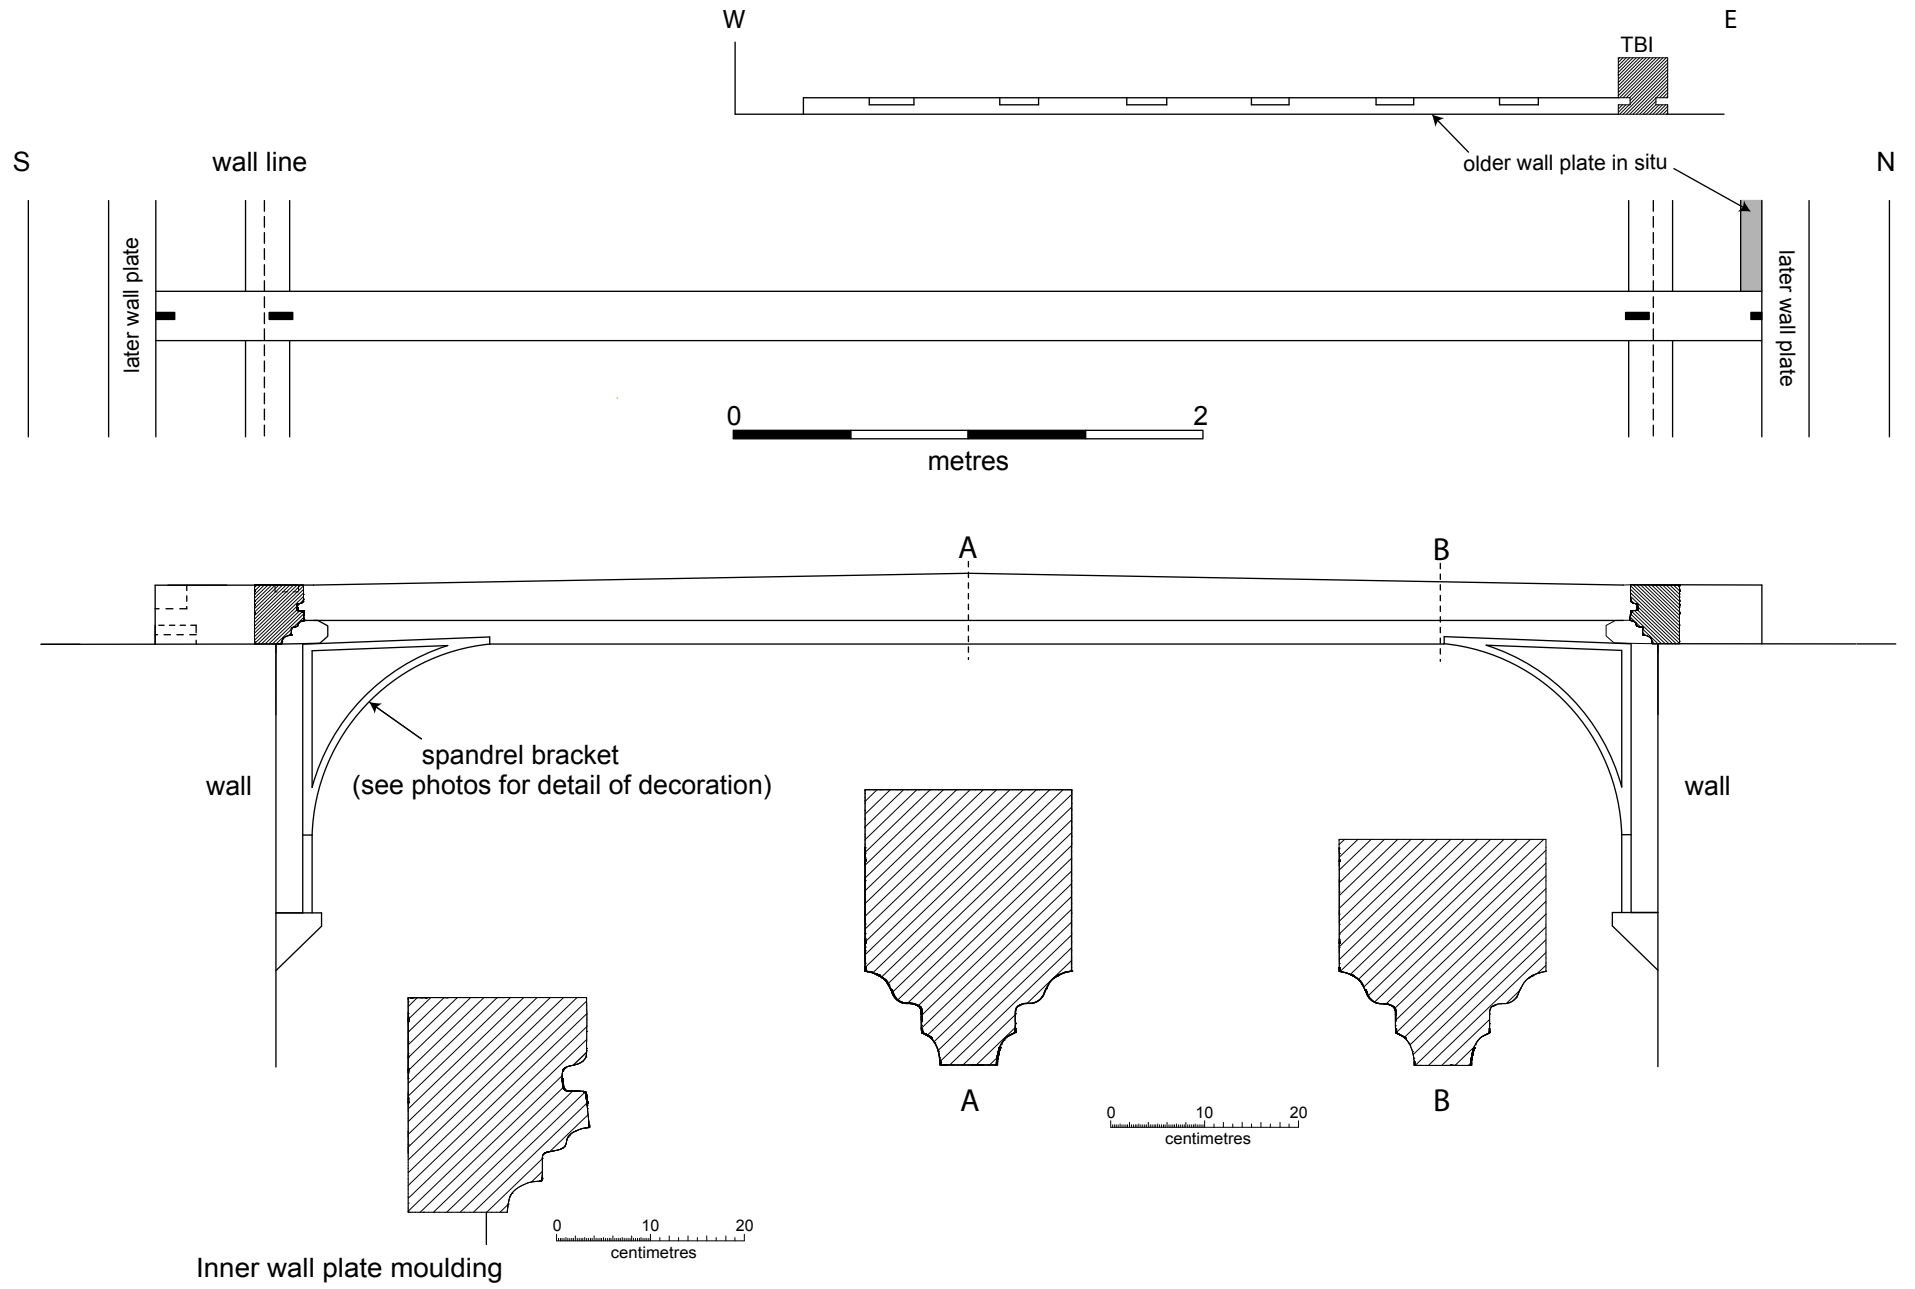
Figure 5: Tie Beam I and Wall Plates with details

Tie Beams I, II and III have been cut short to accommodate the later outer wall plate. It was observed that at both ends of Tie Beams I and III and at the south end of Tie Beam II this had cut through a mortice in the upper face of the beam (figure 5). The lower struts of rafter pairs 8, 15 and 22 make use of a second mortice in the top of the beams, c. 400mm inside the outer one. The outer mortice indicates the position of the common rafters in the earlier roof. There is no evidence that any of the tie beams supported a central pillar as seen in some roofs of the type.

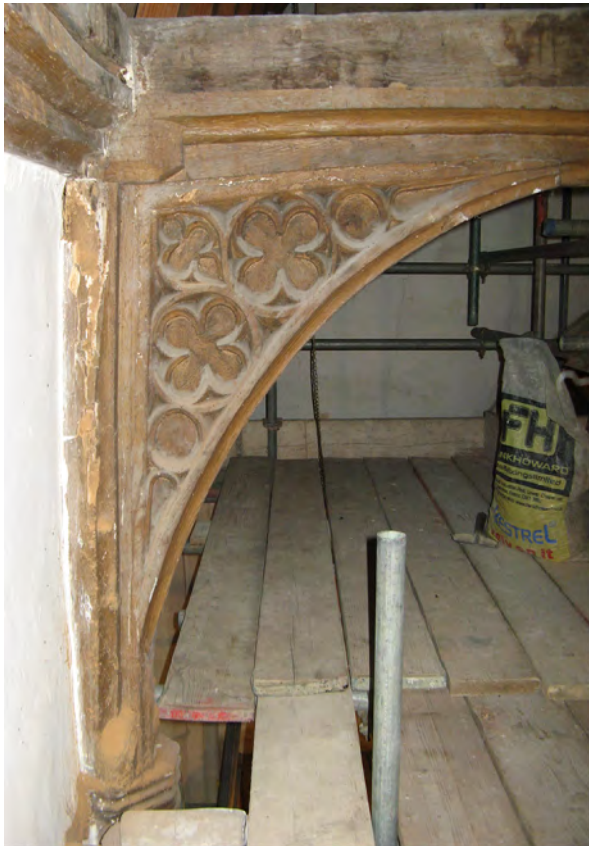
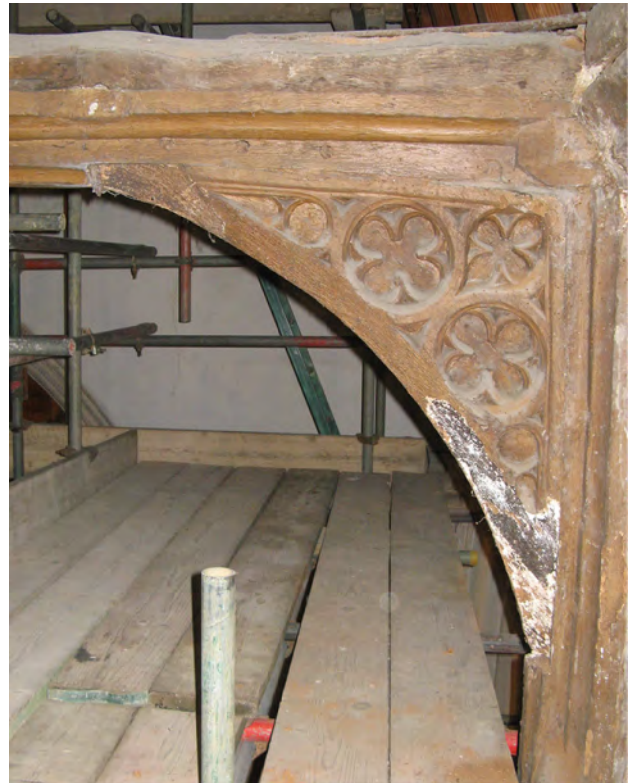
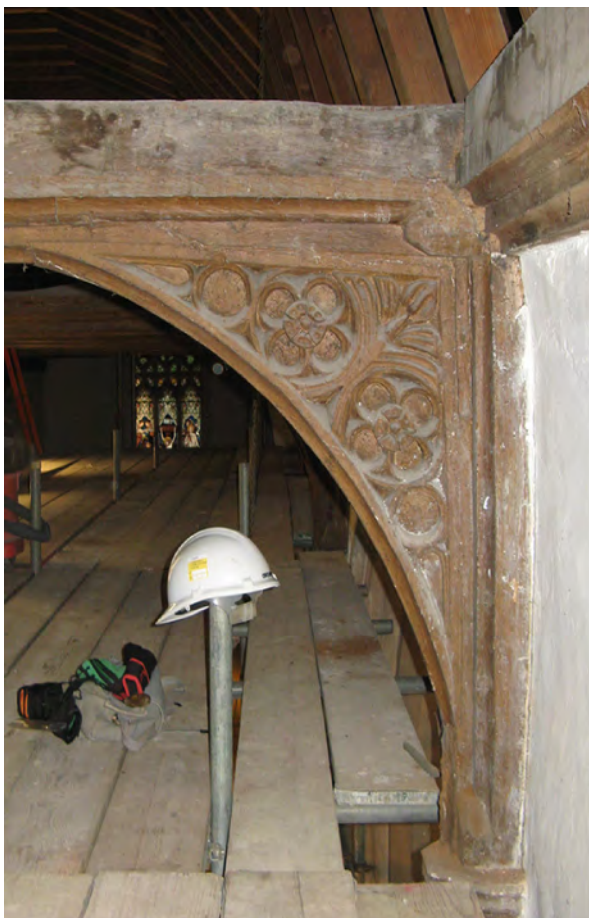
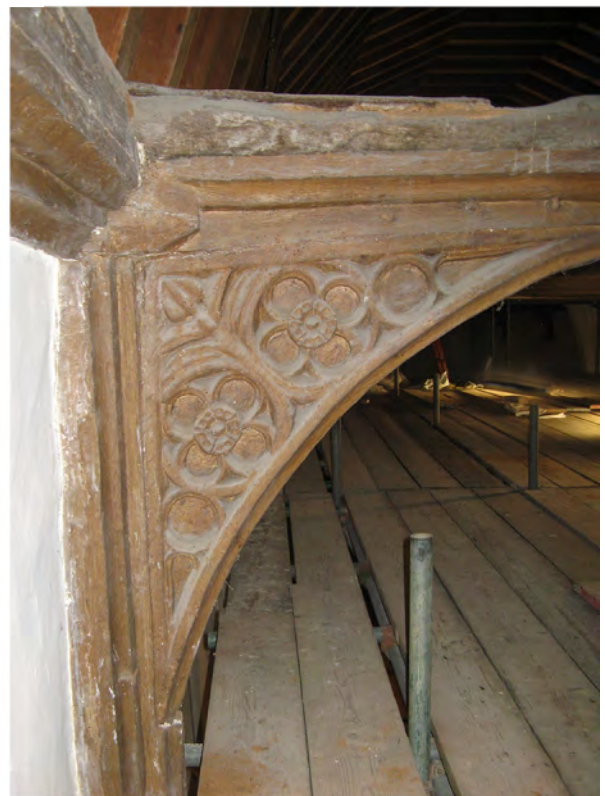
Figure 6: Tie Beam I Spandrel Bracket Decoration Details

TBI – east face - north and south ends match (design 1); west face - north and south ends match (design 2) (i.e. the front and back of each spandrel has a different design).

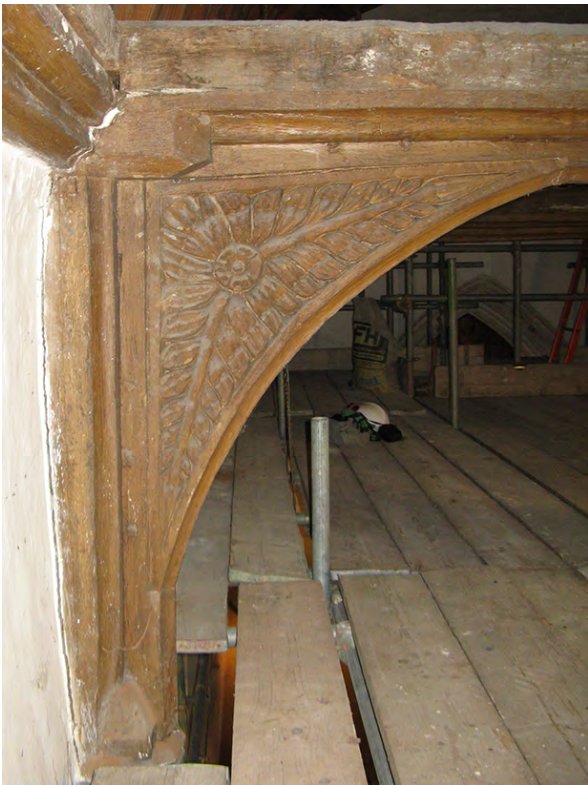
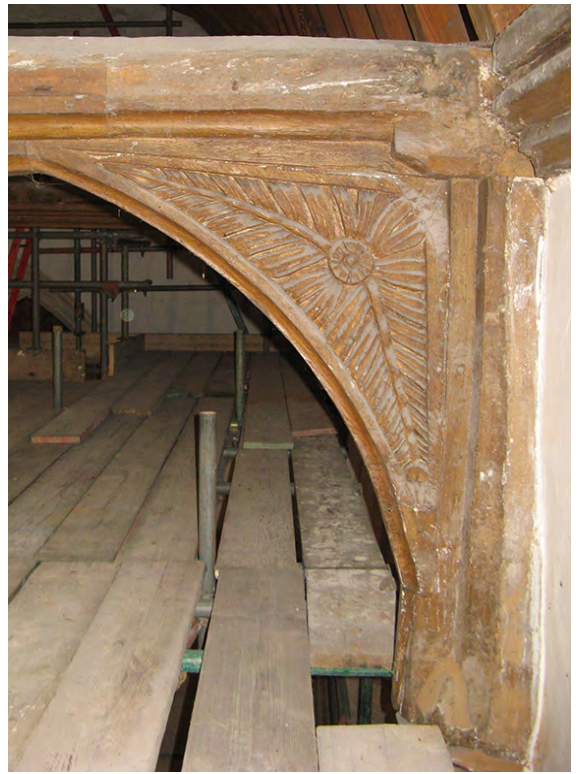
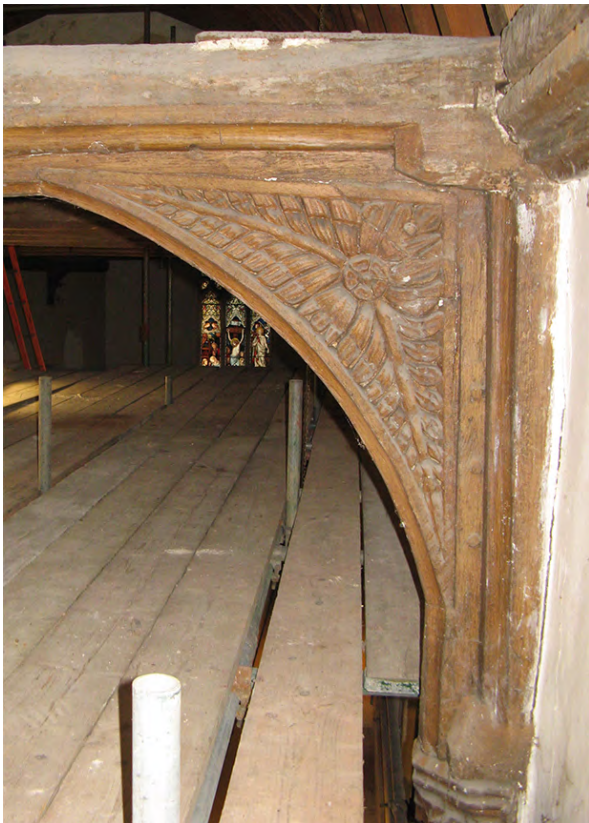
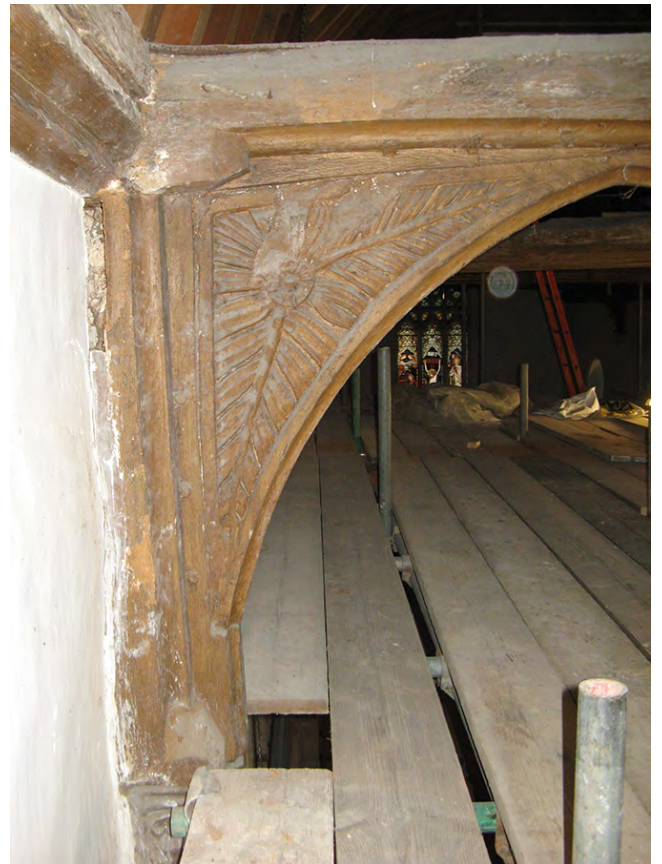
Figure 7: Tie Beam II Spandrel Bracket Decoration Details

TBII – all spandrel brackets the same (design 3)

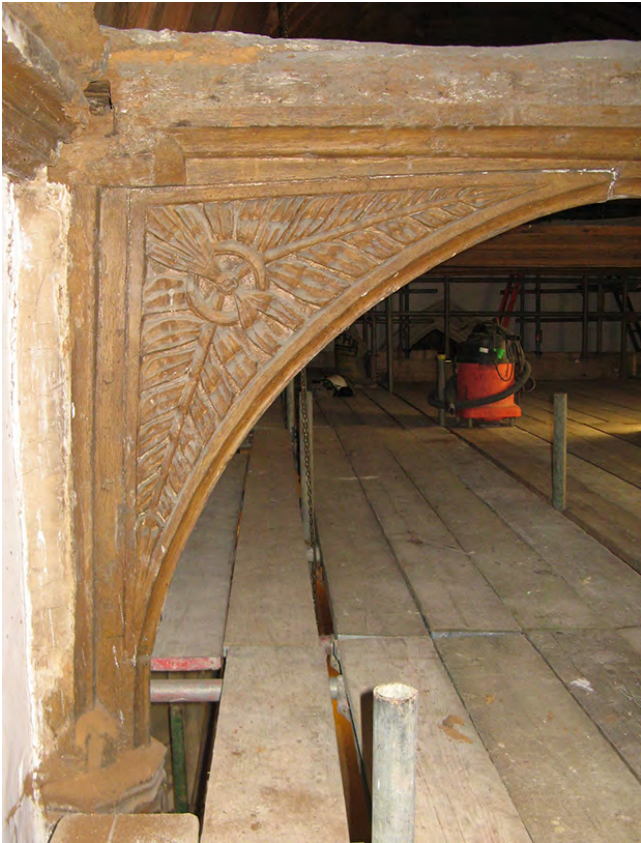
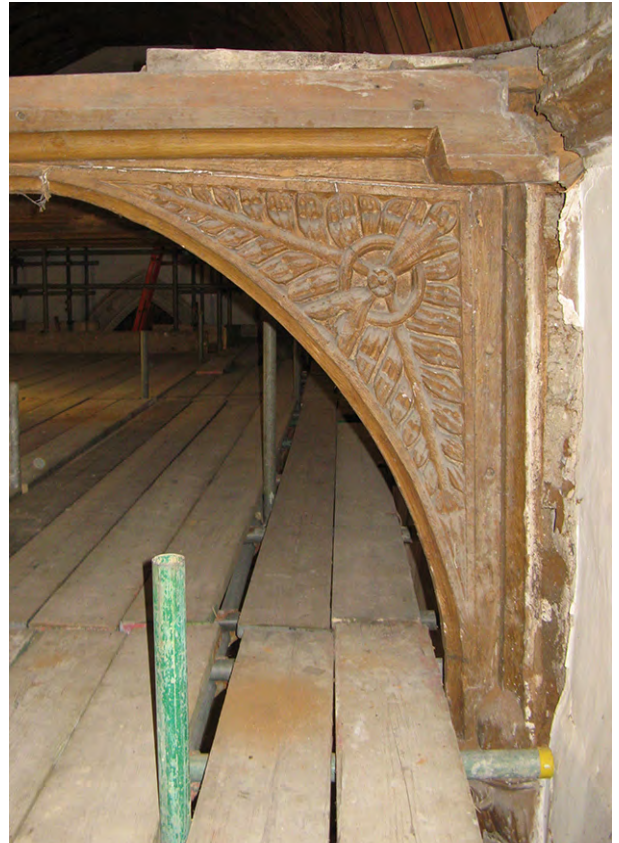
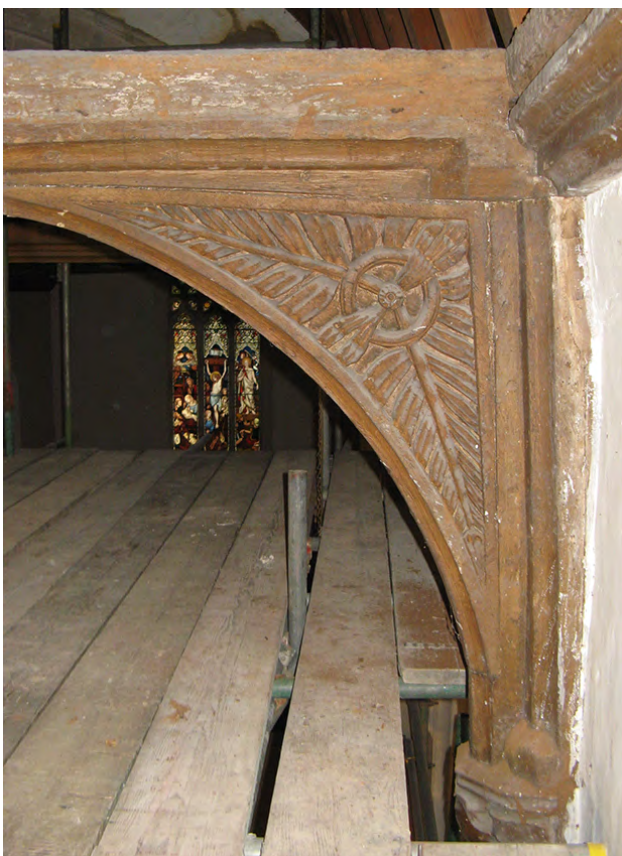
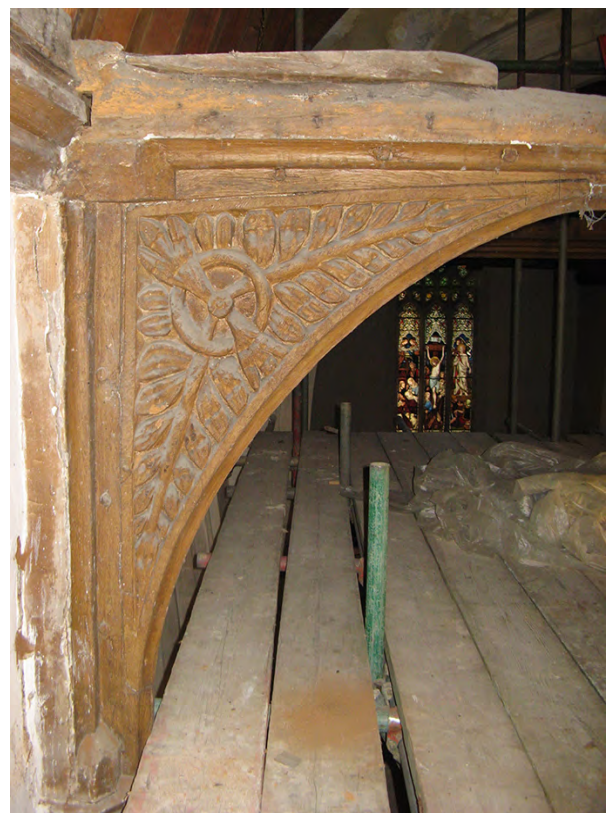
Figure 8: Tie Beam III Spandrel Bracket Decoration Details

TBIII - all spandrel brackets the same (design 3)

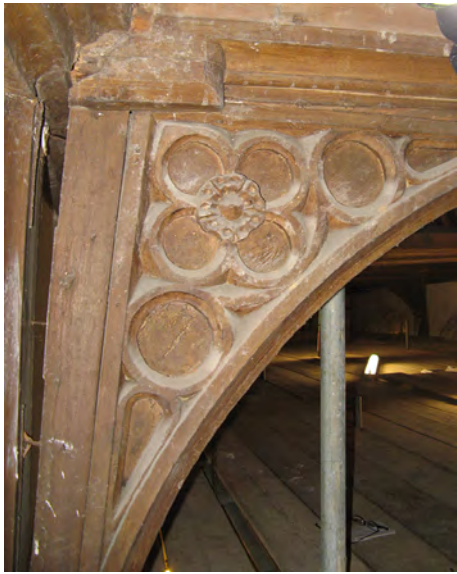
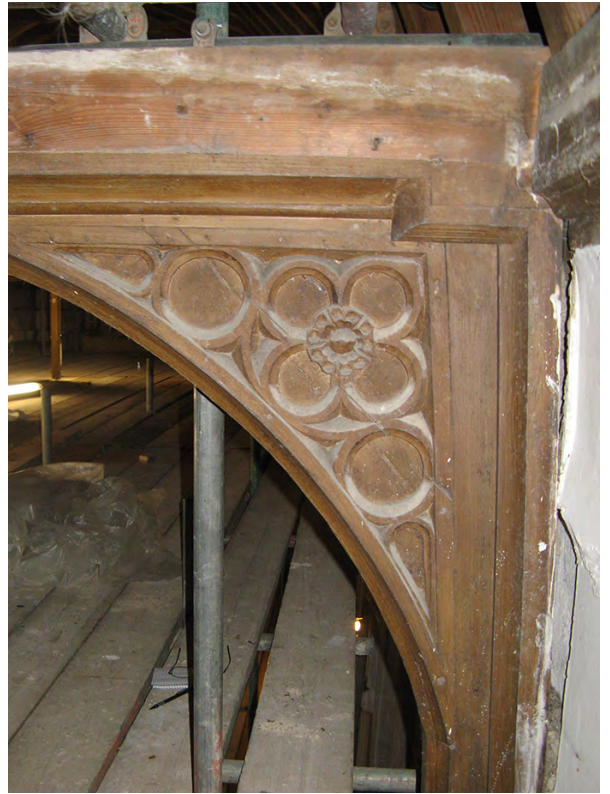
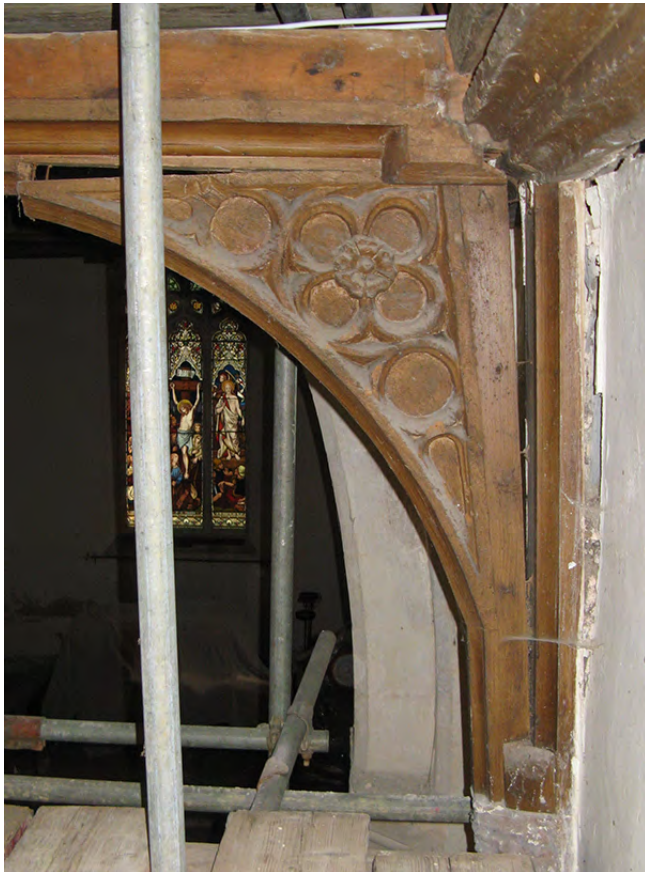
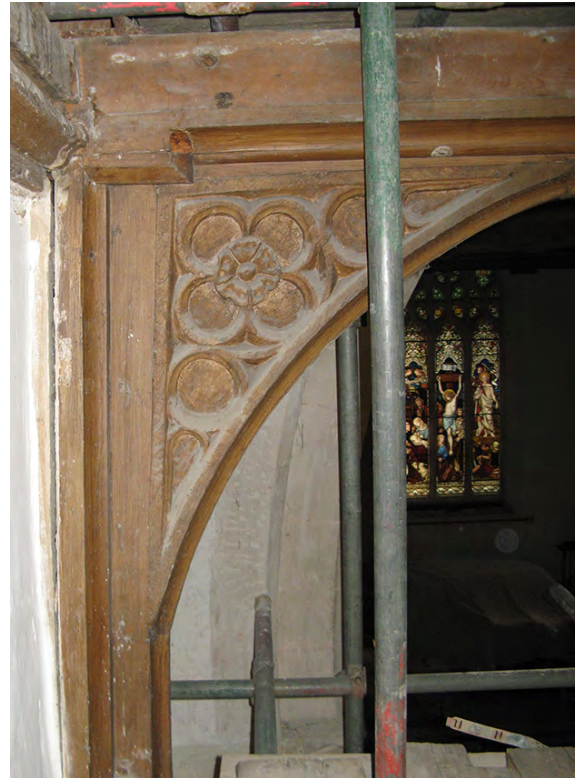
Figure 9: Tie Beam IV Spandrel Bracket Decoration Details

TBIV - all spandrel brackets the same (design 4)

The spandrel brackets are a single piece of shaped timber (100mm thick, 810mm high, 796mm long) fitted into a slot cut into the lower moulding on the tie beam and into the shaped front of the short wall posts (1.14m long), themselves resting on carved corbels below. At the south end of TBIV, where the bracket has pulled away slightly, iron nails have been inserted in an effort to keep the brace in place. These are remedial rather than original components.

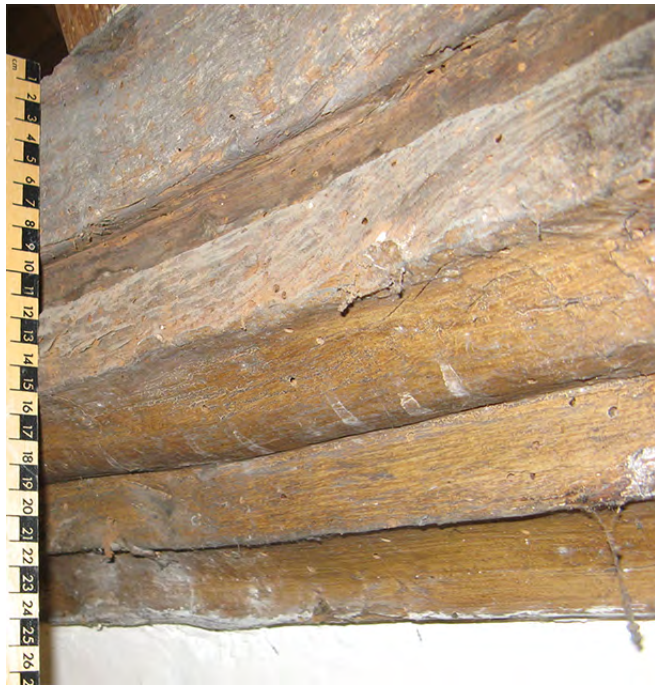
The front face of the plate has a moulded decoration (figures 5, 10) and extends 110mm forward from the wall face. The timber is 250mm high and a maximum 190mm deep. Where the inner wall plate meets Tie Beams I, II and III it is tenoned into mortices cut in either side of the beams. As noted above at Tie Beam IV it continues beyond the beam with a notch cut in to receive the end of the tie beam.

(a) Inner wall plate moulding detail

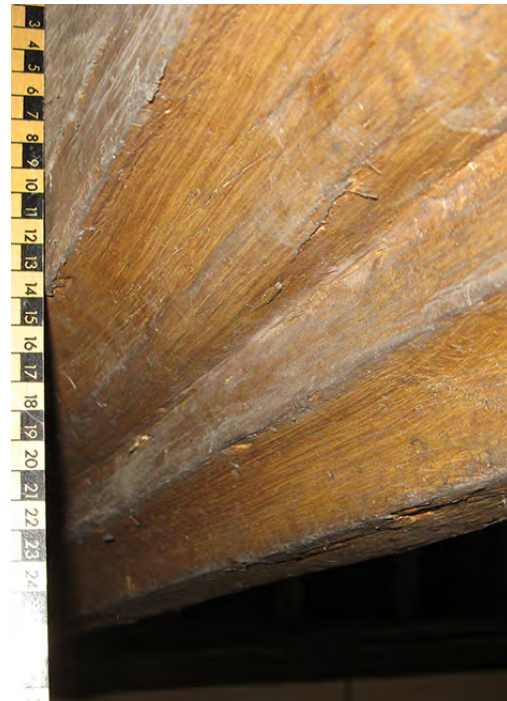
The lower edge of each tie beam (including IV, of which only the upper part has been replaced) has a moulded decoration extending for the entire length (figures 5, 10). At each end is a solid curved brace, effectively an integral brace and spandrel or spandrel bracket. These have carved decoration on both faces as noted below; four distinct designs were noted (figures 6-9).

(b) Tie Beam I moulding detail

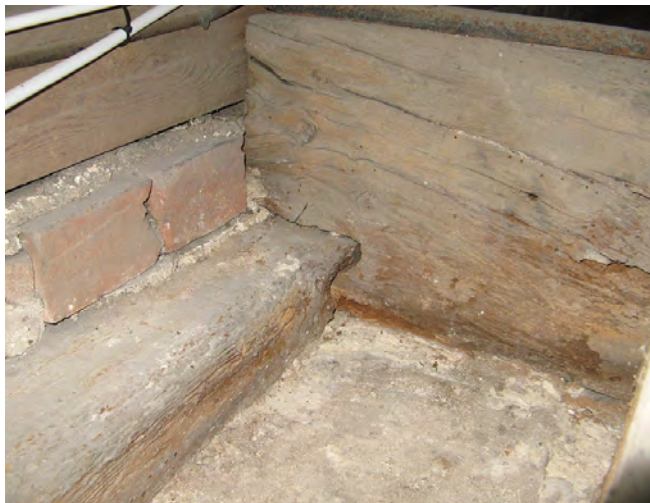
A single section of the original outer wall plate is still *in situ*, although not in use (figures 5, 10). It is located at the west end of the north wall, between Tie Beam I and the tower wall. The plate is tenoned into a mortice on the west side of TBI. There is a matching mortice on the east side but the timber is missing. The present wall plate at this point is made up by a single course of bricks on top of the old plate with a wooden plate on top.

(c) Earlier outer wall plate tenoned to TBI

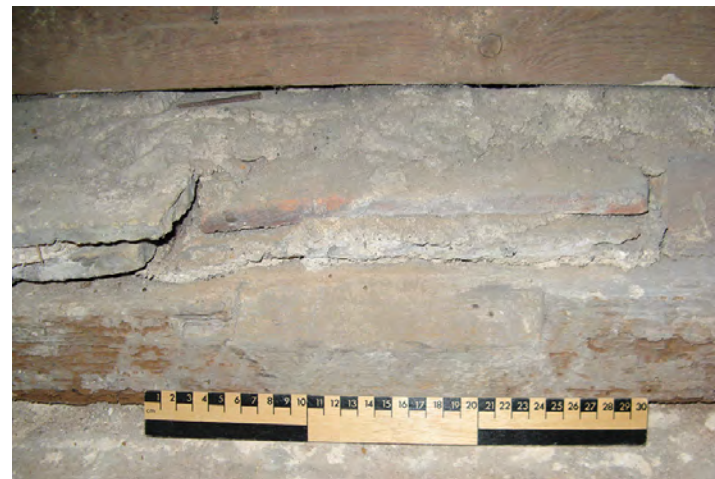
Cut into the front face of the plate are six notches varying in width from 160mm to 190mm and set on centres varying between 540mm and 520mm (compared to the regular 510mm on centres of the 1894 roof). The face of the notches are angled at c. 66°. The wall plate timber is cut slightly shorter than the distance to the end wall leaving sufficient space for a further notch to have been present. This would indicate that the earlier roof, whilst not perhaps as regular as the later, contained the same number of trussed rafters.

(d) Front notch in earlier outer wall plate
