## **Dunbar Town House Dunbar, East Lothian**

### **Phase 2 Internal Building Recording & Archaeological Watching Brief**

**Report No. 1896**

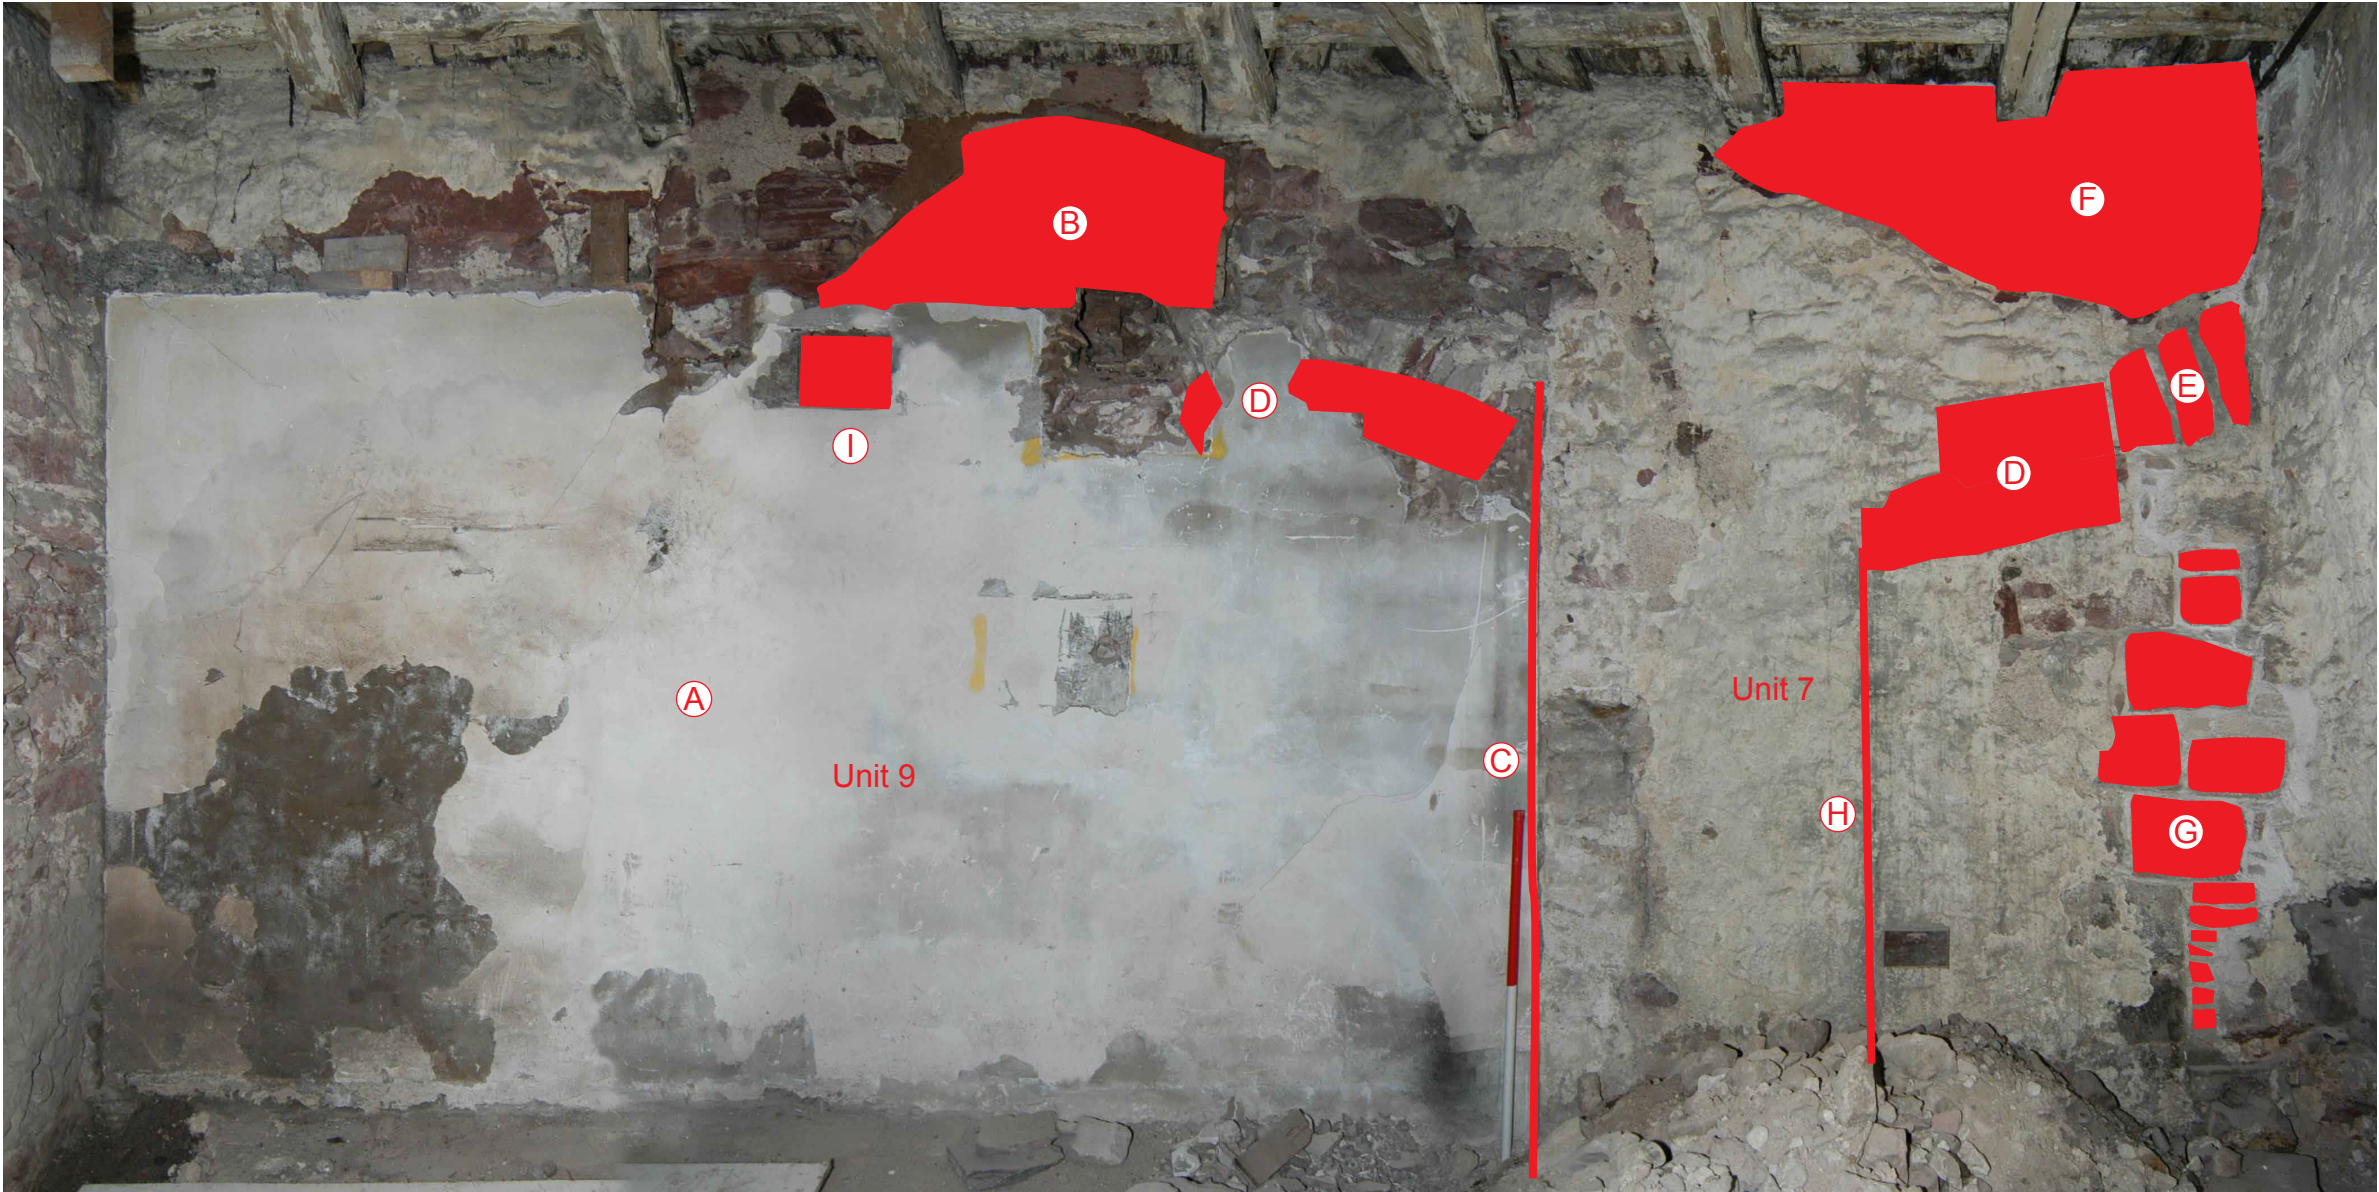
- A. Concrete render formerly lining the 1927 strongroom, 2cm thick

B. Area of brick repair work below the timber floor joists

E. Large blocks of sandstone forming the remains of a relieving arch for a window
- F. Older stonework repairs below the floor joists, red sandstone bonded with lime mortar

G. Modern repair work (post 1927) stugged blocks of cream coloured sandstone bonded with lime mortar

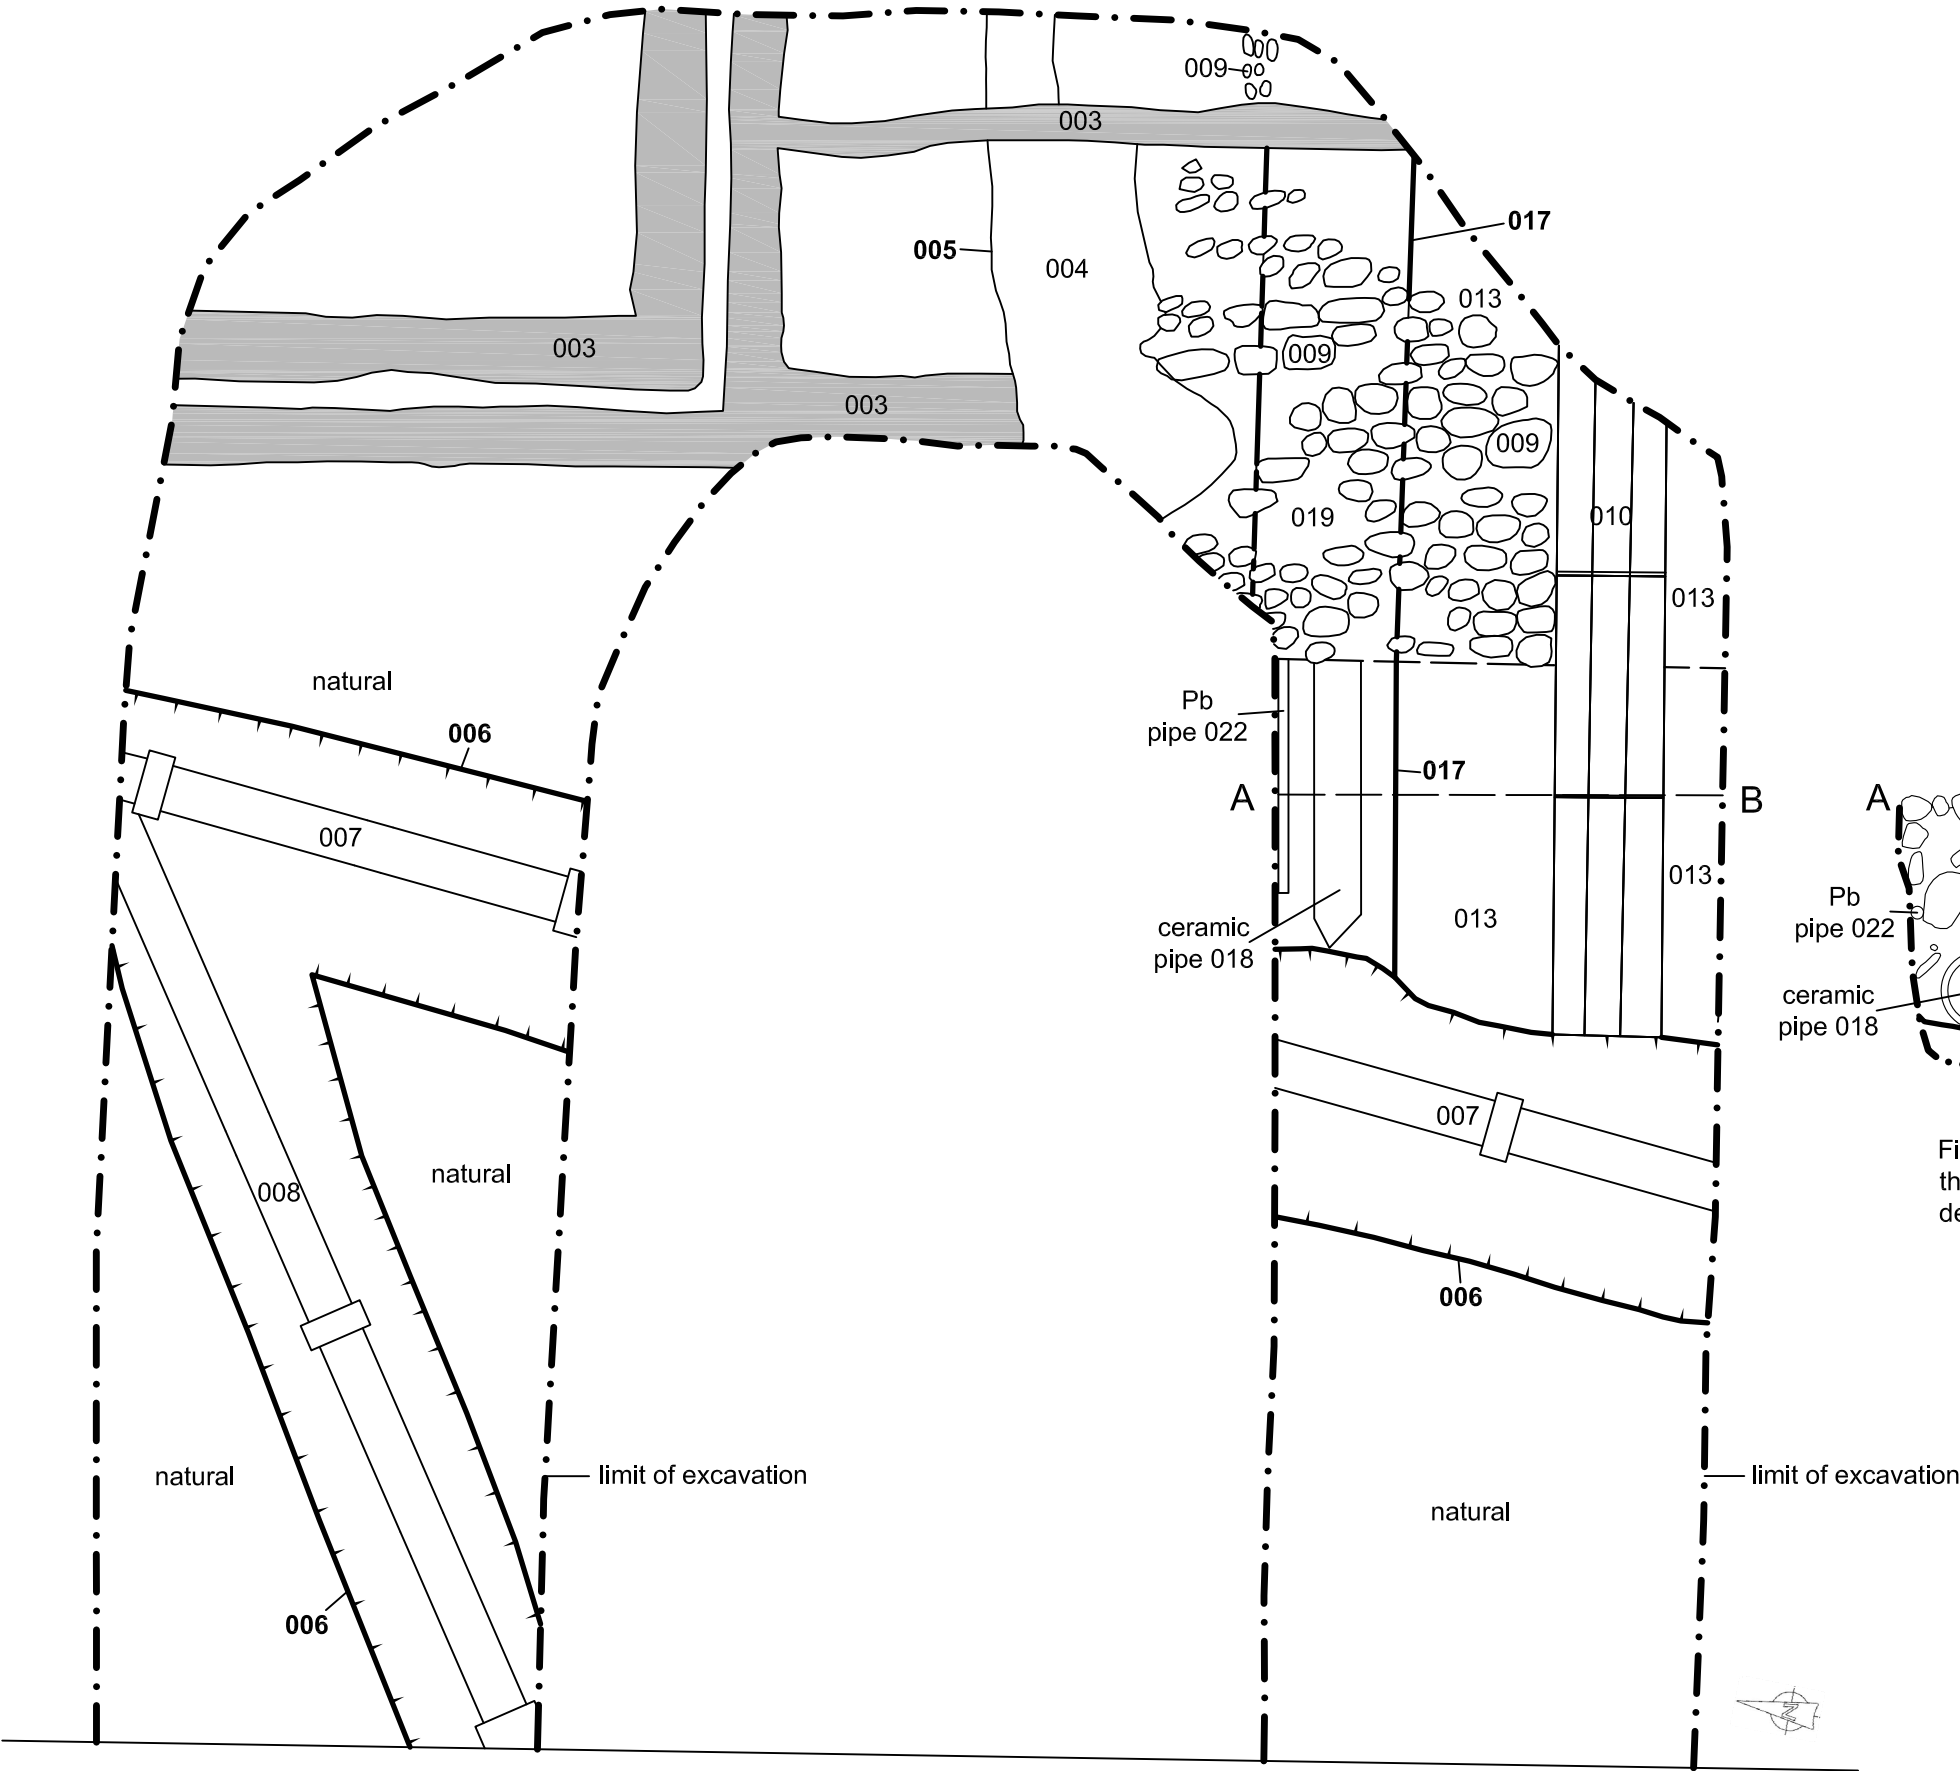
Fig. 9A Plan of the excavated external stair tower foundations

The new external stair tower was situated in the yard area on the east side of the Town House (Fig. 3). The part coffin-shaped footprint of the stair tower measured 4.6m by 4.25m with the foundation trench measuring 1.12m wide (Fig. 10a). A section was dug through the stair tower foundation trench deposits (Section A-B, Fig. 10b).

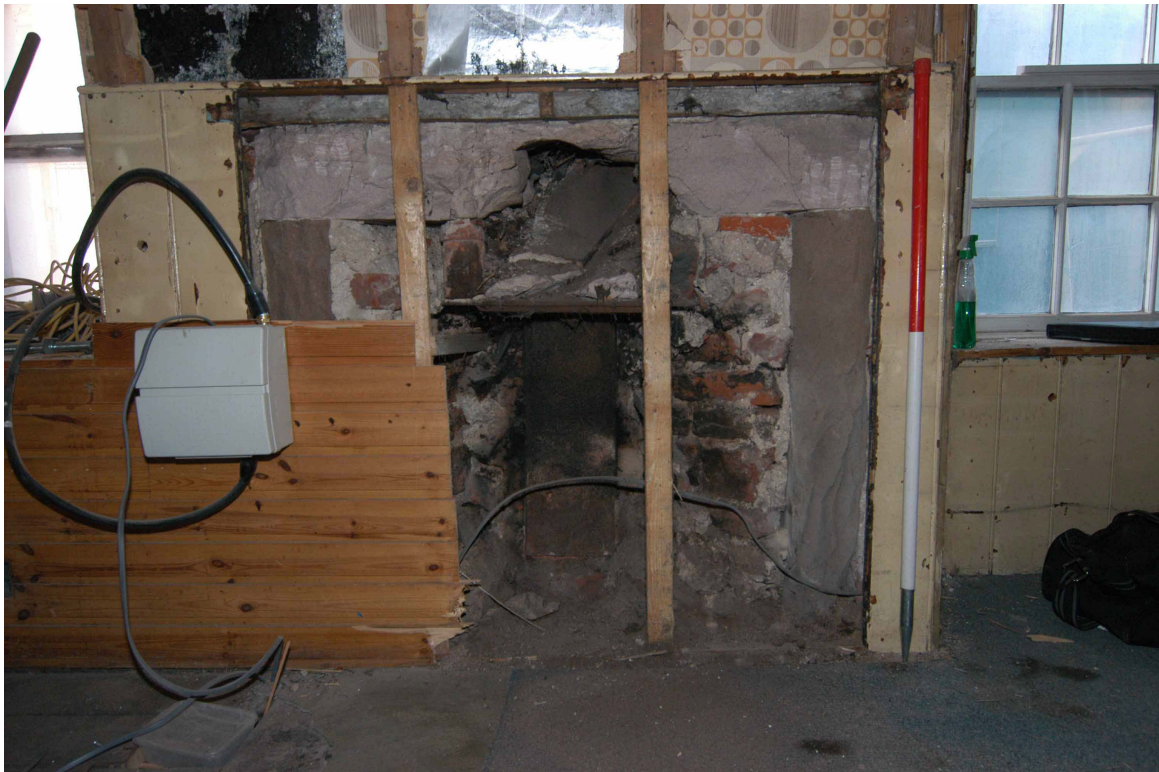
Plate 1. Unit 1, exposed fireplace on the north-facing elevation

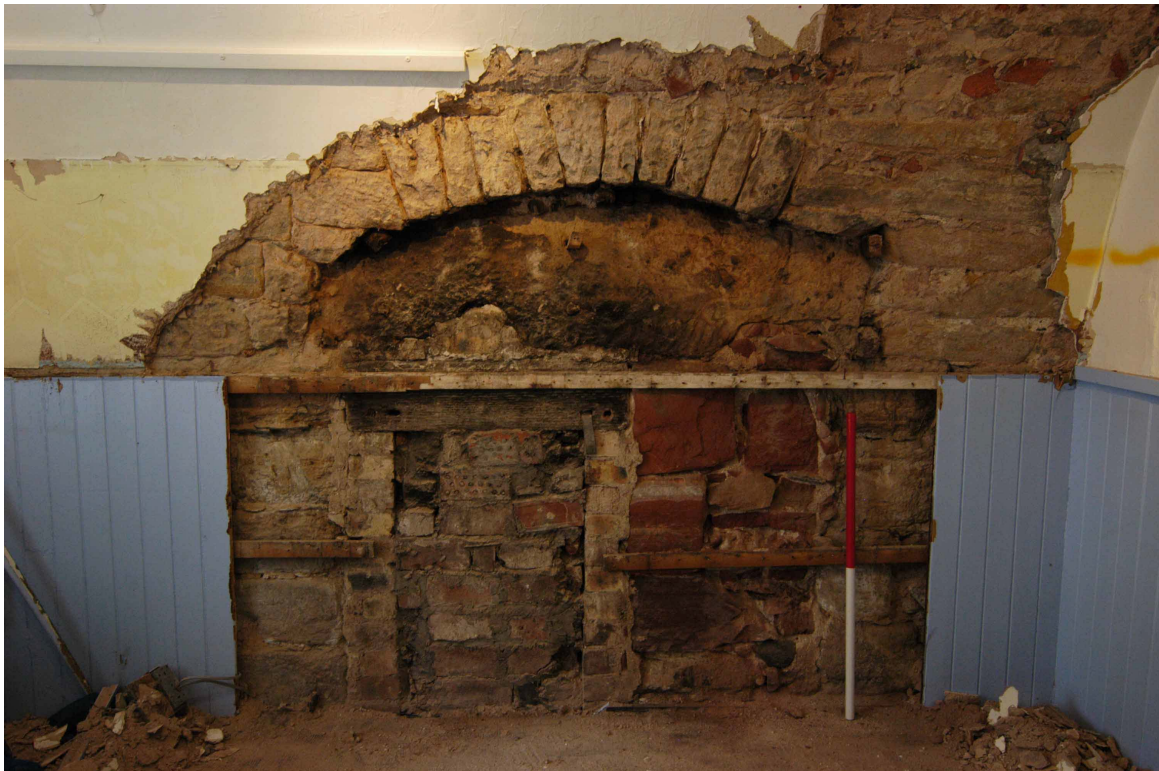
Plate 2. Unit 3, exposed blocked fireplace on the south-facing elevation

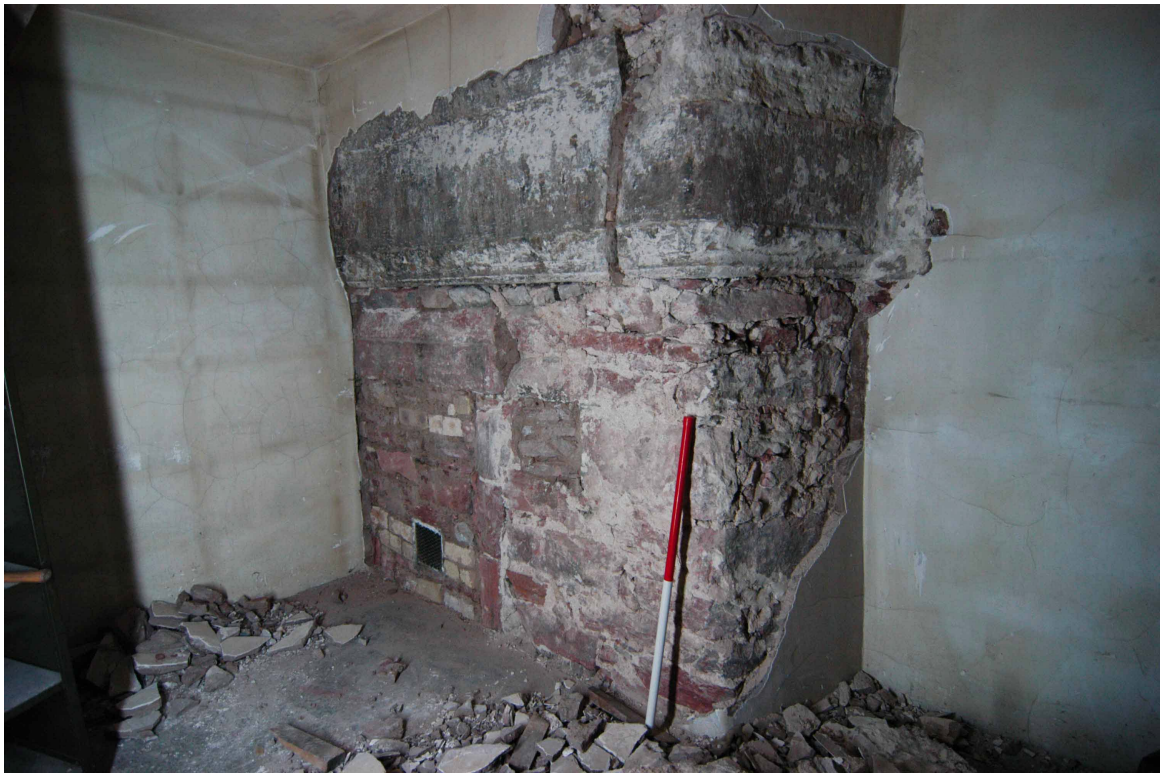
The fireplace occupied three quarters of the south-facing elevation of the former strong room and measured 2.65m wide and 2.15m high. On the west side of the fireplace was a moulded sandstone column surmounted by a carved countersunk overmantle which formed the corner of the massive stone lintel. The lintel measured 2.6m long and 0.68m wide and it had large structural cracks at each end. The lintel had, at one time, a moulded margin on its top and lower edges but this had been removed using a hand chisel to create a heavily broached finish in which to key in the cement render of the strong room wall. There were no visible remains of the corresponding eastern moulded upright of the fire surround.

Plate 3. Unit 9, exposed fireplace on the south-facing elevation of the former strongroom

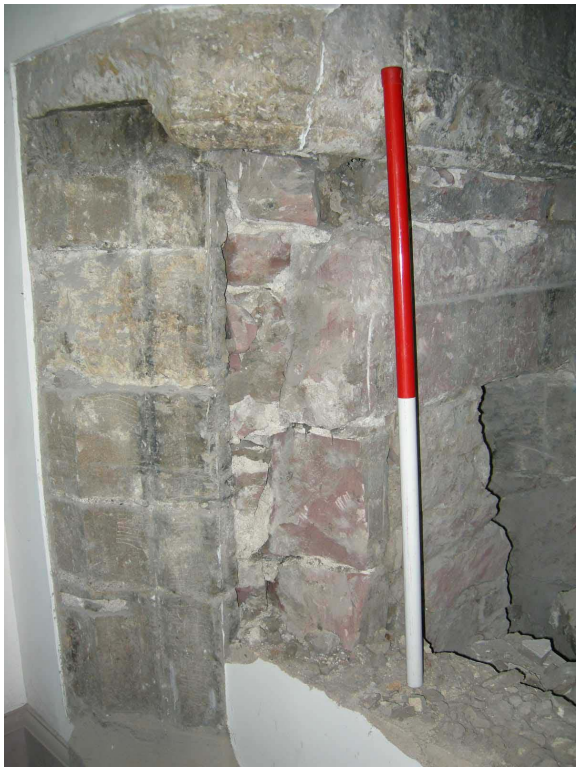
Plate 4. Unit 9, moulded ashlar stone surround on the west side of the fireplace exposed during the demolition of the strongroom

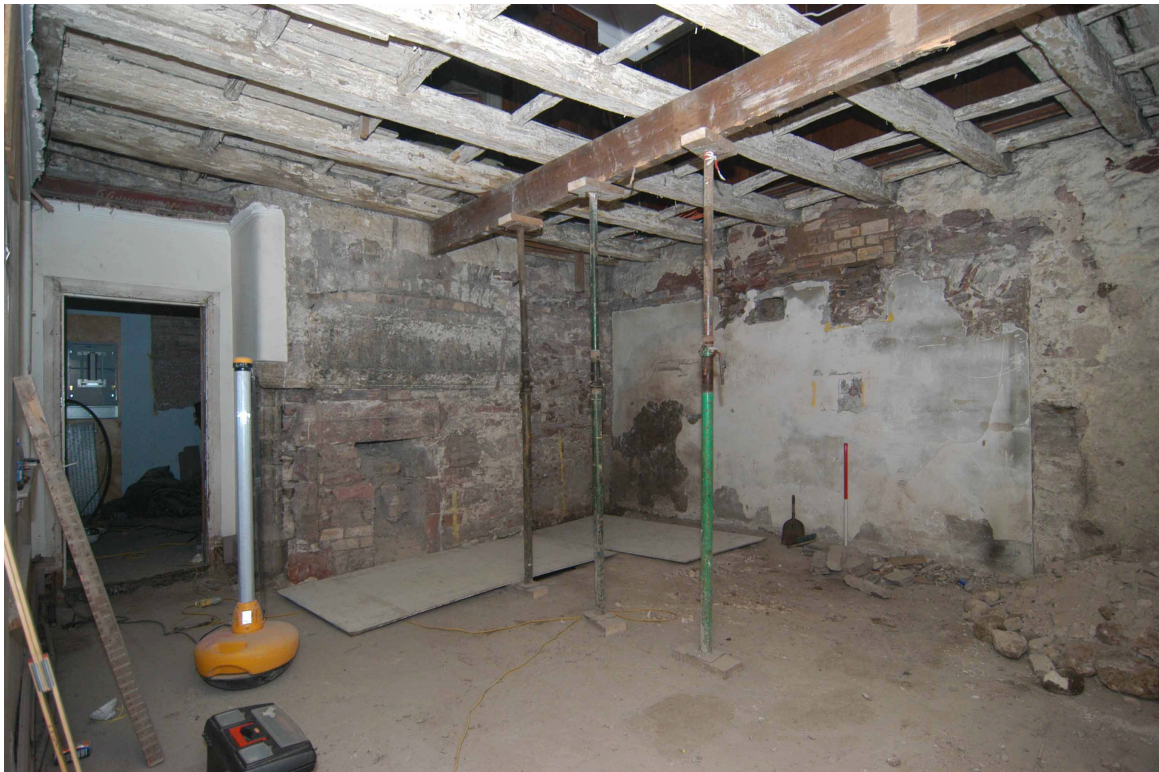
Plate 5. Unit 9, the fireplace in context with the enlarged room created following the demolition of the strongroom

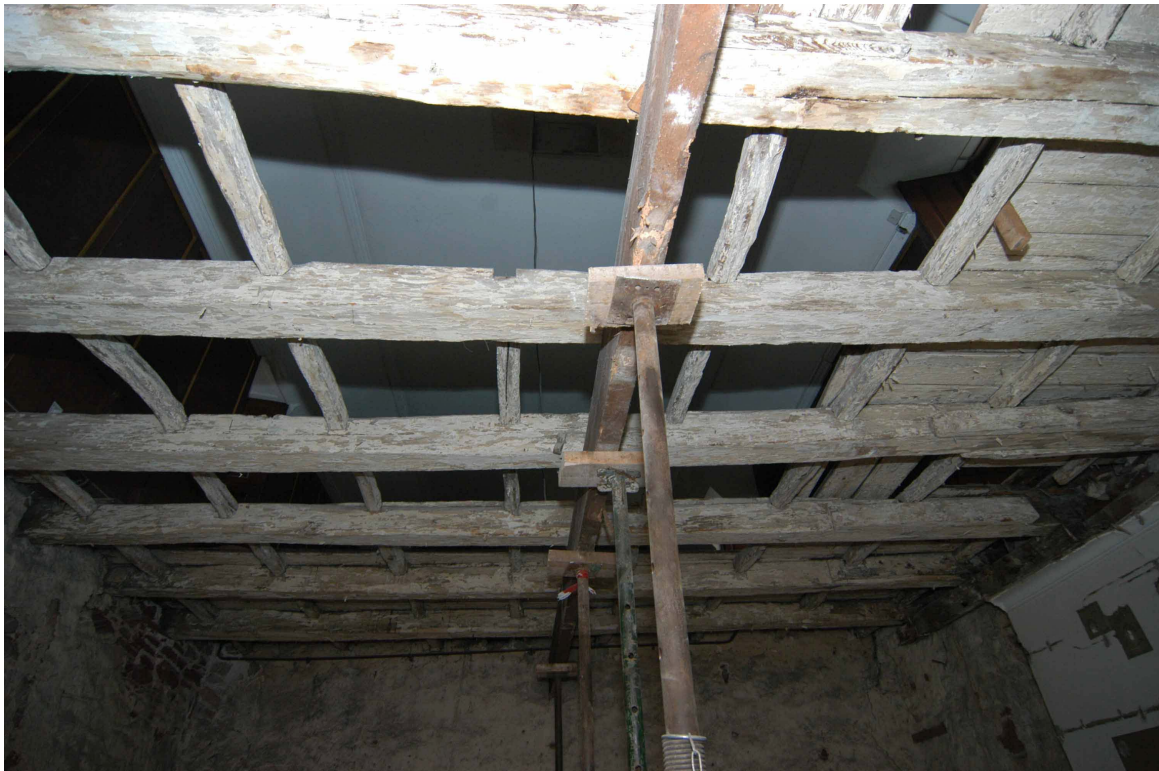
The floor joists between the first and second floors appear to be original oak beams with cross-braces inserted to support the plank-built floor of the Council Chamber. These joists appear to share the same characteristics as those observed in Unit 6, the former prison cell, although the latter were re-aligned north to south when the partition wall was put in. It is possible that these timbers are all original and date to the primary construction of the Town House; however, dendrochronological dating would be required to be absolutely certain to determine the felling date of the timbers and, importantly, if the timbers were imported from Scandinavia. Previous dendrochronological dating carried out during the Phase 1 works (Crone 2006) on three floor joists obtained from the exterior south-facing gable (second floor level) confirmed that Sample DTH3 was likely to have been felled sometime between AD 1524 and AD 1539. A calendar date could not be obtained from DTH1.

Plate 6. Unit 9, oak floor joists above the former strongroom

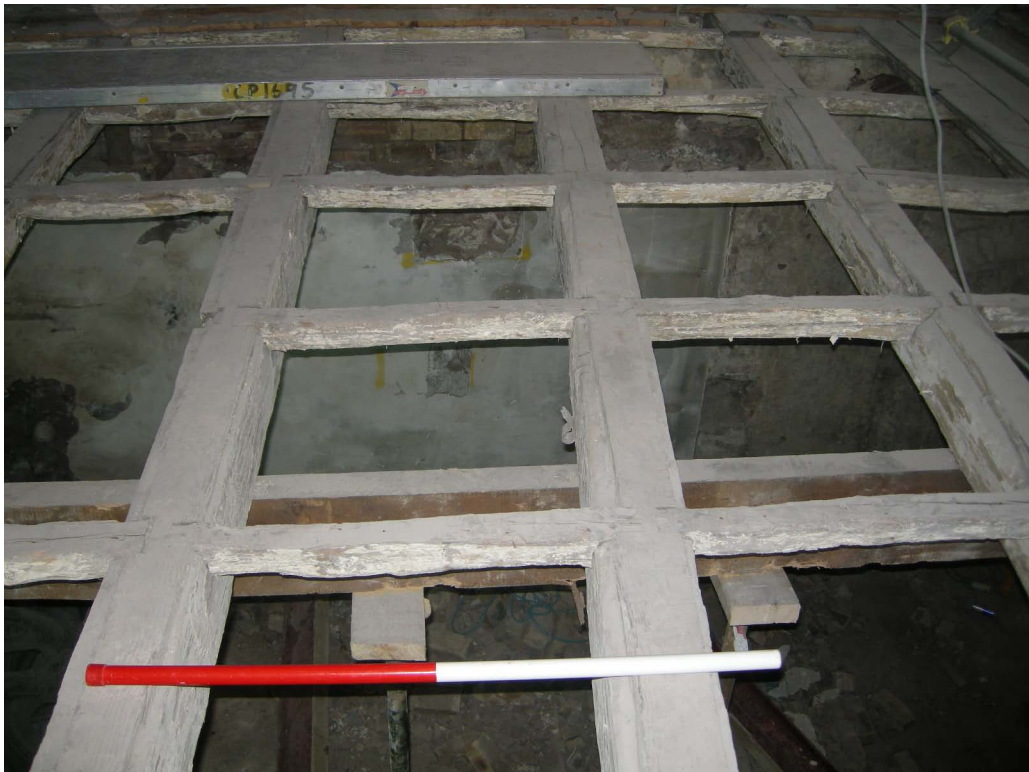
Plate 7. Unit 11, exposed floor joists following the partial removal of the Council Chamber floor

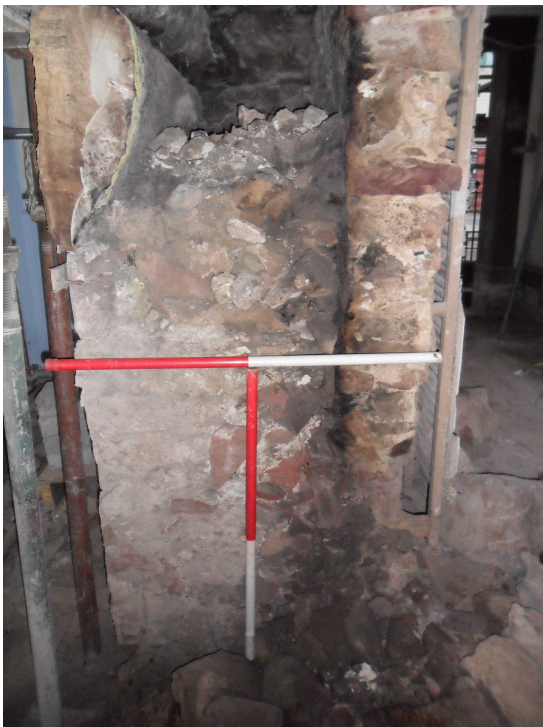
Plate 8. Unit 3 and 21, exposed east-facing section through the former north gable of the Town House, see Fig. 7A

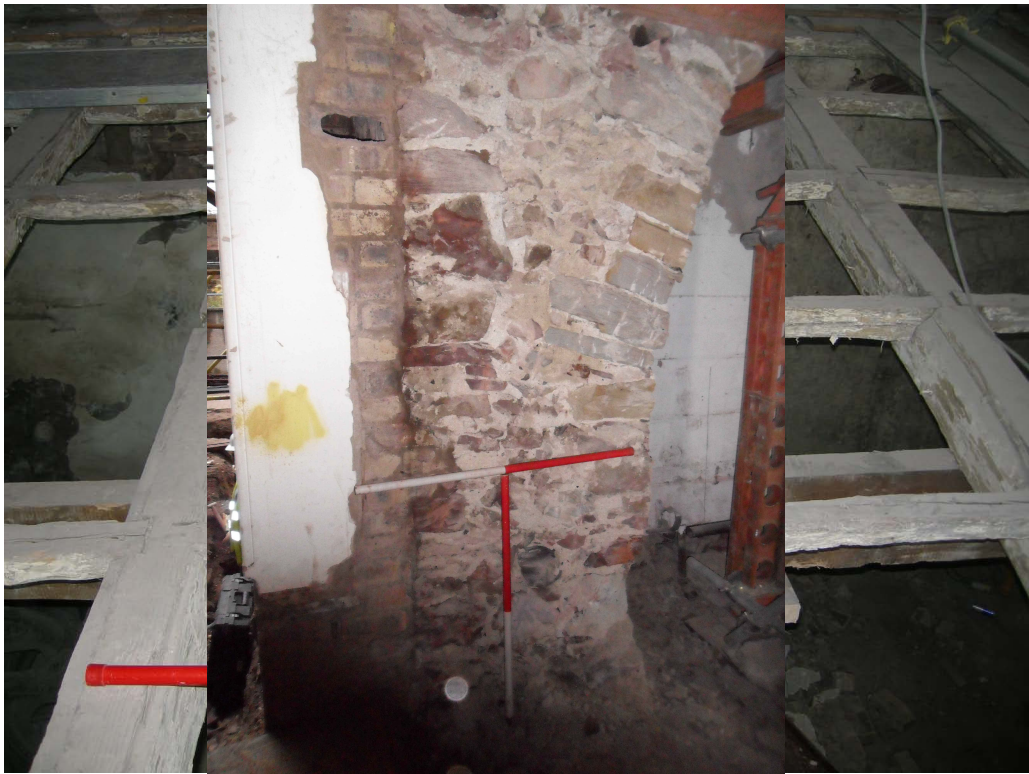
Section B measured 2.4m high and 1.4m wide and exposed the west-facing section through the former gable wall and vaulted ceiling in Unit 3 and the brick-built wall of Unit 12, the hallway. The wall and vault line fabric measured c. 0.6m thick and there was rubble infill between this and the rear brick-built 1927 wall. The brick-built 1927 wall was loosely keyed into the fabric of the Town House. The rubble infill was an assortment of sub-angular and rounded stones bonded with lime-mortar.

Plate 9. Unit 11 and 12, exposed west-facing section through the former north gable of the Town House, see Fig. 7B

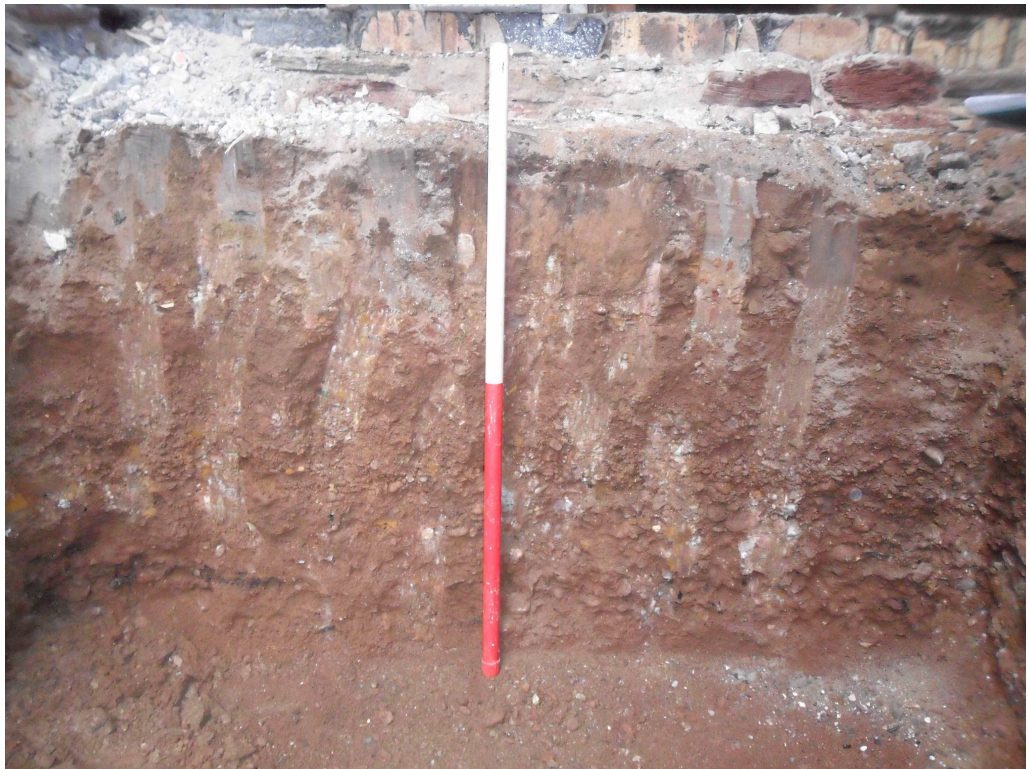
The lift shaft base was located within the ground floor of the former Council Offices, on the corner of Units 30 and 31 (Fig. 3). The lift-shaft trench measured 1.4m by 1.4m and was dug to a depth of 0.8m. Immediately below a brick floor foundation layer was very compact rubble to a depth of 0.2m. Below this layer was very compact natural gravel derived from Old Red Sandstone (Plate 10).

Plate 10. Exposed section on the lift shaft showing natural gravel

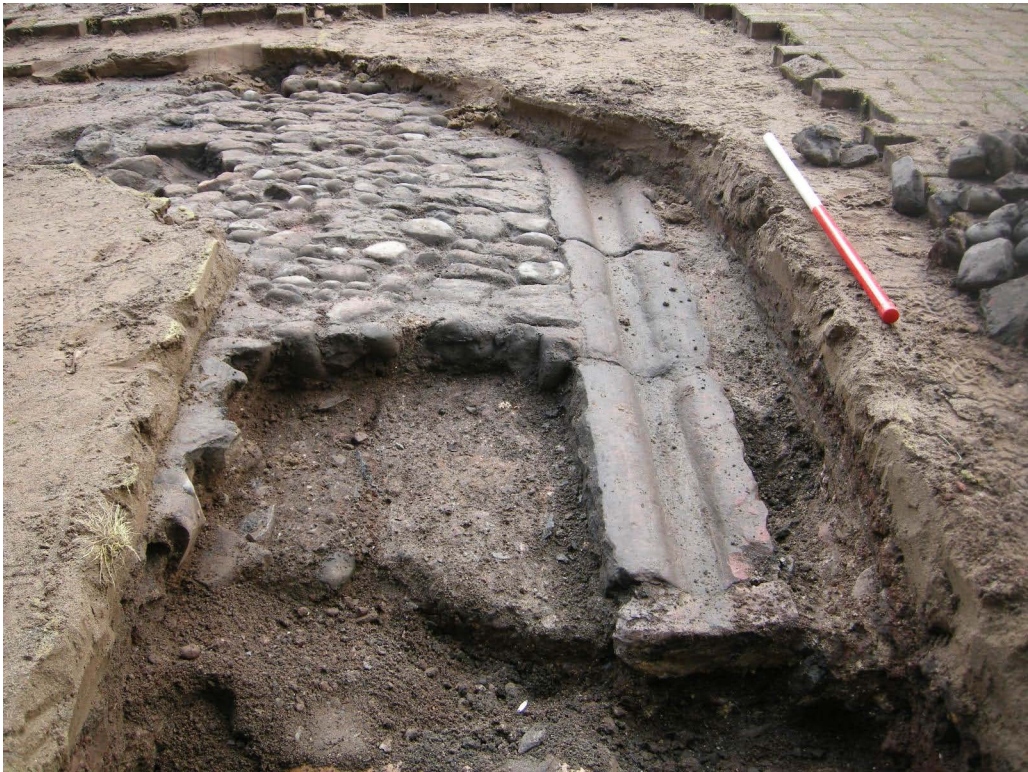
The yard was covered in mono blocks laid in herringbone fashion (**001**). The mono blocks were laid on sharp sand (**002**) to a depth of 0.1m. Situated at the north-east corner of the foundation trench was a concrete foundation with a slot for a timber sill (**003**). At the centre of the trench was a disturbed area of shallow mixed clay (**004**) within an irregular cut (**005**). A ceramic waste pipe (**007**) was located within a pipe-trench measuring 0.6m wide (**006**). A second pipe (**008**) was found slightly deeper than pipe (**007**). The cut for this trench was difficult to detect owing to the disturbed nature of the underlying fills.

Plate 11. Exposed cobble yard surface recorded during the excavation of the foundation trench for the new external stair tower at the rear of the Town House
