Trees Farm, Armadale, West Lothian Standing Building Survey and Evaluation

Data Structure Report

Data Structure Report No. 1957

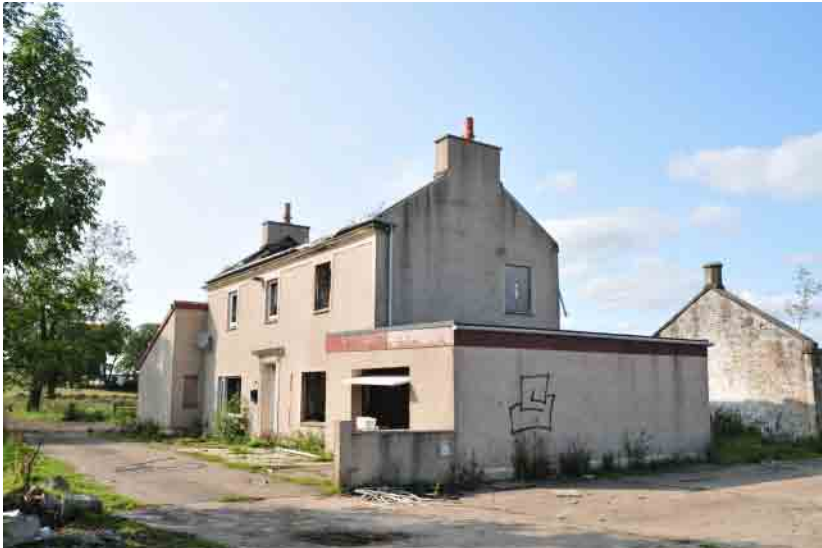
The south-facing elevation (1) formed the front of the house (Fig. 2). It was harled and painted pale pinkish-beige with raised moulded margins. The wallhead had a projecting concrete moulded cornice. The ground level had a centrally placed main doorway with two large windows set either side of the door, with concrete surrounds and the partial remains of modern double-glazed windows. It is possible that these windows were enlarged from earlier smaller windows, although it was not possible to ascertain this. The first floor had three small windows, all featuring concrete sills and moulded surrounds.

Fig 2 - View of house from south-east

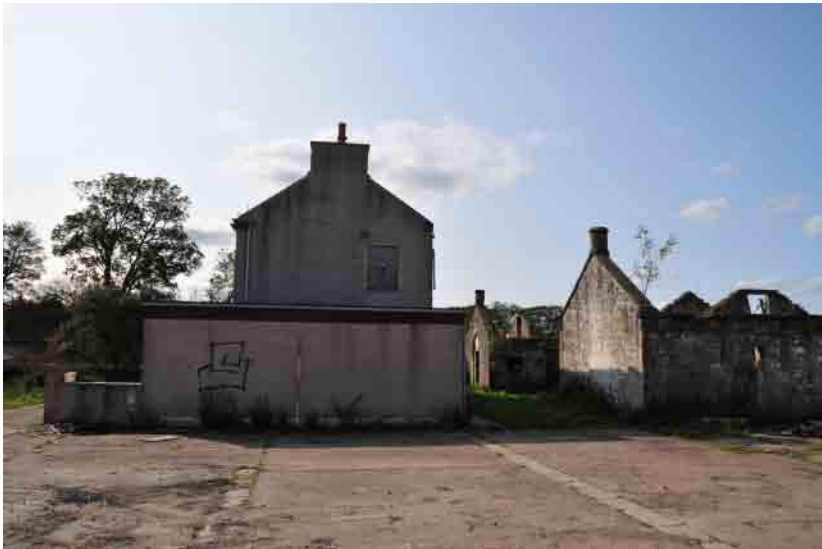
The east-facing elevation (2) formed a pitched gable. It was harled and painted off-white. A wide chimney stack was set across the apex of the gable with a single pot. A single window with a concrete sill and raised surround was situated on the first floor. The lower half of the gable was obscured by the adjoining garage (6), described below (Fig. 3).

Fig 3 - View of house and steading from east

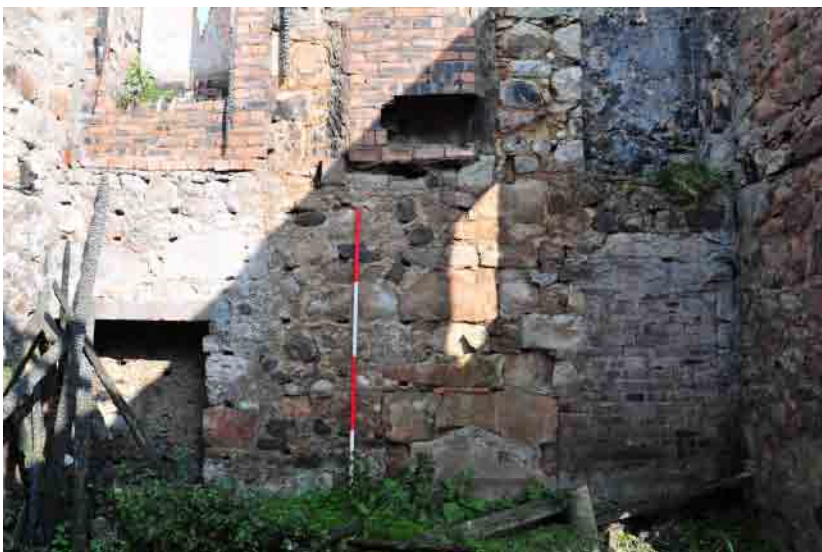
The lounge (7) was completely destroyed and the ceiling had collapsed (Fig. 4). The wall coverings and plasterwork had been destroyed, exposing the bare stonework of the walls. This revealed a break in the build that may indicate the building was originally built as a single storey; however, it could also simply represent that a less substantial build was required for the upper storey. The bare stonework also revealed that the wall heads had been heightened slightly and that the original roof pitch was steeper. At ground floor level the west-facing elevation (interior of the east gable) had a recessed alcove to the left hand side and a possible blocked doorway or alcove to the right hand side (Fig. 4). The first floor window (visible on the exterior east-facing gable) had a brick surround. A brick fireplace and chimney breast were located in the centre of the wall and an alcove/press was set into the wall at its right hand side.

Fig 4 - House Units 7 & 14, west-facing elevation

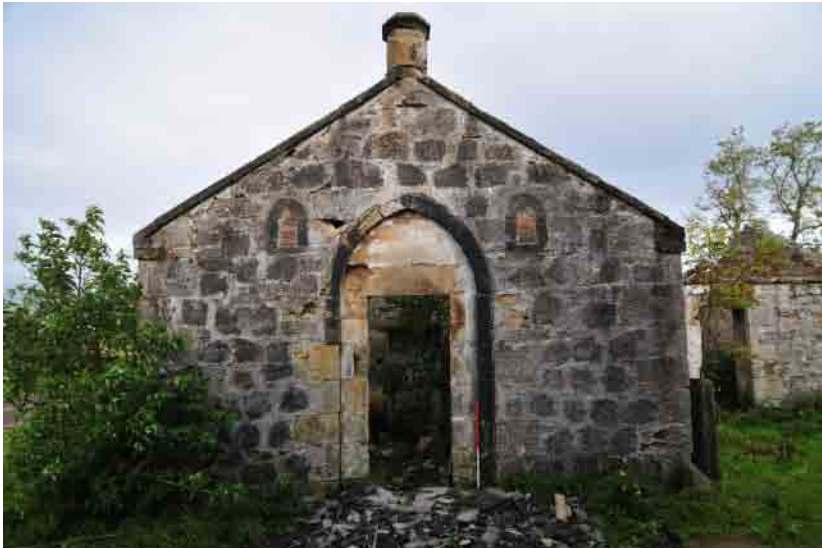
The south-facing elevation (21) featured a false gothic arch in the centre, partly blocked with ashlar and housing a smaller doorway framed by the ashlar blocking (Fig. 5). It is unclear whether the gothic arch was originally fully open or whether it was only a decorative surround to the main door. Two small decorative window arches, one either side of the main doorway arch, were set into the elevation, level with the top of the main arch. They had raised margins and were blocked with brick.

Fig 5 - Steading west range entrance from south

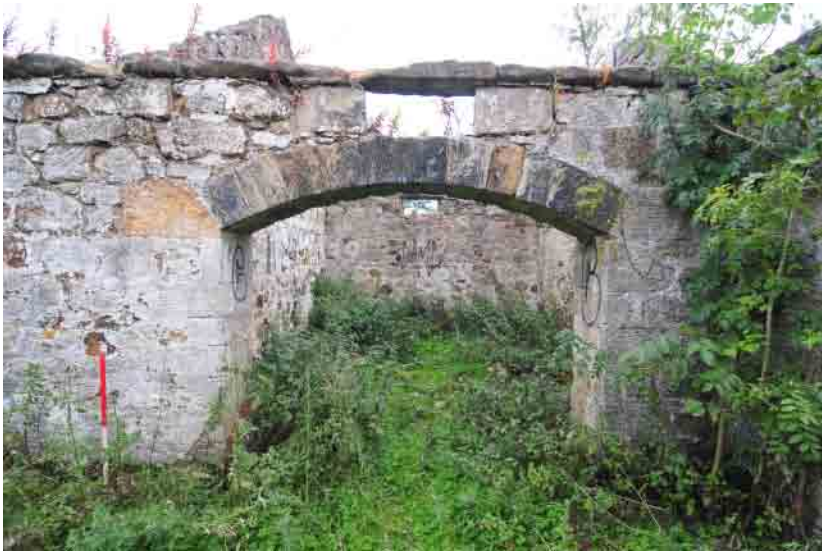
The south-facing elevation (19) of the central range had two openings. To the west side was a doorway framed by quoins and a lintel. It had tooled rabbets on the inside indicating it was once fitted with an inward opening door. To the east side was a wide opening with a shallow arched top with a small window opening or vent above. The arch was built from vousoirs with a central keystone and the sides were formed by large quoins (Fig. 6).

Fig 6 - Steading entrance to Unit 26

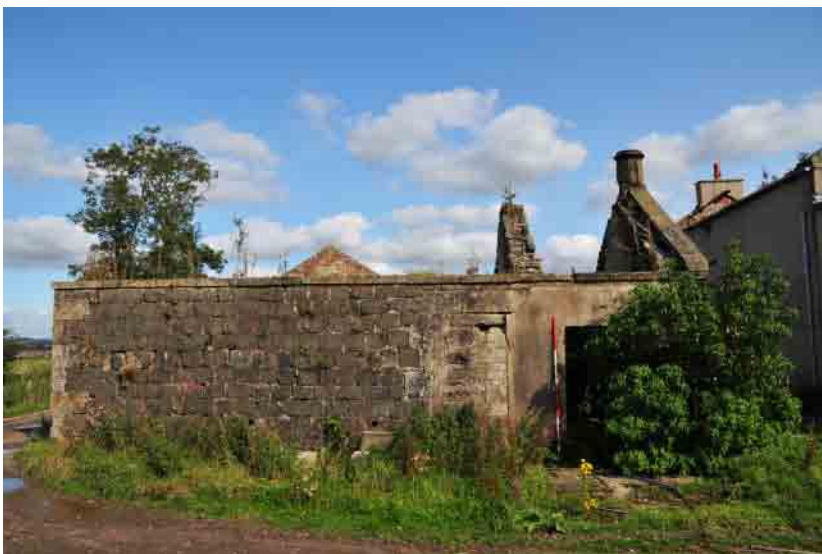
The west-facing elevation (24) featured sandstone quoins at the corners but the main wall build was of dark grey whinstone blocks (Fig. 7). The south end of the wall was rendered in concrete and had a doorway slapped through it. An earlier doorway, which would have accessed the main shed (28), had been blocked up with sandstone blocks and was partly covered by the concrete render.

Fig 7 - Steading west range from west

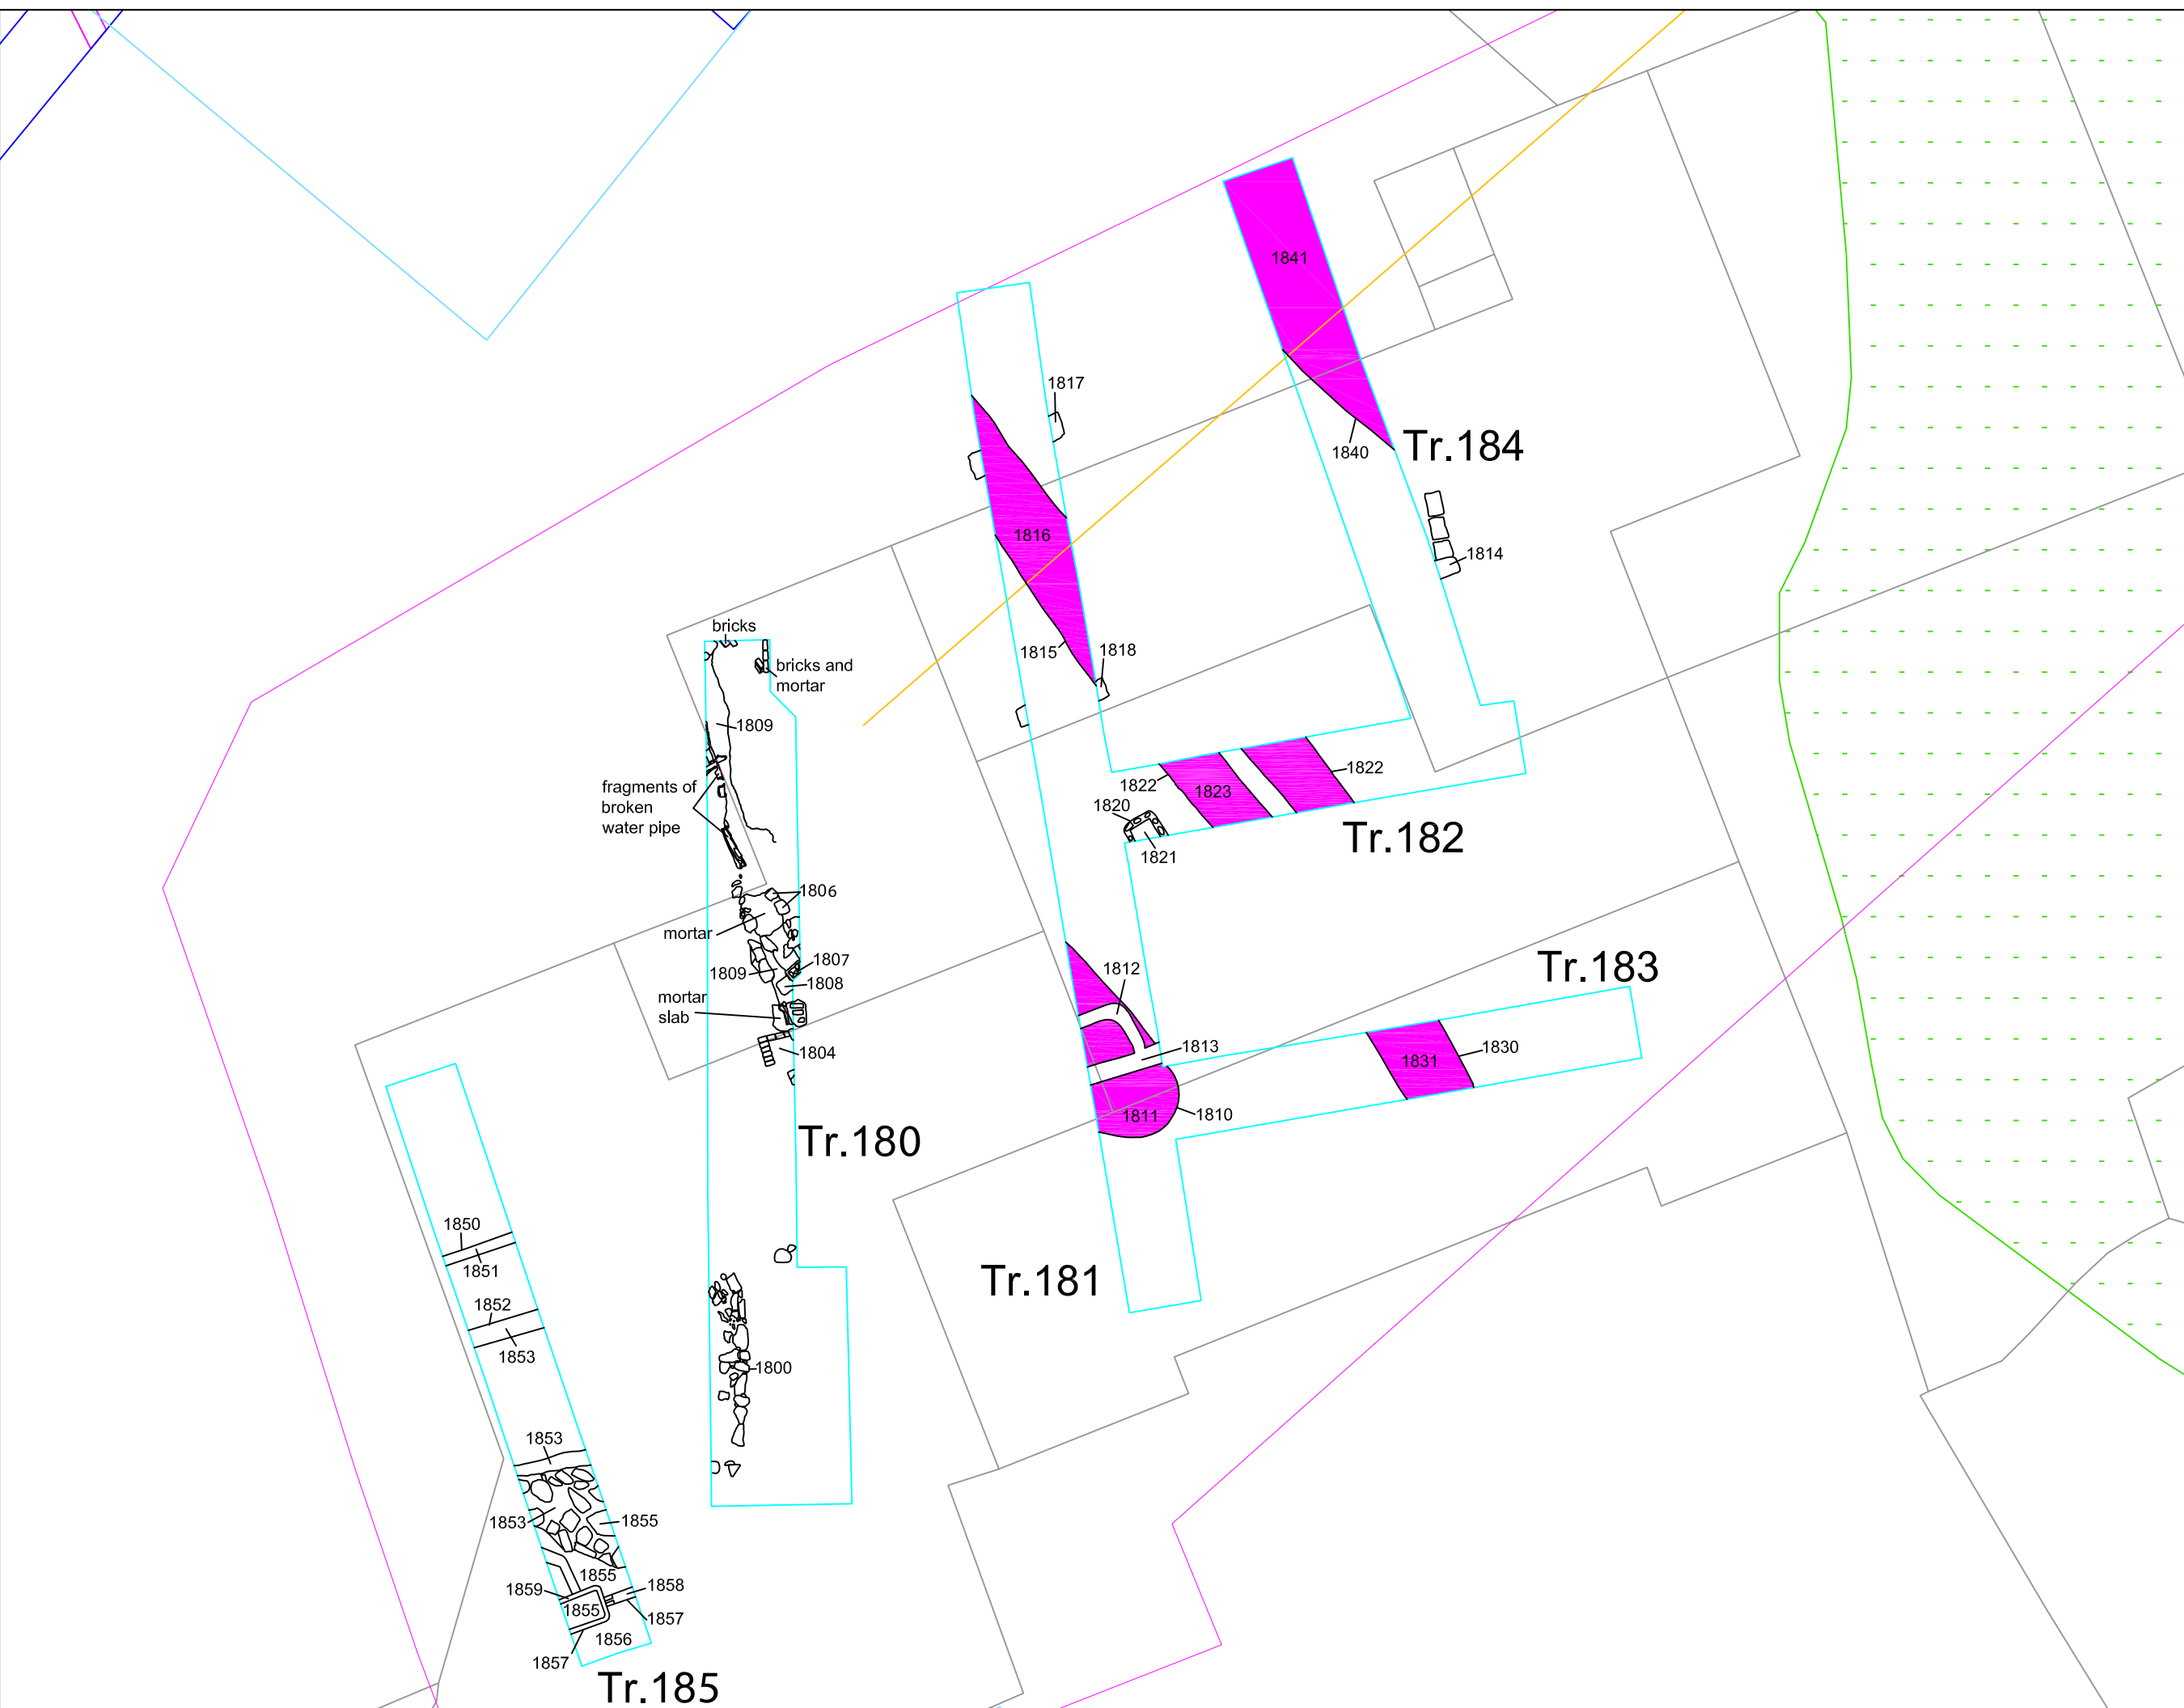
Fig. No: **8** Revision: **A**

Six trenches (Fig. 8) were excavated covering a total of 175m².

The evaluation revealed that no earlier structural remains underlay the footprint of Trees farmhouse and steading. Linear cultivation furrows, continuing the alignment of those recorded in evaluation Trenches 110, 114-116 (Suddaby 2011a) were recorded under the buildings. A wall was recorded in Trench 180 to the west of the former buildings, located under the access track that formerly led around the northern side of the steading (Fig. 8).

To the east of Trench 180, Trenches 181-184 (Fig. 8) revealed that cultivation furrows (**1810, 1815, 1822, 1824, 1830, 1840**) underlay the footprint of the farmhouse and steading.

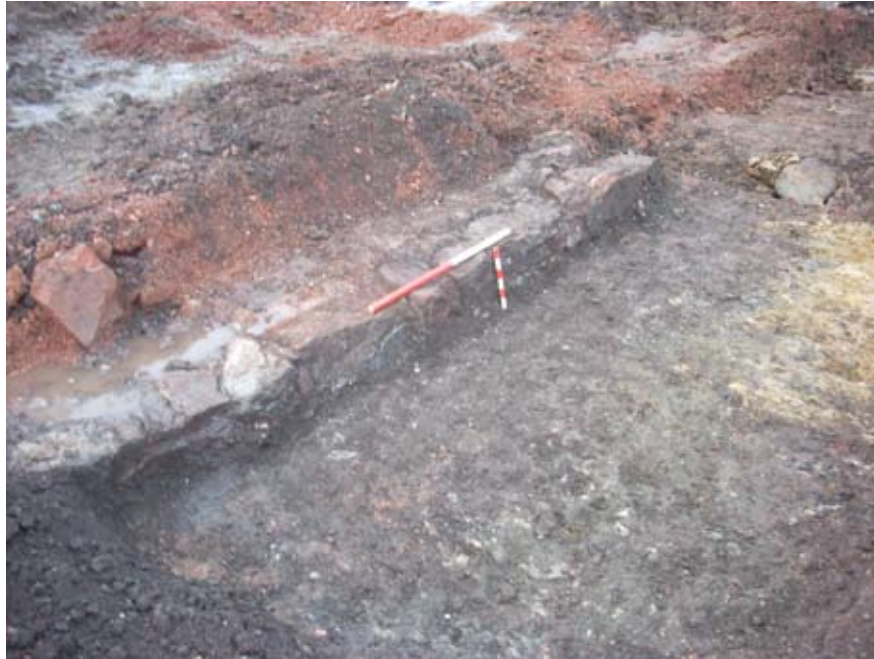
A slightly curving wall (**1800**) with a length of 4.2m, width of 0.8m and height of 0.25m (Fig. 9) was recorded at the southern end of Trench 180. Formed from angular blocks of volcanic stone without mortar, it appeared to have been built on natural subsoil (**003**). A deposit of grey-black gritty silt (**1801**) had built up around the wall. A sondage to the west of the wall revealed that **1801** overlay natural subsoil. There was no indication of any associated paving or floor deposit.

The curving wall revealed in Trench 180 is on the opposite side of the Trees Farm access track from the building revealed in evaluation Trench 126 and subsequently excavated (Suddaby 2011b). It was, however, of different construction and there was no trace of the paved area that was associated with the previously excavated building.

Fig 9 - Shot of Trench 180 showing wall 1800

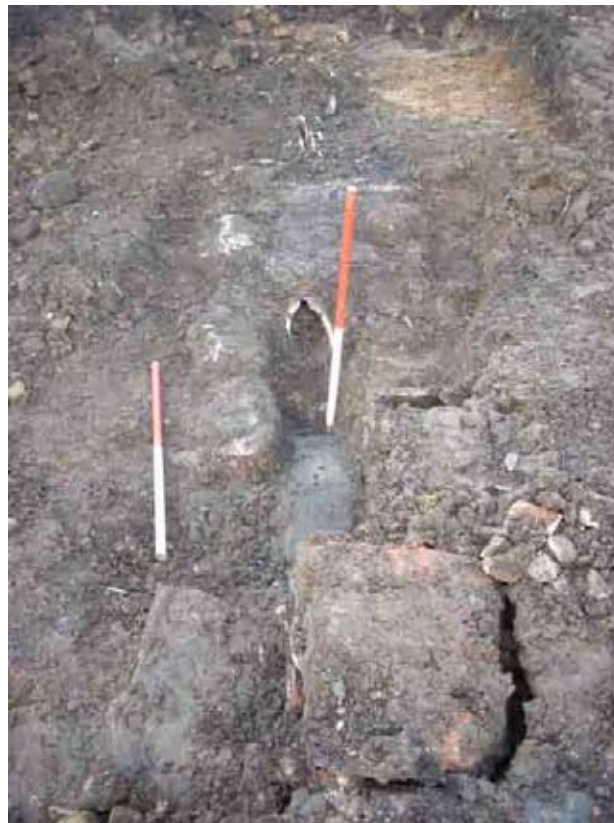
Further north in the same trench, a parallel alignment of volcanic boulders (**1806**) had had a concrete-covered ceramic foul drain (**1809**) inserted between them (Fig. 10). This drain appeared to be fed from a sump (**1805**) within the footprint of the former steading. The ceramic sump overlay several flat stones (**1808**). Adjacent to **1805**, a brick-lined sump (**1804**) utilising frogged bricks is considered to be modern.

In Trench 180, both the stone alignment surrounding the ceramic foul drain and the stone slabs under the ceramic drain sump may be associated with the 19th-century steading buildings.

Fig 10 - Shot of Trench 180 showing culvert 1806 with later ceramic drain 1807 inserted
