High Crindledyke Farm, Carlisle, Cumbria **Standing Building Survey**

Report No. 1973

This report presents the results of a Level 3 standing building survey undertaken by CFA Archaeology Ltd (CFA) at High Crindledyke Farm, Kingmoor, Carlisle, Cumbria (NGR NY 3381 5604, Fig. 1) during October 2011. The work was commissioned by Story Homes Ltd.

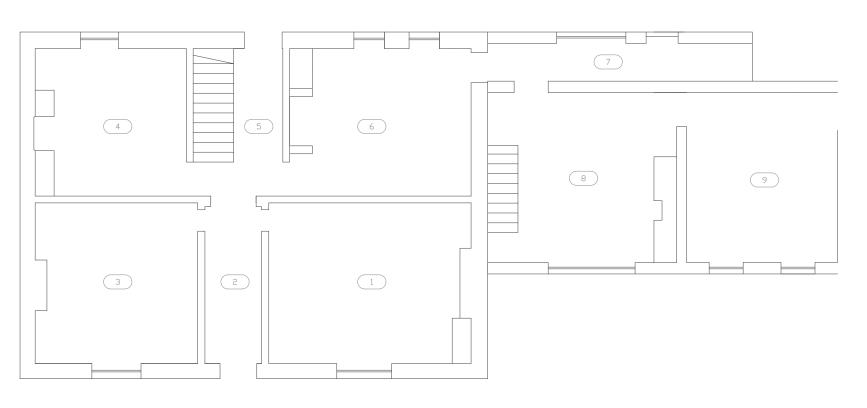
Fig. 4a - Farmhouse, South Range, Ground Floor Plan

A single room is present on the ground floor (Room 8) which measures 5.1m by 4.5m (Fig 4a). The room is lit by a casement window on the north-facing elevation and a window (3/10) on the south-facing elevation. The interior walls are all modern. A modern 12-paned glass door allows access into the passage. A simple softwood staircase is situated on the east-facing elevation.

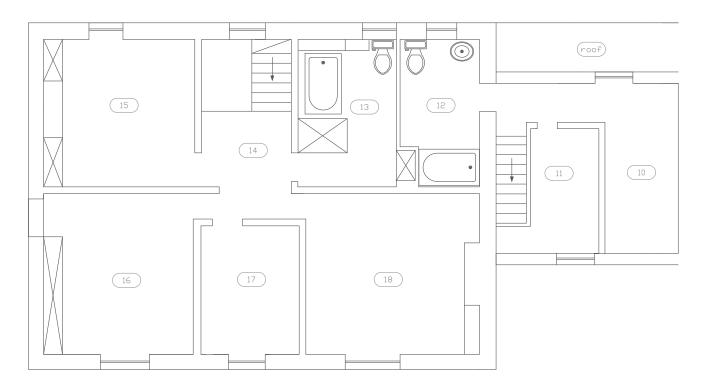
Fig. 4b - Farmhouse, South Range, First Floor Plan

The first floor has three rooms (Rooms 10-12) (Fig 4b). Rooms 10 and 11 have been created by the installation of a very thin stud-partition wall. Room 10 is lit by window 3/6 on the exterior north-facing elevation. Room 11 is a small box-room lit by a small window on the exterior south-facing elevation. A doorway leads off the landing into a small bathroom which included modern sanitary wares.

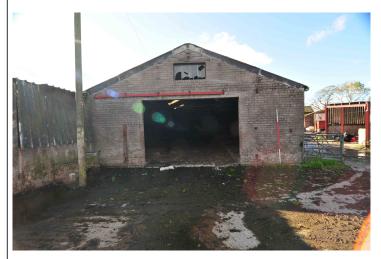
Building 1 comprises a brick-built byre that was originally a milking shed prior to its conversion to a byre. The building is rectangular and measures 13.4m by 5.6m. The north-facing elevation is largely featureless with red-brick walls (1/1) incorporating ventilation grilles (Fig 3a). The wall is built in English Garden bond (5:1). The roof is clad with corrugated asbestos (1/2). At the west end of the building there is a distinct break in build where the main build meets a section of earlier brickwork (1/3). A large sliding metal door (1/4) leads into a general storage area. The east gable (Fig. 3d, Plate 1) incorporates a large rectangular bay opening (1/5) but the sliding door has been removed. Above the doorway is a four-paned window (1/6).

Plate 1 - East-facing entrance to Building 1

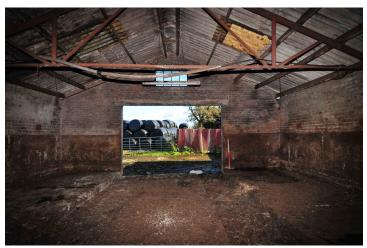
Three composite iron A-frame trusses support the asbestos roof (Plate 2). The north and south-facing elevations have been rendered with cement to a height of 1.2m. Scars within the render mark the position of milking stalls. The floor is concrete with a central drain.

Plate 2 - Interior of building 1 showing the steel roof trusses

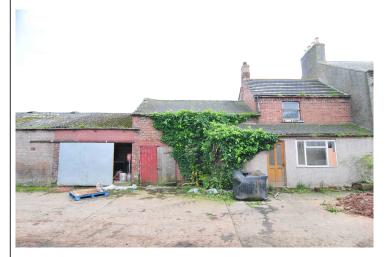
Building 2 occupies a rectangular footprint and is built of brick (2/1, English Garden bond 5:1) on the north-facing elevation (Fig. 3a, Plate 3) and a mixture of brick and cobbles on the south-facing elevation (Fig. 3c). The building is accessed by a double-leaved plank-built door (2/2) on the north-facing elevation. The pitched roof is coved with slate (2/3).

Plate 3 - Part of the north-facing elevation of the South Range showing Buildings 1-3

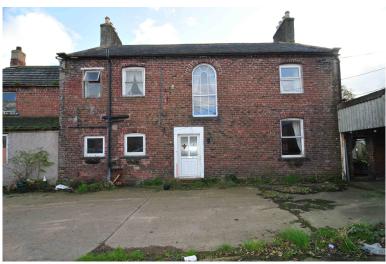
The north-facing elevation of the farmhouse has four bays, the third bay being asymmetrical (Fig 3a, Plate 5). The building is constructed of hand-made brick using English Garden bond (5:1) resting on a foundation course of cobbles measuring 0.3m high. The windows and door (4/3, 4/4 and 4/5) are modern PVC replacements; window 4/6 is a wooden 1-over-1 sash-and-case window. On the first floor, windows 4/7 and 4/8 light the bathroom of the extension. Window 4/9 lights the staircase and is a modern PVC replacement and has a fine segmented brick arch above. The flanking windows (4/8 and 4/11) have flat arches. Between the stair window (4/9) and 4/8 is a lead insurance plaque (4/24). The skews are sandstone with moulded skewputs (4/12). The pitched roof is covered with slate (4/13). The two chimney stacks are brick-built and covered with pebble-dash render.

Plate 5 - North-facing elevation of the farmhouse

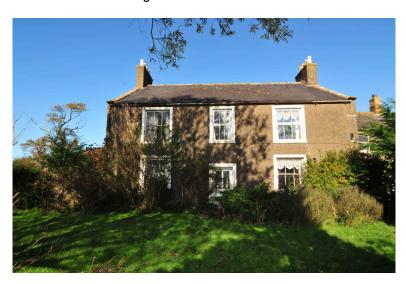
The south-facing elevation of the farmhouse is covered in pebble-dash render and has three bays (Fig 3c, Plate 6). The middle bay has a door with window directly above, flanked on each side by windows at ground and first floor. The roof (4/13) is the same as on the north-facing elevation. Windows 4/21 are all the same dimension (c1.2m by 1.2m) whereas window (4/22) on the first floor above doorway 4/23 is slightly narrower (c. 1m by 1.2m). All the fenestration has raised margins of white-painted sandstone.

Plate 6 - South-facing elevation of the farmhouse

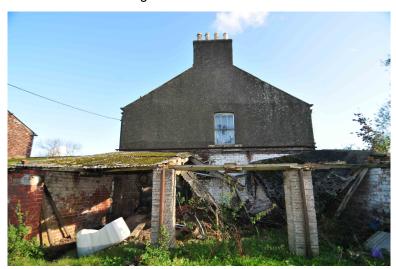
The west-facing gable of the farmhouse is partly rendered with pebble-dash render (4/16). The only notable feature is a sash-and-case window that is not aligned to the chimney stack (Fig 3b, Plate 7). The projecting skewput stones (4/12) are more visible on this elevation. The lower part of the elevation to the height of the window sill is masked by the rear wall of a dilapidated lean-to building (4/18). The lean-to roof

(4/20) is corrugated asbestos and has collapsed. The roof was supported by the flanking walls and two piers constructed using breeze-blocks (4/19).

Plate 7 - West-facing gable of the farmhouse

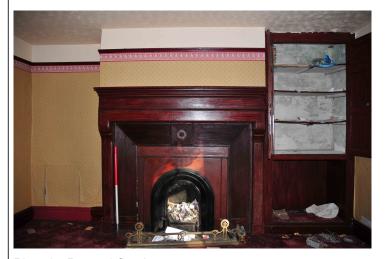
Plate 8 - Room 1 fireplace

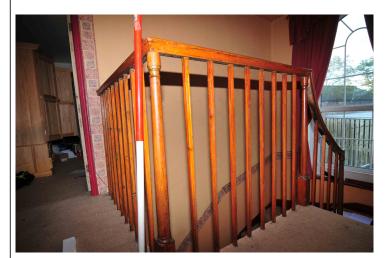
Plate 10 - Staircase and landing

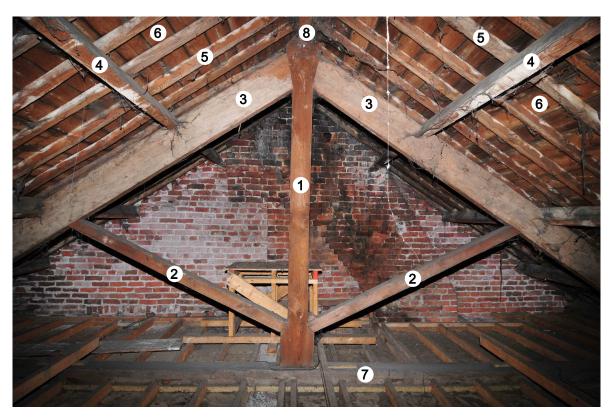
Three king-post roof trusses are present within the roof of the farmhouse (Plate 12-13). All are dressed softwood and are peg- jointed. The purlins are trenched. Table 6 lists the principal features present on the king-post trusses.

Feature No	Description
1	Pine king post with shouldered base and soffit carrying the ridge plate (8)
2	Squared pine struts supporting the principal rafter (3)
3	Rectangular dressed principal rafters with trenches for the purlins (4)
4	Dressed pine purlins (through purlins) supporting the common rafters
5	Dressed pine common rafters supporting the sarking boards
6	Sarking boards (pine) c. 0.25m wide.
7	Timber tie-beam
8	Timber (pine) ridge plate

Plate 12 - King-post roof truss, feature descriptions listed are in Table 4

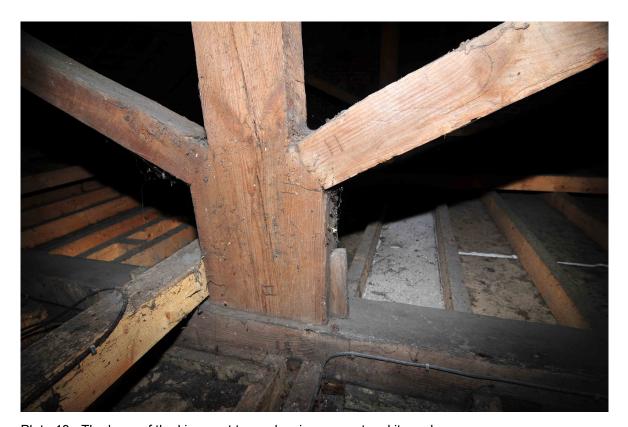
Plate 13 - The base of the king-post truss showing carpenters kit numbers

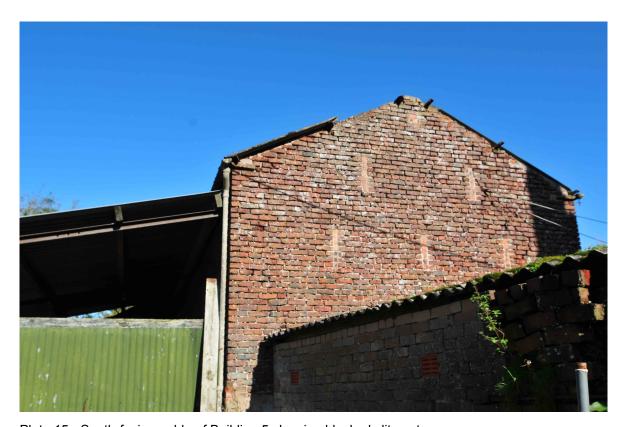
The south-facing gable (Fig. 6a, Plate 15) is pitched and has five blocked slit vents (5/6). Six blocked slit vents are visible on the north-facing gable which has been incorporated into Building 6, the steel-framed workshop.

Plate 15 - South-facing gable of Building 5 showing blocked slit vents

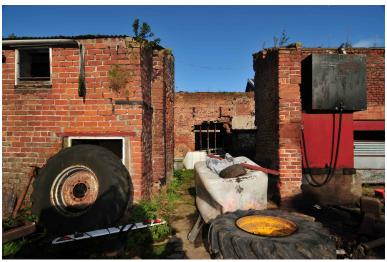
The sockets for the main loft timbers are visible surmounted by a series of slit vents that occupy the full length of the rear (south-facing) elevation (Fig. 6a, Plate 16). There is also minor blocking work at the east end of the building. On the ground floor a large hole in the wall shows that the barn is constructed from a double skin wall. Several large fire-damaged oak beams still lie on the floor of the adjacent building (Building 9).

Plate 16 - South-facing elevation of Building 8

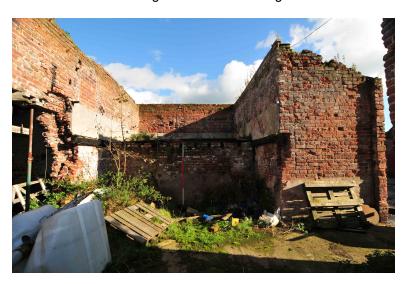
Plate 17 - Interior of Building 8

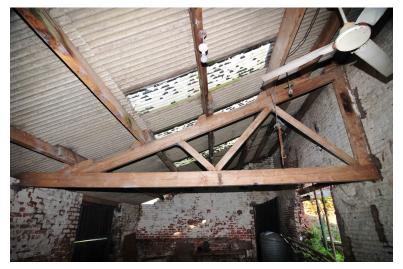
Plate 18 - Timber mono roof in Building 9
