**St Martin's Church, 4 Magdalene Drive,  
Edinburgh**

**Historic Building Survey**

**Report No 2039**

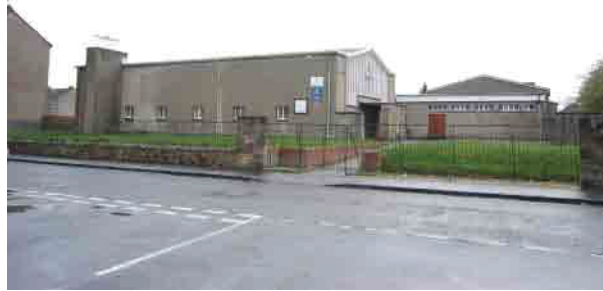
The north-facing elevation of the church measures 24m long and includes the church and gable of the Large Hall. The church is lit by a large window that occupies nearly the full height of the elevation at its east end. On the west side of the window there is an out-shot rectangular bellcote that extends c. 1m above the eaves. The fenestration comprises five square-headed casement windows. The main entrance porch extends off the west gable of the church.

Set back off the main church alignment is the gable and annex entrance to the Large Hall measuring c.12m wide. The annex has a flat roof and is lit by a series of small square windows. The roof of the Large Hall is pitched. Both the church and Large Hall are covered with pebble-dash render.

Fig. 3 North-facing elevation of St Martin's Church

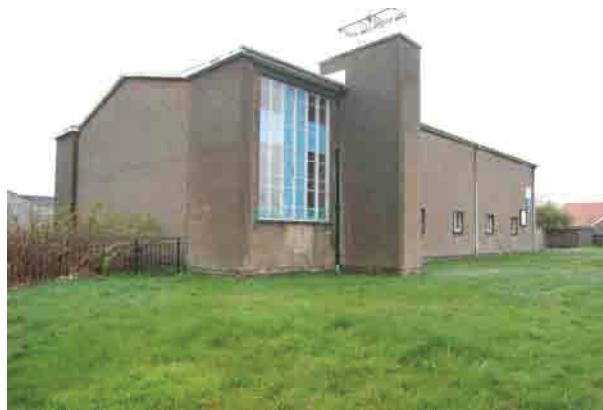
The east-facing elevation includes the church gable, the gable wall of the Small Hall and the main wall of the Large Hall with combined length of 42m. The church gable is pitched with flat corners. The gable of the Small Hall has slight pitch to its roof which is asymmetric. Two windows occupy the centre of the gable with a door situated on the north side. The Large Hall's east-facing wall includes three tall windows and a fire exit at its south end. At the south end of the hall a two storey outshot block has casement windows on the ground and first floors. All the walls are covered with pebble-dash render.

Fig. 4 North and east-facing gable wall of St Martin's Church

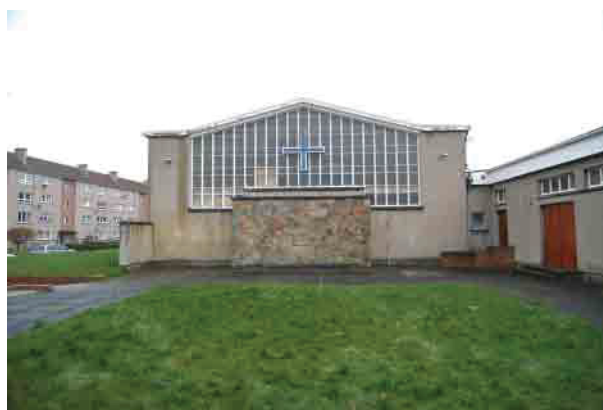
The west-facing elevation includes the main gable of the church, the annex to the Large Hall and its main wall with a combined length of 41m.

The church gable is dominated by a large window with c160 panes of glass. A blue painted crucifix is situated at its centre. The flanking walls are plain. The main entrance is hidden behind a stone-built wall that has a date-stone at its centre inscribed 1957 (Fig. 6).

The church gable adjoins the main block of the annex and Large Hall which is lit by a series of rectangular windows situated towards the top of the wall. The south end of the elevation is outshot slightly with a steel doorway into the boiler house.

Fig. 5 West facing gable of St Martin's Church

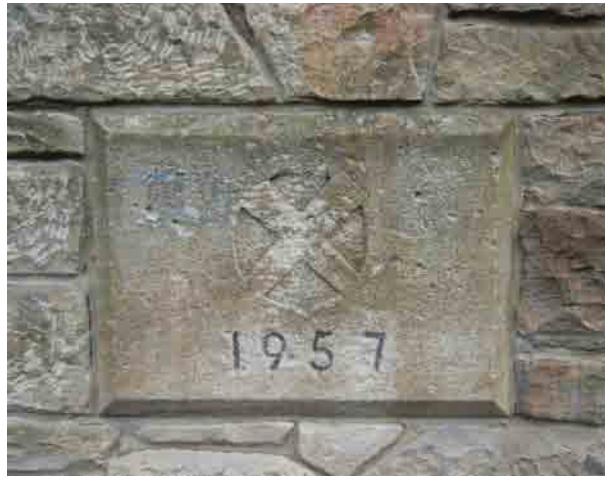
Fig. 6 Date stone 1957 on the wall fronting the main church entrance

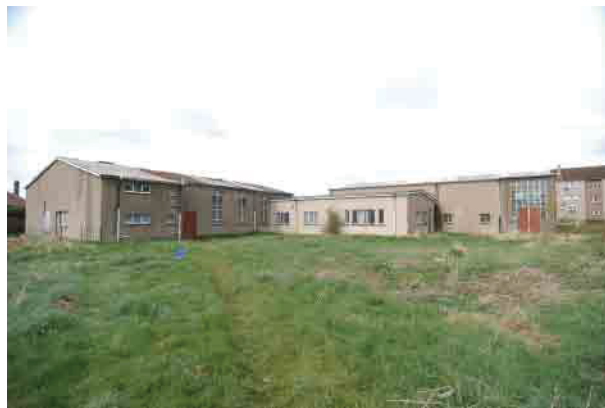
The south-facing elevation includes the east end of the church, the main wall of the Small Hall and the gable end of the Large Hall with a combined length of 37m. The east end of the church is lit by a large rectangular window that occupies more or less the full length of the wall and is broken by a double-leaved doorway. Two narrow buttresses flank either side of the wall. The rest of the wall is plain with two casement windows on the ground floor.

The main wall of the Small Hall contains three bays of modern casement windows and is otherwise featureless.

The gable of the Large Hall has a central door on the ground floor flanked by a blind three-paned casement window. Another blind window is present on the west side of the doorway. The walls are featureless and covered with pebble-dash render.

Fig. 7 South-facing elevation of the church complex

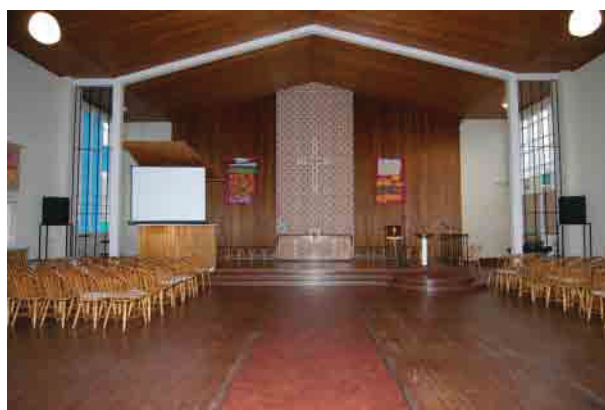
Fig. 8 Church chancel and altar

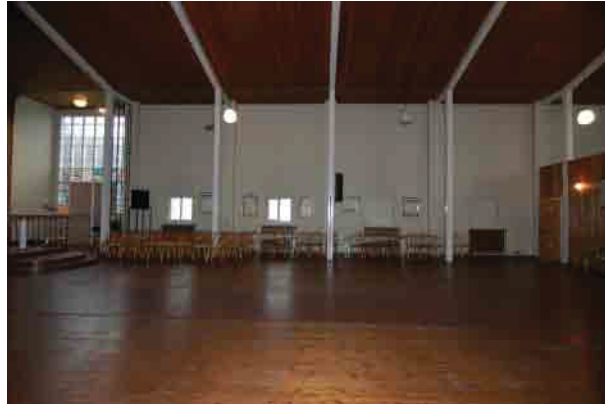
Fig. 9 Interior steel frame of the chancel

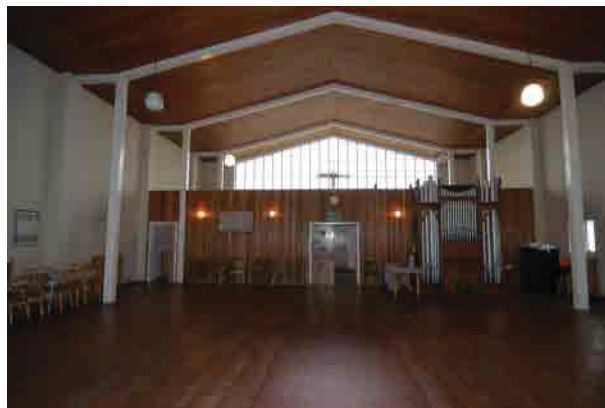
Fig. 10 Vestibule partition wall and south gable of the church

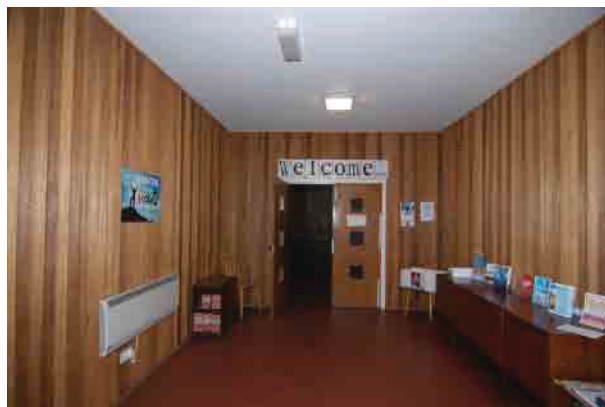
Fig. 11 Interior view of the pine clad vestibule

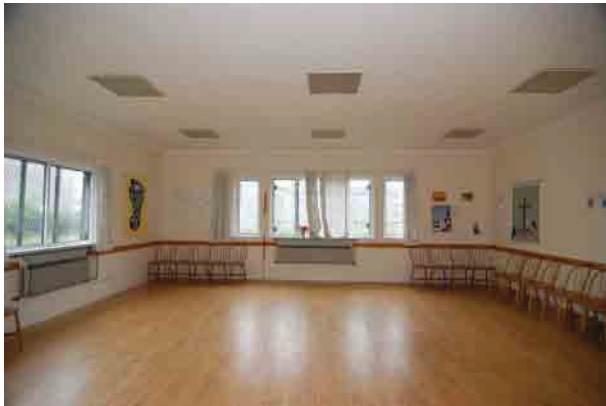
Fig. 12 Interior view of the Small Hall

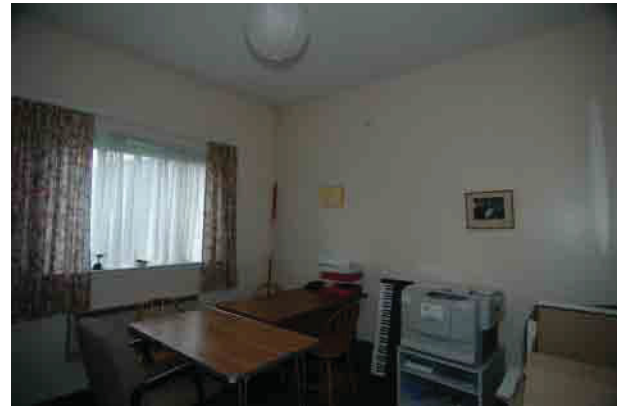
Fig. 13 General view of the Vestry

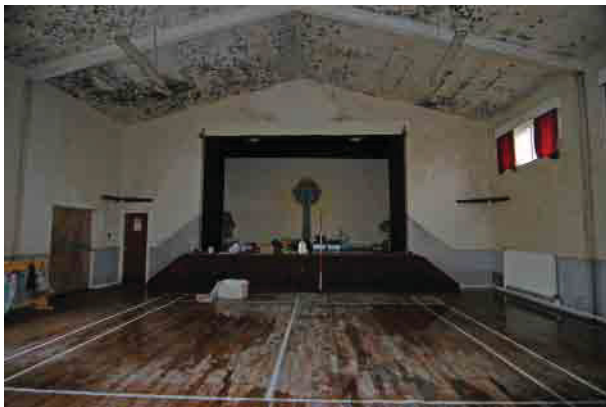
Fig. 14 South end of the Large Hall with wooden stage

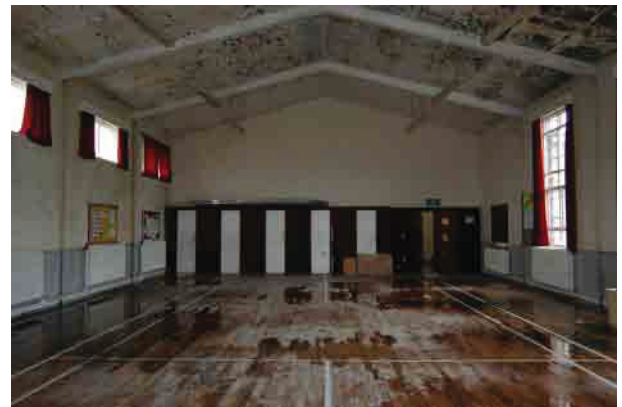
Fig. 15 North end of the Large Hall with lockers
