**Arcleoch Forest Wind Farm,
South Ayrshire**

**Programme of Archaeological
Mitigation Works**

Report no. 1637

Author	Phil Moore BA
Illustrator	Shelly Werner BA MPhil PhD
Editor	Bruce Glendinning BSc PgDip MifA
Commissioned by	ScottishPower Renewables
Date issued	December 2011
Version	0
Grid Ref	NX 173 791
OASIS ref	cfaarcha1-129197

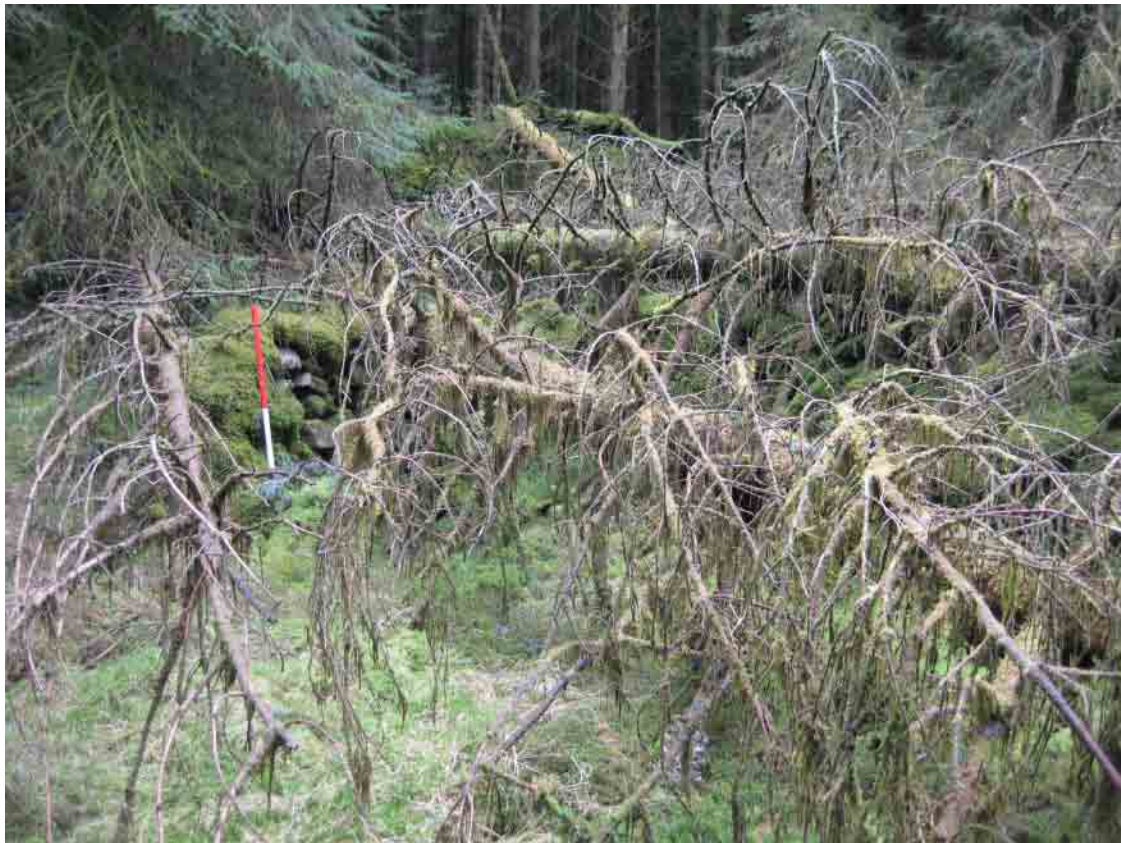
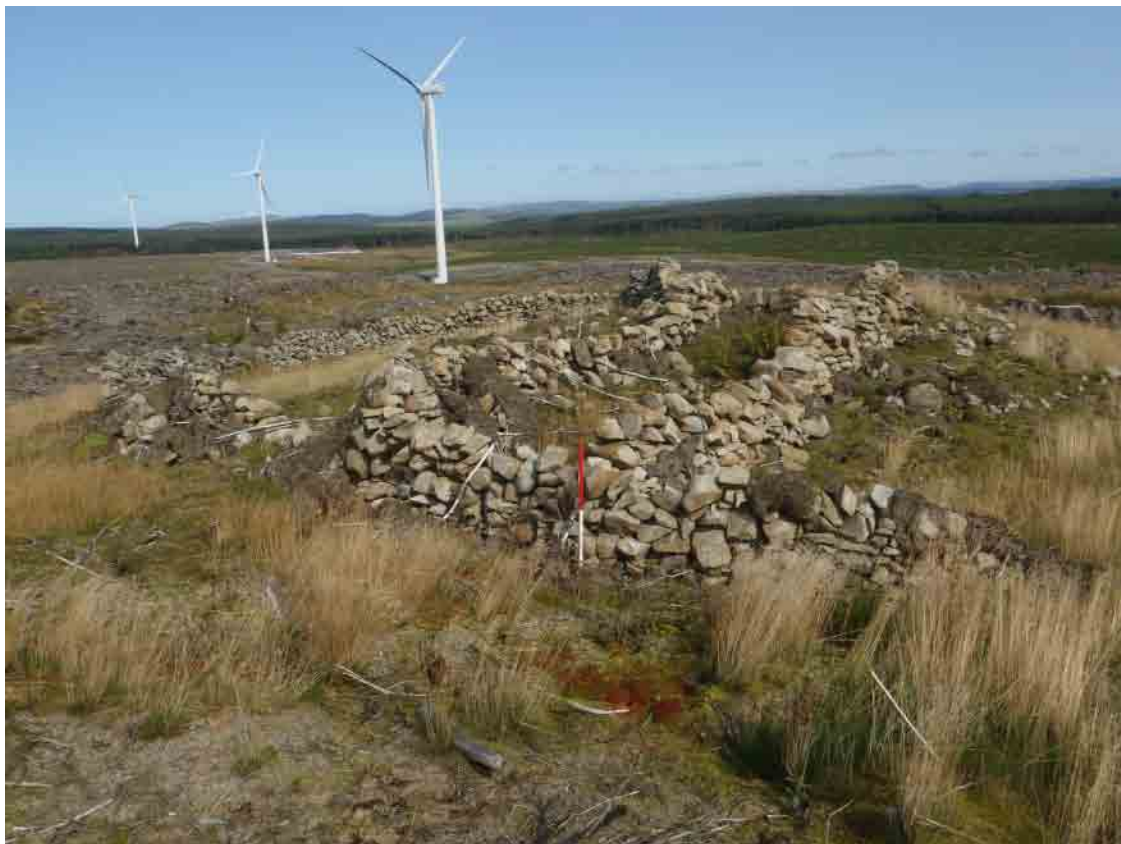
The 'Druids Cairn' (Fig. 3) was located and found as described in Appendix 1. Fencing with a 10m buffer zone was erected to protect the monument from damage during the felling process. CFA liaised on behalf of the client with WoSAS who advised that the area around the site should be felled with care. The felling of trees within the demarcation zone was done by hand and all trees outside the demarcation area were felled away from the site. The post-construction site visit confirmed that no damage had occurred to the monument (Fig. 4).

Fig 3 - Shot of Site 1 'Druids Cairn' during demarcation works

Fig 4 - Shot of Site 1 'Druids Cairn' after windfarm construction

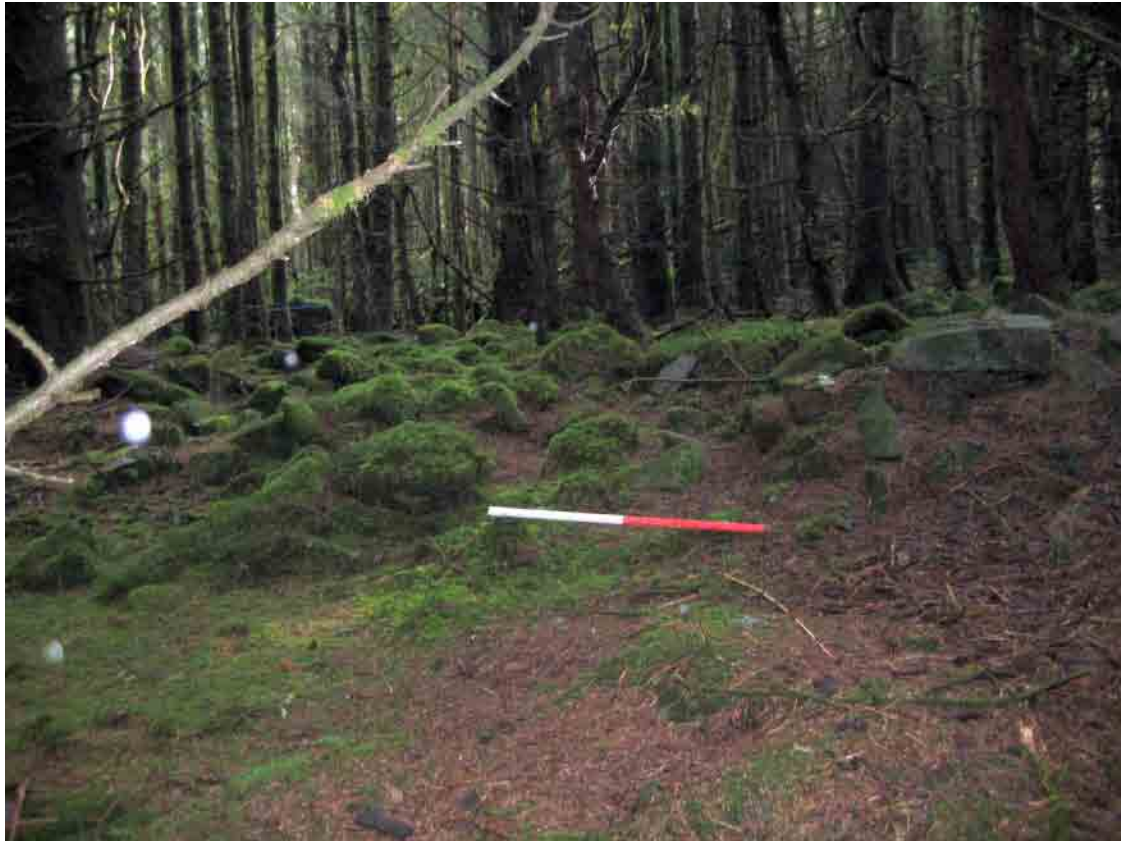
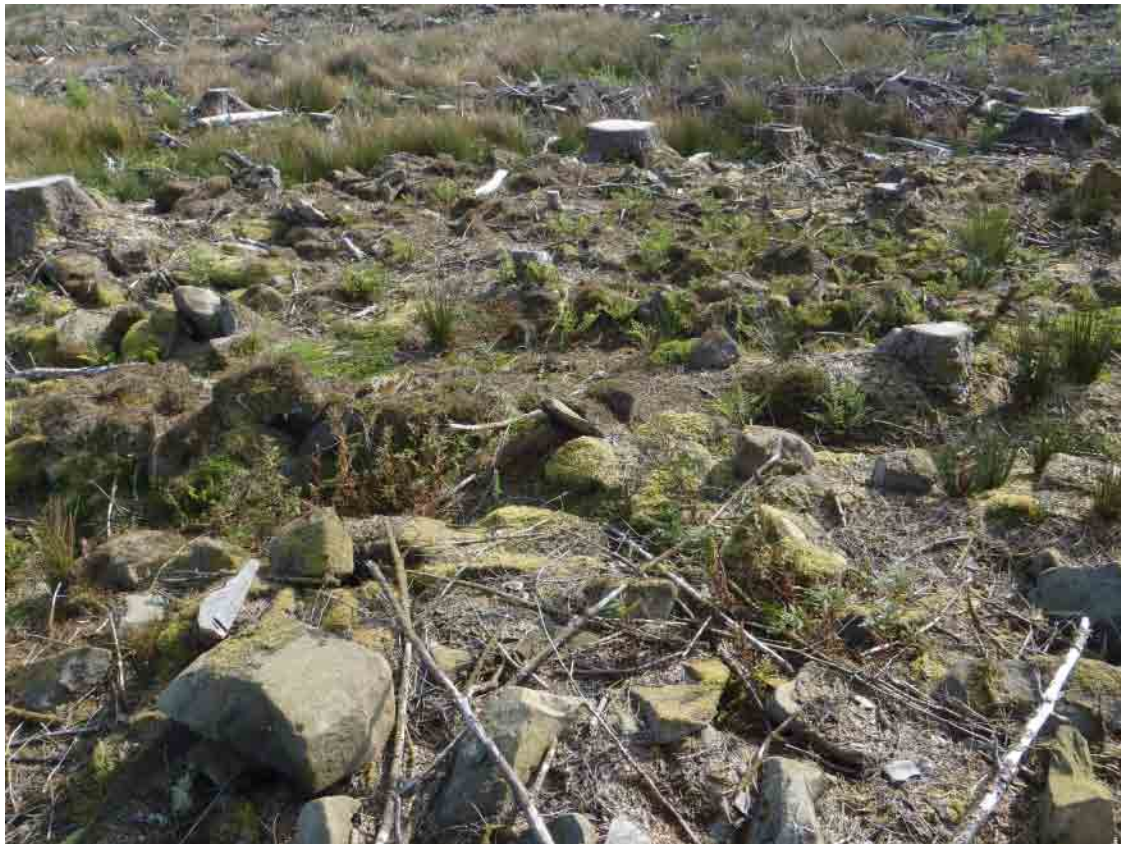
The fragmentary and very badly damaged remains of a field boundary and associated structure were located in dense forest (Fig. 5). The field boundary comprised low relief, fragmentary stonework, whilst the structure was only discernible as a badly denuded rubble scatter. Both sets of remains were fenced off as they lay within an area of proposed deforestation. CFA liaised on behalf of the client with WoSAS who advised that felling should proceed with care around the site. All trees within the buffer zone were either felled by hand or reached by forestry machinery from outside the buffer zone. The post-construction site visit confirmed that no damage had occurred to the remains (Fig. 6).

Fig 5 - Shot of Site 4 during demarcation works

Fig 6 - Shot of Site 4 after wind farm construction

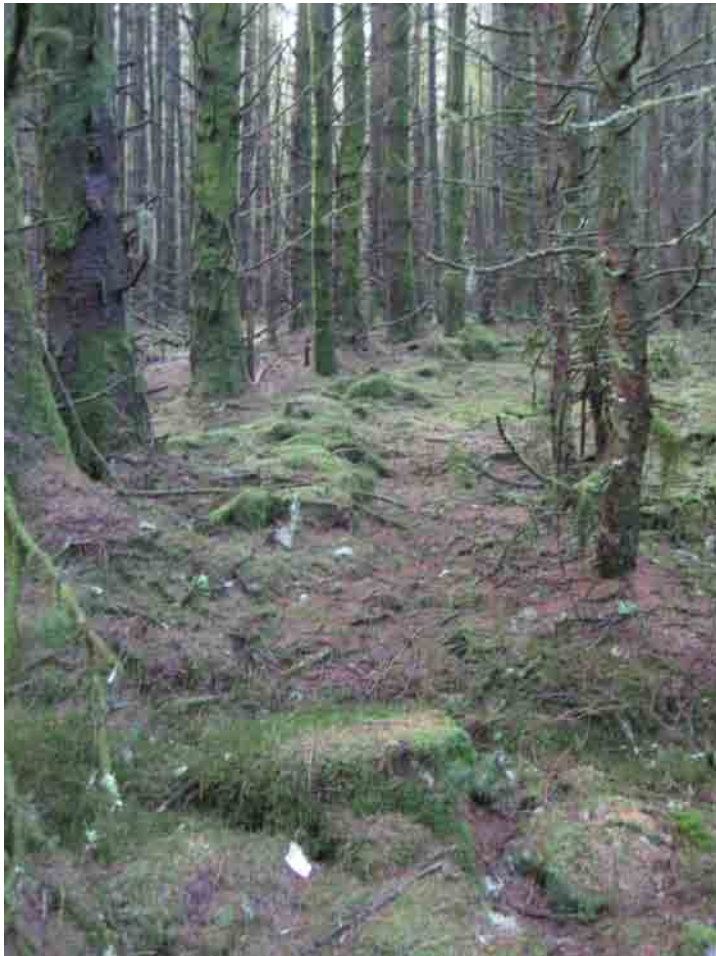
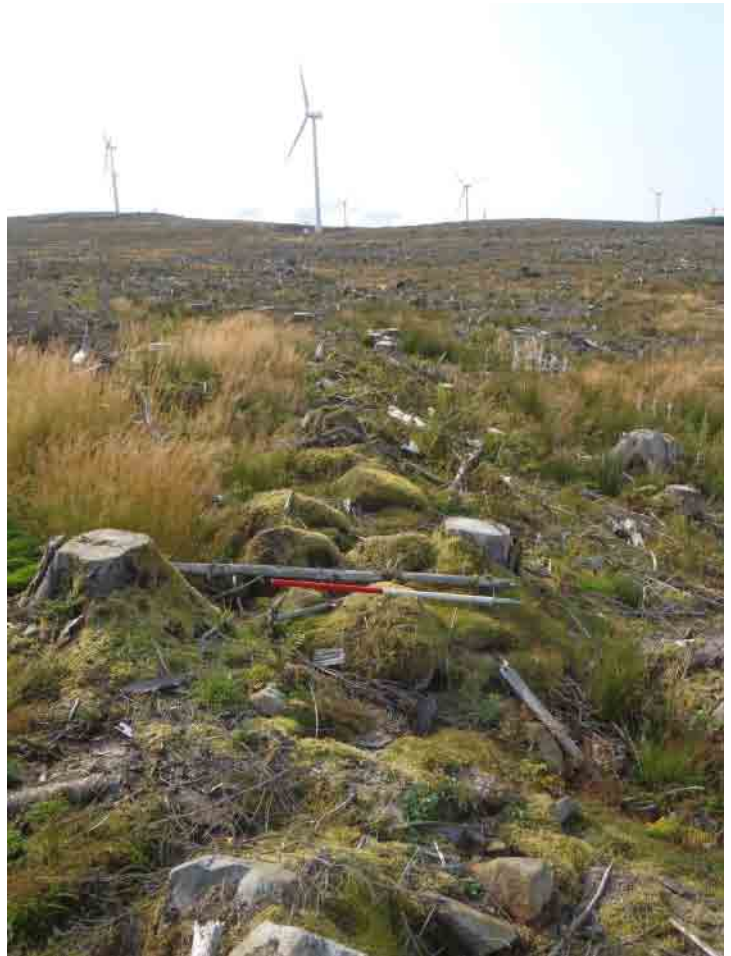
Described in the ES as an unroofed structure attached to a field, the only tangible remains of this site located by the field visit were the fragmentary rubble spreads of the denuded line of the field boundary. These remains were demarcated as the site lay within an area of proposed felling activity (Fig. 7). Windblown trees covered some of the remains and CFA liaised on behalf of the client with WoSAS regarding their removal. It was agreed that the windblown trees would need to be dragged out of the area in such a manner so as not to cause any damage to the site. To gain access to the site it was agreed that a brash mat would be used so that the machine could cross a

section of the upstanding wall without causing any damage. The post-construction site visit confirmed that no damage had occurred to the remains (Fig. 8).

Fig 7 - Shot of Site 5 during demarcation works

Fig 8 - Shot of Site 5 after wind farm construction

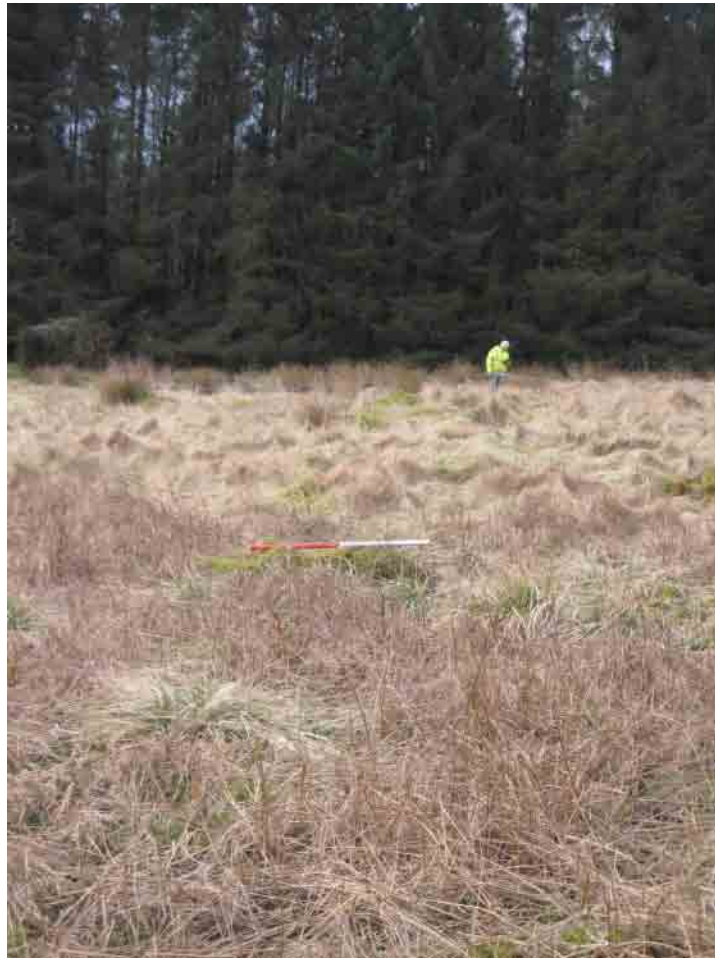
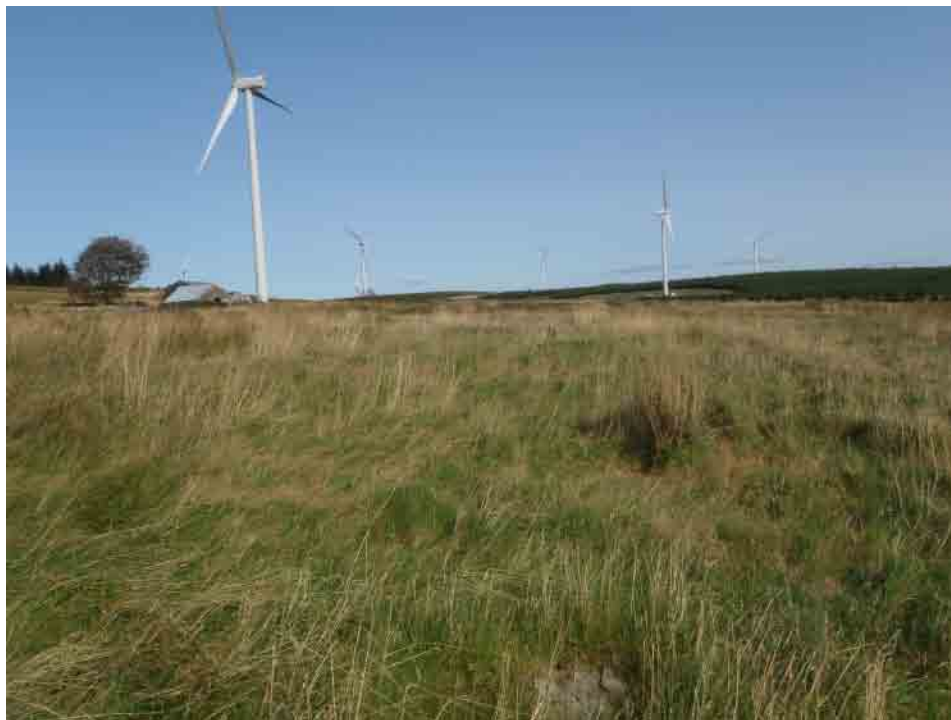
The field survey located the scant remains of a stock enclosure represented by a vestigial spread of rubble obscured by vegetation (Fig. 9). These remains were fenced off as they lay within 50 metres of an access road which required improvement. The post-construction site visit confirmed that no damage had occurred to the remains (Fig. 10).

Fig 9 - Shot of Site 7 during demarcation works

Fig 10 - Shot of Site 7 after wind farm construction

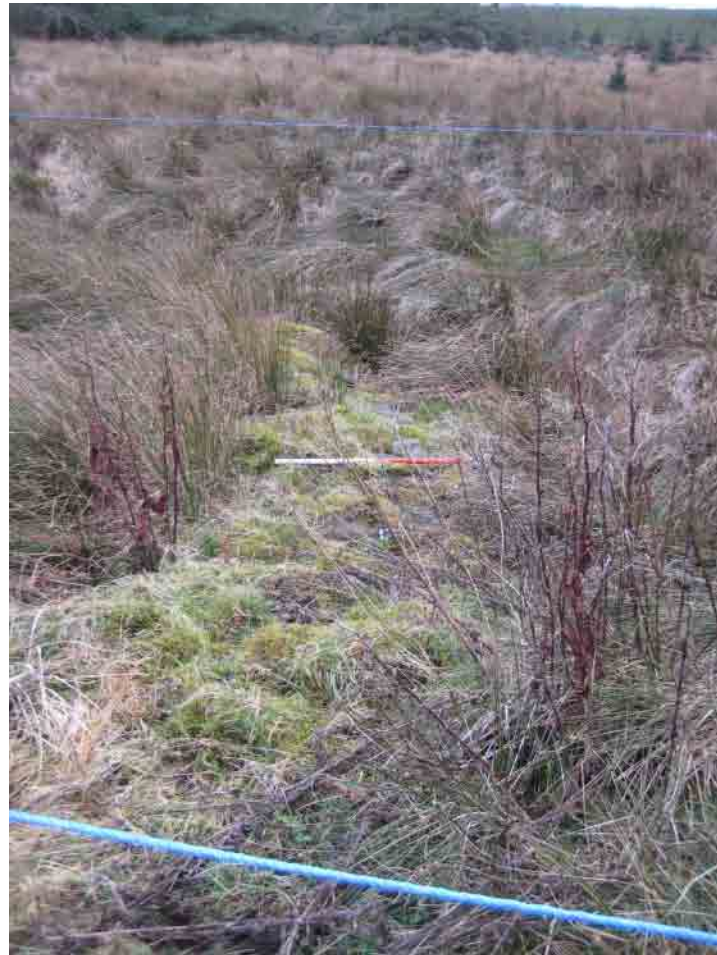
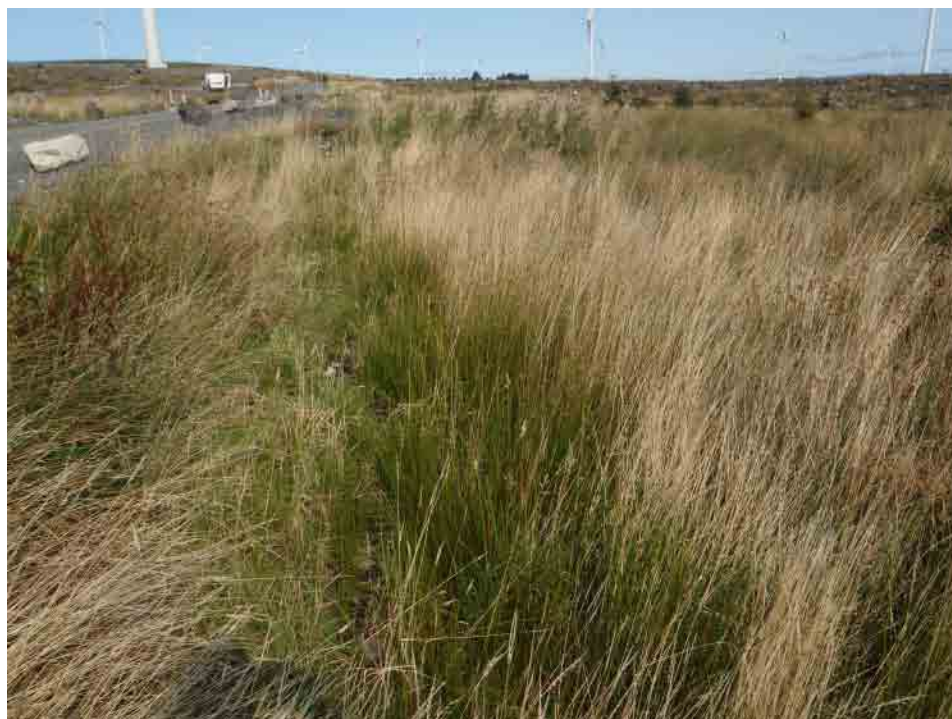
The remains of a probable sheepfold (Fig. 11) were located as described by the ES. The western extent of the structure had been destroyed by earlier development not associated with Arecleoch Wind Farm. A fenced buffer zone was erected around the remaining structure. The post-construction site visit confirmed that no damage had occurred to the remains (Fig. 12).

Fig 11 - Shot of Site 8 during demarcation works

Fig 12 - Shot of Site 8 after wind farm construction

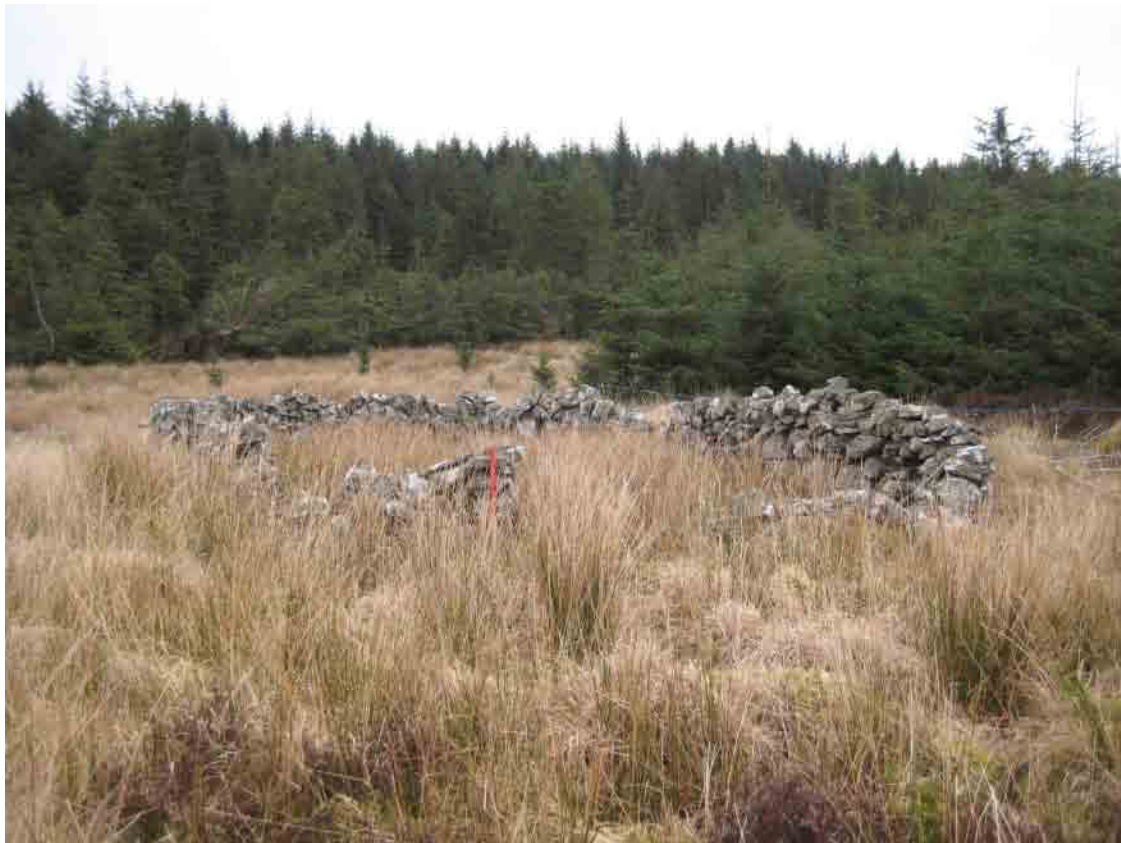
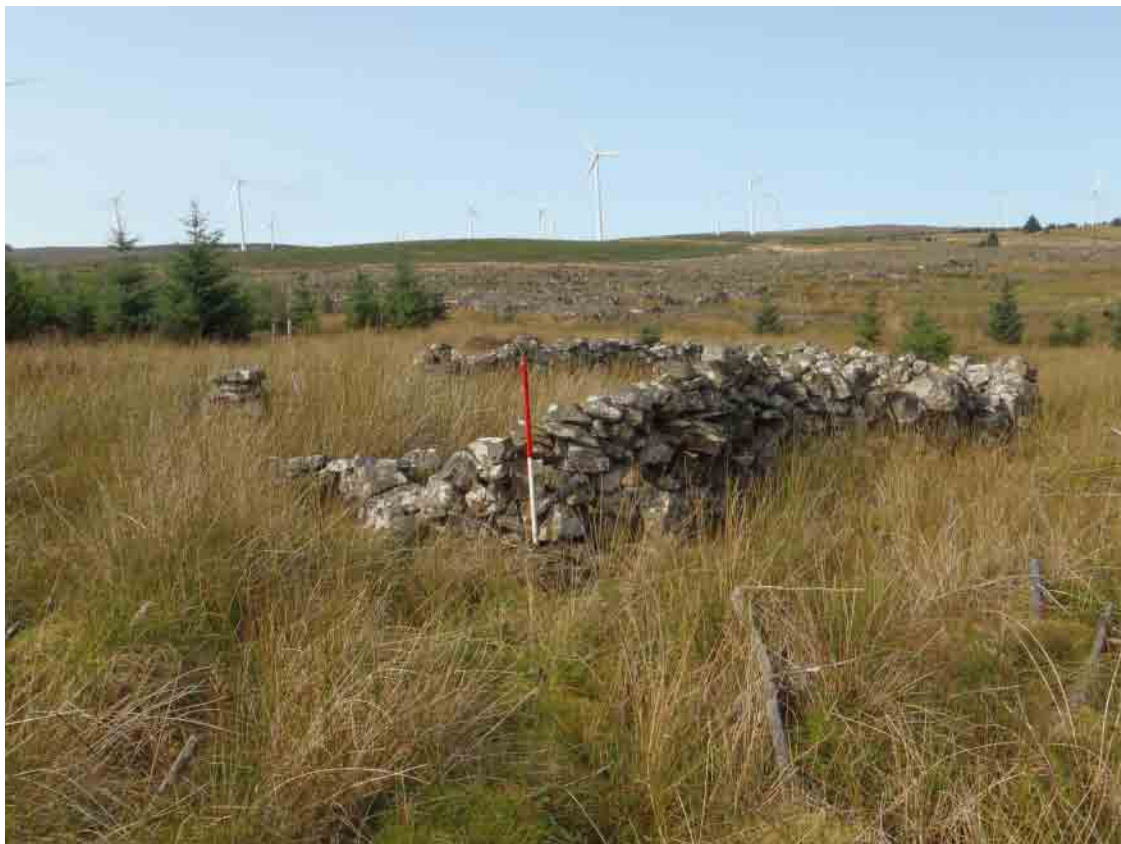
The site of a 'Hay Ree' (Fodder Barn) and small section of drystone wall was located and fenced off with a 10 metre buffer zone (Fig. 13). The site was found in good overall condition as described in the ES. The post-construction site visit confirmed that no damage had occurred to the remains (Fig. 14).

Fig 13 - Shot of Site 9 during demarcation works

Fig 14 - Shot of Site 9 after wind farm construction

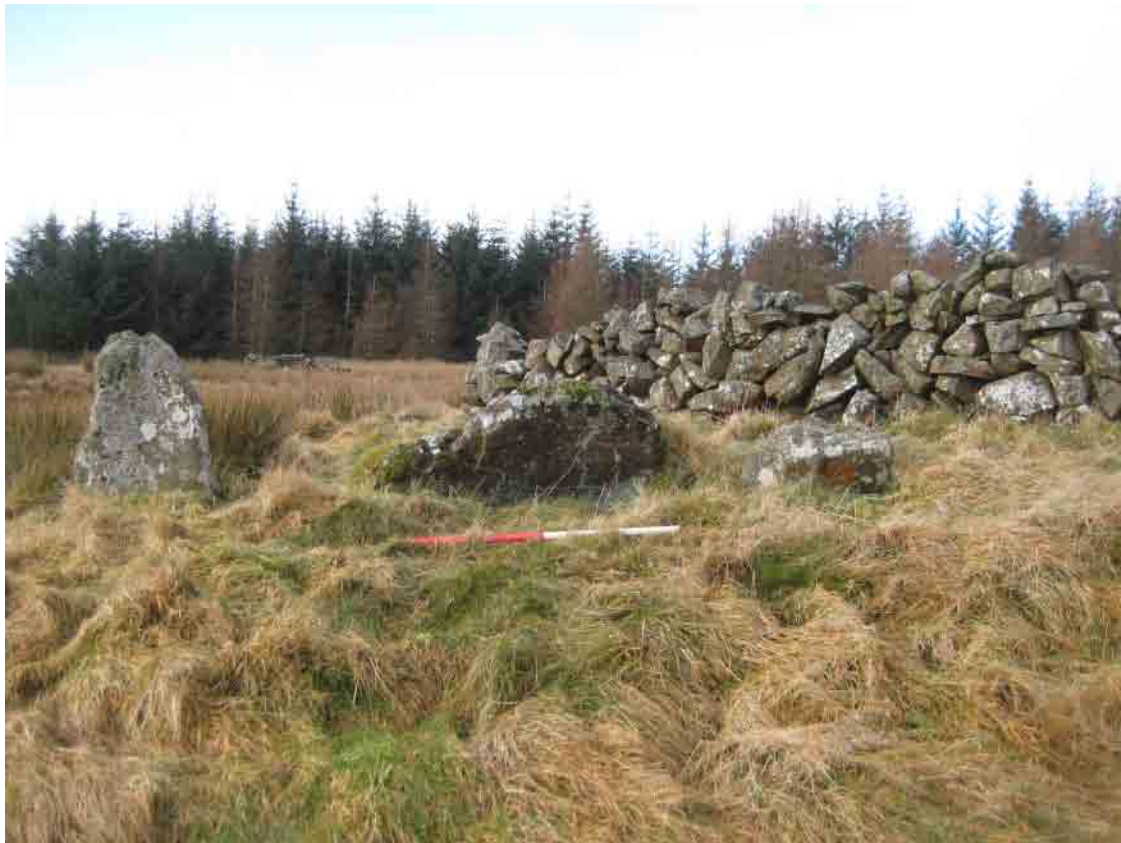
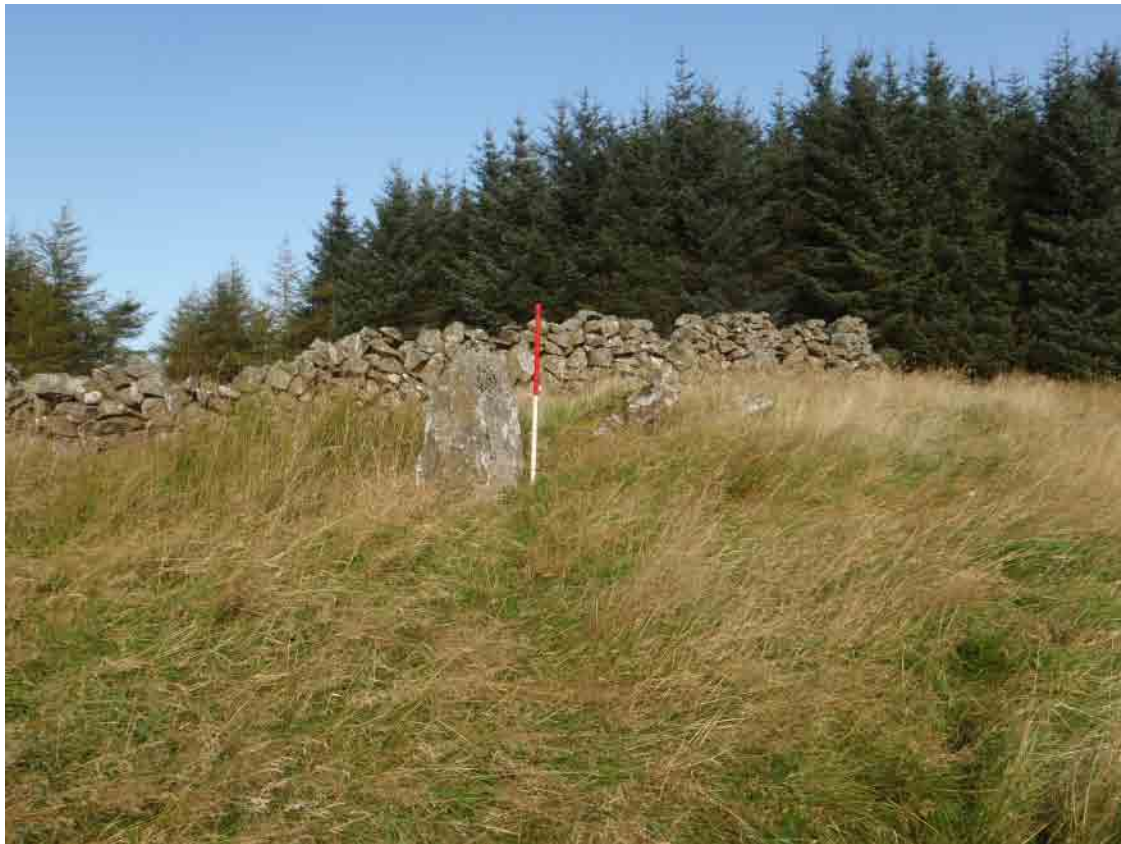
This group of sites was clustered to the north of the Arecleoch Wind Farm (Fig. 15). Sites 27 and 84 were fenced off and a 10 metre buffer zone was erected around these monuments. Field survey was unable to locate Site 26, although the grid reference given by the ES fell within the curtilage of the already demarcated area, and therefore the location was deemed to be protected. The post-construction site visit confirmed that no damage had occurred to the remains (Fig. 16).

Fig 15 - Shot of Sites 27, 84 & 26 during demarcation works

Fig 16 - Shot of Sites 27 & 84 façade and sheepfold after wind farm construction

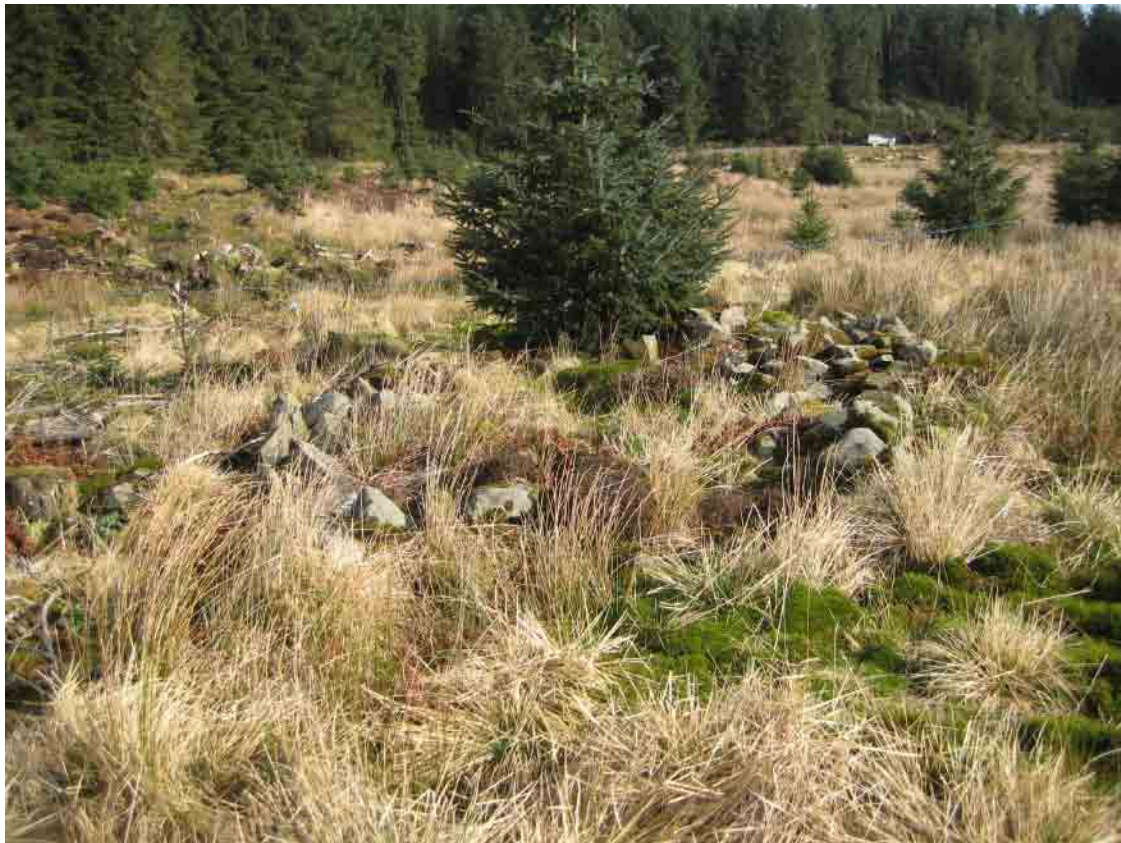
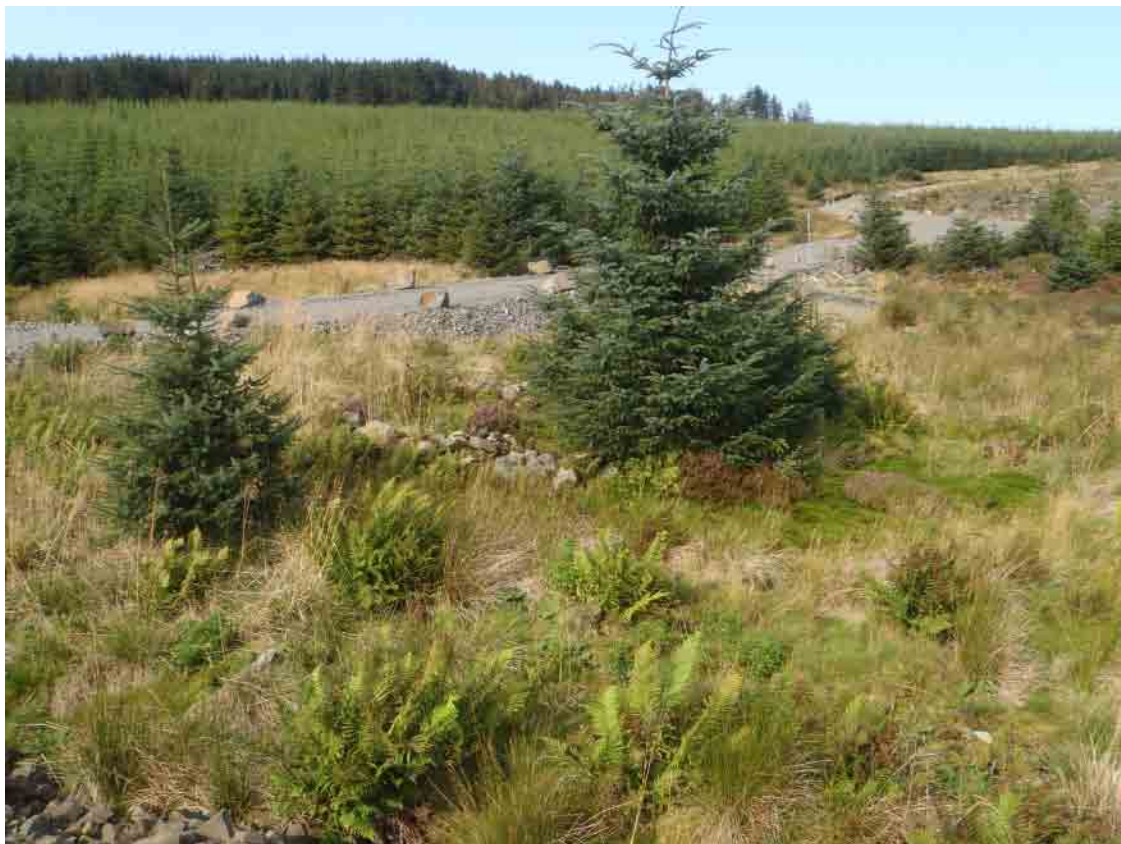
The ruins of a 'Hay Ree' (Fig. 17) were fenced off at the location given by the ES. The post-construction site visit confirmed that no damage had occurred to the remains (Fig. 18).

Fig 17 - Shot of Site 36 during demarcation works

Fig 18 - Shot of Site 36 after wind farm construction

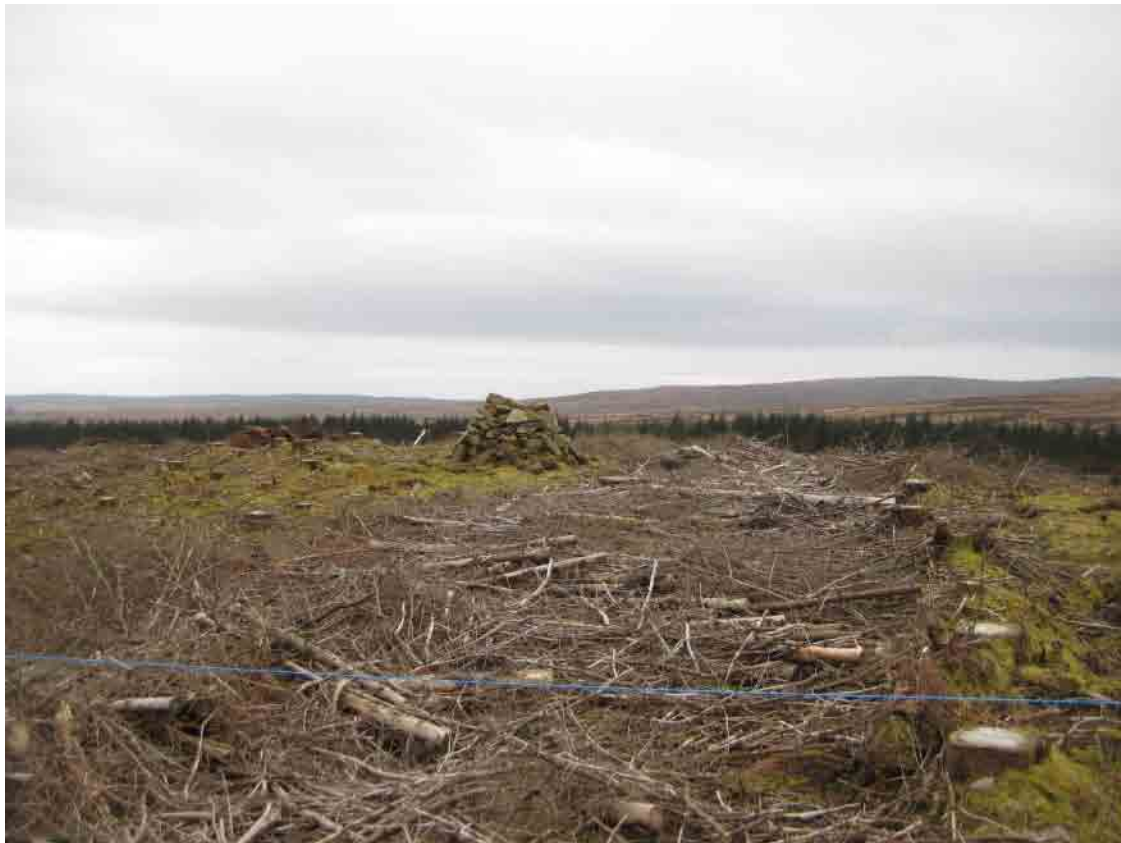
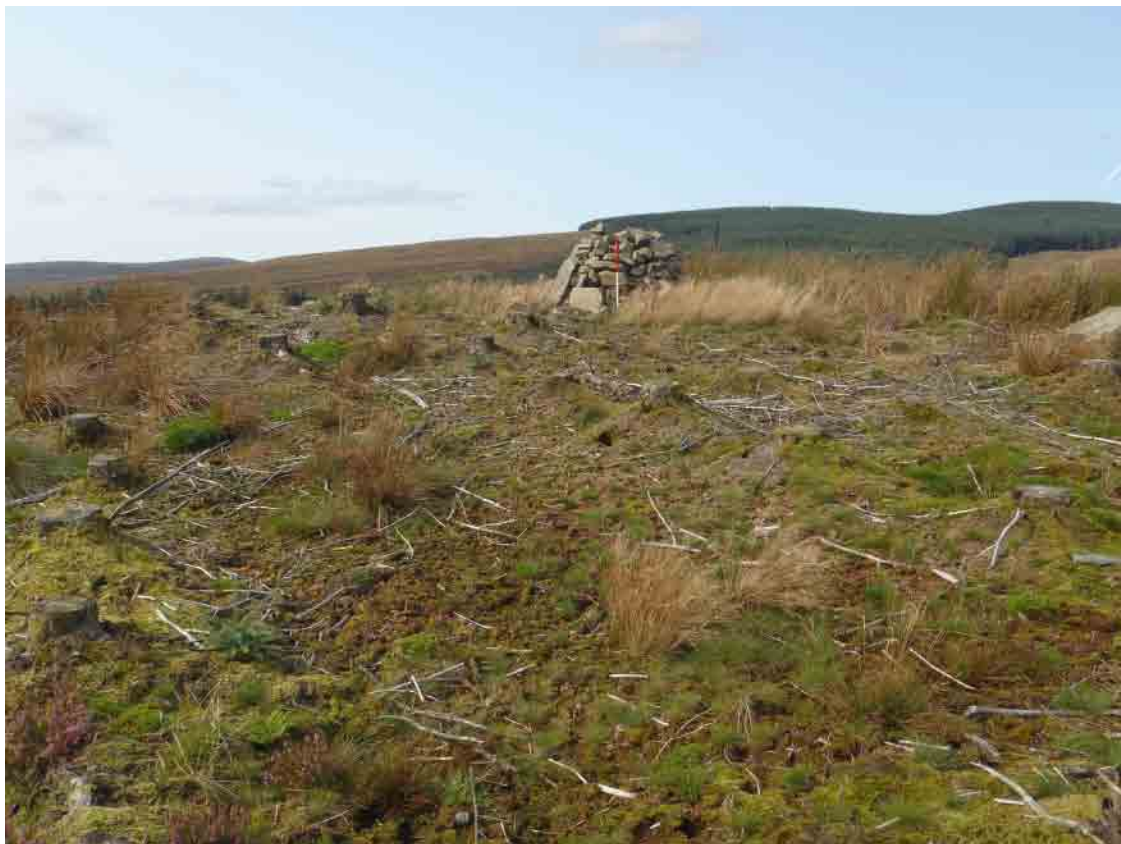
A kerbed cairn surmounted by a modern cairn was within 50m of felling activity. Field survey revealed the area had already been deforested by the Forestry Commission in 2008 (Fig. 19). The curtilage of the kerbed cairn, although heavily disturbed by plantation, was cordoned off including a 10 metre buffer zone. The visual inspection conducted by field survey confirmed the modern cairn survived in good condition. However, the perimeter of the kerbed cairn had been heavily truncated by commercial forestry ploughing prior to the Arecleoch Wind Farm application. The

post-construction site visit confirmed that no further damage had occurred to the remains (Fig. 20).

Fig 19 - Shot of Site 37 during demarcation works

Fig 20 - Shot of Site 37 after wind farm construction

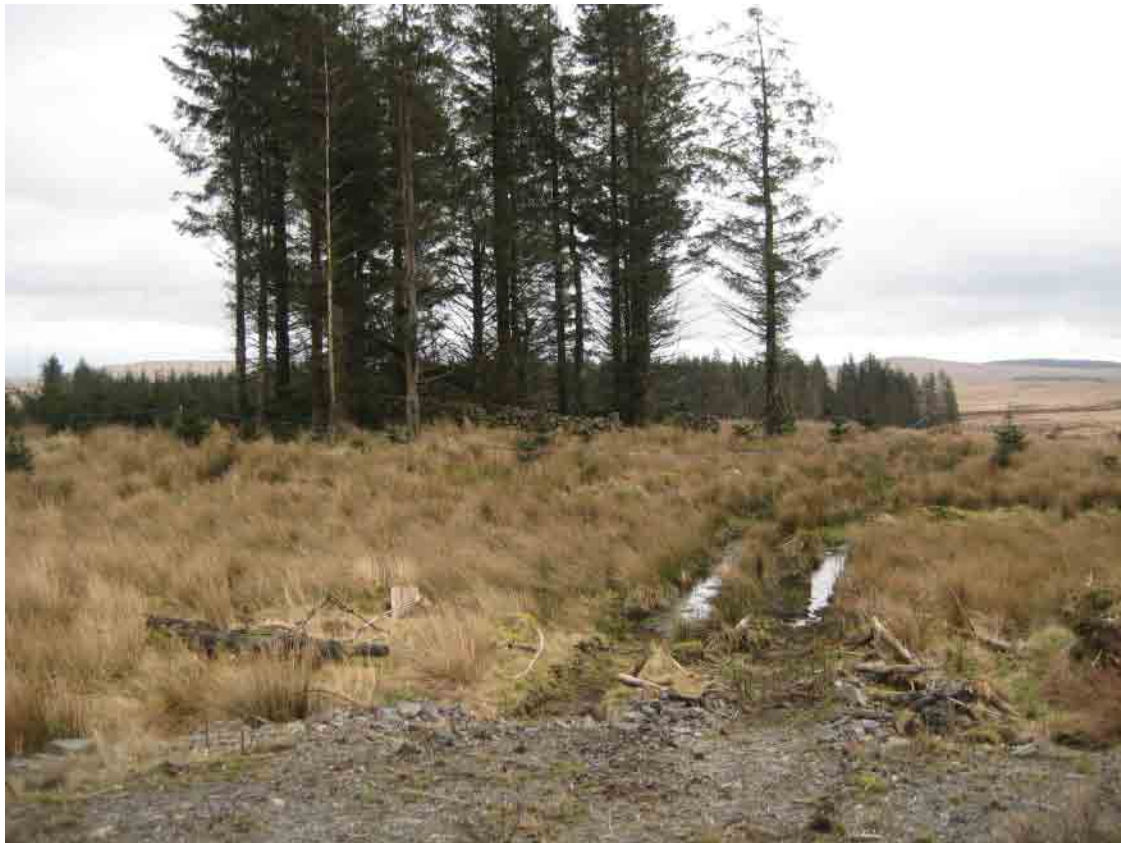
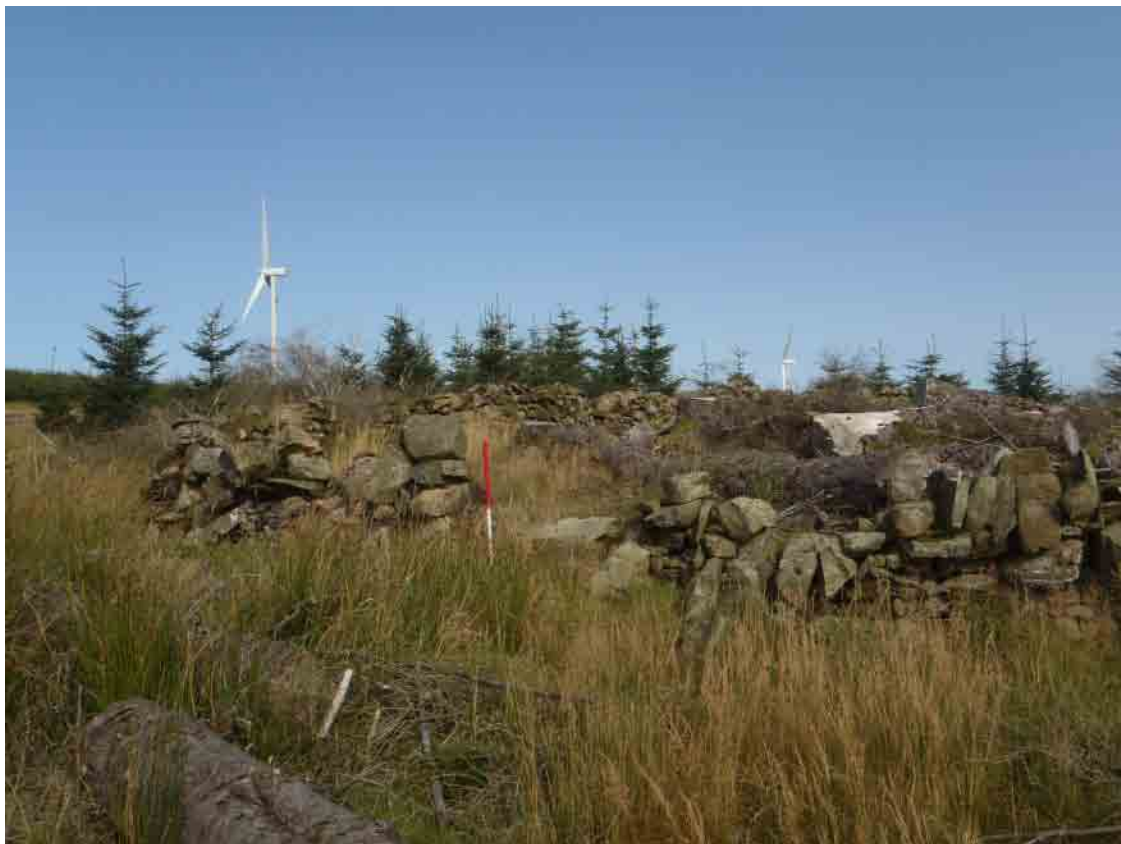
The well preserved remains of a sheepfold were fenced off due to the close proximity of T2 and the proposed improvement of an access track which passed to the north of this location (Fig. 21). Field survey noted the area around the site, which fell within the clearance circumference of T2, had already been felled by commercial forestry activity. A number of windblown trees had fallen into the interior of the site and these were removed in a controlled manner under archaeological supervision (Fig. 32). The post-construction site visit confirmed that no damage had occurred to the remains (Fig. 22).

Fig 21 - Shot of Site 81 during demarcation works

Fig 22 - Shot of Site 81 after wind farm construction

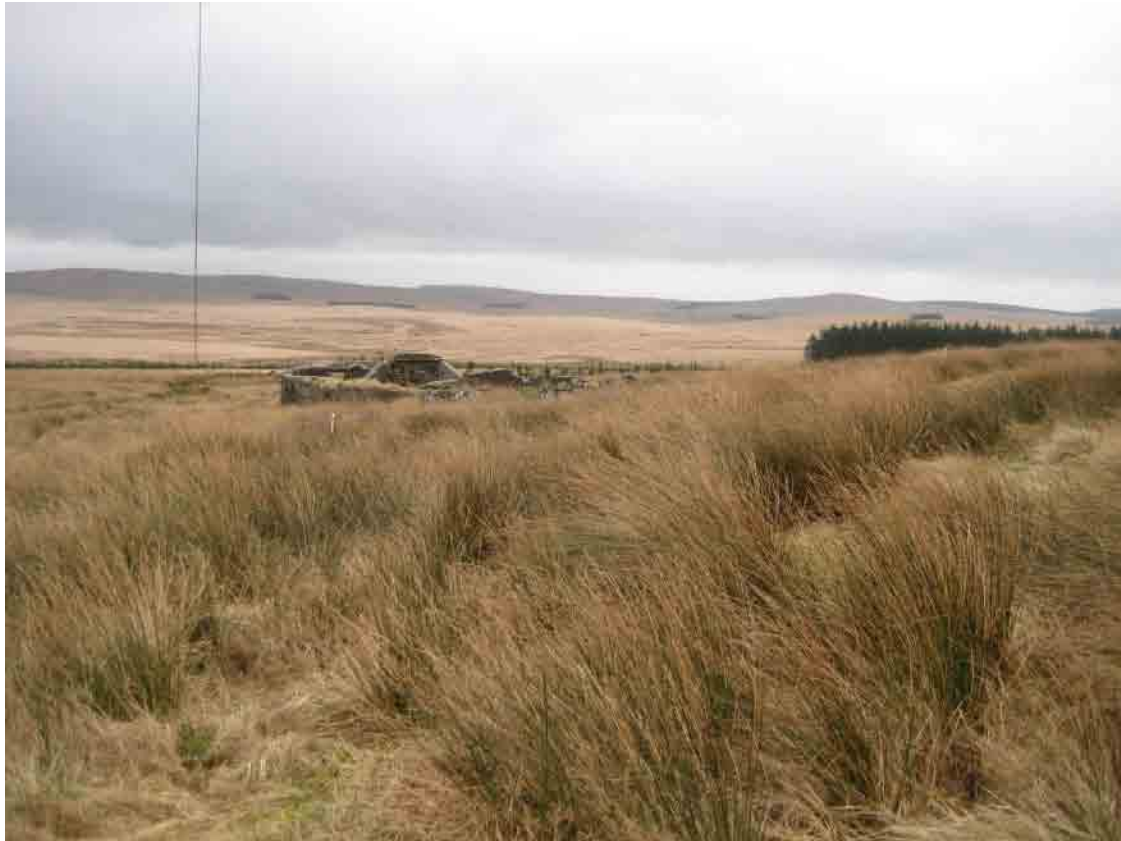
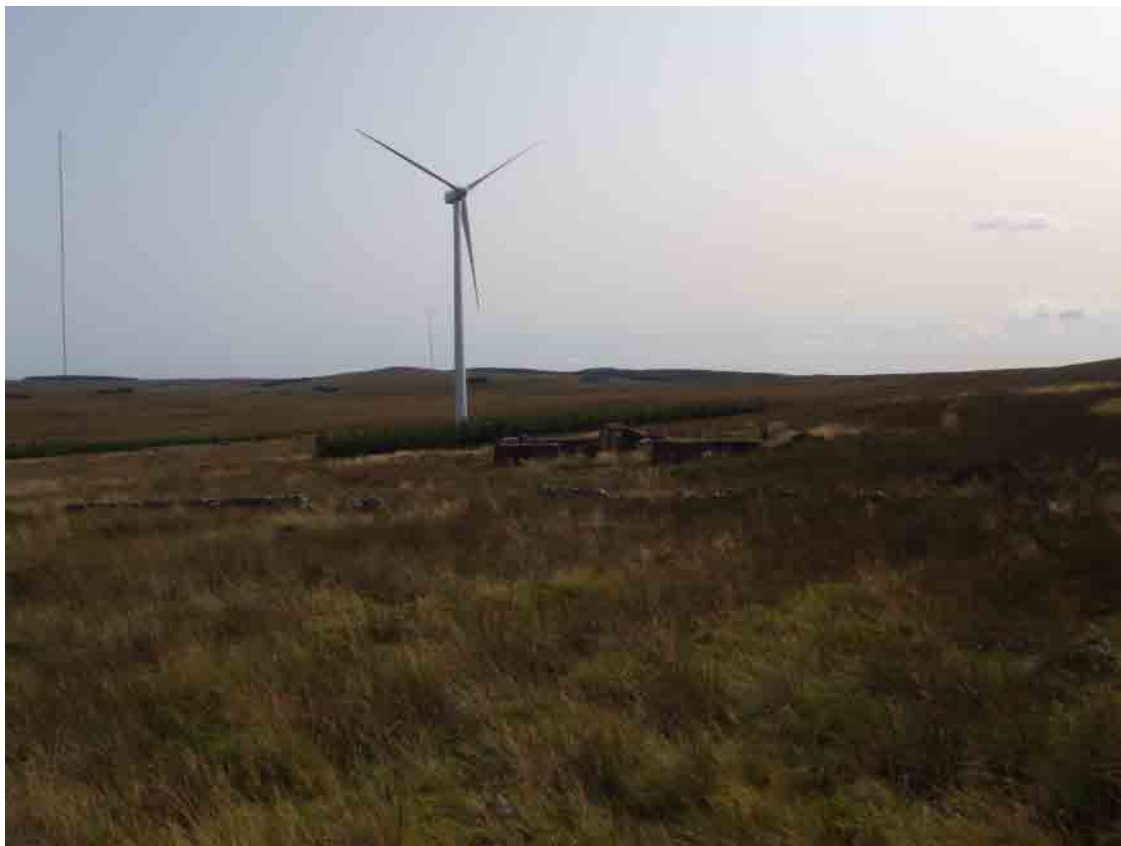
The upstanding remains of Site 82, which comprised two structures and a series of smaller enclosures (Sites 38 & 39), were fenced off with a 10 metre buffer zone (Fig. 23). The site was within 50 metres of a proposed access track which passed to the north of this location. The main farmstead site was not affected but the construction of the access road and a cable trench in this area required the localised removal of a small section of a drystone field boundary. This was a linear feature and only a 6m section of wall was removed under watching brief conditions (Fig. 24).

Fig 23 - Shot of Sites 82, 38 & 39 during demarcation works

Fig 24 - Shot of Sites 82, 38 & 39 after wind farm construction
