**Arcleoch Forest Wind Farm,
South Ayrshire**

**Programme of Archaeological
Mitigation Works**

Report no. 1637

Author	Phil Moore BA
Illustrator	Shelly Werner BA MPhil PhD
Editor	Bruce Glendinning BSc PgDip MifA
Commissioned by	ScottishPower Renewables
Date issued	December 2011
Version	0
Grid Ref	NX 173 791
OASIS ref	cfaarcha1-129197

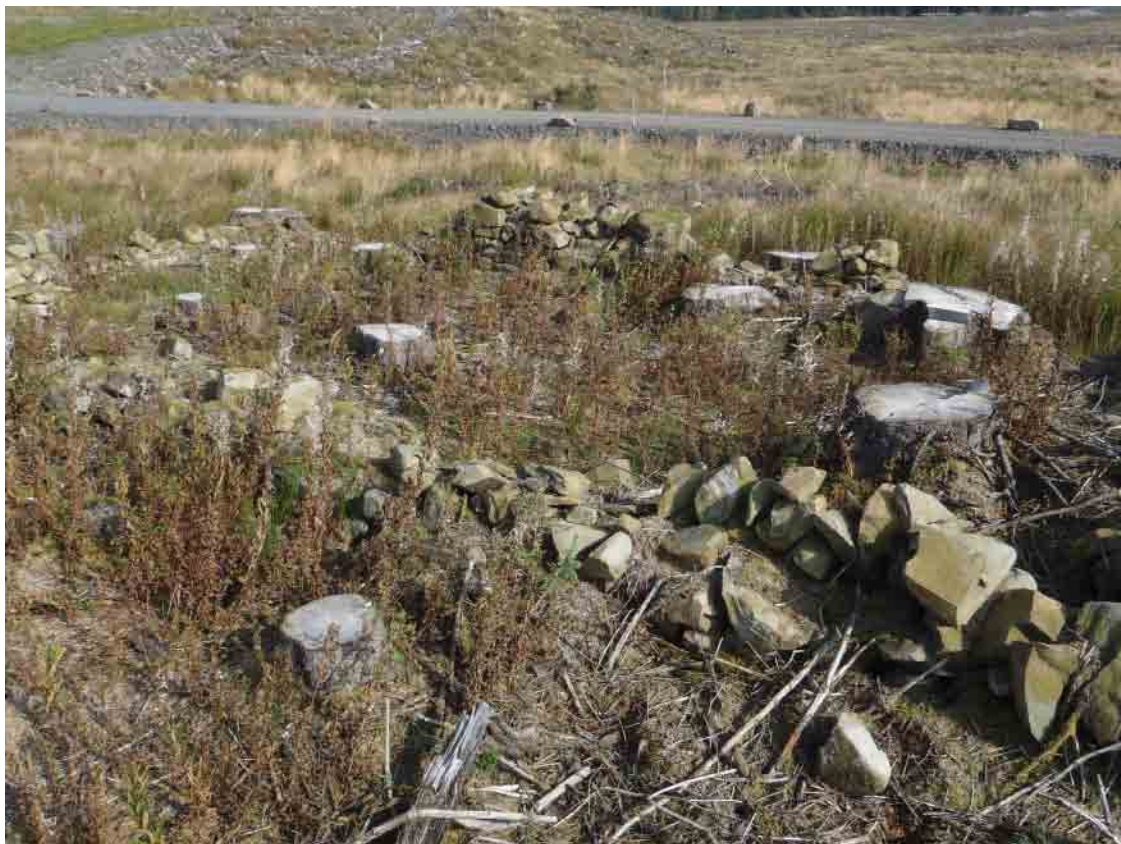
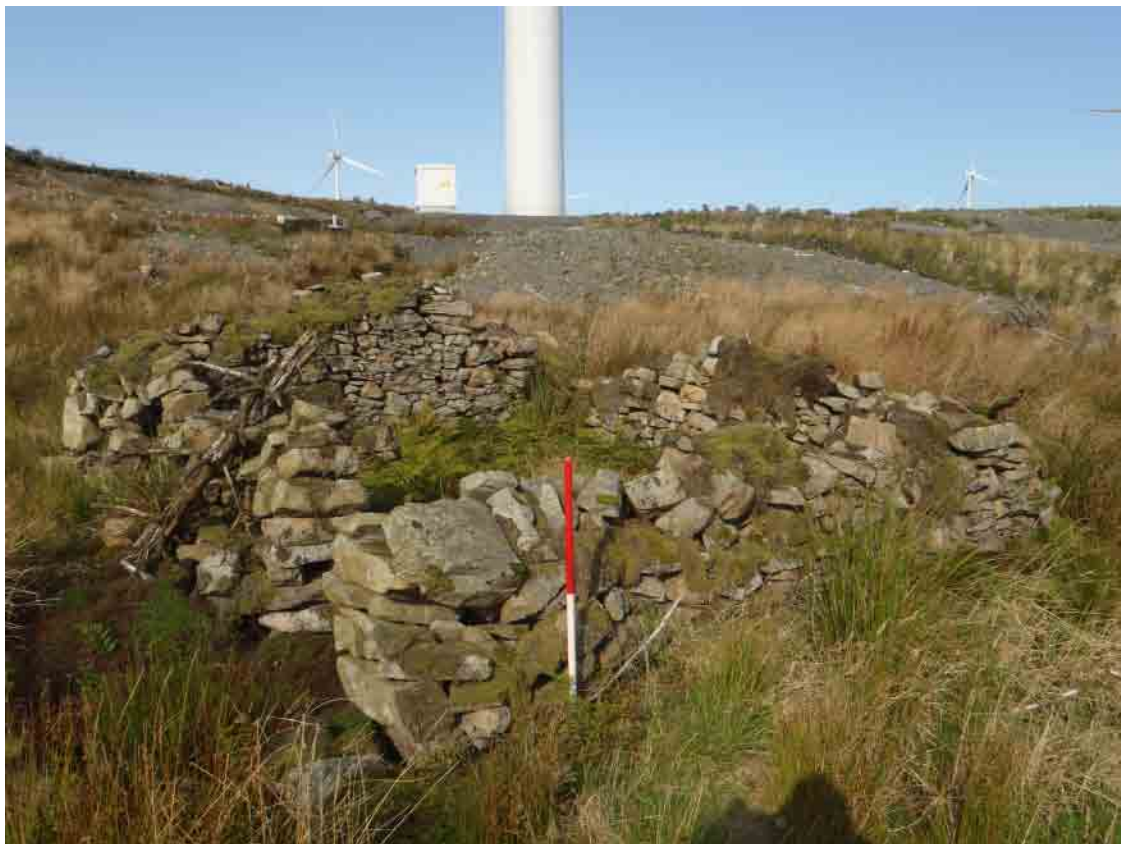
CFA liaised with WoSAS on a suitable scheme of mitigation. It was decided to remove sections of the drystone wall that would be unavoidably damaged by the felling under archaeological supervision prior to felling taking place. However, due to health and safety issues, this was not possible. The felling operations removed a section of the walling and the resulting section was then cleaned and recorded; this proved the wall be of simple drystone construction. The post-construction site visit confirmed that construction had had no further affect on the remains (Fig. 29, 31). Site CFA12 was not affected.

Fig 29 - Shot of Site CFA 11 after wind farm construction

Fig 31 - Shot of Site CFA 12 after wind farm construction

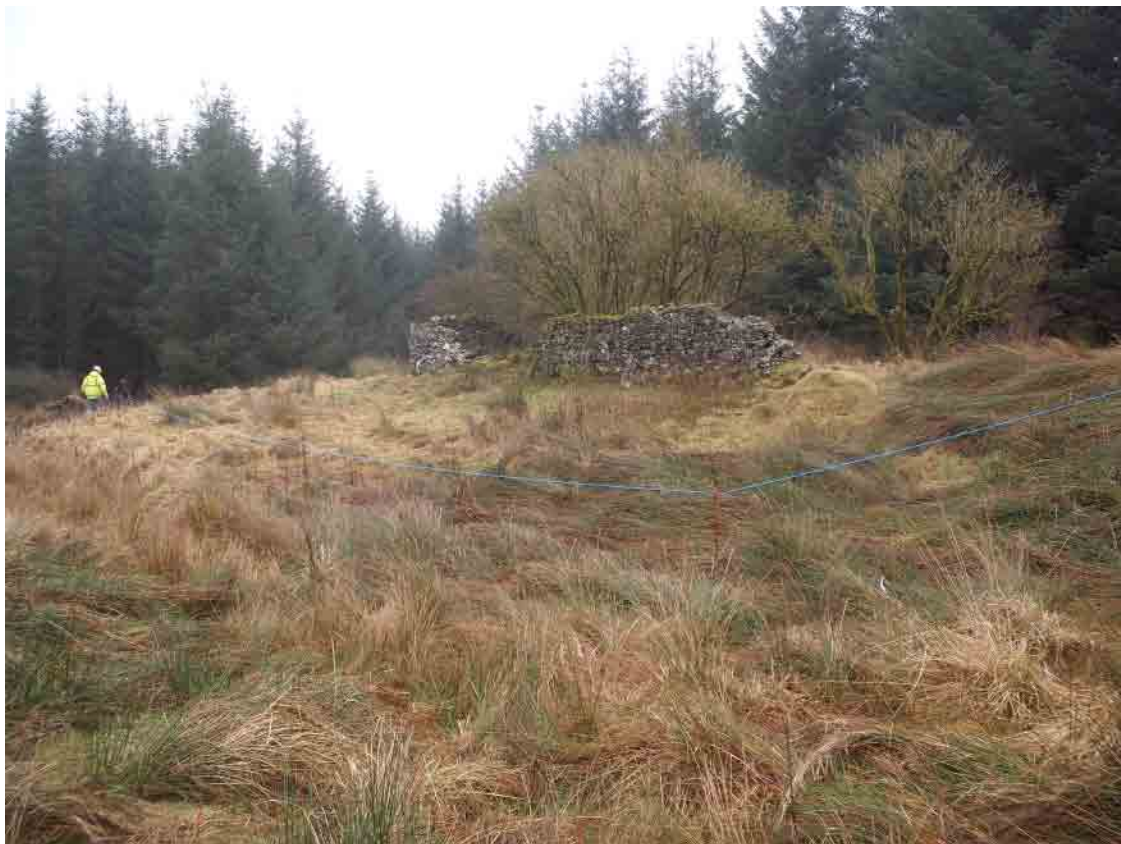
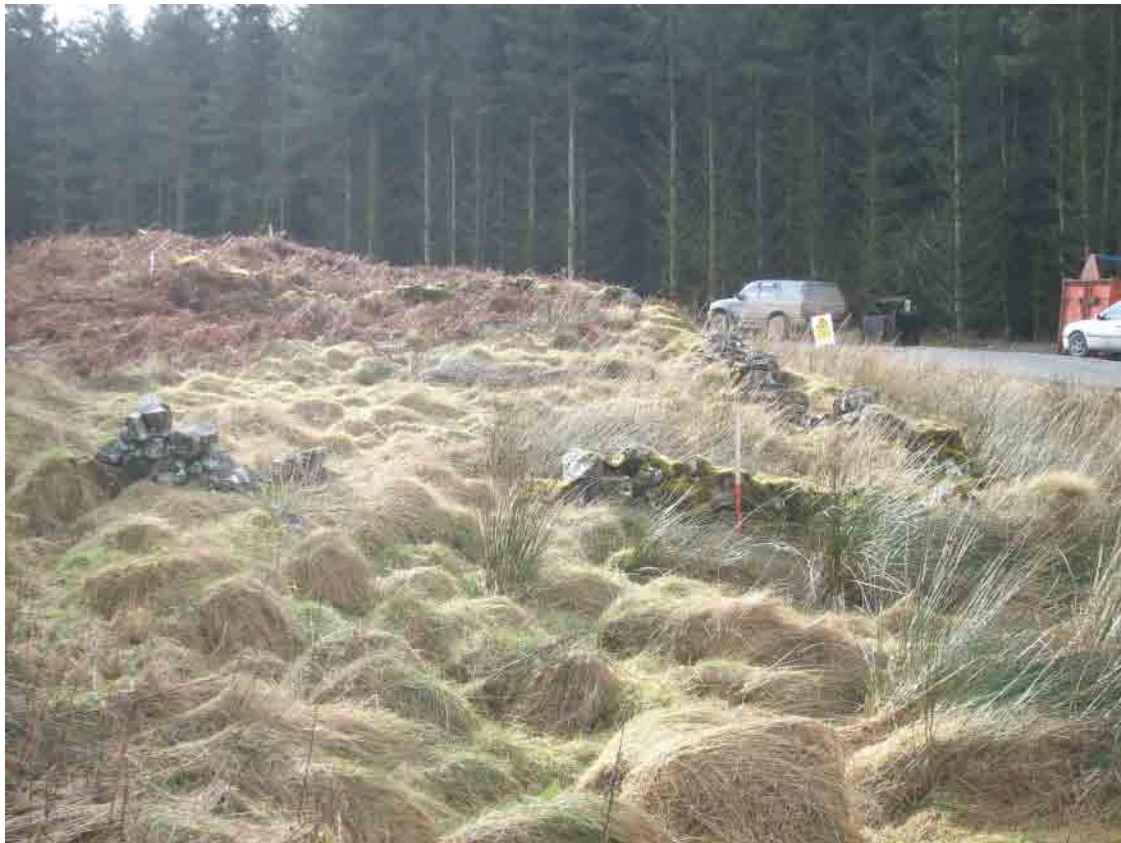
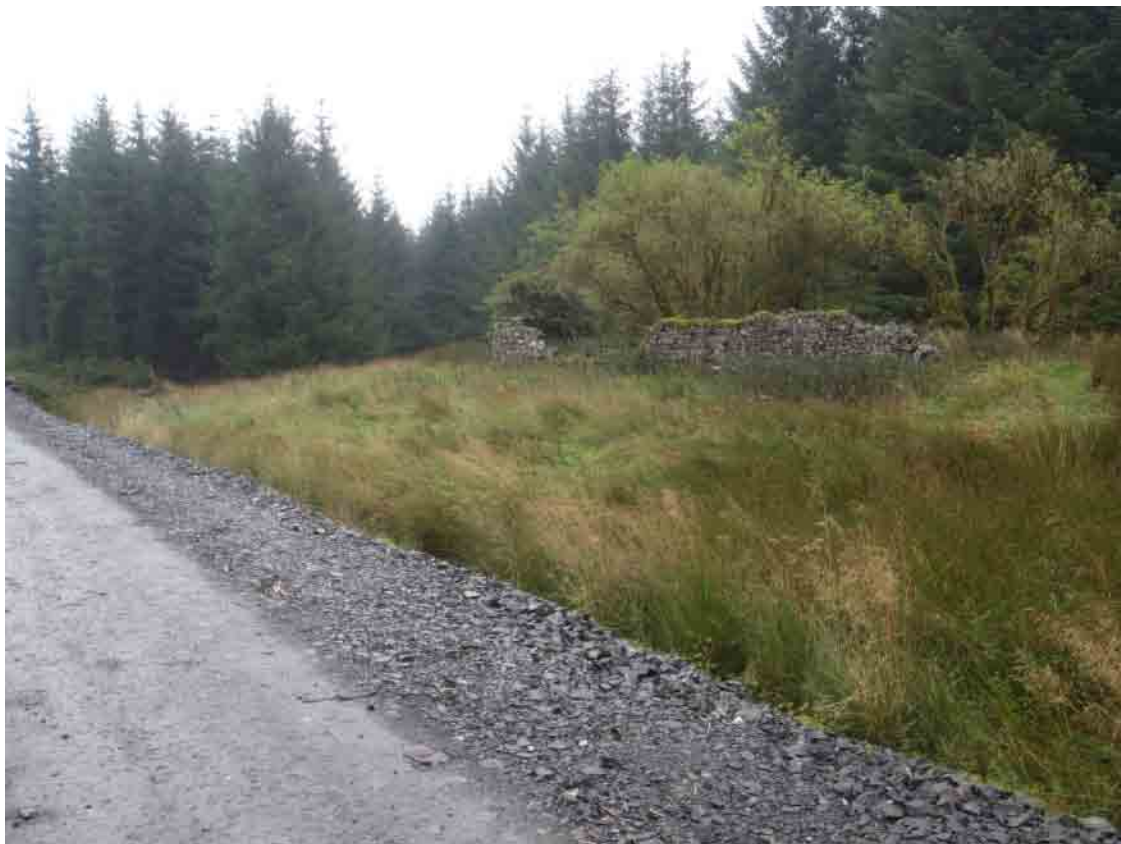
The desk-based assessment identified the remains of a series of ruinous structures and enclosures associated with the Farmstead of 'Craigs' or 'Halfmerk' (Fig. 33-34). These remains were fenced off by CFA as per the WSI due to the close proximity of felling activity and the proposed location of Borrow Pit 1; no further mitigation was required in this location. The post-construction site visit confirmed that no damage had occurred to the remains (Fig. 35).

Fig 33 - Shot of Site CFA 1 'Halfmerk' during demarcation works

Fig 34 - Shot of Site CFA 1 enclosure during demarcation works

Fig 35 - Shot of Site CFA 1 after wind farm construction

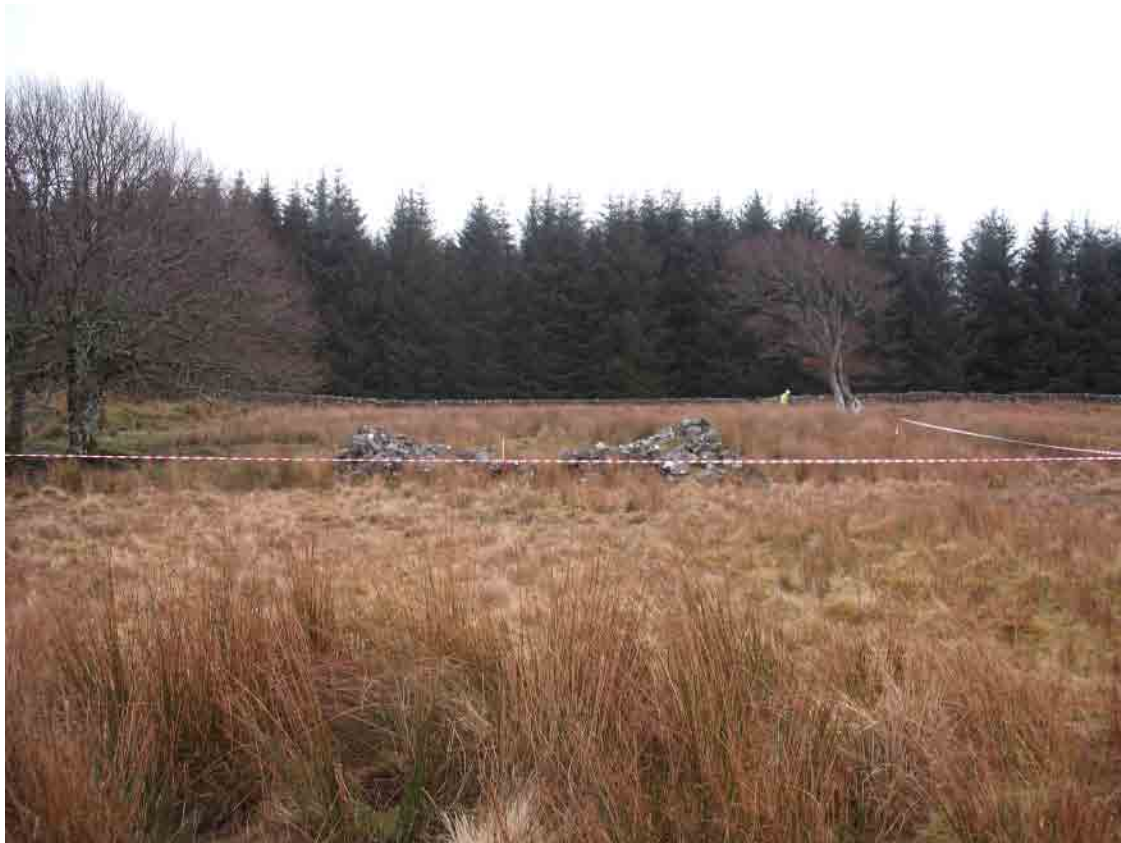
The remains of a single ruinous structure with an associated enclosure were identified and fenced off as a precaution (Fig. 38). No further mitigation was required at this location and the post-construction site visit confirmed that no damage had occurred to the remains.

Fig 38 - Shot of Site CFA 2 during demarcation works

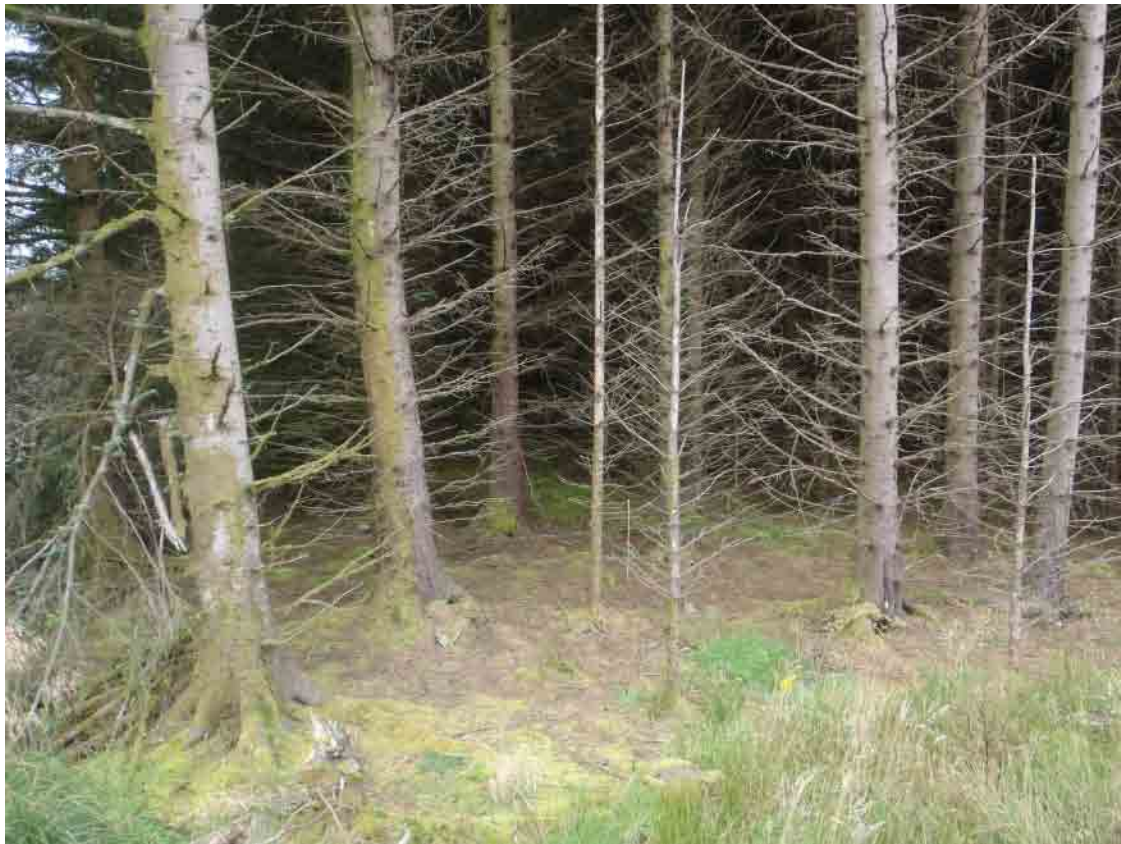
The badly disturbed remains of Site CFA4 were located in dense plantation parallel to the access track in the vicinity of 'High Drumlamford'. The remains were heavily damaged and only survived as an incoherent scatter of rubble. The site location was cordoned off, with the northern boundary of the access track providing the perimeter of the buffer zone. The post-construction site visit confirmed that the site remained unaltered from the description above (Fig. 39).

Fig 39 - Shot of Site CFA 4 after wind farm construction

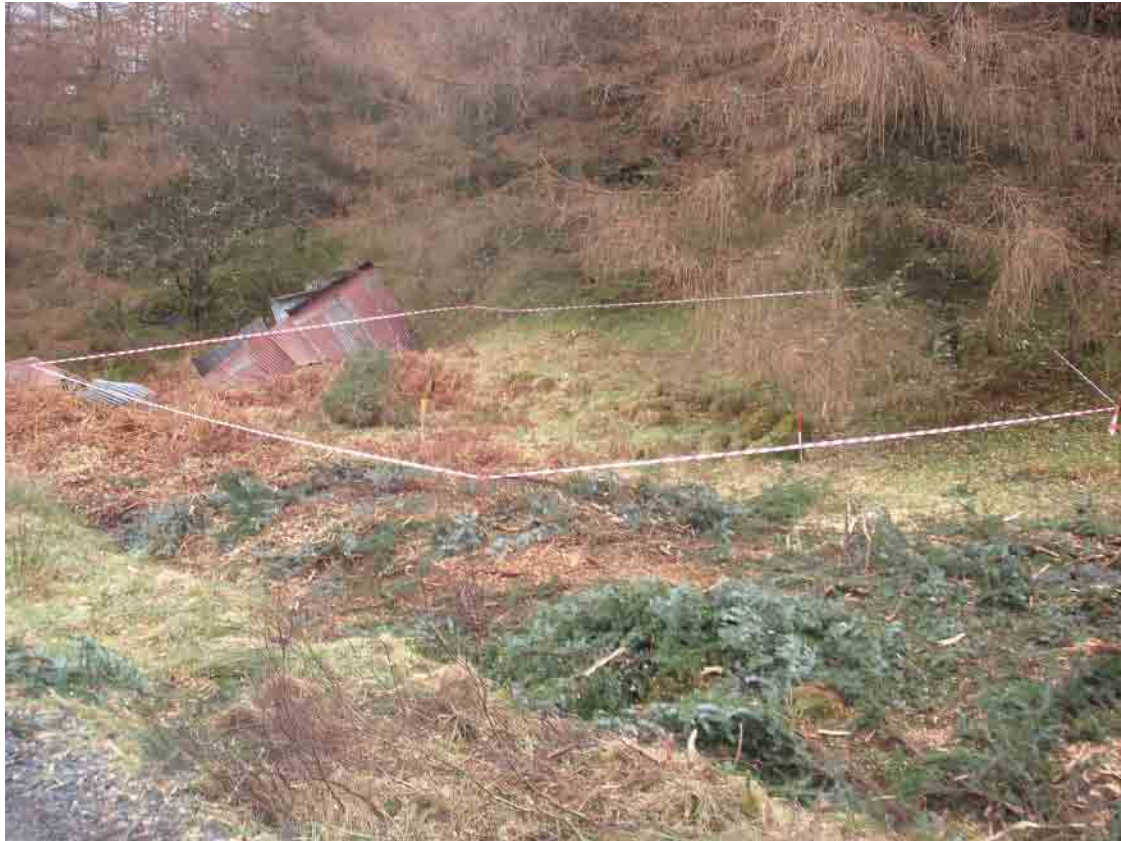
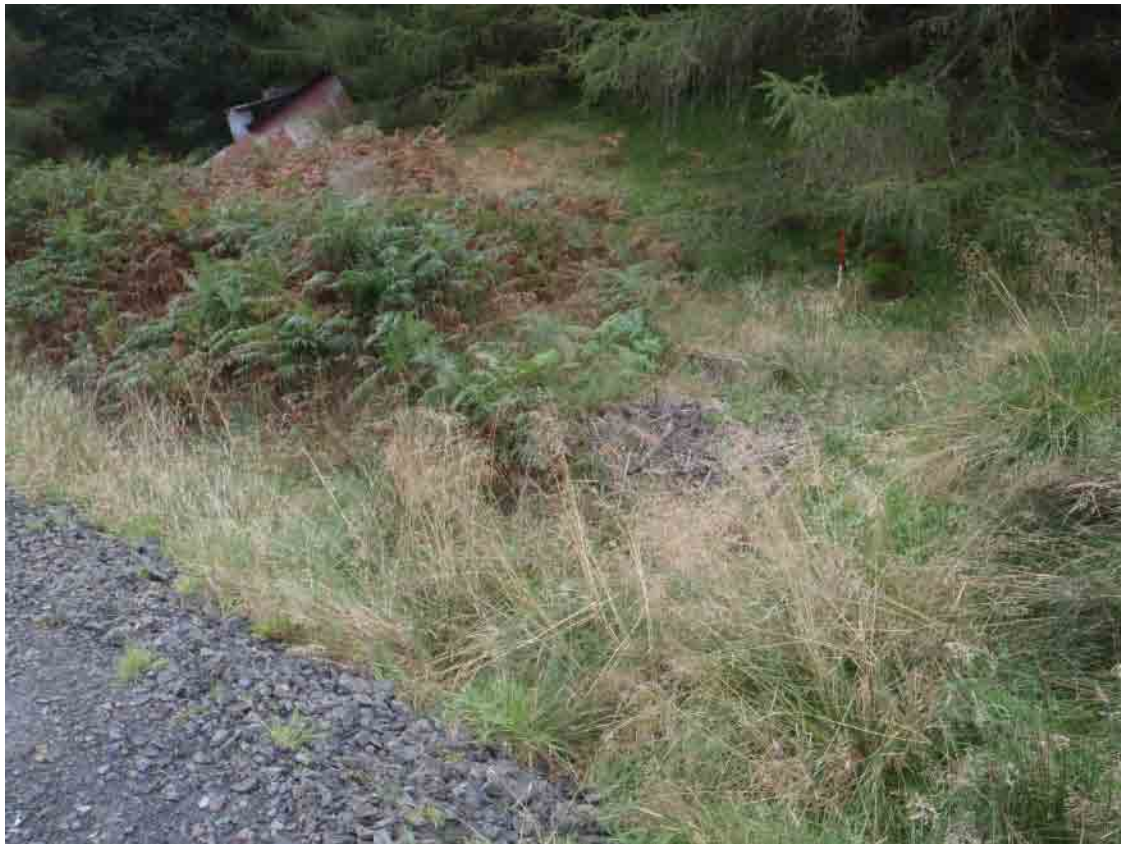
The remains of a sheepfold annotated on the Ordnance Survey 1st Edition map were located and cordoned off (Fig. 40). The visible remains were largely obscured by vegetation, but appeared to be heavily denuded and survived only as spreads of rubble. The post-construction site visit confirmed that the no damage had occurred to the remains (Fig. 41).

Fig 40 - Shot of Site CFA 6 during demarcation works

Fig 41 - Shot of Site CFA 6 after wind farm construction
