Heritage Assessment Union Canal, Glen Village Falkirk

Report No. 2117

Author	Jamie Lewis BSc, MA
Illustrator	Kevin Hicks BA FSA Scot
Editor	Bruce Glendinning BSc PgDip MIfA
Commissioned by	Scottish Canals
Date issued	August 2012
Version	0
OASIS Reference	cfaarcha1-132589
Grid Ref	NS 68860 27822

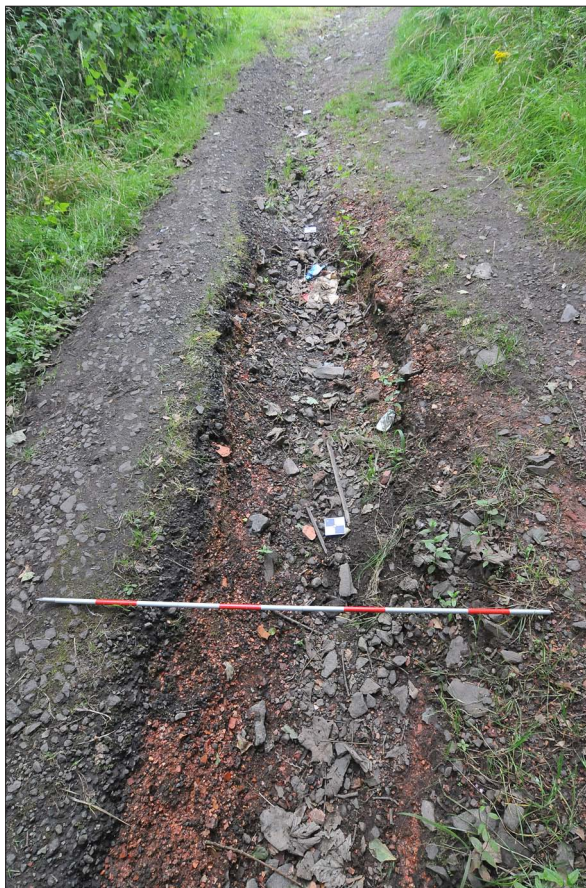
Fig 2:
Top of path at 9.60m
looking NW showing
significant or total
erosion of stonework

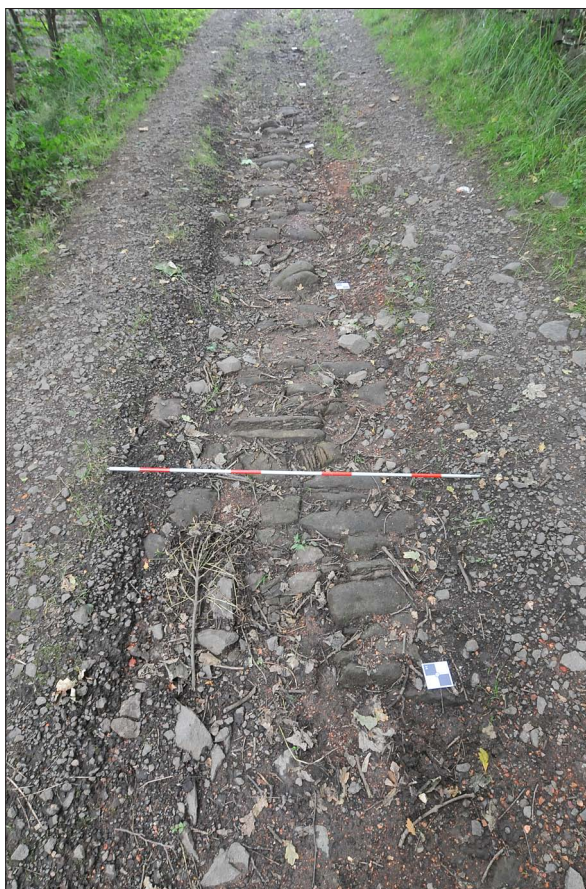
Fig 3:
Path at 24.40m looking
NW showing original
stonework and erosion to
surface

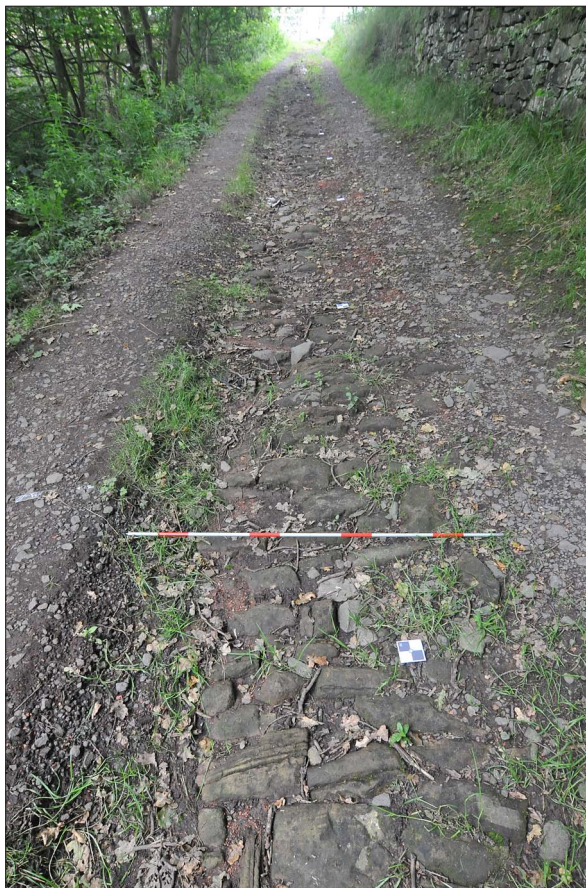
Fig 4:
Path at 33.50m looking
NW showing stonework

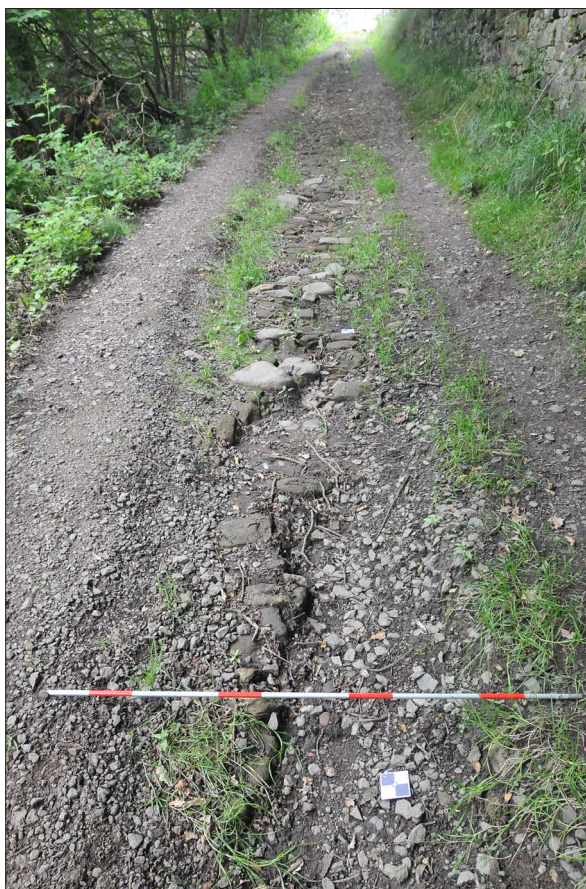
Fig 5:
Path at 40.80m looking
NW showing eroded
stonework

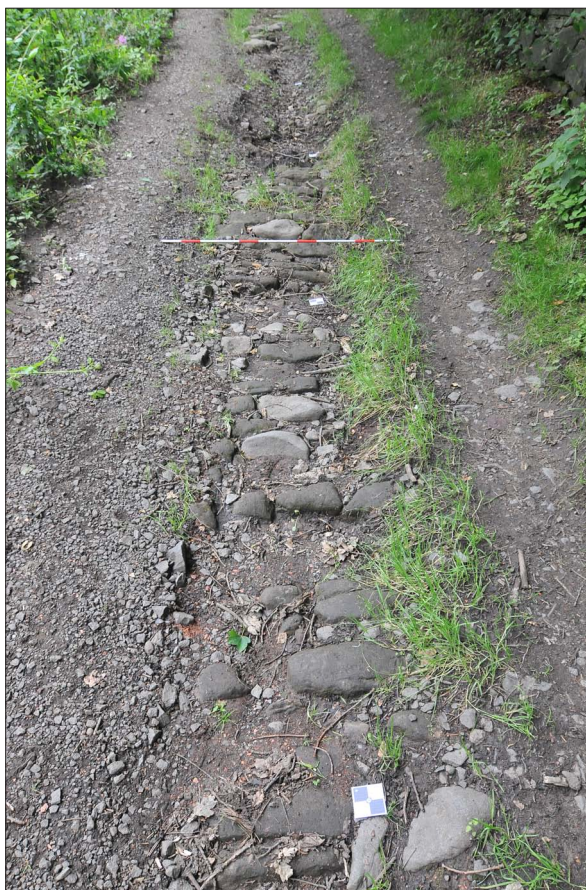
The modern pathway measures approximately 73m by 2m wide with the bank dropping off sharply to the south and rising steeply to the north. The erosion was observable in the form of a channel which runs down the middle of the modern path and exposed the original surface which runs to approx 55.04m in length from the NW top of the path. The width of the erosion channel varied; at the top of the channel the eroded channel was 0.70m wide and showed considerable or near total erosion of the original surface (Figs. 2 and 3). At 33.50m it was 1.20m wide and exposed more regular metamorphic blocks alongside sub-rounded stones (Fig.4). At 40.80m erosion had removed a large portion of the original path surface (Fig.5). At 47.90m sub-rounded metamorphic rock had been exposed and at 54.40m the path became untraceable as it appeared to continue under the modern surface (Figs. 6 and 7).

Fig 6:
Path at 47.90m looking
NW showing erosion

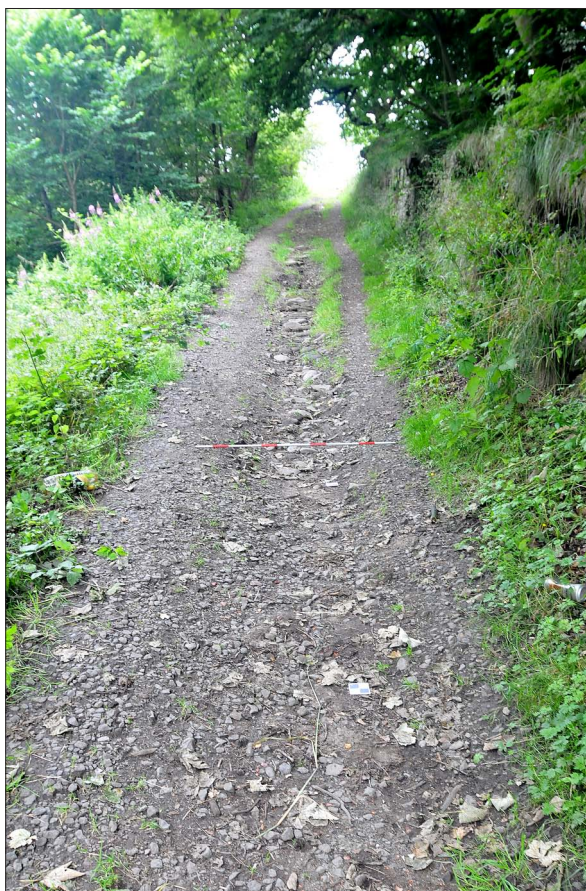
Fig 7:
Path at 54.40m looking
NW at point where
stonework continues
under the modern
surface.
