## **Abbotsford House, Melrose, Scottish Borders**

### **Architectural recording and archaeological Watching brief**

**Report No. 2135**

## **CFA ARCHAEOLOGY LTD**

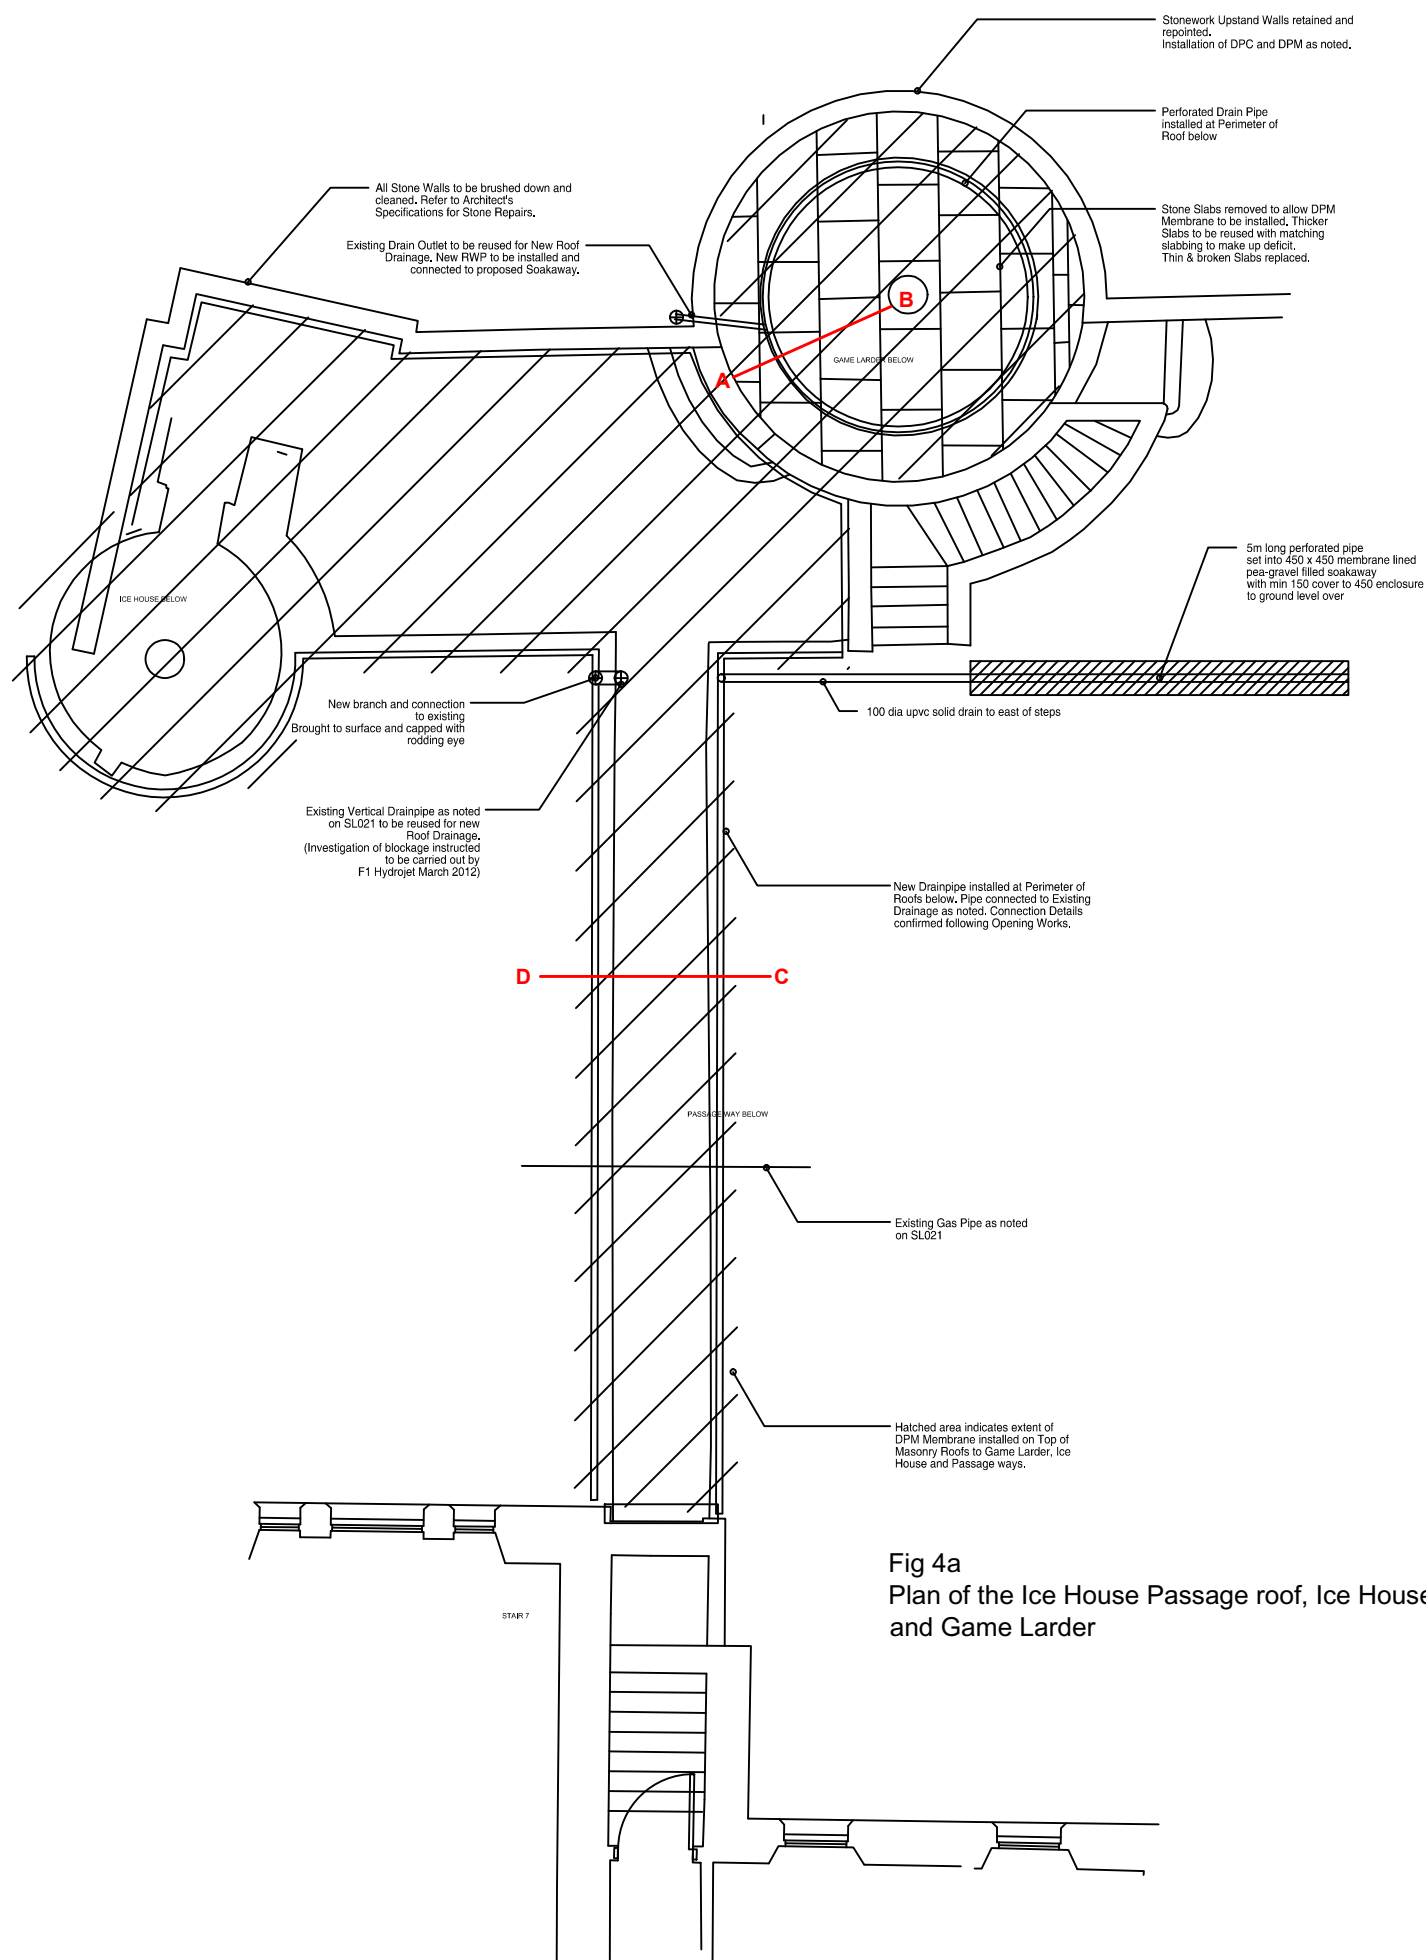
**Fig 4a**  
Plan of the Ice House Passage roof, Ice House and Game Larder

The Game Larder was designed by the Architect William Burn and constructed for Charlotte and James Hope-Scott in the early 1850's (it is dated 1851). It incorporates an earlier Ice House built for Sir Walter Scott circa 1820 (CMP). Access from the house to the Game Larder and Ice House is down a flight of stone steps and an inclined underground corridor with barrel-vaulted roof (Fig 4a).

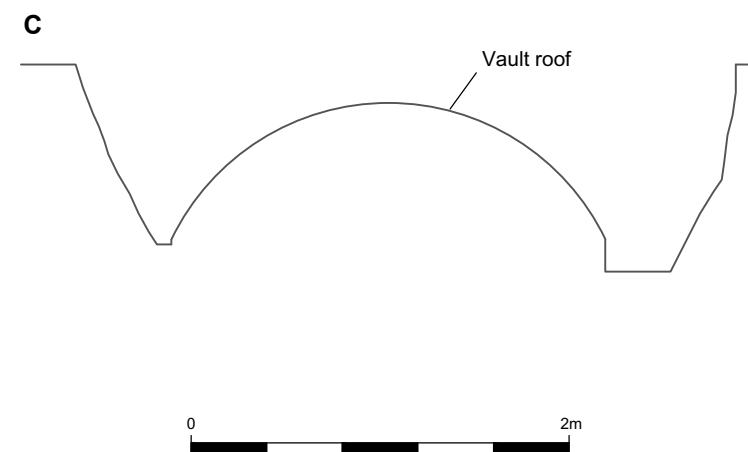
**Fig 4c**  
Profile of the Ice House roof (Section D-C)

The vaulted passage leading to the ice house was found to be overlain by fluvioglacial deposits that had been used to backfill the passage roof to a depth of 0.25m. A profile of the roof shows that it was barrel vaulted.

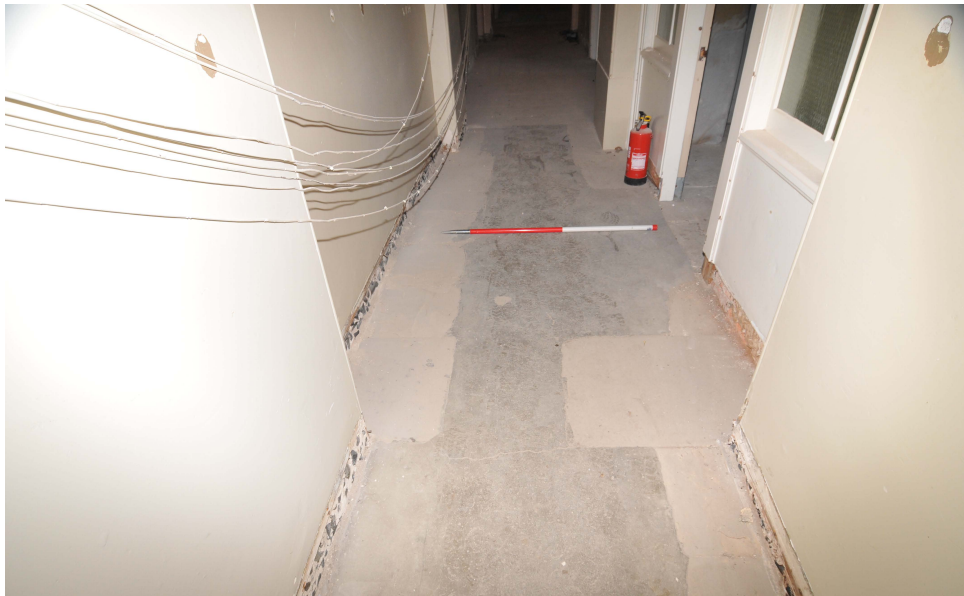
Plate 1: Basement corridor in area B.48 showing flagstones in situ prior to removal

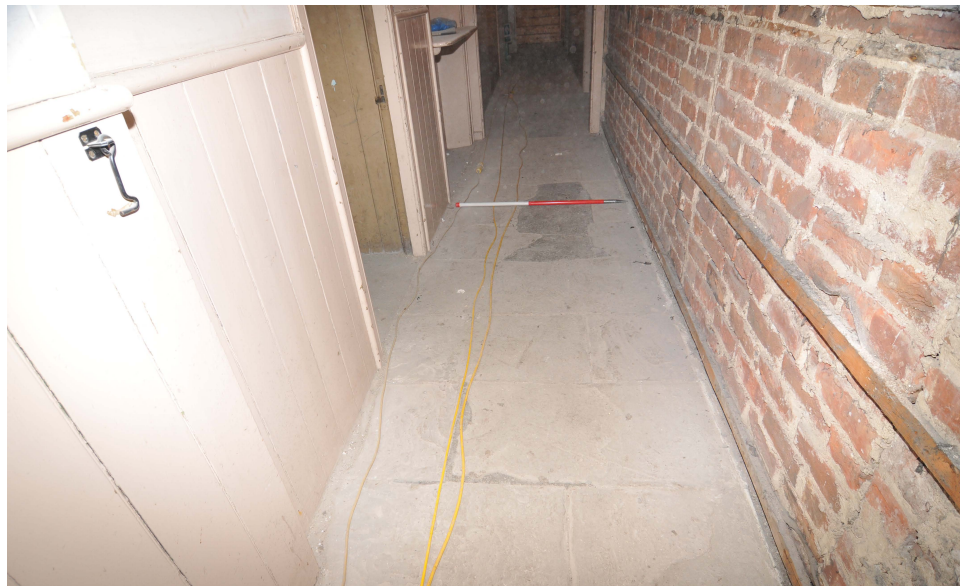
Plate 2: Basement corridor in area B.17 showing flagstones in situ prior to removal

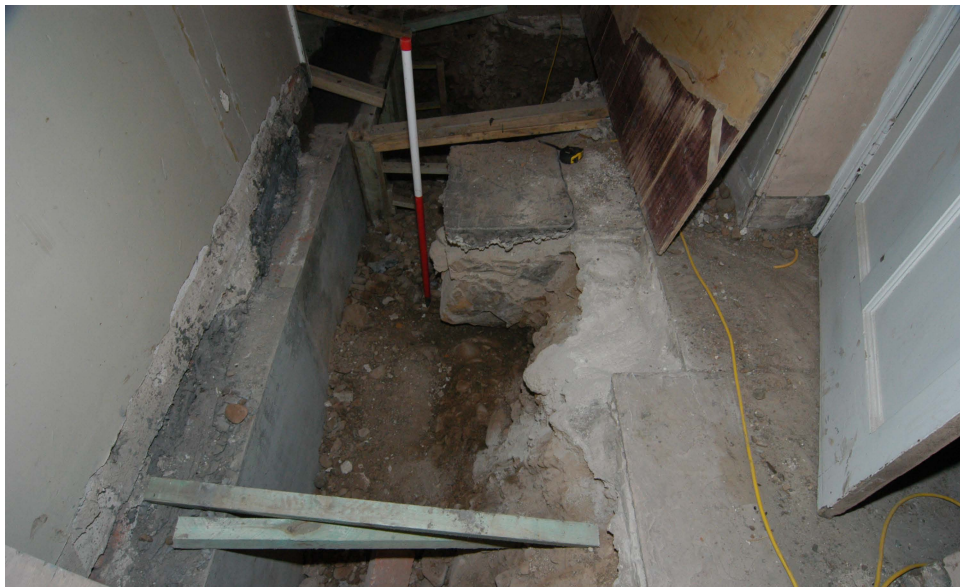
Plate 3: Basement corridor area B.48, exposed wall foundations recorded during underpinning work

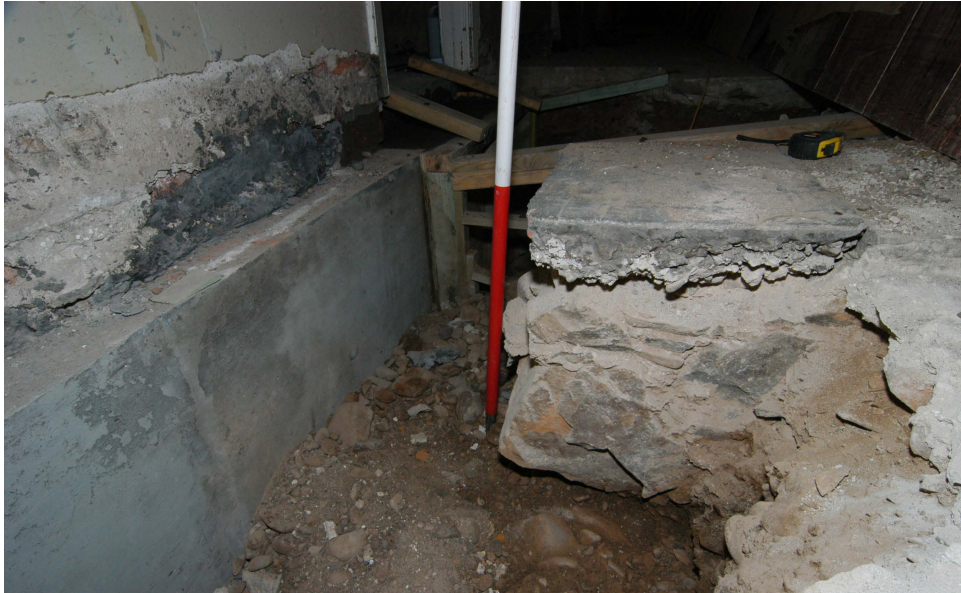
Plate 4: Basement corridor area B.48, close-up of exposed wall fabric

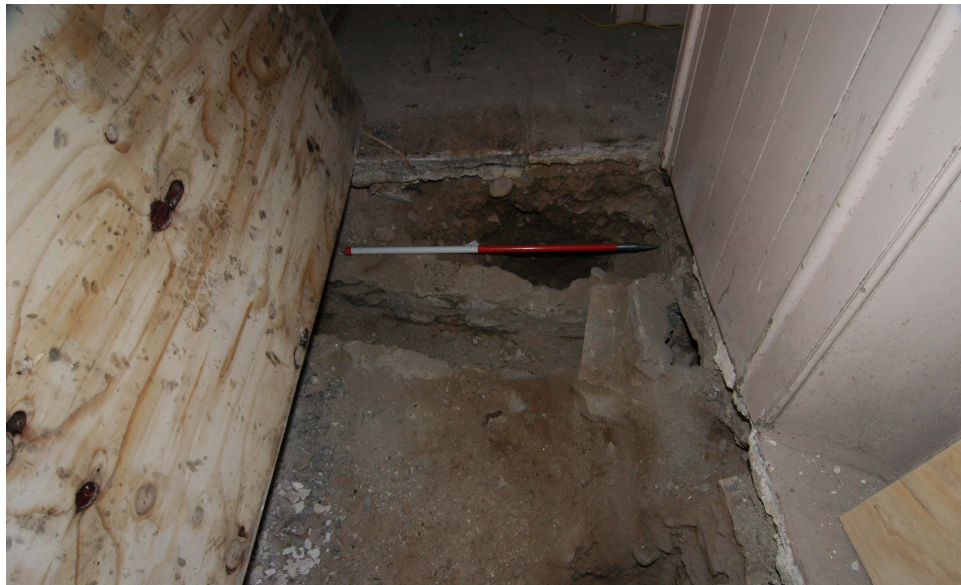
Plate 5: Basement corridor area B.17, general shot of exposed culvert

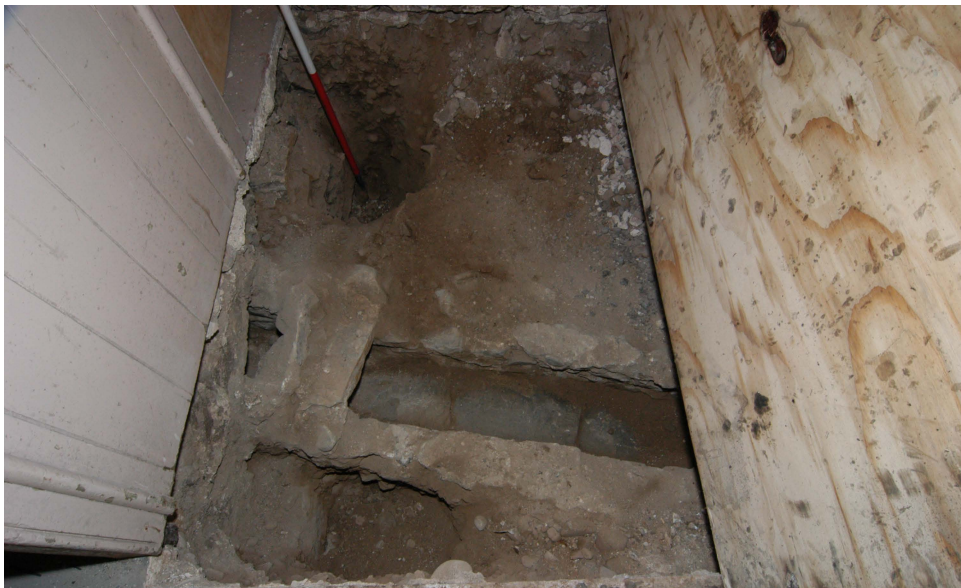
Plate 6: Basement corridor, area B.17 detailed shot of the culvert

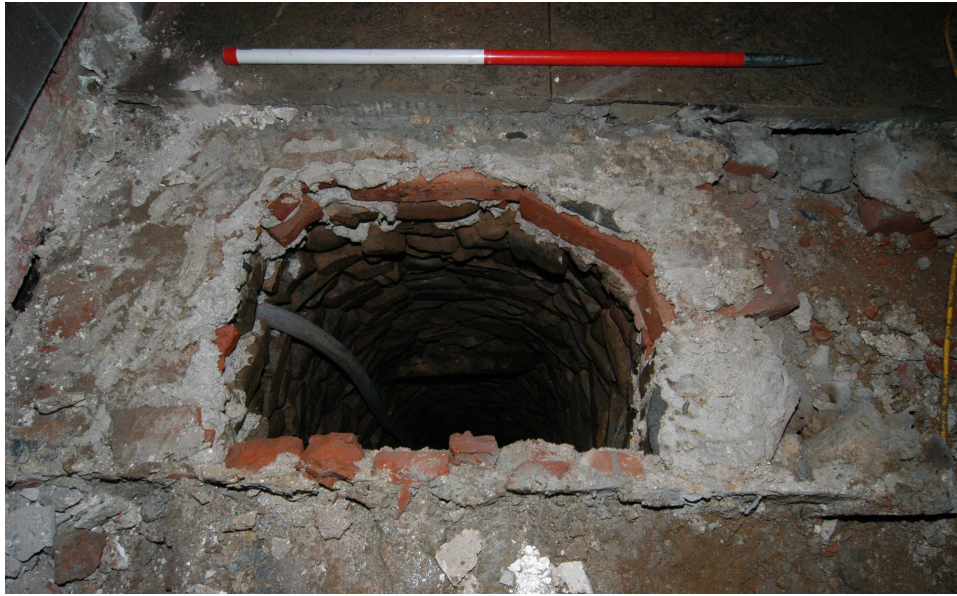
During the removal of the flagstone floor in Hall B.38 a well measuring 0.75m in diameter and 4.7m deep was found directly underneath the flagstones. The well had been capped recently (c.1980s) by a mixture of brick and cement. The well was constructed of dry stone sub-rounded and rectangular stone. At approximately 1.5m from the top of the well were two wooden planks. A lead pipe with a diameter of c.0.05m had been inserted into the well. The pipe had been bent in order for it to run under the floor. It is presumed that the pipe ran under Staircase B.40 through to the Boiler house B.37.

Plate 7: Hall B.38, exposed well with modern capping material

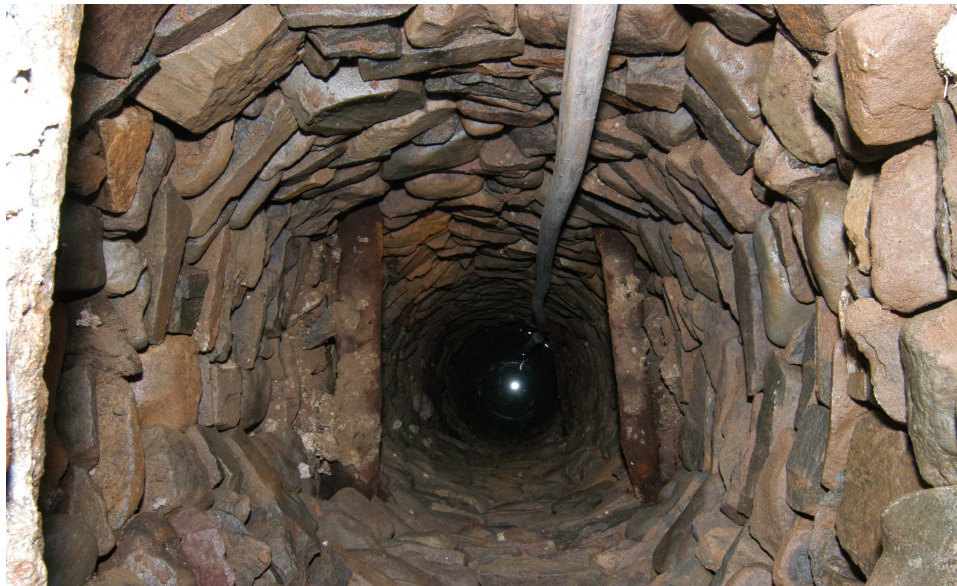
Plate 8: Hall B.38, vertical photograph looking down the well

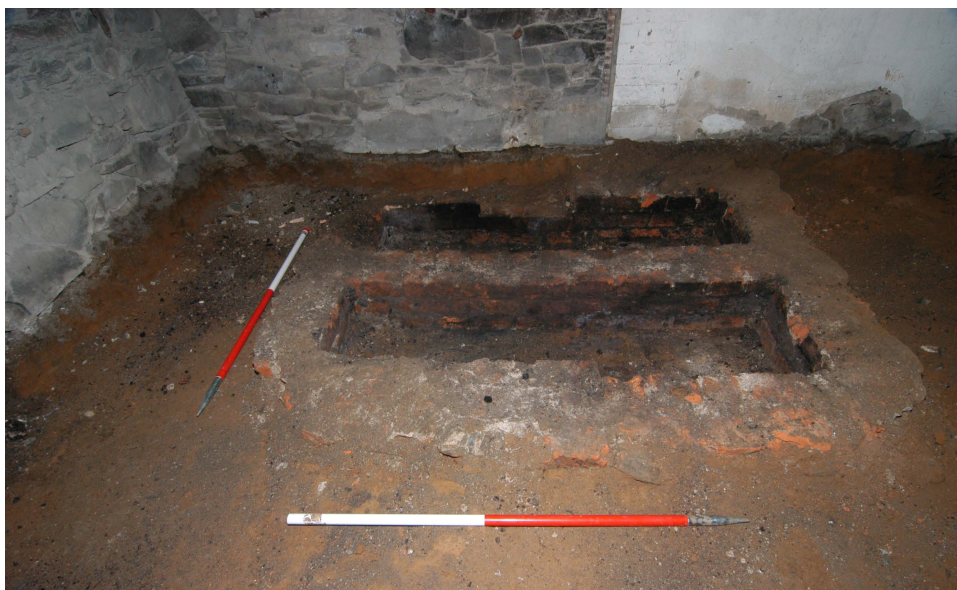
During the removal of the flagstone floor in the Store/Workshop B.28 the remains of the foundations for a domestic boiler were exposed in the south-east corner of the room (Fig 3). The feature comprised two brick-lined fire-boxes aligned east-west divided by a central section of brickwork with a combined measurement of 1.56m in length and 0.42m in width and 0.26m deep. The bricks measured 9 by 4½ inches and were laid in a crude stretcher bond. The interior of the boxes contained soot, cinder and fragments of coal. It is presumed that the foundations rose to about waist height and supported a cast-iron cauldron that would have been heated by coal to provide hot water suggesting that this may have been a washhouse.

Plate 9: Storeroom B.28, general view of the boiler foundations

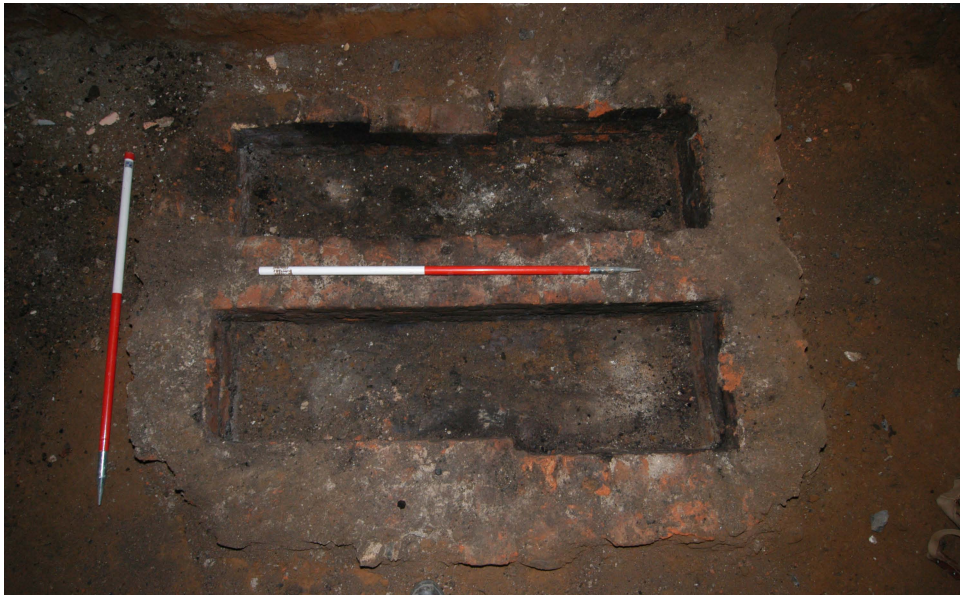
Plate 10: Storeroom B.28, general shot of the interior fireboxes

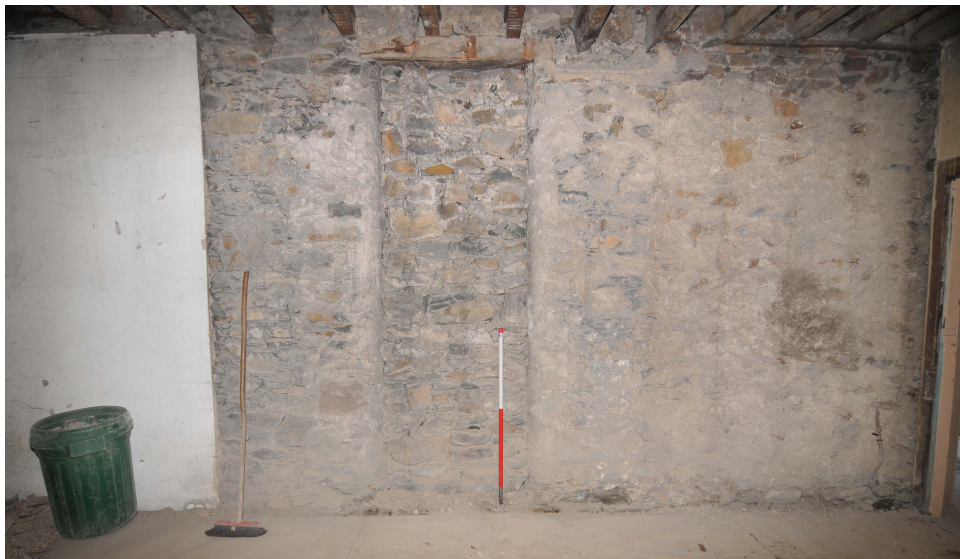
Plate 11: Storeroom B.28, general shot of the blocked opening on the south-west wall

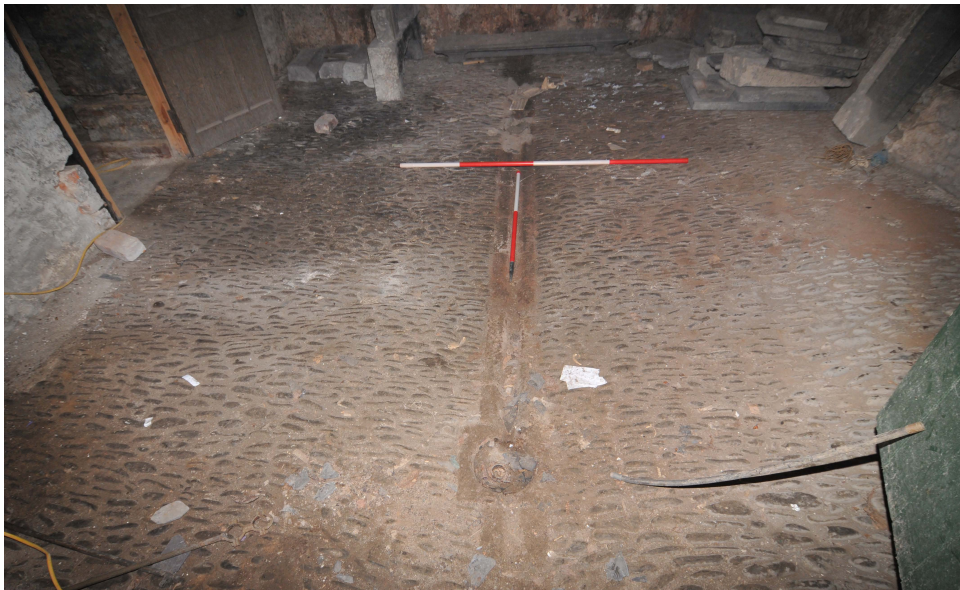
Plate 12: Store B.35 general view of the cobble floor and central drain

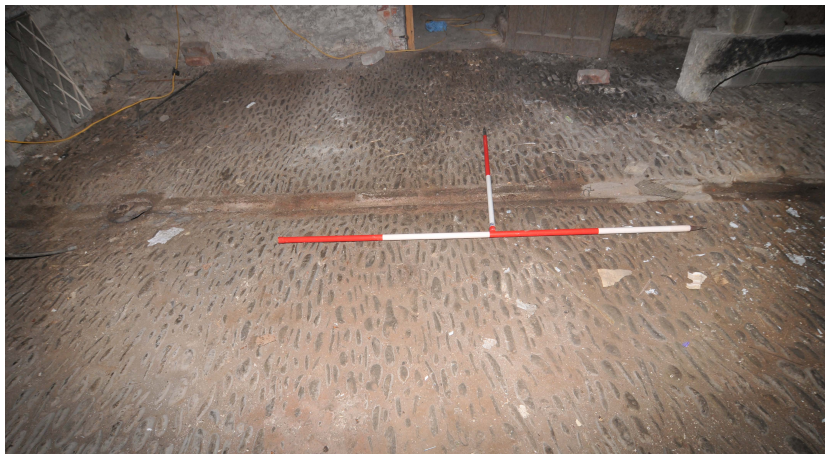
Plate 13: Store B.35 general view of the cobble floor

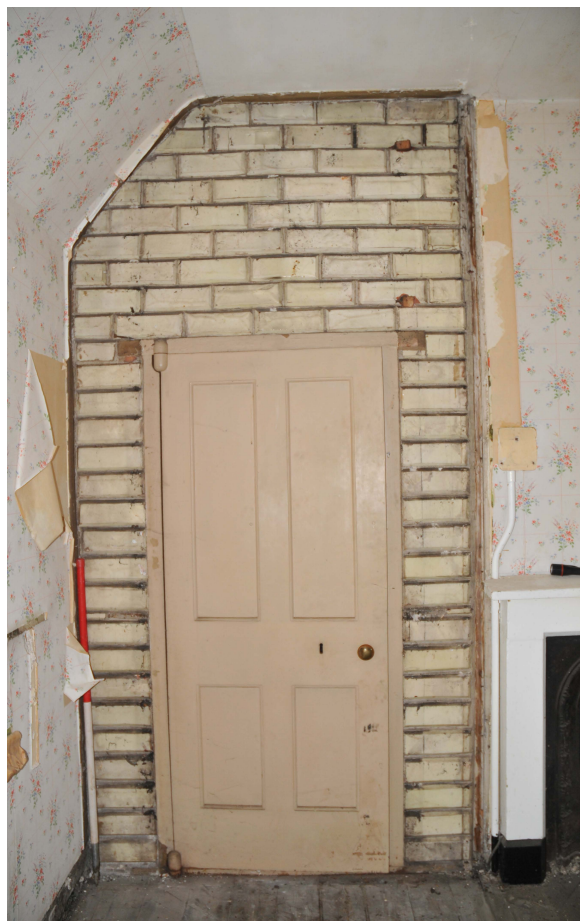
Plate 15: Room G.14 showing the cast-iron four paneled door

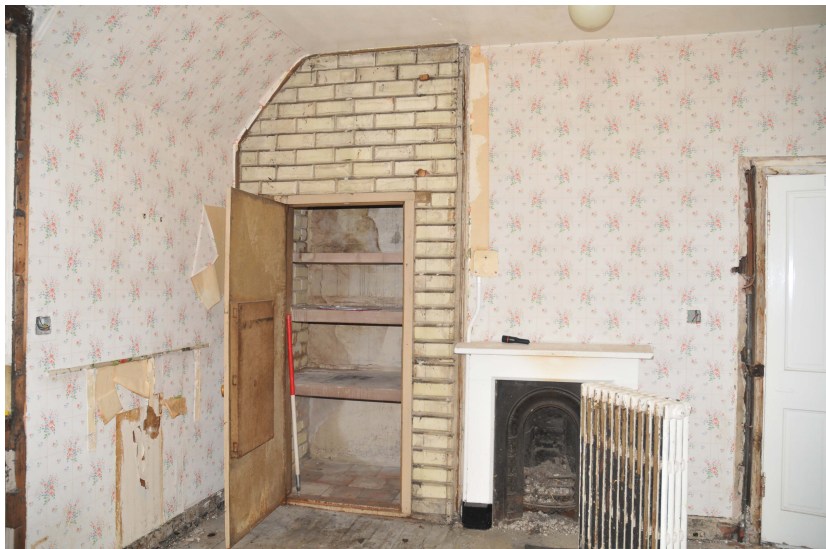
Plate 14: Room G.14 showing the fireproof cupboard in the corner of the room

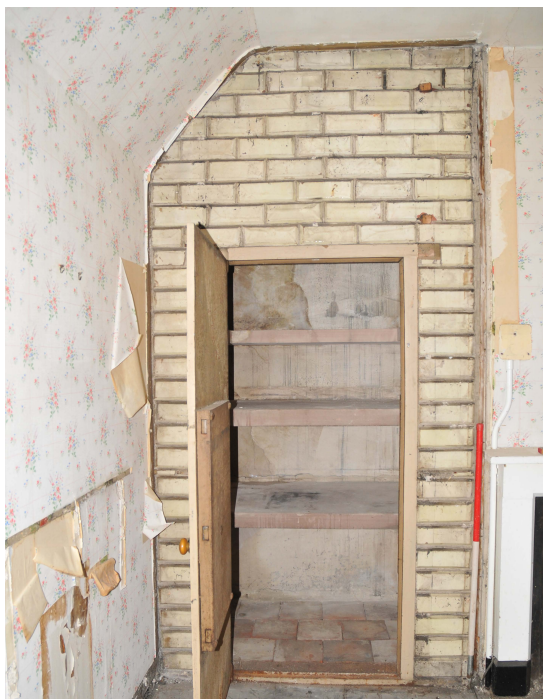
Plate 16: Room G.14 showing stone shelf detail

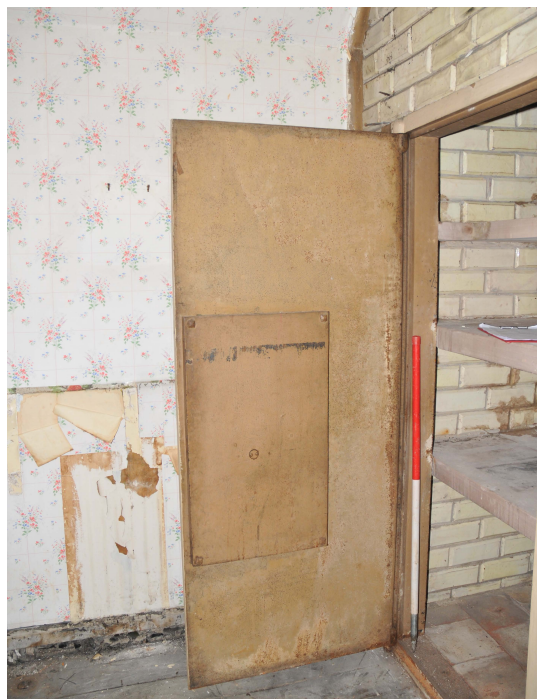
Plate 17: Room G.14 showing lock plate on the rear of the door

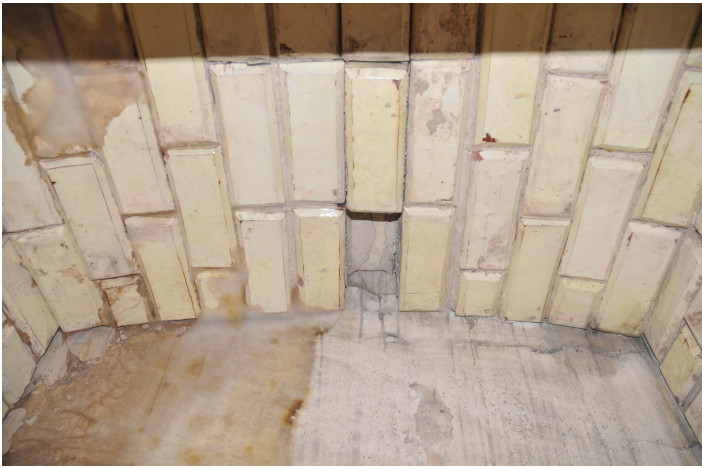
Plate 18: Room G.14 showing the arched brickwork on the cupboard interior

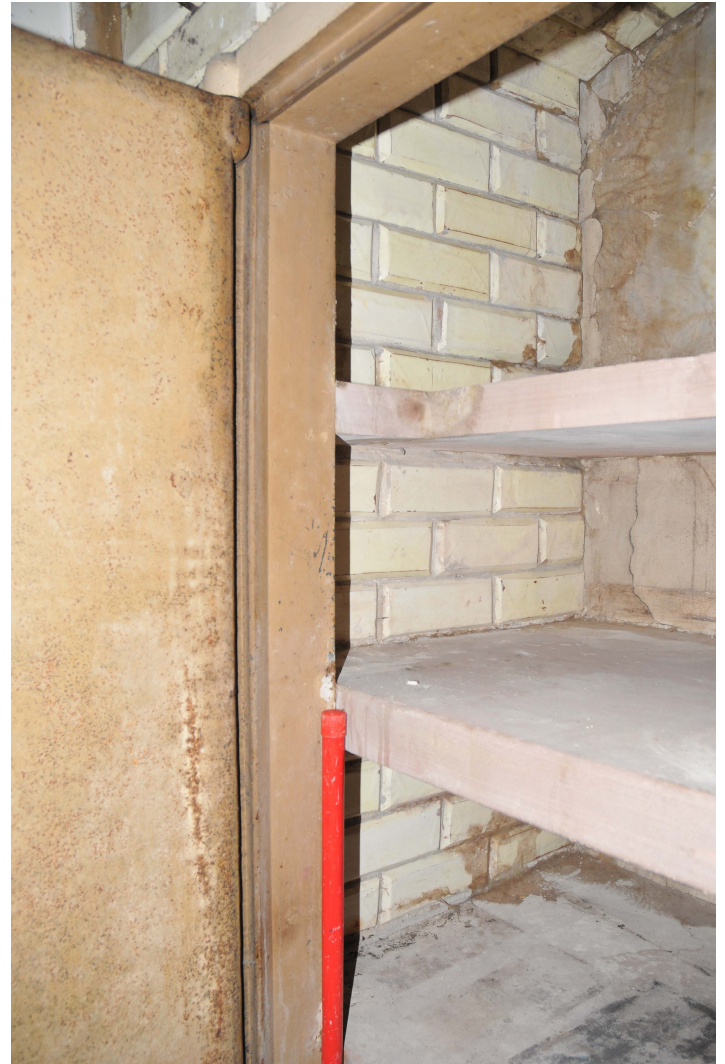
Plate 19: Room G.14 showing the arched brickwork

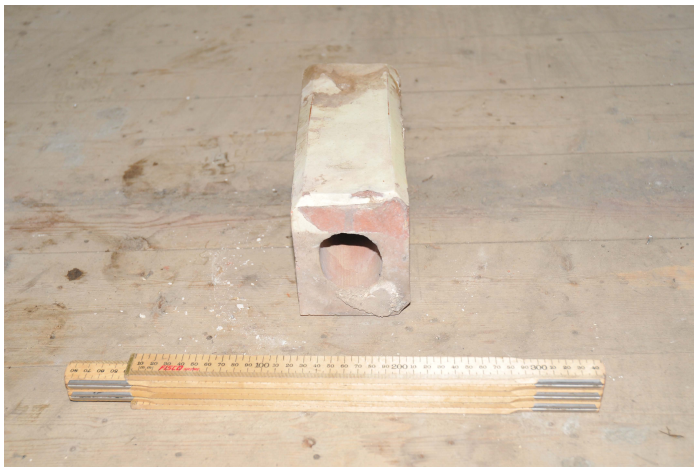
Plate 20: Room G.14 showing a cross-section of a fire-proof brick taken from the cupboard

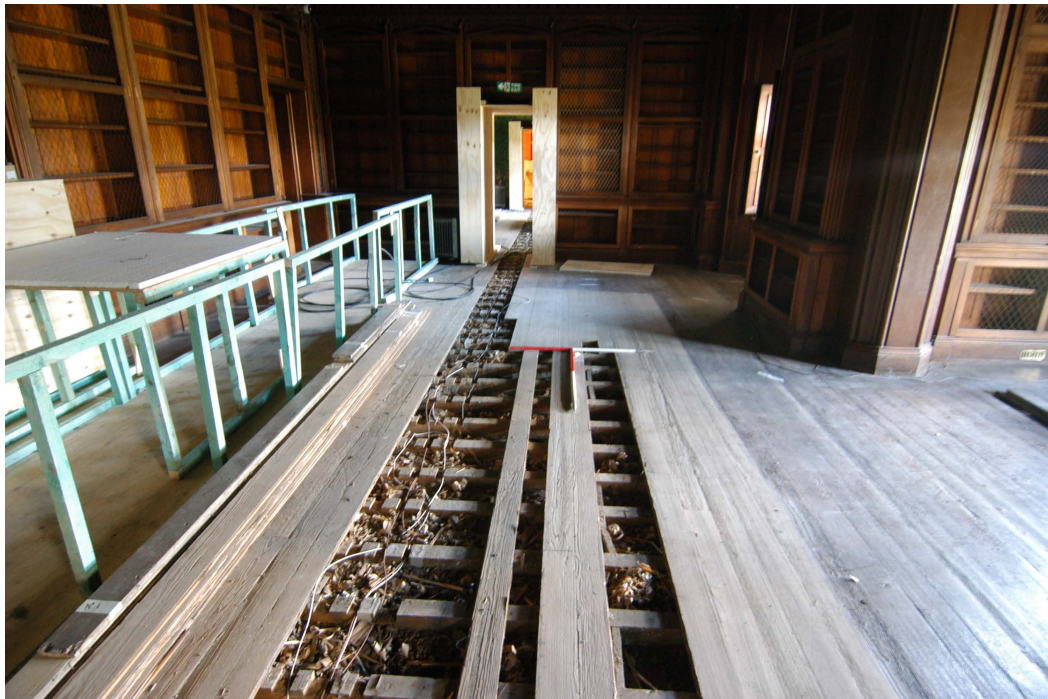
Plate 21: Library G.07 showing the exposed floor-joists exposed during refurbishment work

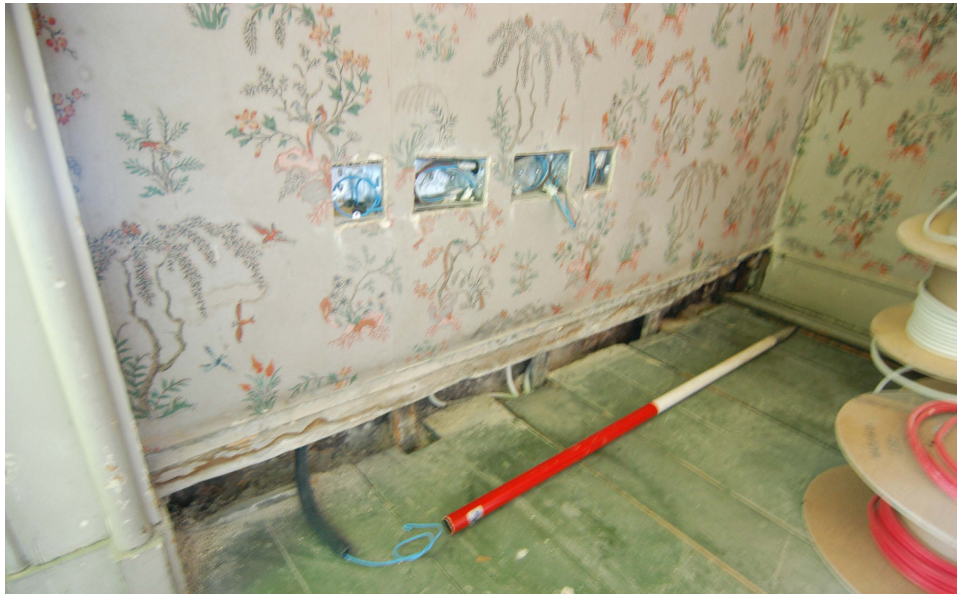
Plate 22: Room F.21, exposed cast-iron beam at the base of the wall

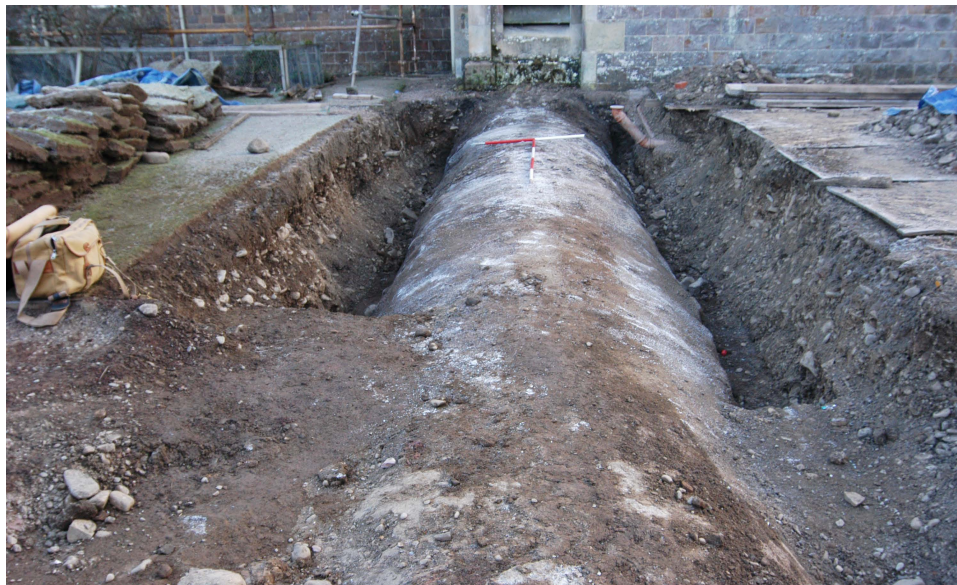
Plate 23: Ice house passage roof exposed prior to conservation work

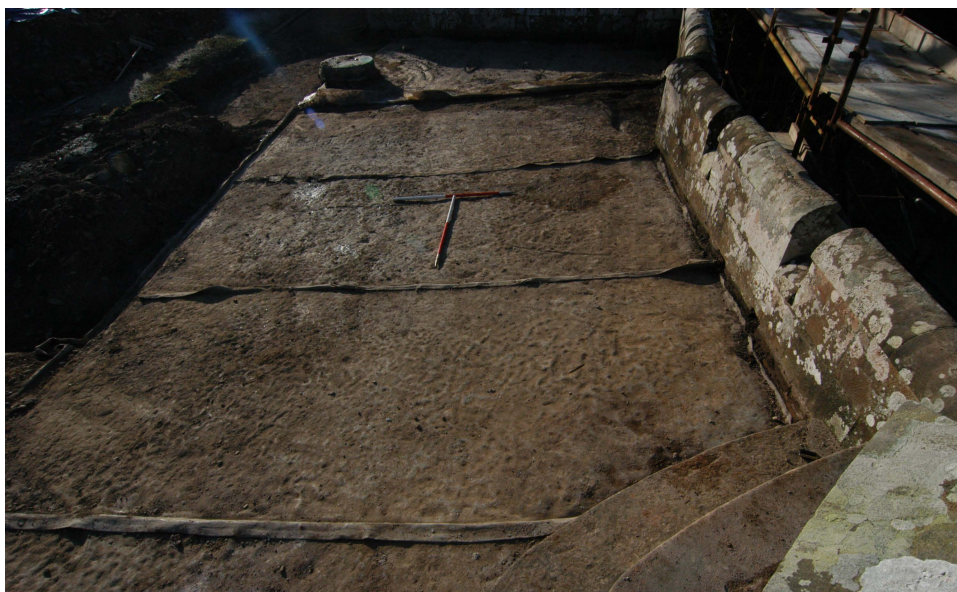
Plate 24: Lead sheets covering the roof of ice house and game larder

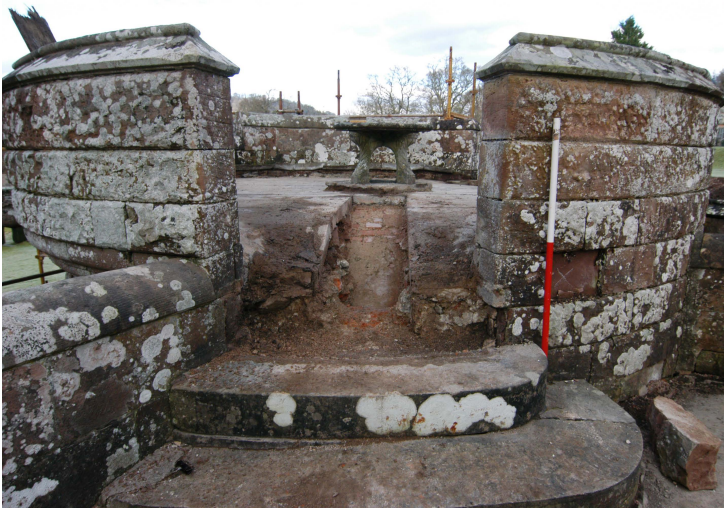
Plate 25: Game larder roof inspection trench within the domed interior of the parapet

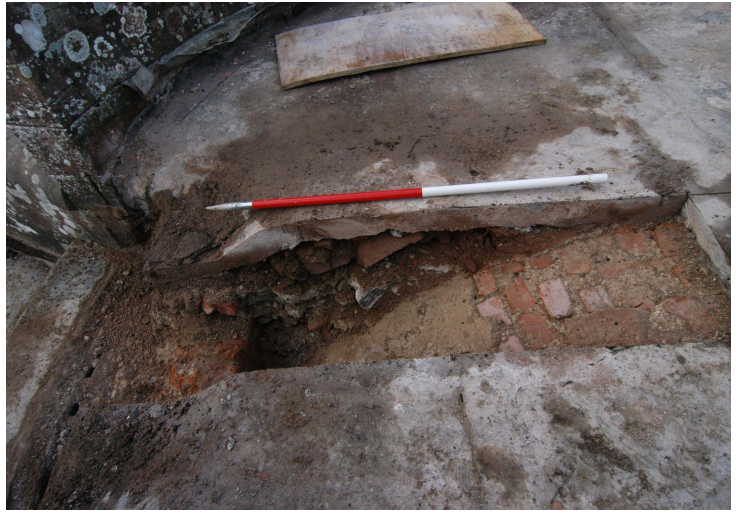
Plate 26: Game larder roof construction material exposed in section

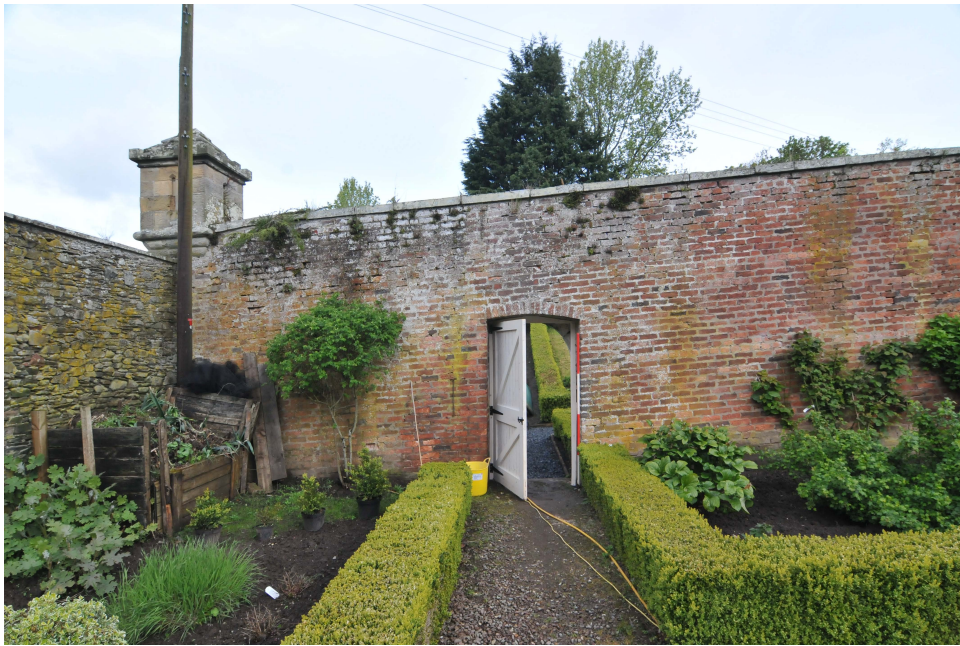
Plate 27: Kitchen garden wall entrance and wall detail

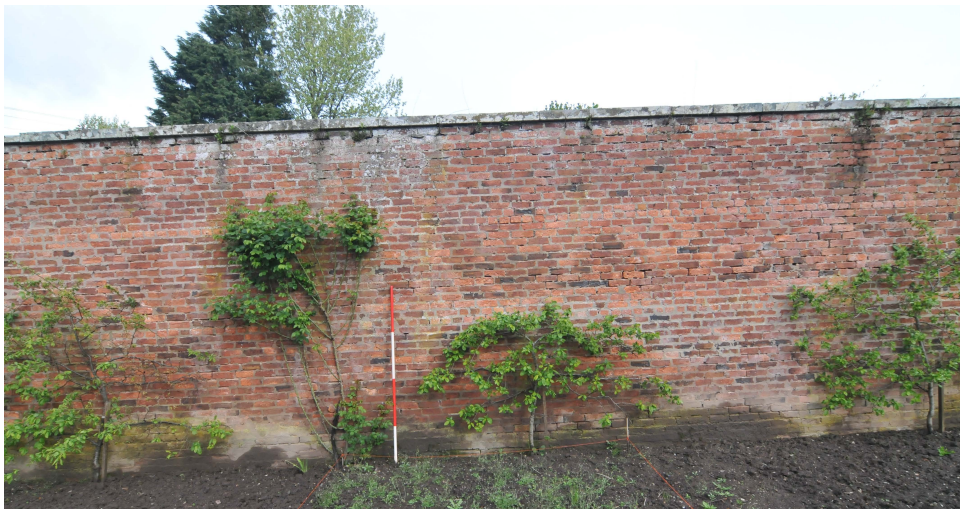
Plate 28: Kitchen garden wall showing poor condition of the brickwork

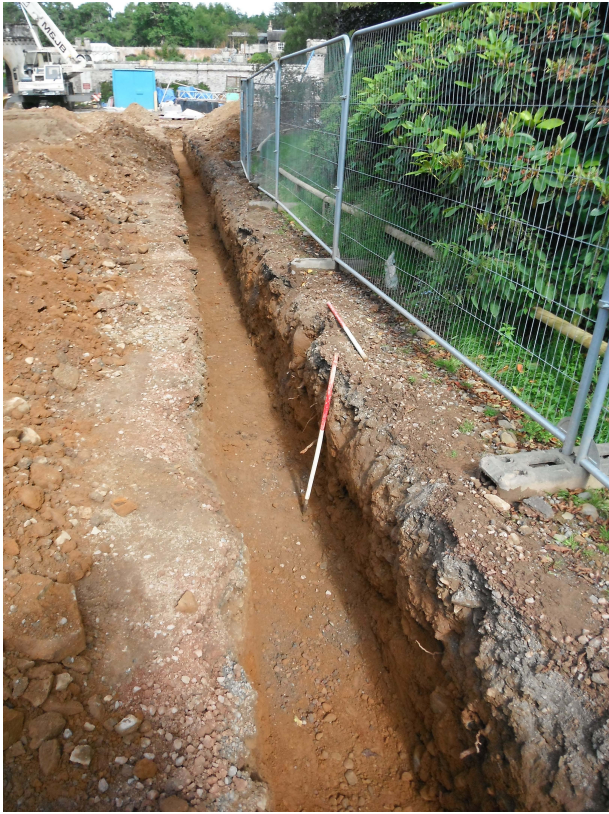
Plate 29: Water pipe trench leading to Abbotsford House

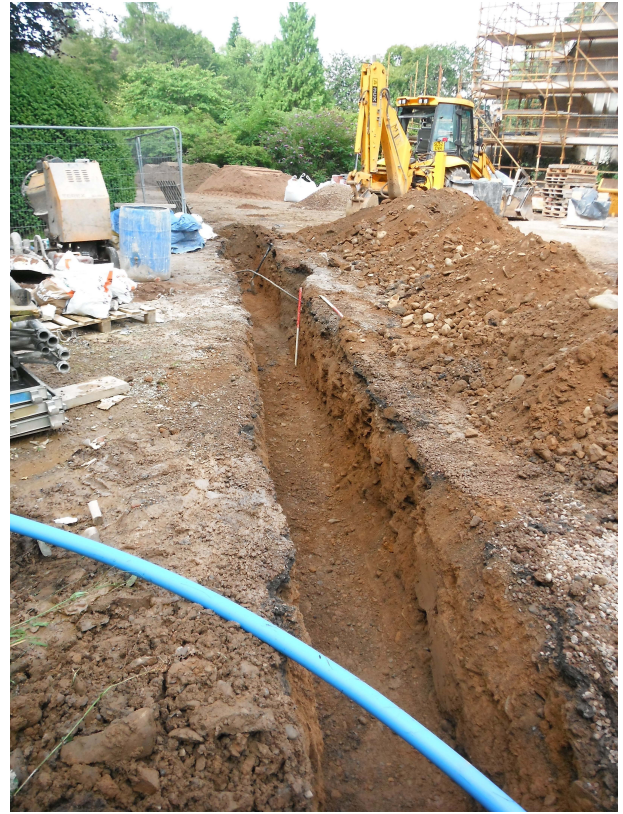
Plate 30: Water pipe trench leading to Abbotsford House

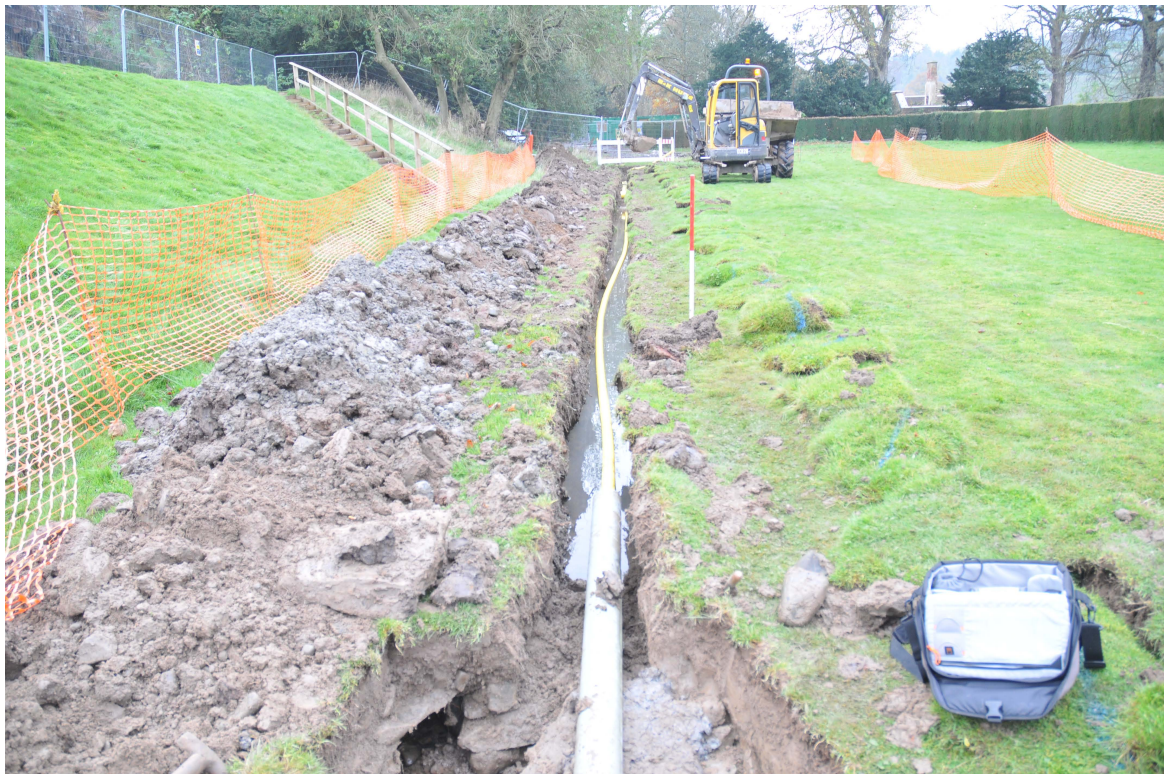
Plate 31: Gas pipe trench on the north side of Abbotsford House, general view looking east

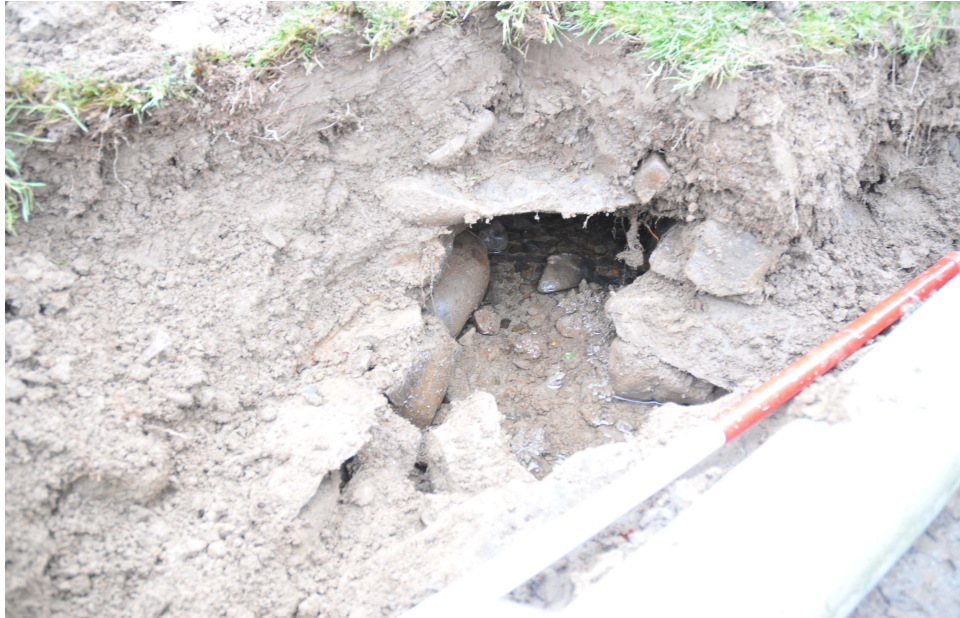
Plate 32: Gas pipe on the north side of Abbotsford House showing in-situ box-drain

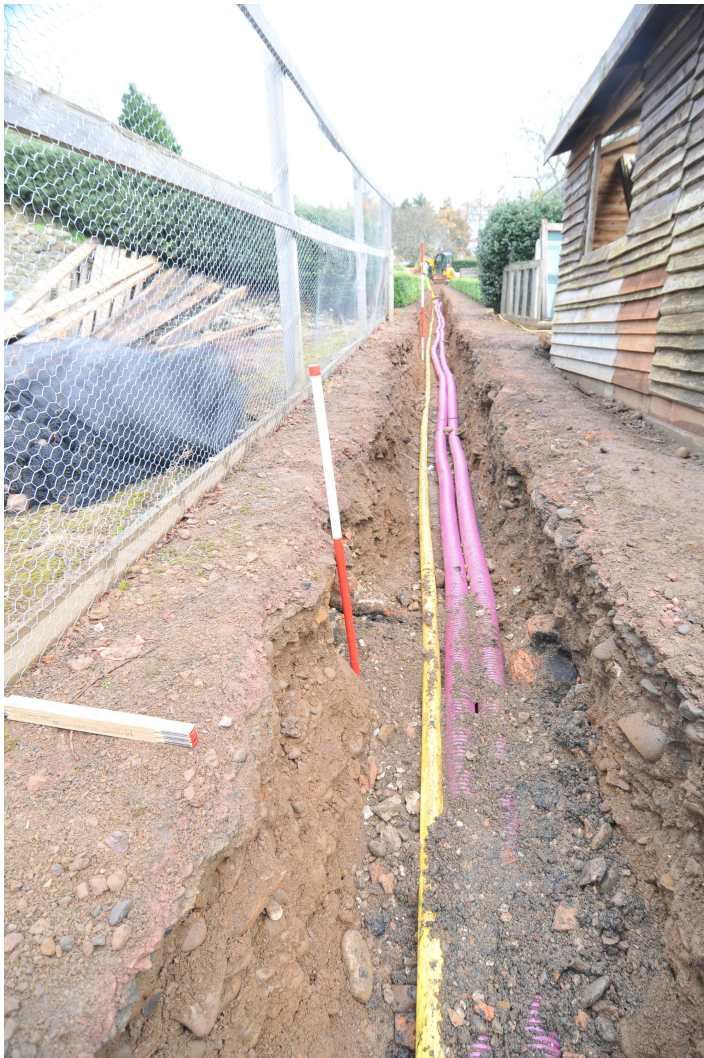
Plate 33: Gas pipe trench through the gardeners' path, general shot showing the route

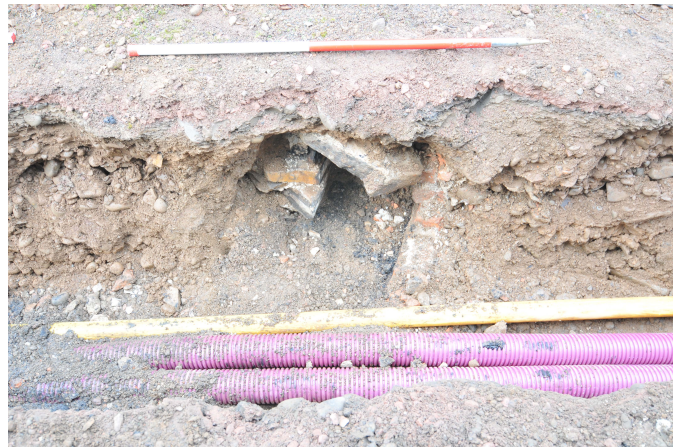
Plate 34: Gas pipe trench through the gardeners' path, general shot of the hypocaust flue

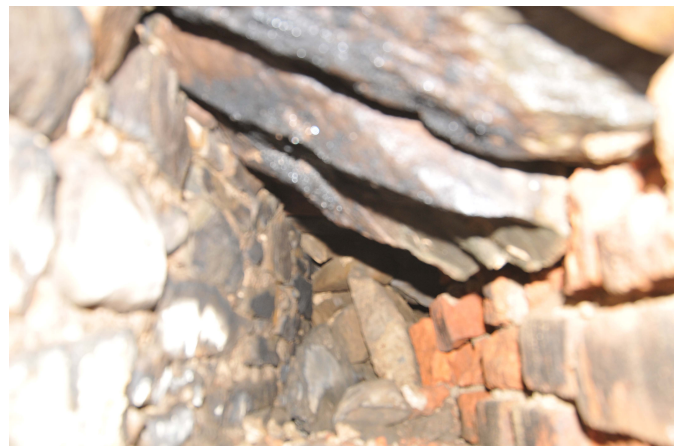
Plate 35: Gas pipe trench through the gardeners path, interior of the hypocaust flue
