Overhead Line, Dunloskin Wood, Dunoon, Argyll & Bute

**Archaeological Mitigation Works**

Report No. 2160

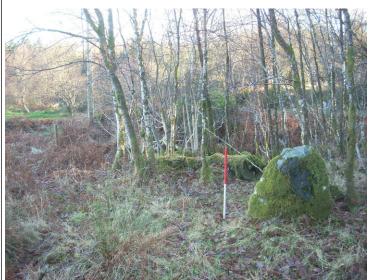
Site 1, the Ardnadam High Road Standing Stones (RCAHMS No. NS17NE 107), do not lie at their published location. These were located and found to lie outside the OHL corridor (Figs. 1a, 2). A pile of large stones, probably from the formation of the access road to the nature trail car park, had been piled next to the pylon close to the standing stones. What may be an alignment of boulders was recorded close to the pile of stones.

Fig. 2 - Site 1. One of the possible standing stones (NS17NE 107) with the pylon visible beyond the fence on the left.

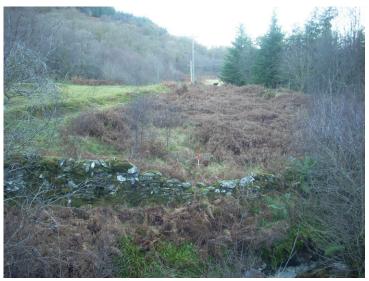
Site 2, the Ardnadam Chapel and Burial Ground (SM No. 3235, RCAHMS No. NS17NE 7) was visited and the Scheduled Area surveyed by DGPS (Fig. 1a). A wooden pylon (Fig. 3) lies close to the surrounding enclosure. This was later cut down in sections (Fig. 4) to avoid damage to the monument.

Site 13 (Fig. 1a) consists of a drystone wall and this feature is shown in the foreground of Fig. 3. It cuts the turf and stone bank (Site 14) on the northern side of the Eas a'Chaibeil.

Fig. 3 - Site 2. Ardnadam (NS17NE 7) showing the pole adjacent to the enclosure bank.

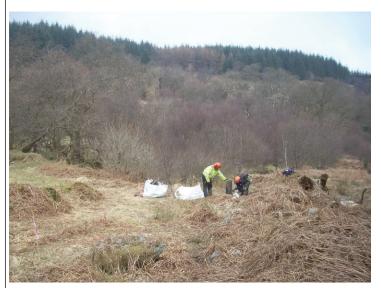
Site 14 (Fig. 1a) consists of a meandering dyke which may define the historical boundary between the improved fields and the steeper hill slopes. Much of the surface is bracken covered but a stone face is visible on the western side in places. This site is shown on the right hand side of Figs. 3-4. It is cut by the drystone wall (Site 13) on the northern side of the Eas a'Chaibeil.

Fig. 4 - Site 2. Ardnadam (NS17NE 7) with the final section of the pole being cut by hand.

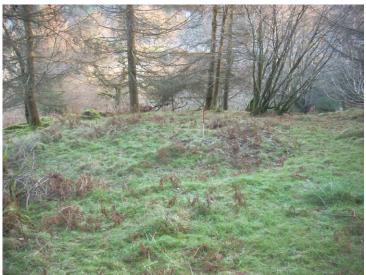
Sites 3A-F (Figs. 1a-b) consist of six of the Dunloskin Wood Platforms (SM No. 3894, RCAHMS No. NS17NE 9). An example of these platforms within the oak woodlands, where bracken was much less prevalent, is shown in Fig. 5. Within the OHL corridor, none of these platforms were located at the areas shown on the scheduling documents (Figs 1a-b). Site 3A had had a wooden pylon inserted into it previously (Fig. 6). Felling of this pylon caused slight turf damage (Fig. 7) well beyond the visible edge of the platform. This site, and others within the OHL corridor, were often obscured by dense bracken (eg Site 3B, Fig. 8).

Fig. 5 - A typical platform (part of NS17NE 9) within the woods where bracken is much reduced.

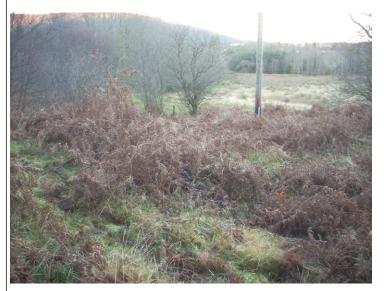
Fig. 6 - Site 3A. One of the platforms comprising NS17NE 9 with a pylon on it.

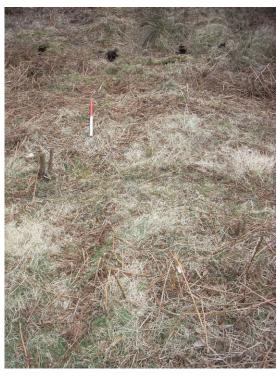
Fig. 7 - Site 3A. The pylon has been felled resulting in slight turf damage well beyond the platform.

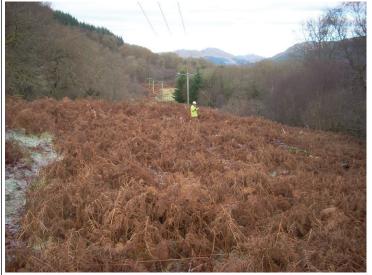
Fig. 8 - Site 3B. Bracken covered platform under the pylons.

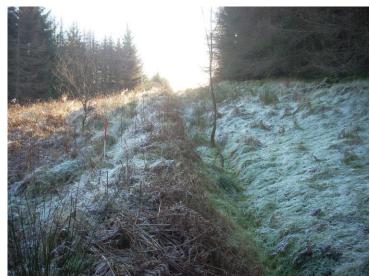
Sites 7A-H (Figs. 1a-b) consist of linear and curvilinear turf banks and a drystone wall collectively forming RCAHMS No. NS17NE 15. Elements of these features are shown in Figs. 9-11. Several wooden pylons lie adjacent to these banks and wall and one pylon had previously been inserted into the centre of the wall. Felling was, in all cases, directed away from the features and no damage was caused. At the southern end of the OHL, new stays and anchor blocks were added to an existing wooden pylon (Fig. 12).

Fig. 9 - Site 7B. General view of the turf bank which is part of NS17NE 15.

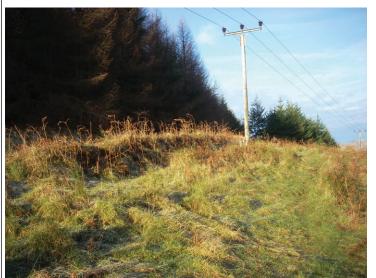
Fig. 10 - Site 7B. Turf bank with adjacent pylon.

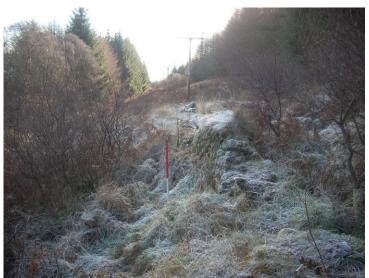
Fig. 11 - Site 7C. General view of the drystone wall which is part of NS17NE 15 and adjacent pylons.

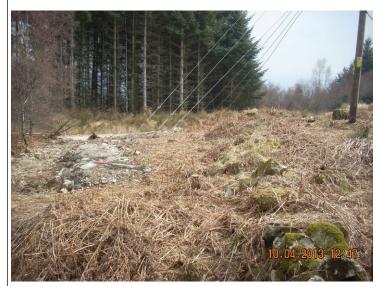
Fig. 12 - Site 7B. Stay block anchor points and pylon on either side of the wall at Tom na Bruanaig.

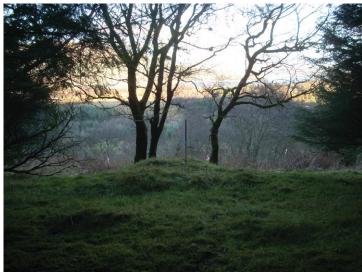
Site 16 (Figs. 1a-b, 13) consists of what appears to be a Bloomery Mound. It may be the Bloomery Mound recorded as RCAHMS No. NS17NE 11 but the grid references differ slightly.

Fig. 13 - Site 16. Bloomery Mound may be that recorded as NS17NE 11.
