Site & Landscape Survey

Stroupster Farm, **Nybster, Caithness**

Standing Building Survey

Report No. 3064

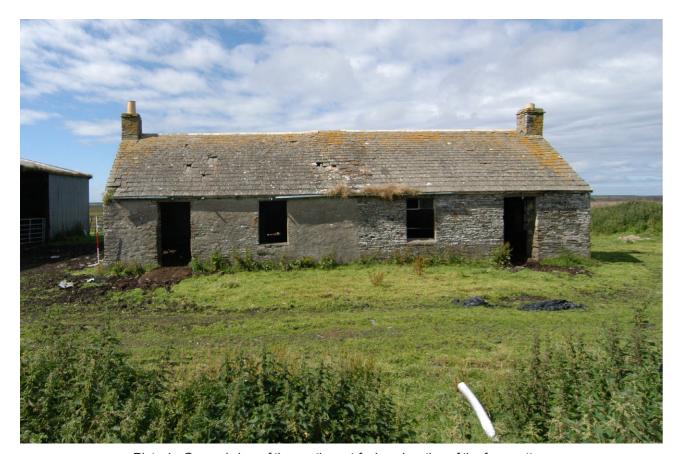
The south-east-facing elevation of the farm cottage measures 15.4m long and is 2.8m high from the ground to eaves level. The walls are 0.6m thick and constructed of Caithness flagstone bonded with lime mortar. There are four bays that include two doorways at each end (accessing Units 1 and 2) with two windows in the middle that lit the same. The south-west half of the elevation has been rendered with grey cement. The roof is covered with slate and with a chimney stack at each end. A cast-iron window-frame is still in situ at the north-east end (Unit 2). Some heavy cement pointing has been carried out on the corner of the north-east gable.

Plate 1 - General view of the south-east-facing elevation of the farm cottage

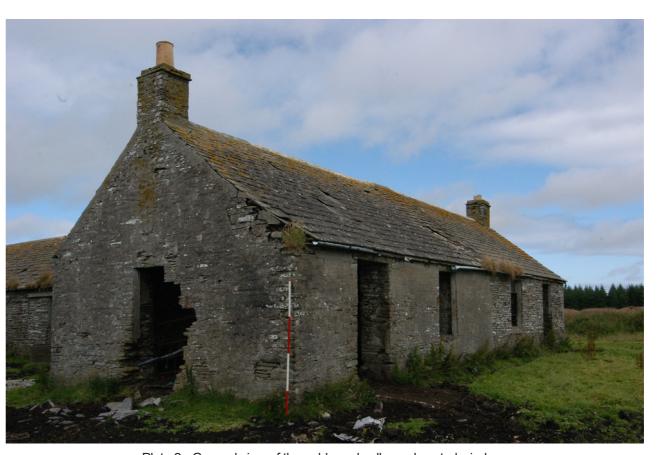
The south-west-facing gable is exactly the same as that on the north-east end of the cottage. The lower half of the window has collapsed exposing the hearting within the gable wall. This is a mixture of random rubble bonded with lime mortar.

Plate 2 - General view of the gable and collapsed central window

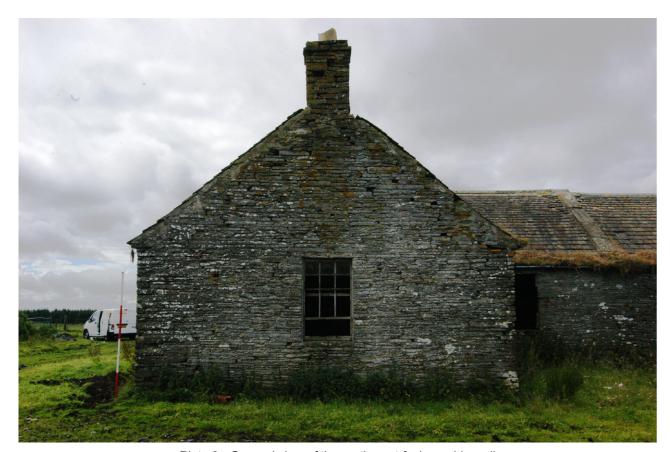
The north-east-facing gable is 5.7m wide and contains a single central window with the aforementioned cast-iron window frame still in situ. The gable is pitched and constructed of Caithness flagstone with a central chimney stack.

Plate 3 - General view of the north-east-facing gable wall

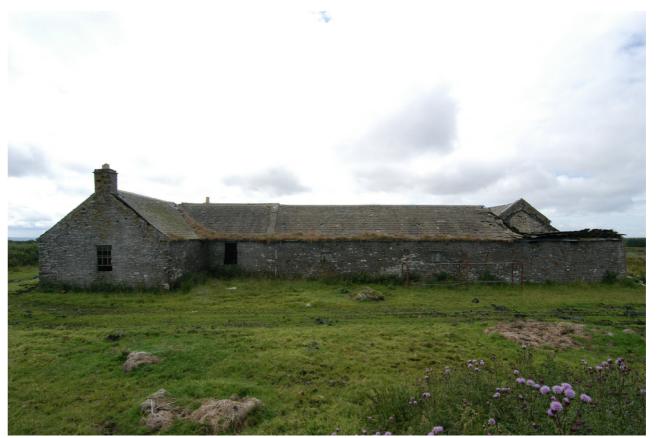
The exterior North-east-facing elevation includes the north-east-facing gable of the cottage (Unit 1-2) and the main spine wall of Units 4-6. The wall measures 25.6m long and contains a rectangular splayed bedroom window opening for Unit 4 and two hatch vents for Units 5 and 6. The vent openings measure 0.5m x 0.5m and have plank-built doors. Concrete breezeblocks were used to construct a later doorway on the north-west elevation and these have been keyed into the existing Caithness flagstones on the corner of the main elevation

Plate 4 - General view of the north-east-facing elevation

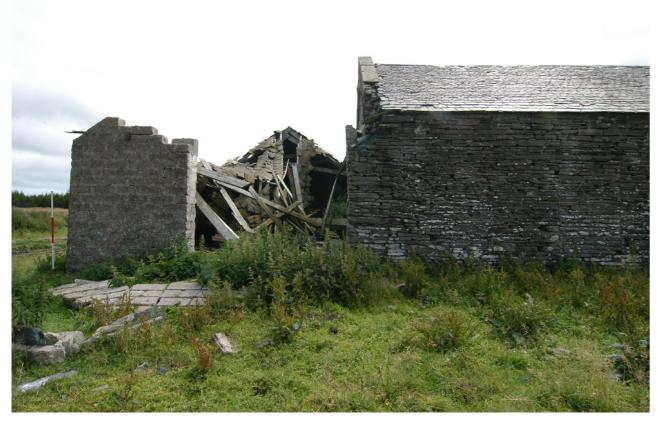
Plate 5 - Collapsed gable wall of the byre (Unit 60), north-west-facing elevation

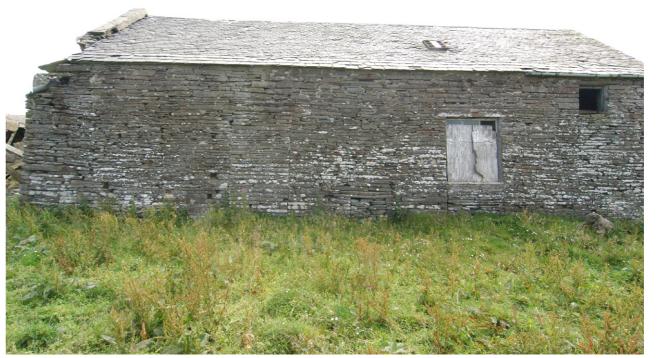
The exterior west-facing elevation contains the now collapsed entrance to Unit 6 and the main wall of the one-and-a-half storey barn (Unit 7). There are two blocked doorways on this elevation (c. 2m high and 1m wide), the southernmost doorway has been converted into a window that is now blind. Midway along the base of the wall between the two former doorways is a small blocked opening measuring 0.6m x 0.45m with a single slab lintel. This was probably a drive-shaft aperture associated with the circular horse gang shown on Fig 2b. Situated close to the south-west-facing gable is a square hatch vent which is open.

Plate 6 - General view of the north-west-facing elevation, thresing barn (Unit 7)

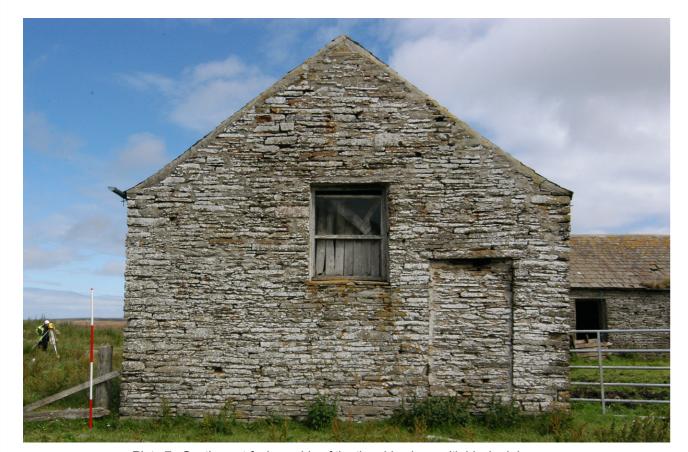
This elevation contains the south-west-facing gable of Unit 7 which is outshot from the main spine wall of Units 3-6 by 12.4m. The gable contains a central square-headed window and a blocked doorway on its east side. The blocked door measures 2.3m high and 1m wide and has been blocked with Caithness flagstone.

Plate 7 - South-west-facing gable of the threshing barn with blocked doorway

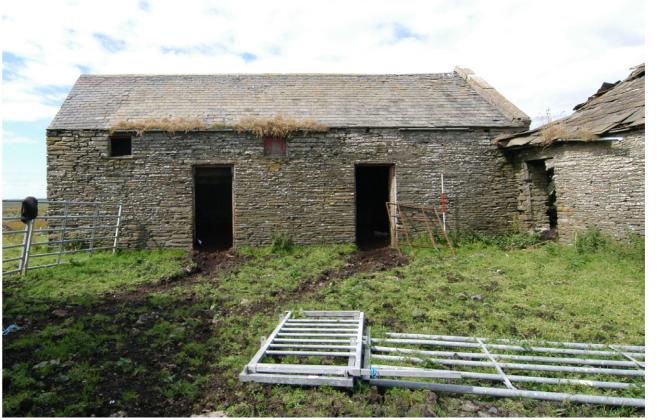
Plate 8 - General view of the south-east-facing elevation of the threshing barn

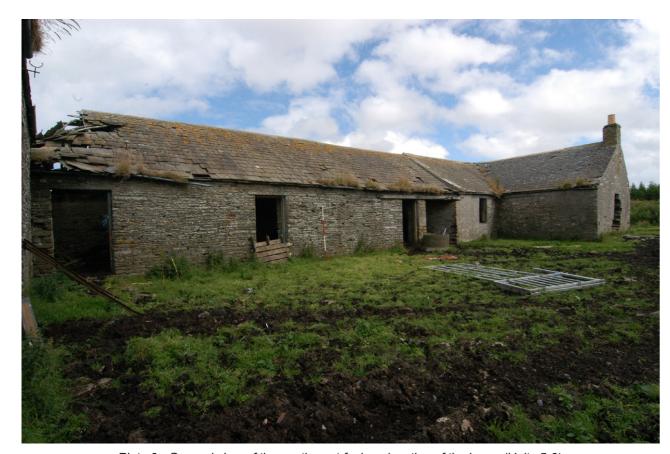
The main spine wall of the south-west-facing elevation contains two open doorways into Unit 6 the byre and two doors into Unit 5. At the east end of the elevation a window opening lights Unit 3. The wall is uniform in its construction and Unit 3 has been harled with grey cement. The roof is covered with slate. The openings into Unit 5 are surmounted by a pair of timbers. These are carried on a flagstone-built pier and embedded at both ends into the wall head. The interior timber is re-used and may have been salvaged ship's timber (see below).

Plate 9 - General view of the south-east-facing elevation of the byres (Units 5-6)

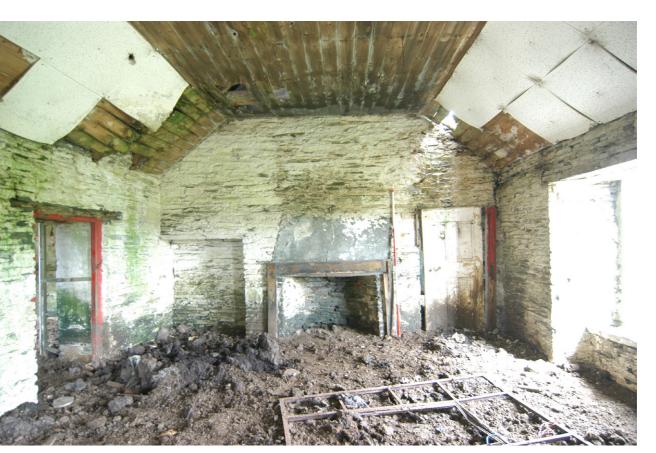
Unit 1 was accessed by a door on its south-east wall and lit by a window on the same wall and one on the gable. Most of the plaster lining the walls has gone but remnants still survive. A small stone-built fireplace is situated to the right of the gable window, The fireplace consists of a small stone lintel and two side stones. At the north-east end of the room there is a central fireplace and small press on its left-hand side. The chimney breast which is well over 1m thick incorporates a large rectangular flagstone lintel and remnants of a timber mantelpiece and fire surround still survive. The back of the fire is curved. A four-panelled white-painted door has been propped up against the opening between Unit 1 and 2 to keep livestock apart. The door is larger than the existing opening and has been brought in from elsewhere. A doorway on the south-east elevation leads into Unit 3 the bedroom. Within Unit 1, the ceiling is combed and lined with planks nailed directly onto the A-frame tie-beams. Mid-way along the ceiling, on both sides there are a series of white gypsum board tiles that have been used to line the ceiling. The floor is hidden by animal waste.

Plate 10 - Interior view of the cottage living room (Unit 1) showing the fireplace

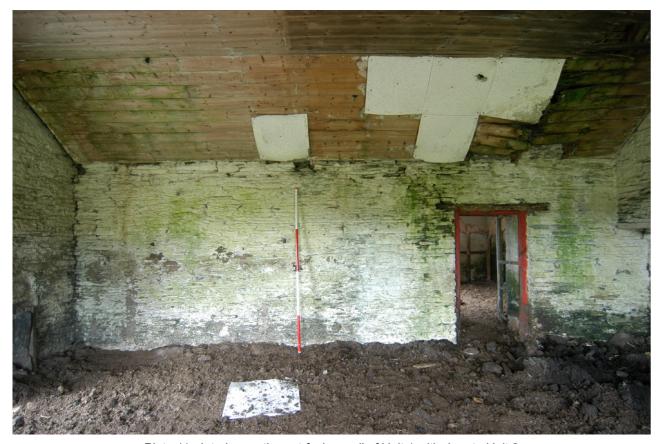
Plate 11 - Interior south-east-facing wall of Unit 1 with door to Unit 3

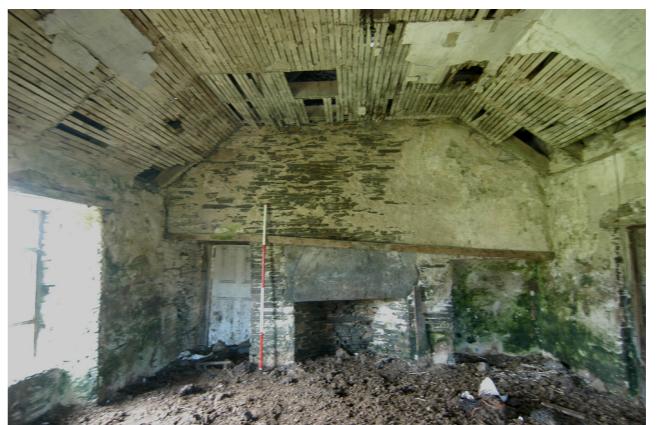
Unit 2 shares the same layout as Unit 1 with a central fireplace on the thick partition wall that has again made use of a large flagstone above the curved-back fireplace. A cast-iron window frame is in situ within the window opening on the south-east elevation. A doorway leads into Unit 4 on the north-west wall.

Plate 12 - Interior of the living room fireplace in Unit 2

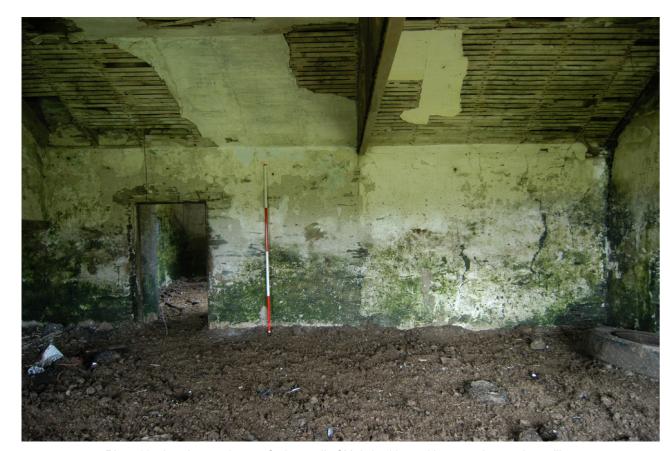
Plate 13 - Interior south-east-facing wall of Unit 2 with partition remains on the ceiling

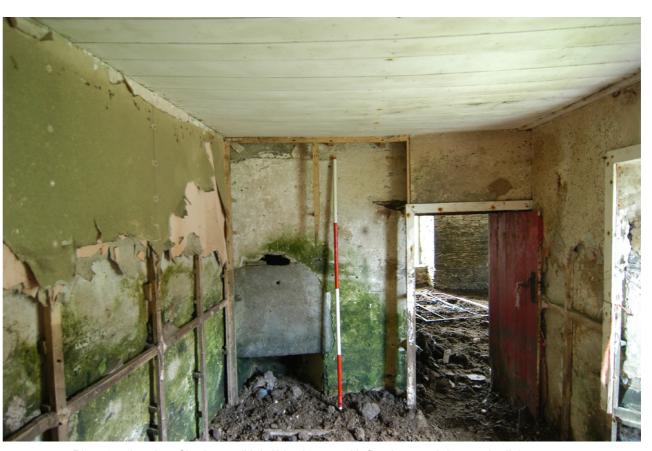
Unit 3 is a small bedroom serving Unit 1 and is lit on its south-west elevation and was heated by a small fireplace on the south-east elevation. The walls are lined with studwork that supported gypsum plaster board some of which still survives. The fireplace with a large flagstone chimneypiece has been built in the south-west-facing wall near the red-painted plank-built door. The aforementioned window has splayed reveals and the remains of a sash-and-case window surround. The ceiling is lined with white-painted tongue-and-grooved planks.

Plate 14 - Interior of bedroom (Unit 3) bedroom, with fireplace and door to the living room

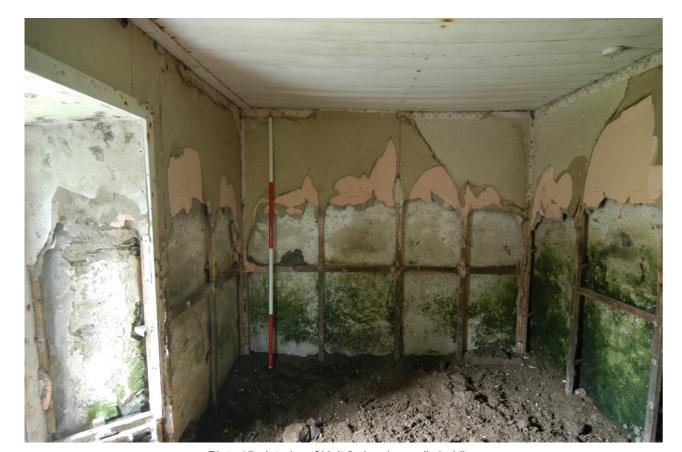
Plate 15 - Interior of Unit 3 showing wall cladding

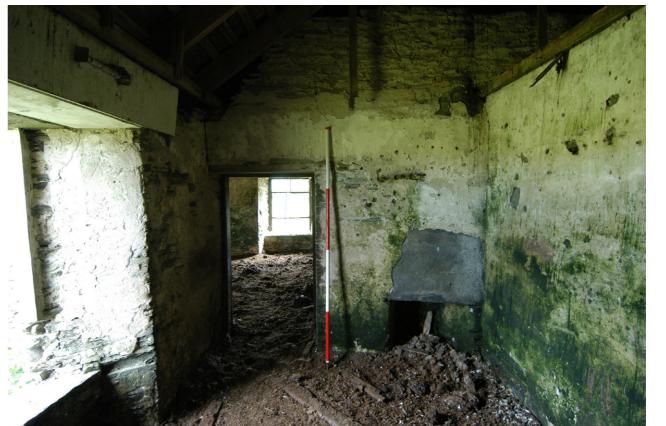
Unit 4 is a small bedroom serving Unit 2 and is lit on its north-east elevation and was heated by a small fireplace on the south-east elevation. The room has bare plaster covered walls with a splayed window on its north-east elevation. The fireplace is in the same location as Unit 3. No ceiling survives and the common A-frame rafters are exposed.

Plate 16 - Interior of bedroom Unit 4 showing fireplace and door to Unit 2

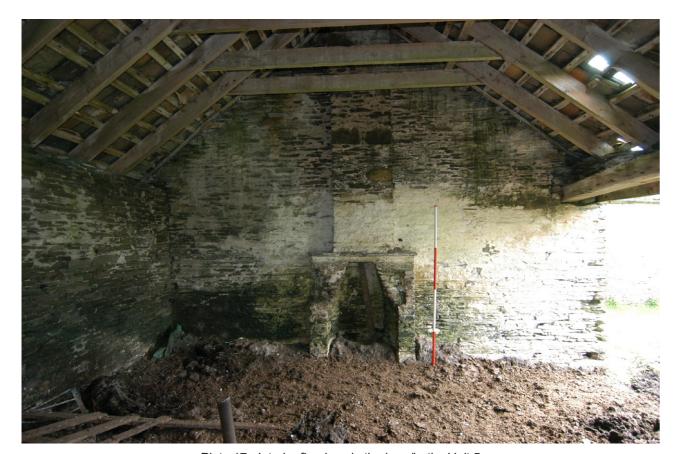
Unit 5 is rectangular in plan with two doorways on its south-west elevation. At the centre of the north-west-facing elevation there is a fireplace and chimney built of Caithness flagstone and advanced of the wall (Plate 17). The doorways were at one time much larger, one having been reduced in size by blocking half of its opening. Above the doorway are two large relieving timbers. The innermost timber is thought to be a re-used ship's timber (Plate 18-19). It has a distinct curve typical of a deck timber with drill-holes on its underside. On the opposite wall there is a plank-covered hatch vent. On the back wall, facing the fireplace, the wall has a large flagstone projecting off it forming two animal stalls (Plate 20). The A-frame roof rafters are exposed and are machine sawn, scarfe-jointed and nailed.

Plate 17 - Interior fireplace in the byre/bothy Unit 5

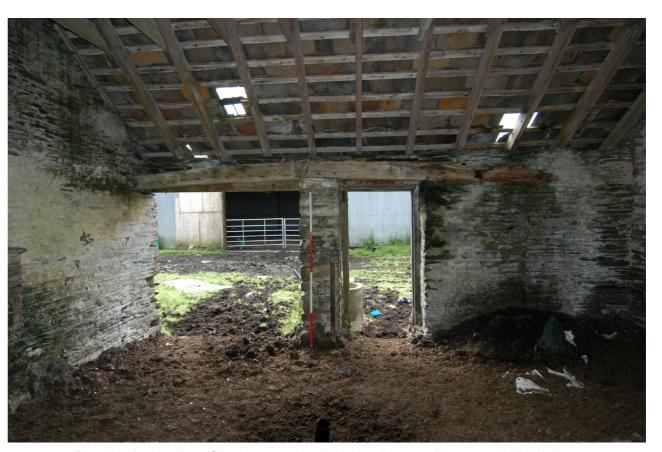
In Byre/Unit 5, one of the timbers (inner) above the doorways might be a re-used ships timber (deck-beam?). It has a distinct curve and tapers at each end. It also has two bolt-holes on its underside; this may have been associated with a below-deck iron support column. Beading carved on the inner edge (to round its corner and stop head injuries) lends additional weight to the theory that it is a re-used ship's timber and it

is probably not uncommon to find re-used ships timber in the area being so close to the harbour town of Wick.

Plate 18 - Interior view of the door openings in Unit 5 with a possible re-used ship's timber

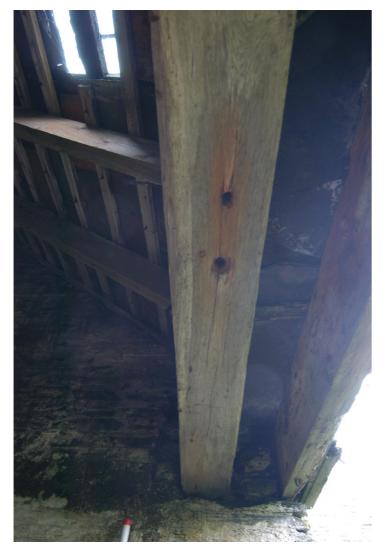
Plate 19 - Detailed shot of the underside of the possible ship's timber with drill holes

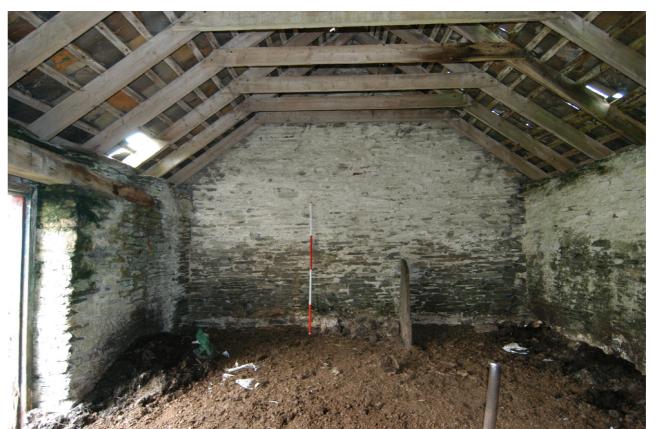
Plate 20 - Interior south-east-facing wall with a stall made from a large fireplace

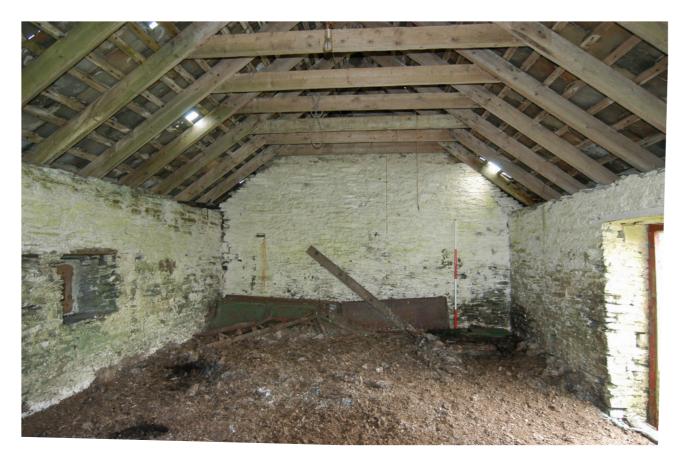
Plate 21 - Interior party wall between Unit 5 and 6, the large byre

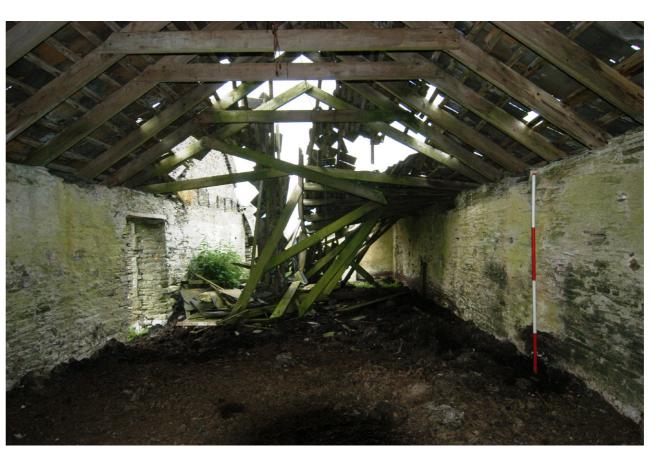
Unit 6 is rectangular in shape and it had a large bay opening at its south-west end but which has collapsed. The opening was rectangular and a recent (20^{th} century) insert as its surrounds were constructed of breeze blocks. The A-frame constructed roof at this end of the building has collapsed. There are two doorways on the north-west-facing elevation and both are the same size (1.8 m x 1.1 m). On the opposite wall there are two timber clad hatch vents.

Plate 22 - Interior north-west end of Unit 6 showing collapsed roof

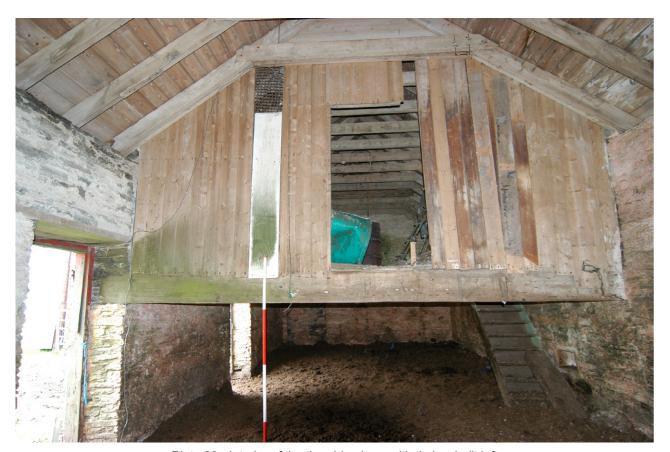
Unit 7 is a one-and-a-half storey stone-built barn, now used as a byre but it was a threshing barn during the 19th century. Two thirds of the interior of the building is occupied by the loft (Plate 23) that is accessed by a wooden staircase (Plate 25) on the south-east-facing elevation. The interior south-west-facing gable shows evidence for

Plate 23 - Interior of the threshing barn with timber-built loft

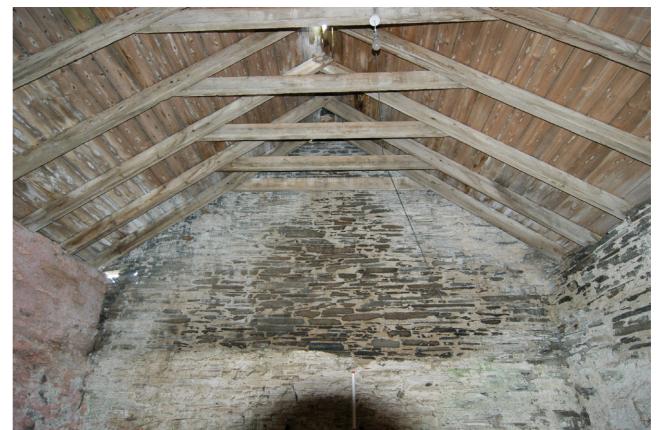
heightening by approximately 0.5m to accommodate a later roof (Plate 24). The south-east-facing elevation has two doors that have been blocked; the southernmost window has been converted into a window which is now boarded. Between these two features adjacent to the staircase is a wooden bearing box built into a recess in the wall. The opposite wall has two open doorways which are exactly in line with the two aforementioned blocked doors. This arrangement is typical of threshing barns where threshing by hand could be carried on indoors with the draught supplied for winnowing. On the north-facing gable there is a blocked doorway and no other features.

Plate 24 - Interior south-west facing gable of the threshing barn showing wall heightening

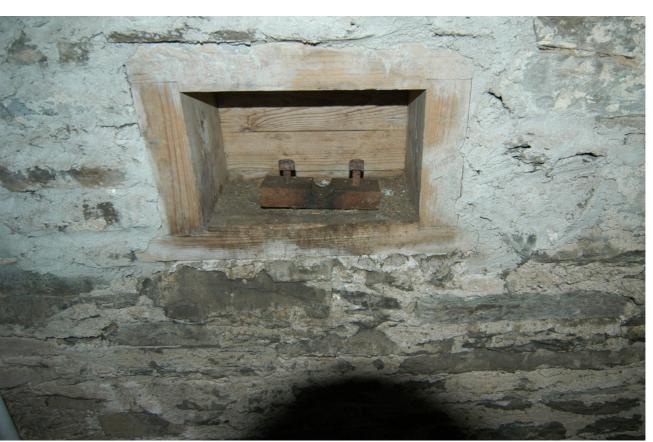
Plate 26 - A bearing box at loft level

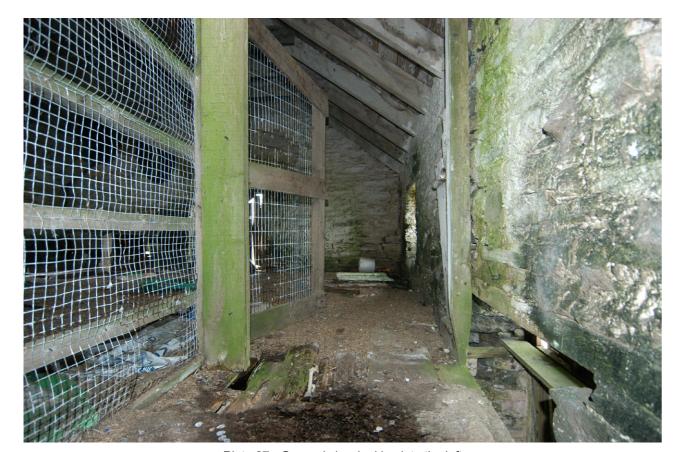
The loft is supported by large timber beams that are carried through the wall. The north end of the loft is boarded by planks. Above the loft stairs there is another bearing box set within an aperture in the wall (Plate 26). The loft space is vented by hatch vents set below the eaves (Plate 27 shows one near the gable).

Plate 27 - General view looking into the loft

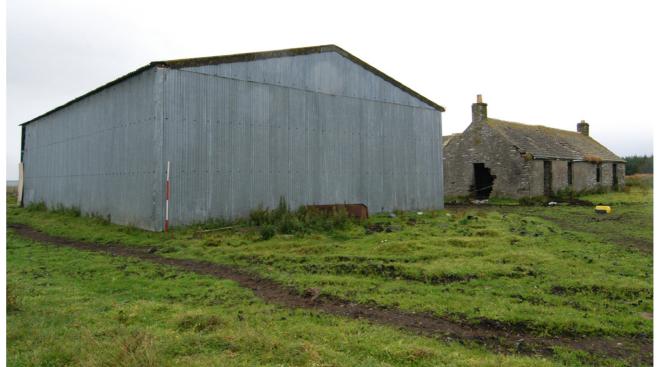
The modern steel-framed agricultural shed was erected during the 1980s and is of no historical interest (Plate 28).

Plate 28 - General view of the modern steel-framed agricultural shed on the south side of the steading
