Howden House Level 2 Historic Building Survey Report

Report No. 2038

CFA ARCHAEOLOGY LTD

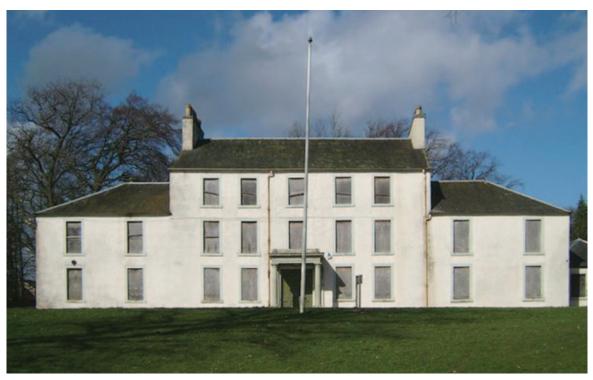
Fig. 6 - South-facing (front) elevation of Howden House

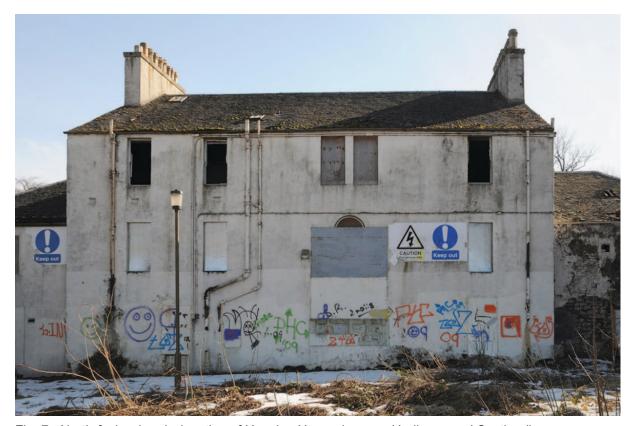
Fig. 7 - North-facing (rear) elevation of Howden House (source, Undiscovered Scotland)

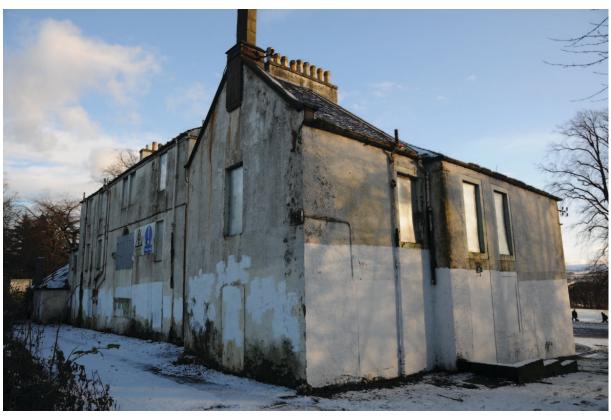
Fig. 8 - West-facing (side) elevation of Howden House (source, Undiscovered Scotland)

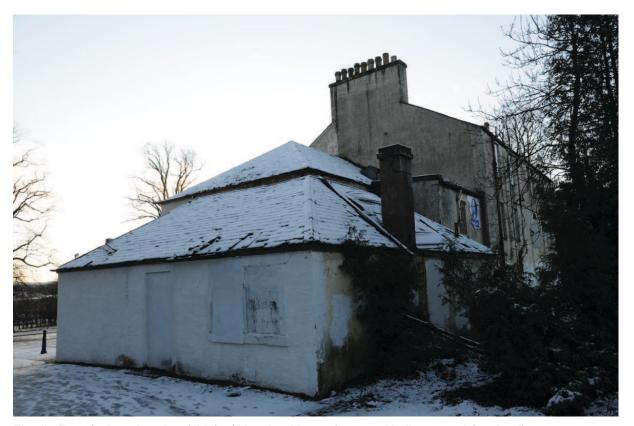
Fig. 9 - East-facing elevation (side) of Howden House (source, Undiscovered Scotland)

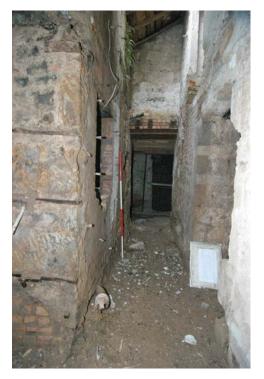
Unit 6 was accessed by a doorway leading from the main passage and measures 6m by 2m. Partition walls have been removed between it and Unit 5 and Unit 7. The remaining walls are rubble built and have been heavily repaired with an assortment of brick types. A wash-hand basin was present below the single window (1m high and 0.8m wide) on the south facing elevation.

Fig. 16 - Unit 6 general view facing east after removal of partition walls

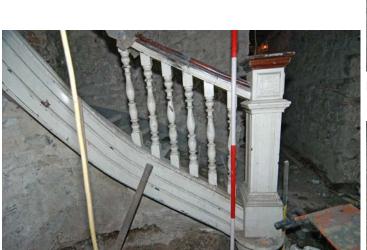
Fig. 18 - Unit 2 main staircase balustrade and handrail

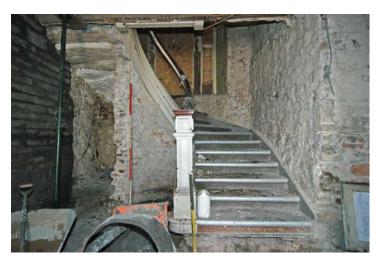
Fig. 17 - Unit 2 main staircase newal post and treads

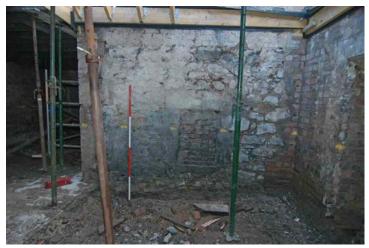
Fig. 21 - Unit 11, East Wing, blocked window with chamfer moulded surrounds

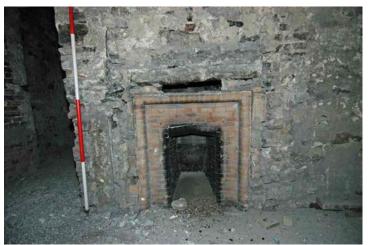
Fig. 23 - Unit 13, fireplace at the west end (east-facing elevation)

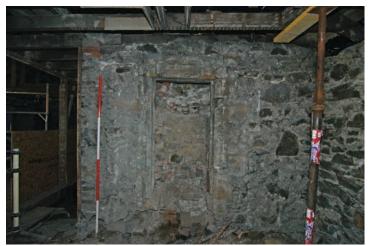
Fig. 27 - Unit 20 blocked window on the early stair tower wall, fabric detail. East-facing elevation

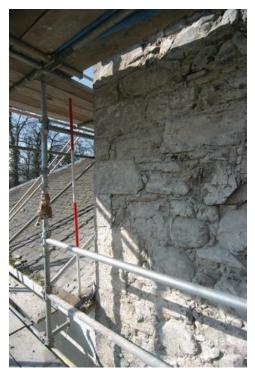
Fig. 35 - Exterior south elevation, quoins on the main block wall above the West Wing

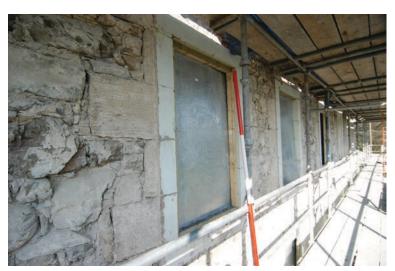
Fig. 36 - Exterior south elevation, dressed stone surrounds around the windows after removal of harling
