Bridgehouse Mill, West Linton Scottish Borders

Standing Building Survey & Watching Brief

Report No. 3156

Author	Michael Cressey BA MSc PhD MifA FSA Scot
Illustrator	Kevin Hicks BA (Hons) FSA Scot
Editor	Bruce Glendinning BSc PgDip MifA
Commissioned by	Bergmark Architects Ltd on behalf of Mr and Mrs Wood
Date issued	July 2014
Version	0
Planning Ref	12/01527/FUL
Grid Reference	NT 1435 5240
Oasis Ref No.	cfaarcha1-178387

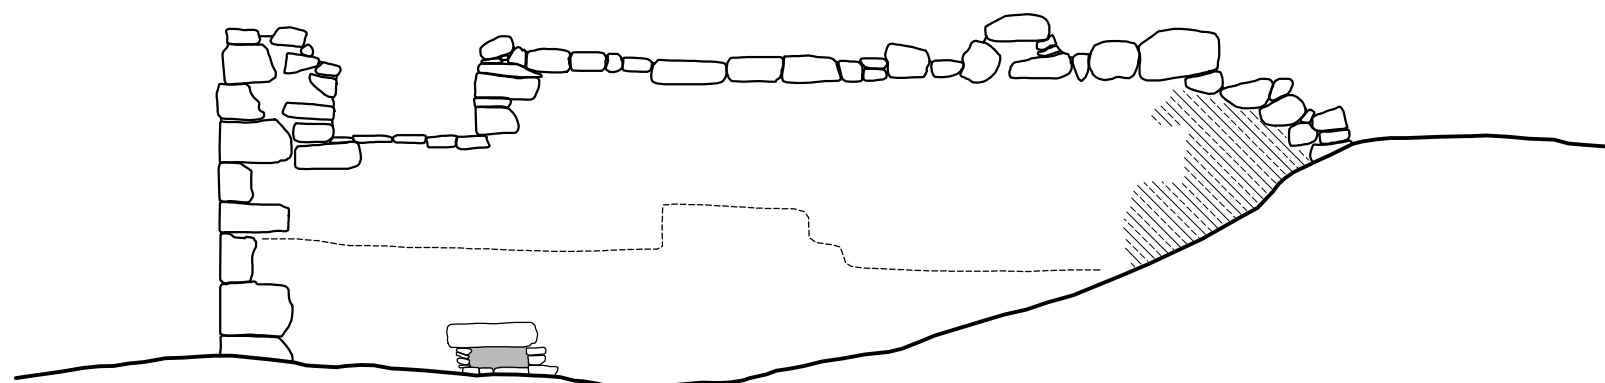
Fig. 4a - North-facing elevation

North-facing Elevation (Fig 4a, Plate 3)

The north-facing elevation is 7.2m long, 2m high and is 0.7m thick and has been constructed using rectangular blocks of coursed sandstone and whinstone. At the east-end of the elevation a series of stugged quoins survive. At the opposite end, the elevation has been terraced into a slope and is approximately 1m high. There is a noticeable change in fabric with courser whinstone blocks used along the base of the wall which are surmounted by blocks of coursed sandstone. The change in construction points to a substantial re-build rather than repair. Situated 0.76m from the east corner of the building is the remains of a window opening which measures

0.9m by 0.6m. The wall head is irregular. At the base of the wall there is a small rectangular opening that may have been a small drain.

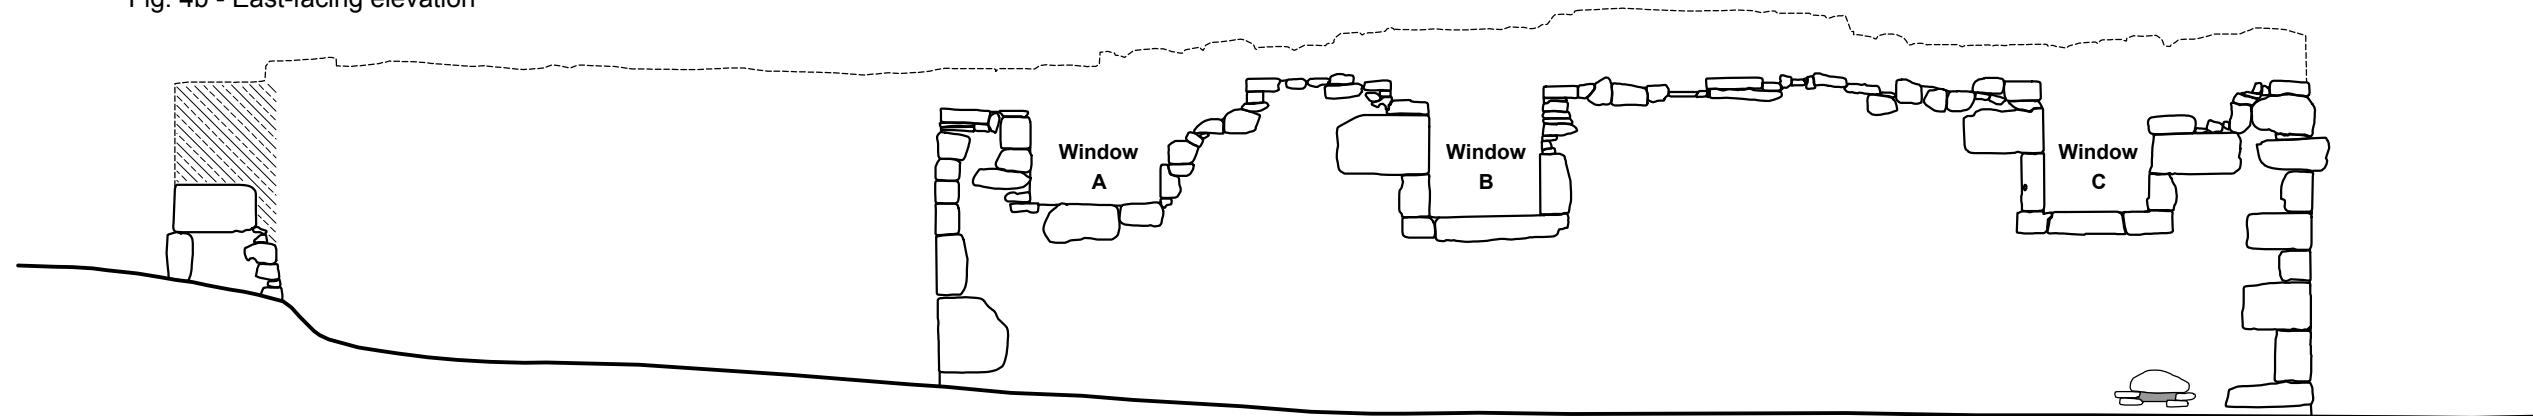
Fig. 4b - East-facing elevation

East-facing Elevation (Fig 4b, Plate 4)

The east-facing elevation is 14.1m long and stands to a maximum height of 2.25m. The elevation is built of random rubble and is 0.6m thick. The fenestration includes the remains of a large bay opening measuring 4m wide and three window openings. Window opening (a) measures 0.87m wide and is 0.5m high, and has no dressed surrounds. The middle window (b) still has a sill and some of its surrounds. These are cream sandstone and droved. The remains of an iron window bar projects from the sill. The northernmost window, window (c) is the best preserved and has a sill and droved surrounds. The sill has lead-filled sockets marking the position of its window bars. A small drain is present at the north end of the building just above ground level.

On the north side of the large bay opening the remains of its stone door surrounds survive with iron spikes in place for retaining a timber door frame. The surrounds are droved and contemporary with the window dressings.

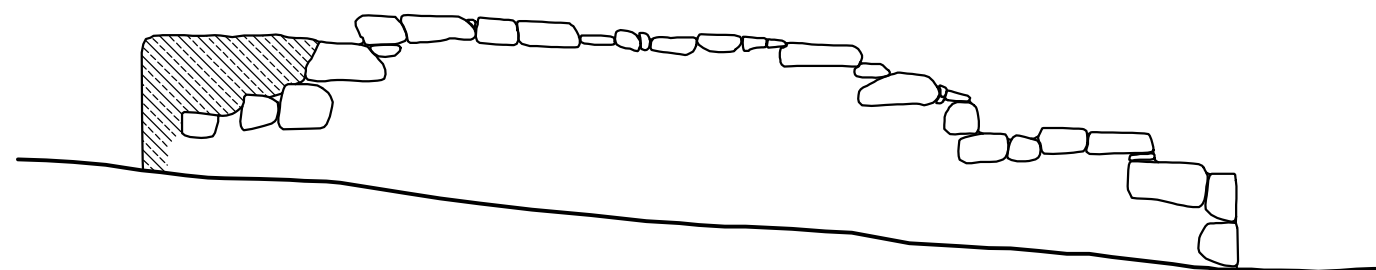
Fig. 4c - South-facing elevation

South-facing elevation (Fig 4c, Plate 5)

The south-facing elevation was the former mill gable wall and this has been reduced to a height of 1.6m. Measuring 7.2m long the wall is constructed of coursed rubble and is 0.7m thick. The quoins at its west end have been robbed. At the east end these survive to a height of 0.5m and comprise Old Red Sandstone blocks with droving.

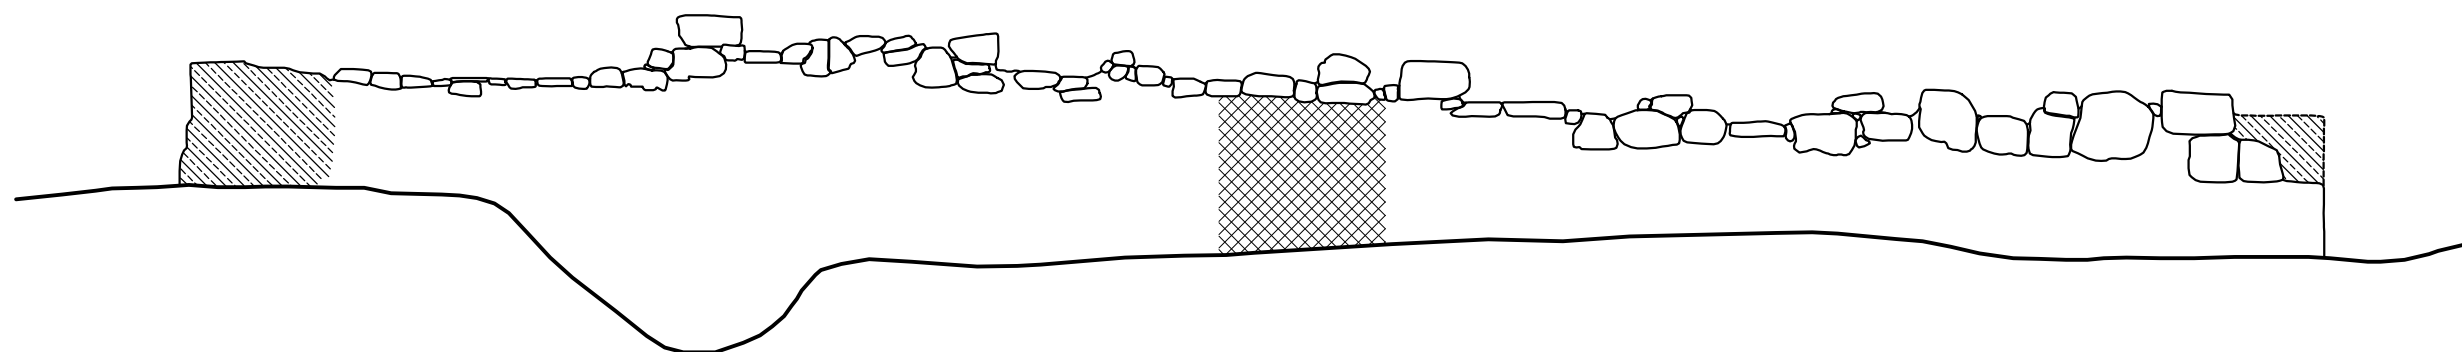
Fig. 4d - West-facing elevation

West-facing Elevation (Fig 4d, Plate 6)

The west-facing elevation 13.9m long and 0.7m high and is constructed of random rubble. An inspection pit recently dug against the wall towards the north end showed its foundations to be at least 2.5m deep below the current ground level. More or less at the centre of the wall is a blocked square opening measuring c.1.05m wide and 0.65m high. The blocking work comprises an assortment of sandstone rubble bonded with grey cement.

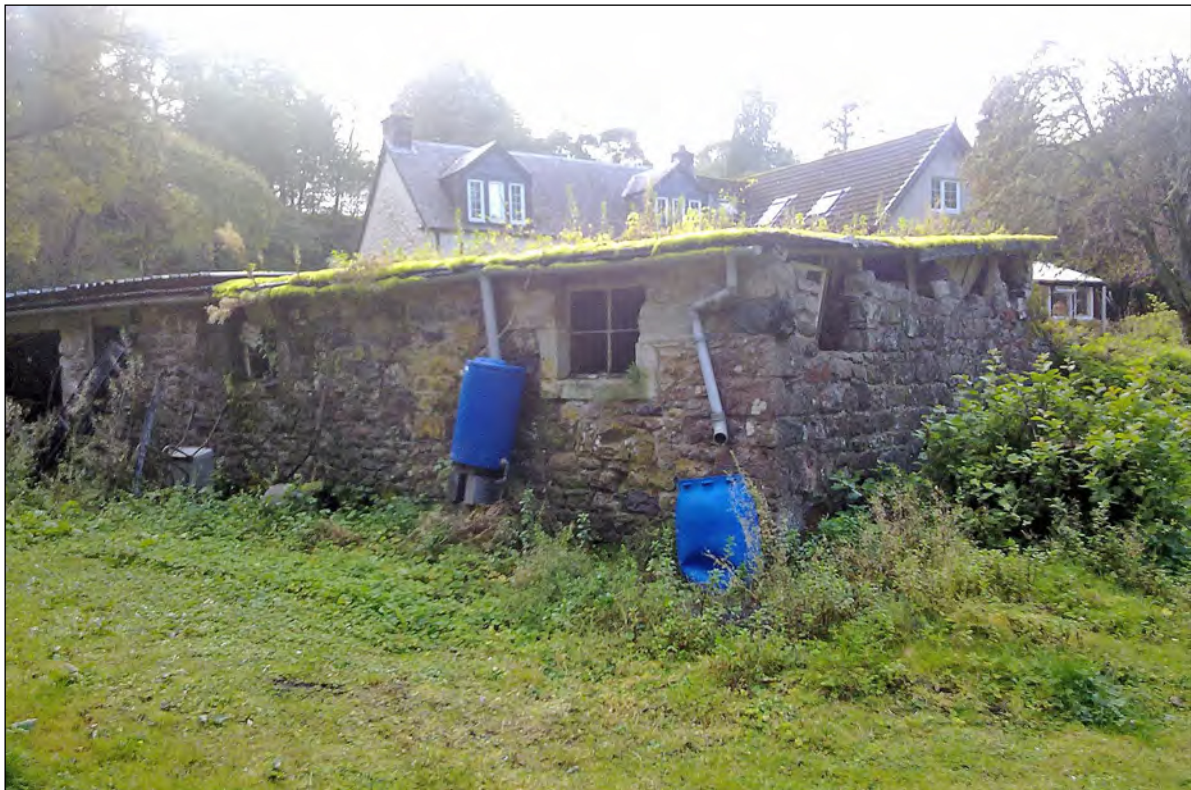
The layout of the mill is described first followed by the external and internal elevations. The roof of the building had been removed prior to the start of the building survey as it was structurally unsafe. Prior to this the roof had been clad with metal sheeting resting on softwood timber (Plate 2).

Plate 2 – North and east-facing elevations of the mill with a roof prior to removal

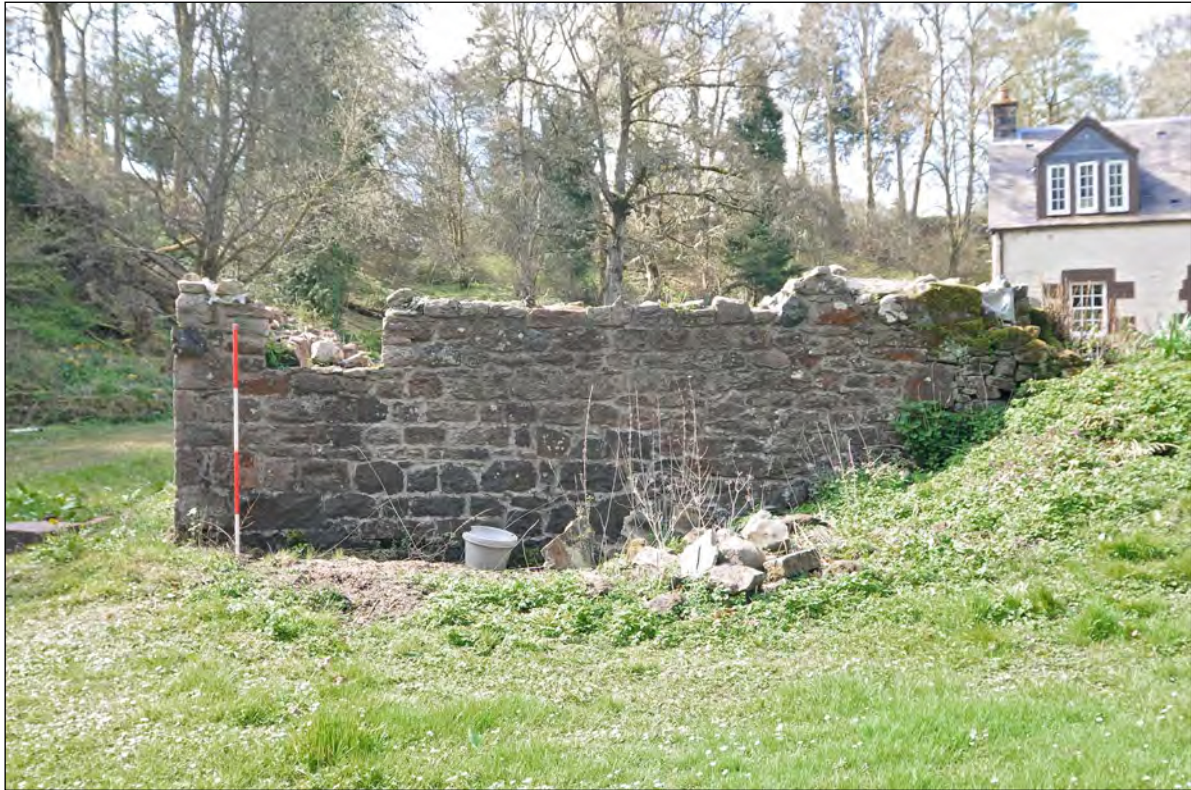
Plate 3 – External north-facing elevation

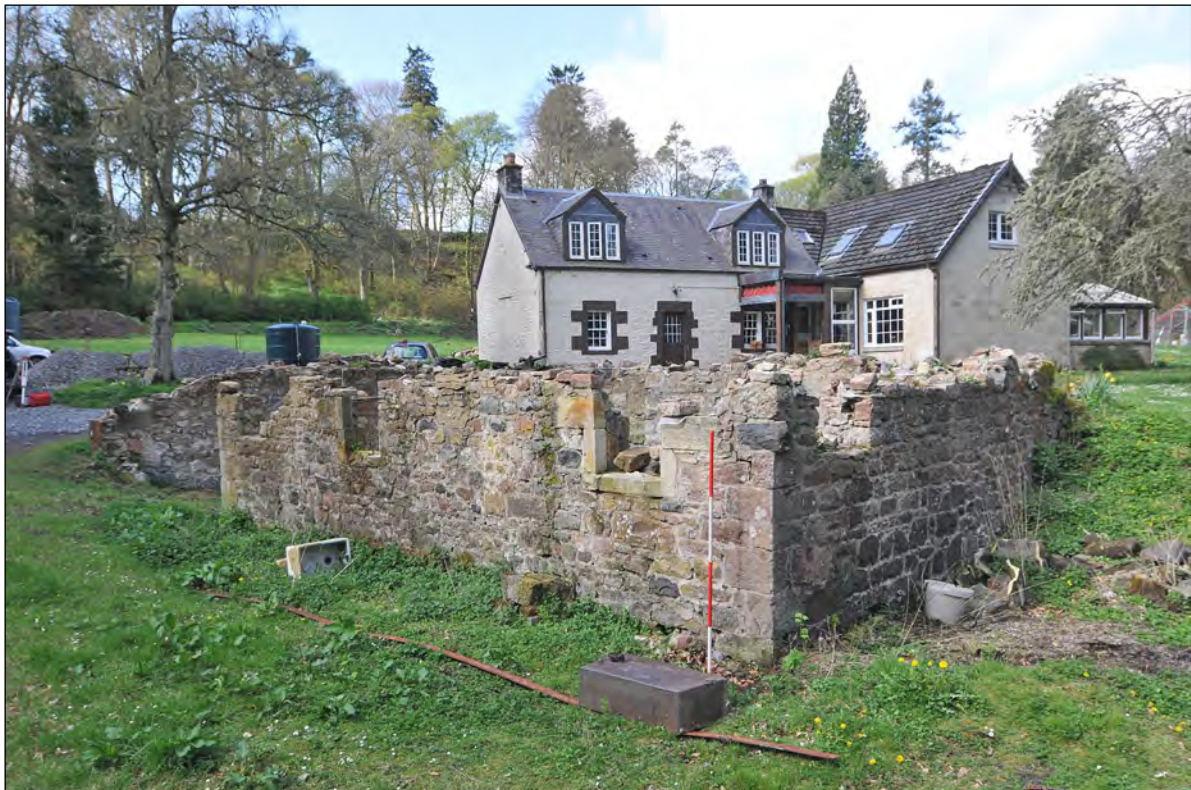
Plate 4 – External east-facing elevation looking south-west

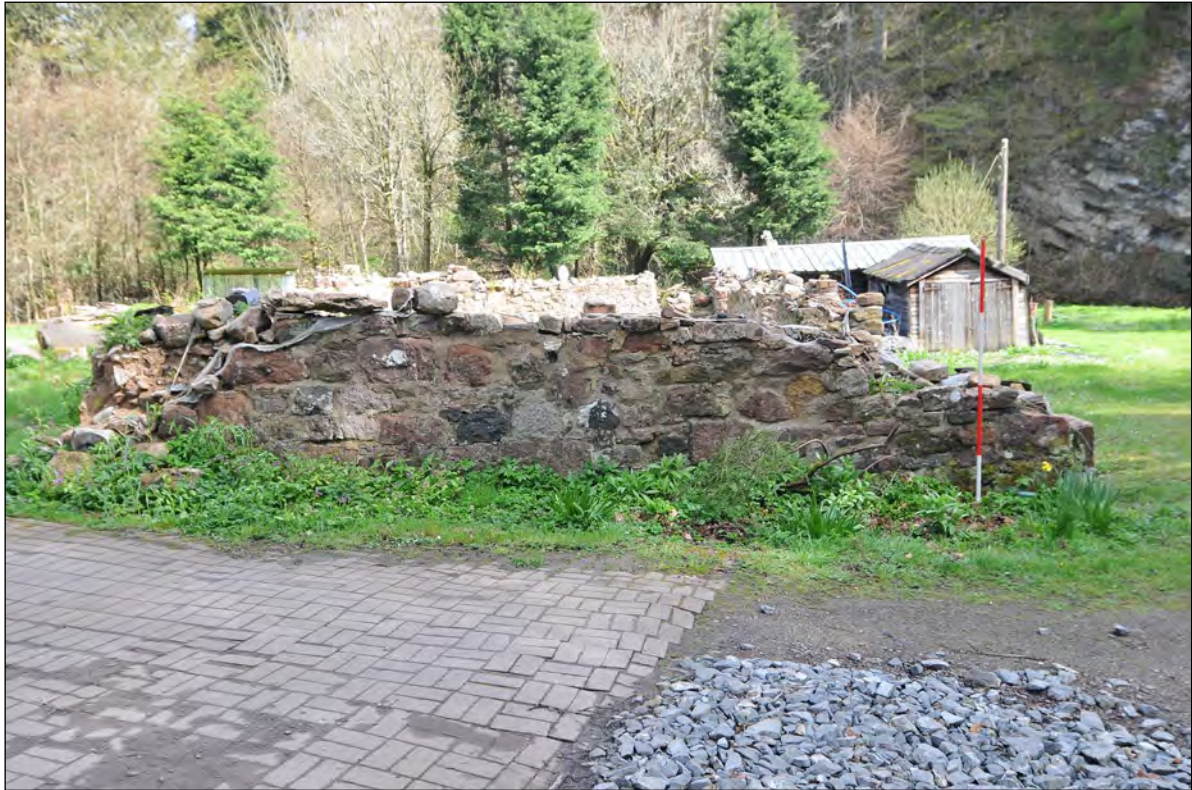
Plate 5 – External south-facing elevation

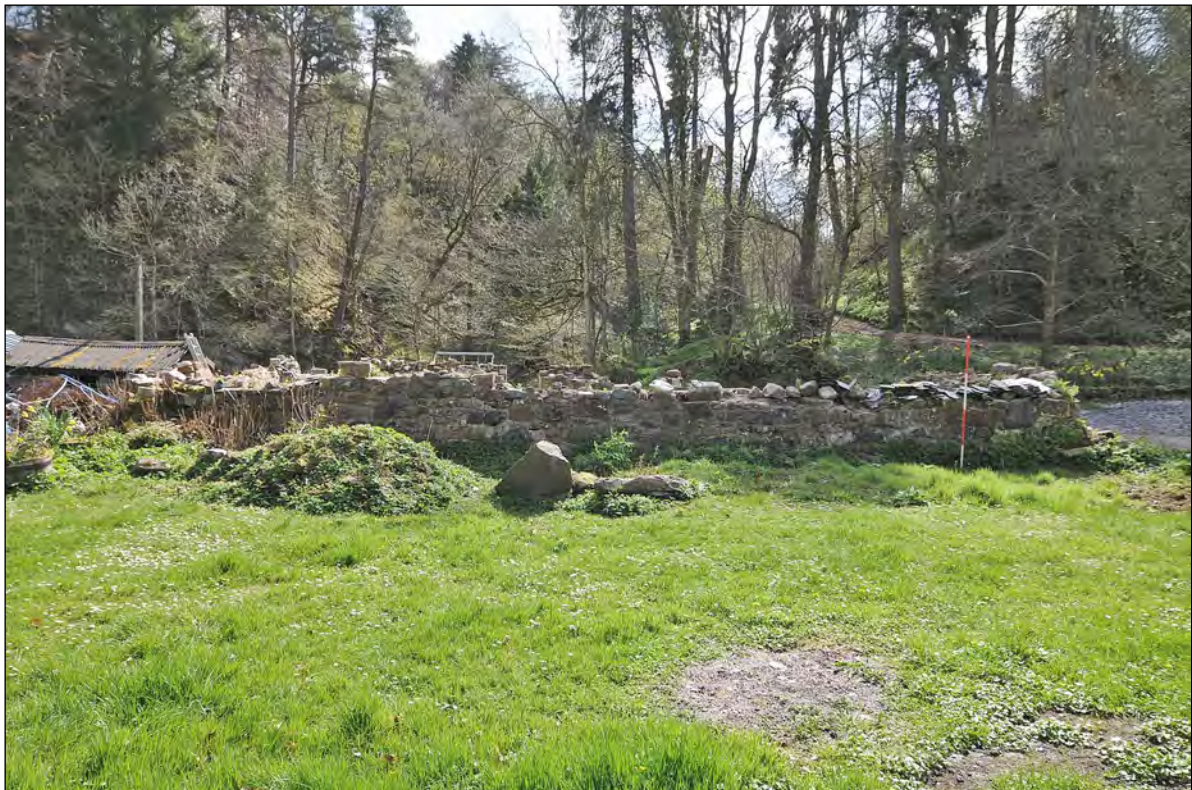
Plate 6 – External west-facing elevation

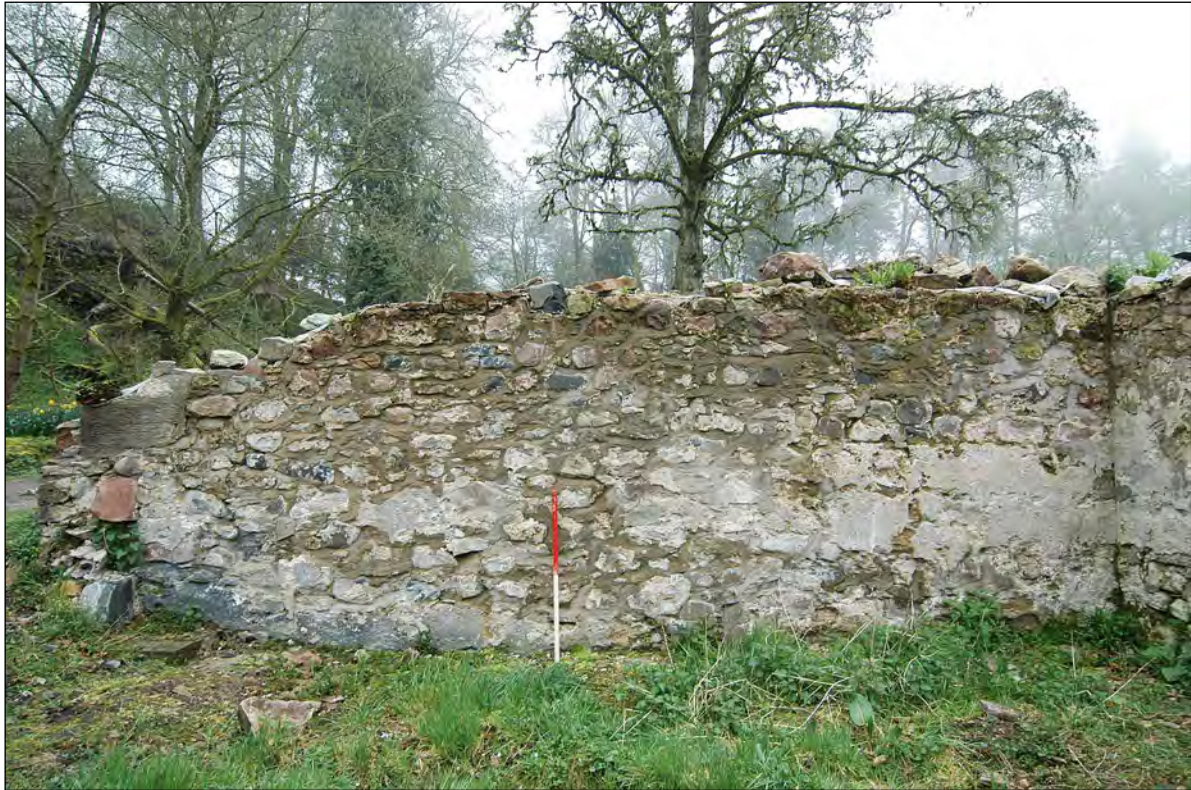
The interior north-facing elevation (former gable) is constructed of random rubble and is 6.8m wide and 2.2m high in the south-west corner. The wall is featureless with the exception of remnants of original cream-coloured plaster that survives best at its west end.

Plate 7 – Internal north-facing elevation

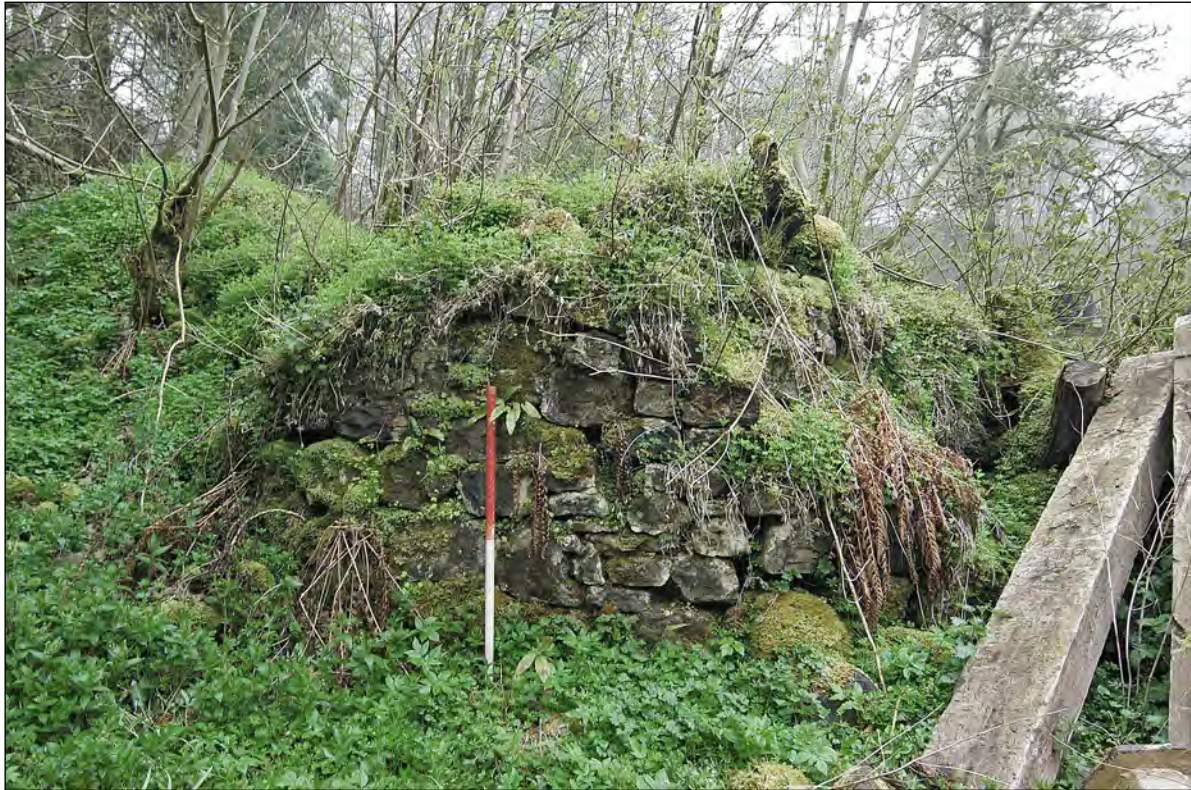
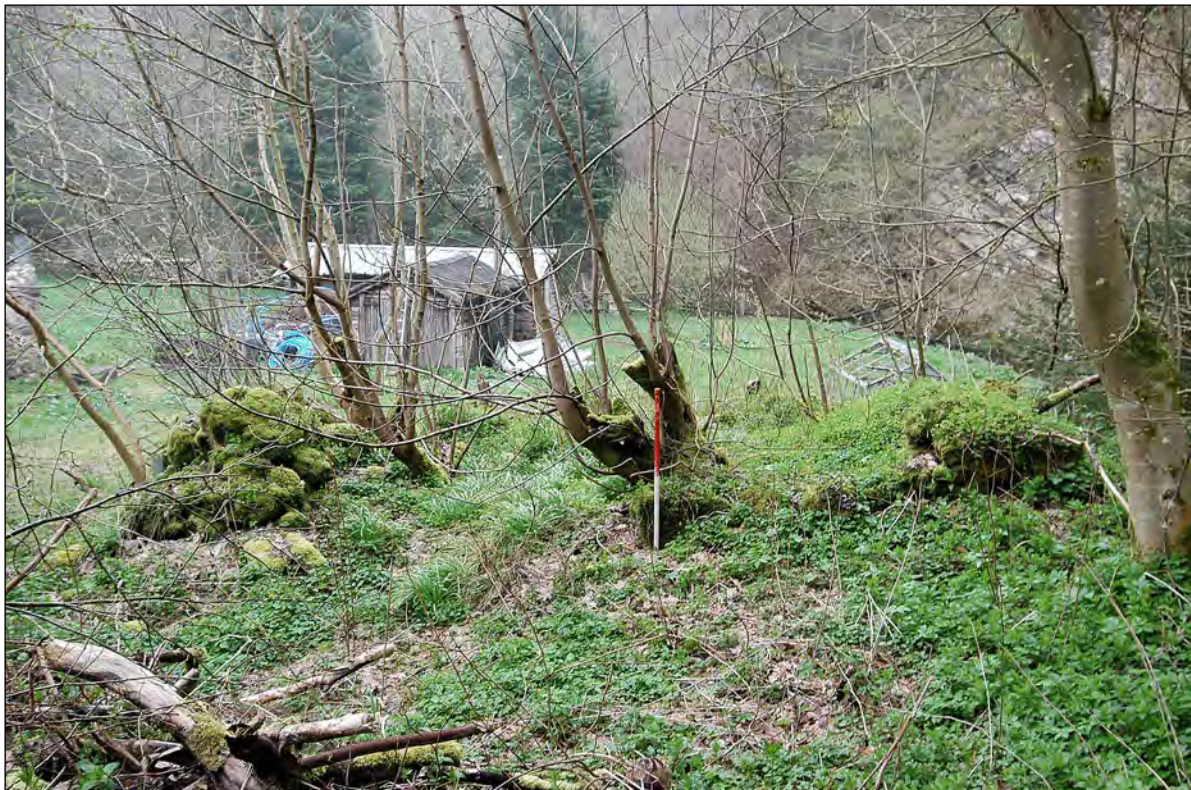
In keeping with a request from Dr Bowles, the ruin of a small ancillary building outside the property boundary to the east of the mill was photographed (Plates 15 & 16).

Plate 15 – Ruined building remains on the east side of the mill looking south

Plate 16 – Ruined building remains on the east side of the mill looking south

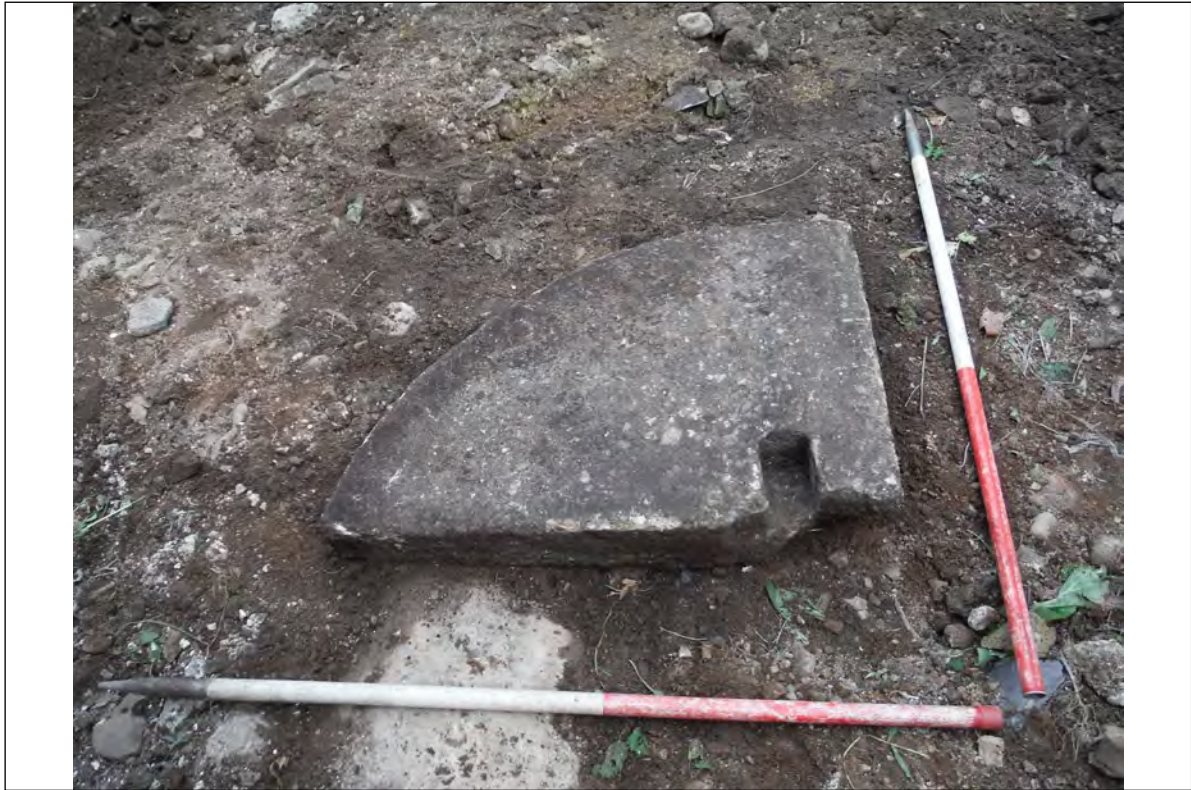
Within the demolition rubble near the north end of the mill a piece of a mill stone was discovered (Plate 17). This had a curved outer edge and the broken remains of a socket and the edge of a possible circular central shaft hole were just visible in one corner of the piece. The dimensions were 0.75m x 0.48m (sub one quarter of a full circle) indicating an original diameter of around 1.50m (the broken centre made an

Plate 17 – Fragment of Mill Stone

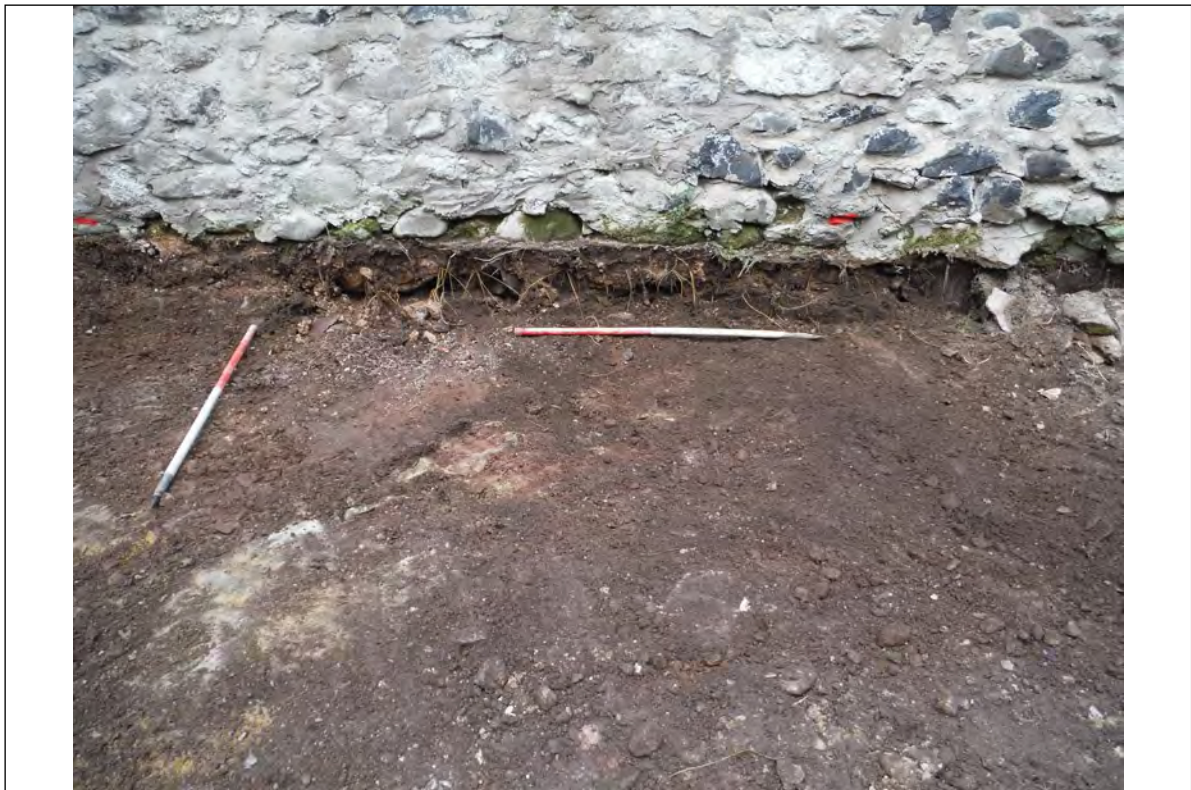
Plate 18 – Wall founded on natural river gravels (007)

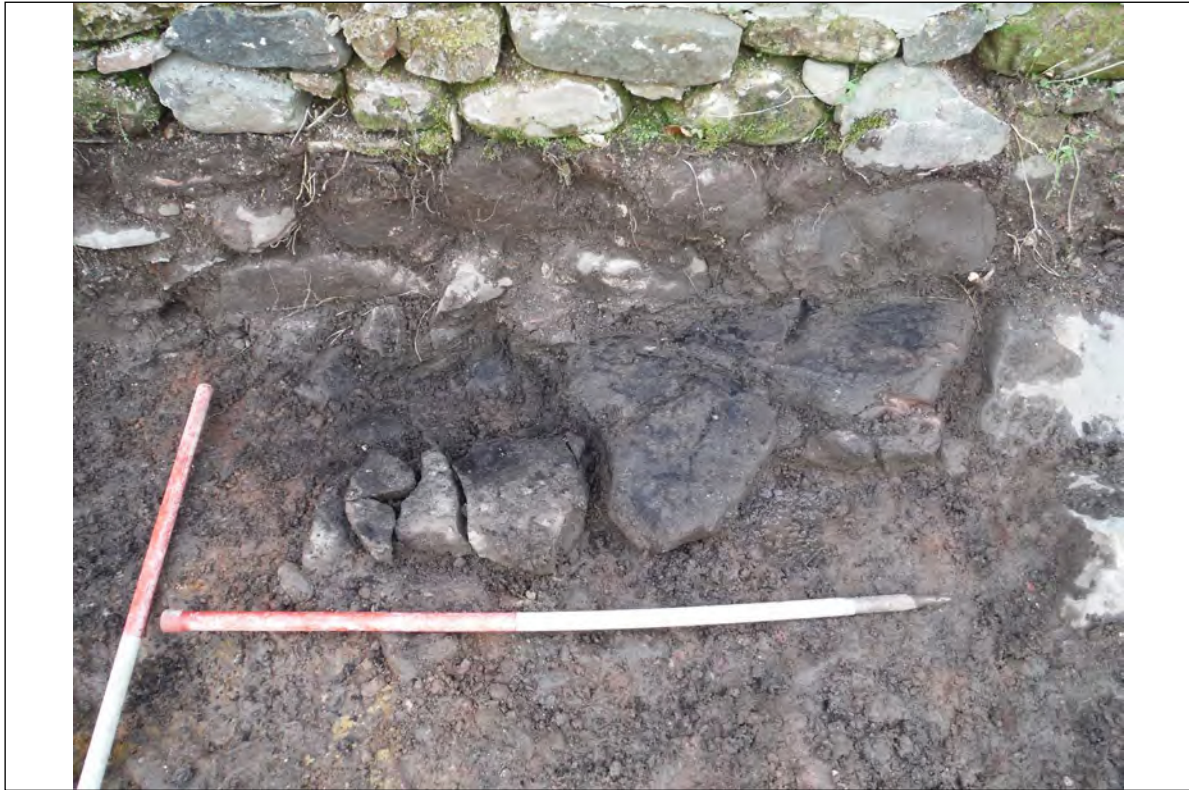
Plate 19 – Slabs (005) below ashy fire derived deposits (011)

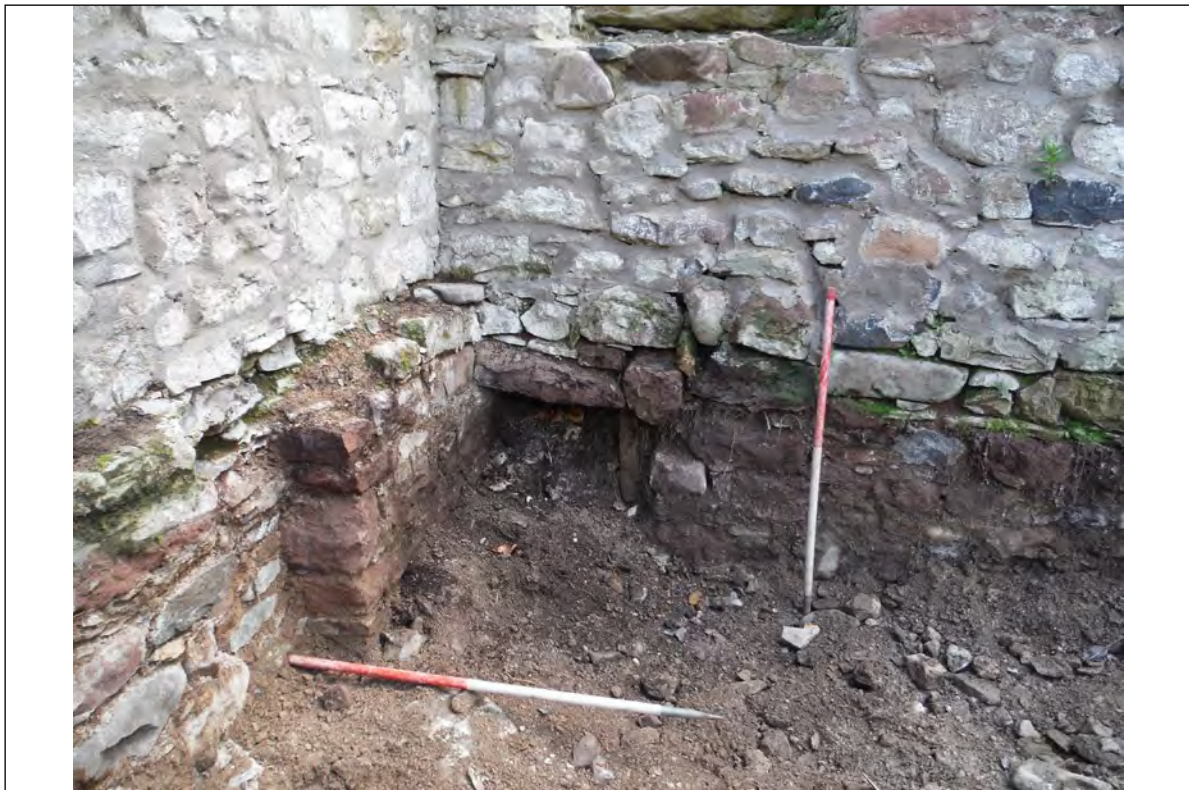
A recess was found built in to the eastern wall (Plate 20) this matched with the external opening in the east facing exterior elevation which is thought to be the remains of a drain.

Plate 20 – Recess in eastern wall
