Pathbrae Maltings Building, Kirkliston Historic Building Survey & Demolition Watching Brief

Report No. 2007

Author	Michael Cressey HND BA MSc PhD MifA FSA Scot
Illustrator	Leeane Whitelaw BSc MifA
Editor	Bruce Glendinning Bsc PgDip MifA
Commissioned by	Turley Associates
Date issued	March 2012
Version	0
OASIS Reference	cfaarcha1-183526
Planning Application No	11/01589/LBC
Grid Ref	NT 12313 74254

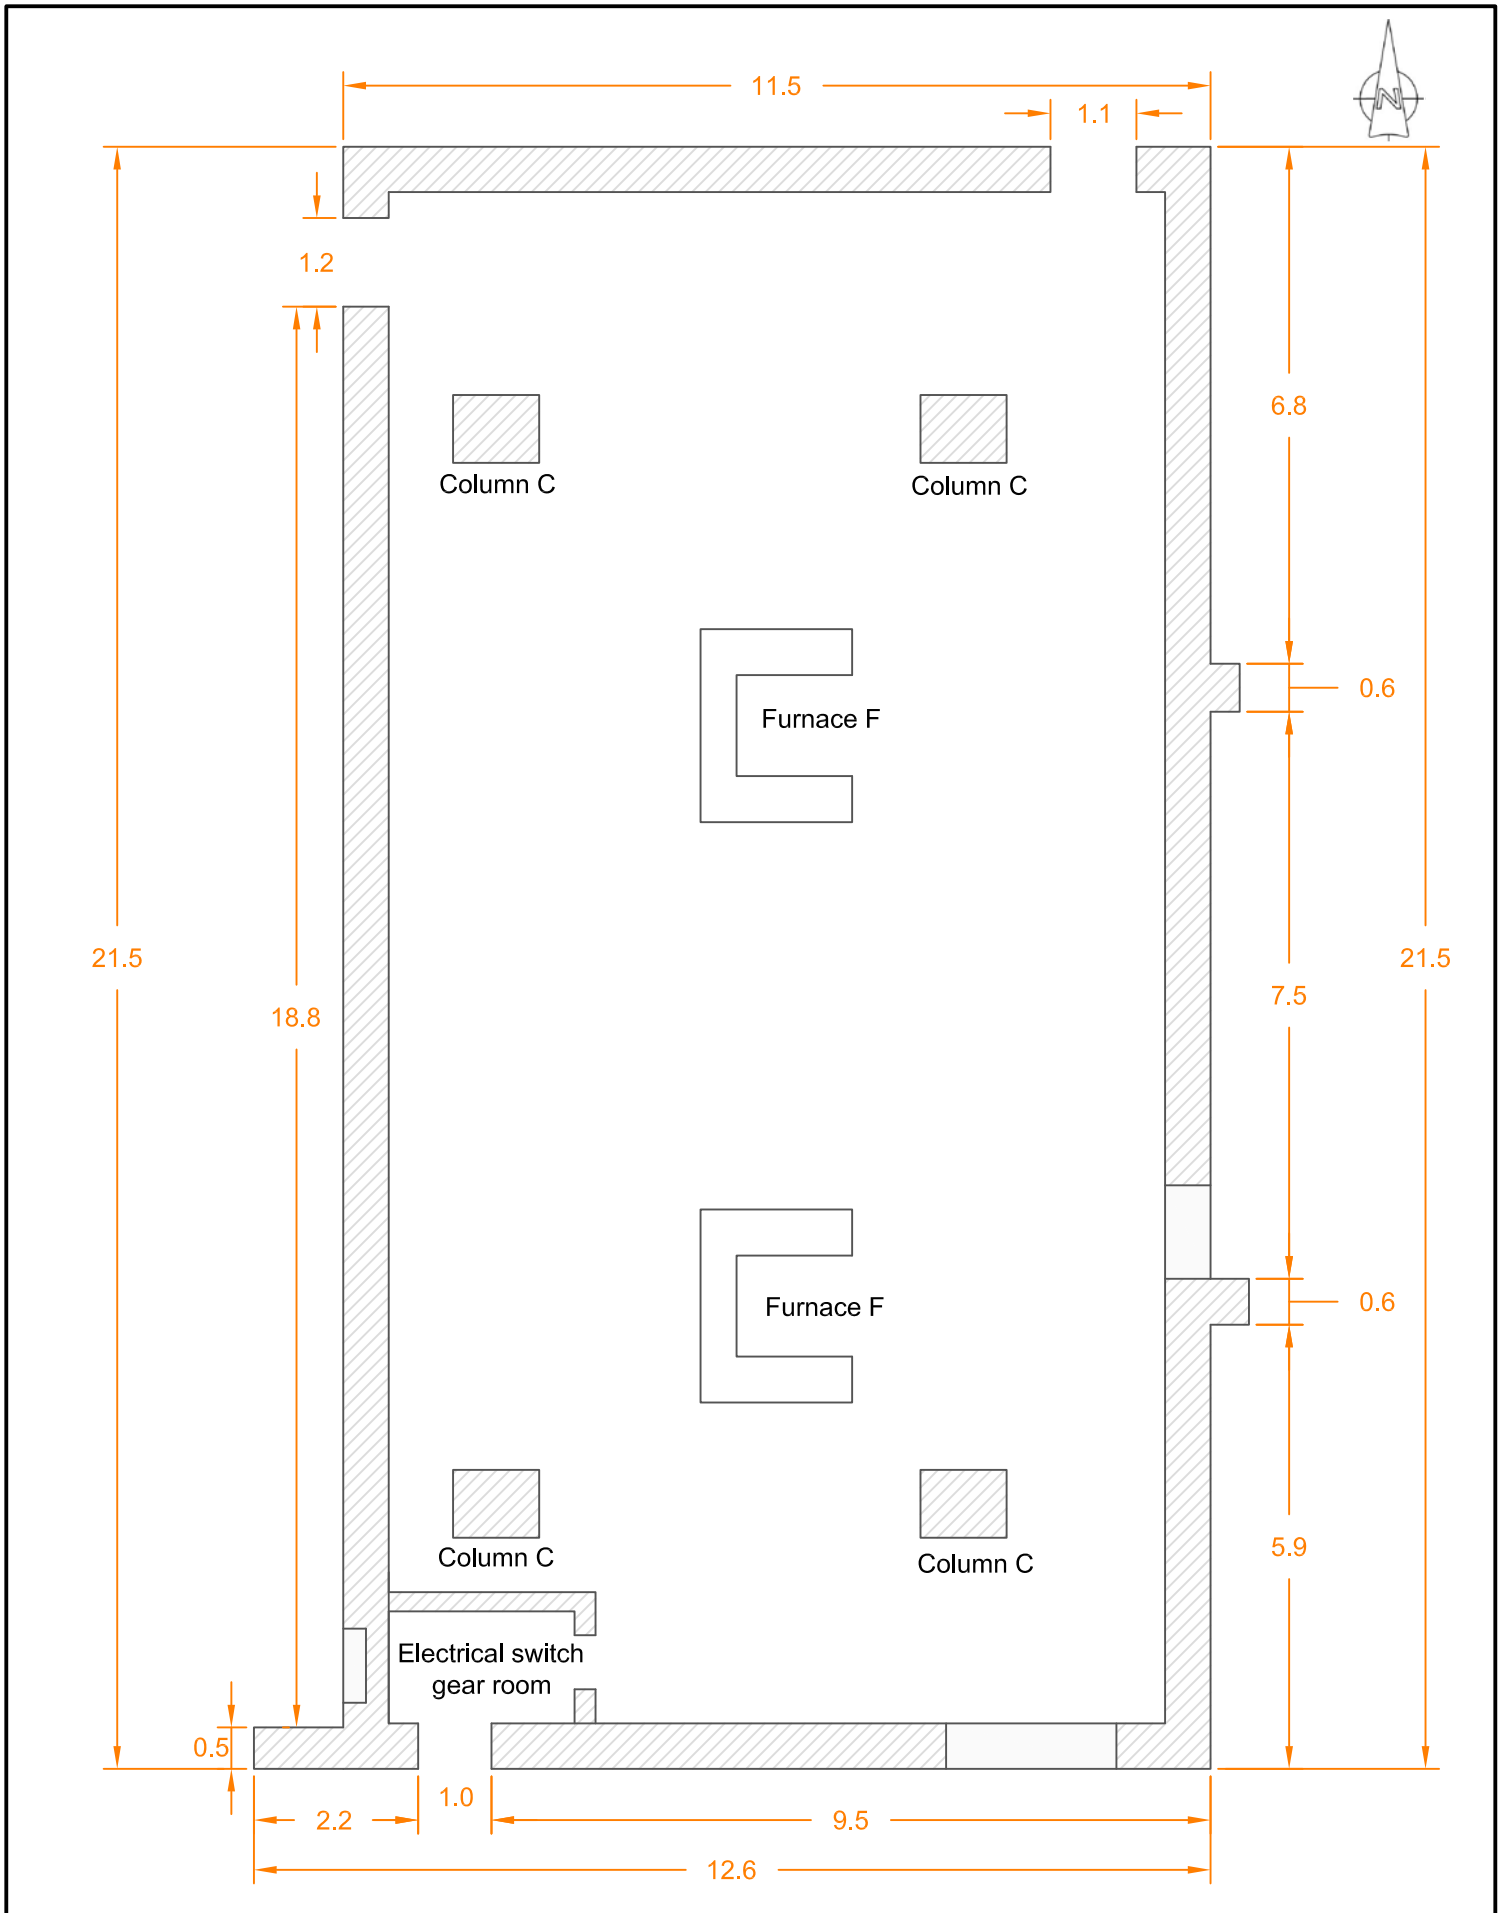
The floor plan is produced as Fig 6. The floor plan was rectangular with an internal measurement of 19.4m by 9.8m. The walls were on average 0.5m thick. The main ground floor openings were via a shuttered bay door on the south-facing elevation. A door way was also present at the north-east corner and at the north end of the west-facing elevation. In the south-west corner, an electrical switch-gear room was present. Occupying the floor were four brick-built columns and two furnaces. The load bearing columns each measured approximately 0.8m x 0.8m. The furnaces (Fig 14) measured c. 4m x 2.5m with east-facing openings lined with fire-brick but all the cast-iron work associated with the furnaces (grates, doors and dampers) had been robbed. The location of these features has been extrapolated from the results obtained during the demolition watching brief.

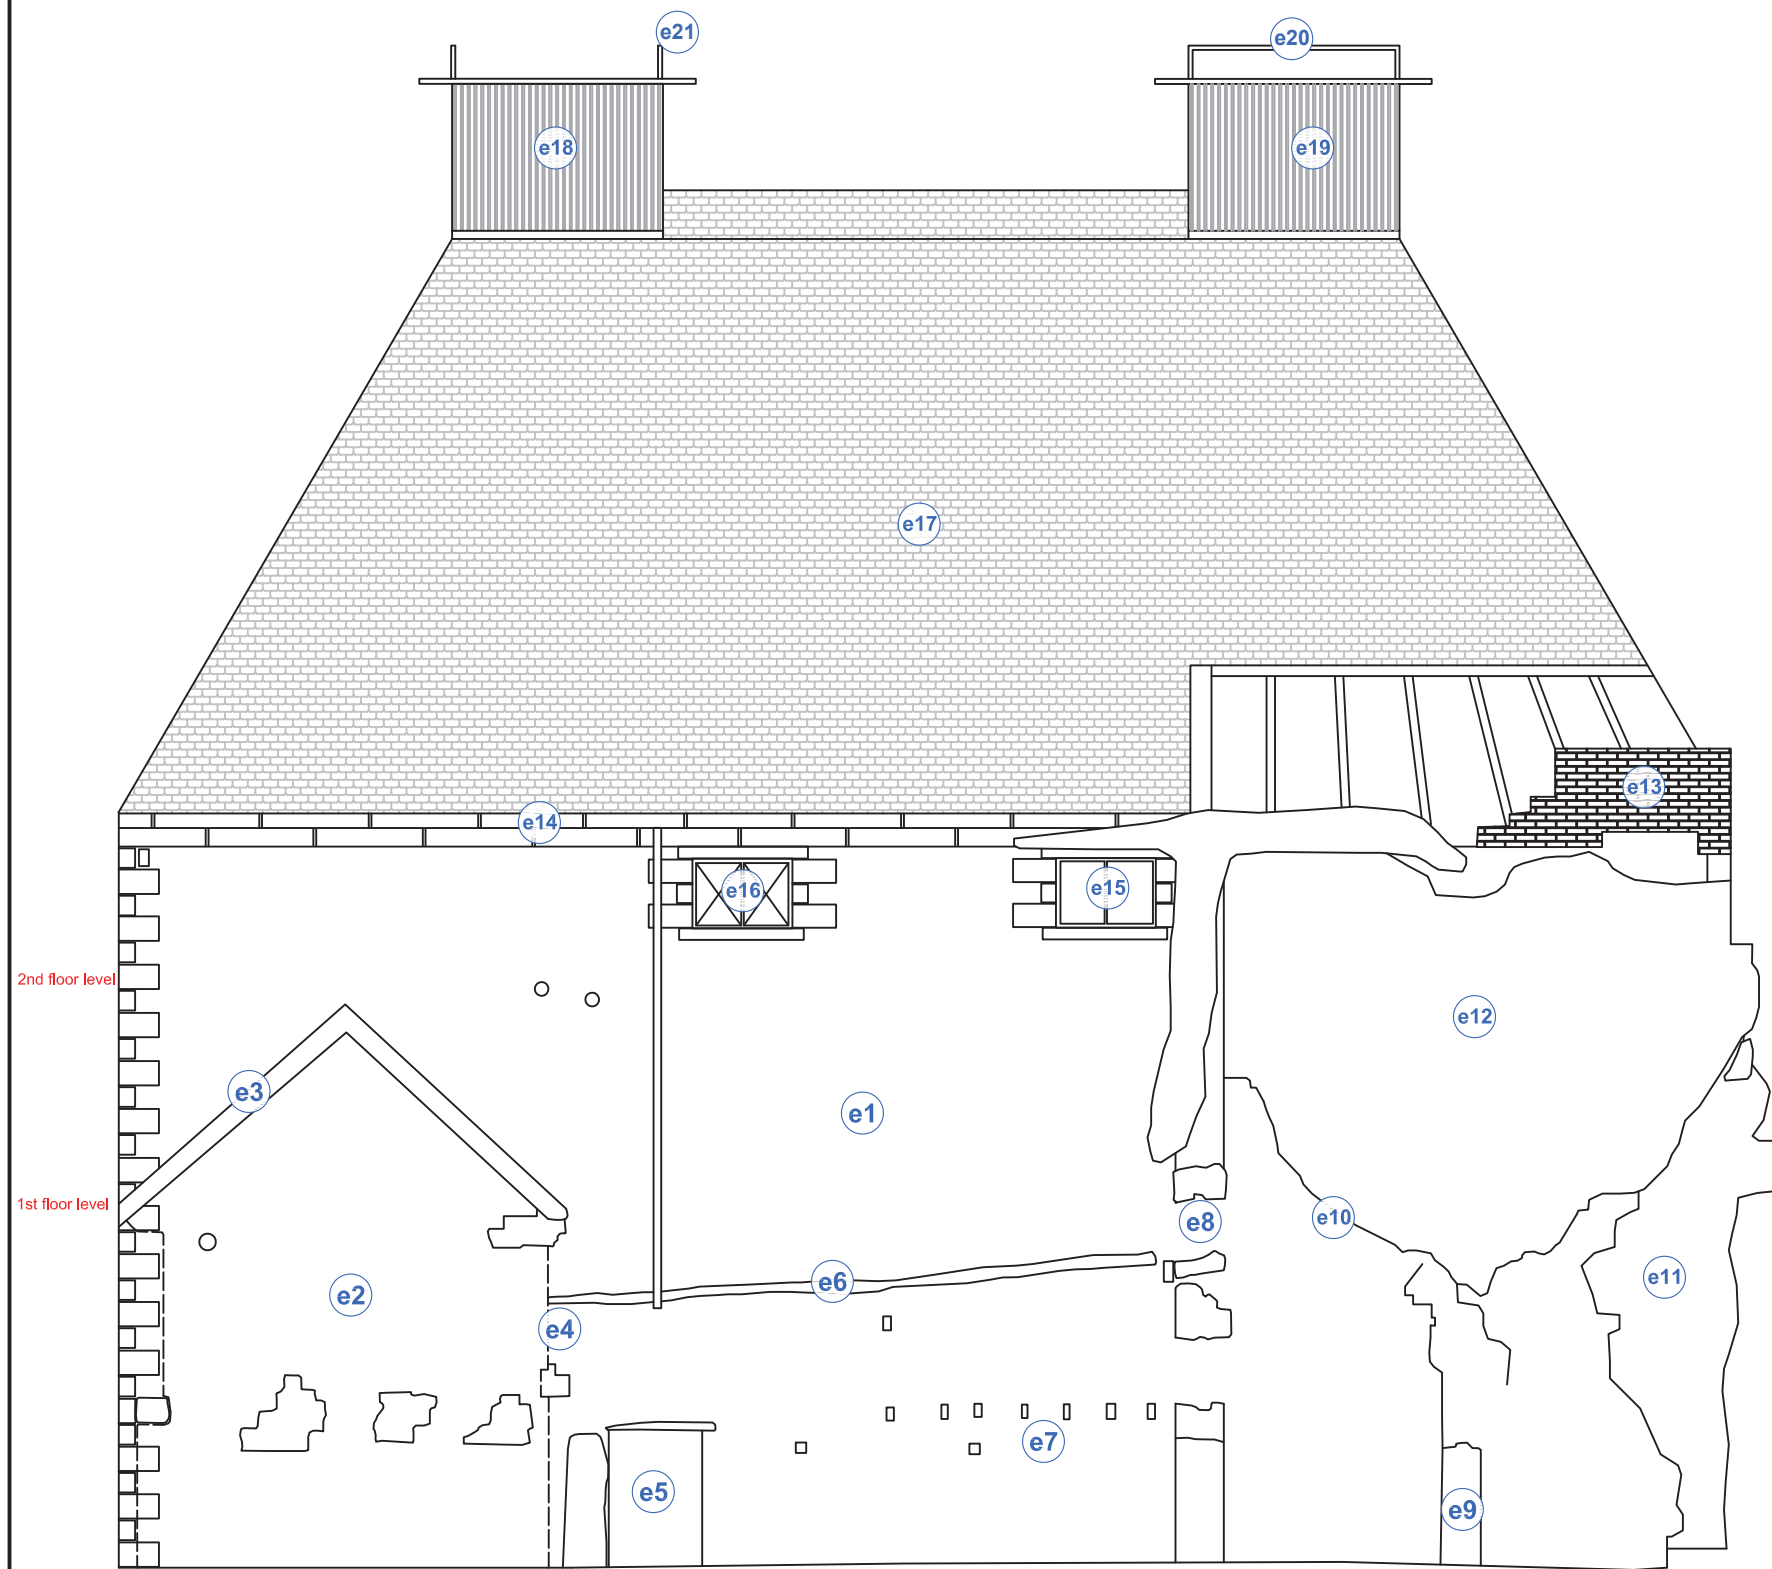
Fig 7b - East-facing Elevation

The east elevation measures 21m long and is 17.5m high. The main build (**e1**) is well coursed sandstone blocks bonded by grey cement. The outline of an attached single-storey building with a pitched roof is marked by its former roofline (**e3**) and whitewashed interior (**e2**). At the base of the wall, a section of masonry (**e4**) forming part of the rear wall of the attached building is present. On the north side of this feature is a blocked door (**e5**) with a wooden lintel. The door interior has been blocked with brickwork laid in stretcher bond. At the centre of the elevation approximately 2.5m above the current ground level is a roughly horizontal roof raggle (**e6**) from a flat or lean-to roof. A series of floor-joist sockets (**e7**) are associated with this attached structure. Running vertically down the wall from its eaves to ground floor is the stub of a return wall (**e8**) a fragment of which still survives at ground level. A fragment of upstanding brickwork, forming the remains of another return wall (**e9**) is present towards the north end of the elevation. The remains of a staircase (**e10**) are visible on the north side of the return wall stub (**e8**). At the north-east corner of the elevation a considerable section of the walls facing stone has collapsed exposing the rubble hearting (**e11**) behind. This material is crude mixture of random rubble, bricks and mortar. Above this feature is a heart-shaped section of cement render (**e12**) pierced by iron reinforcing bar and an I-beam. Above the render at eaves level is a section of brickwork laid in English Garden bond (3:1 and 2:1). At just below eaves level is a section of ashlar stringcourse which terminates above window (**e15**) towards

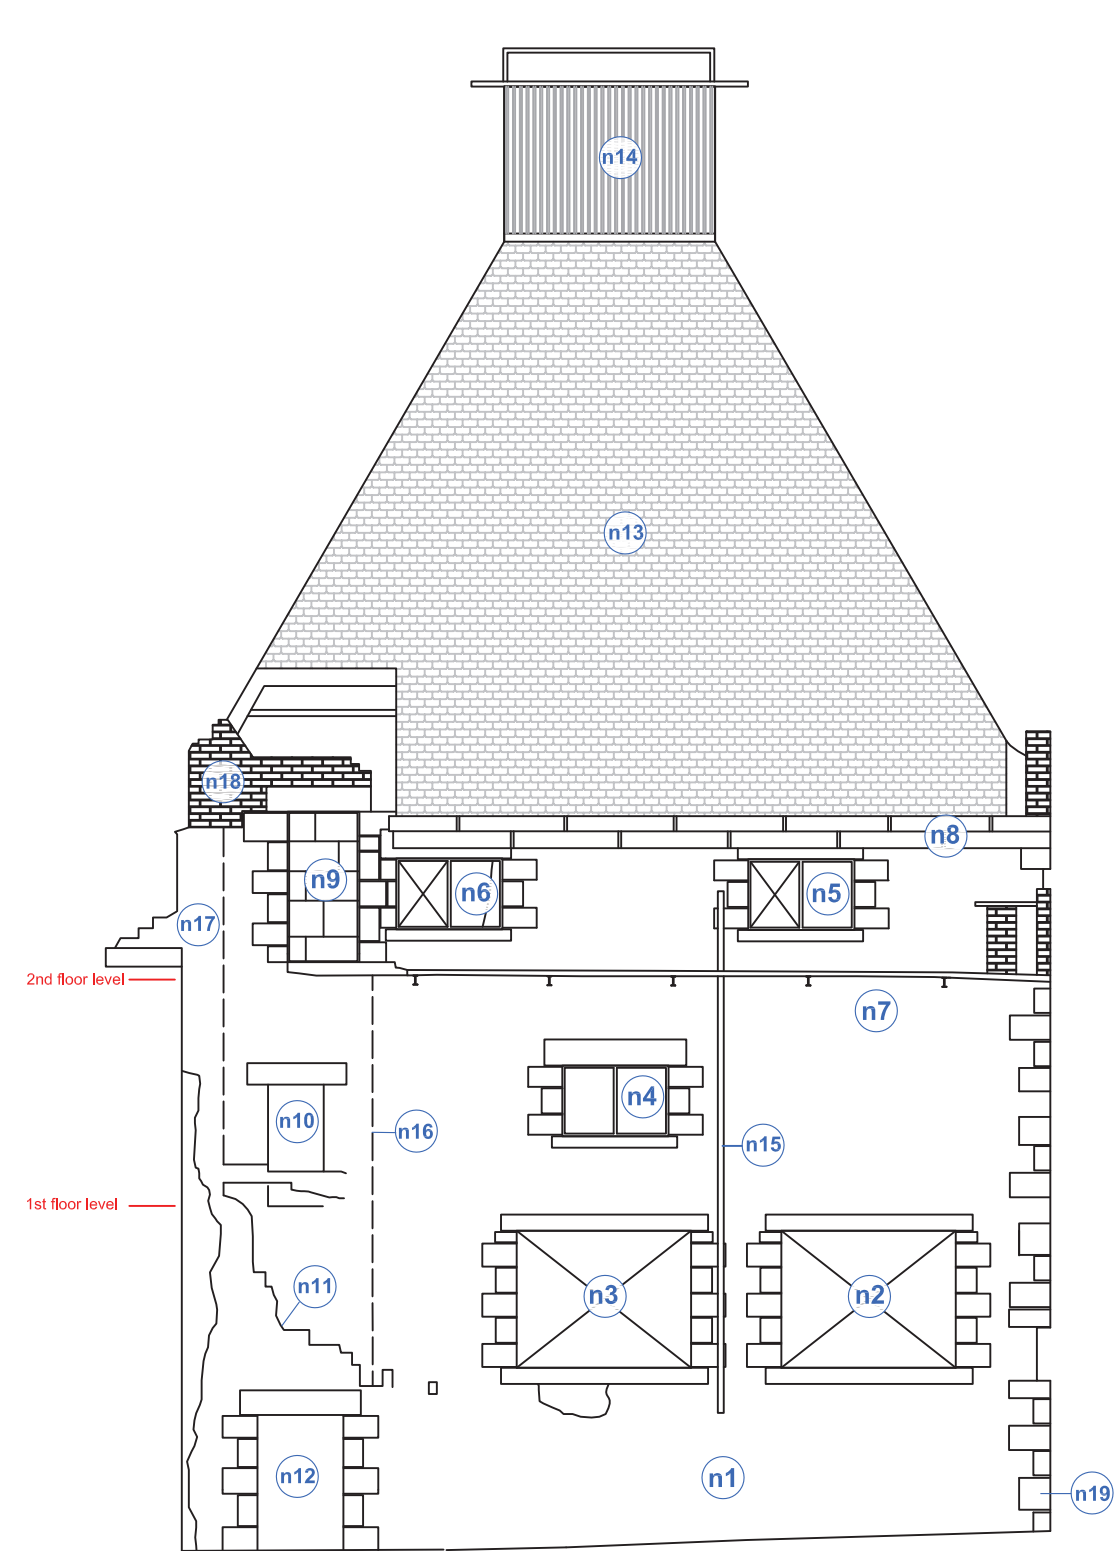
Fig 7a - North-facing Elevation

The principal features on the north-facing elevation are listed in Table 2 and shown on Fig 7a and Fig 9. The north-facing elevation measures 11.4m wide and stands to a height of 17.5m. The main build (n1) is well coursed sandstone blocks bonded by grey cement. The fenestration comprises ground, first and second floor windows (n2-n6) and all have droved ashlar surrounds and iron lintels. The first floor windows are rectangular and not in alignment with the windows above. The second floor windows are half shuttered. The remains of a concrete floor (n7) projects off the elevation for about 1m and is supported by five I-beams. Below the eaves is a sandstone ashlar stringcourse (n8) which terminates above the easternmost second floor window. Two blocked doorways (n9-10) are situated at second and first floor levels of a former staircase that was situated on the east side of the elevation. A scar formed by the removal of the stair treads is visible (n11) situated above the main doorway into the building (n12). The roof is covered with grey slate (n13) which are missing above the former stairwell. The roof is surmounted by a pagoda which is clad with asbestos sheeting (n14). A cast-iron drain pipe (n15) runs down the wall and through the former floor (n7). At the east end of the elevation, two return walls (n16-17) are visible marking the position and width of the former stairwell. Above the second floor doorway (n9) is a section of brickwork (n18) comprising 15 courses laid in English Garden bond (5:1). Situated on the west corner of the elevation is a line of quoins which include both stugged and droved blocks of sandstone. Some minor brick repair is also visible towards the upper section of the elevation.

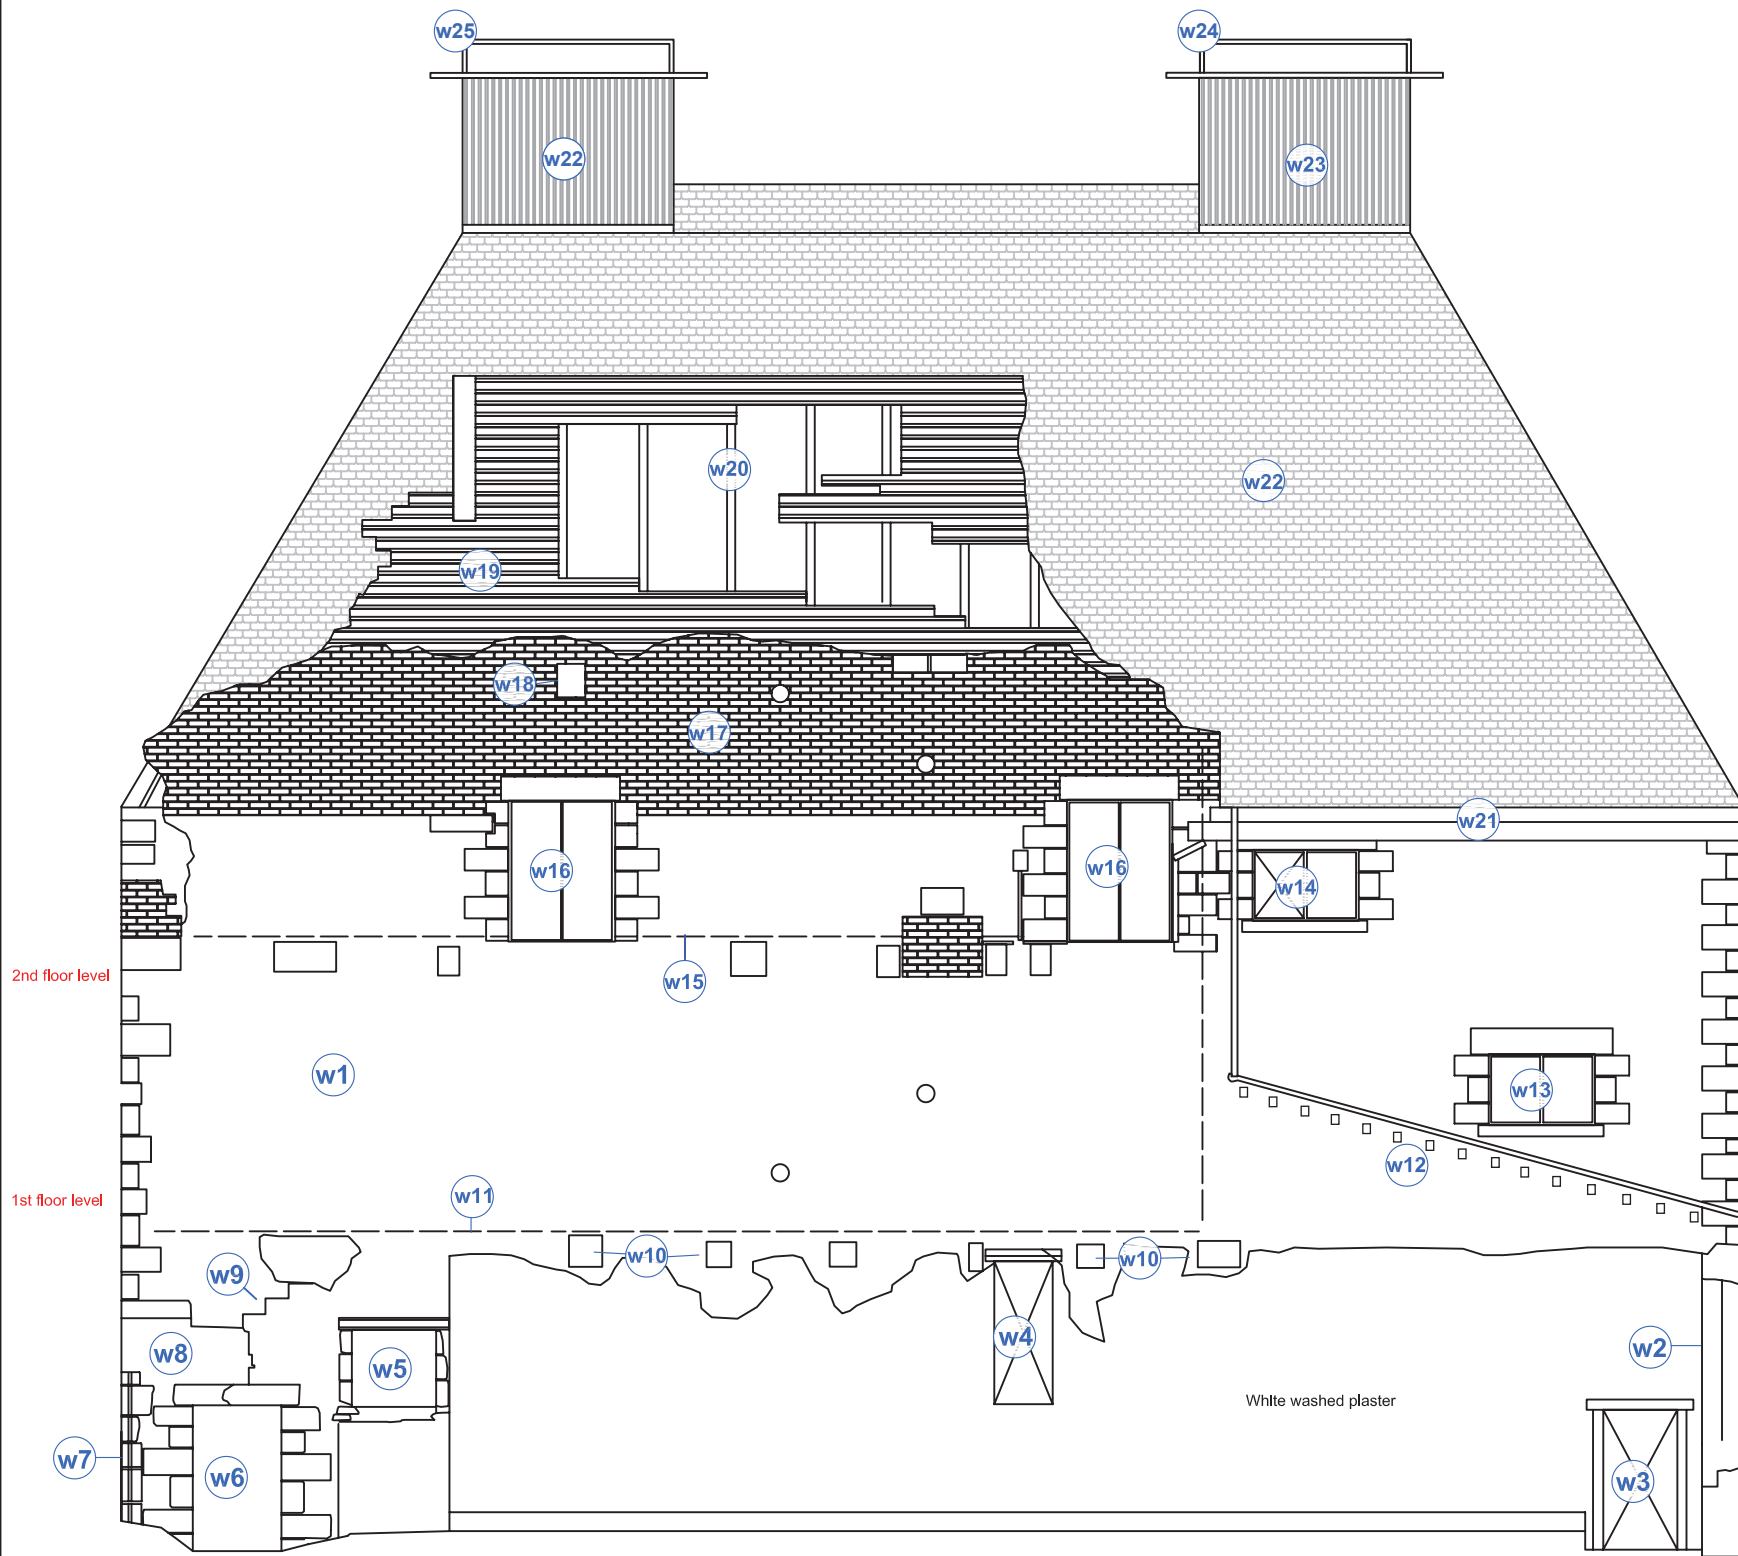
Fig 7d - West-facing Elevation

The west-facing elevation is 20.8m long and 17m high and is constructed of coursed blocks of sandstone (w1). At the ground floor on the south side, is the remains of the buttress which incorporates rubble and ashlar work (w2). Immediately behind the buttress is a blocked doorway (w3). Another doorway is present above the current ground level (w4) which appears to be a more recent insert. A blocked square feature (w5) is present at the north end of the elevation and is blocked with eleven courses of brick. A ground floor doorway (w6) is an original entrance and is surrounded by droved ashlar dressings. At the north end of the elevation are the remains a doorway (w7) in which only its ashlar reveals survive. Above door W6, is a large void (w8) which has exposed the rubble hearting of the main elevation. Above right of the void are the remains of three concrete steps (w9) which have been broached flush with the main elevation. Marking the position of a floor level of an adjoining building is a line of sockets (w10). A channel (w11) has been cut into the wall and is associated with a floor immediately above the sockets. A line of roof-joist sockets are present at the

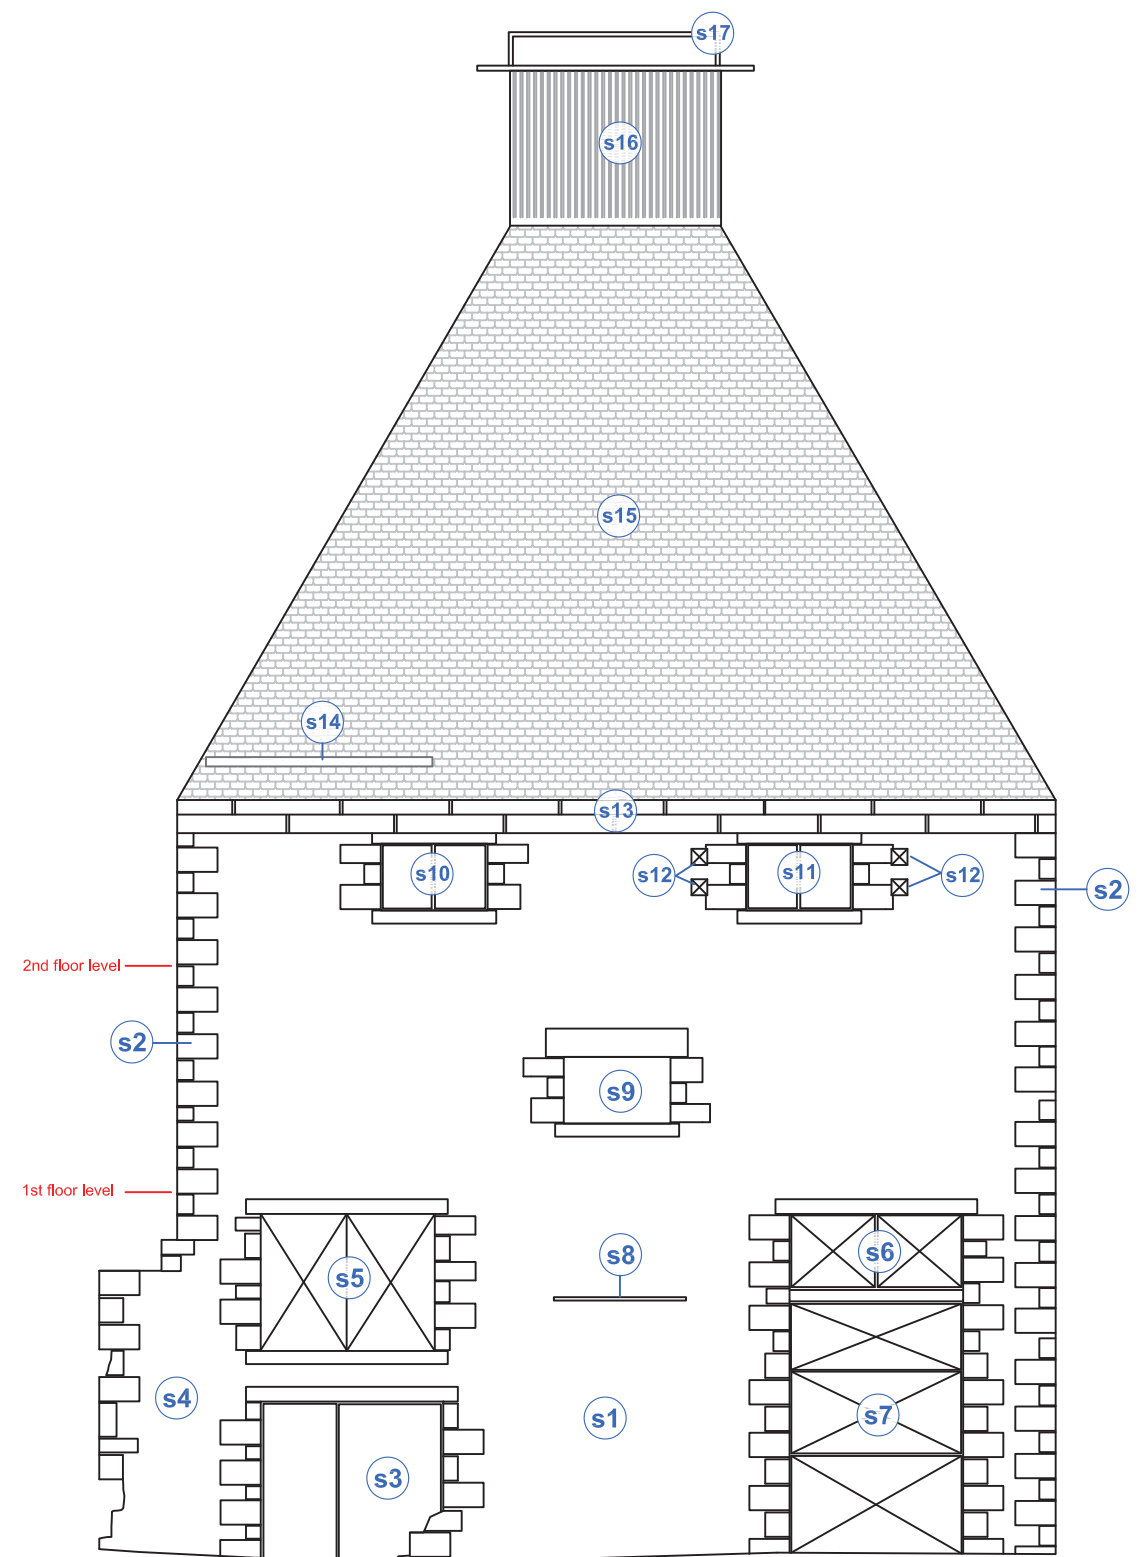
Fig 7c - South-facing Elevation

The south-facing elevation measures 12.3m wide and is 17.5m high and constructed of regularly laid sandstone blocks (s1) with ashlar quoins at each corner (s2). On the ground floor, on the west side of the elevation is a rectangular opening that includes a doorframe (s3) which accessed an electrical switch gear room. Immediately on the west side of the doorway is a buttress (s4) formed from when an adjoining building was demolished. Immediately above doorway (s3) is a blind window with ashlar dressings (s5). On the east side of the elevation there is a large bay door which is

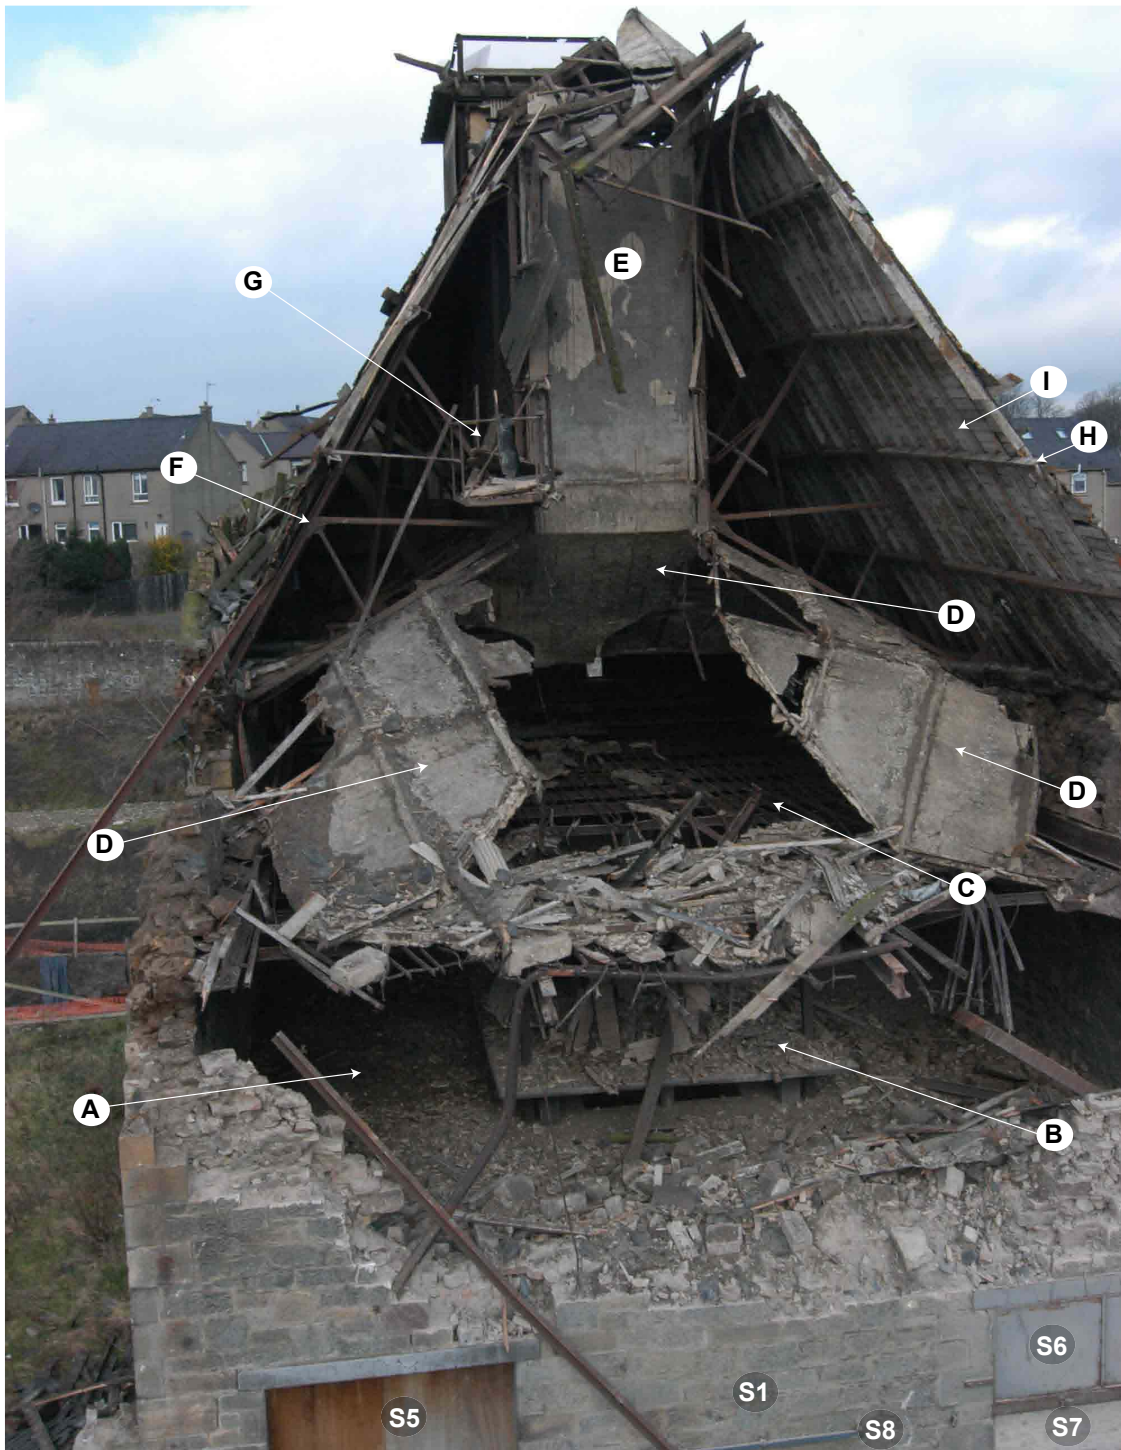
The demolition works were monitored under watching brief conditions (Figs. 15–21). During the demolition of the south-facing elevation a cross-section through the building was obtained. The principal features exposed are listed alphabetically in Table 6 and shown on Figure 8.

Feature No.	Element	Description
A	Floor	First floor constructed of reinforced concreteFurnace baffle plate
B	Furnace baffle plate	Steel framed concrete baffle plate that allowed heat and fumes to rise out through the sides vents below
C	Drying floor	Steel frame of the second floor formed by east-west trending I-beams with north-south trending lateral beams. No floor cladding was visible
D	Smoke chamber	Concrete and mesh-constructed smoke chamber allowing fumes to vent upwards through a circular opening housing an electric fan.
E	Roof vent	Surviving north side of the pagoda vent constructed of concrete and steel with a lining of plaster.
F	Roof frame	Steel-framed roof frame carrying the ventilator hood and the slate roof. The steelwork was composite steel with mainly L-shaped sections bolted with fish plates at the main junctions.
G	Gantry	An inspection gantry was present more or less at the level of the electric fan housing.

H	Steel purlins	U-shaped steel purlins carried by the main roof frame (F)
I	Roof rafters	Timber roof rafters supporting the sarking boards. These rafters were carried by steel U-shaped purlins (H) that were bolted to the main roof frame.

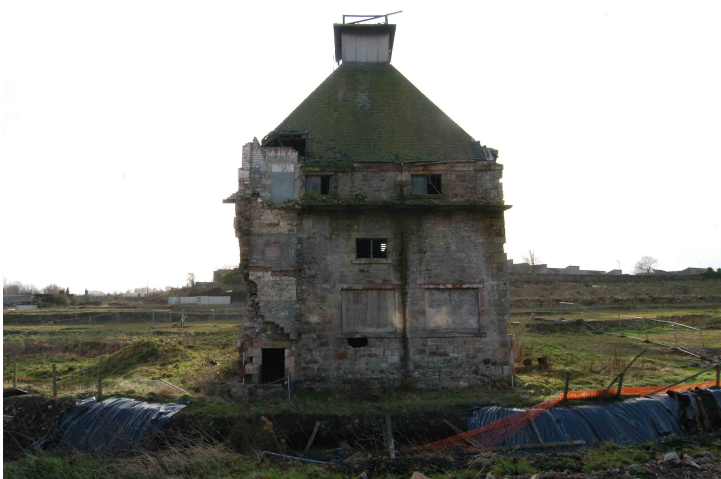
The north-facing elevation has the structural elements associated with a staircase that was attached on the north-east corner of the elevation. The surviving elements of this feature include a staircase scar (**n11**), its enclosing return wall scar (**n16**) and the brickwork (**n18**) surmounting the second floor doorway (**n9**) which carried up to the roof level of an three storey lofted building built against the east-facing elevation.

Fig. 9 - Pre-demolition shot of the north-facing elevation

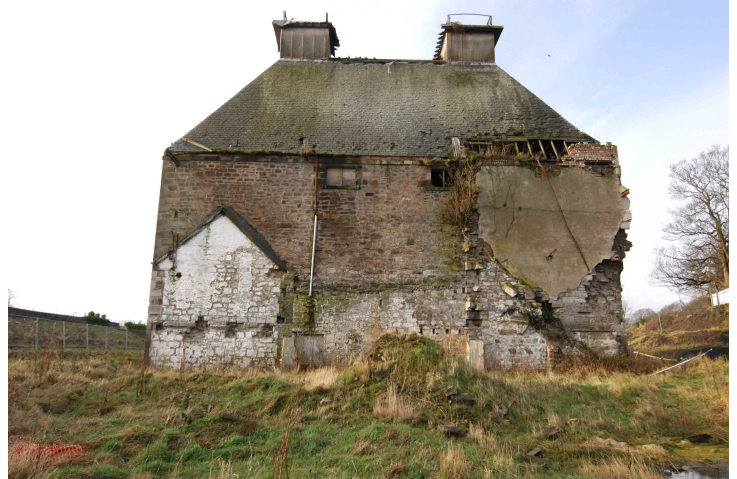
The principal features extant on the east-facing elevation are listed in Table 3 and shown on Fig 7b and Fig 10.

The east-facing elevation displays evidence for the presence of three attached structures that have left evidence of their presence in the form of former roof lines, floor-joist sockets and return wall stubs. Features (**e2-e4**) relate to an adjoining single storey lofted building with a pitched roof (Fig 5). This building was on the same alignment as the south-facing elevation and was approximately c.35m long, trending east to west and fronting a concrete yard. Features (**e6-e7**) relate to a series of pitched roof buildings that ran behind the building just described. Features **E8**, a return wall scar and the render finish (**e12**) mark the position of a stone-built malting building that was three-and-a-half stories high with a pitched roof. The building had a brick-built structure with a doorway providing access to a gantry that ran alongside the east-facing elevation at eaves level. The roof of this structure was roughly keyed into the east-facing elevation and brickwork (**e18**) is related to its adjoining wall.

Fig. 10 - Pre-demolition shot of the east-facing elevation

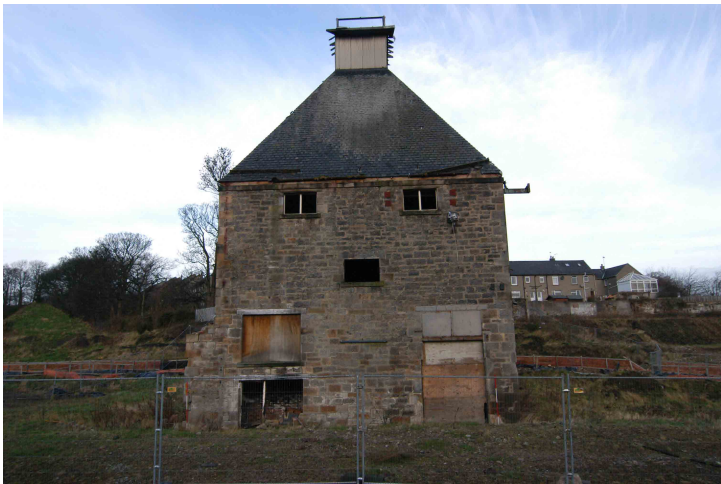
The south-facing elevation is largely unaltered since its construction and as it faced onto a yard it never had any buildings attached to it.

Fig. 11 - Pre-demolition shot of the south-facing elevation

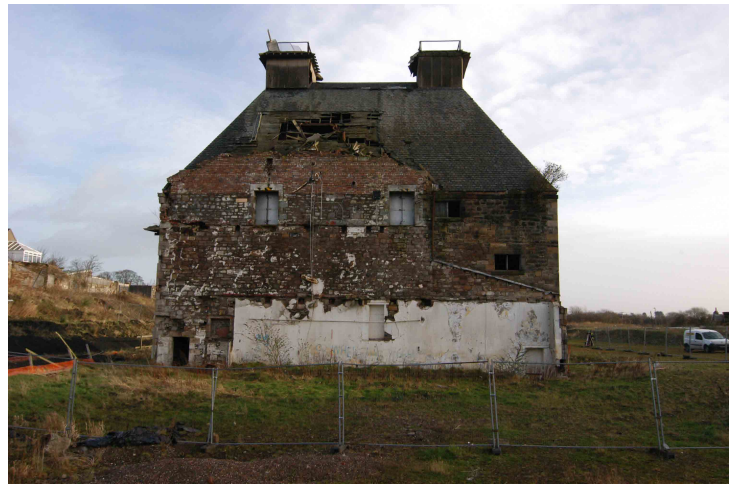
The principal features extant on the west-facing elevation are listed in Table 5 and shown on Fig 7d and Fig 12.

The west-facing elevation was almost entirely enveloped by an adjoining brick-built building that occupied most of the elevation. Figure 3 shows the adjoining building when it was still standing. The roof configuration of this three storey building is evident in the brickwork (**w17**) which has maintained its Mansard shape that stood above the gutter line of the former malting building. Access between this building was via the two steel fire doors (**w16**). The floor level below (**w15**) and a first floor level (**w11**) is extrapolated from the position of the floor joist sockets. The south side of the building had a lean-to roof which relates to Feature (**w12**) and the whitewashed wall below ran the full length of the interior ground floor. Access into the ground floor level kiln floor was via doorway **w6**.

Fig. 12 - Pre-demolition shot of the west-facing elevation

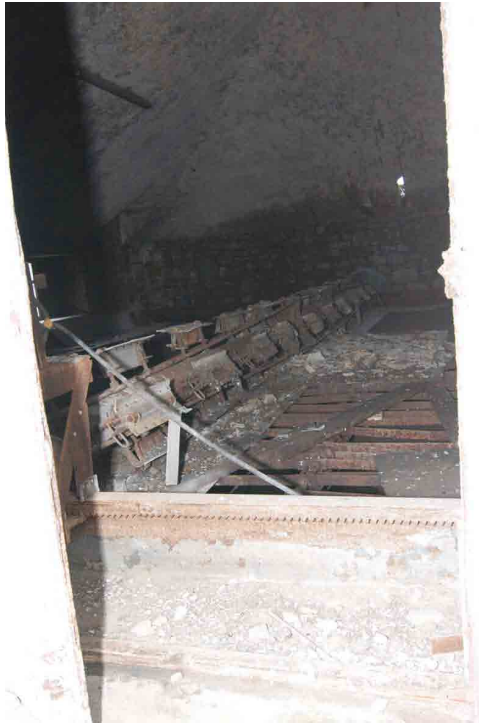
The malting floor (second floor) comprised a series of transverse steel I-beams that were probably covered with a fine mesh that allowed the heat from below to pass through it. The barley or wheat was turned by a mechanical plough (Fig 13) that contained a series of rotating brushes that were attached to a large shaft that ran across the full length of the floor in order that green barley could be turned to aid its drying.

Fig. 13 - Pre-demolition shot of the rotating plough housed on the second floor

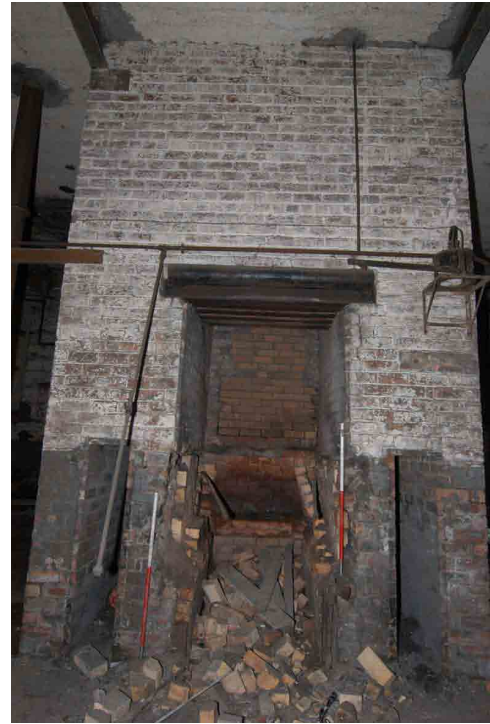
Fig. 14 - Pre-demolition shot of one of the kilns on the ground floor

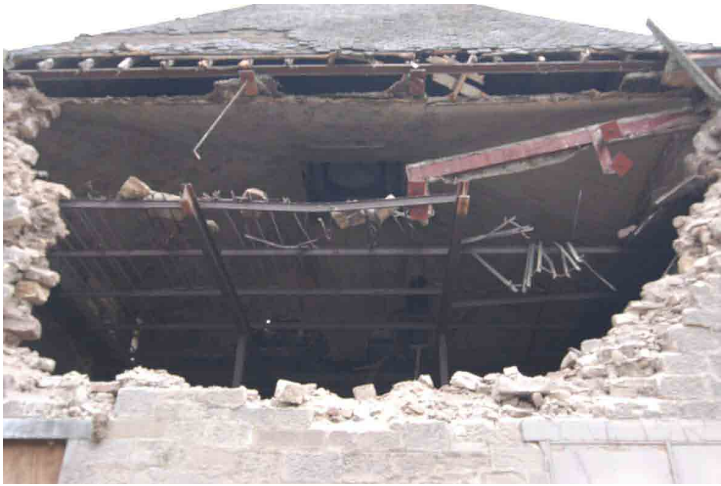
Fig. 17 - Smoke chamber exposed and structural steelwork

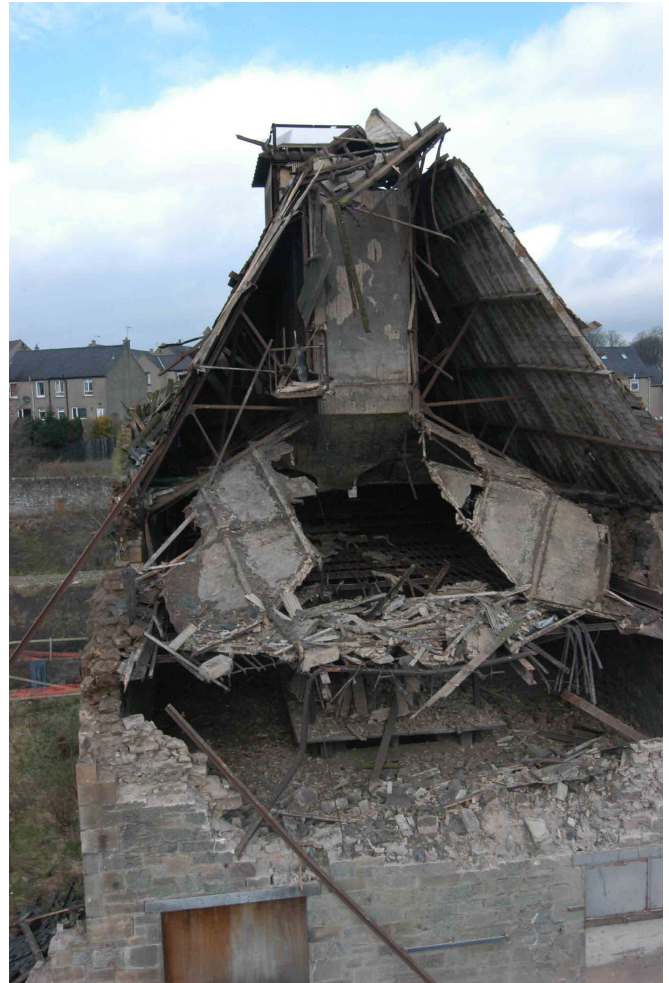
Fig. 18 - Smoke chamber and first floor baffle exposed

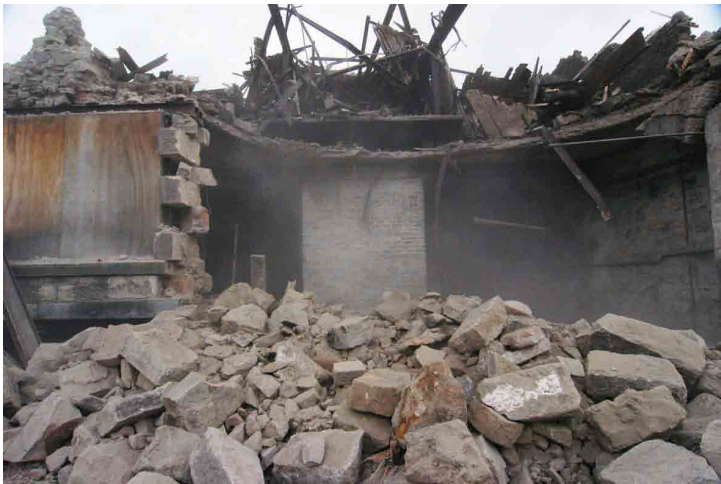
The ground floor of the former malting building was open plan with brick-built columns supporting the steel-frame concrete first floor. The principal features on the ground floor were the two furnaces (Fig 19-21) that were either fired with coke for

high heat generation or peat which would have generated the aromatic peaty input into the malt that was roasted on the second floor (malting floor). The interior of the first floor was occupied by the two re-enforced concrete smoke chambers that vented fumes out through the roof pagodas. An electric fan was housed at the top of the smoke hoods to allow smoke and fumes to pass through the pagoda vents. The two smoke hoods were supported on composite steel trusses that also carried the steel purlins that in turn supported the wooden roof rafters. Grain was fed directly into the malting floor by a large iron pipe from an adjoining grain store on the west-facing elevation.

Fig. 19 - Southern-most kiln exposed on the ground floor

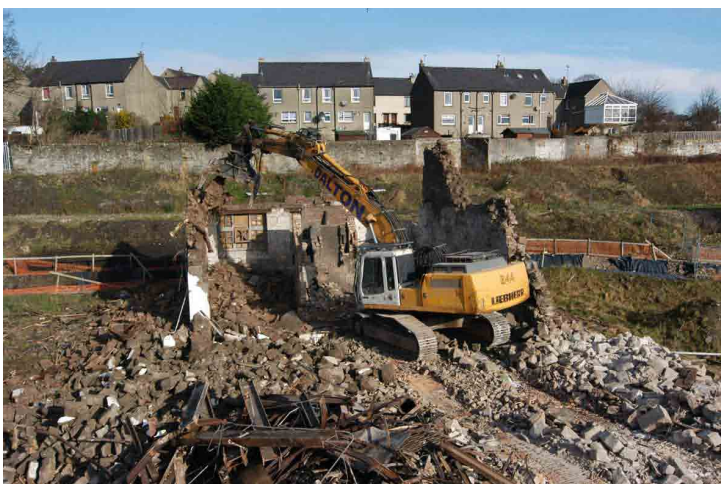
Fig. 20 - Northern-most kiln exposed within the near demolished building

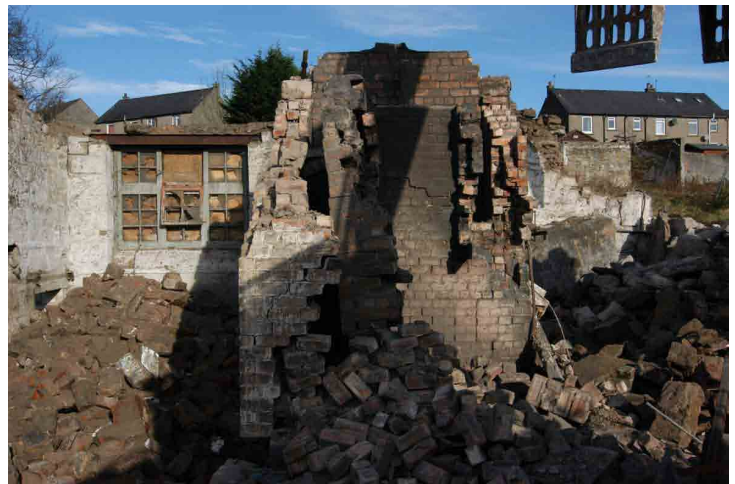
Fig. 21 - Close-up of the northern-most kiln part demolished
