## **Strathbrock Parish Church Uphall, West Lothian**

### **Archaeological Watching Brief**

**Report No. 3228**

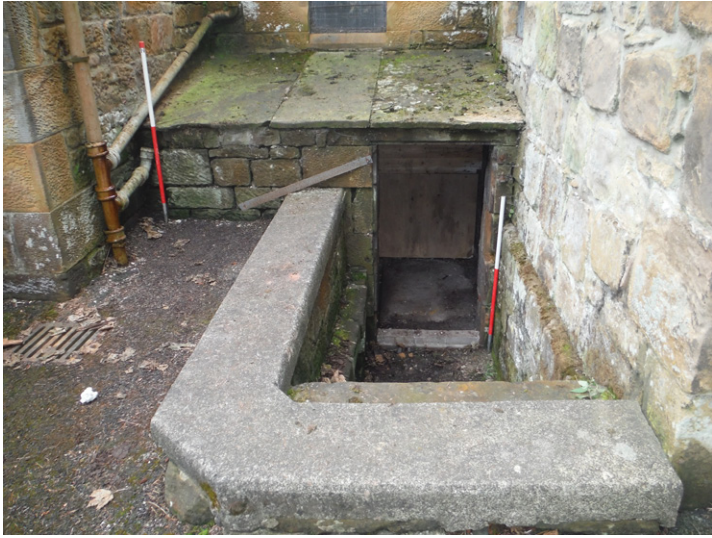
The former stone-built boiler house was situated on the west-facing elevation of the church and built between the nave wall and vestry. The boiler house occupied a rectangular footprint and measured c. 2.4m by 1.7m and stood to a height of 2m. The walls (**001**) had been constructed using rectangular blocks of lime mortar-bonded sandstone with stugging and incorporated a small doorway surmounted with a sandstone lintel with fluted moulding. The lean-to roof comprised three large sandstone flagstones that rested at their highest just below a round-headed aisle window. The ground (**002**) surrounding the exterior of the boiler house had been made up to a depth of 1m requiring the need for a flight of access steps surrounded by a low concrete wall (Fig. 2).

Fig. 2 - External boiler house prior to demolition.

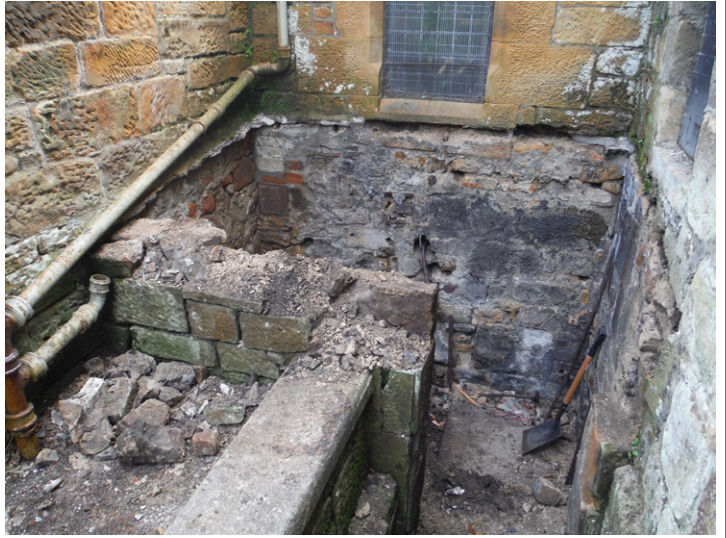
Following the demolition of the roof the lower exterior walls of the church were exposed. These had been greatly altered forming a patchwork of repair work using red brick and an assortment of rubble. A roof raggle was also exposed marking the position where the stone flagstones had been embedded into the wall. A cast-iron soot box was situated on the north side of the exposed wall along with a pipe and a length of steel electrical conduit (Fig. 3).

Fig. 3 - External boiler house demolished.

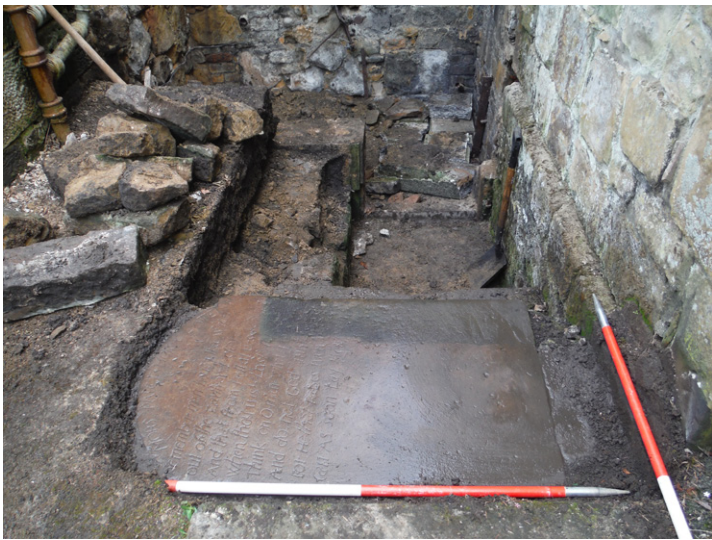
The concrete wall was removed to expose the sandstone steps. The top step was found to be a large re-used gravestone (**003**) with an inscription on each side (Fig. 4). On the face where the stone had been used as a step the inscription was very worn (Fig. 5).

Fig. 4 - Gravestone used as the top step leading down to the boiler house.

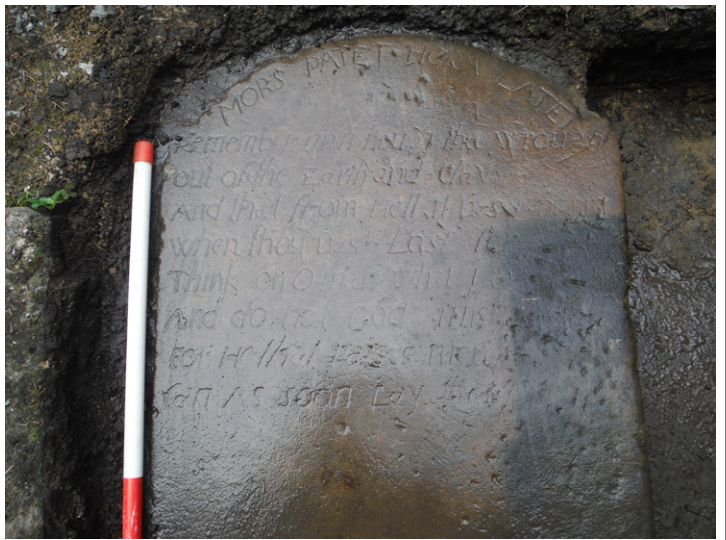
The text included in Latin *MORS PATET HORA LATET* (*Death is Certain The Hour Uncertain*) below which was written:

Fig. 5 - Inscription on the step side of the grave stone.

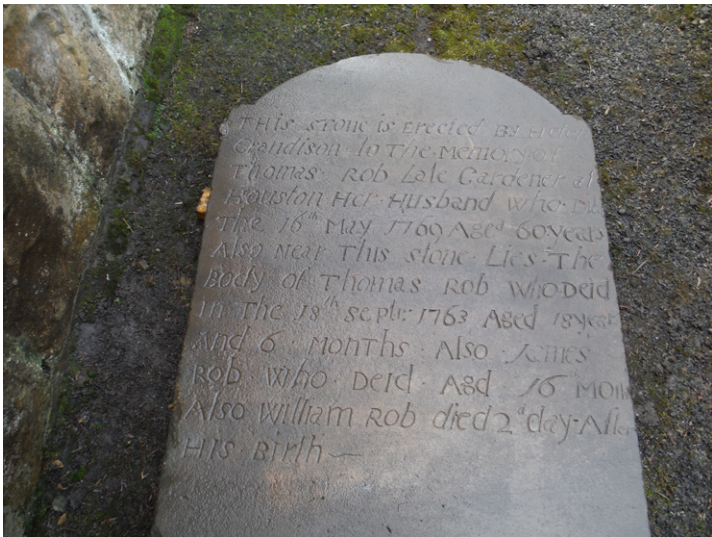
The reverse side of the gravestone had a much clearer dedication (Fig. 6):

Fig. 6 - Memorial inscription dating to the 18th century on the underside of the text.

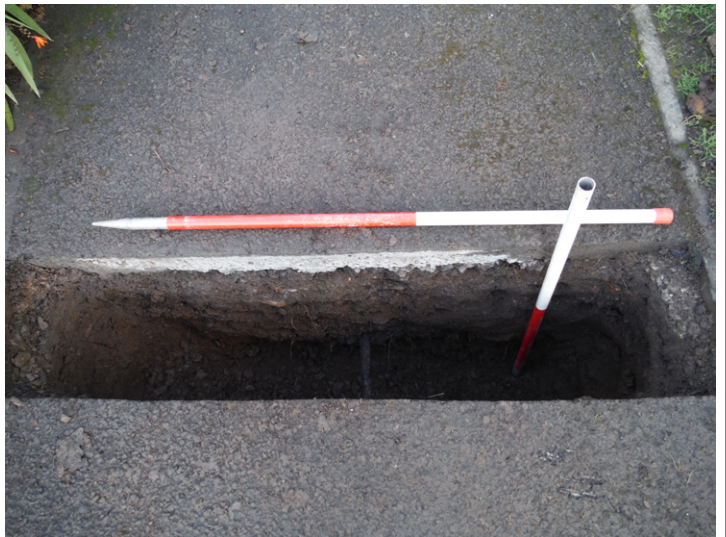
Test pit 1 (Fig. 7) and Test Pit 2 measured 1.4m by 0.3m and 0.8m deep. Tarmac was 0.1m thick and overlay 0.5m of mixed made ground (**006**) with underlying degraded sandstone. A gas pipe and electric cable lay at the base of both test pits and cut into natural subsoil (**007**).

Fig. 7 - One of three test pits dug into the church yard path.

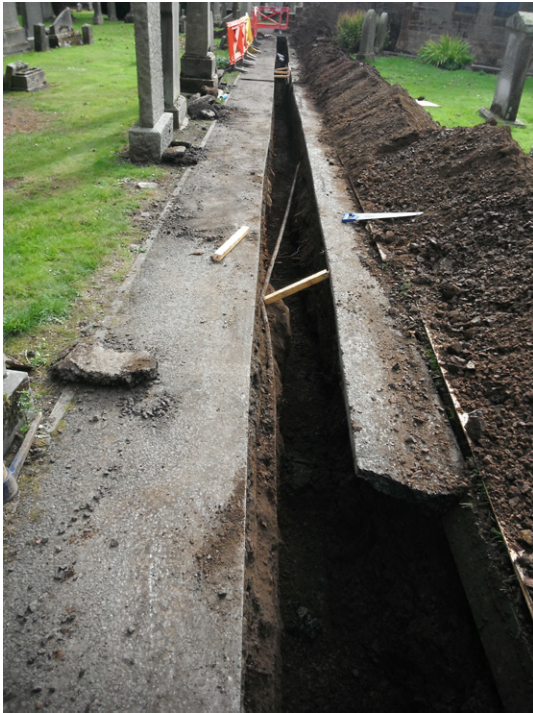
The water main trench was later dug along the full length of the path and the deposits found within it were the same as recorded in all three test pits (Fig. 8). No features or deposits of archaeological significance were recorded.

Fig. 8 - Church path excavated to follow the route of existing service trench.

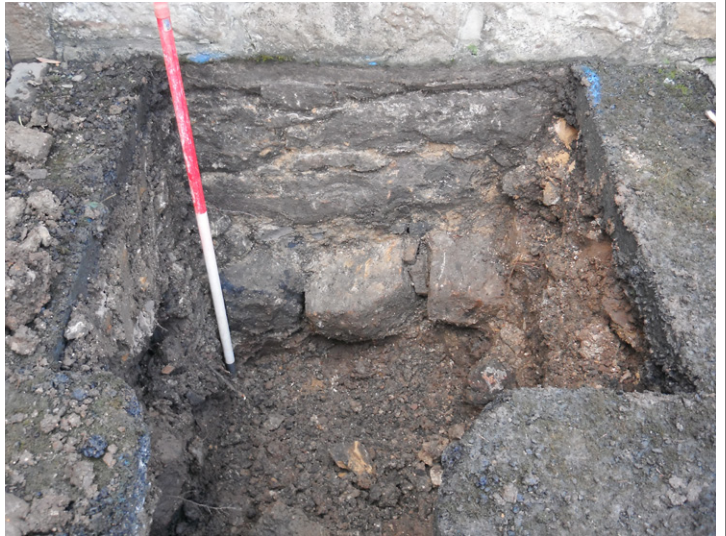
The water main branched off the pathway to the west where a manhole chamber was excavated against the church wall. This measured 1m by 1m and reached a depth of 1.5m (Fig. 9). This exposed the fabric of the church down to its foundations which comprised approximately five courses of irregular mortar-bonded sandstone resting on large protruding blocks of sandstone.

Fig. 9 - Manhole trench outside the church wall.

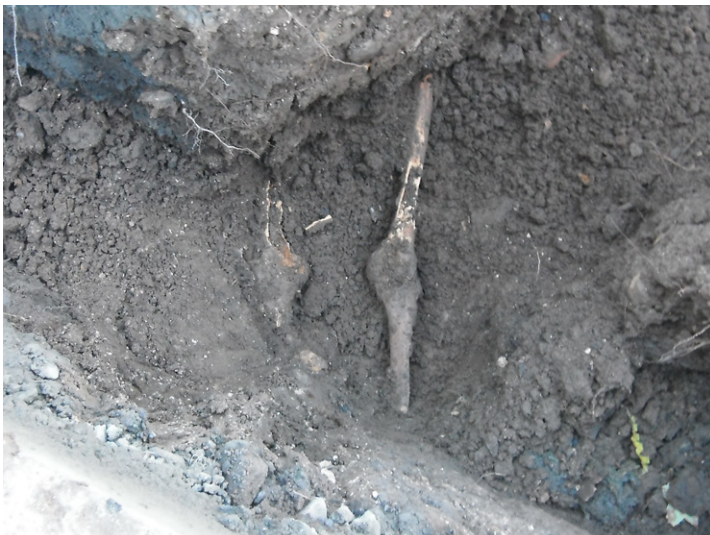
During the excavation of the manhole was a pair of articulated leg bones (**009**) were found at a depth of 0.8m (Fig. 10). These included half of the femur and lower leg and a complete left lower leg. Both legs had their patella and angle bones. Between the thigh bones a few small finger bones survived showing that the person's hands were clasped at the front. The body had previously been cut by a gas main and electricity cable.

Fig. 10 - Upper human remains found inside the service trench.

The human bones were photographed and re-interred within the base of the north-eastern end of TP3 adjacent to the manhole, as close as possible to their discovery location, covered with clean sand and backfilled.

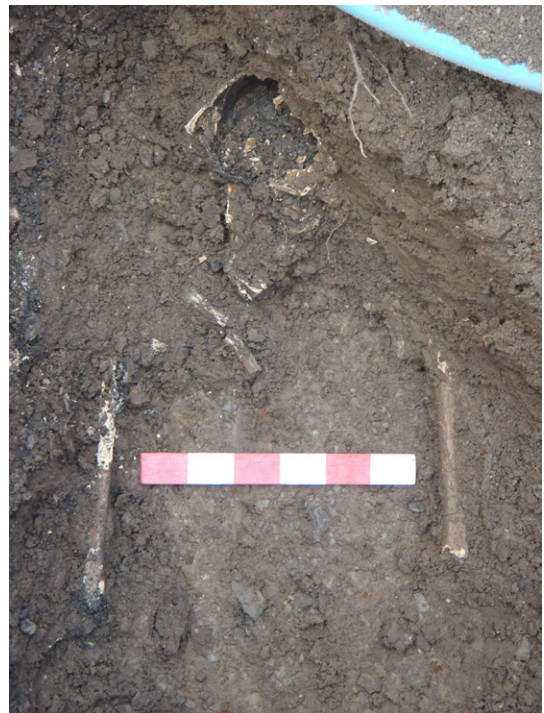
At a depth of 1.2m further human remains were revealed (**010**, Fig. 11). These comprised a badly crushed skull with both clavicle and the top of the humerus bones surviving. No vertebrae or ribs survived nor any bones lower than the elbow.

Running parallel to the skeletal remains (**010**) was the cut for a ceramic service pipe (**011**). Its fill (**012**) was a dark mixed loam with fragments of ceramic pipe and skull and jaw bone fragments, showing that this pipe trench had truncated human remains when it was excavated.

Fig. 11 - Lower human remains found inside the service trench.

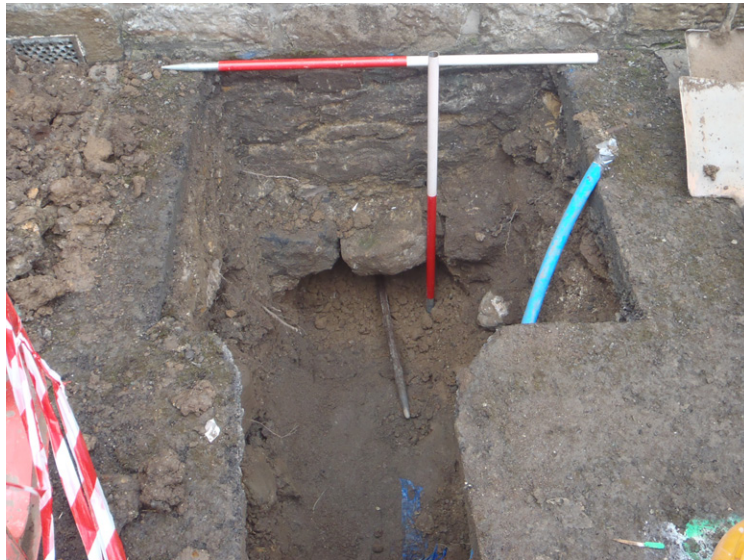
The excavation of a manhole chamber against the church wall revealed the foundation courses of the aisle. These were seen to comprise five courses of irregular mortar-bonded sandstone resting on large protruding blocks of sandstone. During the excavation of the chamber human remains were encountered. These were recorded and re-interred within one of the test pits excavated to investigate the presence of an existing water pipe.

Fig. 12 - Manhole dug to formation level showing foundation course of the church.

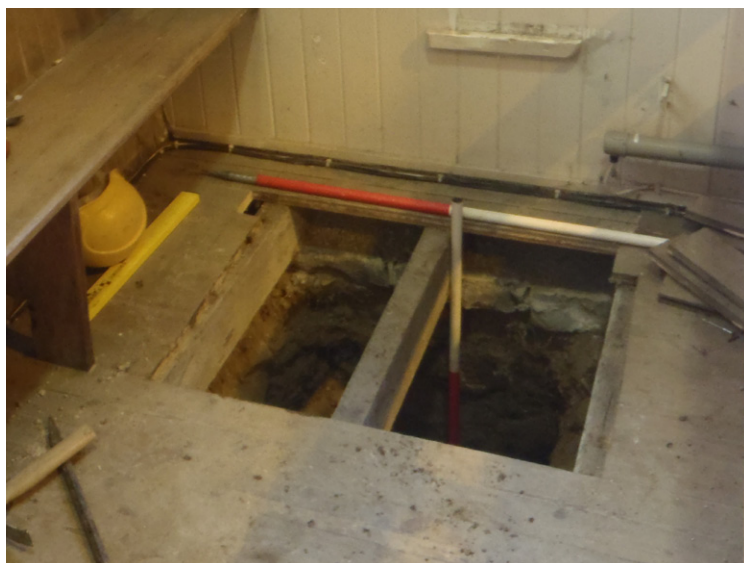
A service trench measuring 0.9m by 0.7m was excavated through the floor of the church at the north-east corner of the aisle. This was designed to allow the new water pipe to connect with the interior pipe work of the new toilet block. Following the removal of the wooden floor boards and joists, the hole was dug to a depth of 0.9m through a loose mid-grey soil (**013**) containing moderately large fragments of sandstone. No structural or human remains were found.

Fig. 13 - Service connection hole dug into the aisle floor.

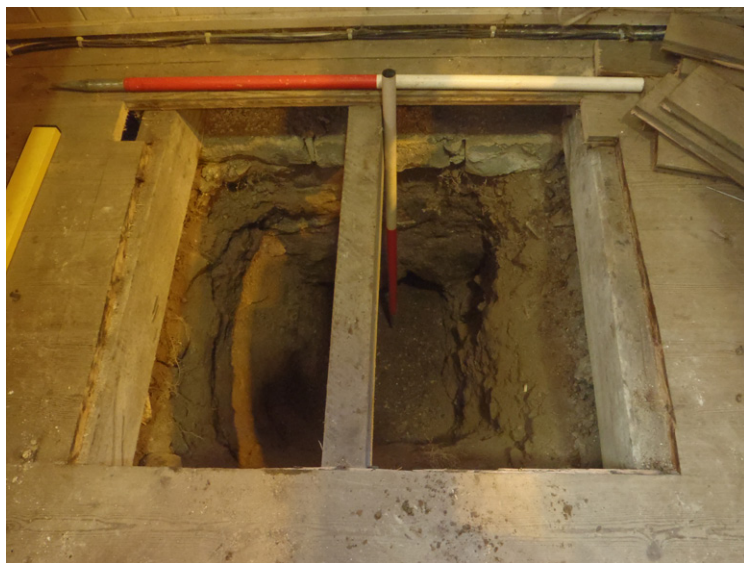
Examination of a small hole cut into the floor within the north-east corner of the aisle recorded no archaeological remains.

Fig. 14 - Service connection hole excavated.
