Dalry Road, No's 11 & 13, Edinburgh **Level 1 Historic Building Recording** Report No. 3218

Author	Stuart Mitchell MA AIfA
Illustrator	Greame Carruthers MA MIfA
Editor	Bruce Glendinning BSc PGDip MIfA
Commissioned by	Interserve Construction Ltd
Date issued	October 2014
Version	0
Planning Application	10/02373/FUL
No.	
Grid Ref	NT 24190 73180

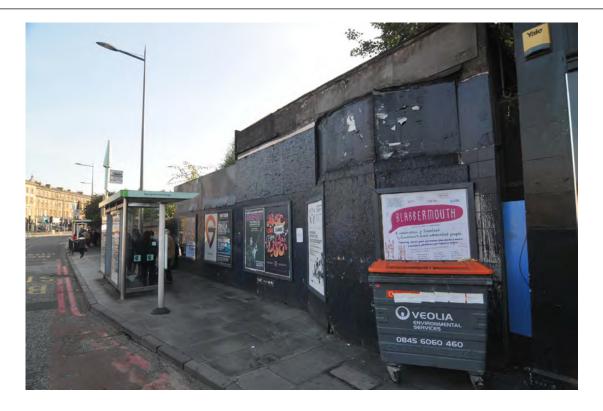
The west facing elevation formed the street frontage of No. 11 and 13 and both had been built up to the edge of the pavement (Plates 1-2). The flat roofline featured a step mid way along. The elevation measured 12.5m long and was 4m high at the south end and 3.3m at the north end. The elevation comprises an open facade framed by the ends of the brick walls of the north and south ends of the building and the interior walls. The north end was harled and painted while the south end was covered by black tiles. The top of the wall was harled covered with black-painted timber and plywood boards. Within the facade were large full-height timber framed display windows.

Plate 1: West-facing elelvation of No's 11 and 13 Dalry Road from the south-west

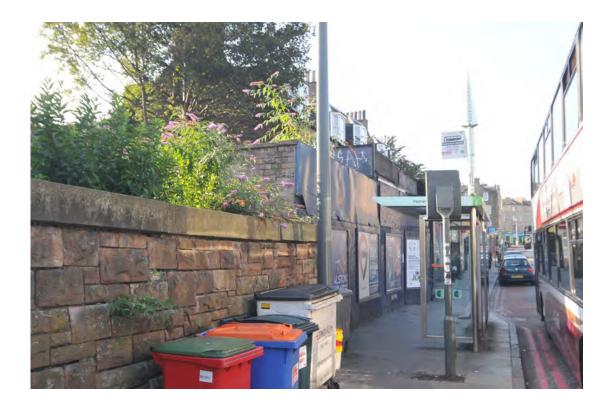
Plate 2: West-facing elelvation of No's 11 and 13 Dalry Road from the north-west

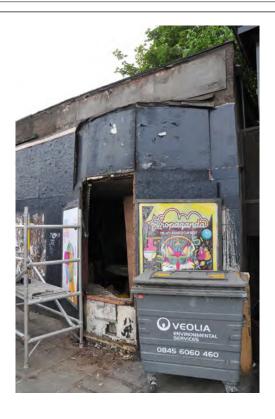
A Victorian style bay window (Plates 3-4) extended from the elevation of No 13. To the immediate north of the window was a recessed steel-framed sliding door that allowed access to the pend. It was set against the original north wall of No. 13. At No. 11 a recessed doorway was set behind a red-painted security grill. The doorway was flanked by two windows set within aluminium window frames (Plates 5-6).

Plate 3: Oblique view of bay window, No.15 Dalry Rd

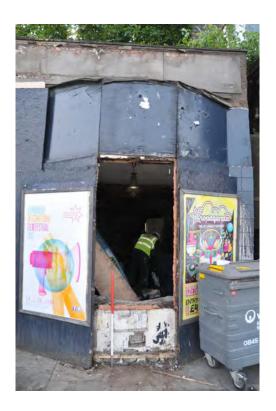
Plate 4: Detail view of bay window, No.13 Dalry Rd

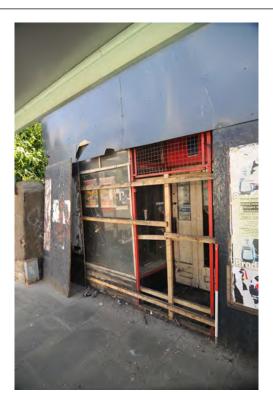
Plate 5: Oblique view of recessed entrance and main front windows of No.11 Dalry Rd

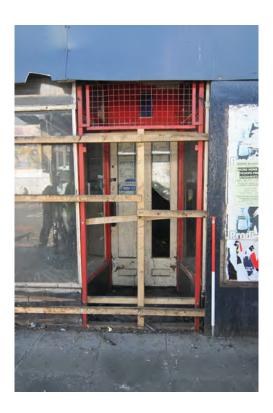
Plate 6: Detail of recessed entrance of No.11 Dalry Rd

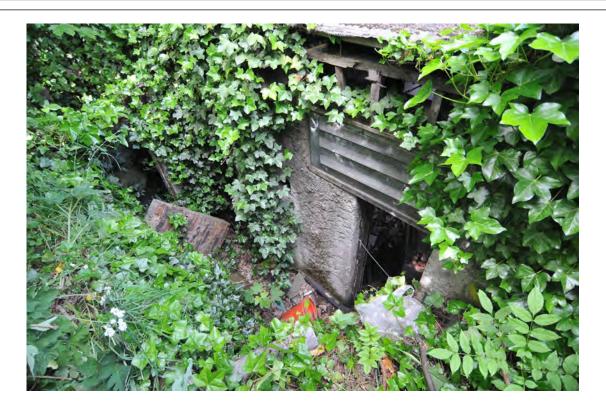
The east facing elevation (Plate 7) formed the back of the building and was set within a yard overlooked by a retaining wall c.2m high. The yard was c.1.5m wide. Part of the back of No.11 was visible. The wall had coarse render and was whitewashed. It featured an open doorway above which was a zinc ventilation panel.

Plate 7: View of back yard and overgrown steps

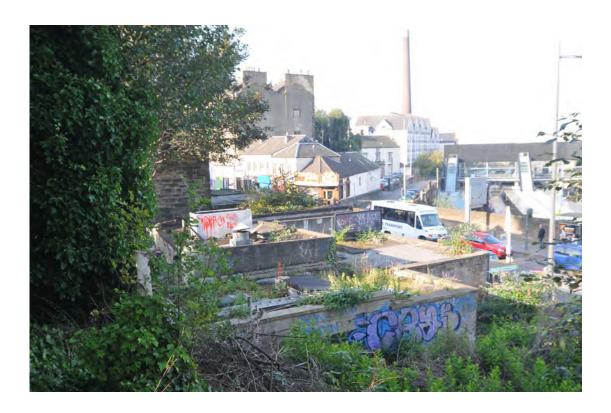
The north facing elevation was mostly obscured by a retaining wall which runs around the current Morrison Street carpark. The visible upper part was built of un-rendered brick with no discernible regular bonding pattern. It had a flat roof with concrete slab capstones (Plate 8).

The roof was flat and covered with bituminous felt.

Plate 8: View of roof in setting from the north-east

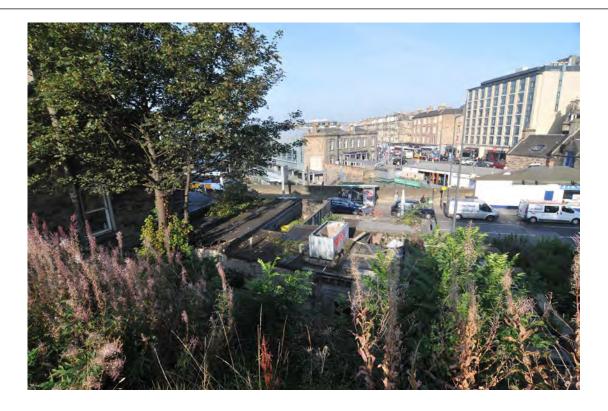
Plate 9: View of roof in setting from the east

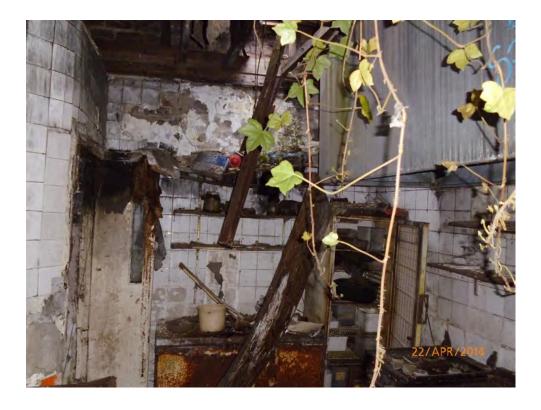
Numbers 11 and 13 Dalry Road were in a very derelict condition and at the time of this survey they could not be entered into on the grounds of health and safety. Two interior photographs taken during an asbestos survey show the unsafe condition of the interior of No. 13 Dalry Road.

Plate 10: Interior view of kitchen of No.11 Dalry Rd (taken by the client)

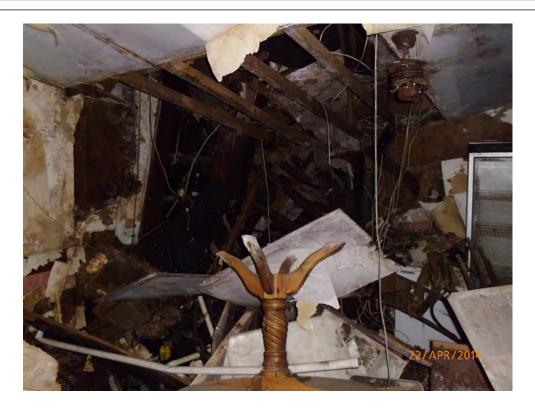
Plate 11: Interior condition of No.13 Dalry Rd (taken by client)
