**Land between Canongate,
Holyrood Road & St John Street,
City of Edinburgh**

**Southern Boundary Wall
Pre-demolition Recording Survey**

Report No. 3059

Author	Stuart Mitchell MA
Illustrator	Graeme Carruthers MA MIfA
Editors	Bruce Glendinning BSc Pg Dip MIfA
Commissioned by	Balfour Beatty
Date issued	August 2013
Version	0
Planning Application No	12/03343/AMC
Grid Ref	NT 26316 73566 (centred on)

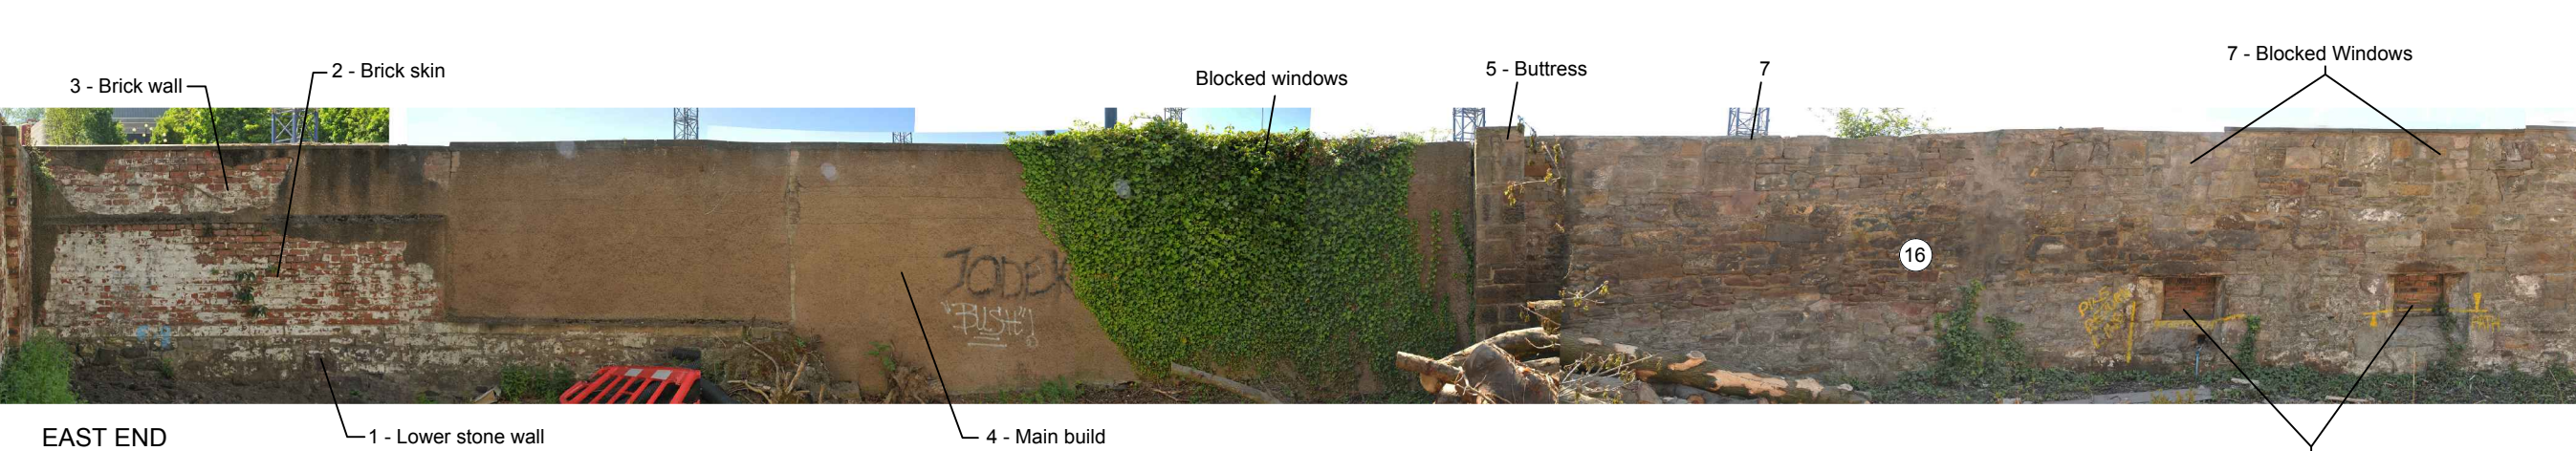
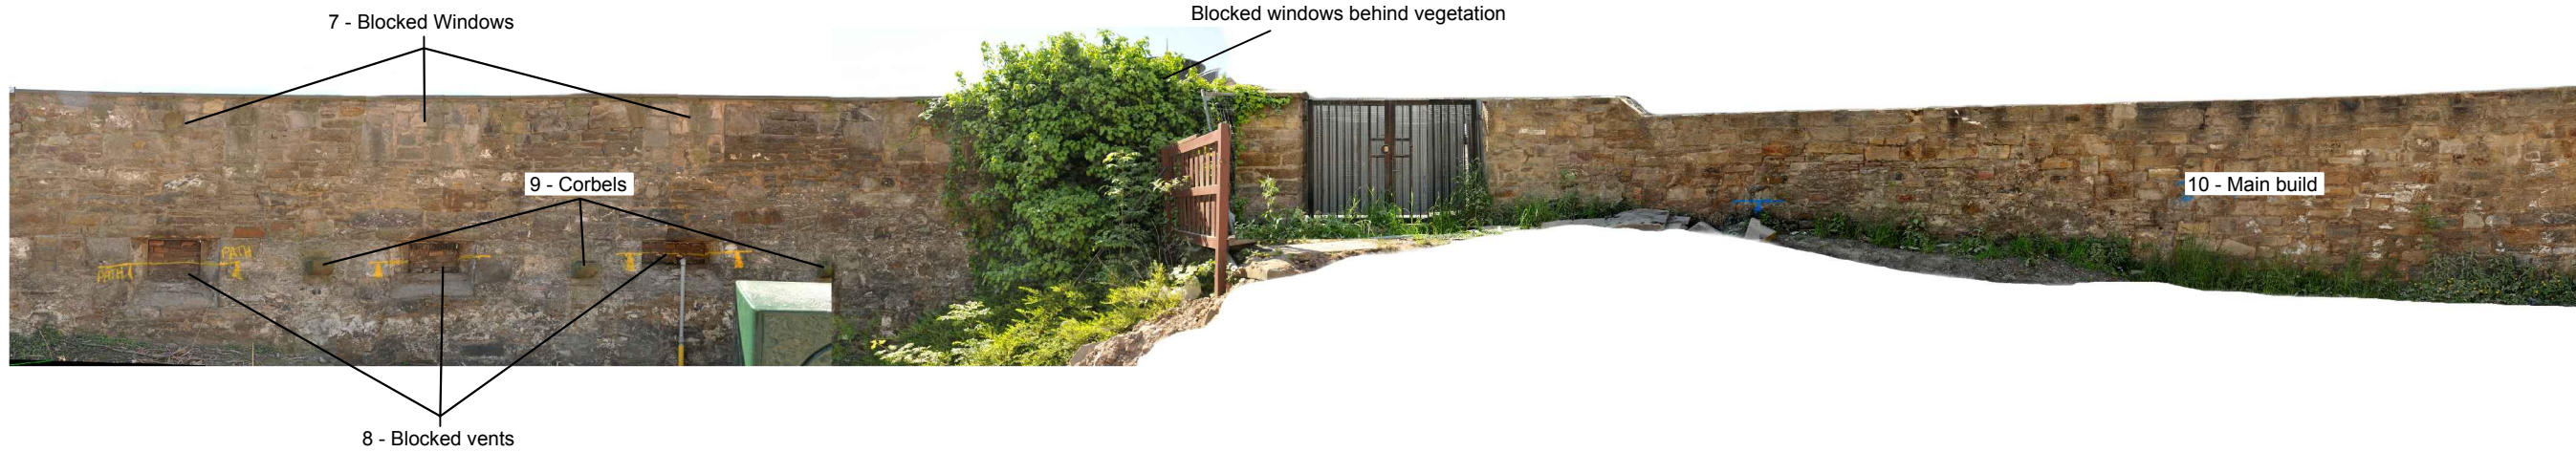
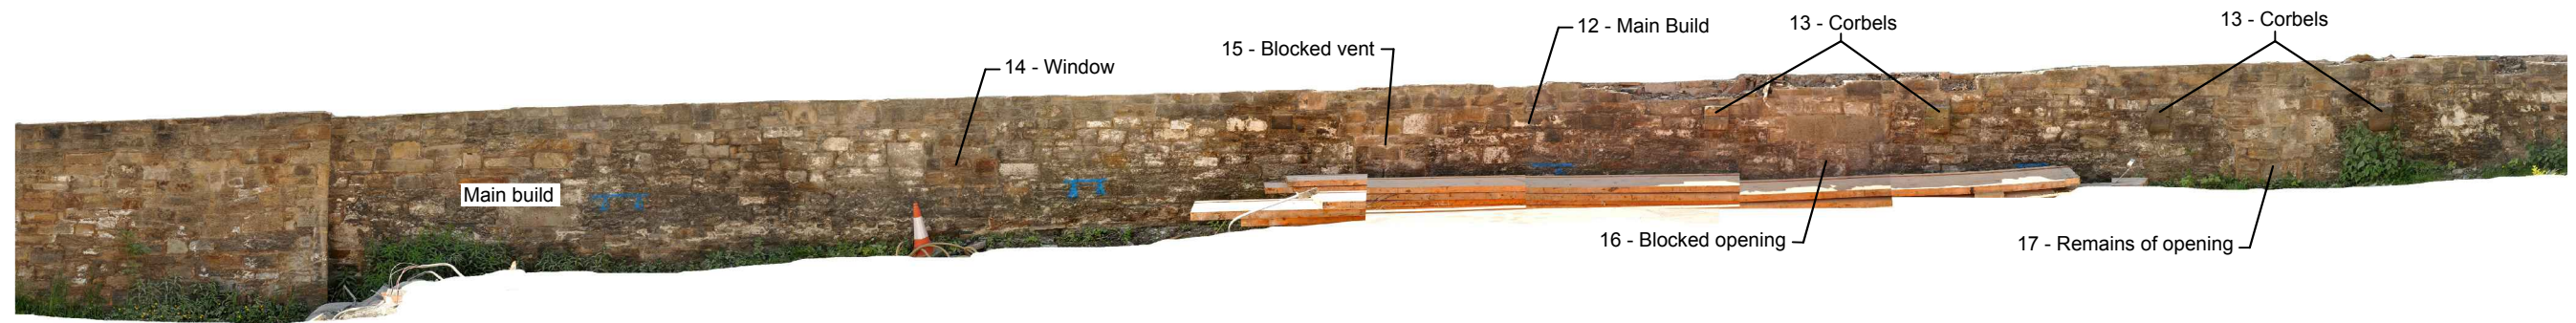
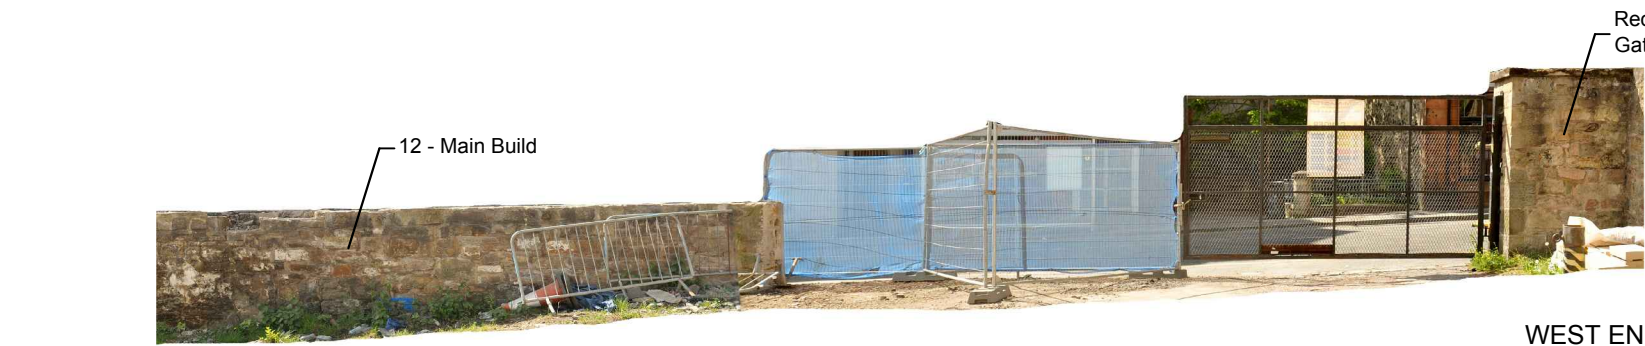
Fig. No:	2	Revision:	A
Title: Photomontage of Wall, North-facing elevation			
Project: Land between Canongate, Holyrood Road & St John Street, Edinburgh			
Southern Boundary Wall Recording			
Client: Balfour Beatty			
Scale at A3: 1:100			
Drawn by:	Checked:	Report No:	
TB	MC	3059

Feature No/Type	Height (m)	Length/Width (m)	Summary description
1 (Wall)	1.1	19	Lower sandstone wall, randomly laid with ashlar and rubble, surmounted by sandstone ashlar coping stones. Evidence of re-pointing and whitewash.
2 (Wall)	1.4	5.5	Second (outer) brick skin with mortar bond. Initially this section was harled but this has fallen away.
3 (Wall)	2.3	5.5	Main brick wall at wall head. Partly rendered. Brick has same bond as below. The wall head is capped with concrete coping stones.
4 (Wall)	2.3	9	Brick wall between (3) and (5). Harled finish with concrete copings stones, hidden behind ivy.
5 (Buttress)	3.5	0.6	Ashlar-built buttress (0.76m x 0.6m x 0.59m) at the east end of the wall and keyed into adjoining wall (6). Possibly built with re-used stone, uniform in build but with random embellishments with horizontal droving and stugging.
6 (Wall)	3.5	25	Main section of wall with sandstone and occasional basalt blocks and bonded with lime mortar. Occasional patched of whitewash. Concrete repairs visible. The wall incorporates a variety of bonds which include mostly random

sandstone blocks was are of random rubble. Incorporates Features (7), (8) and (9). The wall curves at its east end with evidence of heavy cement pointing. The wall below the top edge of feature (8) has more whitewash surviving.
7 (Window)	c.0.6	1	Six blocked (5 are visible one is masked by vegetation) windows framed by rough-dressed sandstone quoins blocked with random coursed blocks of sandstone and rubble.
8 (Vent openings)	0.6 (inner)	0.7 (inner)	A series five stone-built blocked vents (Plate 3) set into the main section of wall (6). The vents are framed by sandstone quoins sandstone lintel. The inner reveals of the vents are splay outwards with an outside opening measuring 1.25m long and 0.96m high.
9 (Corbel)	0.20	0.31	Four corbels protruding from the main elevation all equidistant between the vents (8). Some have been broached back flush with the wall. Two others survive.
10 (Wall)	2.85	18.5	Section of wall reduced in height and capped with concreted coping stones. Fabric includes mainly rough-hewn sandstone blocks and random rubble bonded with lime mortar.

11 (Break)	2.85	0.15	A dog-leg break in the wall formed by ashlar blocks and key work with a variety of stone used including stugged and dressed stone reflecting the use of much re-used stone at this junction.
12 (Wall)	38	2.2-1.2	Main build of wall running from (11) to the entrance at the west end. The fabric includes mostly mortar bonded ashlar with areas of random rubble. Contains features (13) and sparse patches of whitewash.
13 (Corbel)	0.37	0.29	Four corbels protruding from Wall (12). Each corbel (Plate 4) is actually two pieces of stone with the lower being a larger rounded under-stone capped with a rectangular block.
14 (Window)	1.08	0.6	Blocked window framed by rough-dressed quoins. The blocking work comprises blocks of rough-dressed sandstone and bonded using a concrete mix. A repair is visible on the lintel.
15 (Vent)	0.85	1.1	As feature (14) bit with mortar bonded blockwork.
16 (Window)	0.86	1.1	Blocked window or vent opening with large sandstone lintel.

17 (Door)	1.2	1.07	Sandstone blockwork with missing and replaced surrounds. Some whitewash remaining.

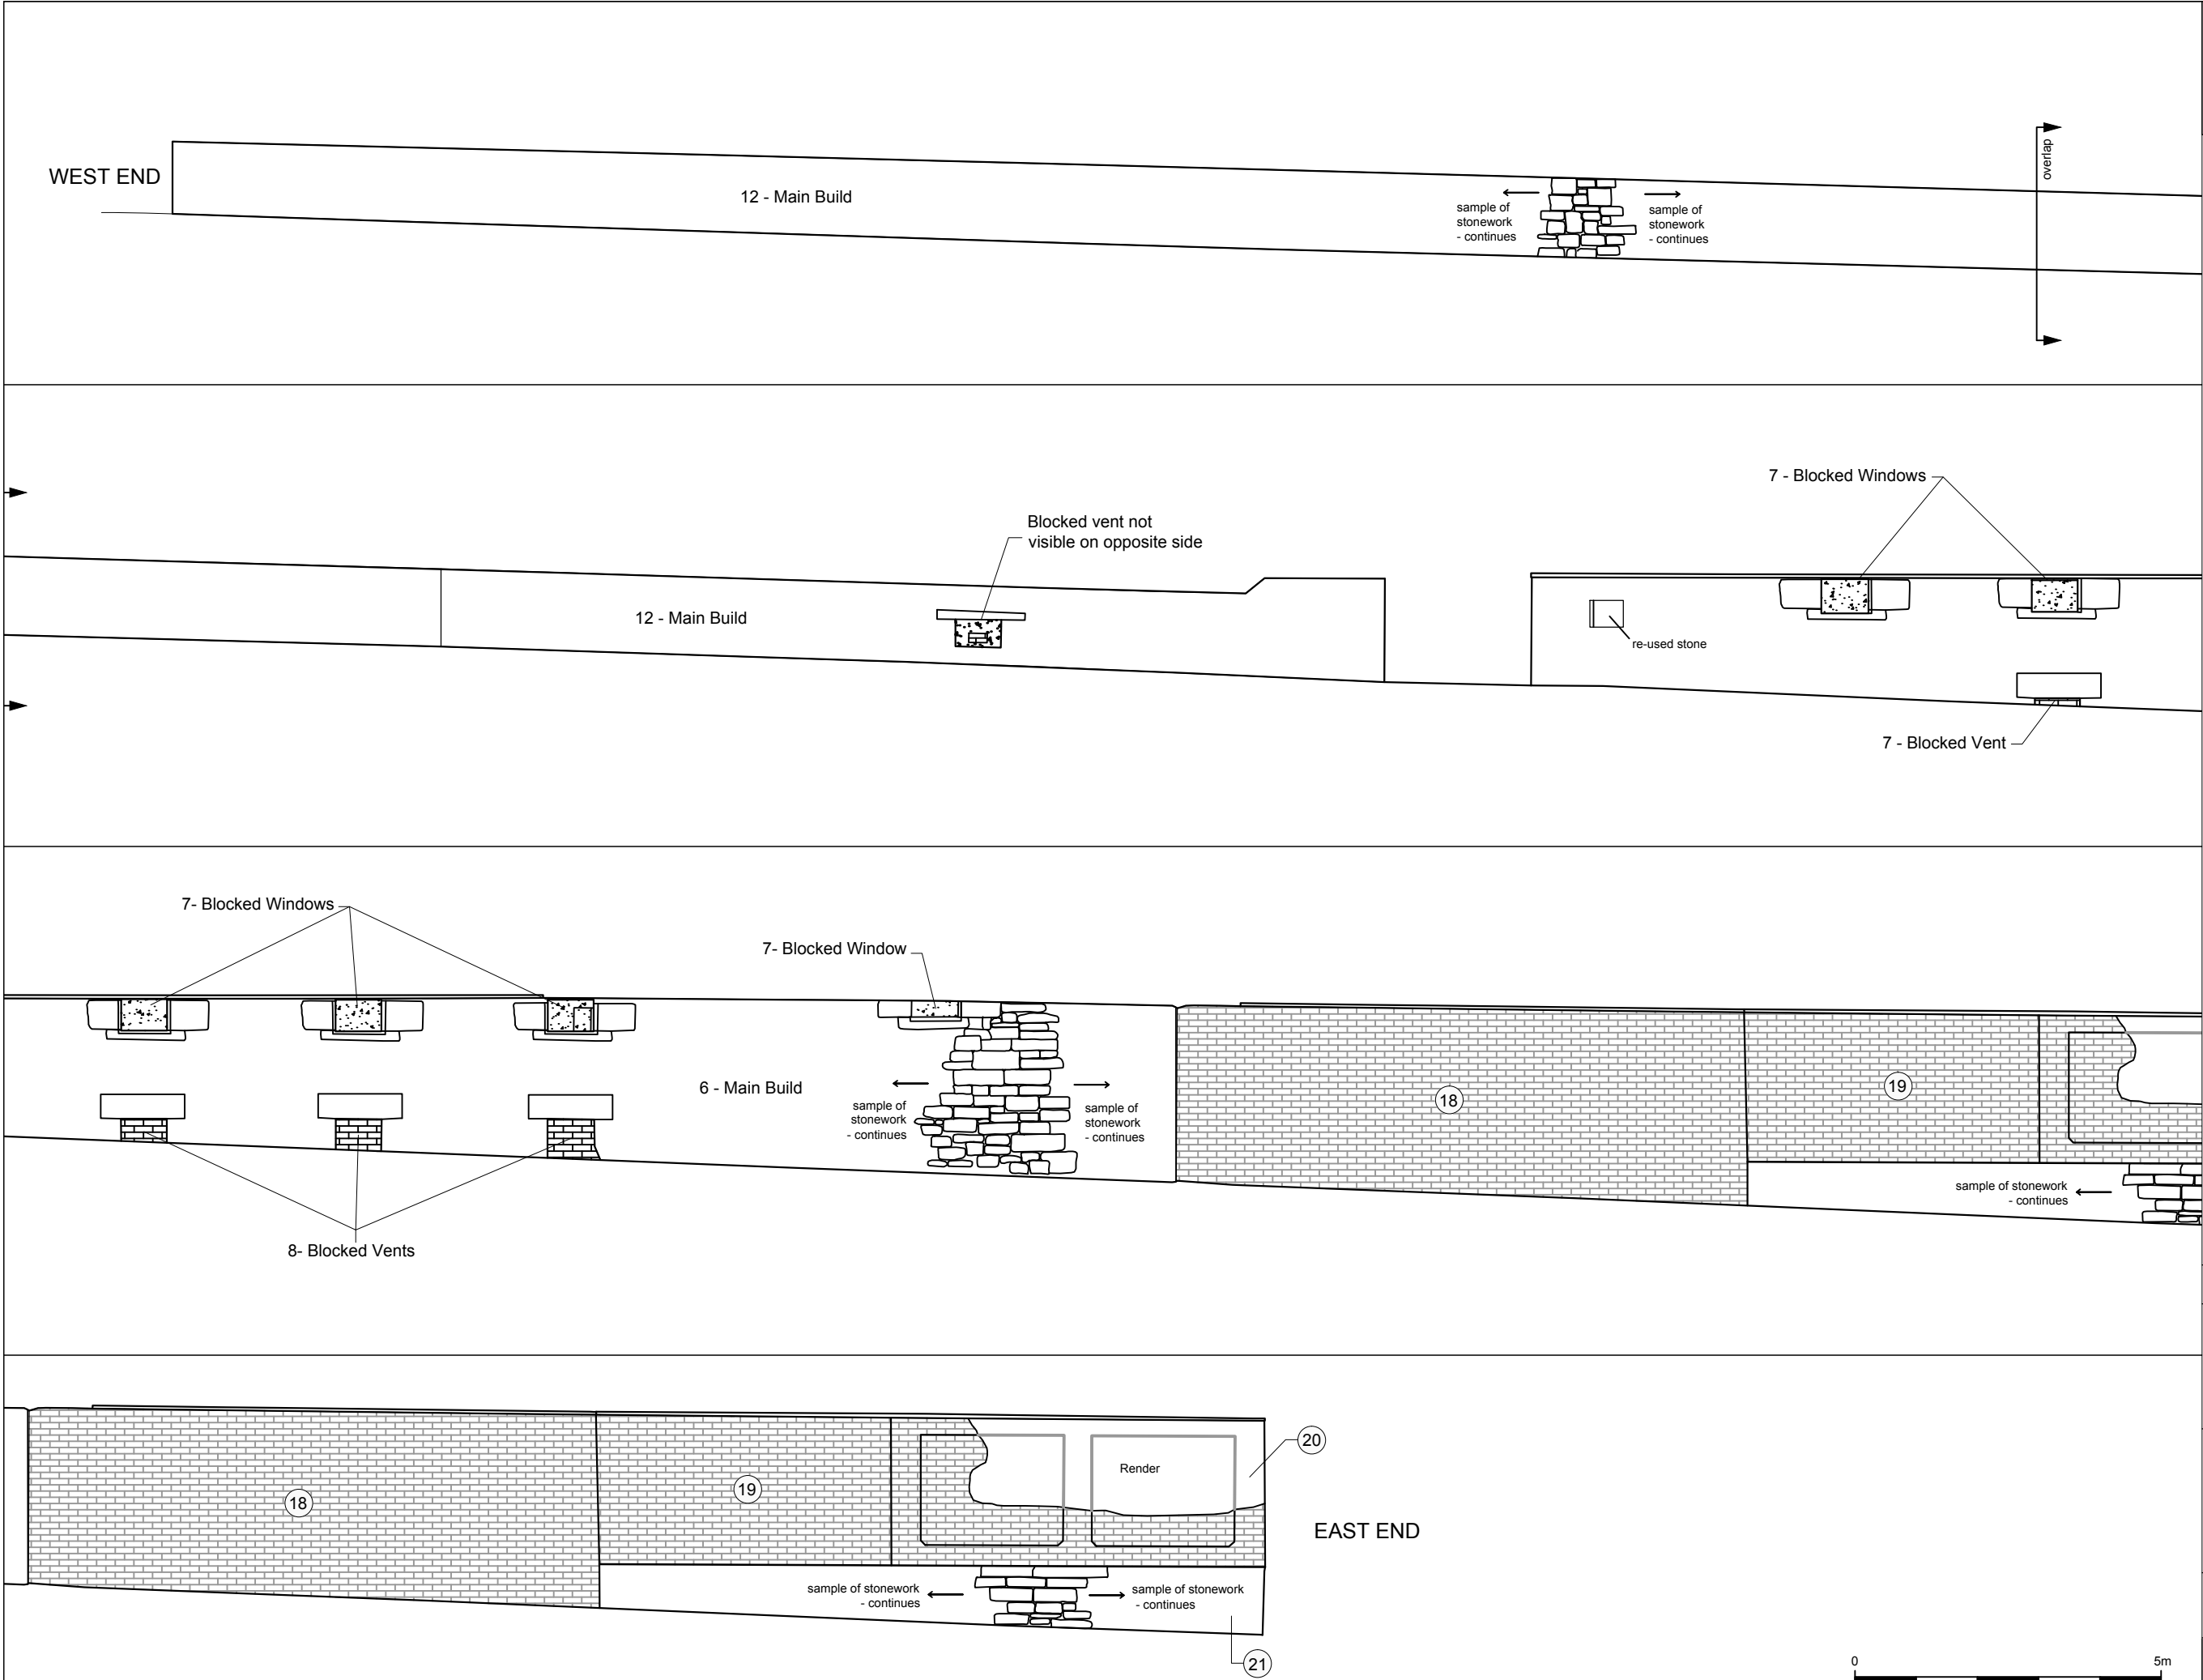
Fig. No:	3	Revision:	A
Title: Elevation of Wall, South-facing elevation			
Project: Land between Canongate, Holyrood Road & St John Street, Edinburgh			
Southern Boundary Wall Recording			
Client: Balfour Beatty			
Scale at A3: 1:100			
Drawn by:	Checked:	Report No:	
TB	MC	3059

Feature No/Type	Height (m)	Length/Width (m)	Summary description
18 (Wall)	1.1	10.5	Sandstone wall, possibly a former garden wall later extended upwards by brick wall 2 (Plate 5). A mix of beige and red sandstone, some rough-dressed and quarry faced. Randomly laid with chamfered coping stones and quoins at the corners.
19 (Wall)	2.4	6	Brick wall built on top of wall (18) with chamfered inset panels. Formerly harled but much has fallen of the elevation.
20 (Wall)	2.4	4.7	Brick wall built onto wall (18) abutting wall (19). Red brick formerly whitewashed with concrete coping stones. Evidence of harling although hardly any remains.
21 (Wall)	3	9	Brick wall abutting wall (20) and formerly harled with concrete coping stones.
22 (Wall)	2.4	25	Main sandstone exterior perimeter wall. Random sandstone build with occasional re-used stone. Substantial blocks of re-used stone with droving present. A curve in the main wall forms a slight return in the wall at the east end. The Main wall contains windows (7) and blocked vents (8).

7 (Window remains)	0.5	1	Six blocked and truncated windows (Plate 6) surviving at the wall head (22). The windows are framed by large quoins and sills. The quoin and sills have chamfered edges. The blocking work is snecked sandstone.
8 (Blocked Vents)	0.6	0.7	Four blocked vents (Plate 7) at ground level blocked with brick. The vents are framed by large quoins and lintels that are stugged and have droved margins.

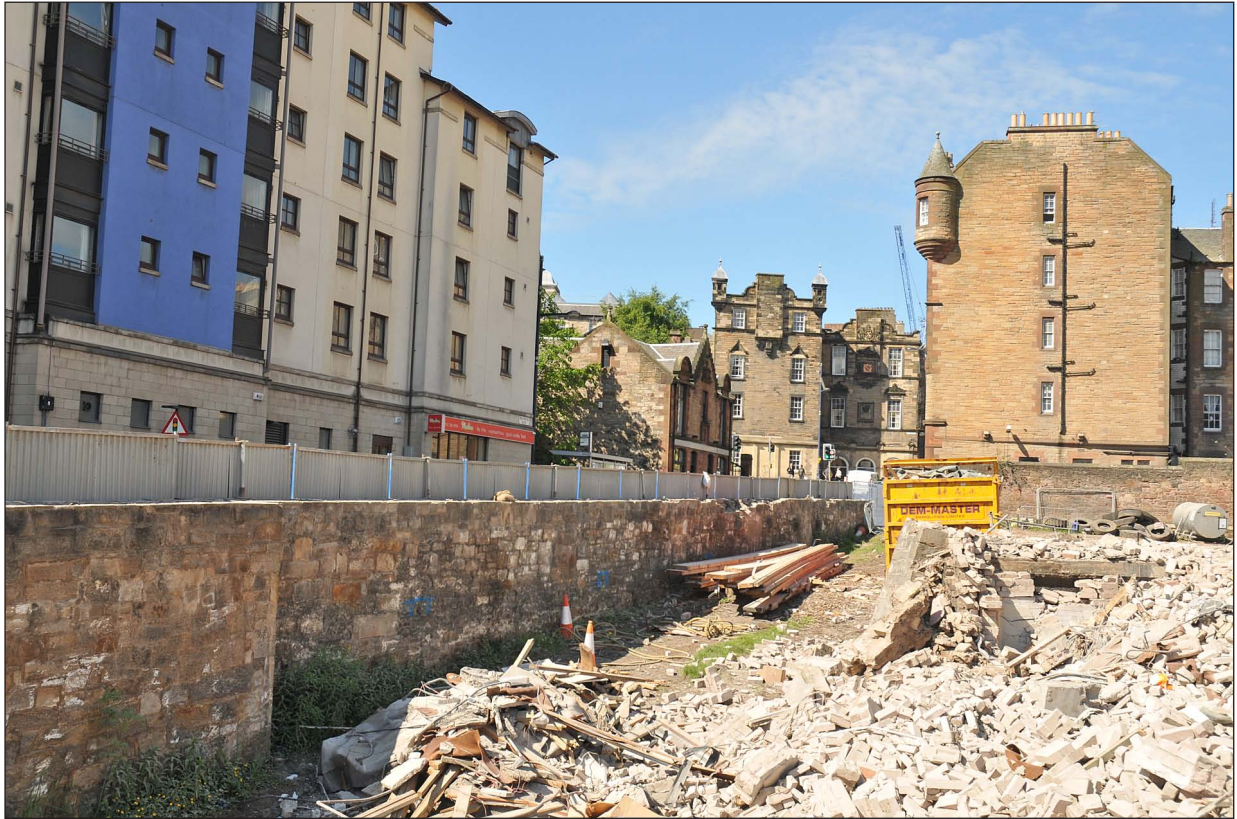
Plate 1 - General view of the north-facing elevation looking west.

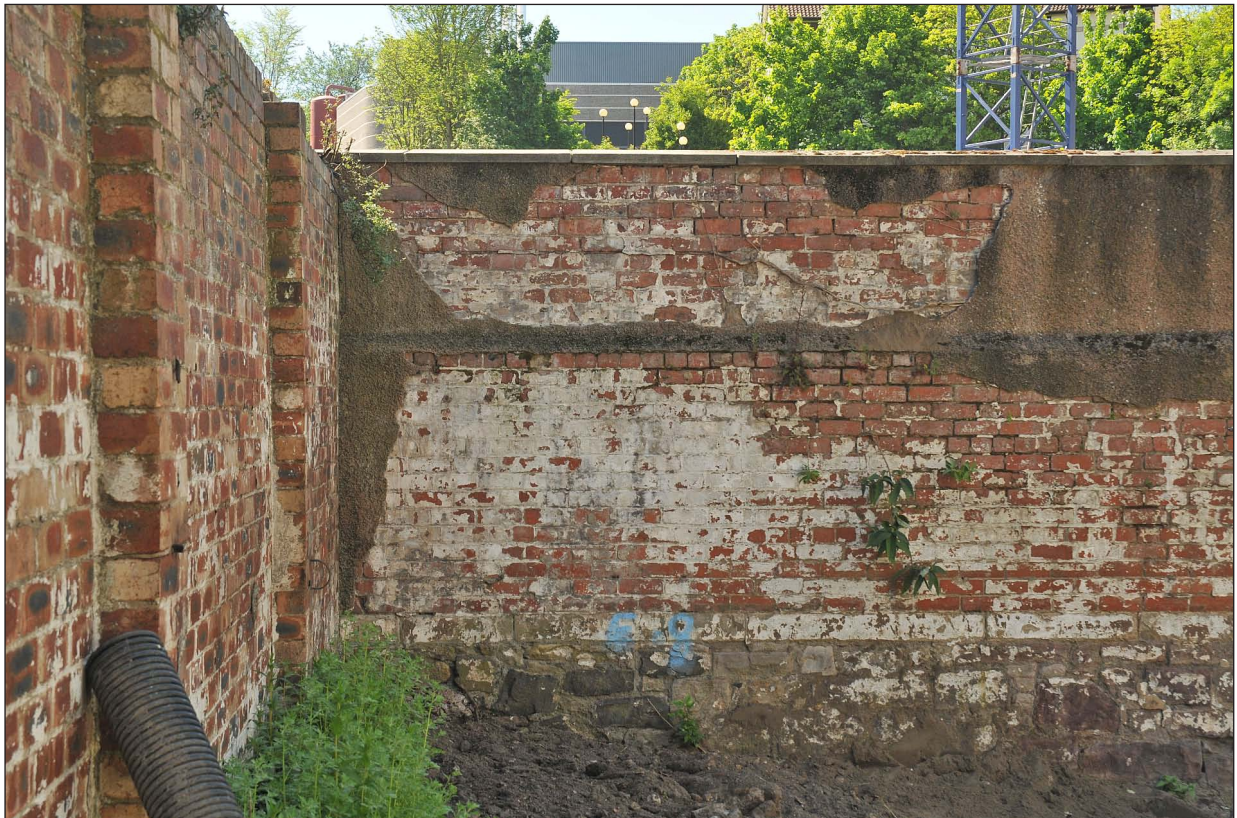
The north-facing elevation incorporates several sections of re-build in the form of discrete sections of brickwork at the east end (Plate 2). Included are the five stone-built vents (8) which were designed to air one of the brewery buildings. The presence

Plate 2 - Brick-built walls (2-3) over rubble wall (1), eastern terminus of the north-facing elevation.

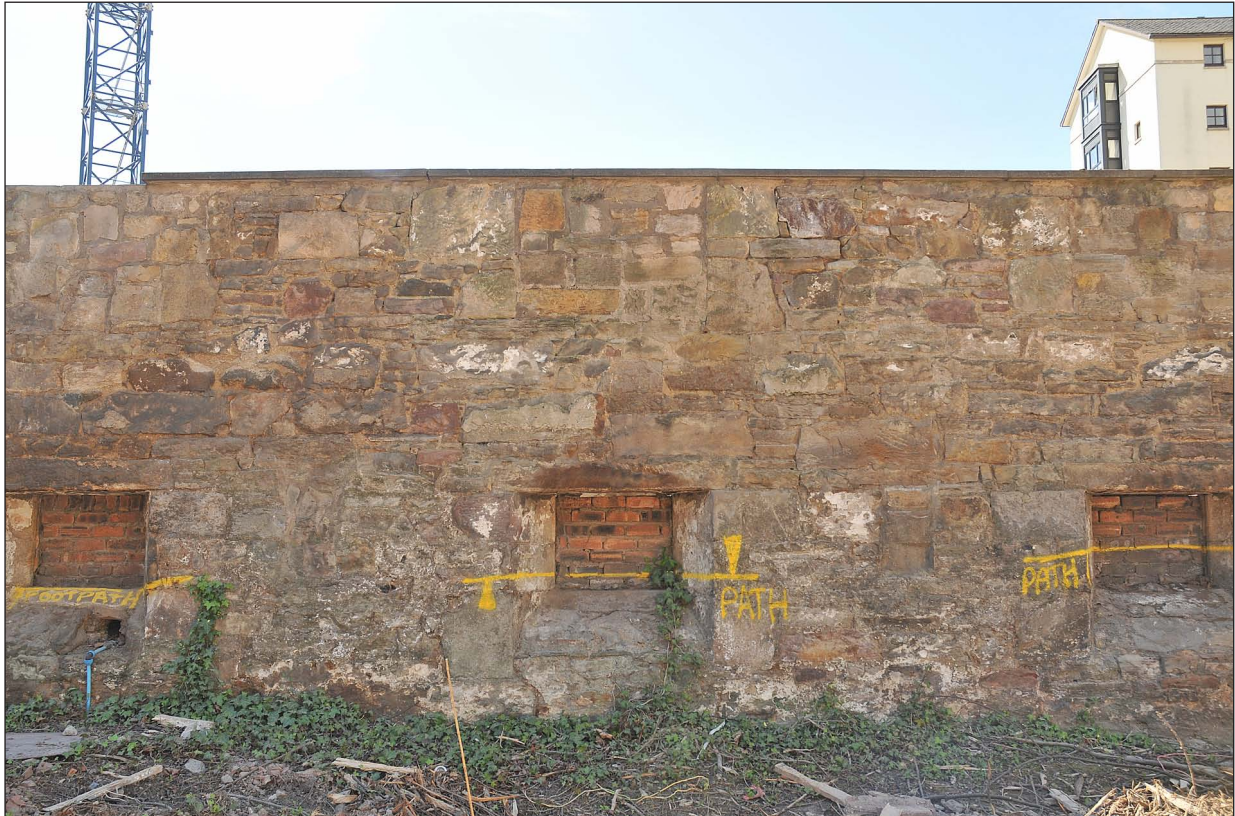
There is a noticeable height difference in the ground level between Holyrood Road (south-facing elevation) and the back of the wall (north-facing elevation). The level of the footpath has also been recently raised to an extent as the blocked vents (8) that survive at the base of the wall are not fully exposed on the south facing elevation.

The blocked windows (7) situated on the north-facing elevation survive as a series of blocked openings. These are more visible on the south-facing elevation where the sandstone sills have a single quoin on either side. On the north-facing elevation the full extent of the vent openings (8) are visible, whereas on the opposite side of the wall, their full height is not exposed. The blocked vents get smaller from east to west as the level of the footpath rises.

Plate 3 - General view of the blocked vents (Feature 8) on the north-facing elevation with the level of the footpath on the opposite side marked in yellow paint.

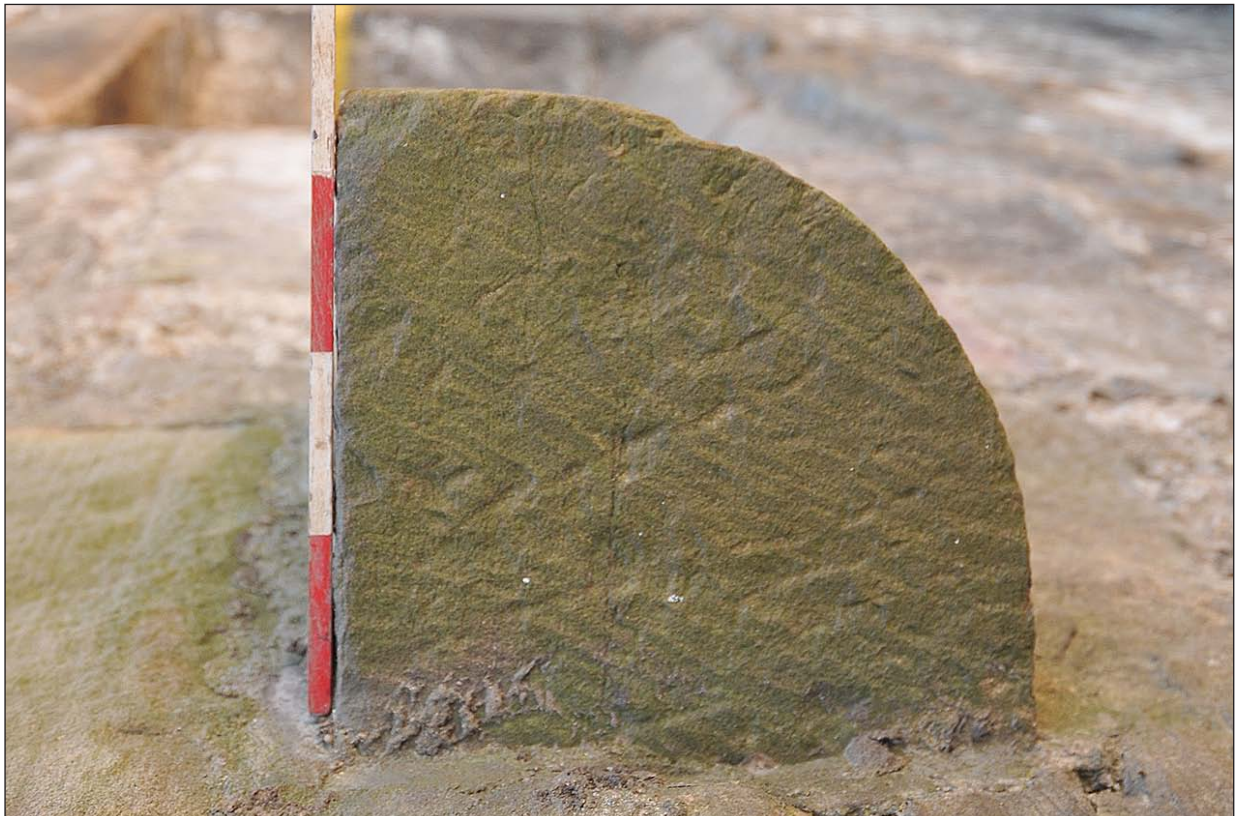
of corbelling (13) strongly suggests they were used to support timber joists of a suspended floor. This would imply that the blocked vent openings (8) were associated with airing the ground floor of the demolished buildings and the corbelling was support for part of the first floor.

Plate 4 - Close up of one of the corbel's (Feature 9) on the north-facing elevation.

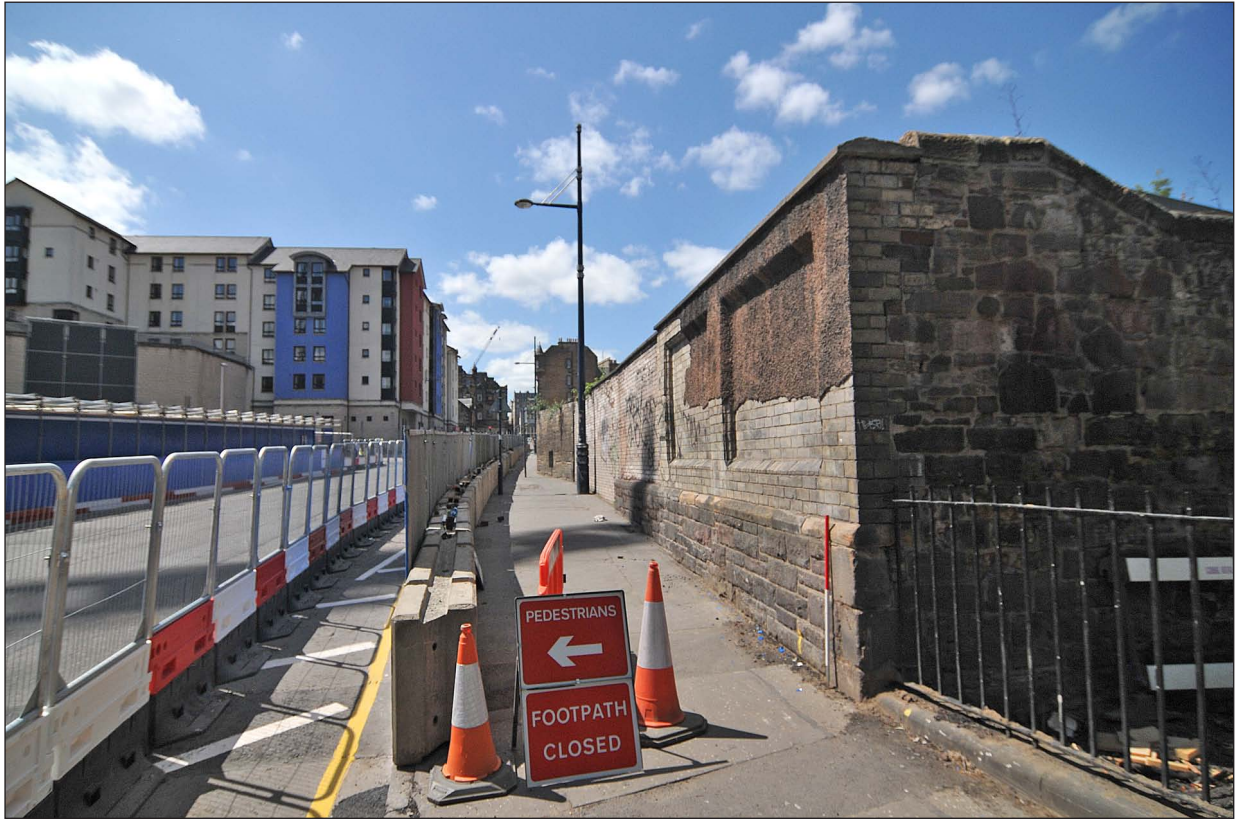
Plate 5 - General view of the south-facing elevation, eastern terminus and Walls (1-3).

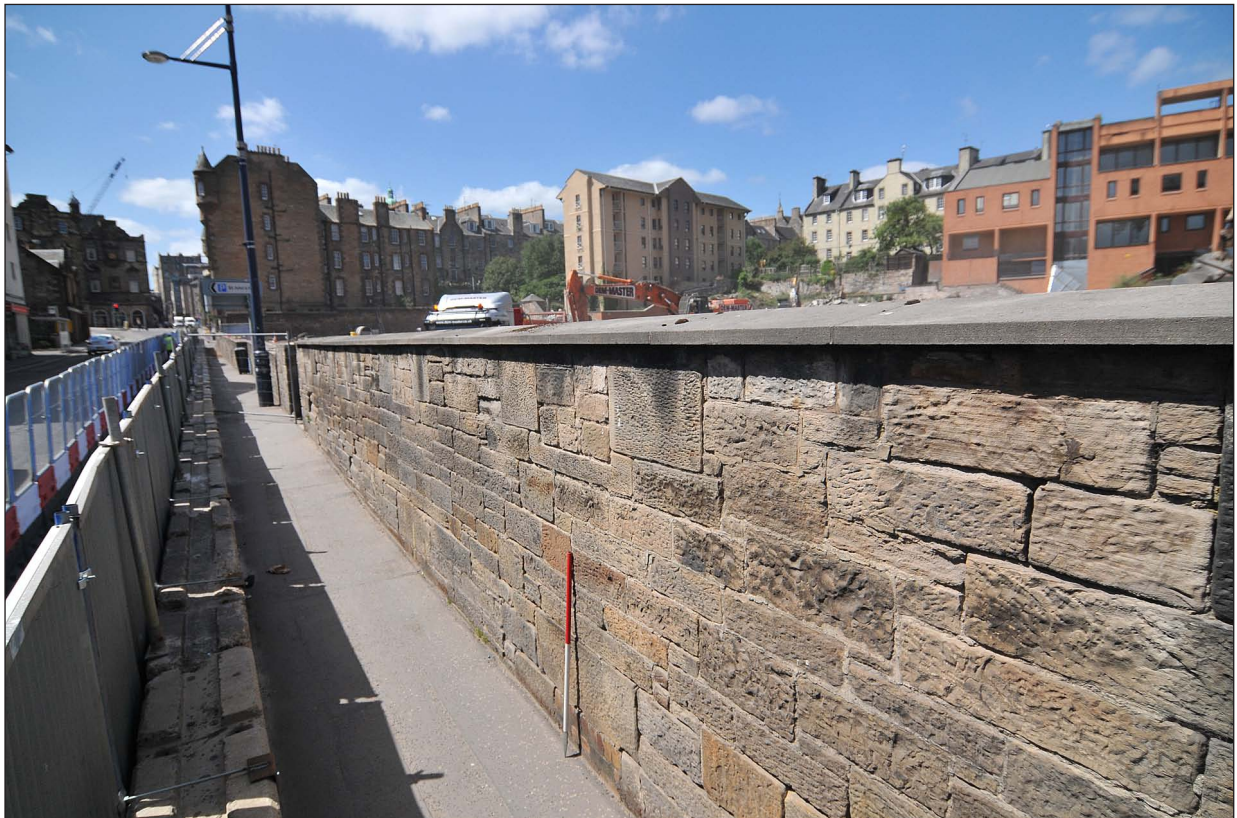
The wall clearly shows evidence of it being reduced in height and the truncation of window openings (7). The blocked vents at pavement level were designed to air the ground floor within the 19th century brewery building that fronted Holy Rood Road.

Plate 6 - General view of the blocked windows (Feature 7) visible on the south-facing elevation.

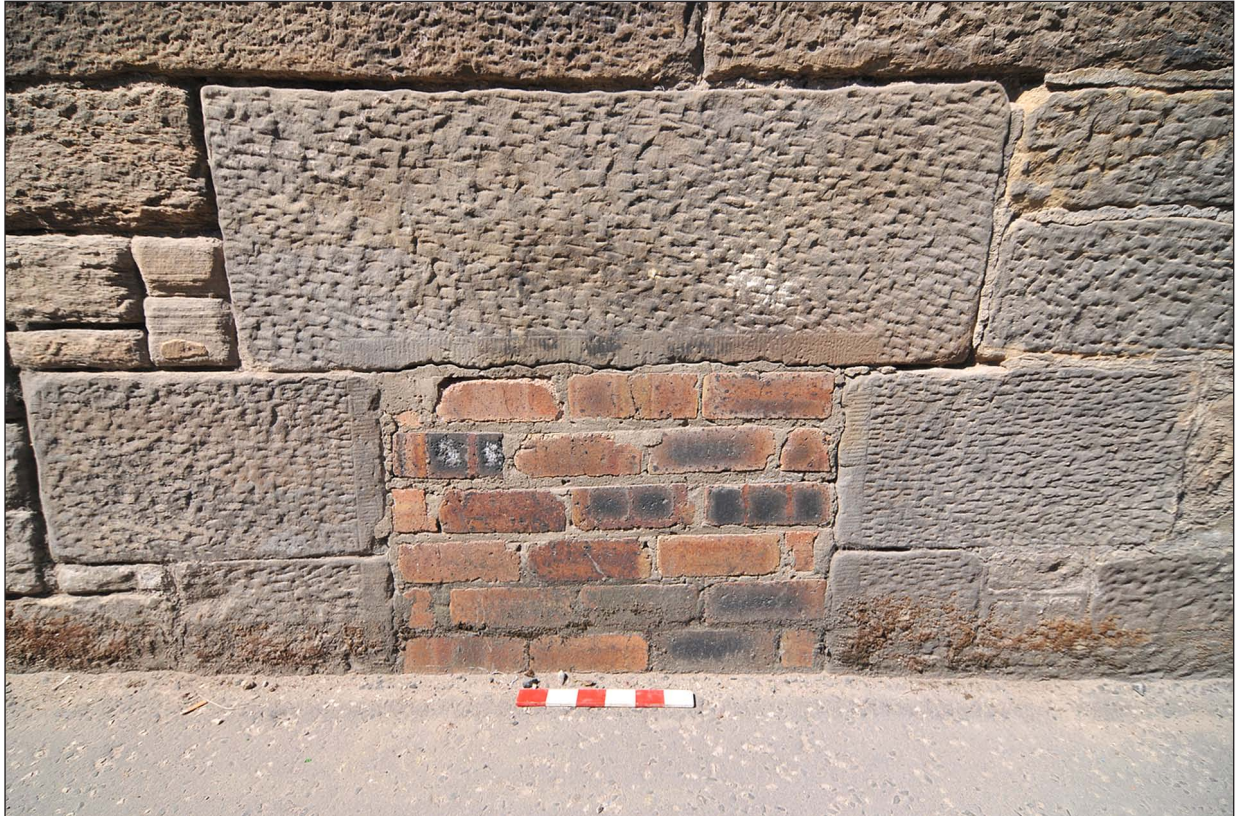
Plate 7 - General view of one of the blocked vents (Feature 8) at ground level on the south-facing elevation.
