**Barn at Gun Lane, Sherington, Milton Keynes  
Buckinghamshire**

**Historic Building Recording**

**Report No. MK019/15**

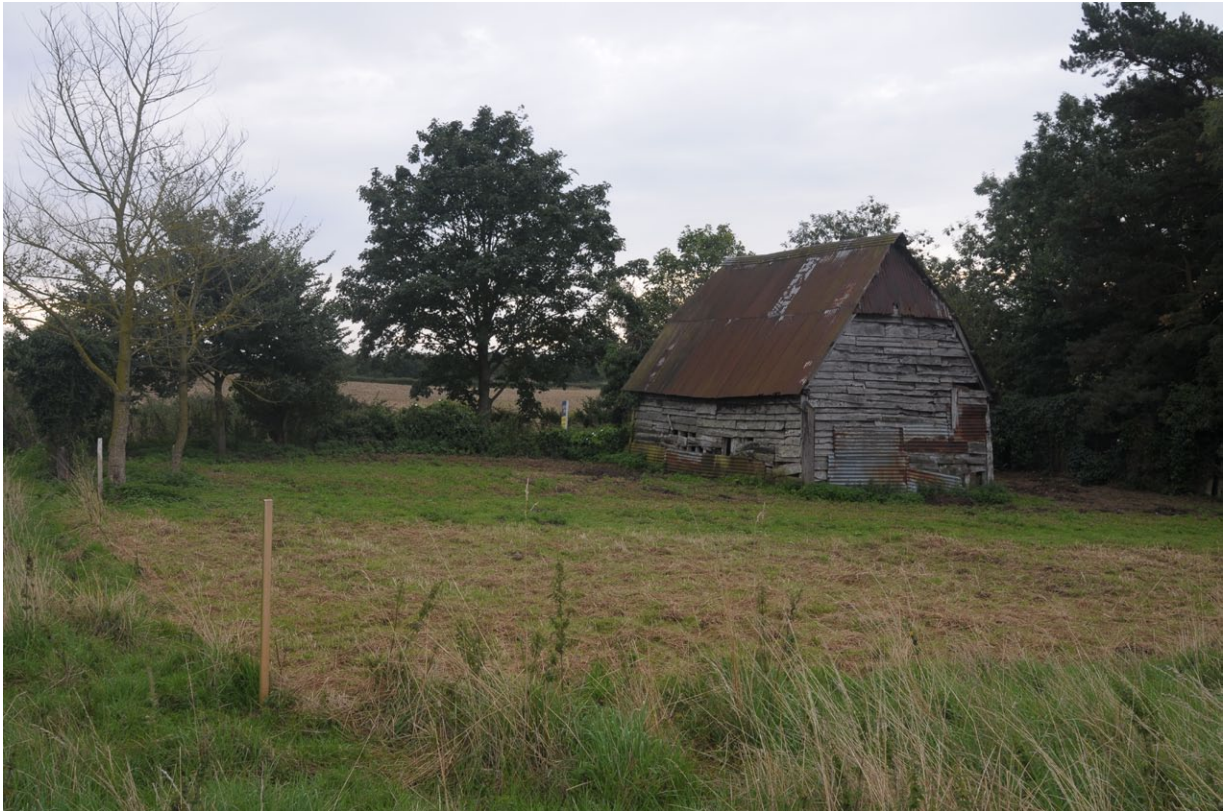
Fig. 7 - View of barn in corner of field

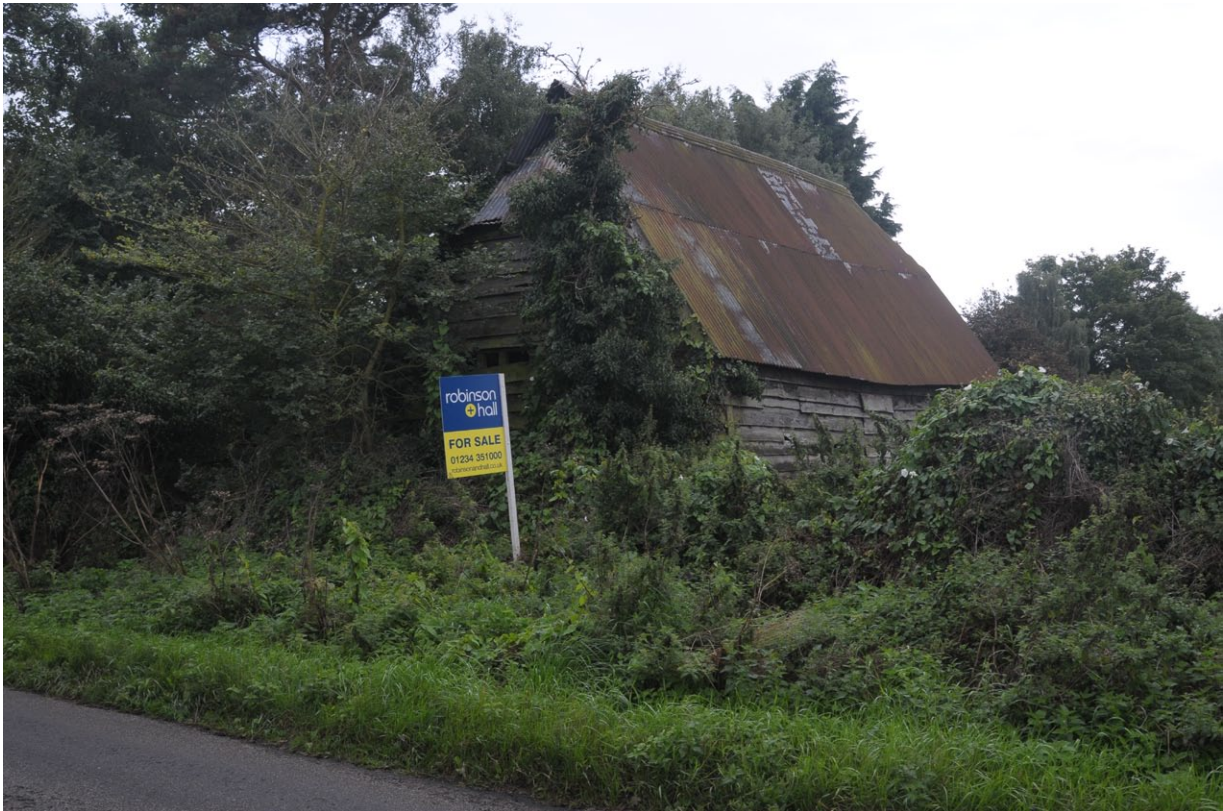
Fig. 8 - View of barn from the east

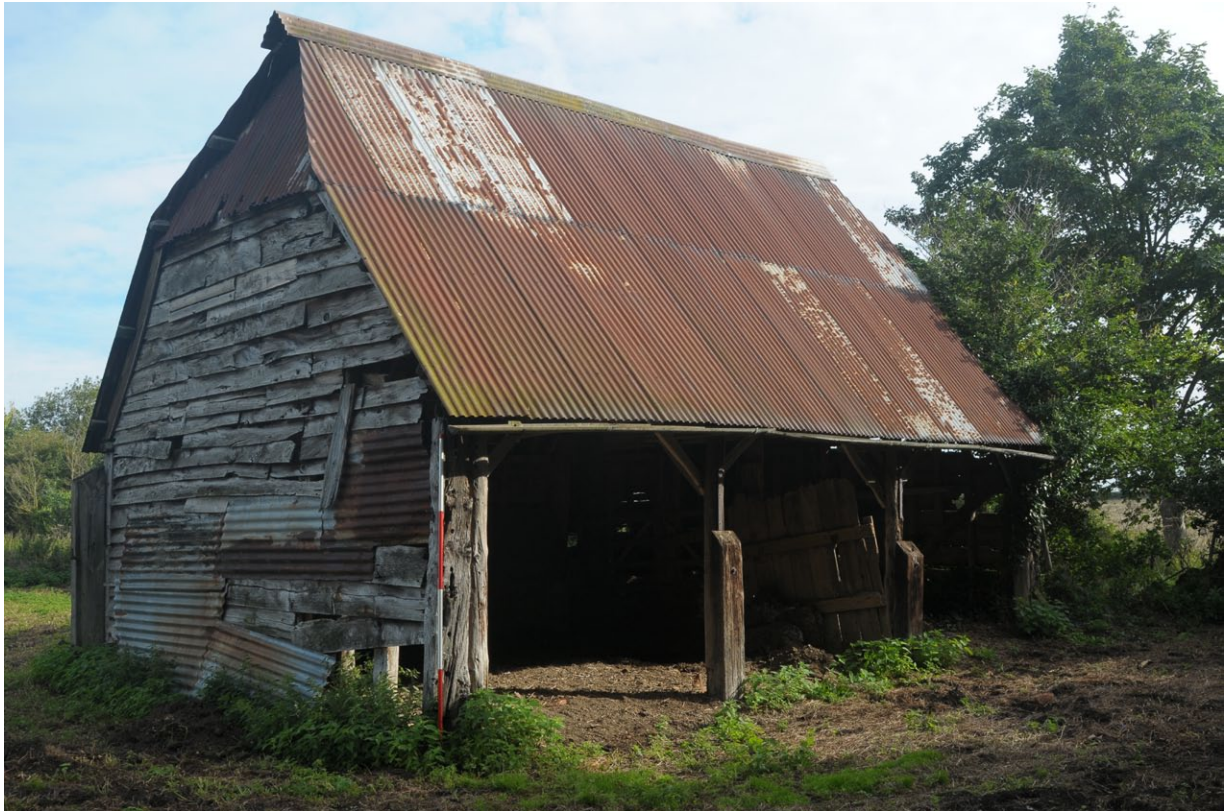
The barn is timber-framed measuring 8.5m by 5m with three equal bays opening to the south (figs. 9 and 10). Wall studs are covered in weatherboarding and where this has rotted or fallen away, patched with corrugated iron and a re-used door (on the east gable, see fig. 11). The weatherboarding comprises a variety of wide circular-sawn pine planks fixed with square and round-headed nails. The roof is covered with corrugated iron and is partially hipped on both gables. Galvanised guttering and a downpipe are present on the front elevation and in the south-east corner. Three railway sleepers have been placed around the barn, two in front of the central posts on the front elevation and one at the north-west corner. The floor of the barn slopes down gently to the south and is of earth. A nailed pine frame for an animal feeding trough is built against the rear wall (fig.12). This trough is partly obscured by chipboard resting against the rear wall. A division has been created between the east and central bays by three vertical posts, clearly re-used planks, nailed to the truss above and buried in the floor (fig.13). A re-used gate, a door and corrugated iron sheet form the main part of the division which is clearly not very old.

*Fig. 9 - Front and west elevations of barn*

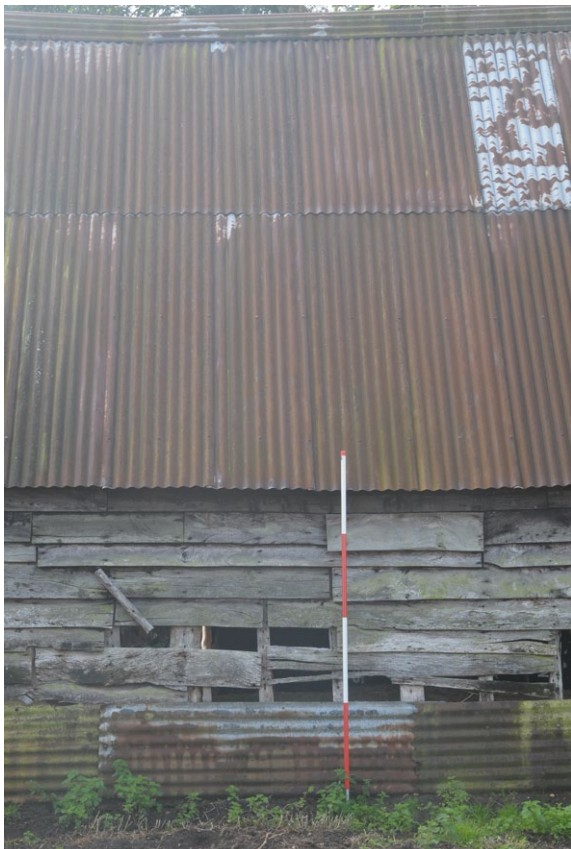
*Fig. 10 - Centre of the rear elevation*

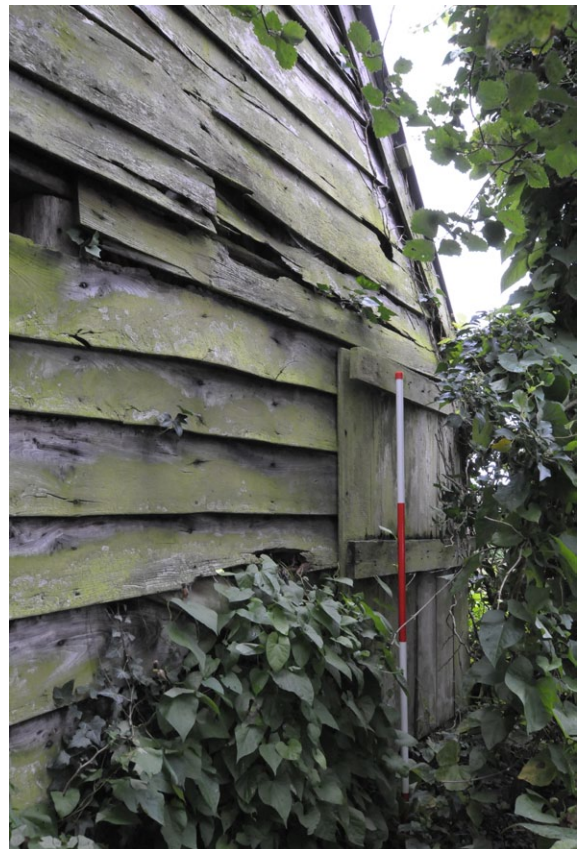
*Fig. 11 - A door patching the weatherboarding on E gable*

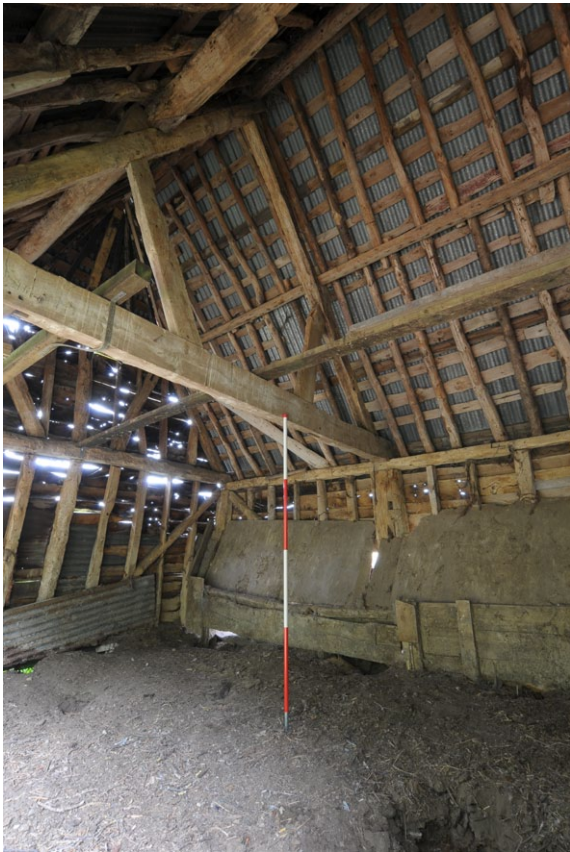
*Fig. 12 - Shot of interior showing boarded up animal feeding trough*

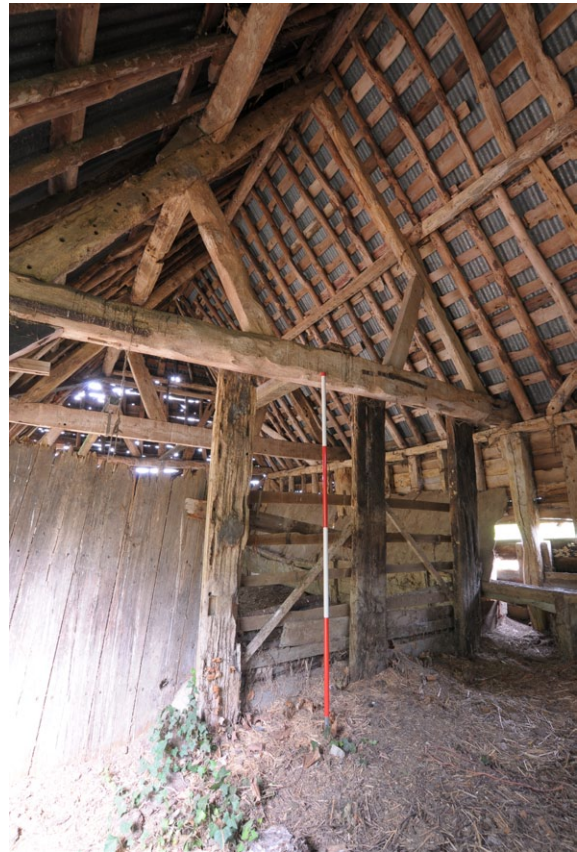
*Fig. 13 - The division between east and central bays*

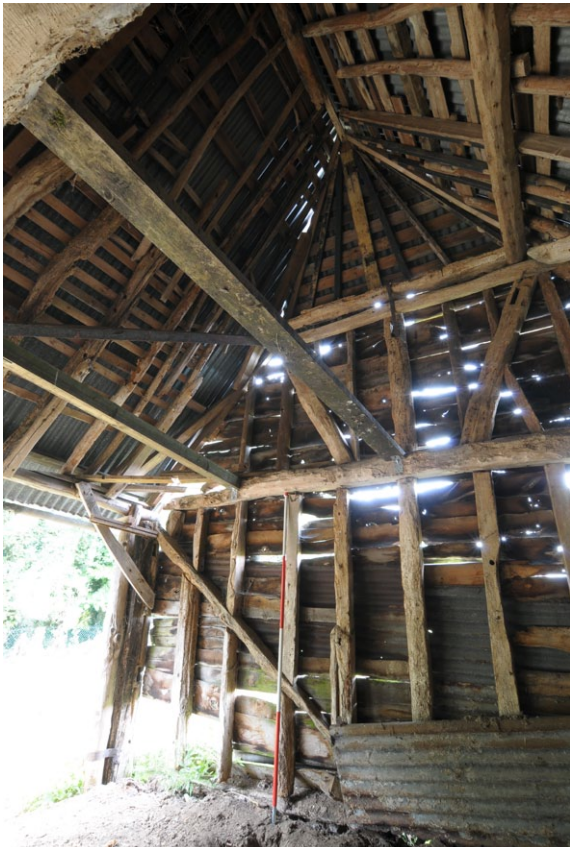
The main structure comprises the two gables (figs. 14 & 15) and the two central trusses marking the bay divisions. These are supported on nine posts connected by tiebeams running north-south and a wall plate and bressumer beam running east-west. The four corner posts and the two posts supporting the middle of the rear wall are re-used hewn and adze trimmed timber with various notches, mortises and auger holes. Three of the posts along the front wall supporting the bressumer show no signs of re-use and are rounded pine poles. The wall plate is constructed from three lengths of squared softwood timber, hewn and adze trimmed, joined with face-halved scarf joints (fig. 16). The wall plate is fixed to the upright posts with mortis and tenon joints. The bressumer is made of two rounded pine poles joined with a splayed scarf joint. Diagonal bracing, sawn softwood, is fixed using round-headed nails to the front posts supporting the central roof trusses. This bracing ties together the posts, the bressumer beam and the tiebeams of the trusses (fig 17).

*Fig. 14 - Interior shot of W gable*

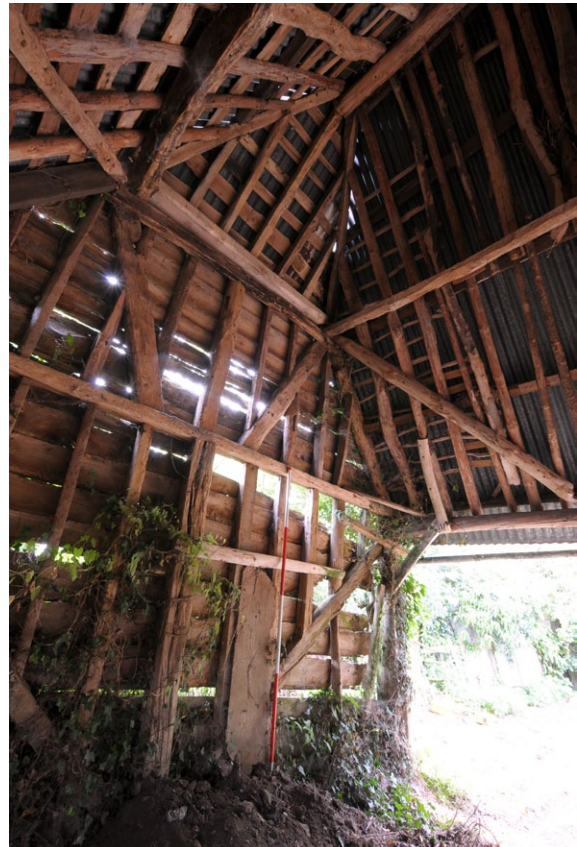
*Fig. 15 - Interior shot of E gable*

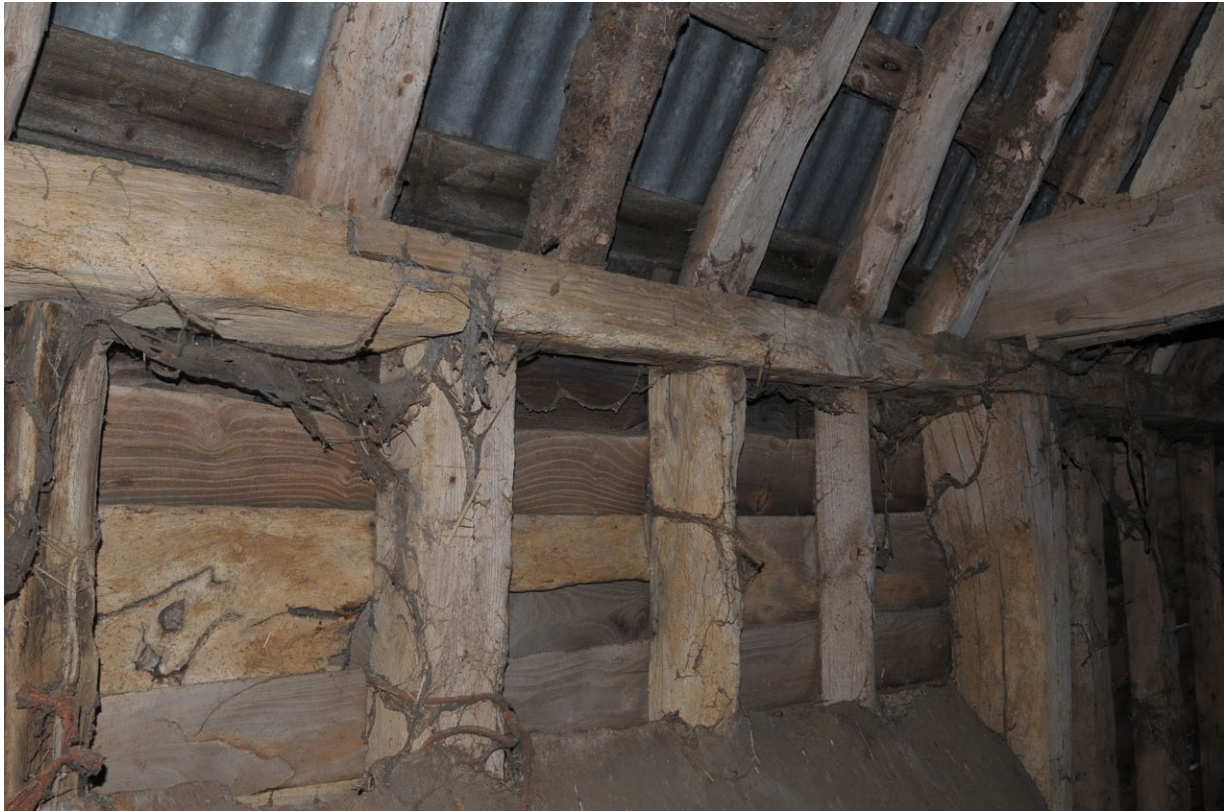
Fig. 16 - Shot of wall plate of rear wall

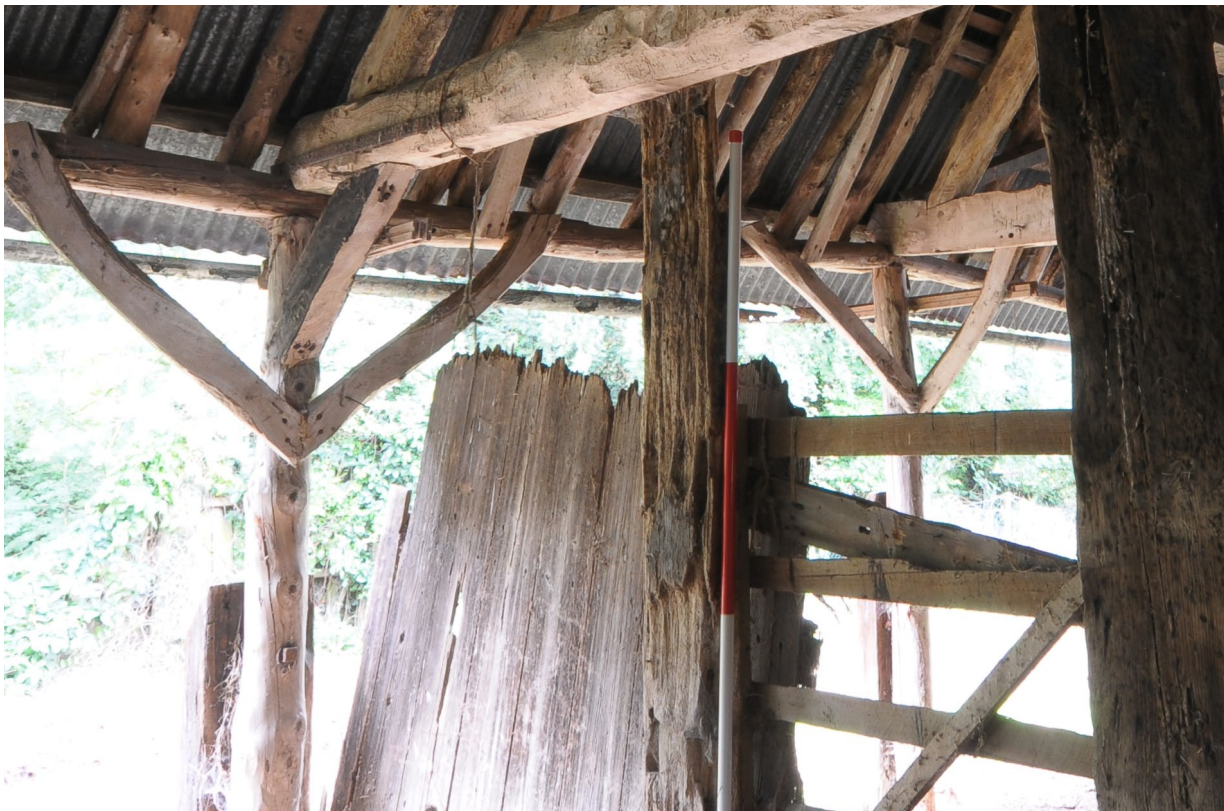
Fig. 17 - Shot of bressumer beam and bracing supporting central posts

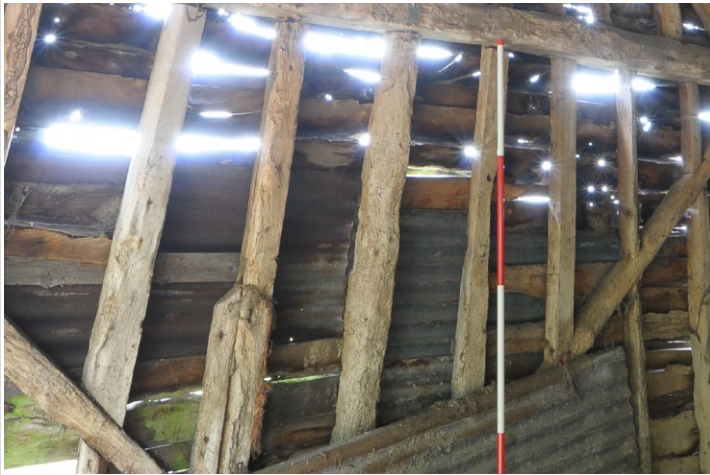
Fig. 18 - Studs, west gable

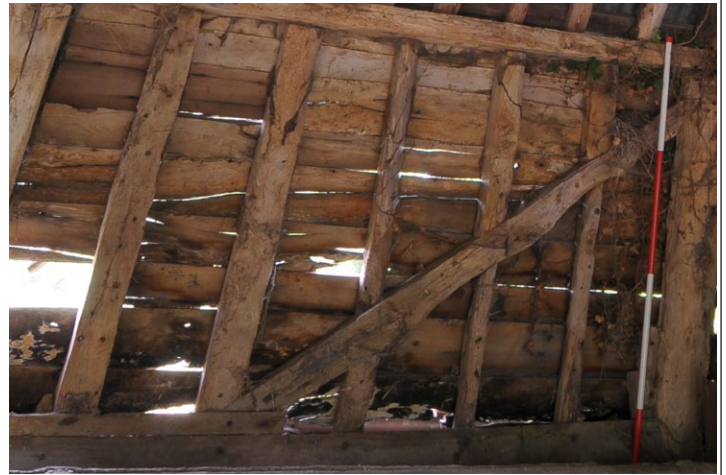
Fig. 19 - Studs, east end of rear wall

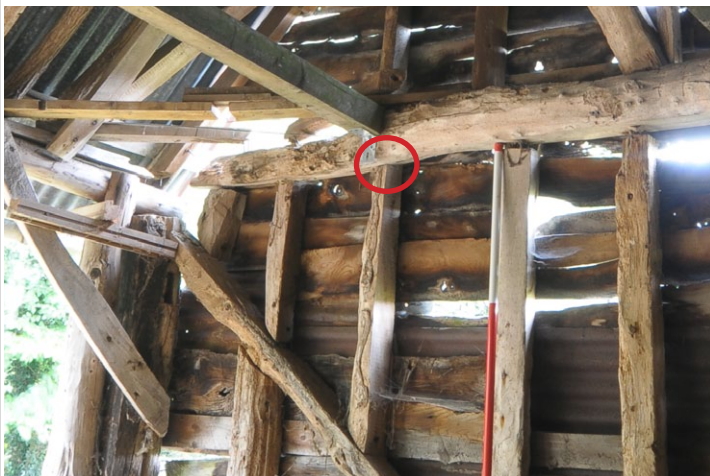
Fig. 20 - Notched stud attached to tiebeam, west gable

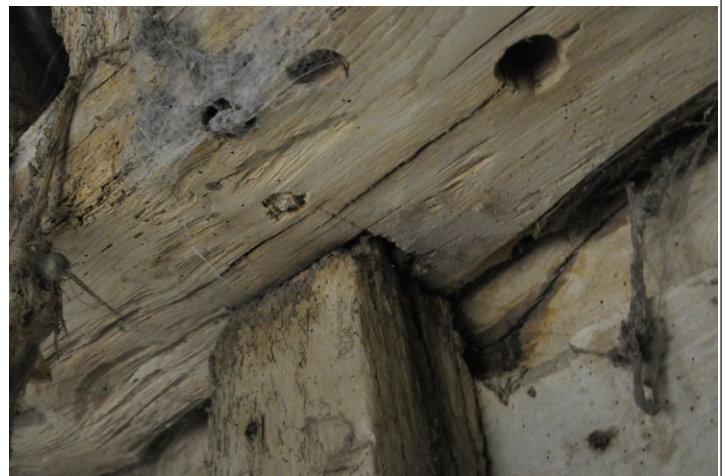
Fig. 21 - Stud mortised to wall plate, east end of rear wall

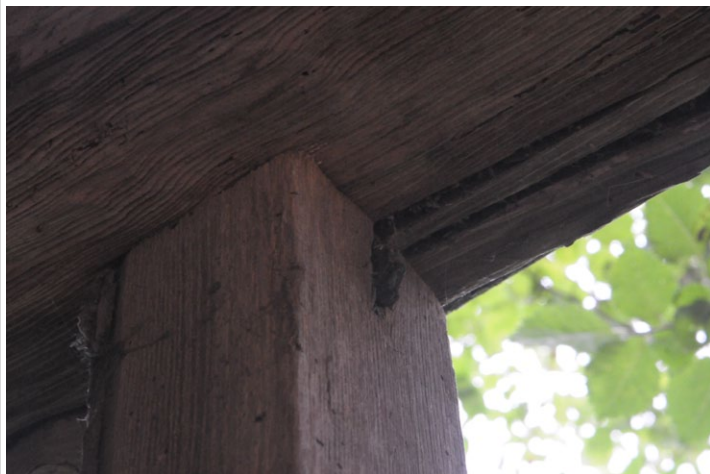
Fig. 22 - Stud mortised and nailed to tiebeam, east gable

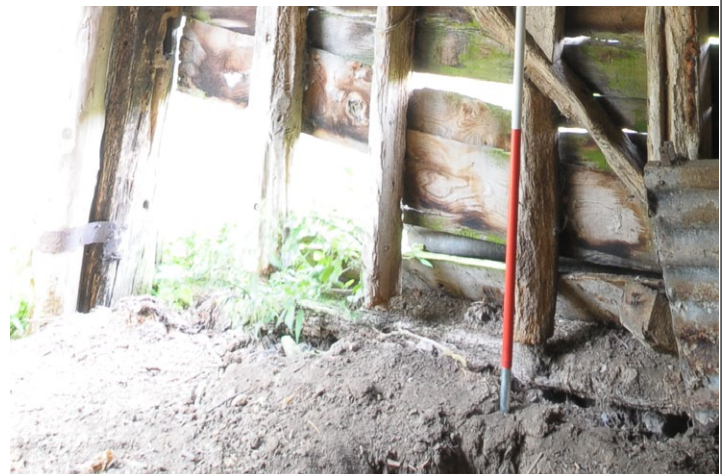
Fig. 23 - Shot of sill beam of west gable

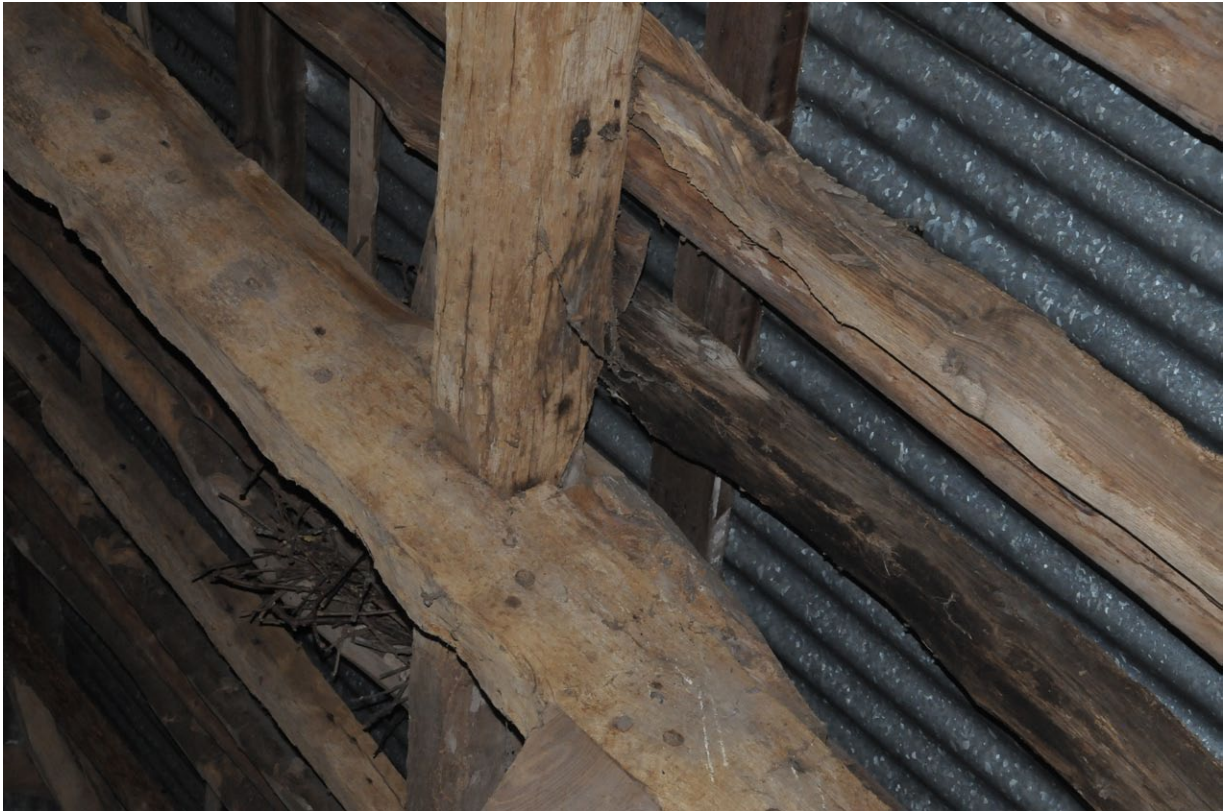
*Fig. 24 - Shot of southern purlin showing trenching*

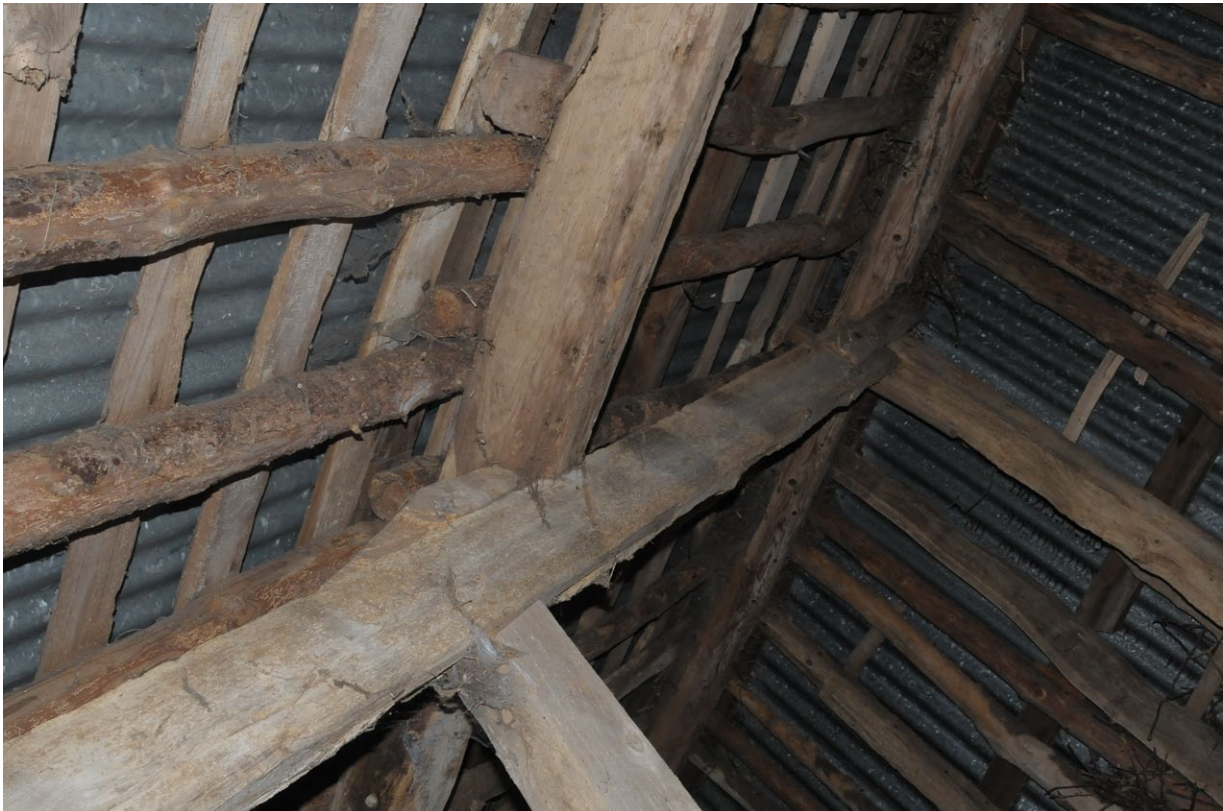
*Fig. 25 - Shot of northern purlin showing chocks*

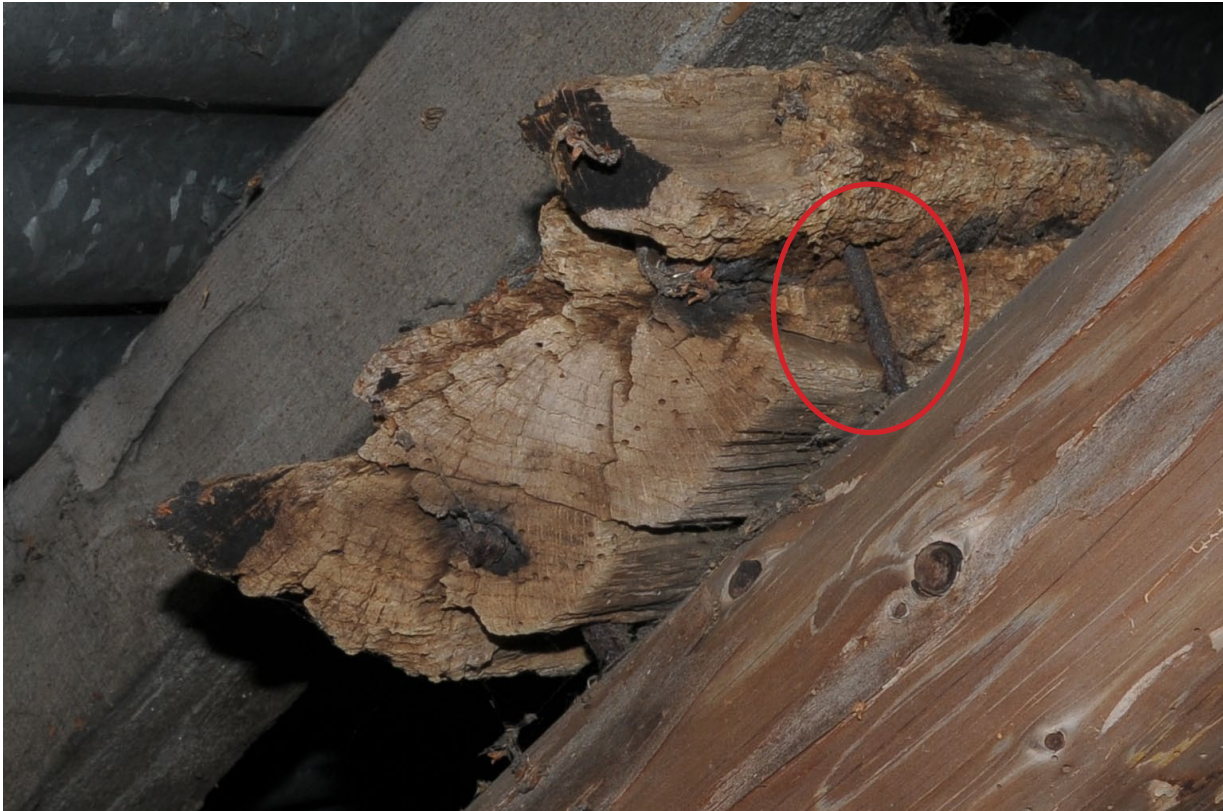
*Fig. 26 - Rafter nailed to the bressumer beam with round nail*

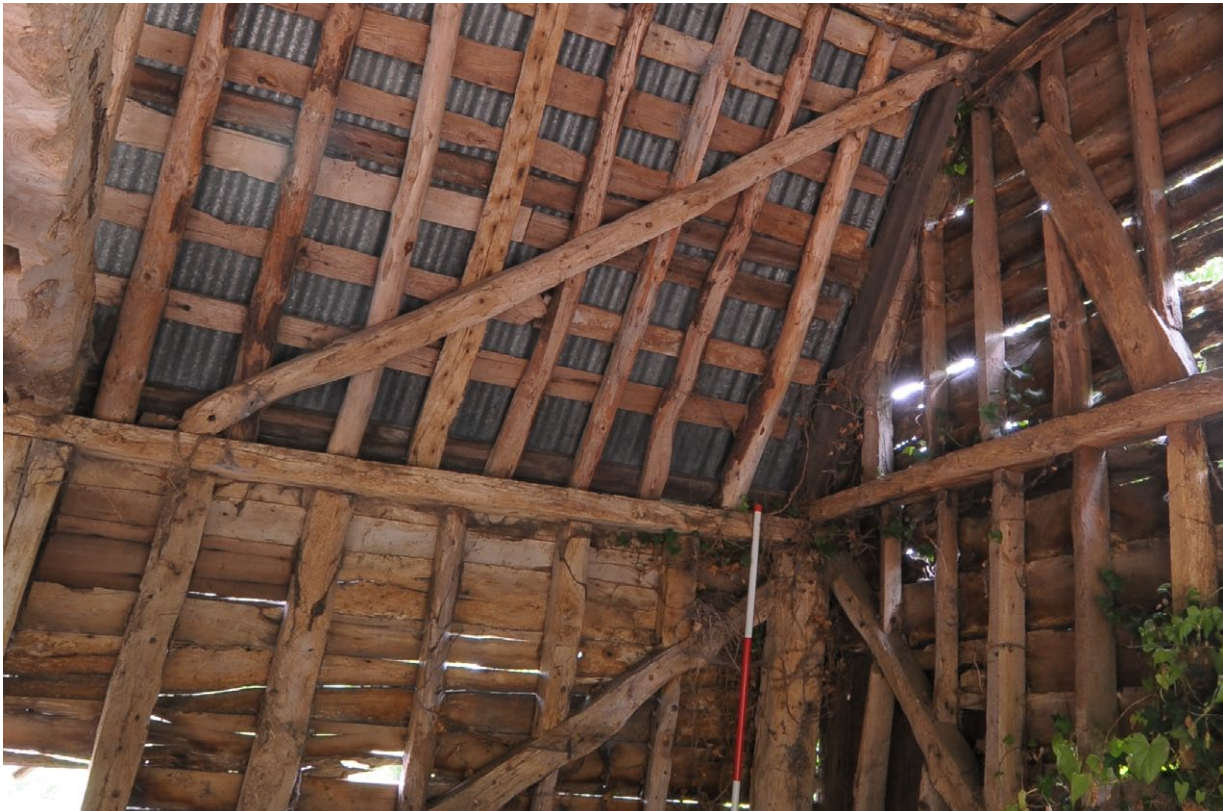
*Fig. 27 - Rafter bracing, east end of northern pitch*

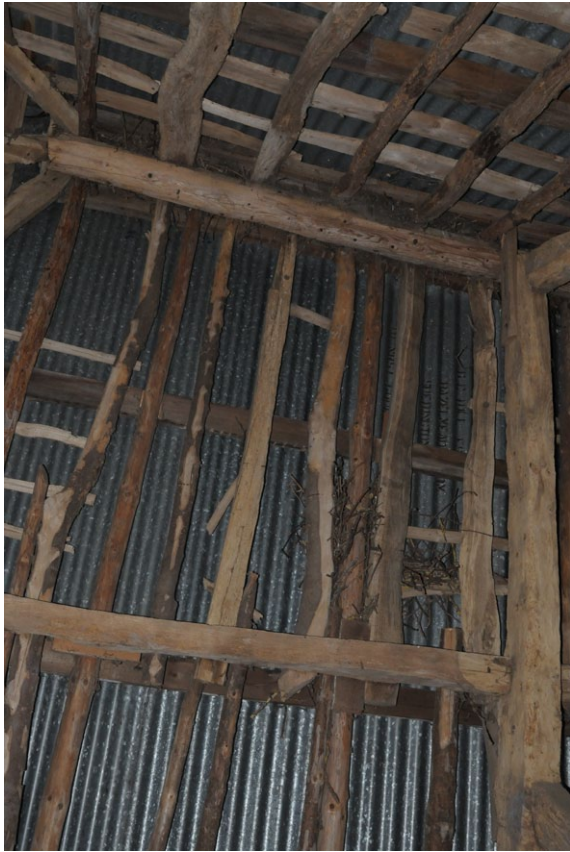
Fig. 28 - General shot of rafters, south pitch

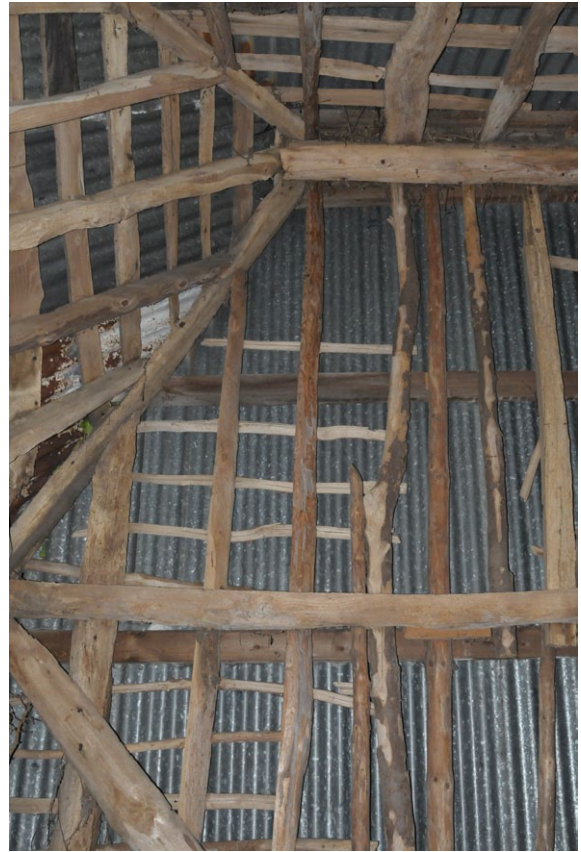
Fig. 29 - Shot of split laths, east end of south pitch

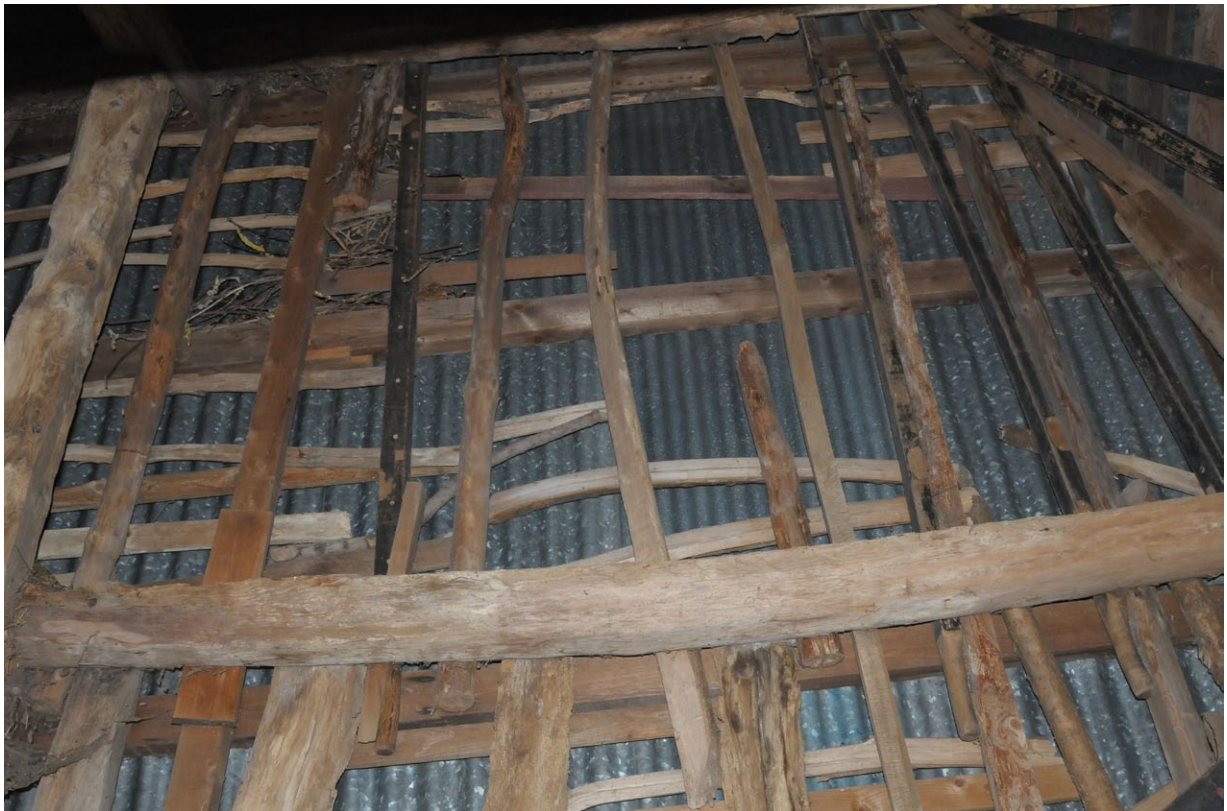
Fig. 30 - Split laths at west end of south pitch

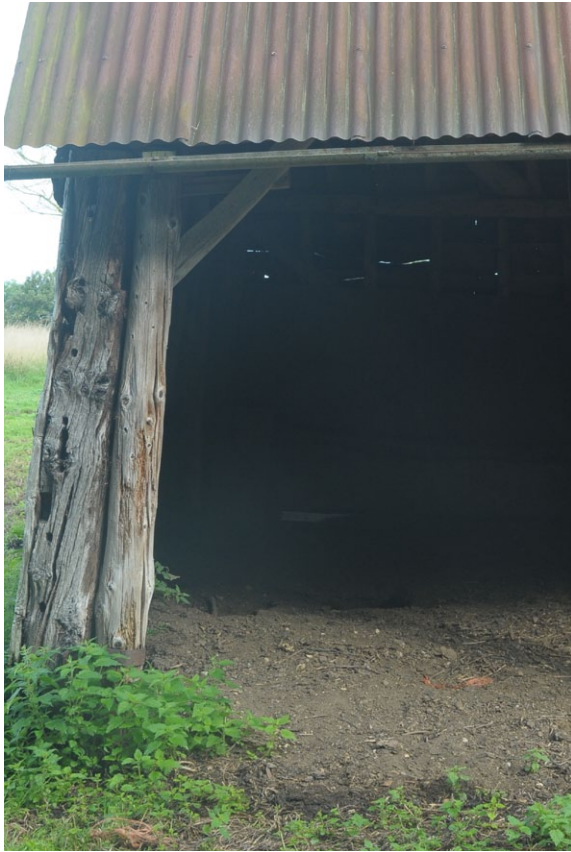
*Fig. 31 - The round pole replacing the original post, south-west corner*

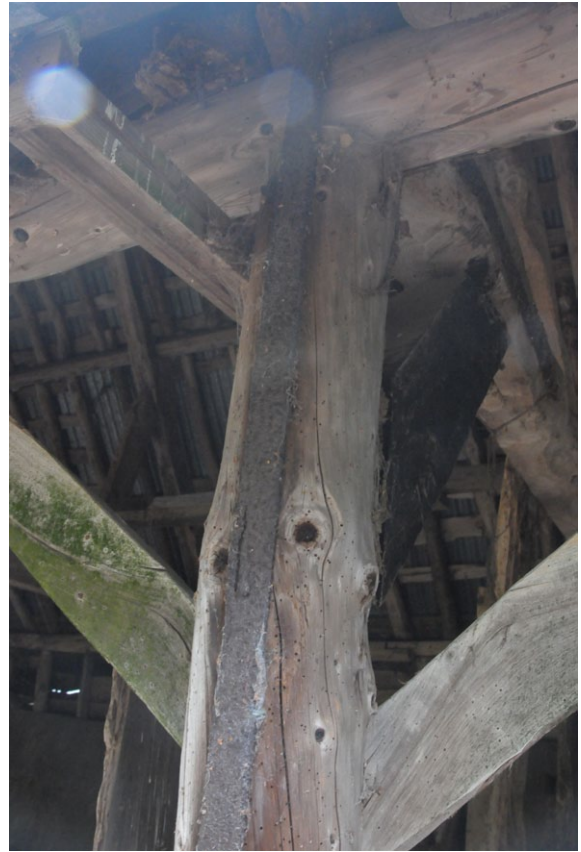
*Fig. 32 - Iron strap joining the post, bressumer beam and tiebeam, east post, front elevation*

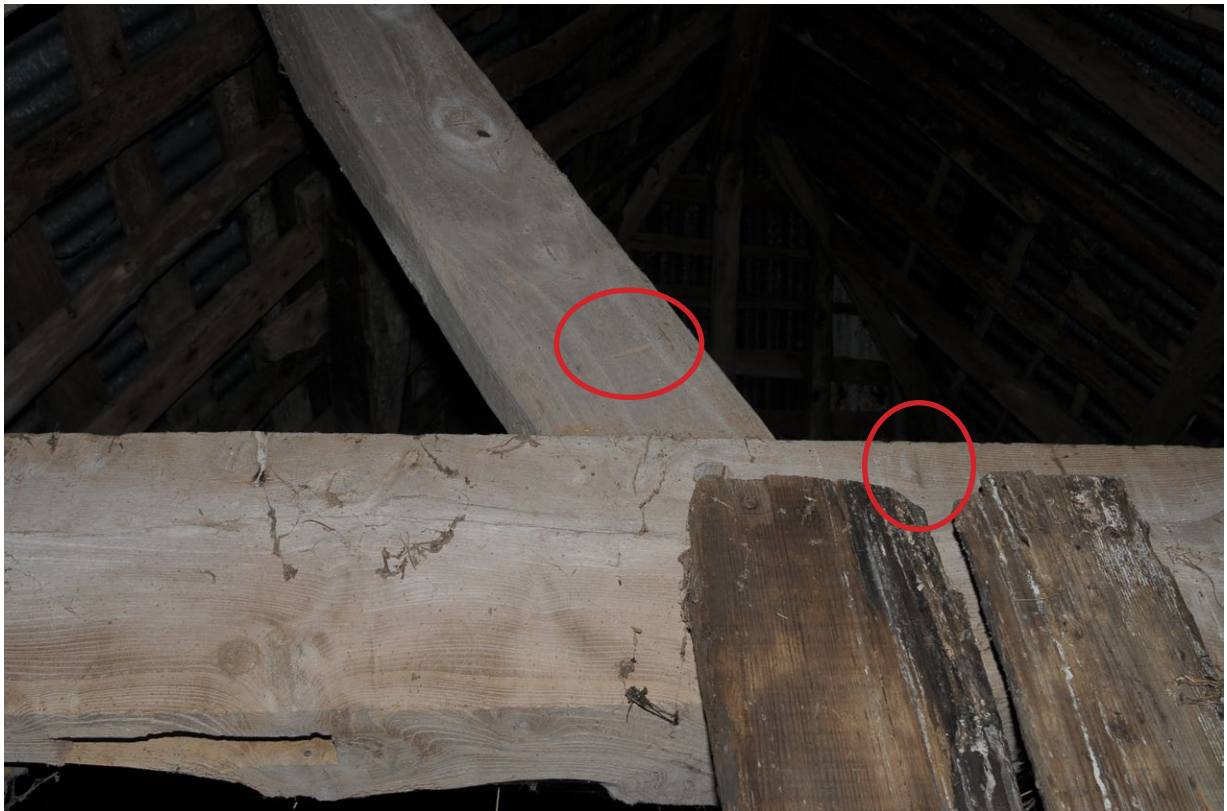
Some structural elements in the barn appear to have been re-used as single units. The central post and two raking struts of east-facing elevation all have mortises in their upper ends which are probably related and it seems likely that the tiebeam, struts and central post were taken together from a previous building. The struts and tiebeam of the eastern truss have corresponding assembly marks 'I' and 'II' and are from similarly finished wood suggesting that this element of the truss was also taken from a previous building without being dismantled (fig. 33).

*Fig. 33 - Assembly marks on eastern truss*
