Castle Inn, Dennis Road, Hugglescote Leicestershire

**Historic Building Recording**

Report No. MK017/15

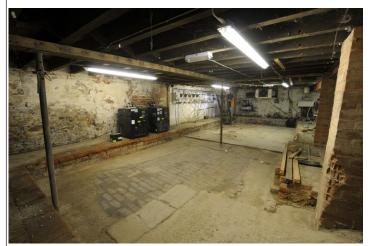
Fig. 9 - The Cellar, Unit 1, looking north-east

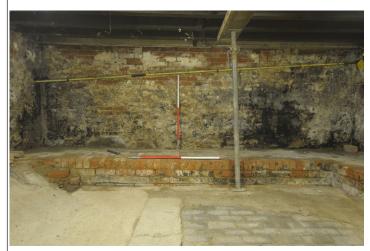
Fig. 11 - West elevation of Cellar, Unit 1, looking west

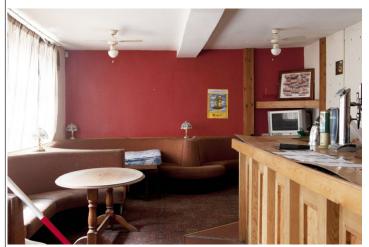
Fig. 13 - Photo of west end of ground floor, Unit 1, looking west

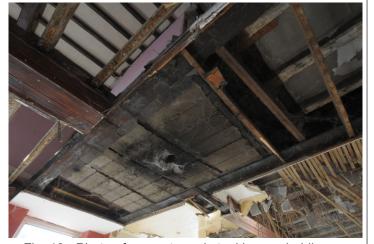
Fig. 18 - Photo of concrete and steel beams holding up chimney above ground floor, Unit 1

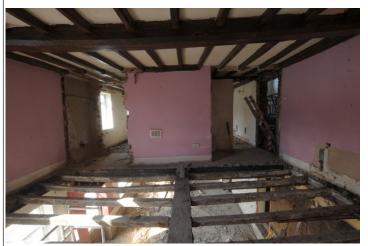
Fig. 21 - Shot of east room, 1st floor, Unit 1, looking west

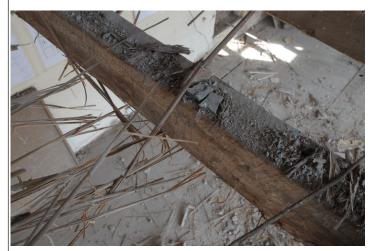
Fig. 23 - Shot of pit sawn floor joist, west room, 1st floor, Unit 1, looking north-east

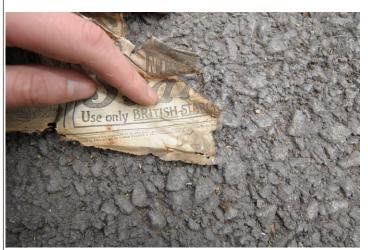
Fig. 27 - Newspaper dated 1897 found stuffed into slot in beam for floor joists of west room, Unit 1

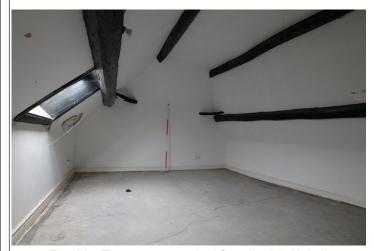
Fig. 29 - The east room, 2nd floor (attic), Unit 1, looking east

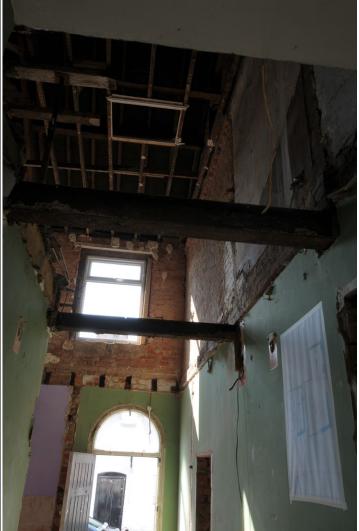
Fig. 37 - Internal view of lower floor of Unit 2 after ceiling removed, looking South

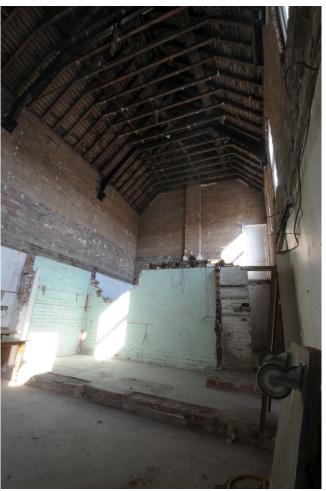
Fig. 43 - Internal view of Unit 4 after ceiling removed, looking south-east

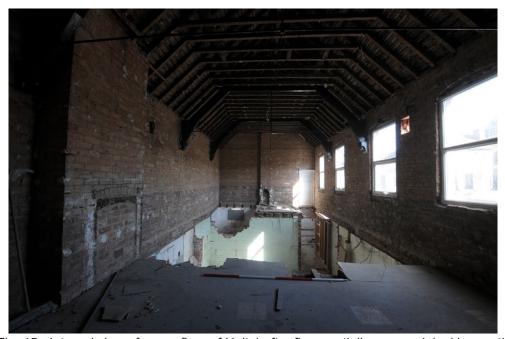
Fig. 45 - Internal view of upper floor of Unit 4 after floor partially removed, looking north

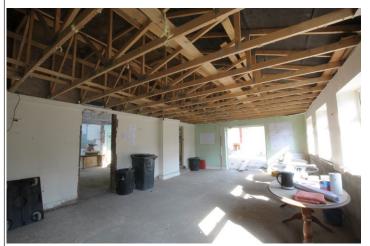
Fig. 48 - Interior of Unit 5, looking north-west
