## **The Brunt Steading, Near Spott, East Lothian Historic Building Survey**

**Report No. 3410**

Author	Michael Cressey HND BA MSc PhD MCifA FSA Scot
Illustrator	Graeme Carruthers MA MCifA
Editor	Bruce Glendinning BSc PG Dip MCifA
Commissioned by	W. N. Thompson & Co.
Date issued	March 2016
Version	1
Planning Ref	16/00114/P
NGR Ref No	NT 68569 73737
Oasis Ref No.	cfaarch1-245888

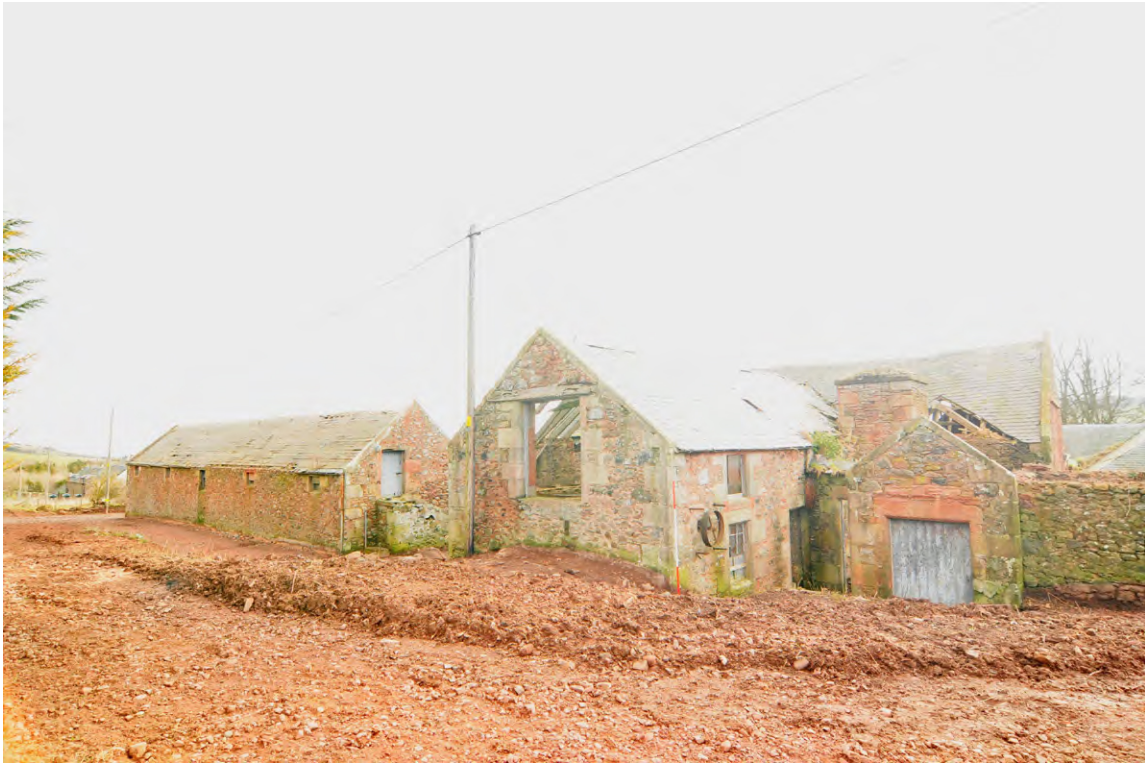
Fig. 6 North Range, general view looking south-east

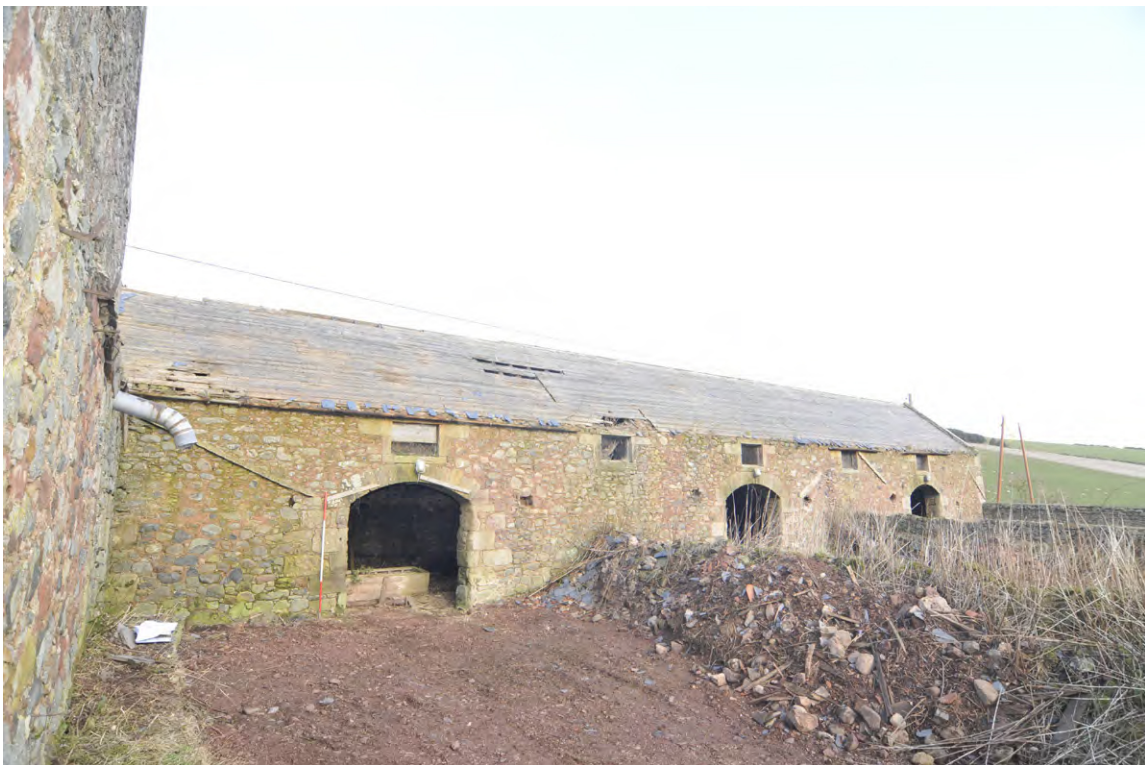
Fig. 7 North Range, south side, looking north-east

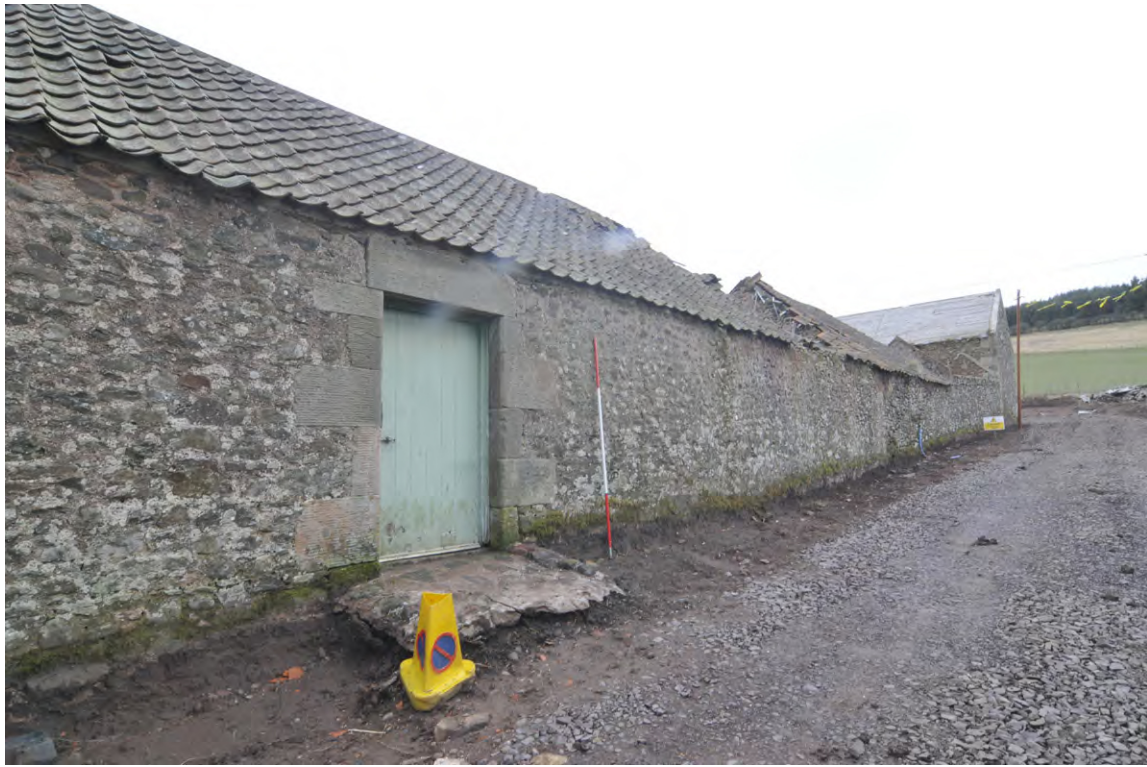
Fig. 8 East Range, east side, looking north

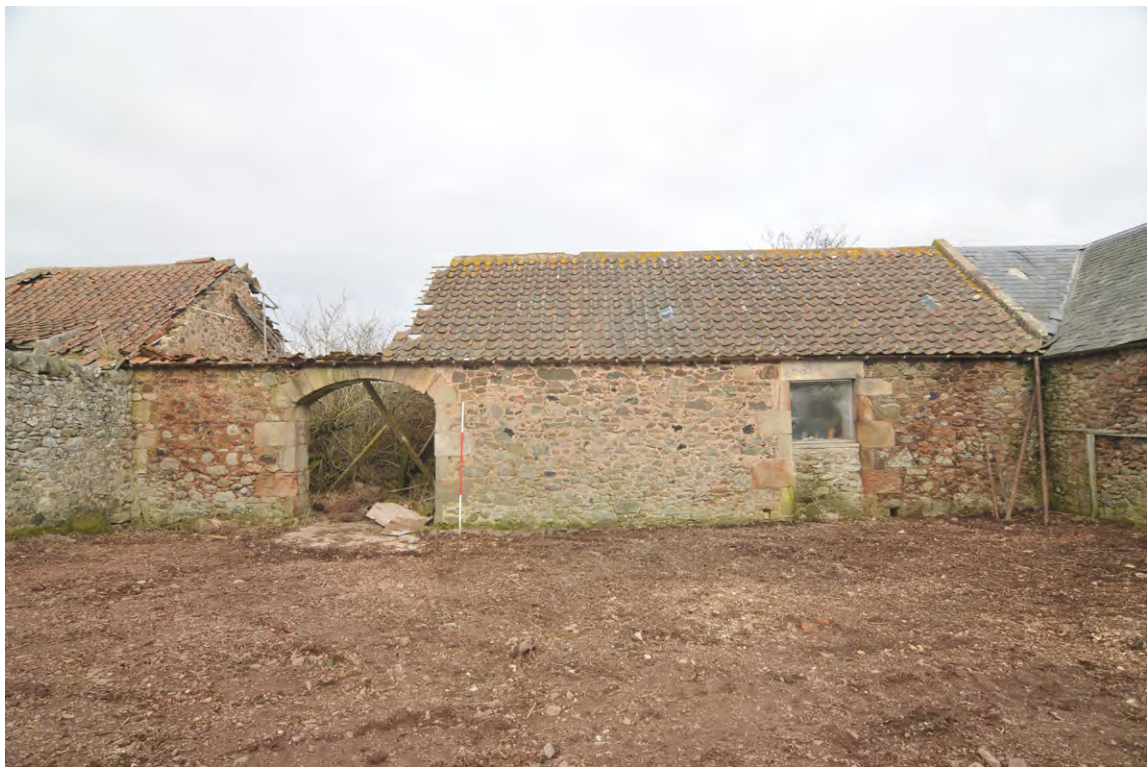
Fig. 9 East Range, west-facing elevation with collapsed byre roof in Unit 11

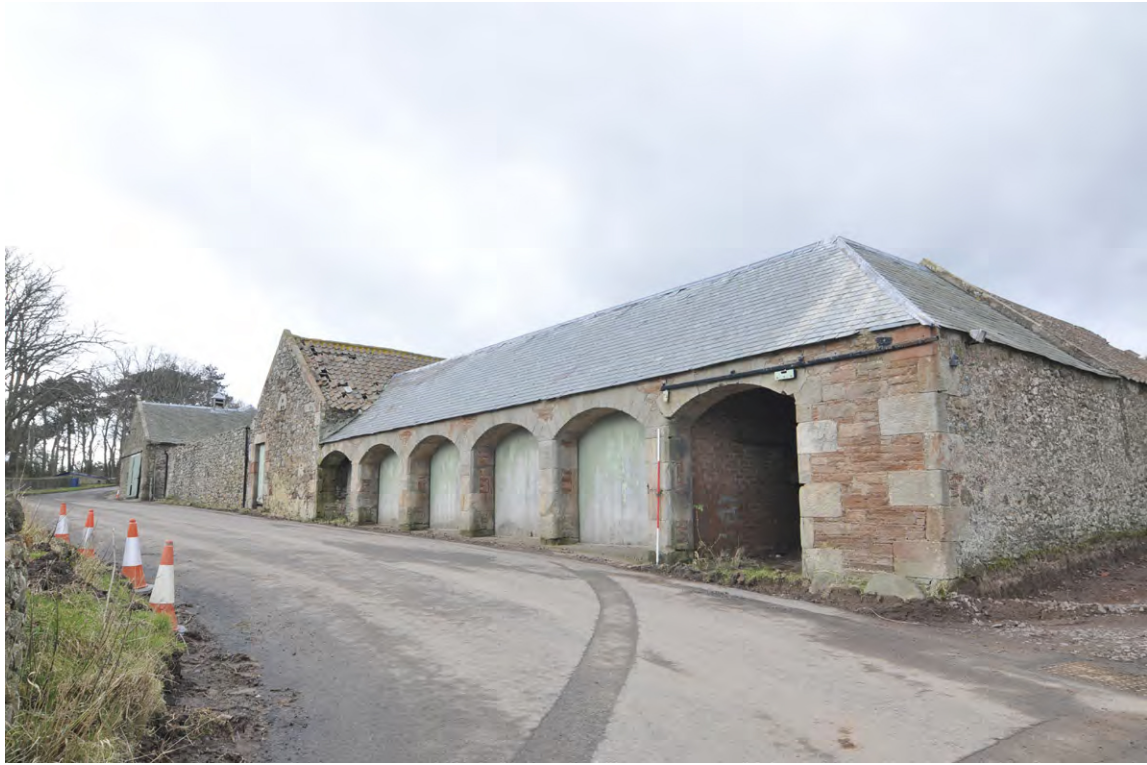
Fig. 10 South Range with cart sheds and central range gable

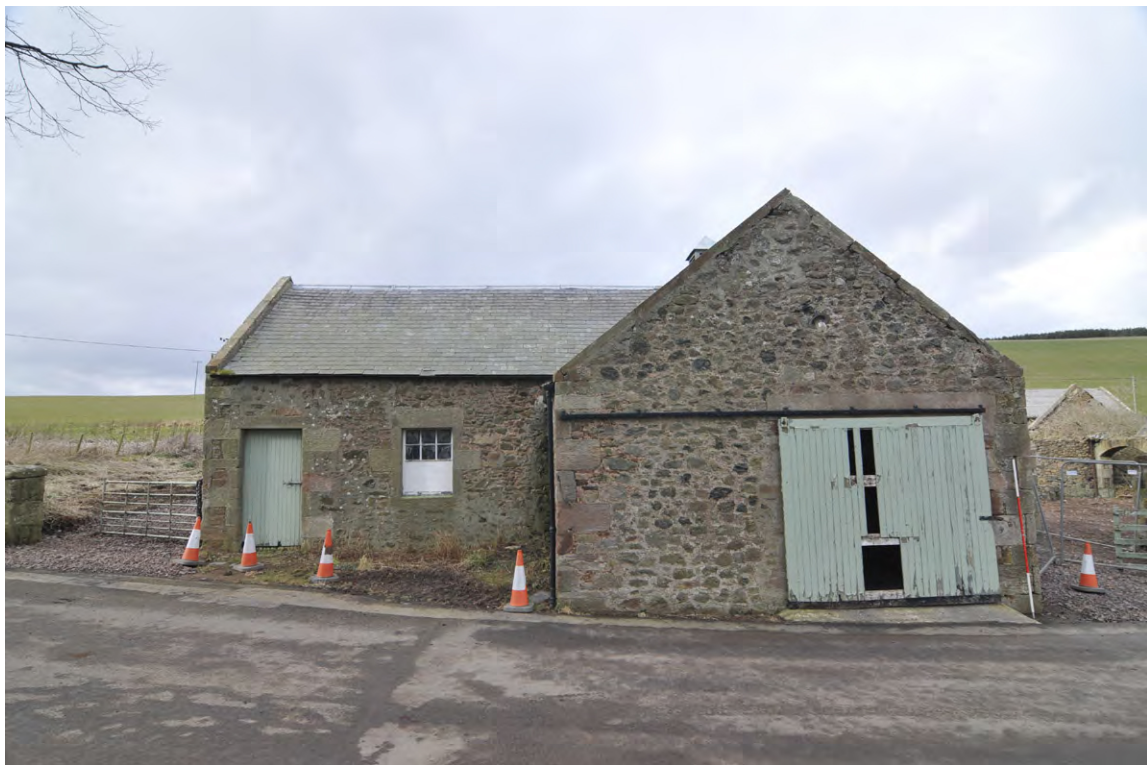
Fig. 11 South Range, west end, the gable of workshop/garage, Unit 31, and workshop, Unit 30

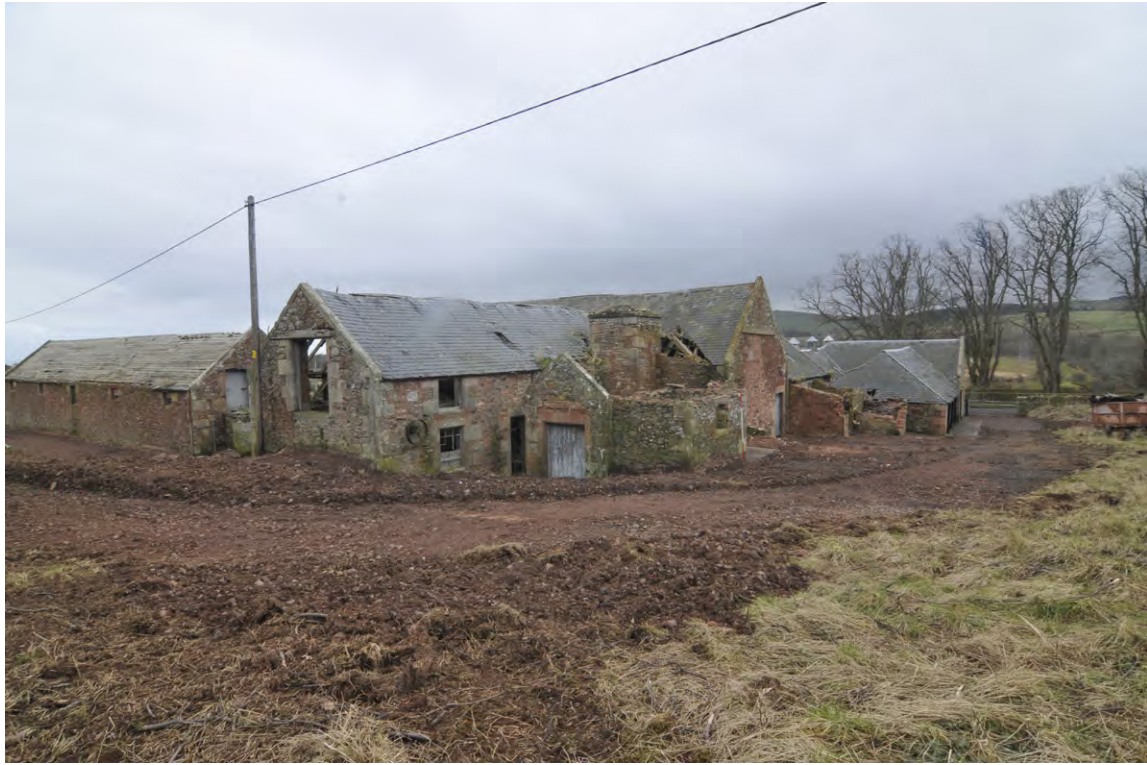
Fig. 12 West Range, general view facing south

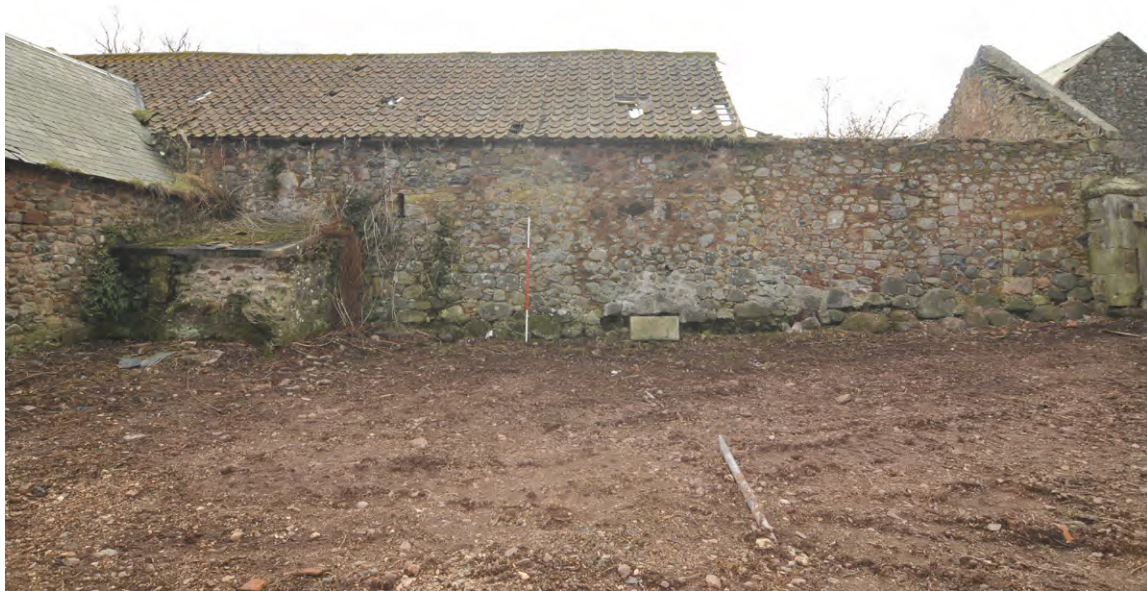
Fig. 13 Central Range, east-facing elevation

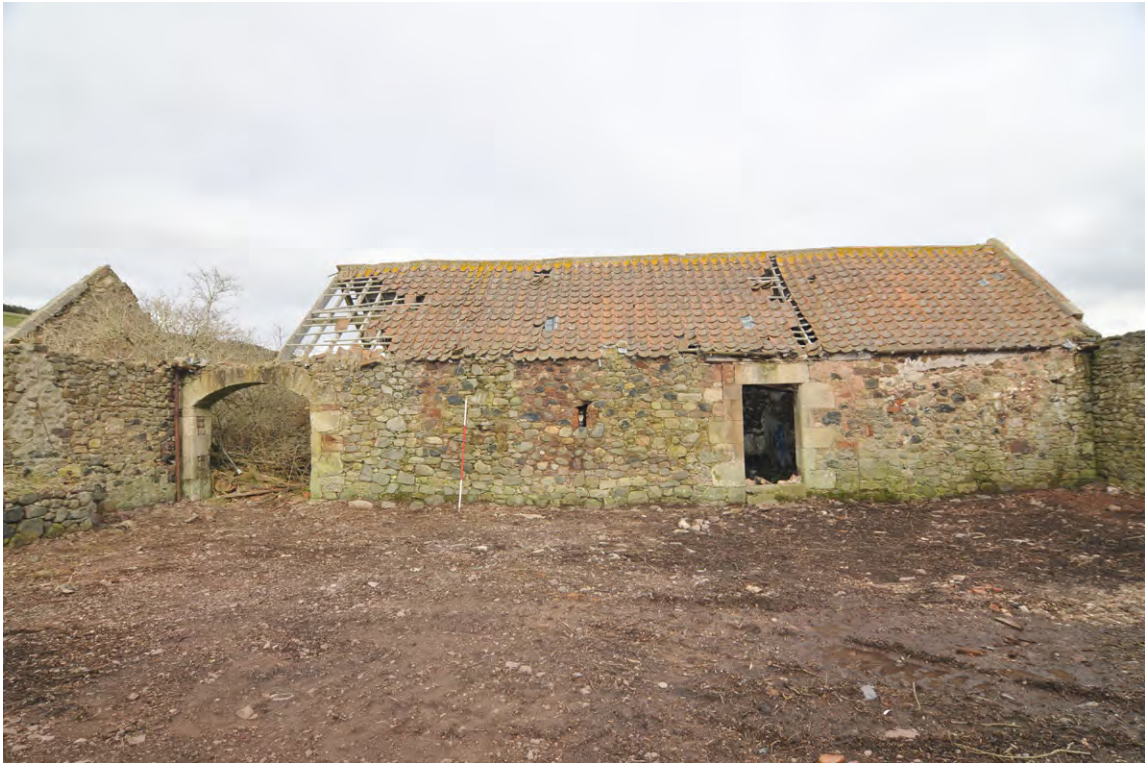
Fig. 14 Central range, west-facing elevation side

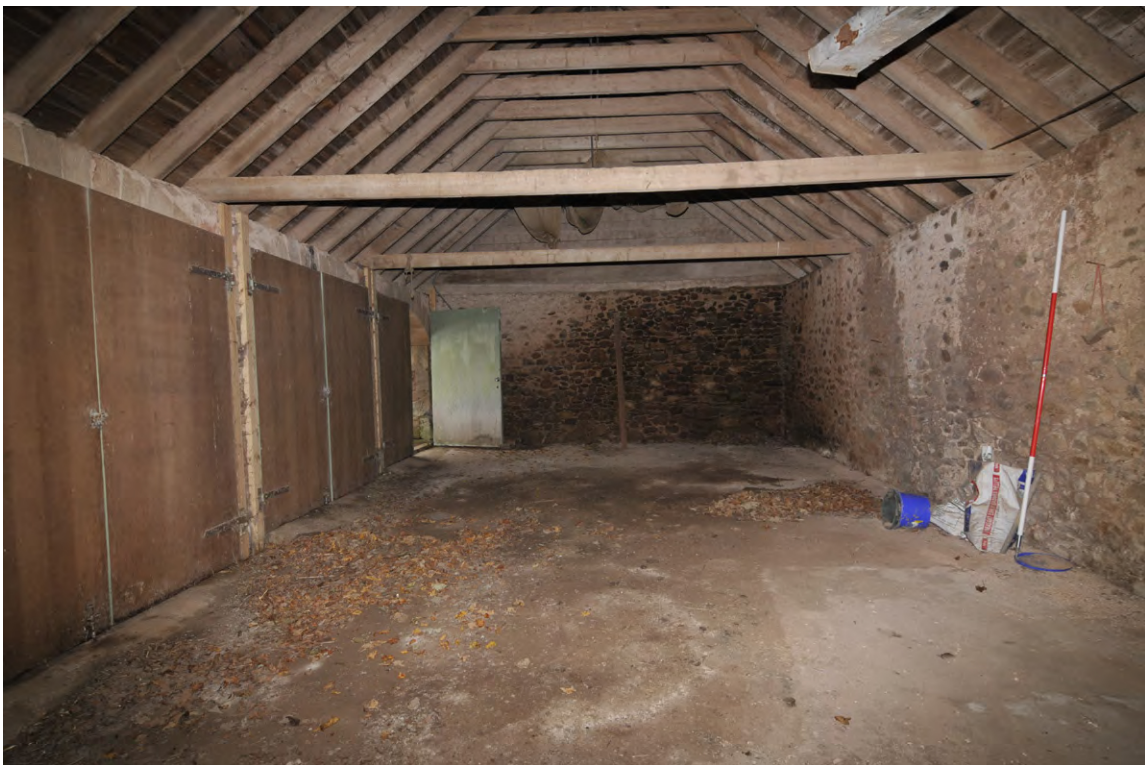
Fig. 15 Cart shed, Unit 2, interior

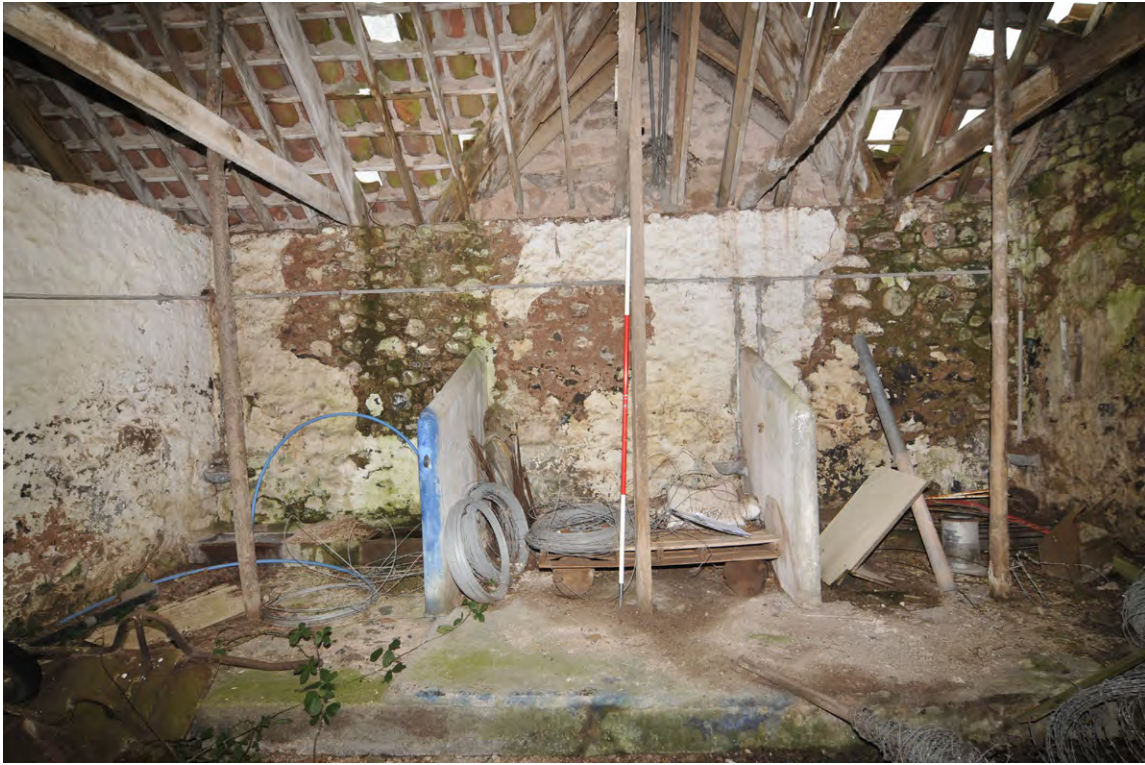
Fig. 16 Animal House, Unit 4, interior cattle stalls

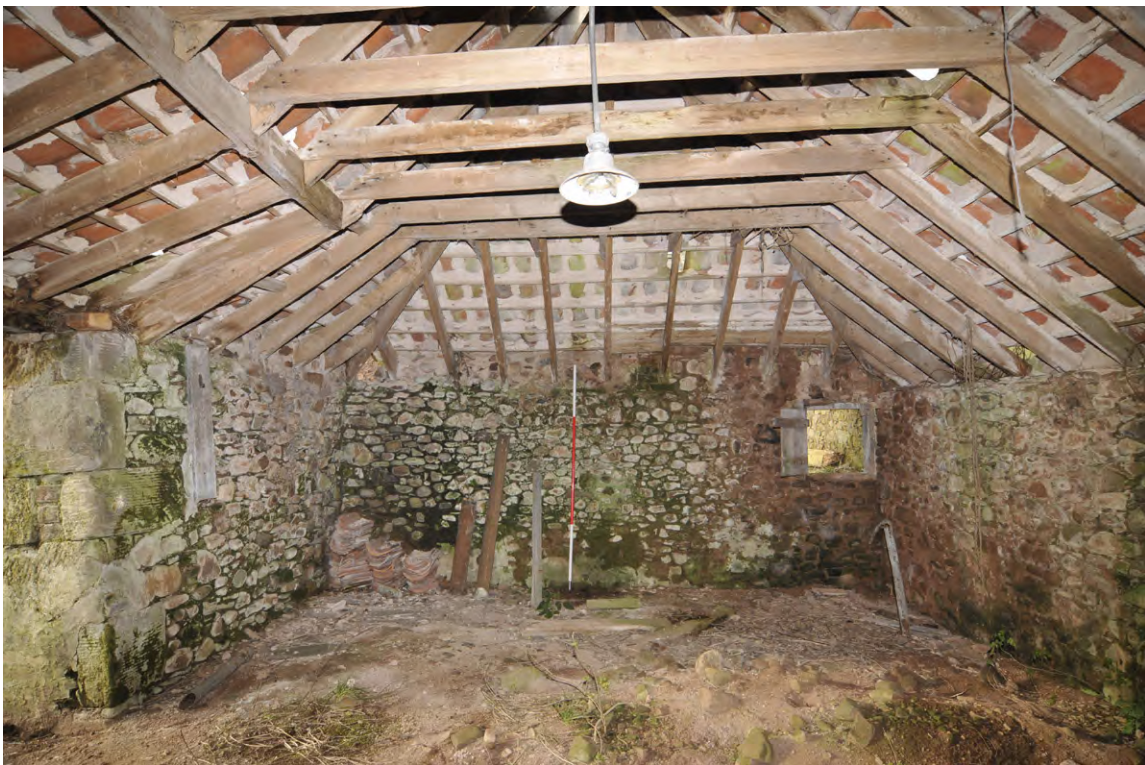
Fig. 17 Feed store with small dispensing hatch

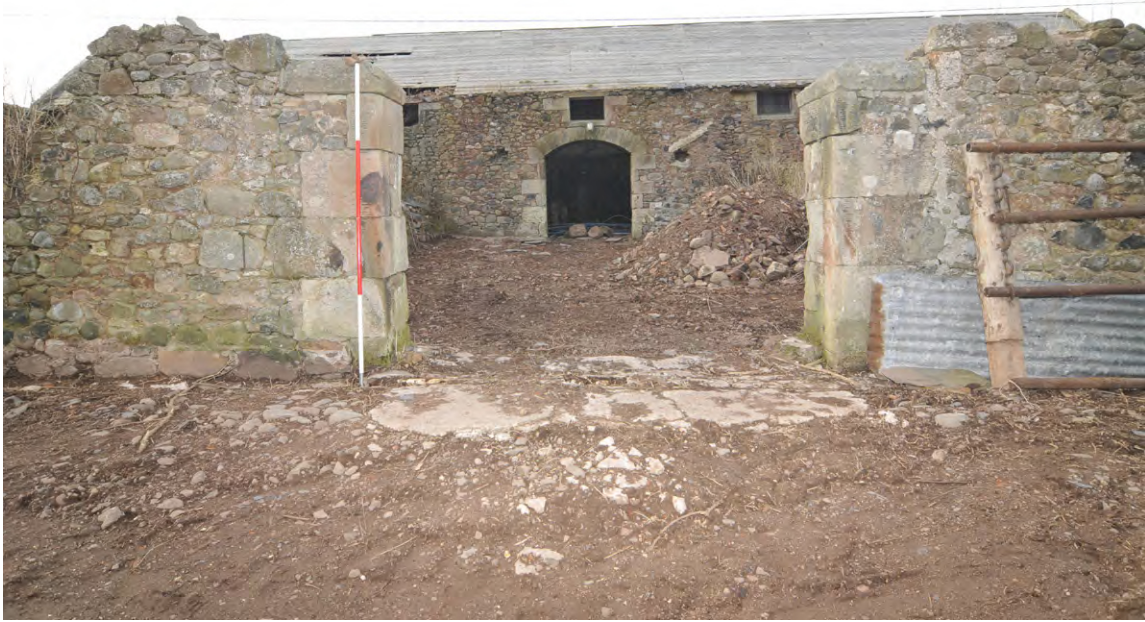
Fig. 18 Entrance to the cattle court, Unit 15

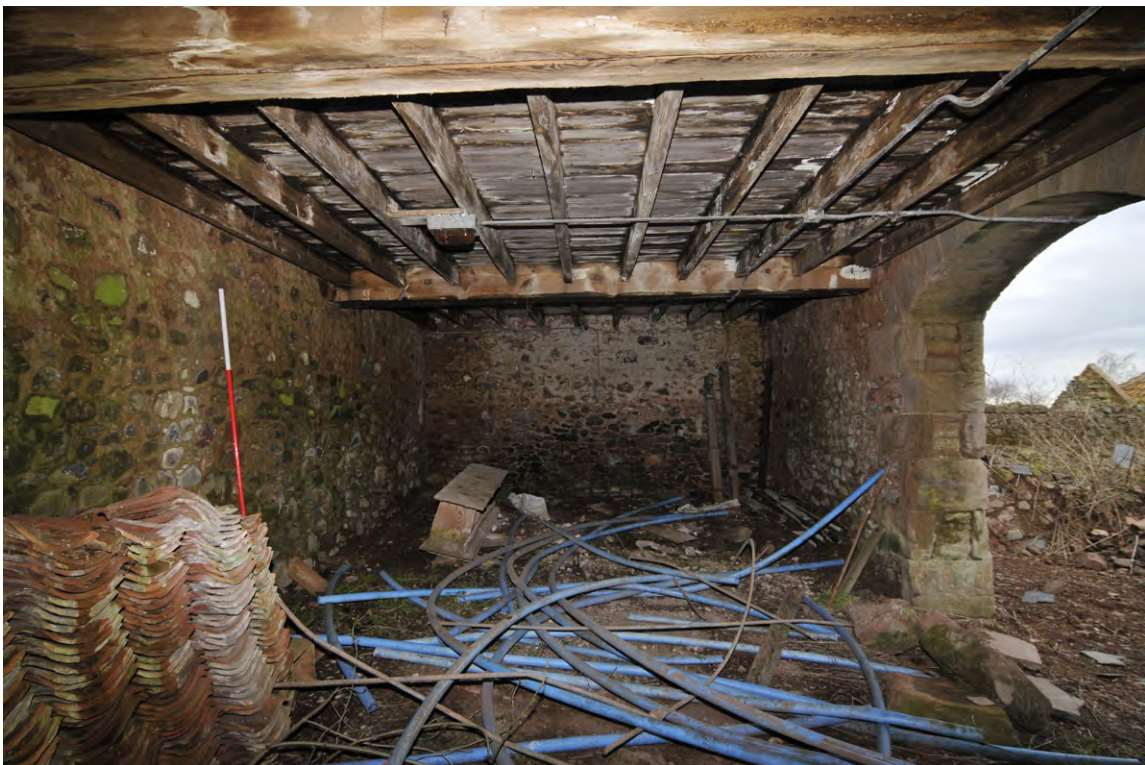
The north wall of all three byres was built of random rubble and featureless. Each wall carried the beams for the loft floor. The loft was unsafe to enter into.

Fig. 19 Interior of the byre, Unit 19

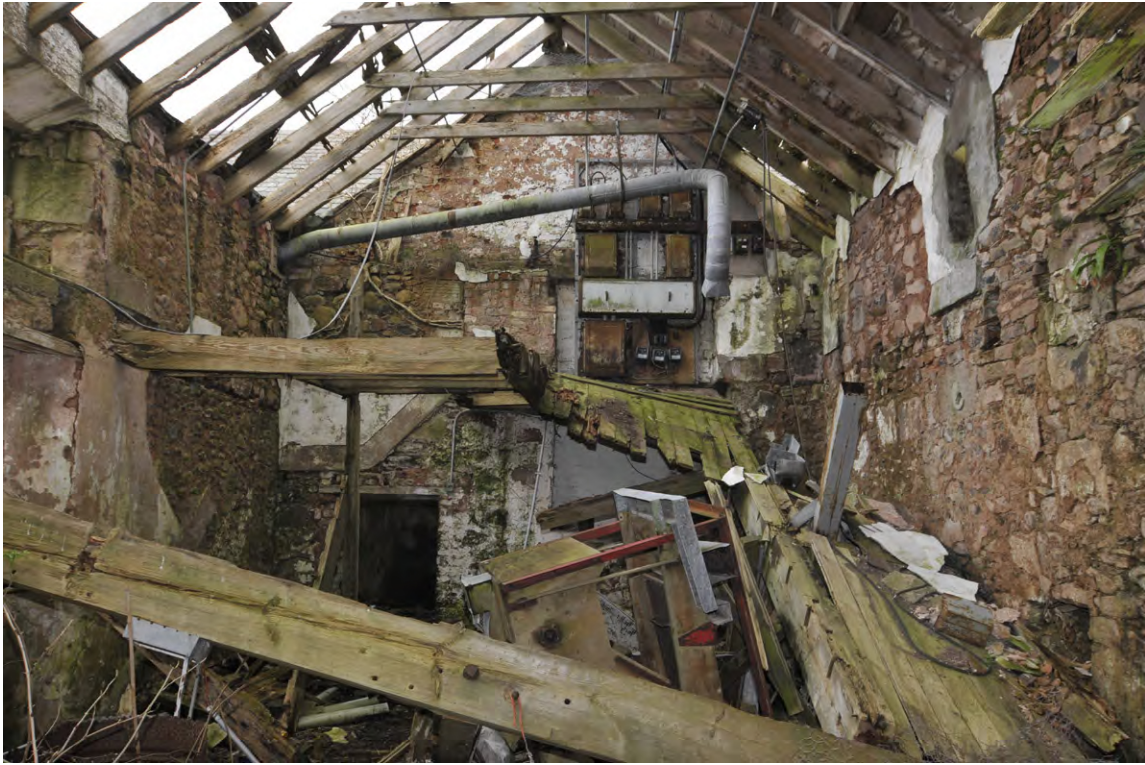
Fig. 20 Interior of the granary, Unit 20, with collapsed loft floor, a blocked fireplace can be seen to the left of the electrical switch gear

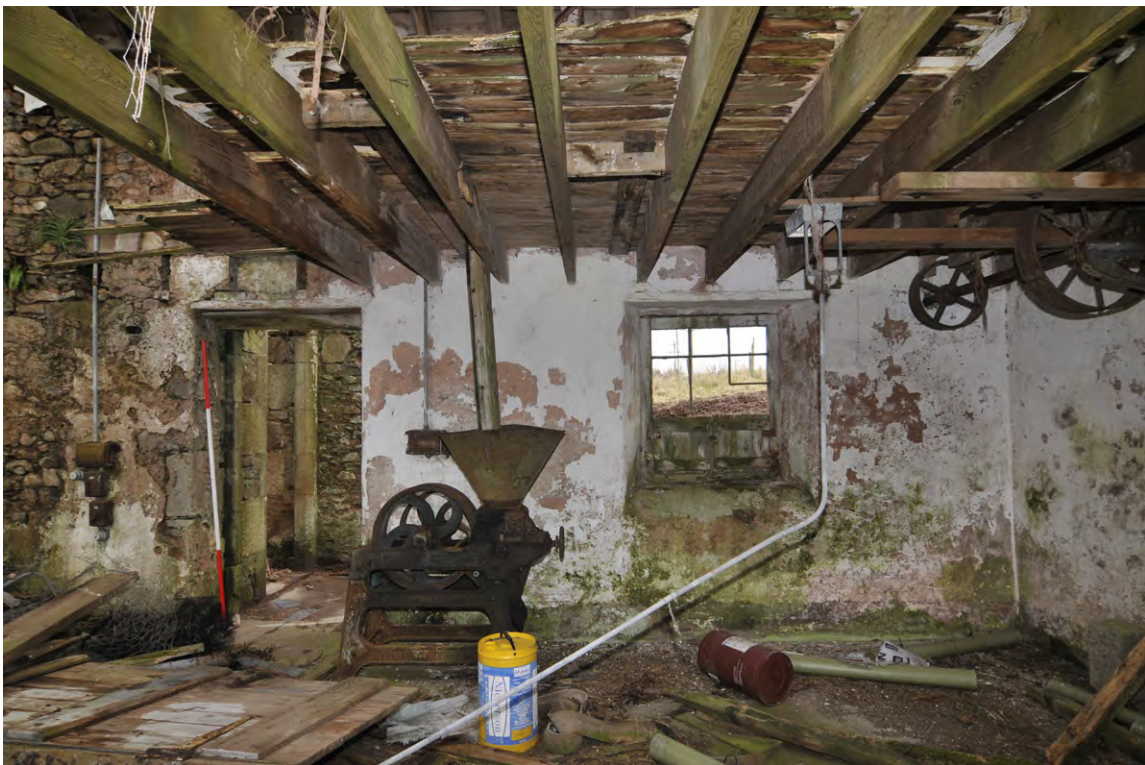
Fig. 21 Interior view of the granary with rear door and window. A belt driven oat crusher and belt drives can be seen

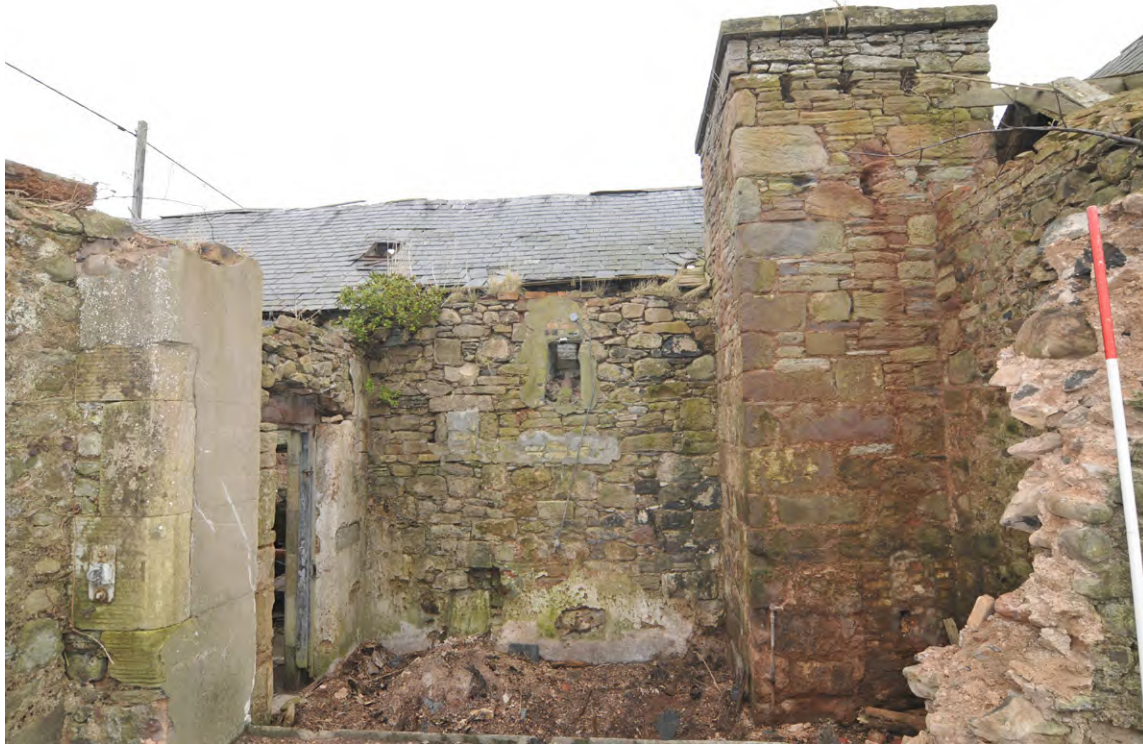
Fig. 22 Boiler house chimney in Unit 21

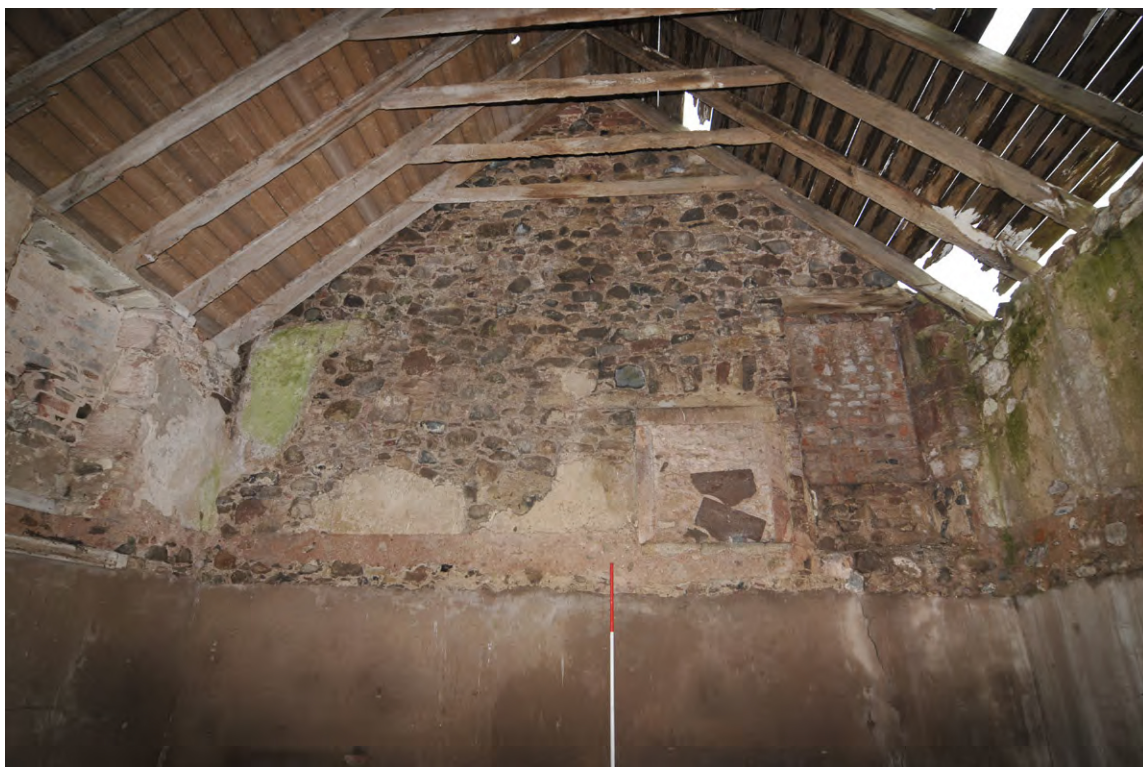
Fig. 23 Interior of the barn, Unit 23, with a blocked fireplace and window on the gable wall

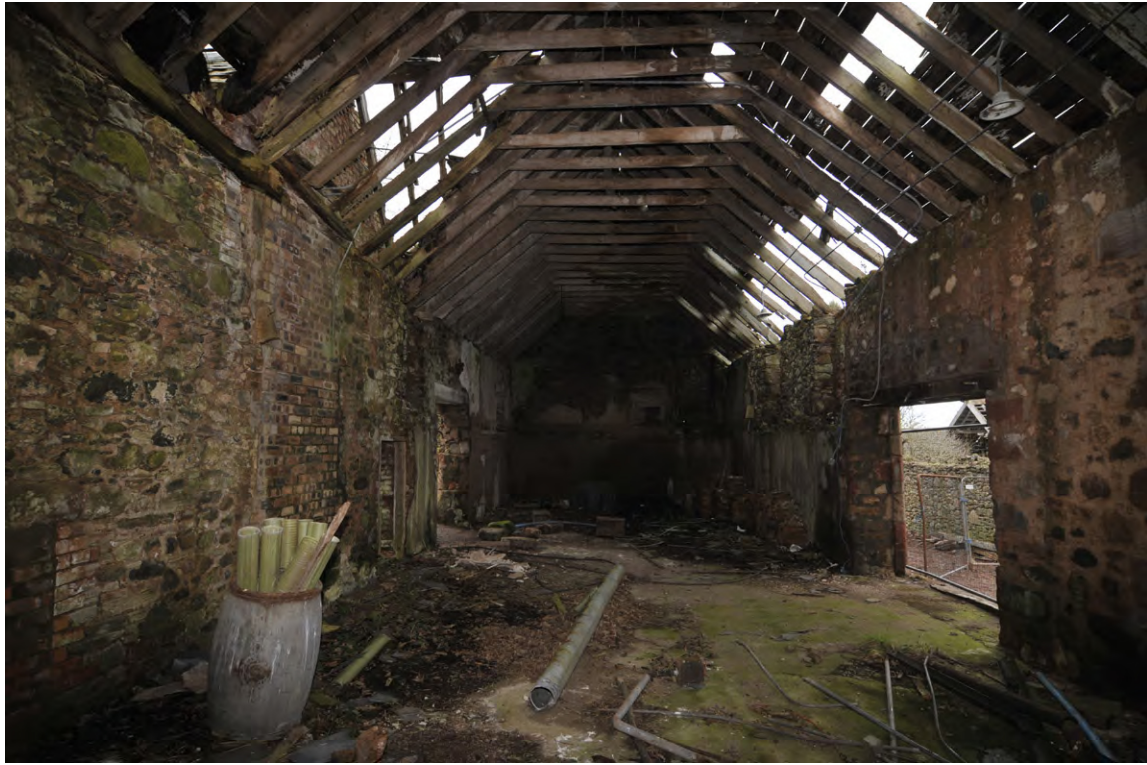
The north wall of the Barn was constructed of random rubble. In places there was also evidence of brick repairs. Towards the mid-section the brick-built pitched gable wall of the granary (Unit 20) was visible. A large panel of later brickwork was visible extending from the wall head to just above the ground floor. Immediately to the right of the brickwork was a timber-framed doorway leading into the granary. Above the door on the right, there appeared to be the remains of a partition wall marked by a risband joint. This probably marks position of the former west gable of the earlier farmhouse.

Fig. 24 General shot of the interior of the former lofted barn looking west, Unit 23

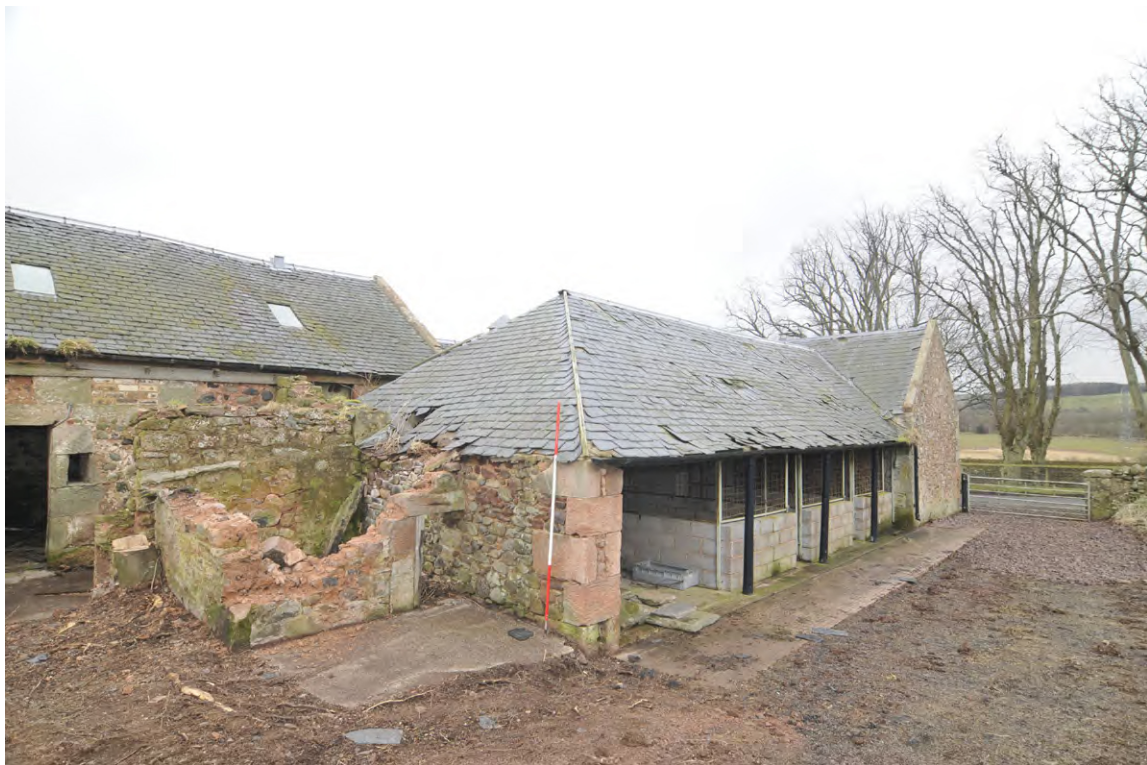
Fig. 25 Open sided shed/kennels with cast-iron columns, Unit 27

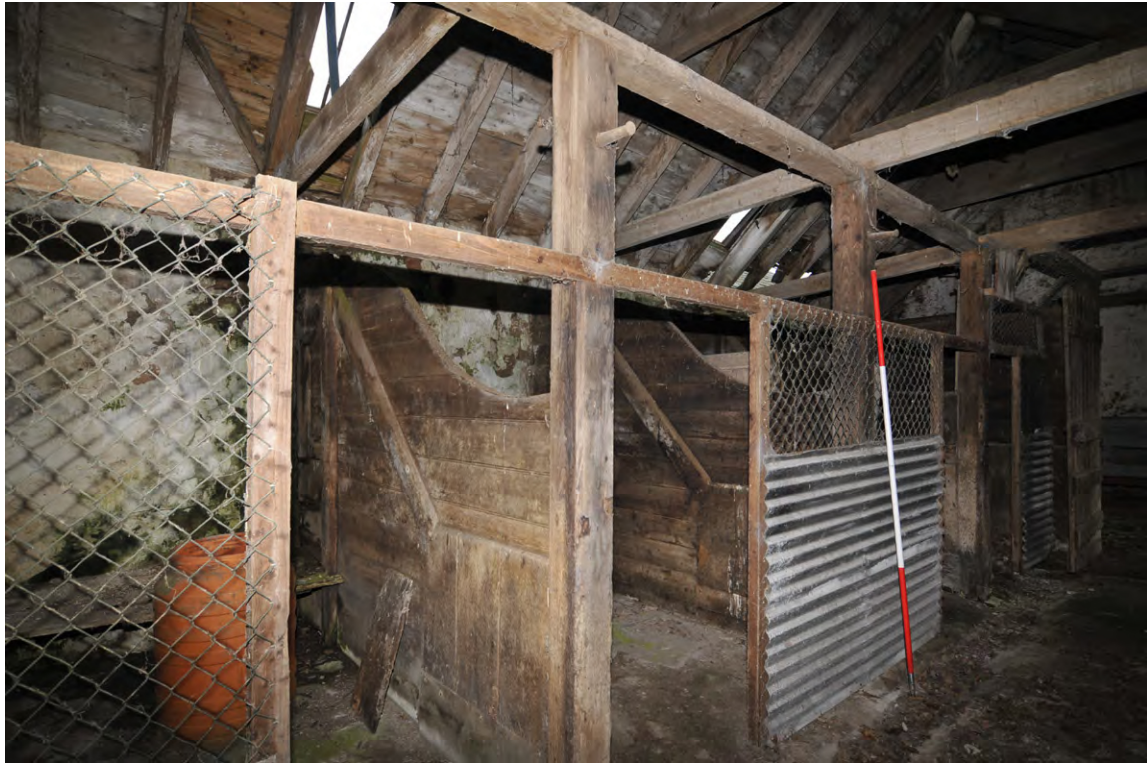
The east wall was whitewashed rubble and partly hidden by three timber-framed loose boxes covered with galvanised corrugated iron sheets and wire mesh. The newal posts for the stalls were fixed to the common rafters.

Fig. 26 Loose boxes within the stable
