**85-87 South Bridge,
Edinburgh
Archaeological Building Survey**

Report No 3374

Author	Michael Cressey, BA MSc PhD MCifA FSA Scot
Illustrator	Shelly Werner BA MPhil PhD MCifA
Editor	Bruce Glendinning BSc PG Dip MCifA
Commissioned by	Mr Joe Crolla
Date issued	January 2016
Version	1
Grid Ref	NT 25958 73496

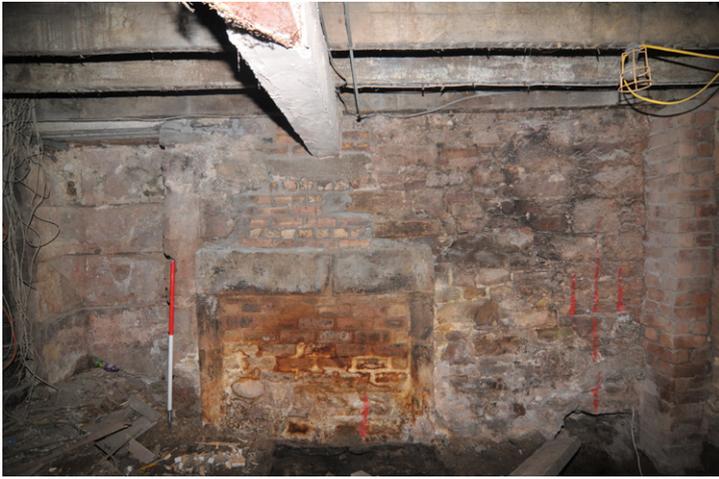
The north wall was stone-built with a press situated in the north-west corner of the room measuring 1.4m high, 0.9m wide and 0.5m deep. Three shelf scars were visible within its interior (Fig. 3). A fireplace measured 1.56m x 1.53m and was advanced off the wall by 0.1m. The fireplace had a broken lintel and molded surrounds. Its interior had been blocked with coursed rubble and brickwork (Fig. 3). A large modern I-beam had been inserted into the chimney breast.

Fig. 3 - Room 1/1, press and blocked fireplace on the south-facing elevation

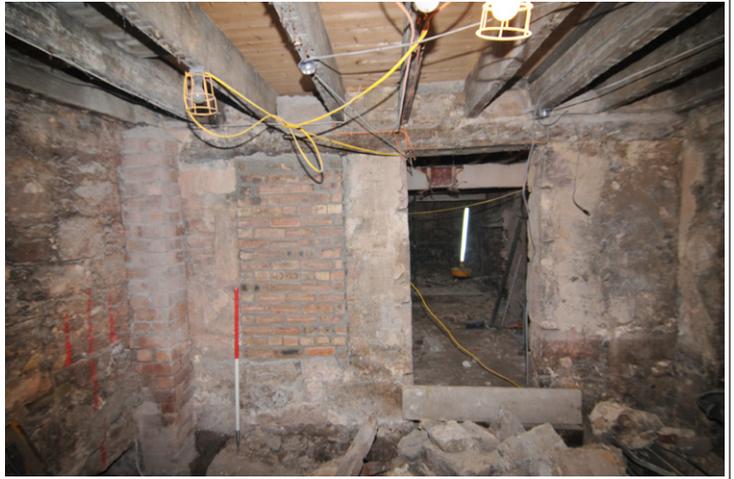
The east wall was rubble-built with a large timber wall-plate on the wall head (Fig. 4). Situated at the centre of the wall was a large doorway leading into Room 1/2. The doorway measured 1.8m by 1m. On the north-side of the door was a blocked rectangular window opening in-filled with brickwork. The position of a window is intriguing as it can only have allowed a minimal amount of light into Room 1/2. The wall on the south side of the doorway contained remnants of wall plaster. The softwood (pine) floor joists above the wall appeared to have once held a lath and plaster ceiling.

Fig. 4 - Room 1/1, blocked window and entrance to Room 1/2 in the west-facing elevation

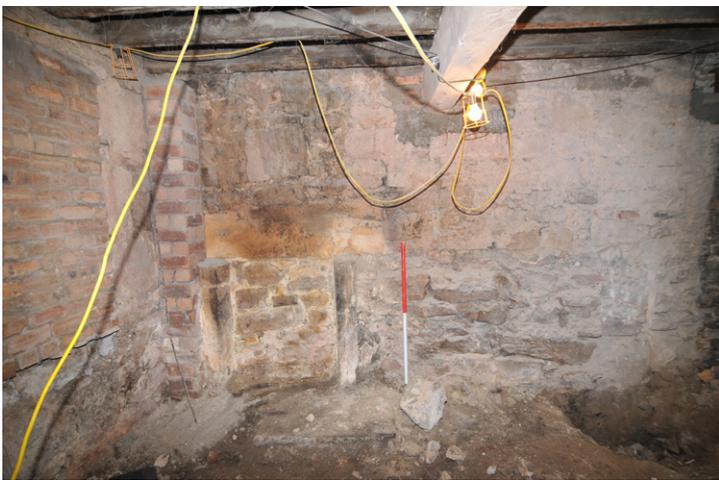
The north wall was constructed of coursed rough-dressed sandstone. A fireplace was situated at the west-end of the elevation (Fig. 5). The fireplace measured c. 1.4m high and 1m wide and had a large rectangular rear lintel above its stone fire surrounds. The surrounds were advanced by c.0.1m and the main front lintel was missing. The fireplace was blocked with coursed rubble. Within the north-west corner of the room between the fireplace and the west wall was a modern brick-built buttress. The rest of the north wall was featureless with the exception of modern I-beams that had been inserted to carry the weight of the floor above. The position of an earlier now demolished partition wall was visible as a wall scar and this wall once formed a sub-division within Room 1/2.

Fig. 5 - Room 1/2, blocked fireplace on the south-facing elevation

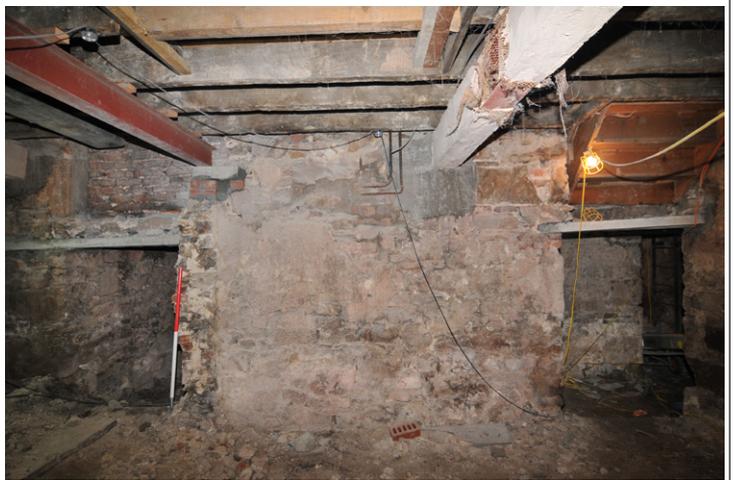
The south wall had two doorways leading into the passage (Room 1/4) (Fig. 6). On the immediate right-hand side of the eastern doorway was the return stub of the aforementioned partition wall. The wall had been impacted on by the insertion of modern I-beams and concrete lintels inserted above the doorways. As with Room 1/2 the floor joists at ceiling level showed evidence for having been covered with lath and plaster.

Fig. 6 - Room 1/2, doorways on the north-facing elevation leading to Room 1/4, the passage

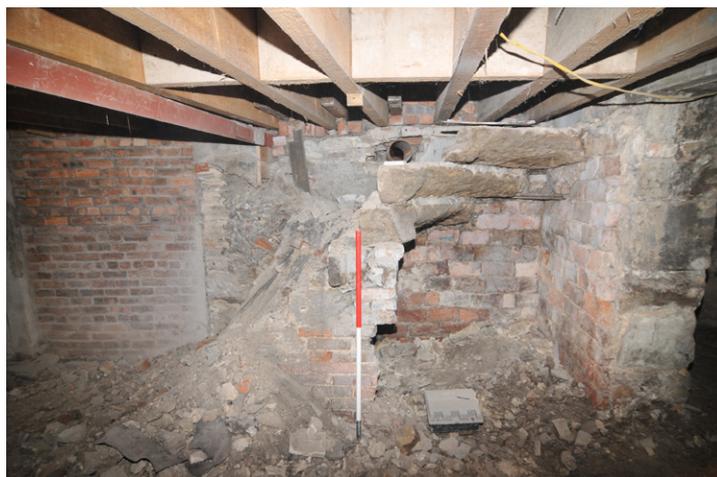
On the north side of the former partition wall a stone built staircase (Fig. 7) had seven stone treads still in situ. These had been built into the stone and brick-faced north-west corner of the room. The bottom of the stairs was hidden behind a heap of rubble but the underside of the stairs showed that each tread was roughly dressed (Fig. 8).

Fig. 7 - Room 1/3, the remains of the staircase on the east-facing elevation

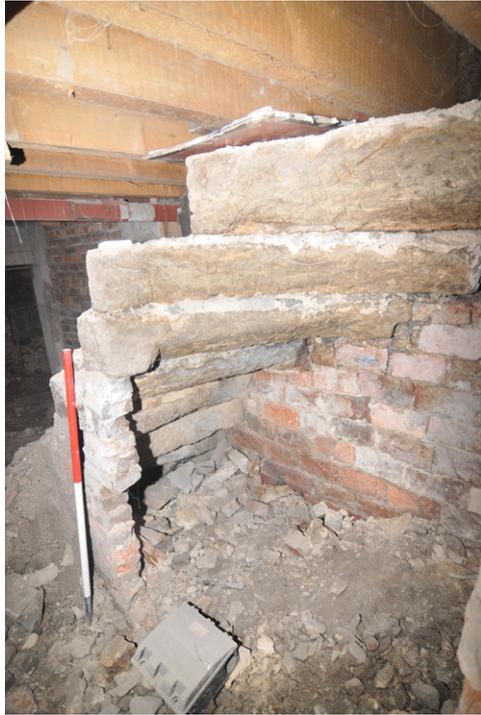
Fig. 8 - Room 1/3, detail of the underside of the stair treads

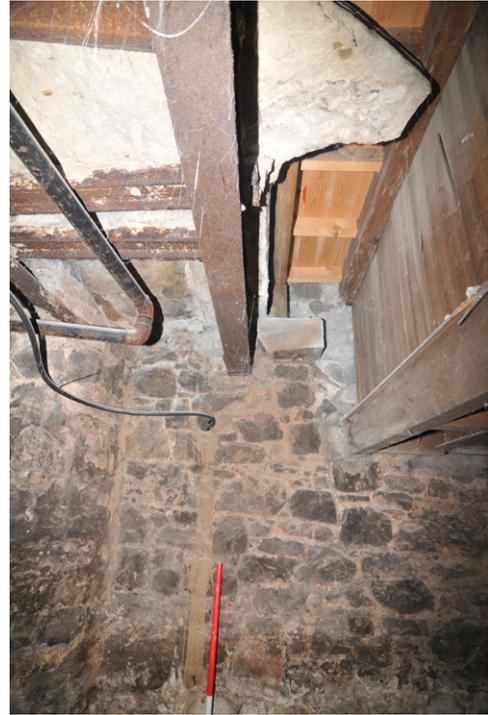
The north wall was rubble-built. Situated near the wall head between a modern I beam and the timber work associated with the floor above was a truncated stair tread (Fig 9). This strongly suggests that the staircase that had previously been identified in this room (Cressey 2105) rose in an anticlockwise direction.

Fig. 9 - Room 1/4, the remains of a stair tread on the south-facing elevation

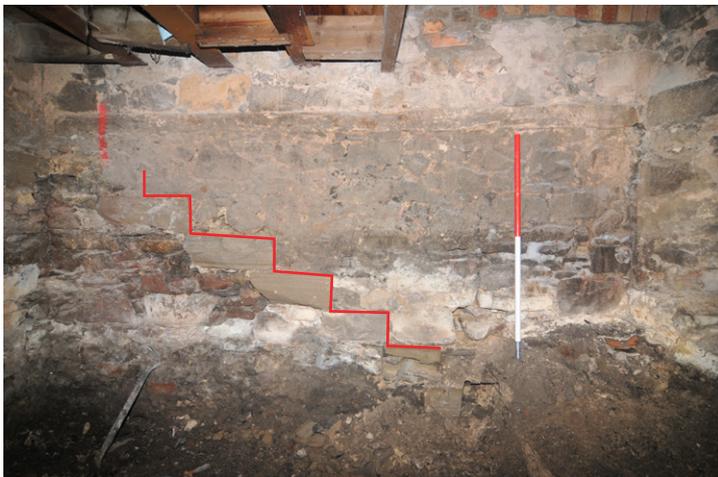
The south wall was built of random rubble and the remains of a flight of steps were visible within the wall fabric (Fig. 10). These had been cut back flush with the wall. The steps rose upwards from west to east. Above the stair treads the wall was constructed of small angular random rubble in contrast to the larger rectangular random rubble used below.

Fig. 10 - Room 1/4, rising stair treads cut flush with the wall on the north-facing elevation

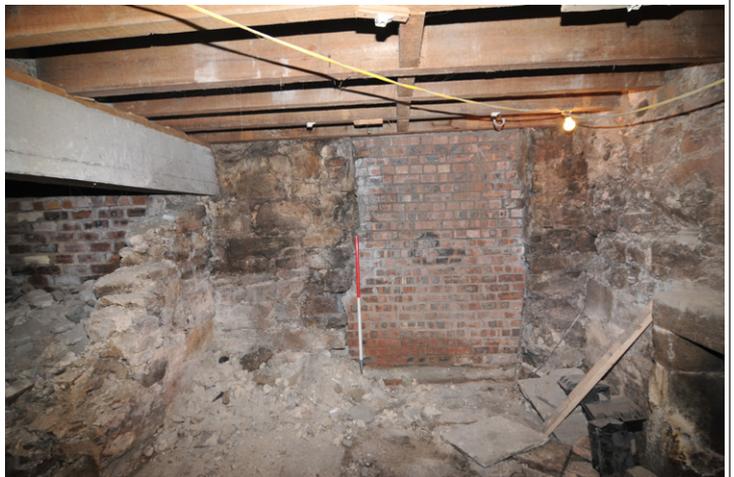
The south wall comprised coursed rubble with an off-centre panel of brickwork for a blocked opening (Fig. 11). This cannot have been a door or a window as this elevation does not open to the outside world. The brickwork was laid in English Garden bond (3:1) and is modern.

Fig. 11 - Room 1/5, blocked opening on the north-facing elevation

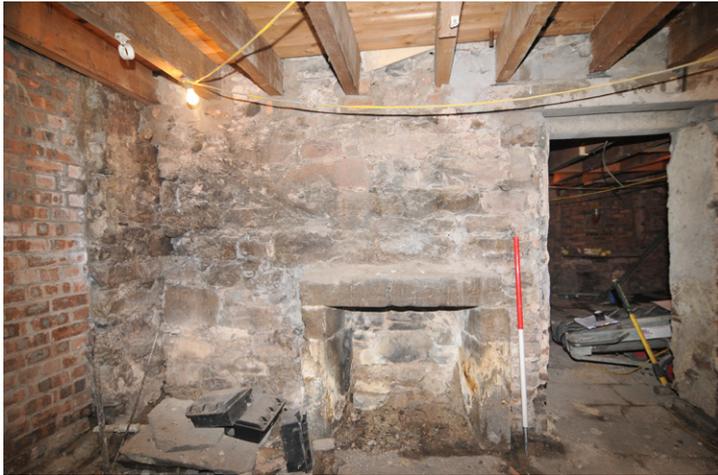
The west wall was built of coursed blocks of rough-dressed sandstone. At the south end a stone-built fireplace was present (Fig. 12). It measured 0.85m high and 1m wide and had a single cracked lintel and stone surrounds that were advanced from the chimney breast by c. 0.10m. A door opening leading into Room 1/6 was situated on the immediate north side of the fireplace. The wall on the north side of the doorway was largely rubble-built with a timber wall plate towards the wall head. Several phases of brick-infill were present and included modern 20th century and smaller 19th century brickwork. At the centre of the wall was a riveted 1930s iron stanchion that had been covered by the brickwork and had been recently exposed. The stanchion had been inserted into a void that cut through the wall plate and the void was then infilled with brickwork (Fig. 13). On the north side of the stanchion the wall was stone-built and contained a door leading into Room 1/6. At the wall head, a single piece of re-used architectural stone with roll moulding had been inserted into the wall (highlighted in Fig. 13). This was one of two pieces of re-used molded stonework recorded and it was probably a 17th century rybatt from a door or window reveal.

Fig. 12 - Room 1/5, fireplace on the east-facing elevation

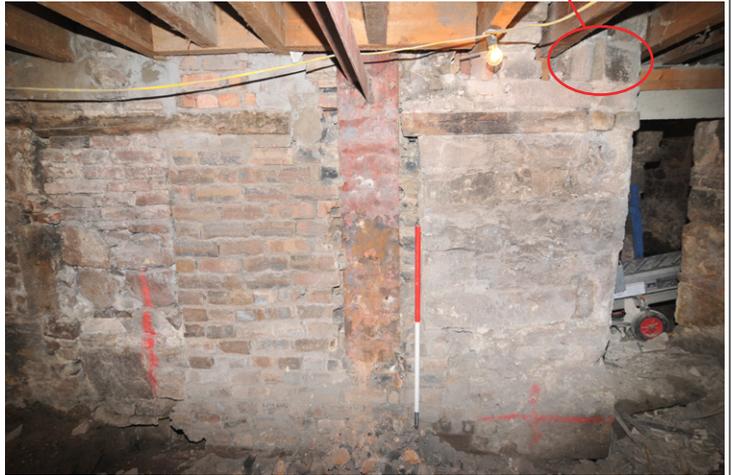
Fig. 13 - Room 1/5, 1930s steel stanchion cutting through a timber wall plate with re-used roll-molded masonry highlighted

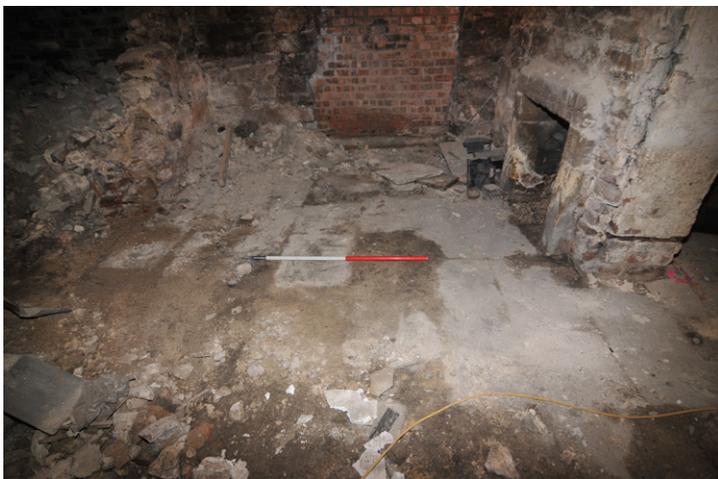
The remains of flagstone floors were recorded in Rooms 1/3 (Fig. 2), 1/5 (Fig. 14) and 1/6 (Fig. 18). The flagstones on the front stairwell area were much larger (c.0.75m x 0.5m) in comparison to those recorded in Rooms 1/5 and 1/6 which measured on average 0.5m x 0.45m. The difference in size probably reflects the difference between living spaces (Rooms 1/5 and 1/6) and the non domestic common stair well in Room 1/3. Rooms 1/1, 1/2, 1/5 and Room 1/6 all contained fireplaces. The latter room had the most ornate fireplace of the five that were recorded (Fig. 17). It seems likely that the rooms with fireplaces formed individual tenancies. A smaller sub-division of Room 1/2 and the larger sub-division of Room 1/3 had no fireplace and these may have functioned as storerooms. However, Room 1/3 had been significantly altered during 20th Century rebuilding so it was possible that any trace of an original fireplace had been masked by this rebuilding.

Fig. 14 - Room 1/5 the remains of a flagstone floor taken from the north

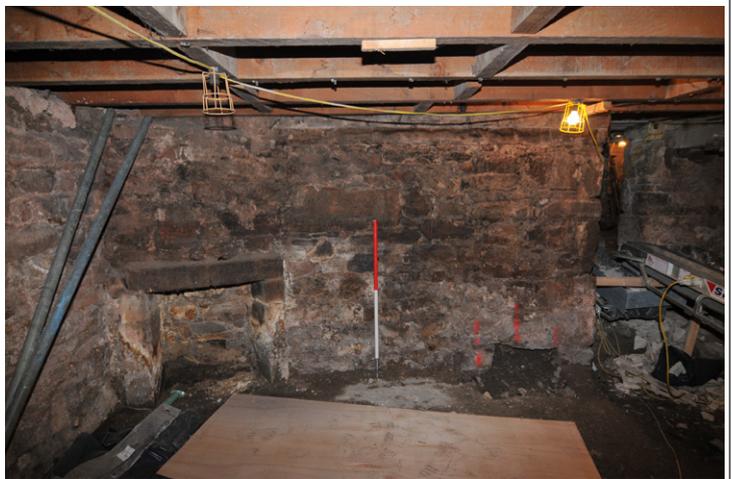
The north wall had been built using coursed blocks of sandstone. Within the corner angle of this wall and the east-facing elevation was a small stone-built fireplace that measured 0.85m high and 1m wide, its surrounds and lintel were c.0.10m thick (Fig. 15).

Fig. 15 - Room 1/6, a small fireplace in the angle of the south-facing elevation

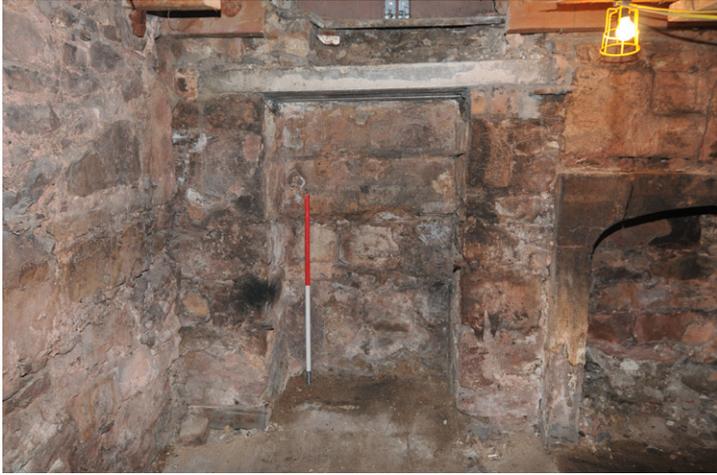
The south wall was rubble built and contained a stone-built press and fireplace. The press (Fig. 16) was situated on the east side of the wall and measured 1.8m high and 0.95m wide and contained four shelf scars surrounded by the remains of wall plaster. A modern (20th century) concrete lintel had been inserted to strengthen the wall above. On the west side of the press was the fireplace which had ashlar surrounds and a three-centred arched mantelpiece (Fig. 17). Incorporated into the chimneybreast immediately above the mantelpiece was a large block of re-used architectural masonry that had an L-shaped moulding on its lower edge (Fig. 17). The rest of the wall on the west side of the fireplace was featureless.

Fig. 16 - Room 1/6, a press on the east side of the fireplace on the north-facing elevation

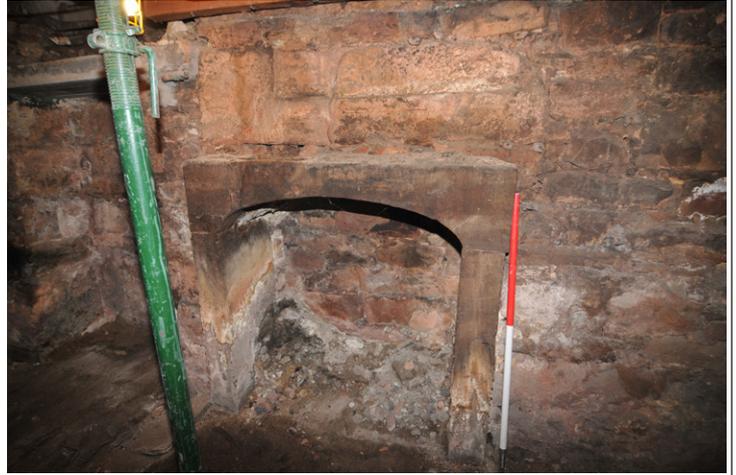
Fig. 17 - Room 1/6, ashlar built fireplace with re-used carved architectural stone in the chimney breast, north-facing elevation

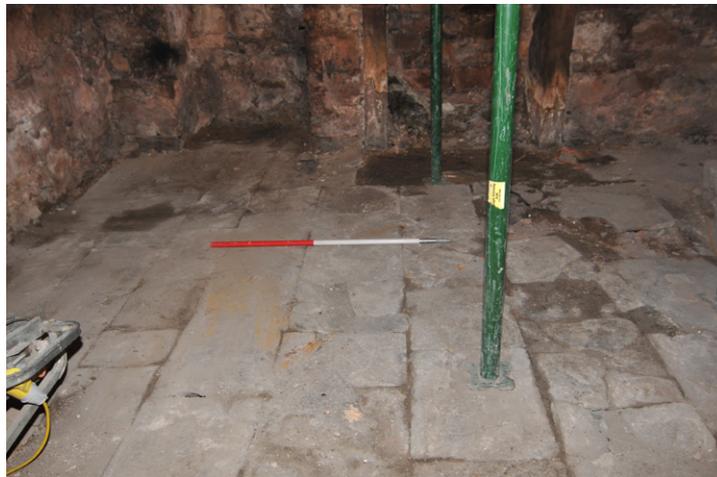
Fig. 18 - Room 1/6 flagstone floor in front of the fireplace taken from the north
