**4, 6, 8 Gilmerton Road, Edinburgh
Historic Building Survey**

Report No. 3429

Author	Michael Cressey, BA MSc PhD MCIfA FSA Scot
Illustrator	Graeme Carruthers MA MCIfA
Approver	Bruce Glendinning BSc PG Dip MCIfA
Commissioned by	NG Archaeology Services
Date issued	June 2017
Version	2
Grid Ref	NT 27198 70695
Oasis Ref No.	cfaarch1-250246

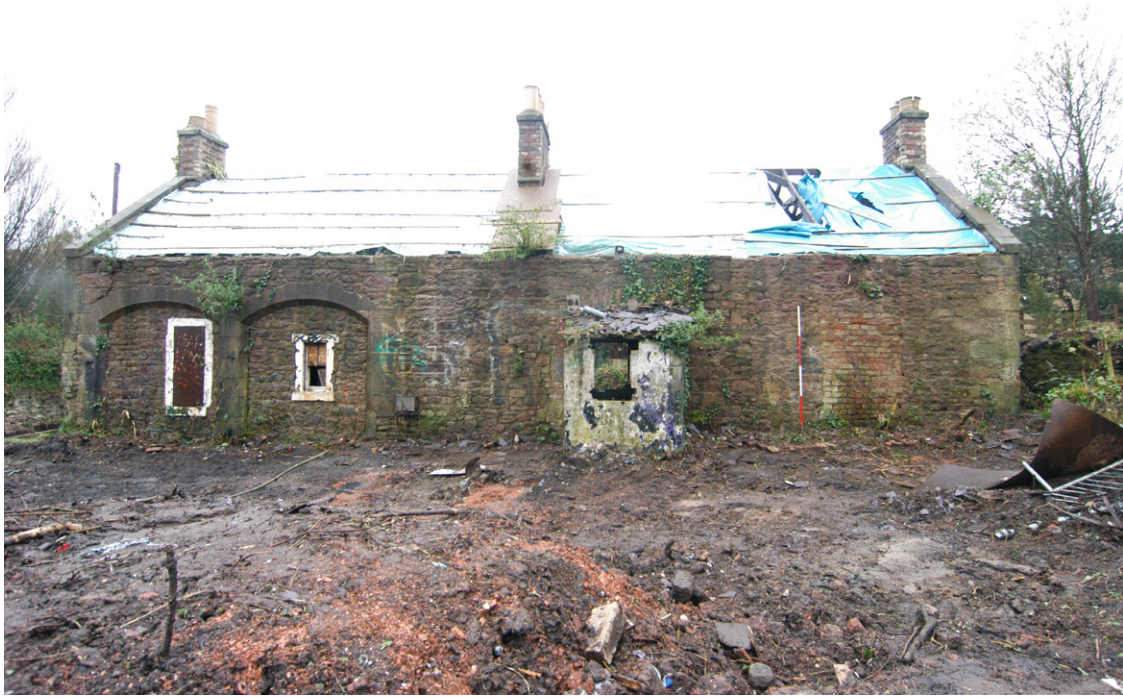
Northwest-Facing elevation, Fig 4a & Fig 6

The main build was randomly laid sandstone (1) bonded with lime mortar. Droved ashlar quoins framed each end of the elevation (3 & 16). Situated at the north end of the elevation was a pair of former carriage-shed openings (4-5). Each arch had nine droved ashlar vousoirs and each had a chamfered arris. Both arches were blocked with blocks of coursed sandstone (6&8) and contained two rectangular window openings (7&9). On the right-hand side of the carriage-shed openings was a small rectangular feature with blocking work (10). The feature may have been an earlier hatch or a possible window opening.

A brick-built porch (11) with cement harled exterior and flat corrugated asbestos roof was attached to the elevation. The porch masked a series of droved ashlar quoins and lintel (12) that surrounds an original doorway. Above the door lintel was a segmented relieving arch (13). On the right-hand side of the porch (facing) was a window (14) blocked with 21 courses of brick (15) that were laid in stretcher bond. The ridge coping stones were ashlar sandstone (2 & 17). Three chimney stacks (18-20) incorporated polychrome brickwork combining cream and red brick laid in alternate bands at the corners of each stack.

Fig. 6 Northwest-facing elevation, general view

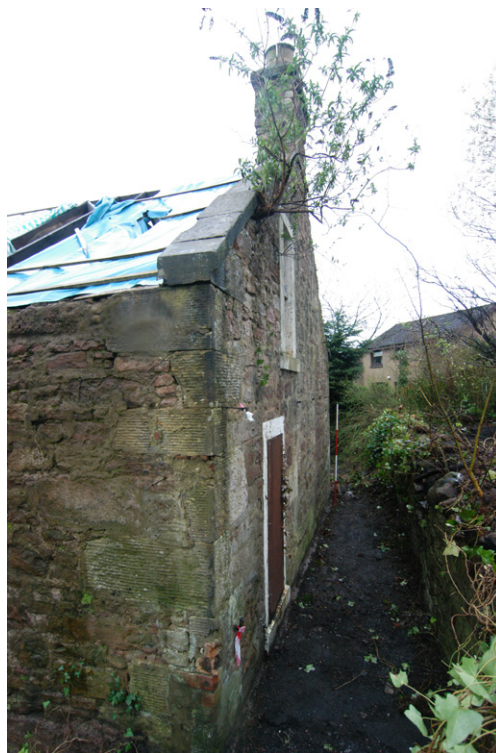
Southwest-Facing gable, Fig.4b & Fig 7

The main build was random rubble bonded with lime mortar (21). A boarded rectangular window (22) was situated on the left-hand side of the gable (facing). It had white-painted droved ashlar surrounds. To the immediate right of the window was an earlier blocked window (23) its position marked by a pair of vertically aligned droved ashlar quoins and a stone window sill. The interior of the window had been blocked with coursed sandstone (24).

At the attic level was a rectangular window with white-painted surrounds (25). Framing the right-hand corner of the gable was a series of droved ashlar quoins (26). The ridge coping stones on the right-hand side of the gable had been removed where as those on the left-hand side were present (17). The gable was surmounted by one of the aforementioned brick-built chimney stacks (18). Set back from the line of the gable was a brick-built porch (27).

Fig. 7 Southwest-facing gable, general view

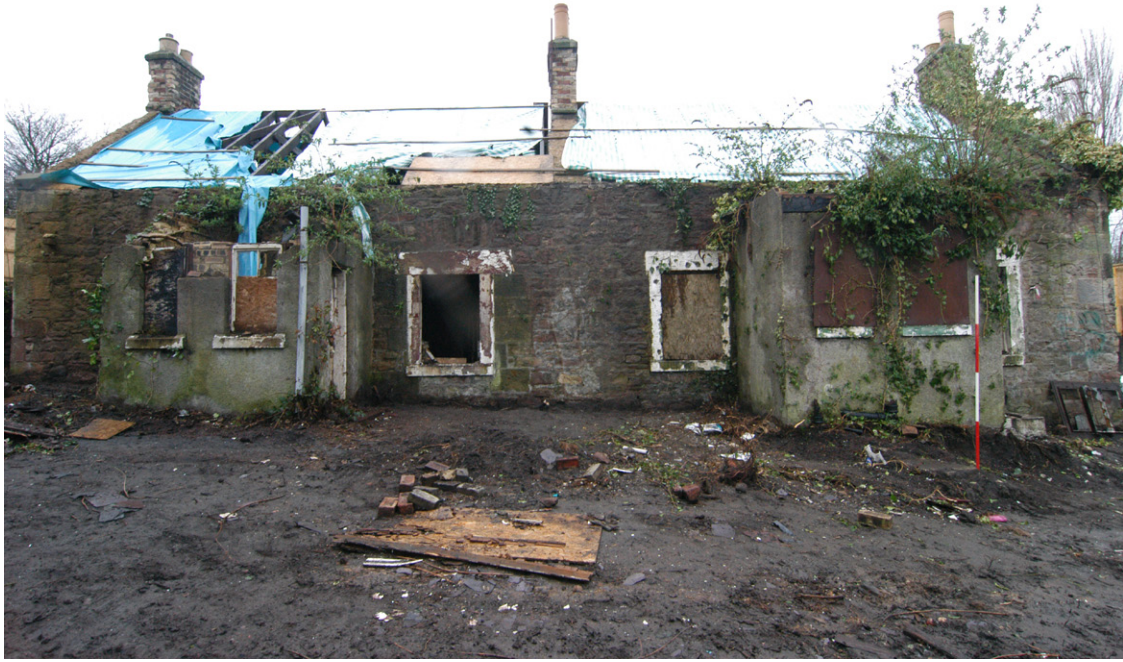
Southeast-Facing elevation, Fig 4c & Fig 8

The southeast-facing elevation was constructed of random rubble bonded with lime mortar (28). At the southeast end of the elevation was a rectangular window (29) with white-painted droved sandstone surrounds. Built against the elevation was a porch (27) that was brick-built and roofless. Set within the porch were a boarded and part boarded window (30&31). On the right-hand side of the porch, on the main elevation, was the outline of an earlier doorway (32) that was represented by a series of droved quoins and large stone lintel. Set within the former doorway was a second window (33) with raised margins. Above the stone lintel was a segmented relieving arch (34). On the right-hand side of the window was another boarded window (35) with white-painted raised margins. Projecting of the main elevation was a brick-built porch (36) with a flat roof. Set within its southeast-facing wet-dash rendered wall were two boarded windows (37&38). On the right-hand side of the porch on the main elevation was another window opening with white-painted raised margins (39).

The elevation was framed by a series of droved ashlar quoins (40). The pitched ridge copings stones were ashlar sandstone (41). The middle copings stones that sat on the main spine wall (42) dividing the two cottages had been removed. The copings that surmounted the southwest-facing gable had also been removed except for the skewput. A series of collared A-frame principal rafters and timber ridge piece (not numbered) could be seen in a gap between two tarpaulin sheets that had been laid on the rafters after the slates had been removed.

Fig. 8 Southeast-facing elevation, general view

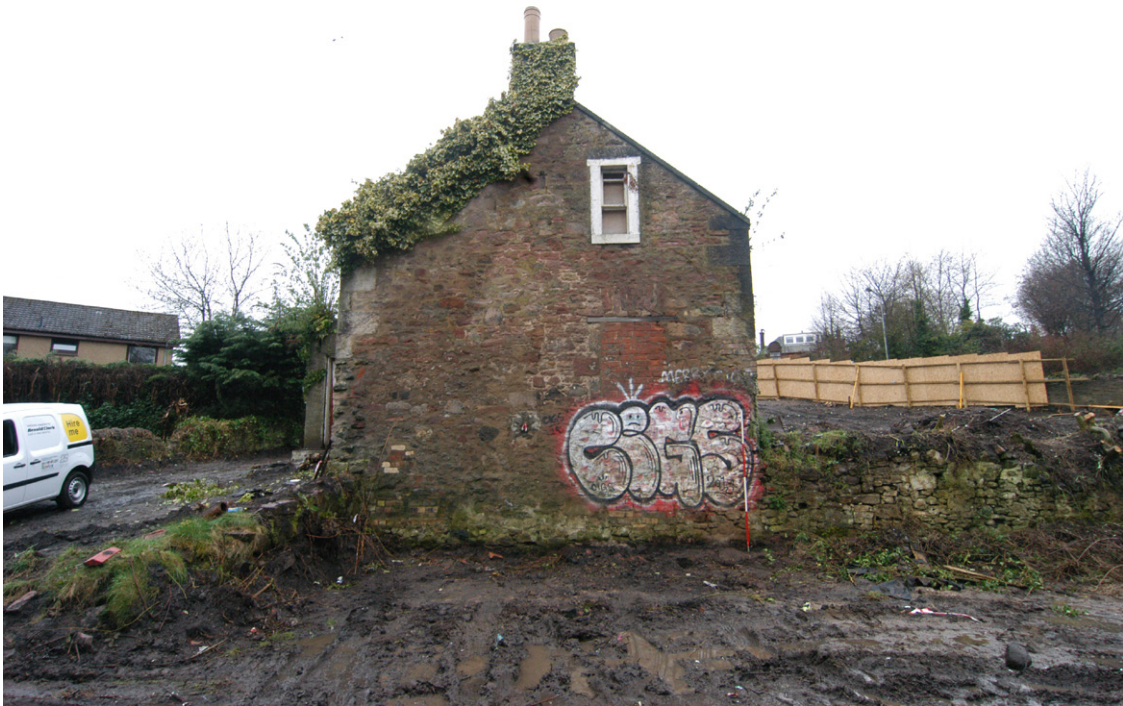
Northeast-Facing gable, Fig 4d & Fig 9

The northeast-facing gable was constructed of random rubble (45). Set back from the line of the gable was the entrance doors (44 & 50) to the two porches (36 & 11). On the northeast-facing elevation rising from the ground floor was a large brick-blocked opening (46) with a wooden lintel. The elongated nature of the blocking work suggests that it may have once been a doorway that allowed access into a now demolished adjoining building. Above the lintel was a segmented relieving arch (47). At attic level was a small rectangular window opening (48) containing a small two-paned sash-and-case window. Half way up the left-hand side of the gable was the remains of a roof raggle (49) of a building with a pitched roof. Its apex was roughly to the left of the attic window (48) and may even have clipped its bottom left-hand corner. Differences in the quality and condition of the cement pointing also indicates the position of the former pitched roofline.

Fig. 9 Northeast-facing gable, general view

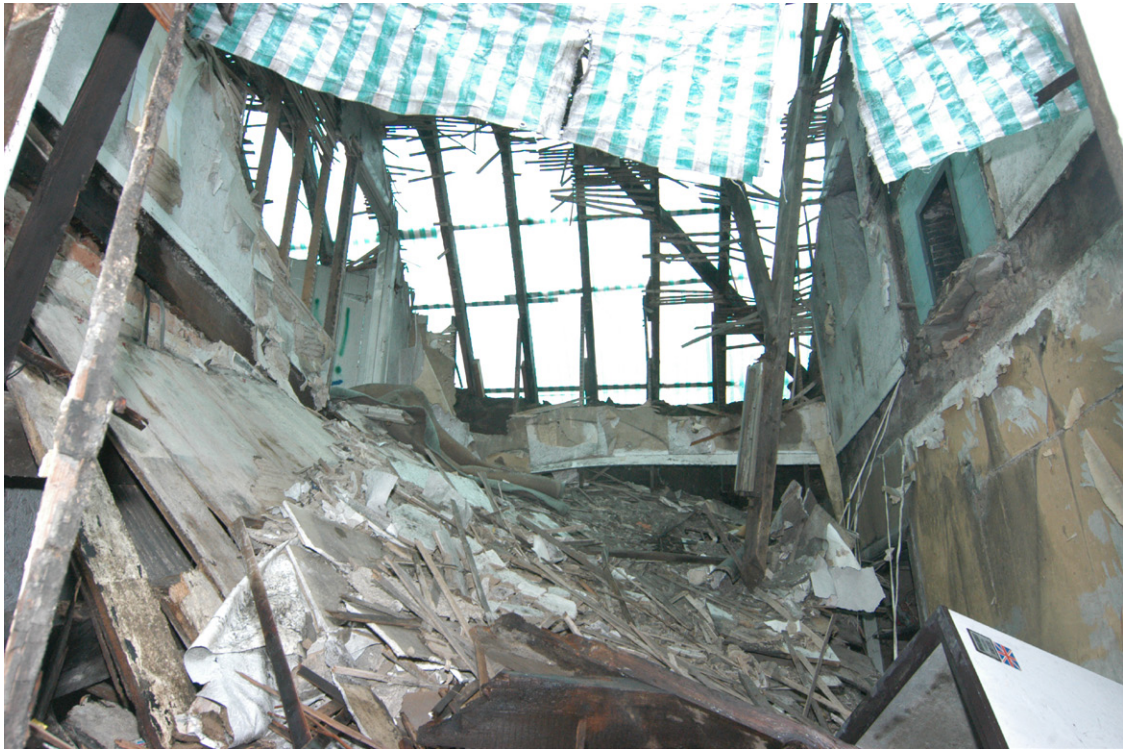
Fig. 10 Collapsed first floor and fireplace

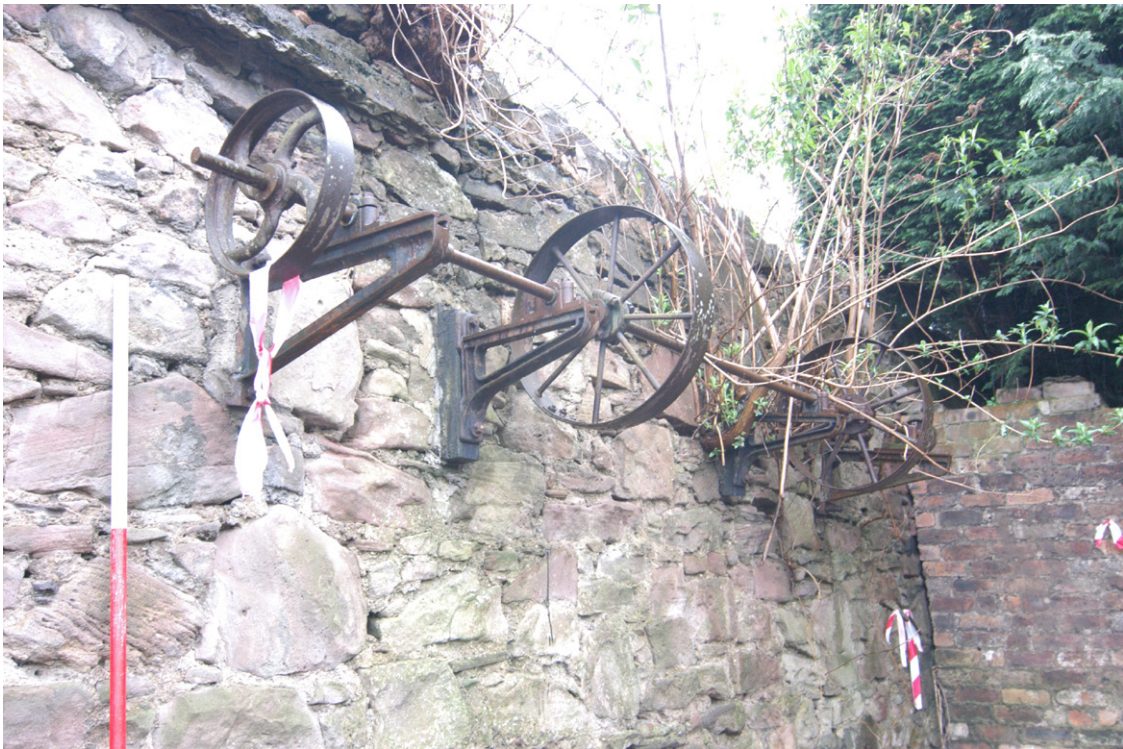
In the easternmost corner of the proposed development boundary stands a c. 4m high stone-built boundary wall that had a drive shaft with belt wheels attached to it (Fig

11). The shaft was suspended on a series of cast-iron brackets. These were part of the belt-operated machinery that operated on the site when Good's Corner was a wheelwright and joiners workshop. Another 'industrial' item recorded includes a belt-driven grinding wheel found during site clearance (Fig 12). Other building remains represented by part of a wall with blocked openings and a gable wall with a fireplace were situated at the western end of the site at the junction of Gilmerton and Liberton Road (Figs 13-14). These remains were also part of the Good's Corner building complex.

Fig. 11 Lineshaft and flywheels fixed to boundary wall

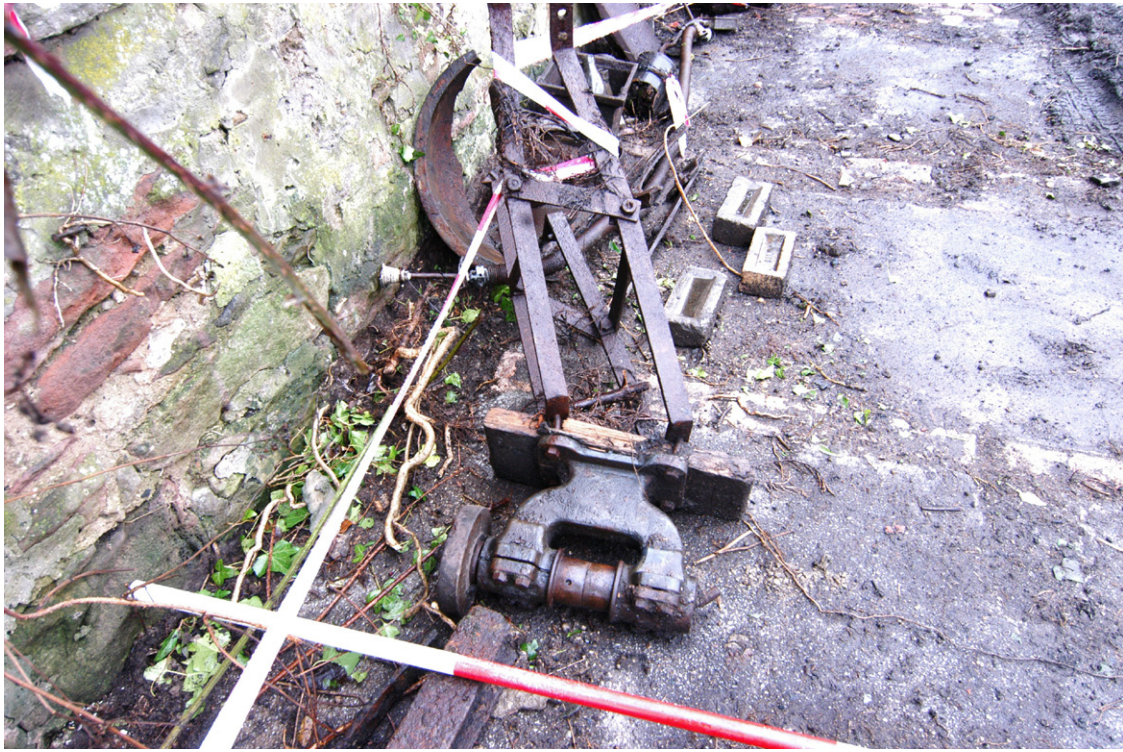
Fig. 12 A belt-driven grinding stone found during site clearance

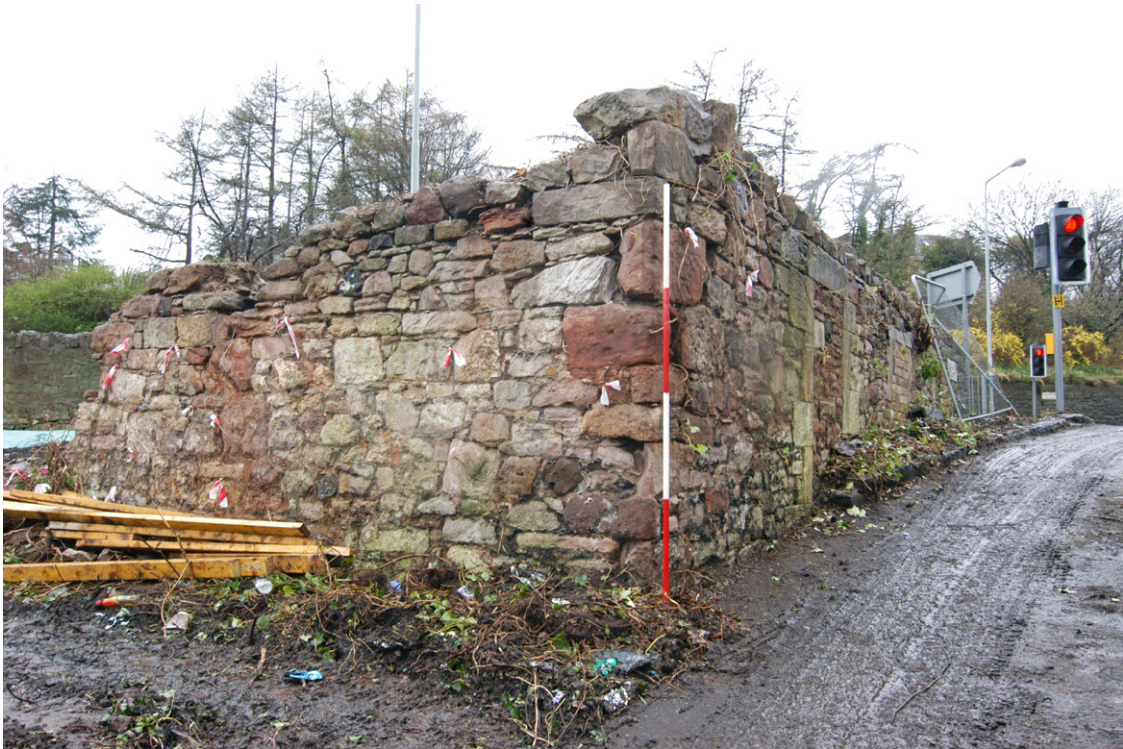
Fig. 13 Upstanding building remains at the north end of the site

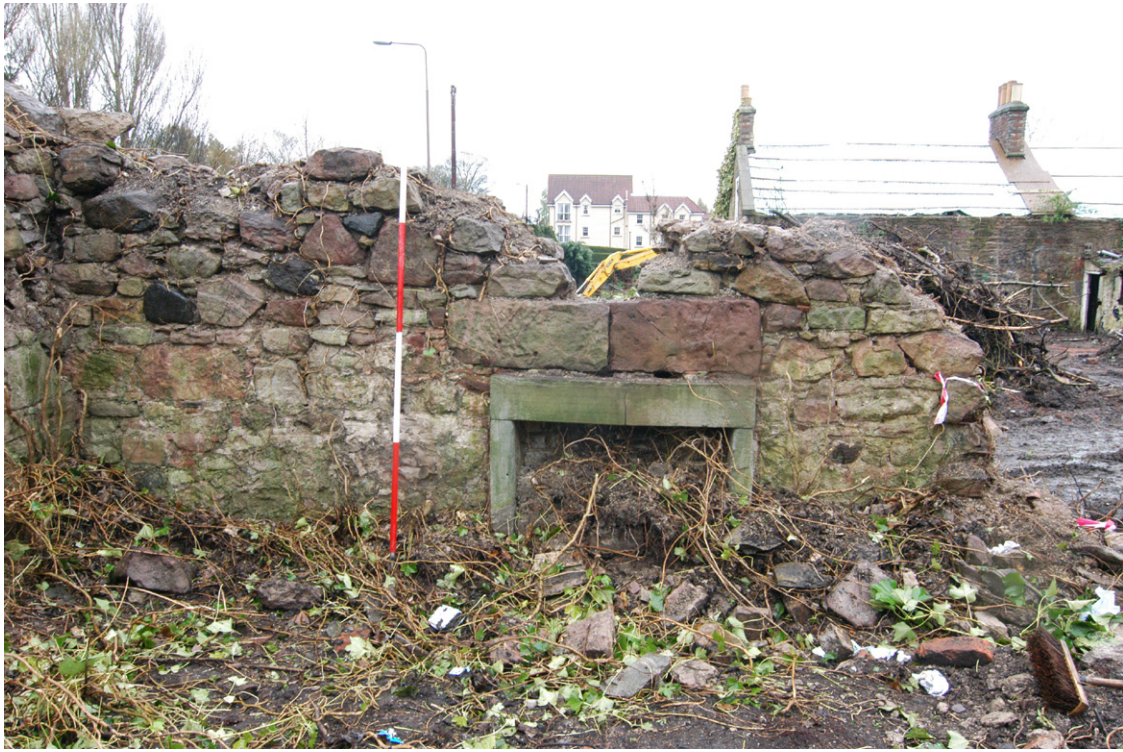
Fig. 14 A fireplace within the shell of the ruined building

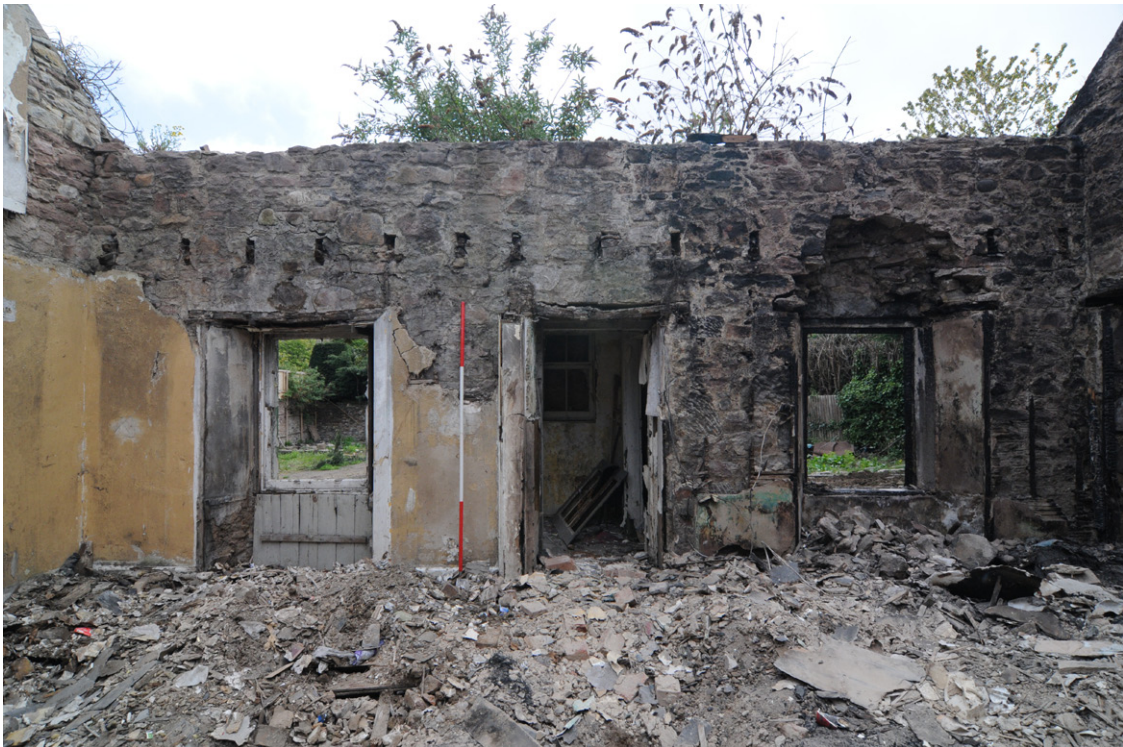
Unit A, Northwest-facing elevation (Fig 3a & Fig 15)

The interior northwest-facing elevation contained the door to Unit 10 (Fig 3a), the external porch was flanked by two splayed window openings. The elevation was constructed of random rubble and had lost most of its yellow-coloured plaster. A line of floor sockets could be seen running across the elevation above the windows. The left-hand window (facing) contained original tongue-and-grooved boards below its window sill.

Fig. 15 Unit A, Northwest-facing elevation, post roof removal

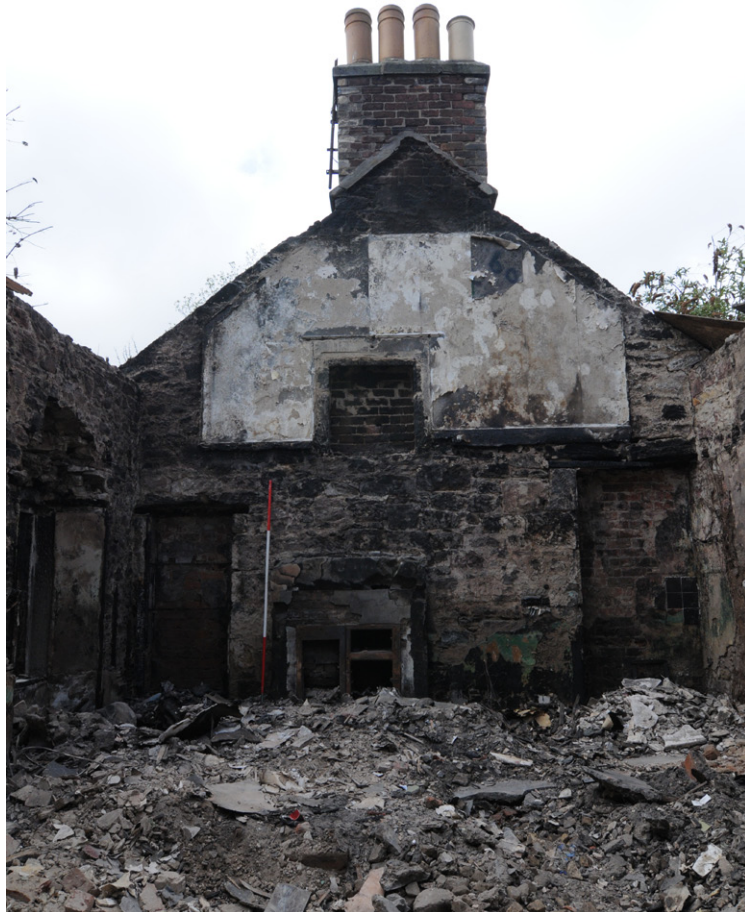
Unit A, Northeast-facing partition wall (Fig 3a & Fig 16)

The northeast facing elevation formed the main partition wall with a chimney and two fireplaces. At ground floor level, an off-centre stone fireplace with a later cast-iron range was present. The earlier fireplace had large sandstone surrounds and lintel. The range appeared to date to the c.1950s (Fig 17). On the left-hand side of the fire-place was a press with shelving scars. On the right-hand side was an earlier door that had been blocked-up with common brick.

At first-floor level there was another fireplace of which only the stone surrounds survived, the fireplace itself having been robbed earlier. The wall surrounding the fireplace contained its original plaster. At roof level there was the cement raggle from the slate roof. The chimney stack contained alternating red and white brick in polychrome style. Four plain chimney pots were present.

Fig. 16 Unit A, Northeast-facing partition wall showing fireplaces

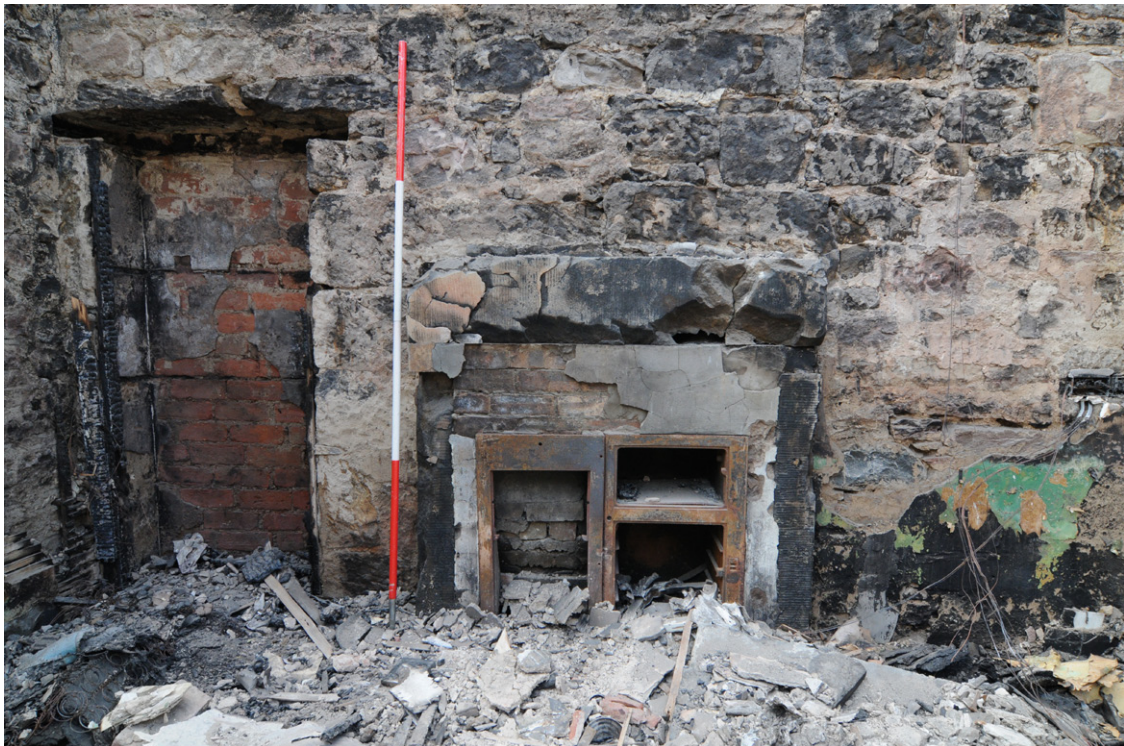
Fig. 17 Unit A, Northeast-facing partition wall showing the cast-iron range

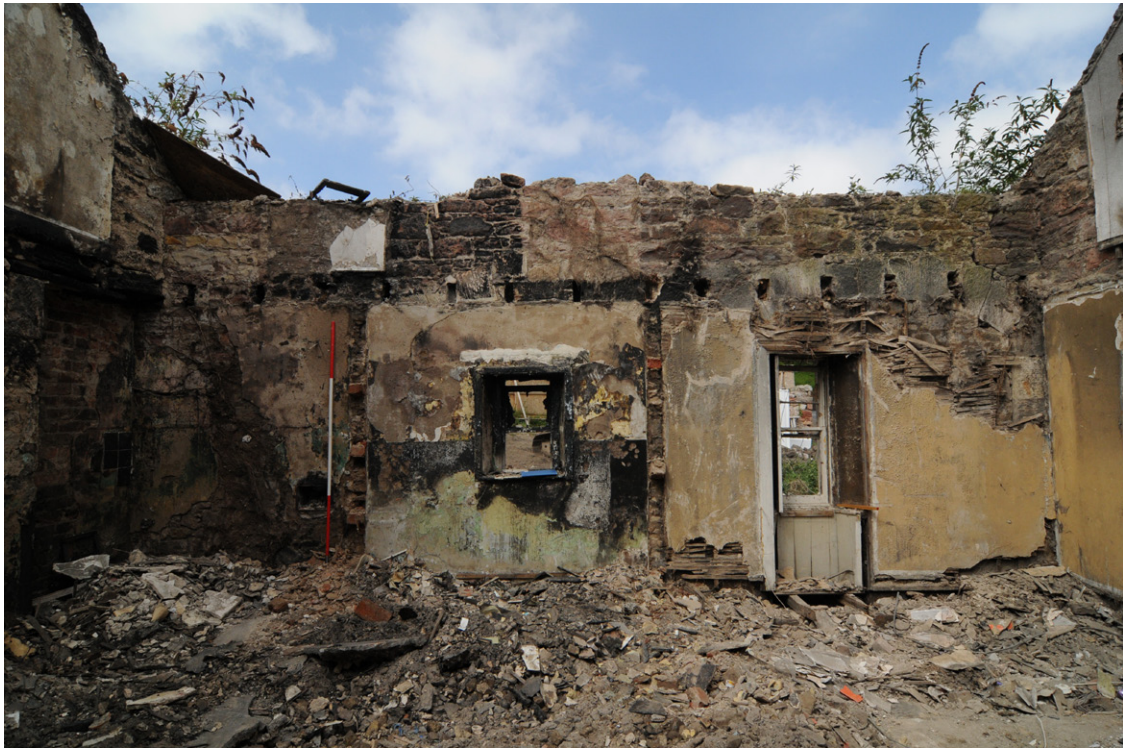
Unit A, Southeast-facing elevation (Fig 3a & Fig 18)

The southeast-facing elevation contained the interior blocking work of the arched openings (Figs 4a and 18). Each arch had had a window inserted into them when they were blocked up. Both had splayed reveals and were lined with lath and plaster. Remnants of the lath and plaster had survived the fire. The arch vousoirs contained floor joist sockets for the first floor. Above these, the wall head was constructed of coursed rubble. Two brick-built partition wall scars were also visible one was associated with a cupboard (Unit 7) and the wall that supported the box staircase (Fig 3a).

Fig. 18 Unit A, Southeast-facing elevation showing the interior of the blocked cart-shed openings

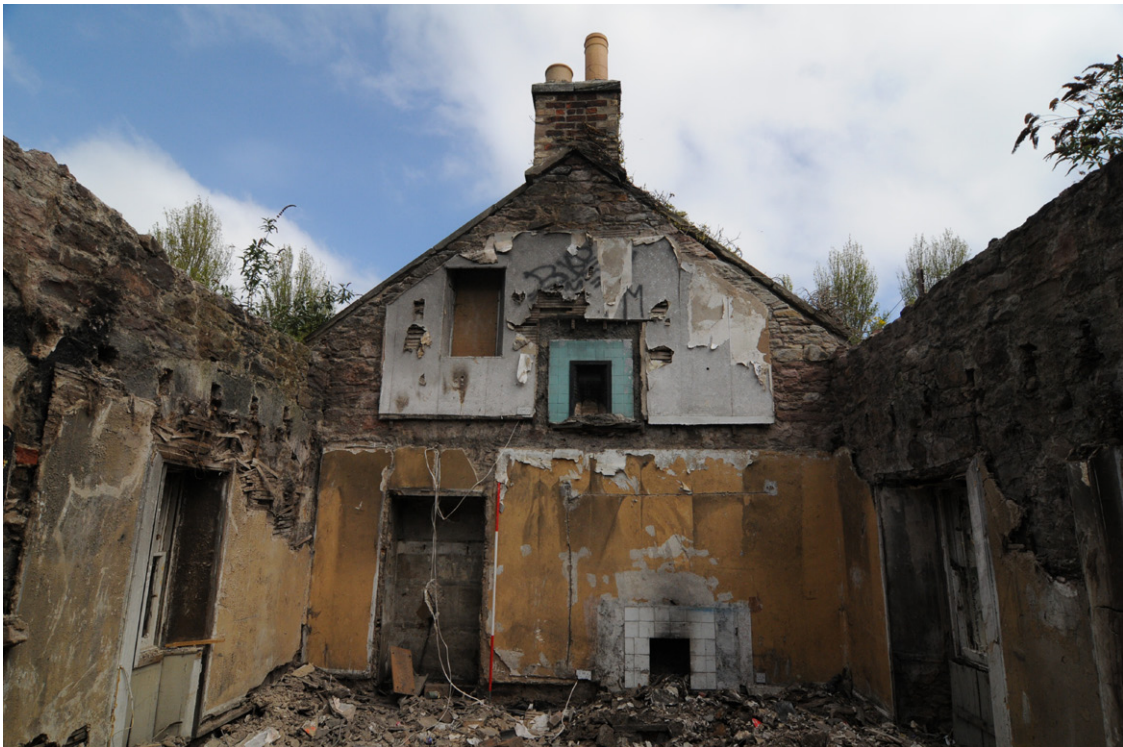
Unit A, Southwest-facing elevation (Fig 3a & Fig 19)

At ground floor level, the elevation contained a small white ceramic tiled fireplace flanked by a small press with shelving scars. The walls were plastered and lined with brown painted wallpaper.

At first floor level a central fireplace with green ceramic tiles was flanked by a lath-and-plaster covered wall that contained a boarded window. The sandstone ridge copings were present. The chimney stack was the same aforementioned polychrome style of brickwork.

Fig. 19 Unit A, Southwest-facing elevation, gable wall with fireplaces

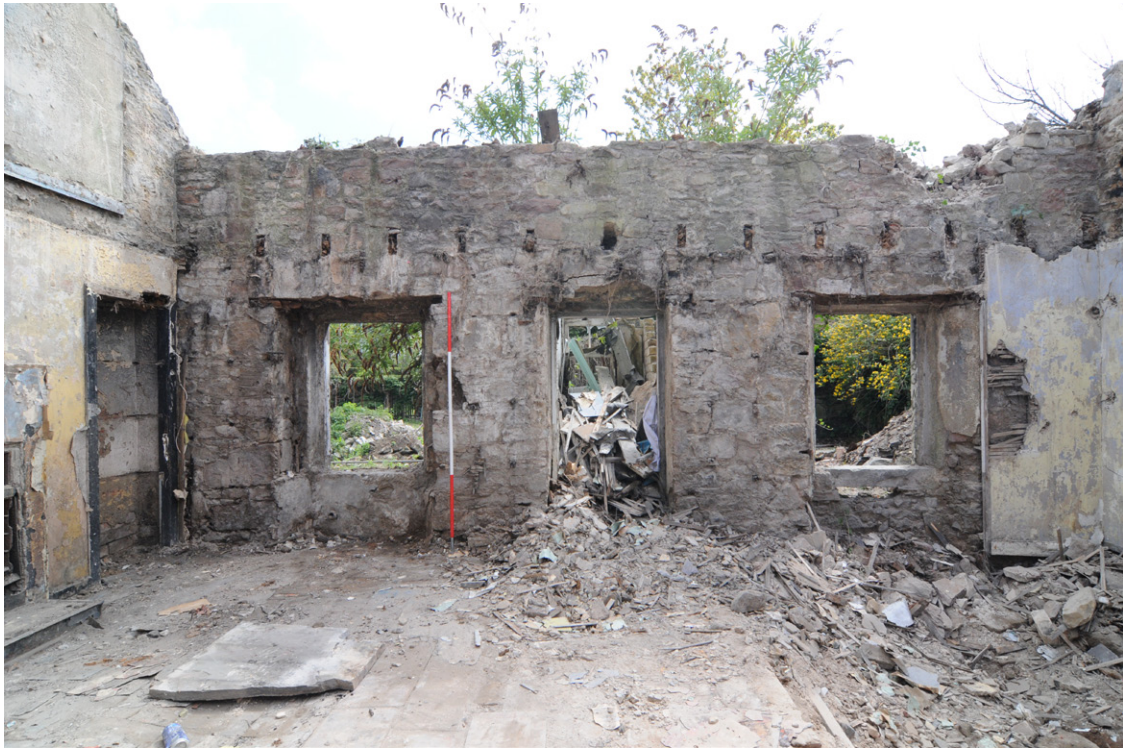
Unit B, Northwest-facing elevation (Fig 3a & Fig 20)

The northeast-facing elevation contained the door to the external porch (Unit 3 in Fig 3a). The door was flanked by two windows with splayed reveals. The fire had destroyed almost all of the original lath-and-plaster revealing the random rubble construction of the walls behind. A line of sockets that supported the first floor was visible and the wall head above comprised random rubble.

Fig. 20 Unit B, Northwest-facing elevation, with ground floor openings

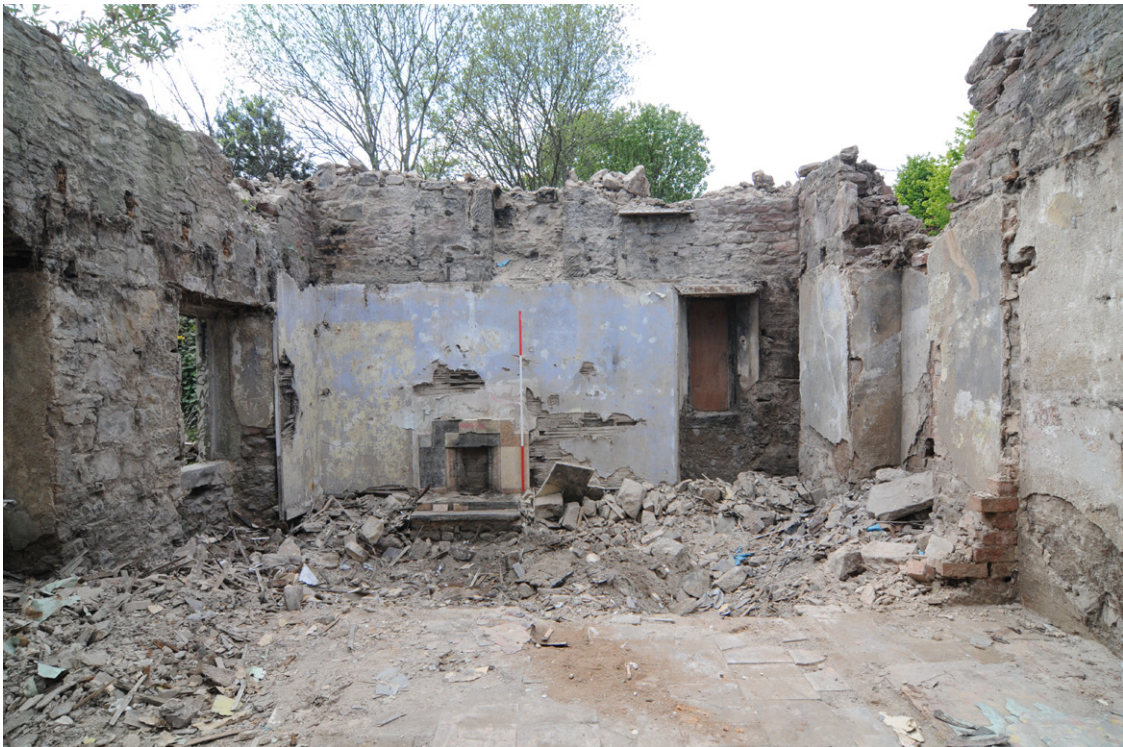
Unit B, Northeast-facing gable wall (Fig 3a and Fig 21)

The northeast-facing gable wall had been reduced to about half its size due to its instability. At ground floor level the wall contained a small ceramic tiled fireplace dating to the 1950s. It had a brick-built hearth. The walls surrounding the fireplace were covered with lath-and-plaster but this was missing from around a small boarded window with splayed reveals situated on the right-hand side of the fireplace.

At first floor level were the remains of a centrally positioned stone-built fireplace of 19th century date with missing lintel. The rubble-built walls surrounding the remains of the fireplace had been lined with plaster but this had fallen off during the recent demolition work.

Fig. 21 Unit B, Northeast-facing elevation showing the reduced gable wall and fireplace

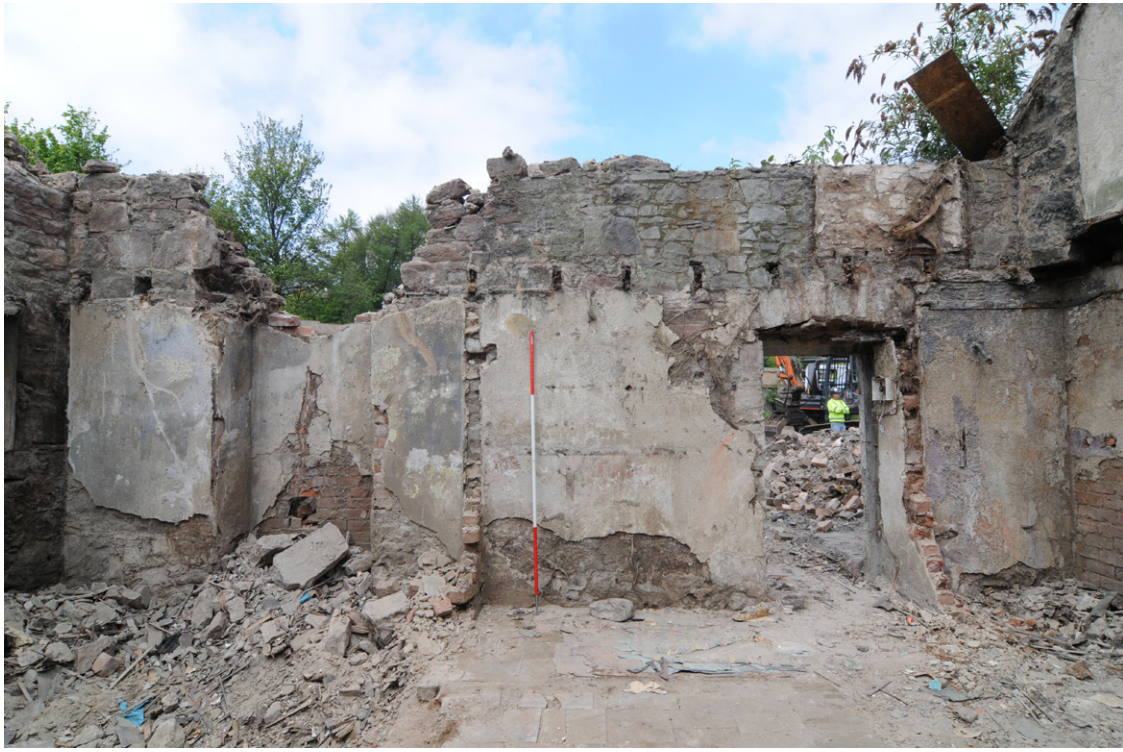
Unit B, Southeast-facing elevation (Fig 3a & Fig 22)

The southeast-facing elevation had a doorway on its north side. Two brick-built wall stubs survived from a porch (Unit 5, Fig 3a) and a small press (Unit 6, Fig 3a). On the south side of the elevation was a doorway blocked with brick. Wall plaster survived on the majority of the elevation. Above the existing doorway was another blocked opening. The line of first floor sockets was visible running across the wall above the existing doorway.

Fig. 22 Unit B, Southeast-facing elevation showing an earlier doorway and the existing doorway

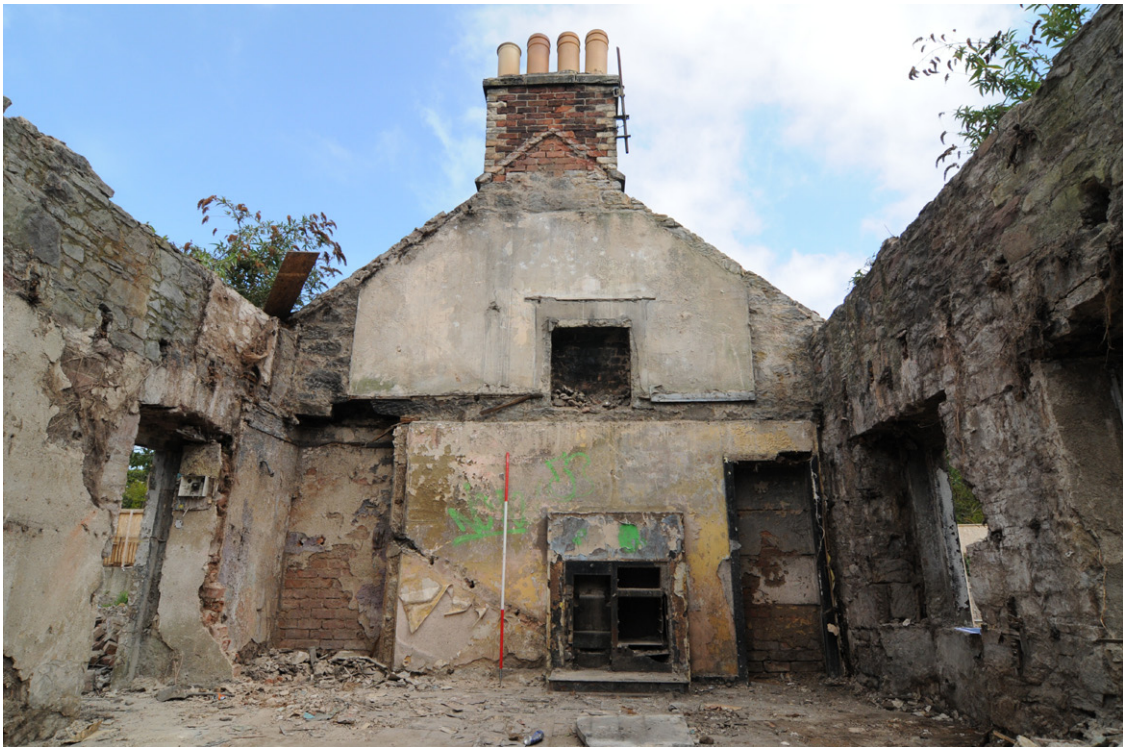
Unit B, Southwest facing partition wall (Fig 3a & Fig 23)

The southwest-facing elevation comprised the central partition wall between the two cottages. At ground floor level, an off-centre cast-iron range was present. The range had been inserted below a stone fire-surround. The range once had a firebox with back-boiler, an oven and plate warmer above and dated to the 1950s. The wall surrounding the fireplace was lined with lath-and-plaster. On the right-hand side (facing) was a press with shelf scars. On the left-hand side was a brick-blocked doorway.

At first-floor level was a centrally placed fireplace opening with a missing wooden surround, the scars of which were visible. The walls flanking the fireplace were lined with lath-and-plaster. Below the position of the fireplace was the scar from the skirting board that was removed when the floor was taken down. At the apex of the elevation, this had been heightened with brickwork to accommodate the polychrome chimney stack which was incised with a raggle for the lead roof flashing. Four plain chimney pots survived on top of the stack.

Fig. 23 Unit B, Southwest-facing elevation showing the partition wall with ground and first floor fireplaces
