**St John's Parish Church & Hall,
Oxgangs, Edinburgh
Building Recording Survey
Report No 3425**

Author	Michael Cressey HND BA MSc PhD MIfA FSA Scot
Illustrator	Graeme Carruthers MA MCIfA
Editor	Tim Neighbour BSc FSA Scot MCIfA
Commissioned by	Bilfinger GVA
Date issued	May 2016
Version	1
OASIS Reference	Cfaarcha1-251625
Planning Application No	4/03807/FUL
Grid Ref	NT 23650 68660

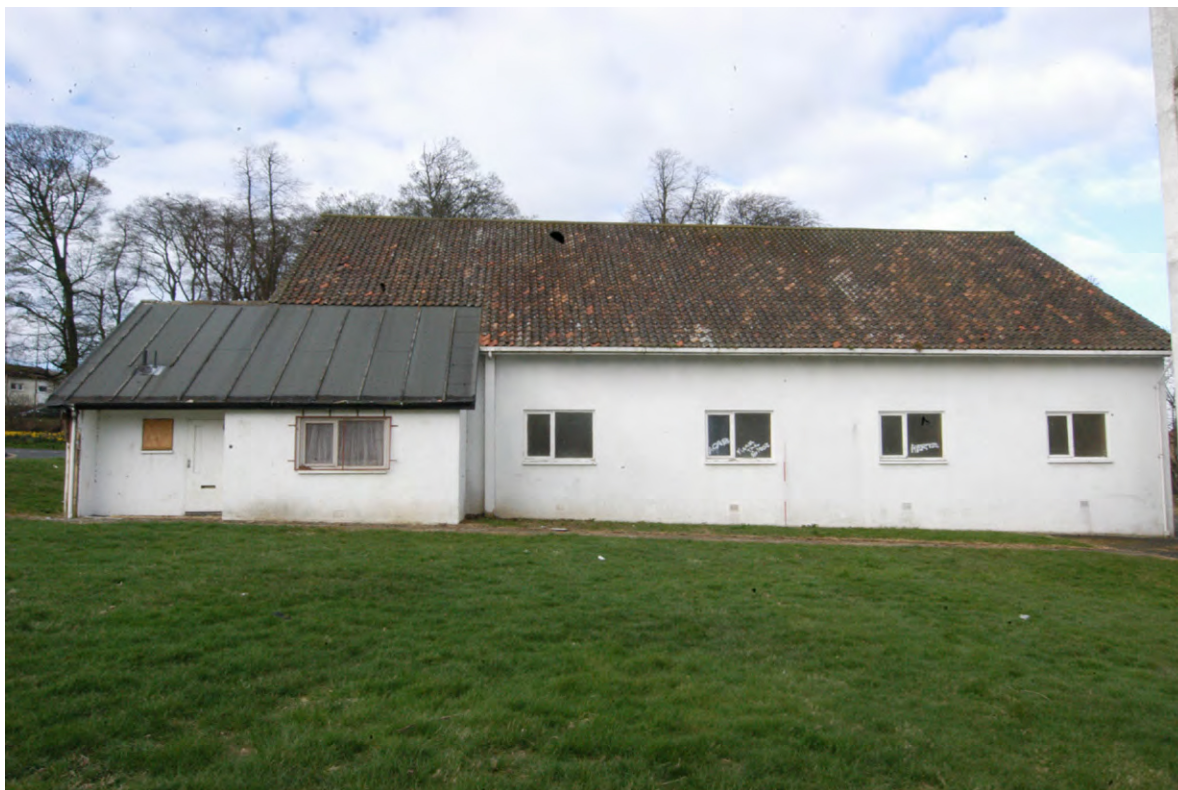
Fig. 3 North-east-facing elevation

The north-east-facing elevation had two distinct elements. The first was an outshot porch with a pitched roof situated at the south-east corner of the elevation. It had white-painted brick-built walls and a felt covered roof. A fire door and a small square toilet window were present within the entrance. A rectangular casement window occupied the centre of the outshot wall. Set back from the wall was the wall of the nave which had four casement windows all equally spaced. The roof was pitched and covered with pan-tiles.

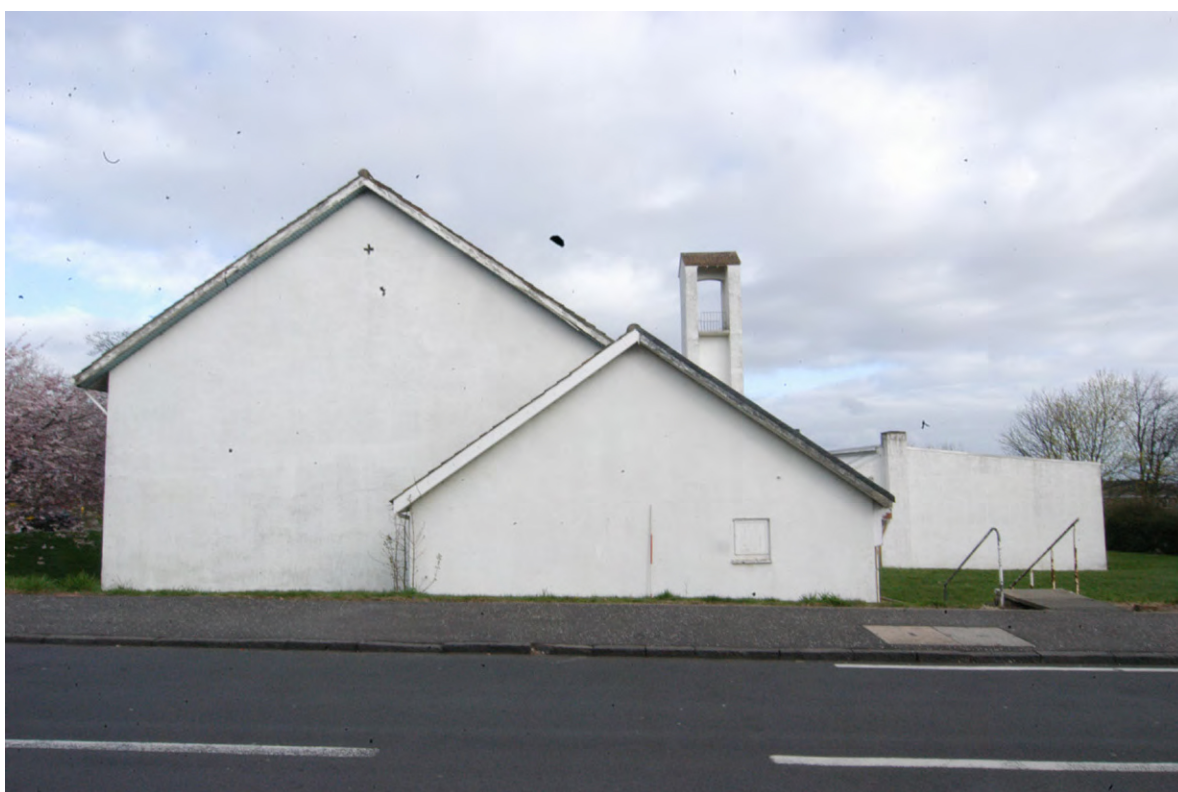
Fig. 4 South-east-facing gables

The south-east-facing elevation includes the roof of the outshot porch and the main gable of the church. The outshot gable for the porch had a small boarded toilet window. Both walls incorporated timber eaves boards. Towards the apex of the church gable was a small crucifix.

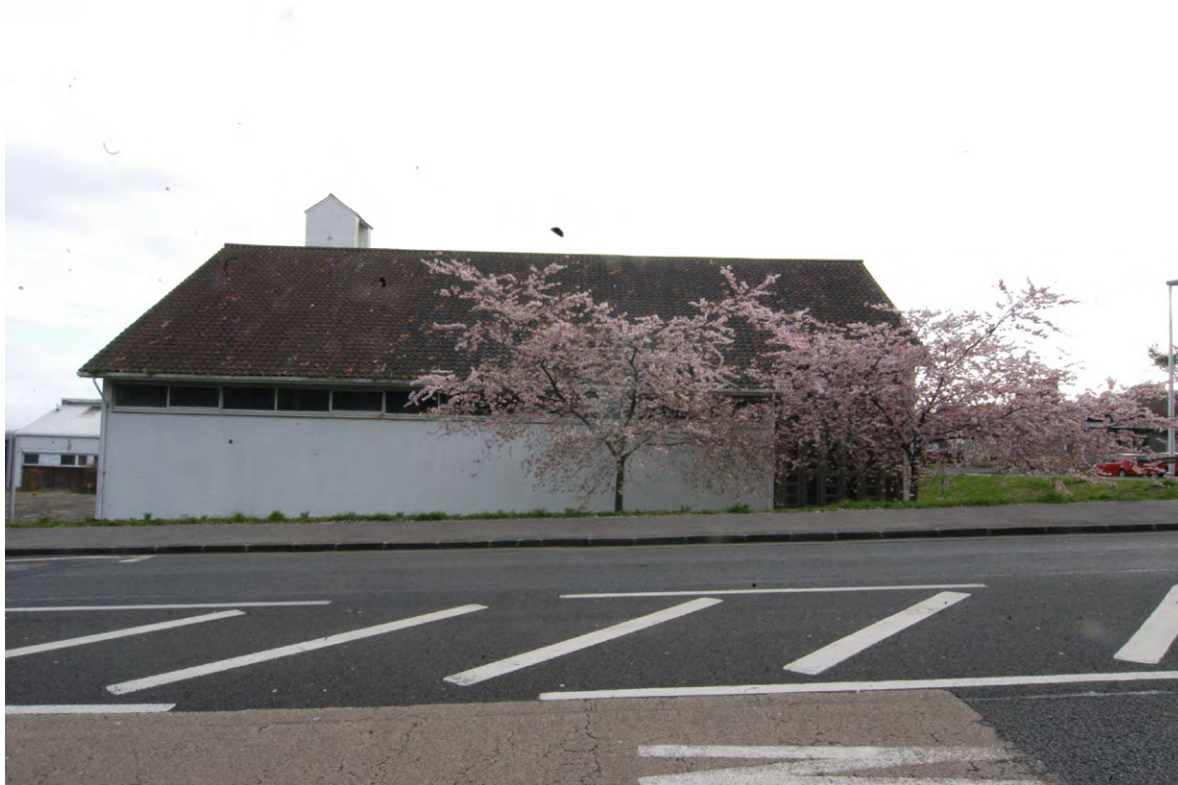
Fig. 5 South-west-facing elevation

Set back from the line of the main church wall was the outshot porch that had a boarded casement window. This window lit the vestry. The roof was covered with pan-tiles and the rain goods were cast-iron.

Set back from the line of the main church wall was a concrete-framed altar window with long and short geometric panes of frosted glass. The main church wall was white-painted brick with rectangular clerestory windows below the advanced eaves. The roof was pan tiled.

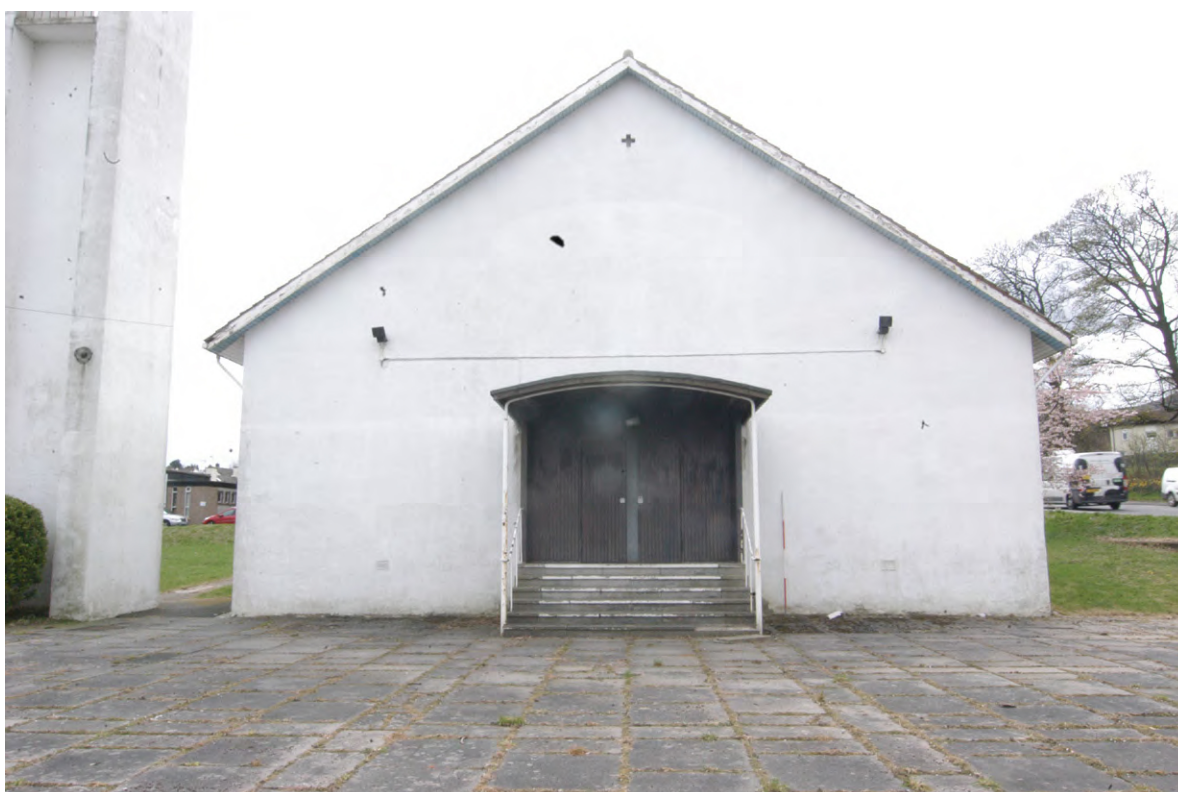
Fig. 6 North-west-facing elevation

The north-west-facing gable was white-painted brick and pitched. Five steps led up to double-leaved doors that were situated below a steel-framed and timber covered porch. The only architectural embellishment was a small crucifix below the apex.

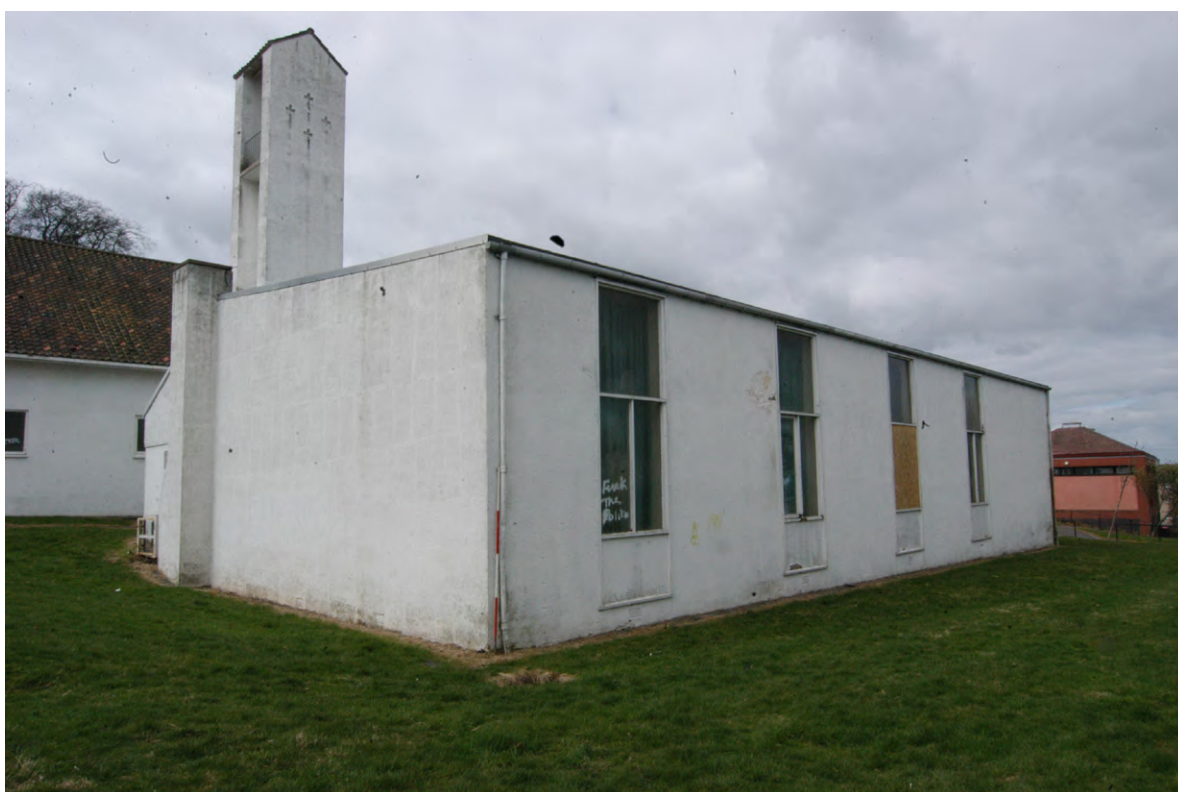
Fig. 12 St John's Church Hall, north-east-facing elevation and south-east-facing gable

The north-east facing elevation had four bays with long casement windows set within plain white-painted rendered brick walls.

The south-east-facing gable had an asymmetric roof. The only notable feature on this otherwise featureless wall was a brick-built external chimney stack probably for a boiler situated in the caretakers storeroom (Unit 18).

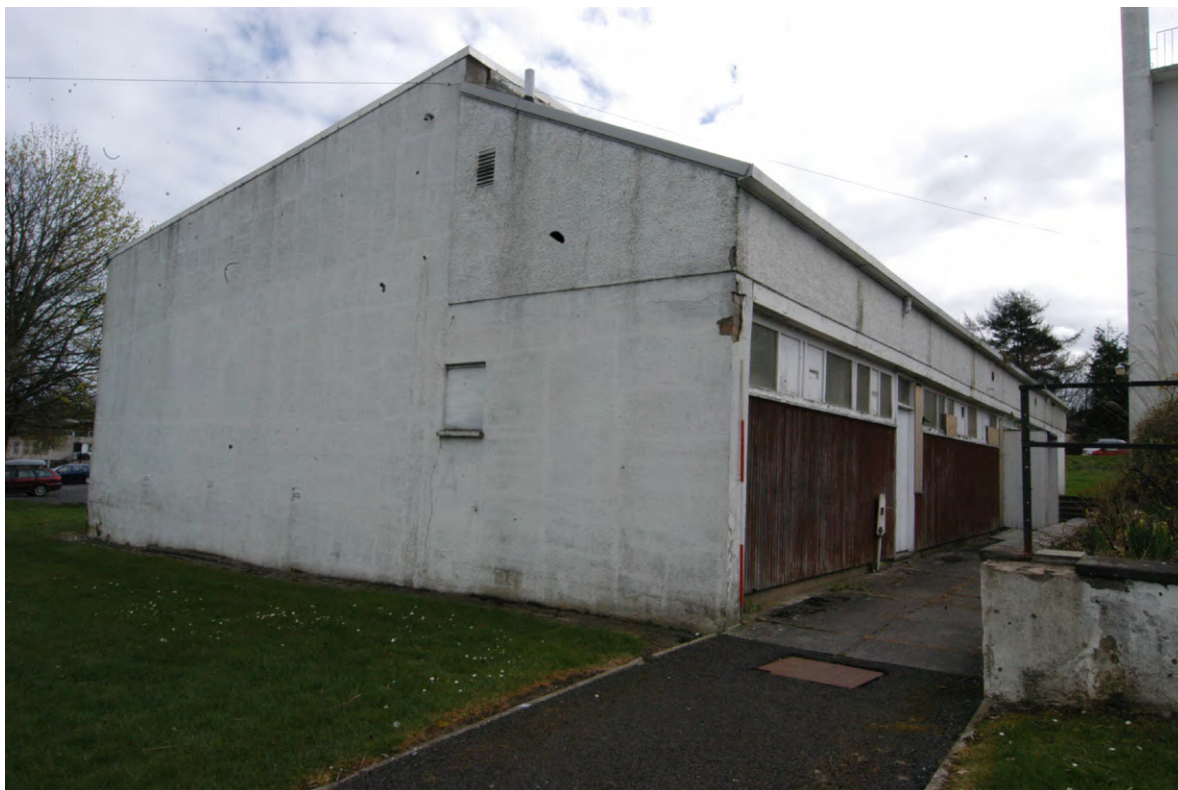
Fig. 13 Church Hall, south-west-facing elevation and north-west-facing gable

The elevation contained three doors. The principal entrance comprised a set of double-leafed doors, flanked by a single paneled door at the north-west end and a third door at the south-east end. The elevation was clad with brown painted planks and surmounted at the north-west end by boarded and frosted clerestory windows. The elevation had a cat-slide roof covered with zinc sheeting.

The north-west-facing gable mirrored the south-east-facing gable but without the attached brick-built chimney. A small boarded window was the only feature.

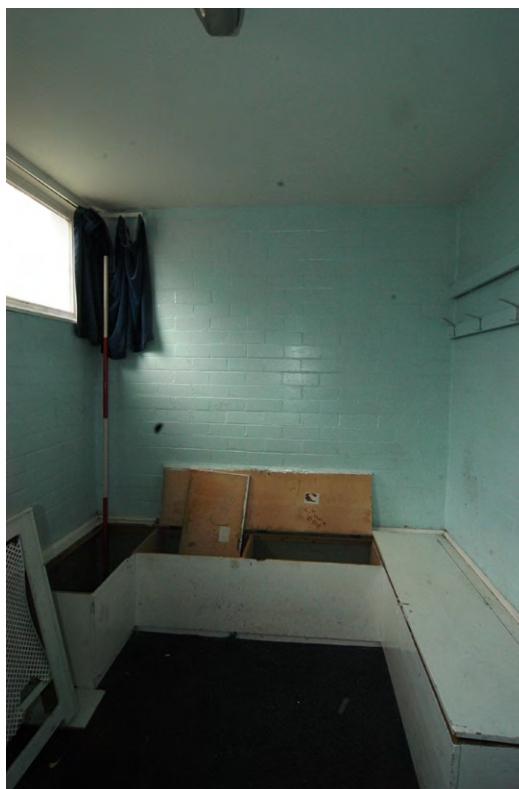
Fig. 16 Church Hall store room, Unit 11

Leading off the kitchen passage were a cleaning cupboard (Unit 10), a storeroom (Fig 16, Unit 11), a cupboard (12) and the kitchen (Unit 13). The kitchen (Fig 17) had modern fixtures and fittings and was lit by clerestory casement windows.

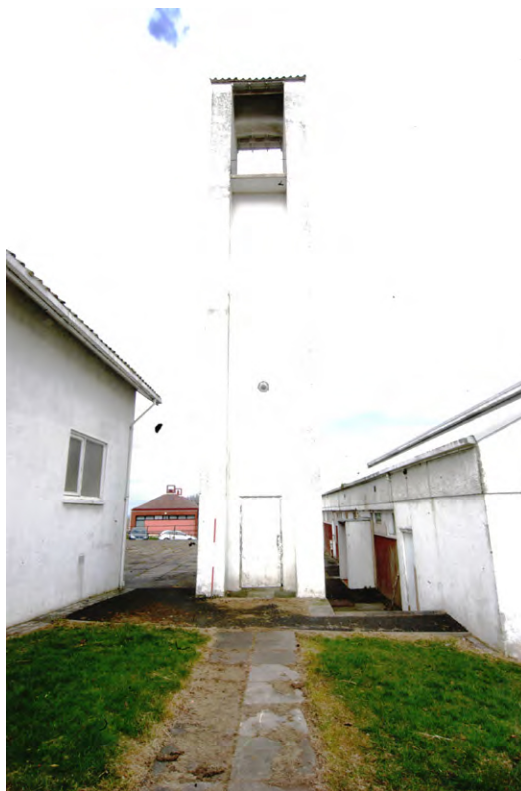
Fig. 18 St John's Church bell tower

The detached bell tower (Fig 18) occupied an H-shaped plan and was a steel-framed and brick-built structure. A steel-covered door was present on the south-east side of the tower. The tower had a small pitched roof covered with pan tiles. The bellcote was open-sided with a steel guard rail on two sides. The sides without the guard rails were pierced with four crucifixes arranged in a diamond formation.

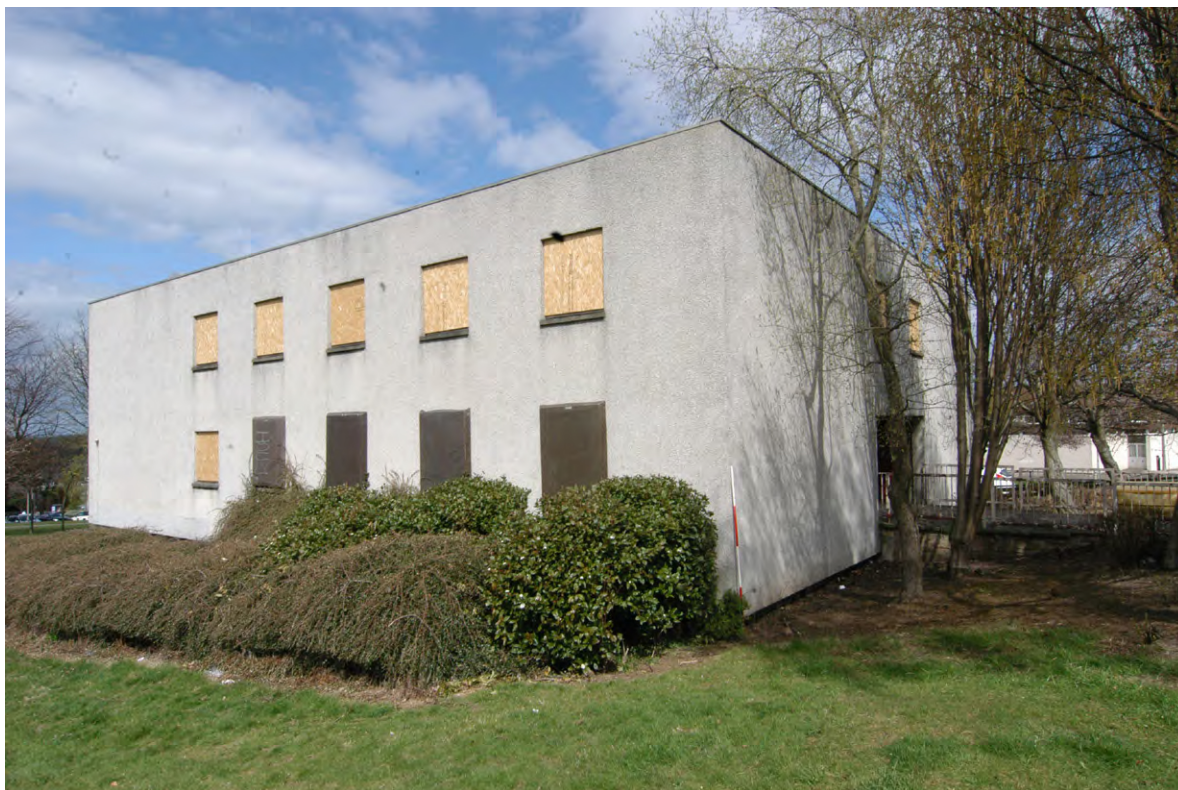
Fig. 19 Social Services building

The two storey Social Services building (Fig 19) occupied a rectangular footprint and had a flat roof. The brick walls were clad with wet-dash render and had five and six bays on the opposing long elevations. The main door was on the south-east-facing elevation. The north-west-facing elevation had five bays. All the windows were boarded.
