## **East Suffolk Road Sports Pavilion Historical Building Survey**

**Report No 3472**

Author	Michael Cressey, BA MSc PhD MCIfA FSA Scot
Illustrator	Graeme Carruthers MA MCIfA
Editor	Bruce Glendinning BSc PG Dip MCIfA
Commissioned by	LDN Architects on behalf of Miller Homes
Date issued	August 2016
Version	1
Grid Ref	NT 27165 71497
Oasis Ref No.	cfaarch1-260949

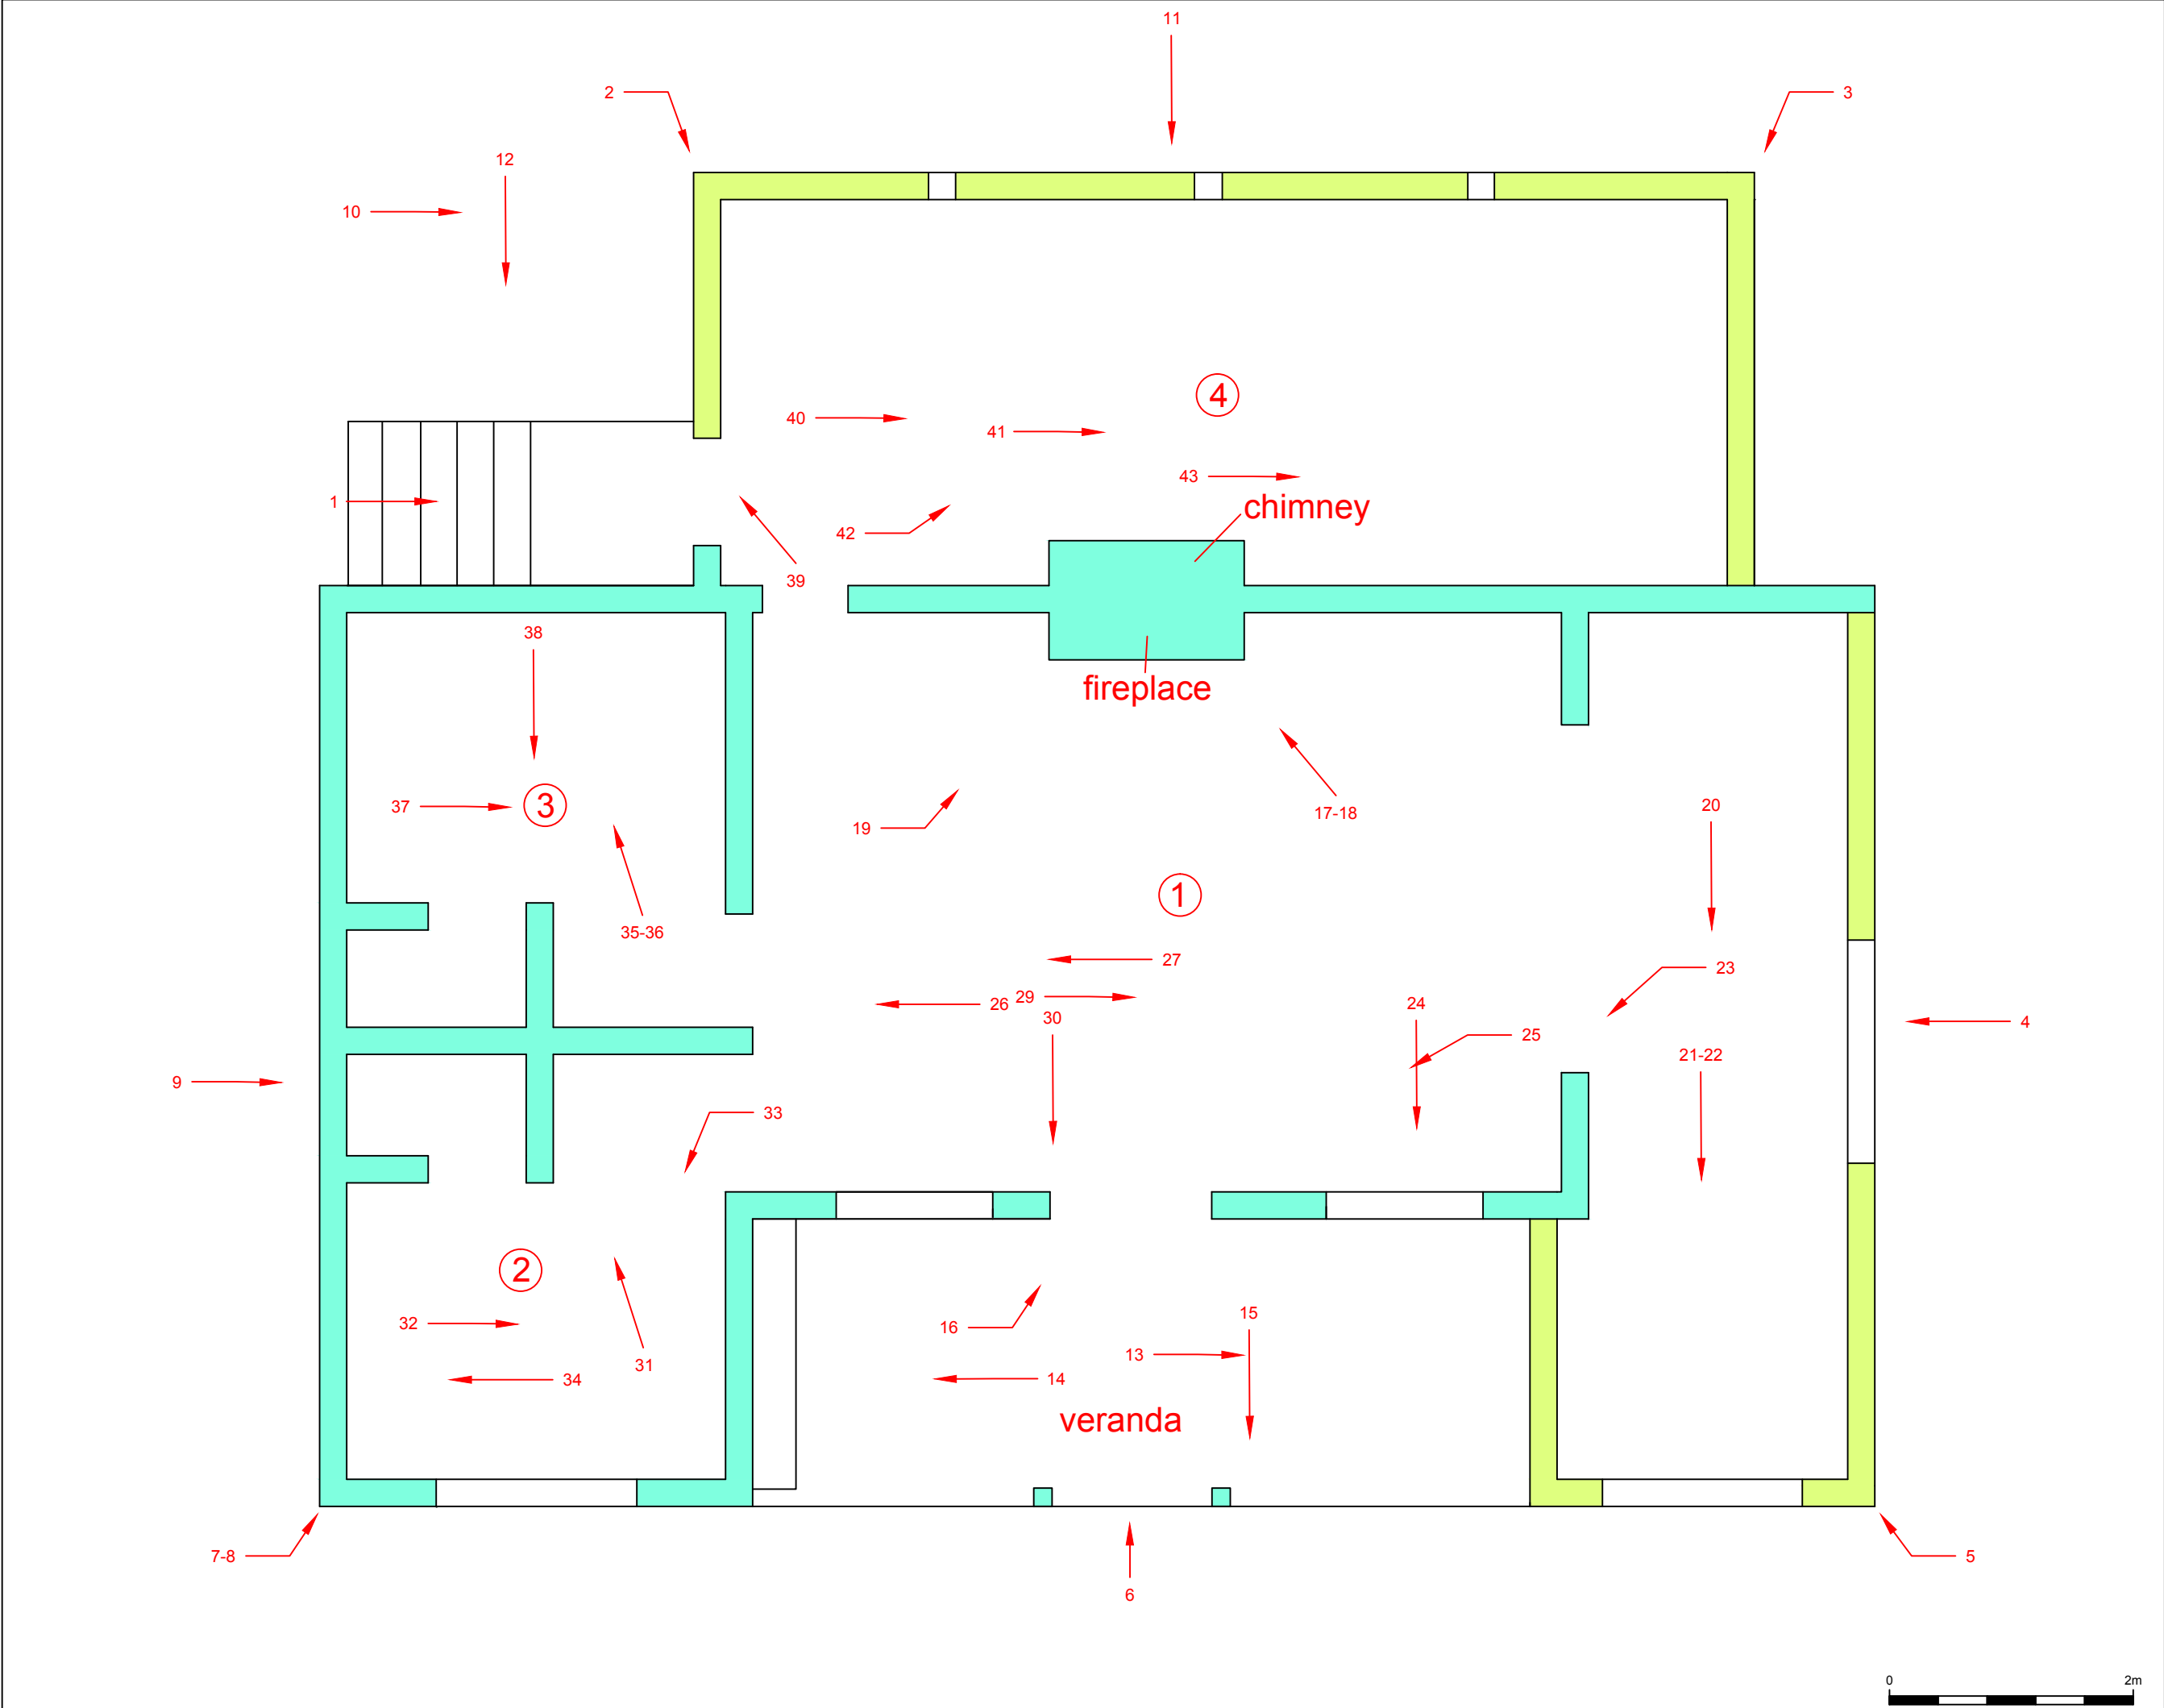
Title:  
Ground plan of the pavillion

The architectural floor plan is shown on Fig 2. The function of each room is summarised in Table 2. There were four individual rooms on the ground floor.

Two main phases are colour coded on Figure 2. The walls shaded in blue represents the original 1895 core block and yellow represents the 1982 east and rear extensions.

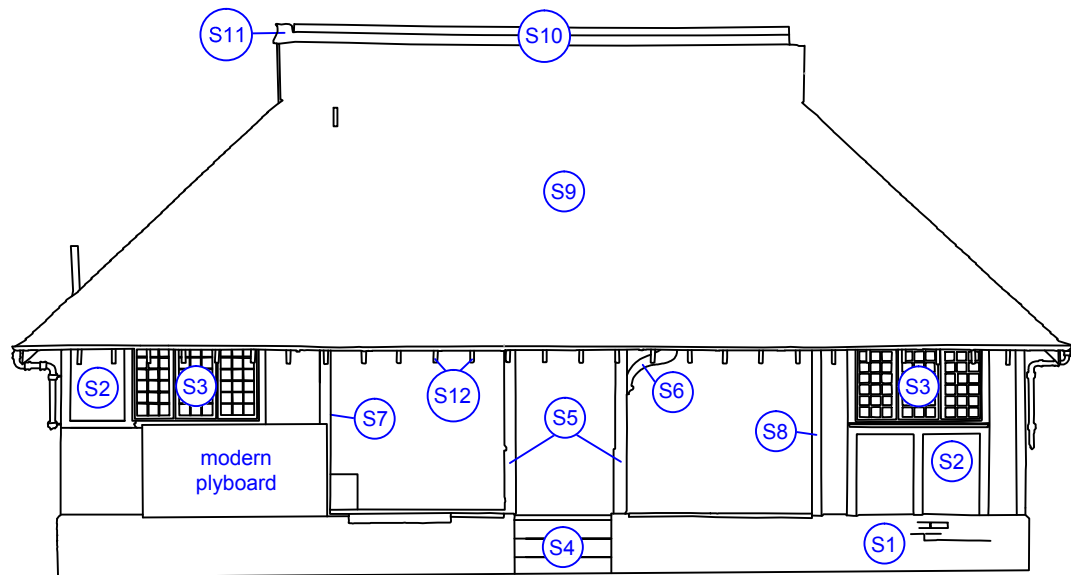
Fig.3a South-facing Elevation

The south-facing elevation measured 12.7m long x 3.4m from ground to eaves level. The main features include a brick-built foundation plinth (S1) laid in stretcher-bonded brick. The walls were timber-framed with lath-and-plaster lining (S2). Two casement windows (S3) were present, with one at end of the elevation. The veranda was accessed by brick steps (S4). Two timber upright posts flanked the steps (S5). The post on the east side of the steps had a curved bracing timber (S6) in-situ. Originally there were two braces on either side of the upright posts and one at either end of the veranda. Both posts contained sockets for a missing hand rail. The interior of the veranda contained a timber-framed and panelled wall at its west end (S7). The opposing wall was featureless (S8).

The hipped roof was covered with grey slate (S9) and capped with terra-cotta ridge tiles (S10). A terra-cotta finial base (S11) survived on the west side of the roof. The pitch of the roof was 45 degrees and was supported on A-framed timber rafters (S12) which were carried down to form wide eaves.

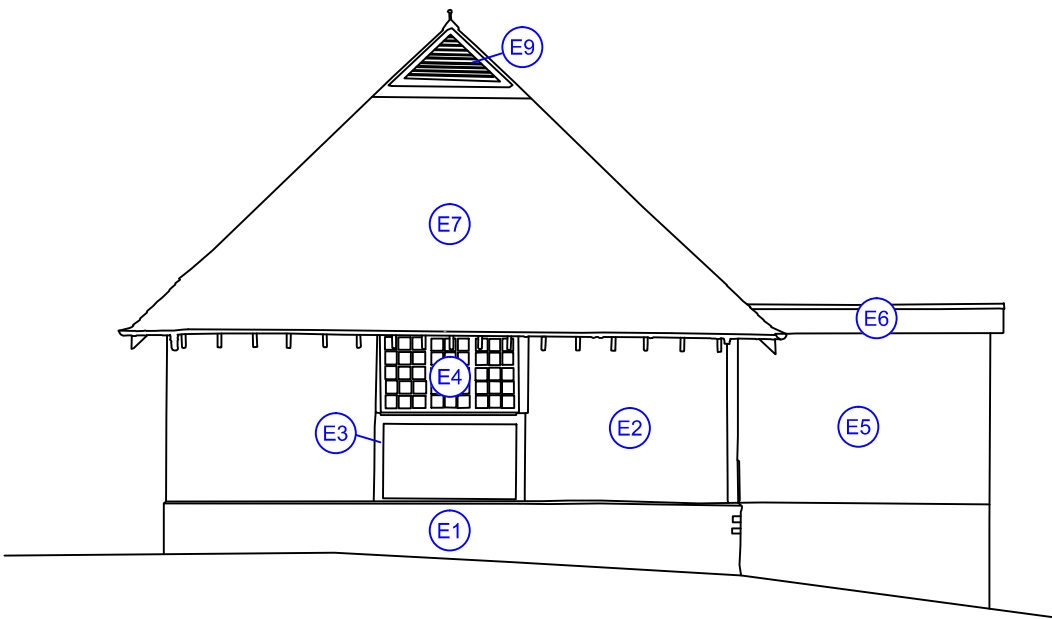
Fig.3b East-facing Elevation

The east-facing elevation measured 10.5m x 3.4m to eaves level. The elevation had a red-painted brick foundation layer laid in stretcher bond (E1). The cream painted walls were plain pebble-dash render (E2). Timber framing (E3) was exposed below a central boarded-up casement window (E4). The north-side of the wall had a return angle measuring 1m where it met the mono-block built wall (E5) of the later extension. This extension had a plain wooden facia board (E6) below its flat roof. The hipped roof of the main block was covered with slate (E7). A small triangular wooden louver vent (E8) was present near the base of the ridge (E9).

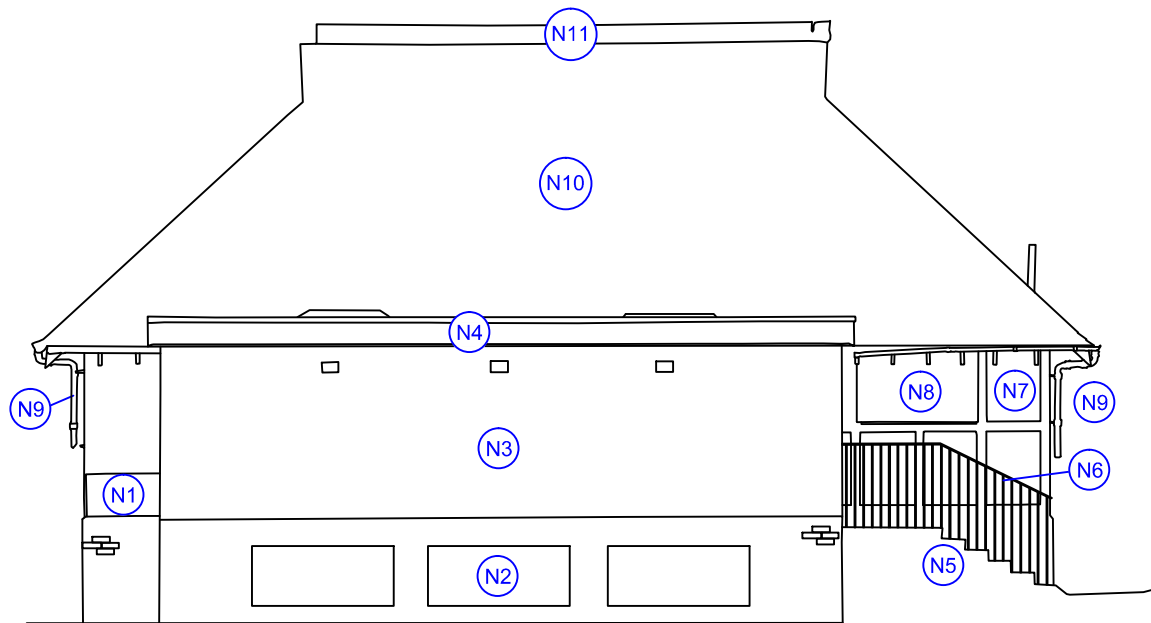
Fig.3c North-facing Elevation

The north-facing elevation measured 12.7m x 3.4m to eaves level and comprised the return wall of the main block (N1) that had a brick-built foundation wall. The rest of the elevation comprised the featureless pebble-dash covered wall of the 1980s extension (N3) which had a timber facia board (N4) below its flat roof. Set back at a distance of 3.3m was a set of concrete steps (N5) with a metal hand rail (N6) leading up to the fire door in Room 4. The elevation flanking the steps was timber-framed (N7) with lath and plaster panelling covered with pebble-dash cement render. A boarded up window (N8) was also present on the same wall. At each end of the

elevation there was a broken cast-iron rain water pipe (N9). The hipped slate roof (N10) had terracotta ridge tiles (N11).

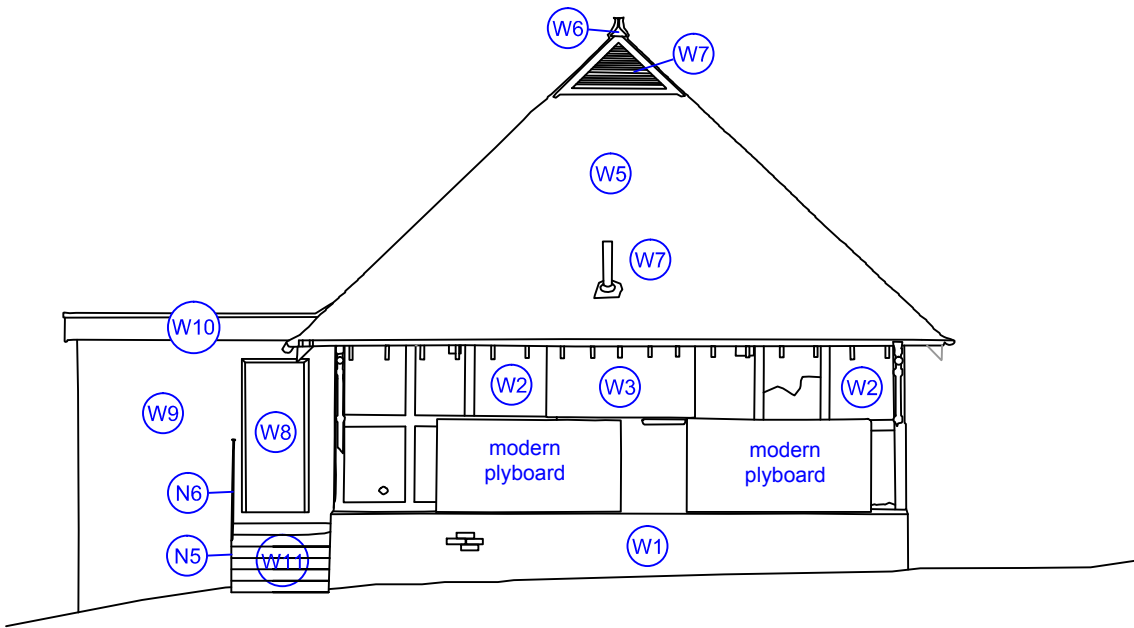
Fig.3d West-facing Elevation

The west-facing elevation measured 10.5m x 3.4m to eaves level and rested on a red-painted brick foundation wall (W1) laid in stretcher bond. The wall itself was timber-framed with panels infilled with laths covered with cream-painted pebble-dash cement render (W2). A central window (W3) had been boarded-up. The hipped roof was covered with slate (W4). A pipe vent (W5) was present at its centre. Below the terracotta ridge (W6) was a triangular shaped louver vent (W7). A terra-cotta base for a finial was present on the end of the ridge.

On the north side of the elevation were the aforementioned concrete steps and hand rail leading to the fire door (W8) in Room 4. The wall of the extension (W9) on the north side of the fire door was featureless and surmounted by a timber fascia board (W10).

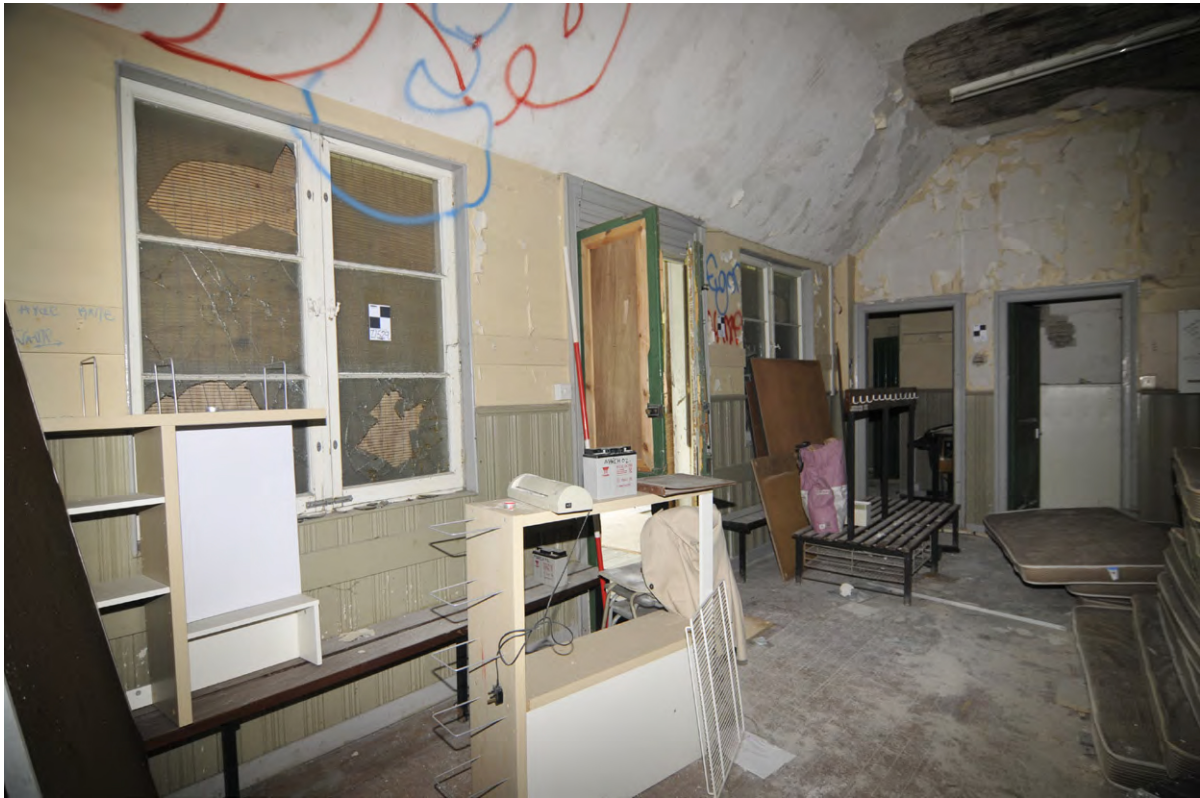
The north-facing elevation within the extension contained a plain grey-painted panelled wall with a treble casement window each with 18 panes. The flanking walls were featureless. The north-facing elevation within the main room was lined with panelling to dado height with two boarded-up double casement windows with three panes. The windows flanked a double-leaved panelled doorway.

Fig. 4 Room 1, internal N-facing elevation

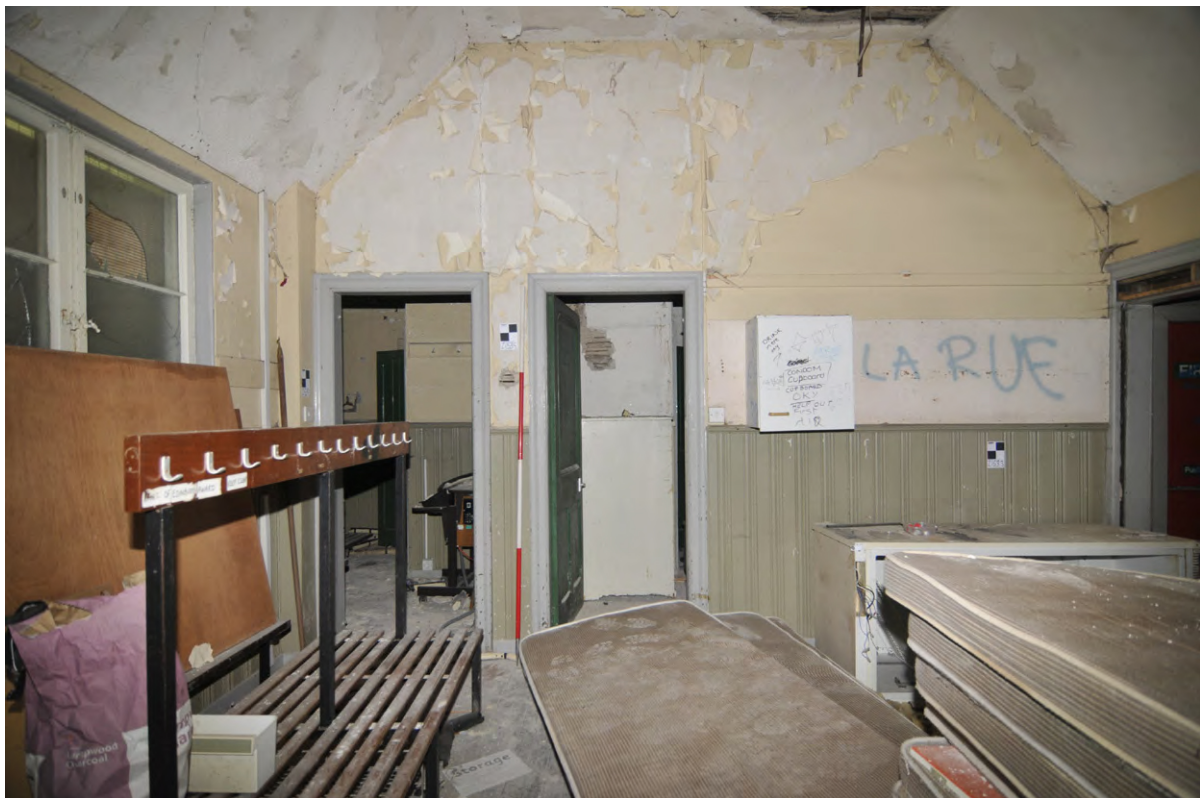
The east-facing elevation was panelled to dado height and the wall above was whitewashed. It contained doorways into Rooms 2-3. The door frames were grey painted.

Fig. 5 Room 1, internal E-facing elevation

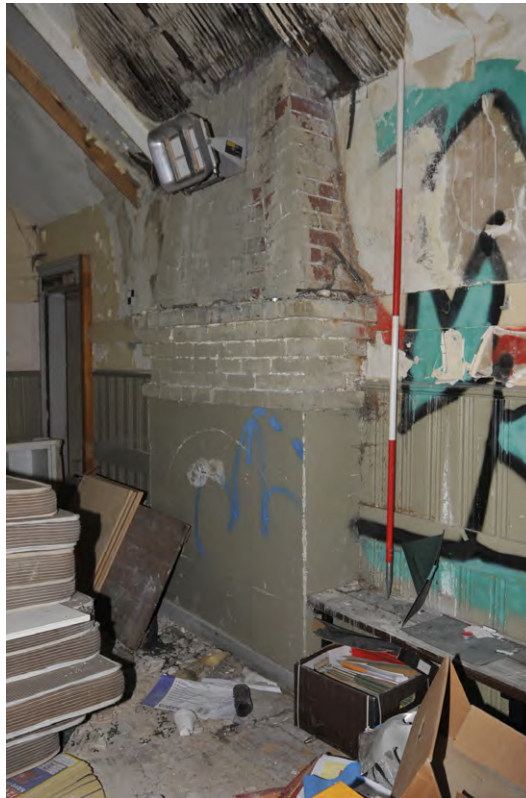
The internal south-facing elevation contained a brick-built off-centre blocked fireplace with a brick-built hood that extended up to the combed ceiling.

The walls flanking the fireplace comprised grey-painted panelling to dado height. The walls above the panelling were cream-painted and contained coat hook rails. A bench was present on both sides of the fireplace. The south-facing elevation on the east side of Room 1 was hidden behind a pile of mattresses but the same grey-painted panelled walls were present. At the west end of the elevation was a doorway that led into Room 4.

Fig. 6 Room 1, internal S-facing elevation

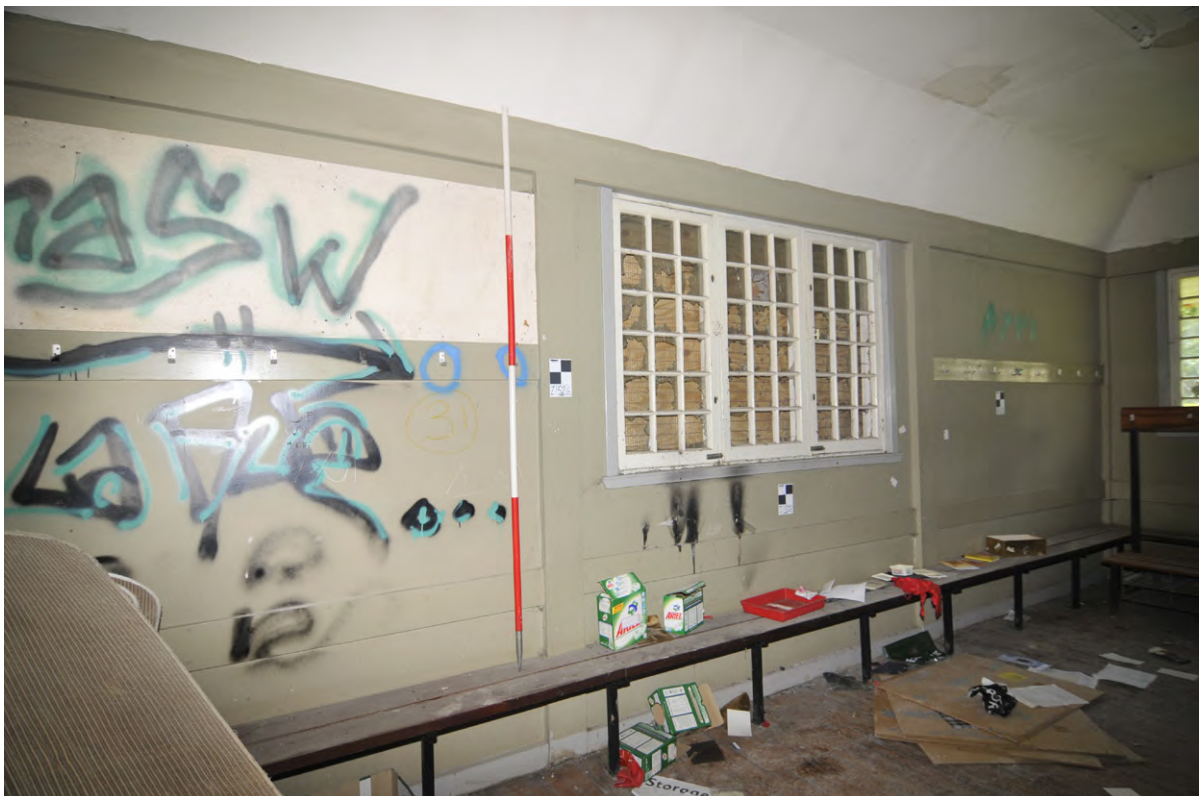
The internal west-facing elevation was within the later extension (see below) and it had pale-grey painted panelled walls with a centrally placed side hung treble casement windows each with 18 square panes. A bench ran the full length of the wall.

Fig. 7 Room 1, internal W-facing elevation

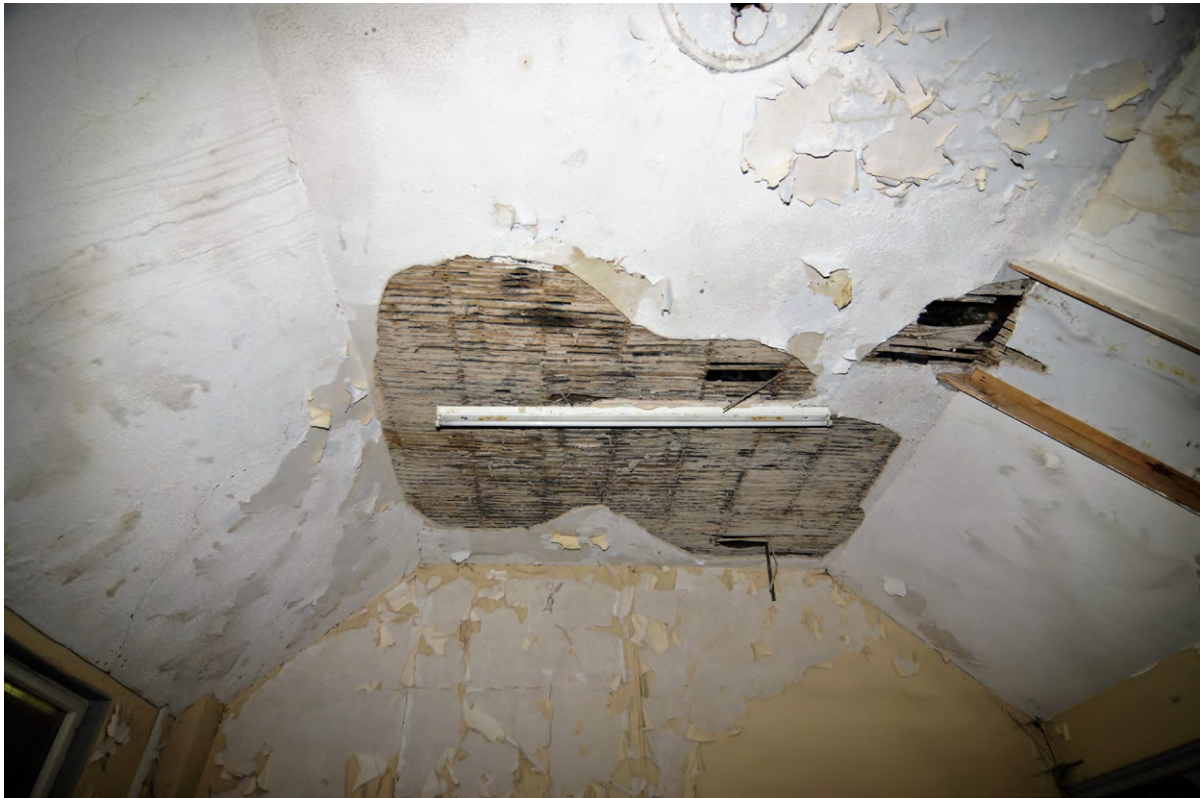
The ceiling was combed within the main room and within the later extension. Lath and plaster was exposed at the west end (Fig 8) and above the fireplace due to water damage. The floor comprised varnished tongue-and-grooved planks.

Fig. 8 Room 1, lath and plaster ceiling

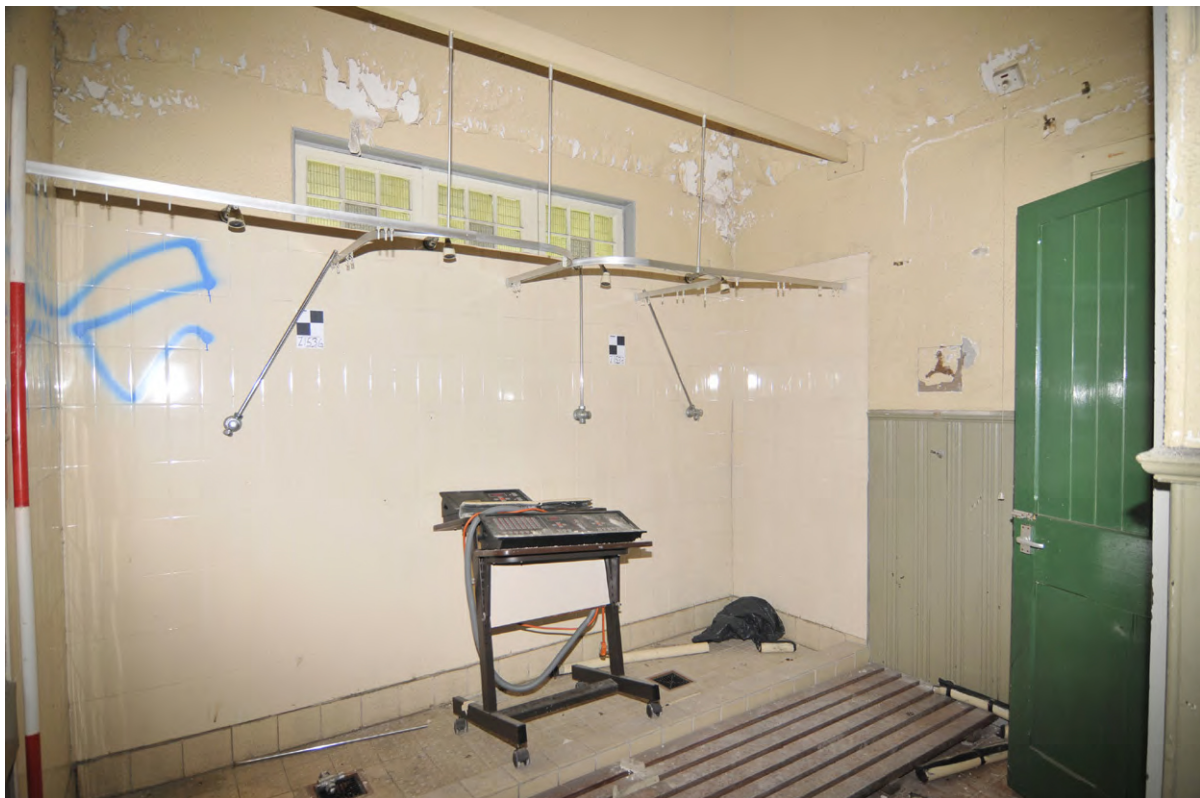
The north-facing elevation contained the shower area that was lined with cream tiles with a sunken shower floor. Three small windows with frosted glass were situated above the tiled wall.

Fig. 9 Room 2, internal N-facing elevation

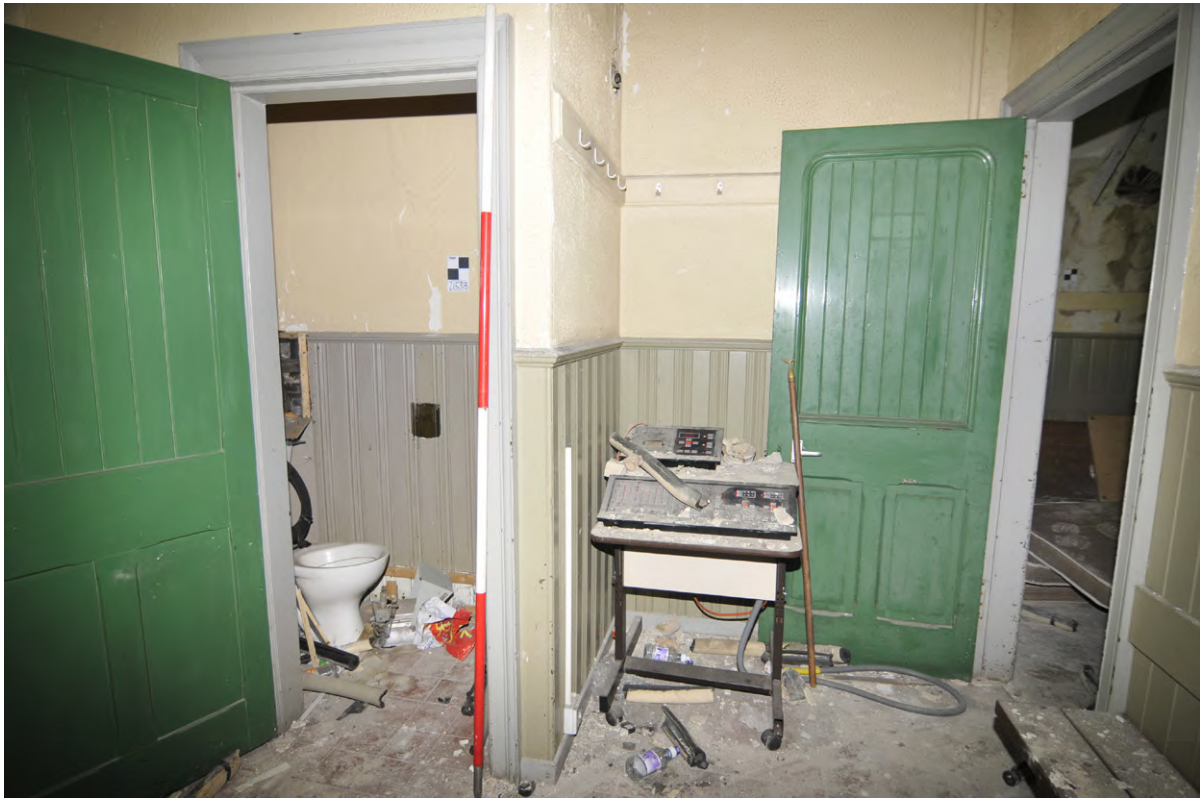
The south-facing elevation contained the cream-painted wall of the toilet that had a grey-painted panelled wall to dado height. The wall outside the toilet was also panelled to dado height with a plain cream-painted wall above.

Fig. 10 Room 2, internal S-facing elevation main door and toilet

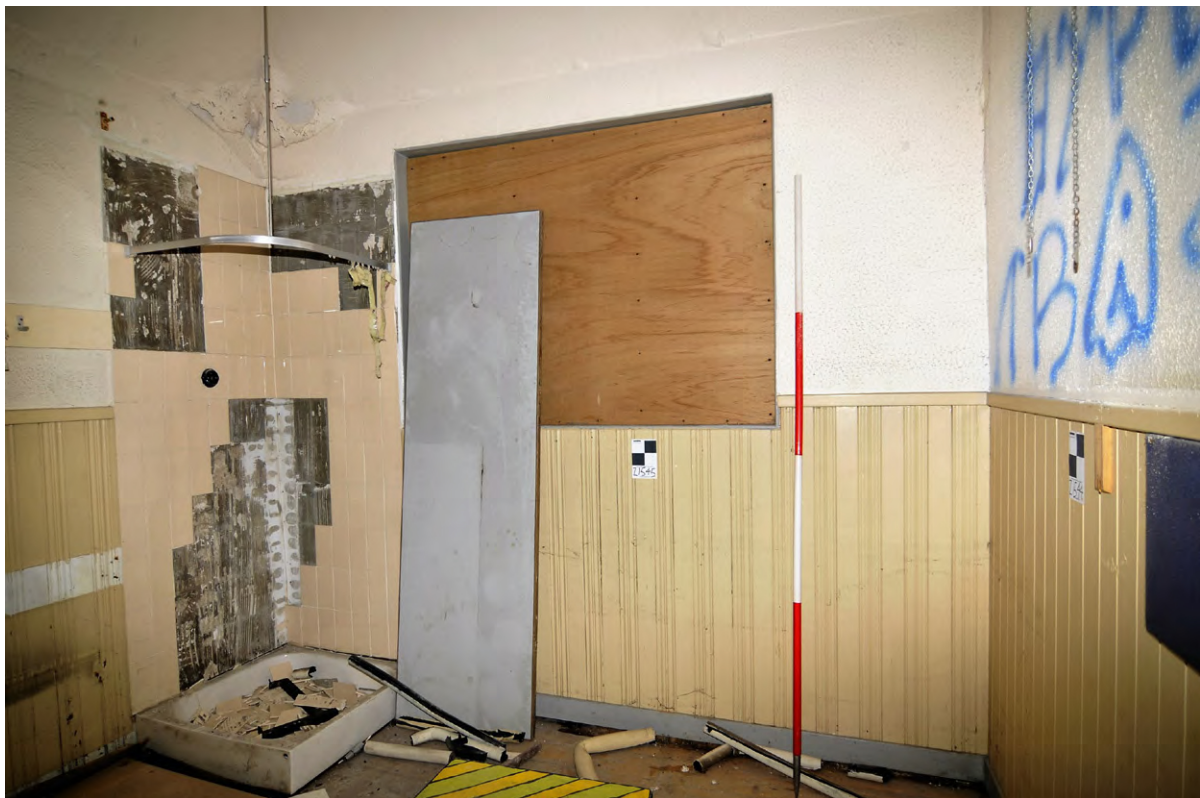
The south-facing elevation was panelled to dado height with a cream-painted wall above that was partly tiled within a shower cubicle. A large rectangular boarded window was also present just above the dado rail.

Fig. 11 Room 3, S-facing elevation

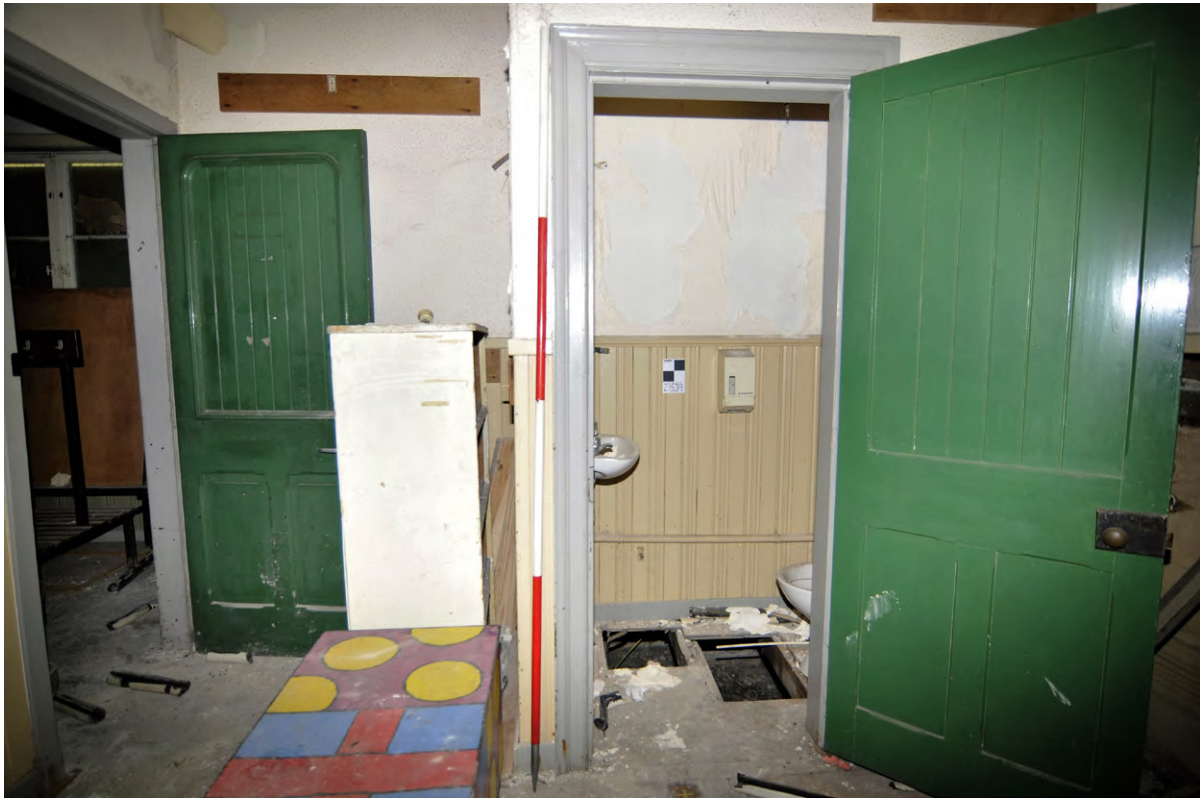
The north-facing elevation had a plain panelled wall to dado height which continued round the wall and into the toilet cubicle. The wall above the panelling was featureless.

Fig. 12 Room 3, internal N-facing elevation

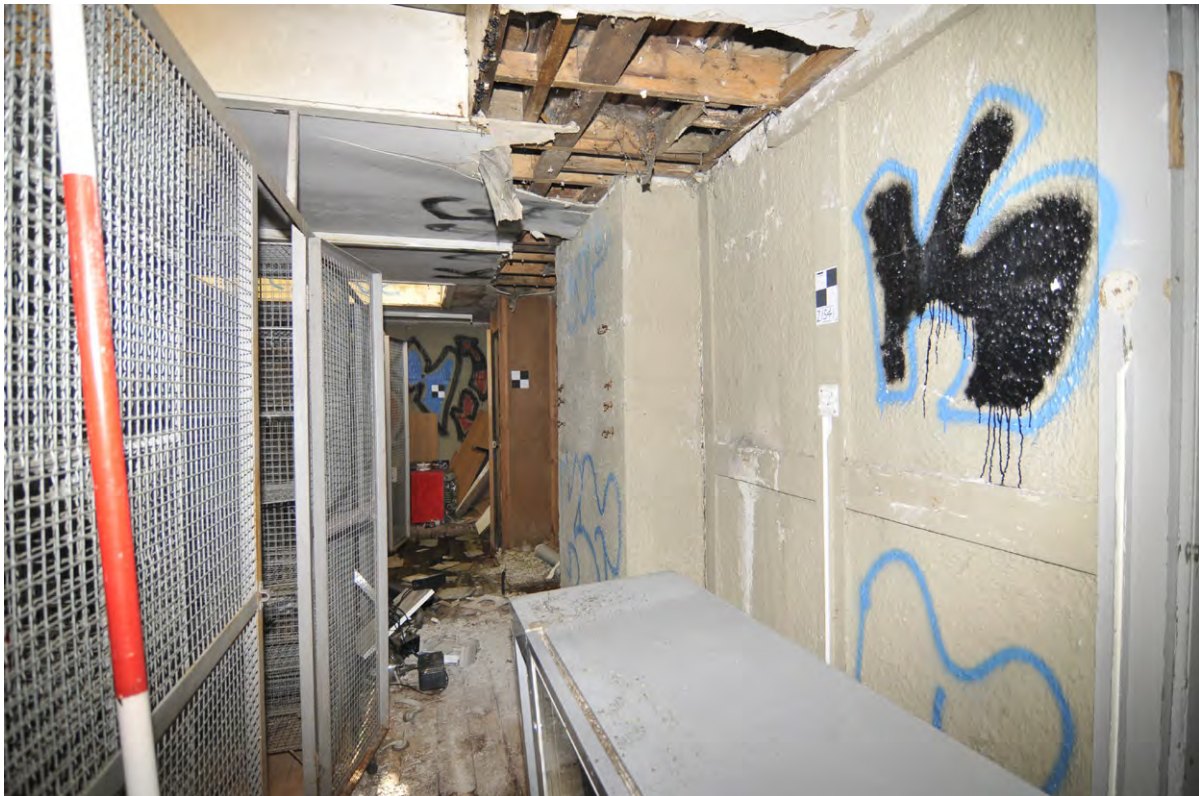
A door into Room 1 was situated at the west end of the north-facing elevation. The elevation was timber-framed with large plastered panels. Towards the centre of the elevation was a brick-built chimney. This wall was the original rear north-facing elevation prior to the construction of the later extension. The aforementioned door was a contemporary insertion.

Fig. 13 Room 4, internal N-facing wall (former outside wall of the pavillion)

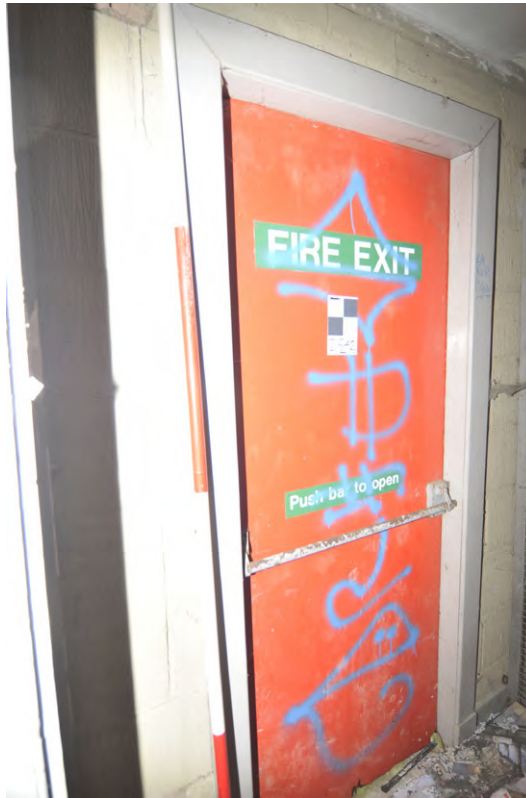
The east-facing elevation was featureless with the exception of a red-painted fire door with a push-bar. The door was set within a plain white-painted wooden door surround.

Fig. 14 Room 4, internal E-facing fire door

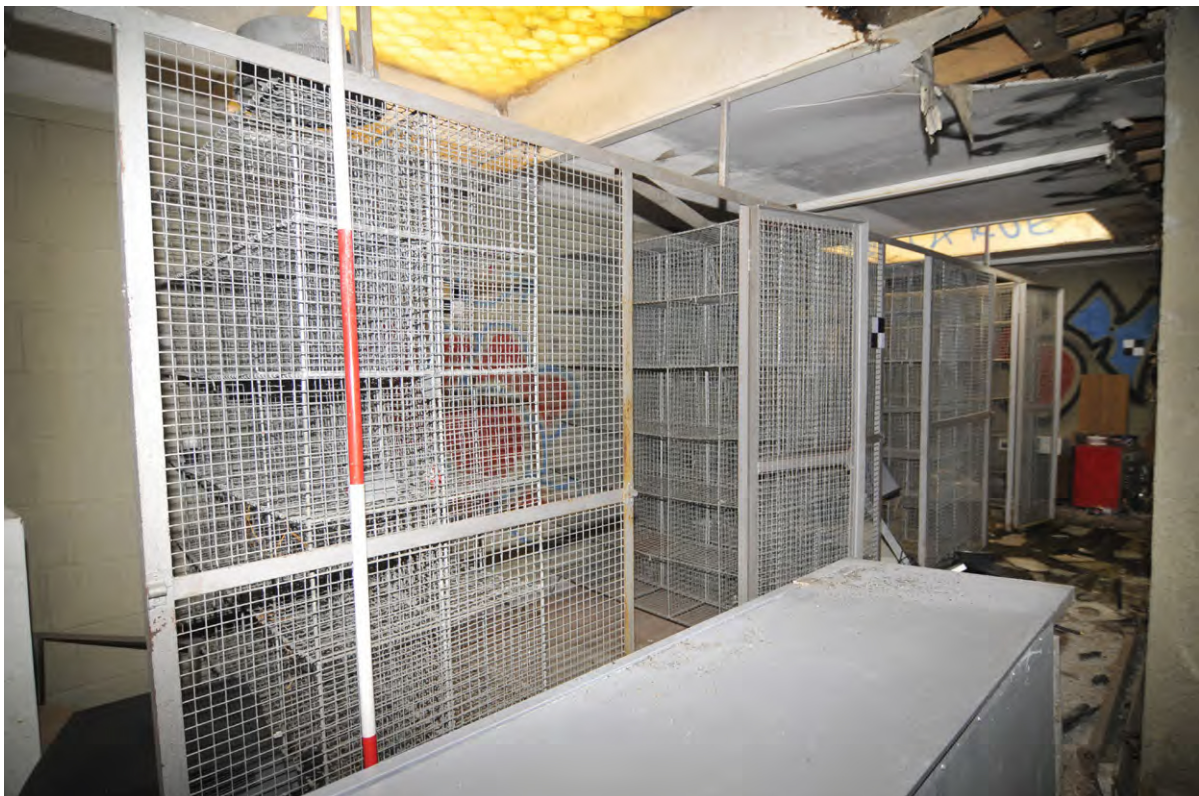
The south-facing elevation was constructed of concrete mono-blocks and was masked behind a series of cage lockers.

Fig. 15 Room 4, internal S-facing elevation hidden behind storage cages

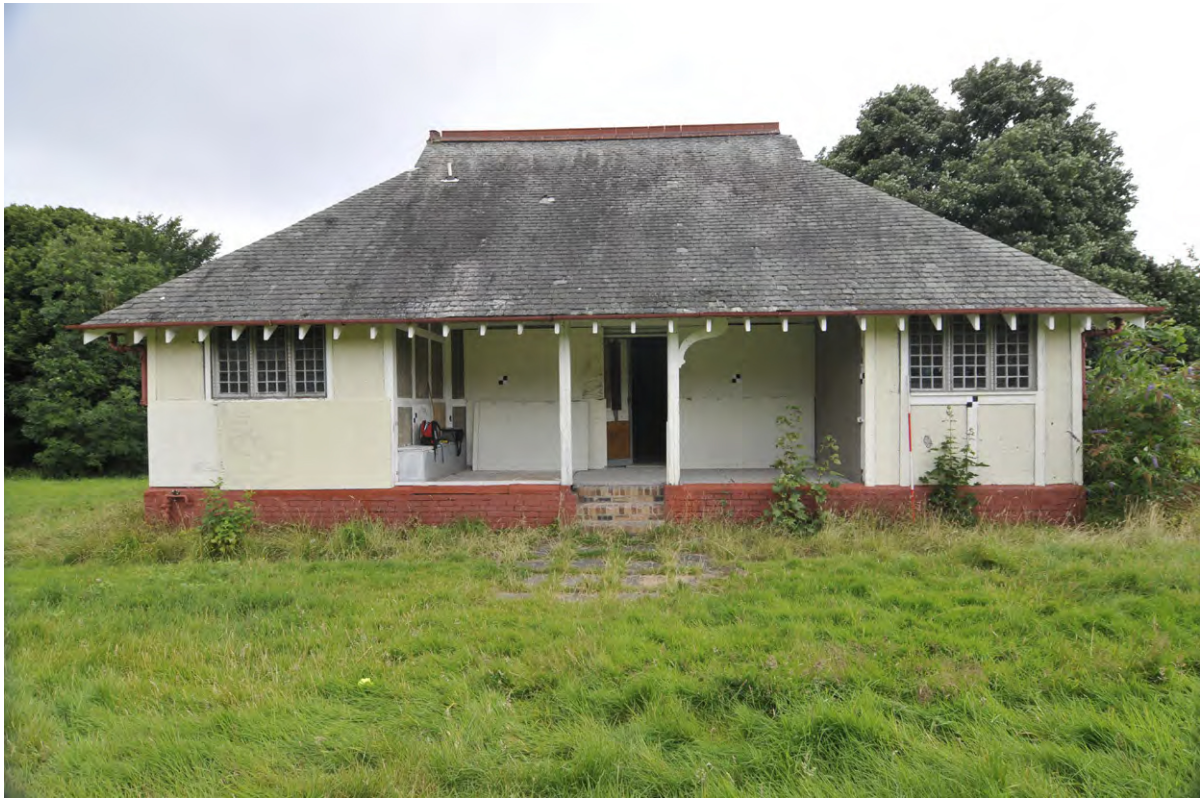
Fig. 16 External S-facing elevation

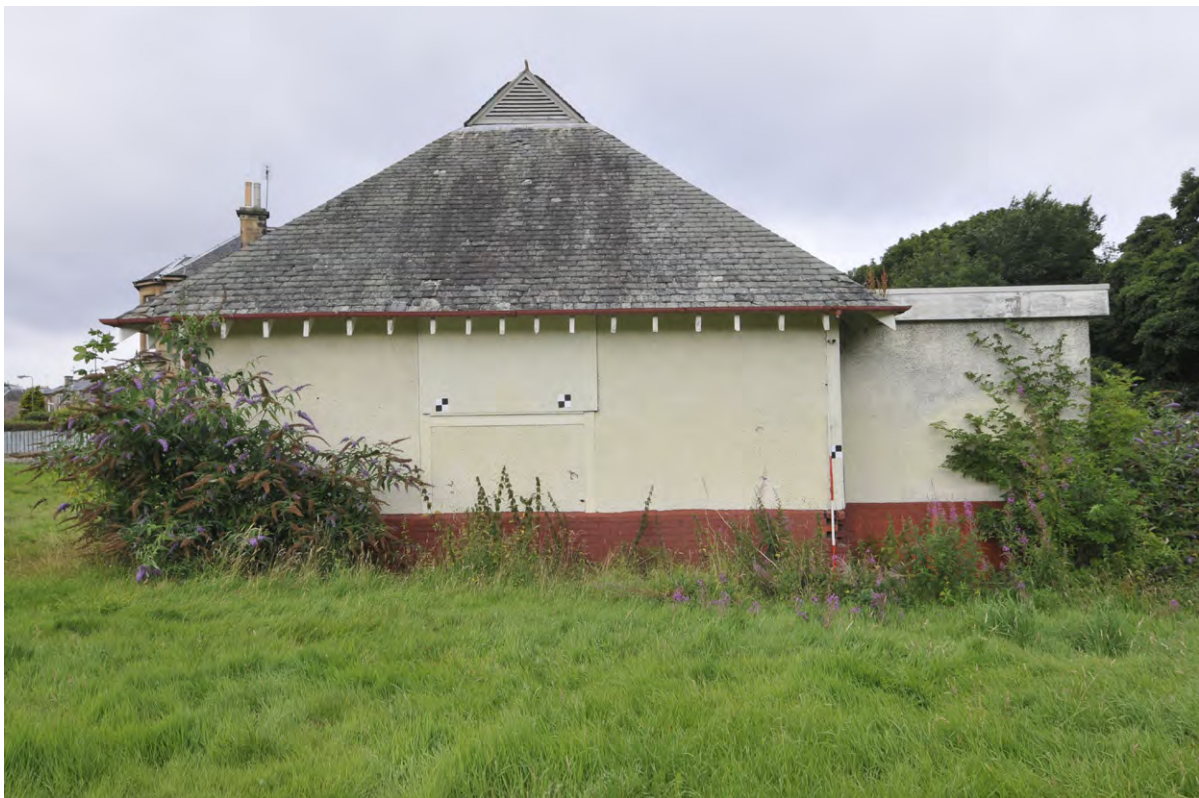
Fig. 17 External E-facing elevation

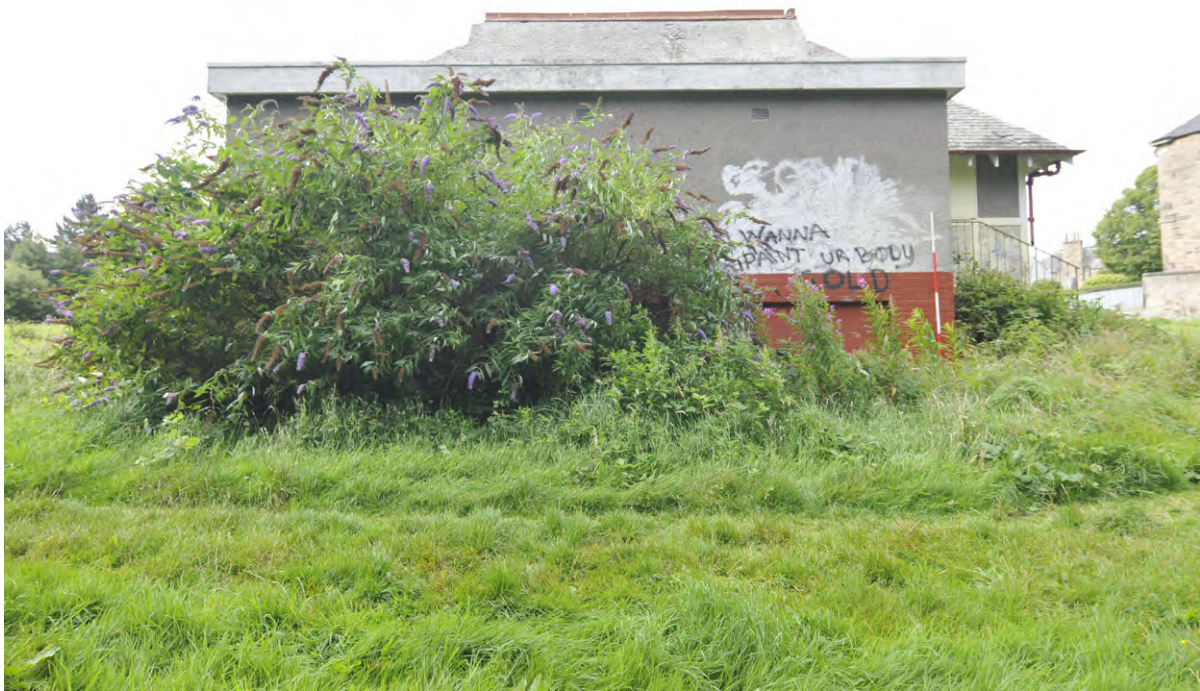
Fig. 18 External N-facing elevation

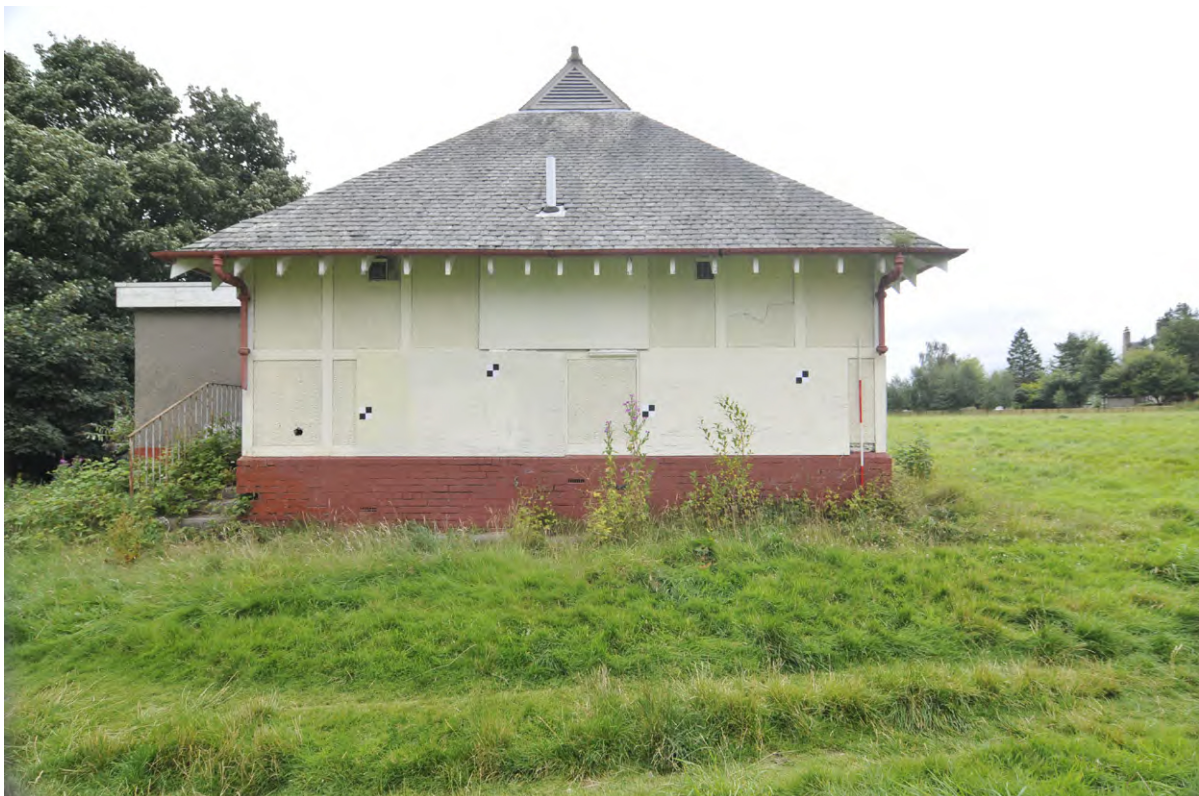
Fig. 19 External W-facing elevation
