## **East Suffolk Road Sports Pavilion Historical Building Survey**

**Report No 3472**

Author	Michael Cressey, BA MSc PhD MCIfA FSA Scot
Illustrator	Graeme Carruthers MA MCIfA
Editor	Bruce Glendinning BSc PG Dip MCIfA
Commissioned by	LDN Architects on behalf of Miller Homes
Date issued	August 2016
Version	1
Grid Ref	NT 27165 71497
Oasis Ref No.	cfaarch1-260949

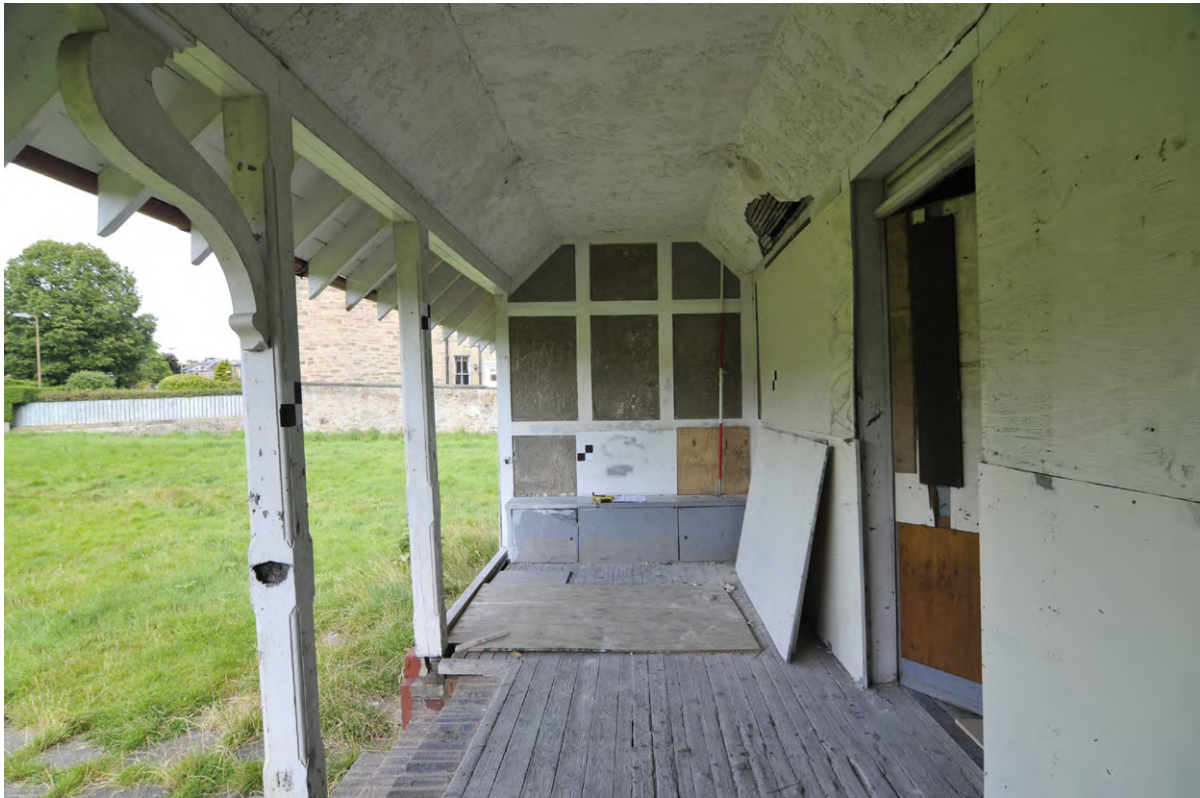
The evidence of these changes is clearly visible in the buildings footprint and the external fabric of the building. The eastern extension has thinner walls than the main core block. The 1982 rear extension is constructed of mono-blocks resulting in the thickest walls within the building footprint. The original timber framing and infilled panels of the west-facing elevation (W2) contrasts sharply with the plain featureless wall (E2) on the east-facing elevation. Probably due to the cost implications, no attempt was made to replicate the former timber-frame detail. The interior elevations at each end of the veranda (Figs 20 and 21) also reflect the same disparity in fabric detail.

Fig. 20 E-facing timber-framed veranda wall

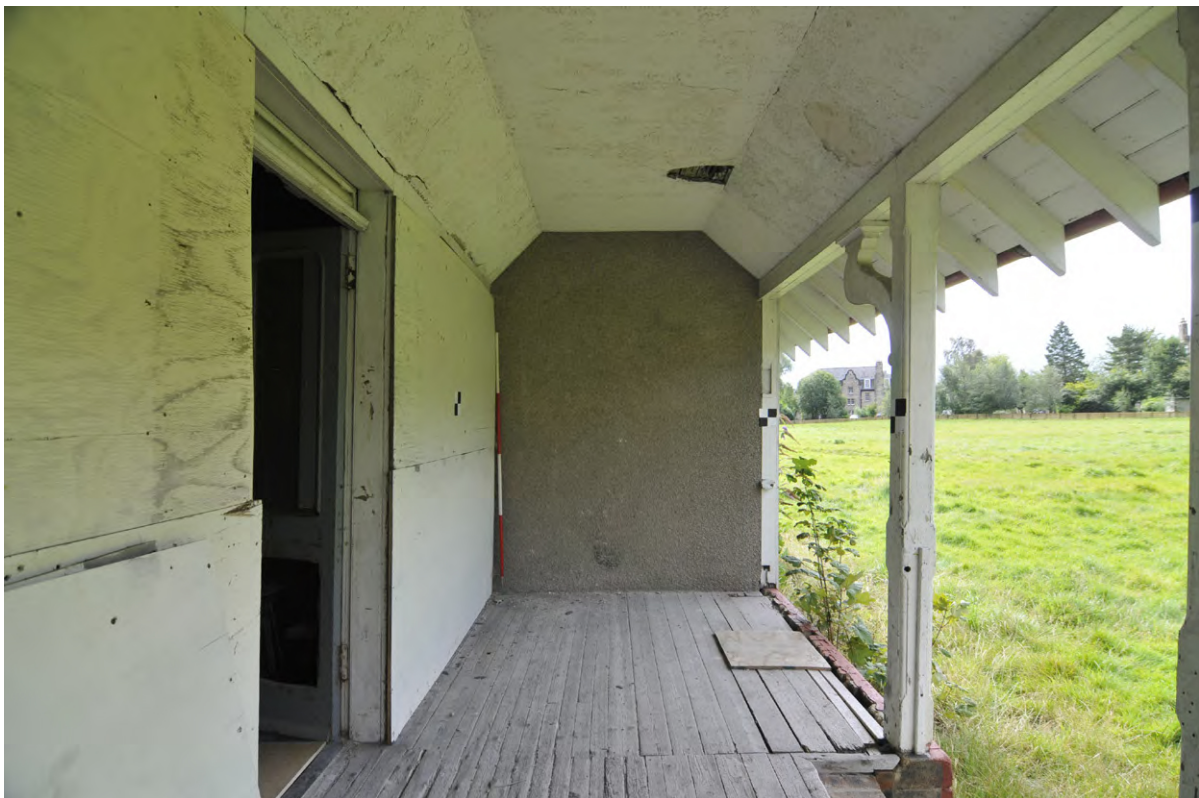
Fig. 21 W-facing featureless veranda wall
