## Riddle's Court, Lawnmarket, Edinburgh (Phase 2)

Historical Building Survey & Archaeological  
Watching Briefs  
Report No. 3423

**Historical Building Survey Recording and  
Archaeological Watching Briefs**

**Report No. 3423**

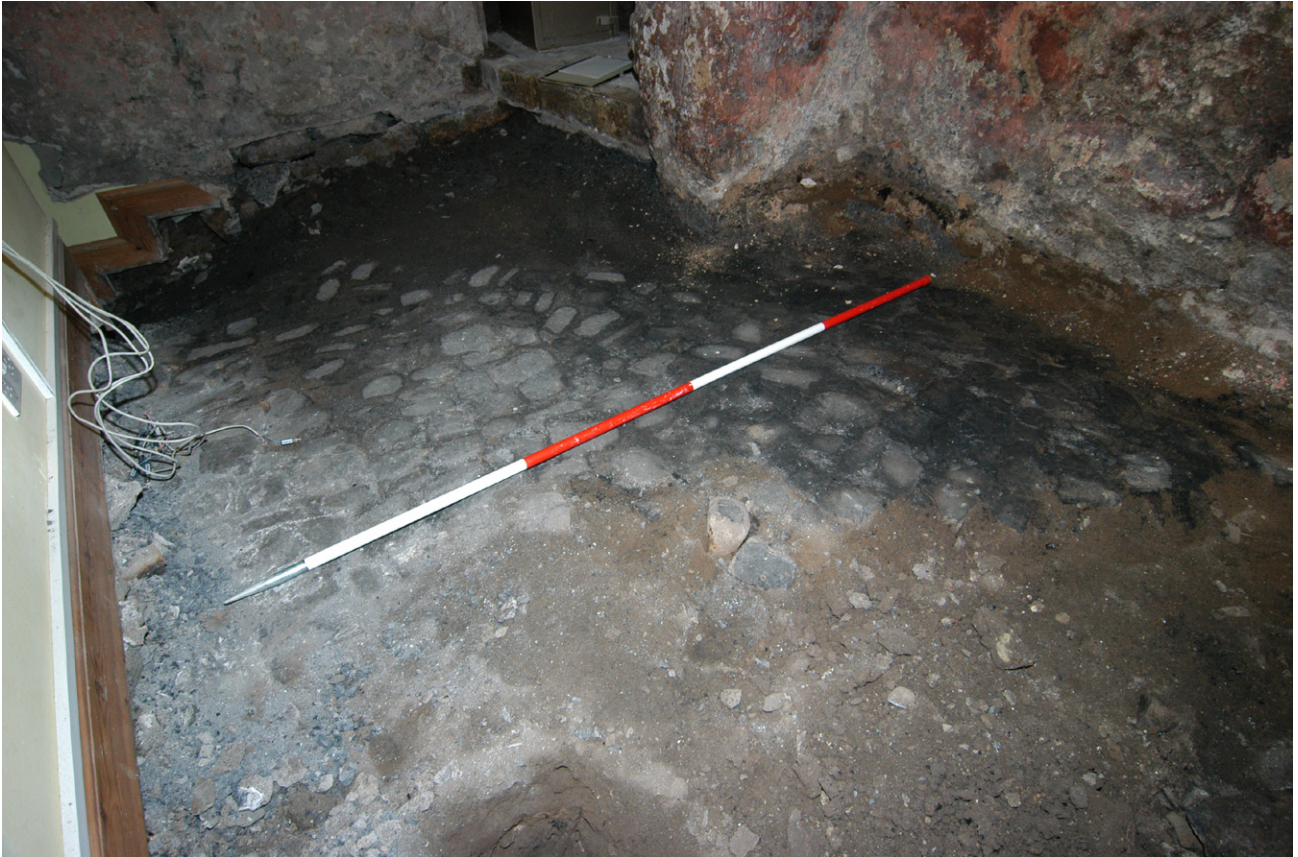
Basement Room B.10 was formerly a rear office with a vaulted ceiling. The walls were stripped of modern cladding and the rectangular concrete floor taken up to accommodate a lift shaft pit. The floor measured 4m by 2.4m and was aligned east-west. To the north was a smaller rectangular concreted floor with an opening into a blocked intra-mural staircase that formerly led to Room F12. Following the removal of the 100mm thick concrete floor (B10/001) a cobble floor (B10/002, Fig 3) was revealed. The well worn cobbles were randomly laid. Fragments of coal were abundant and in some places the cobbles were sealed by coal dust. Below the cobbles was a layer of very compact clay (B10/003) rich in charcoal and oyster shell fragments.

Fig. 3a - Cobble floor (B1/003) recorded in the Basement Room B10

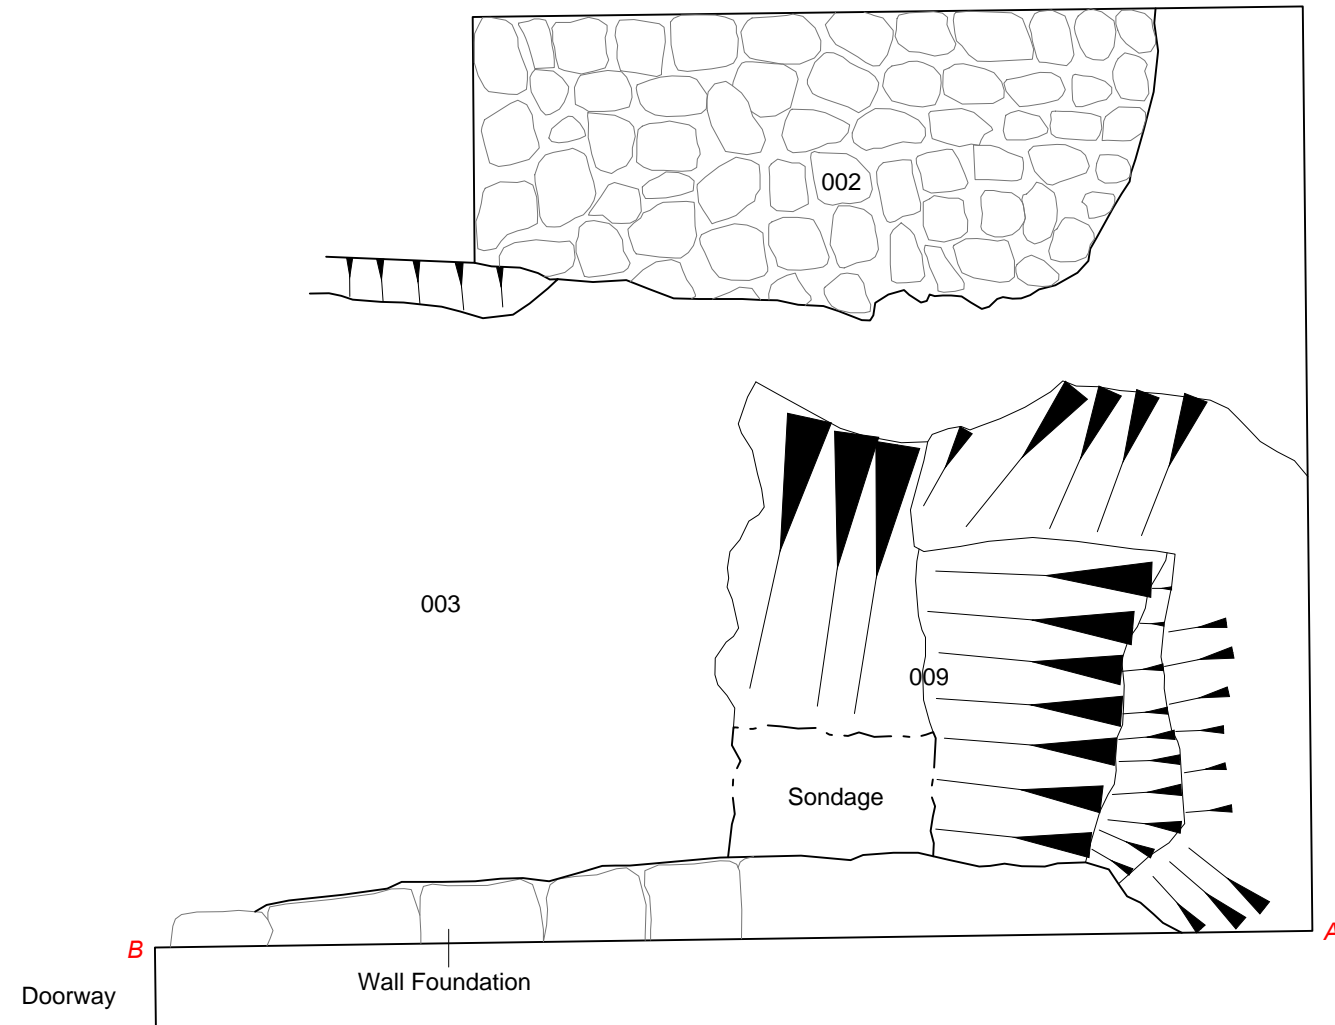
At the north-west corner of the basement was the opening for the intra-mural staircase (B10/005). Running north-south under the concreted floor (B10/001) was a cast-iron water pipe (B10/006) set within a shallow cut (B10/007) c.0.12m deep. As the compact clay (B10/003) was reduced by 0.36m, the footings of the east-west aligned basement wall (B10/008) were revealed and found. The footings comprised sandstone boulders of variable size ranging between 0.45m x 0.2m to smaller rectangular blocks measuring 0.15m x 0.10m. The footings extended outwards off the main wall alignment. Natural bedrock (B10/009) was exposed at depth of 0.65m below the wall footings. The bedrock had vertical and sloping edges that fell with an acute angle. Following the removal of the clay (B10/003) the sondage bottomed out onto natural bedrock.

Fig. 3b - Plan of the lift-shaft pit dug in Room B10

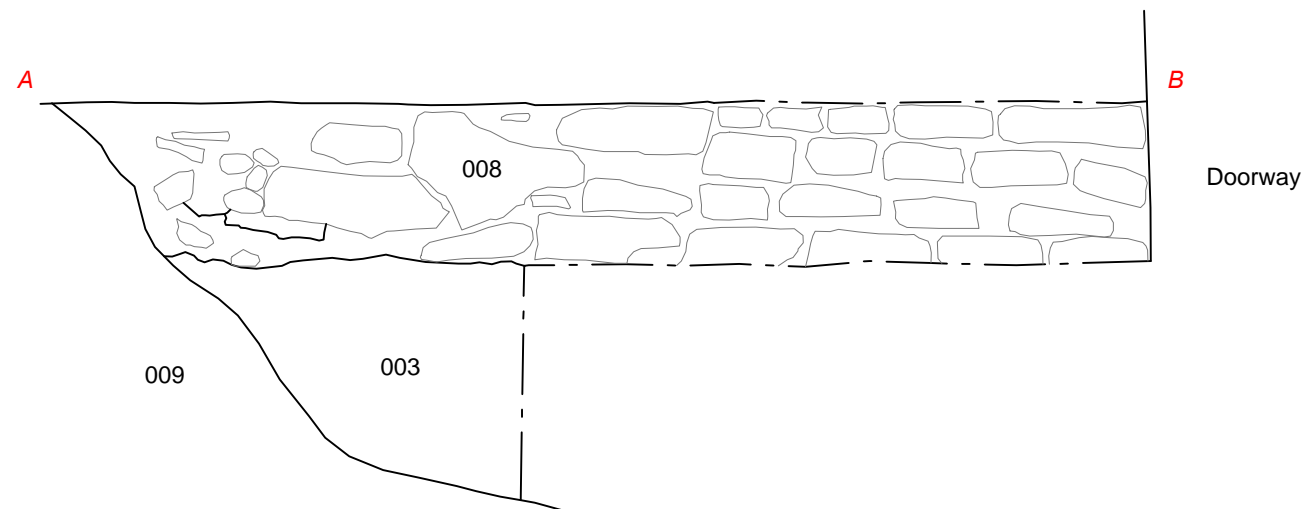
A section exposed on the interior north-facing elevation within B.10 was recorded (Fig 3c). Wall foundations (B10/008) were exposed to a depth of 0.4m and comprised coursed and rubble sandstone bonded with lime mortar. The wall rested directly on top of bedrock (B10/009) at the east end and a 0.6m deep layer of compact clay (B10/003) with variable amounts of charcoal within it, suggesting it was a dump deposit. A foundation trench for wall B10/008 was not visible.

Fig. 3c - North-facing section recorded in the lift-shaft pit in Room B10

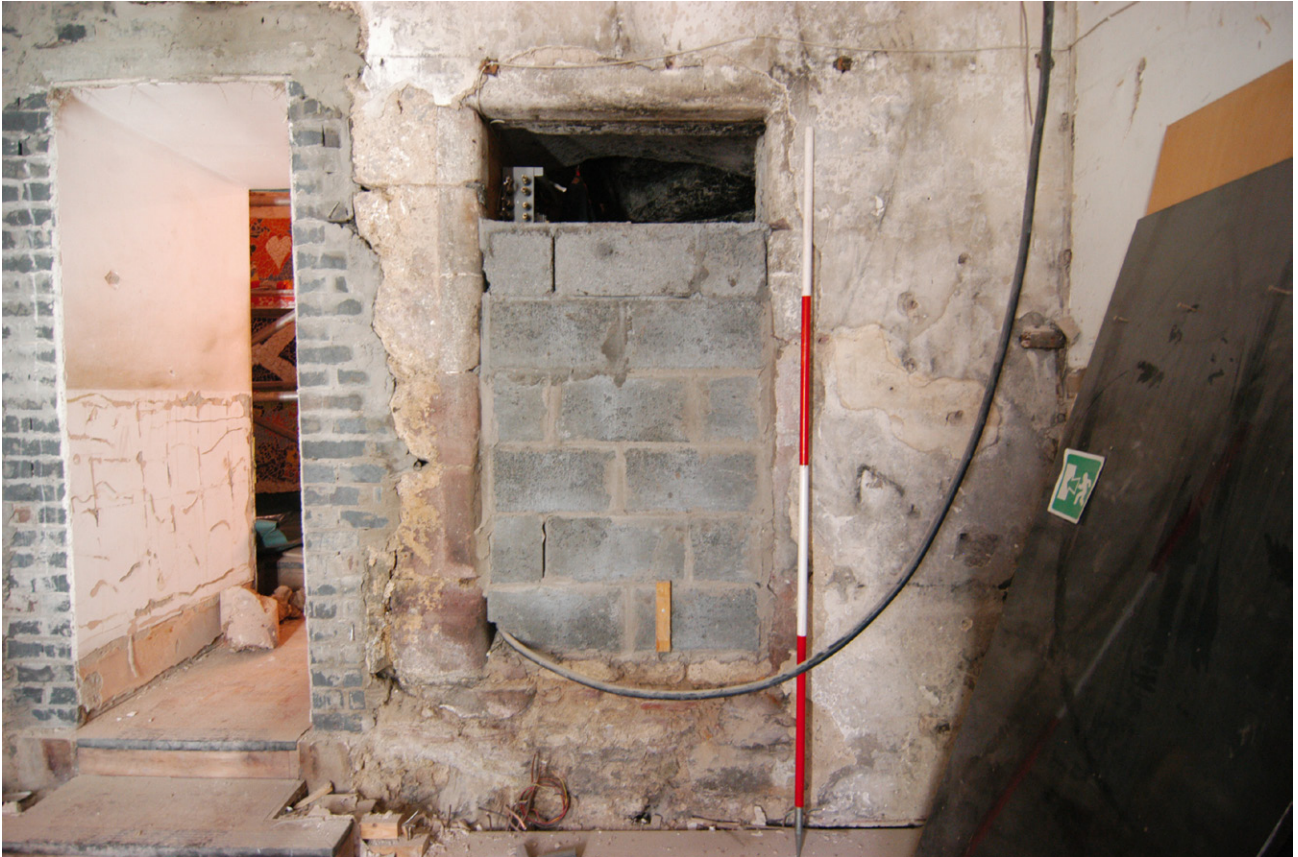
Fig. 4 - An early 16th century doorway in Basement Room B02 with modern blocking

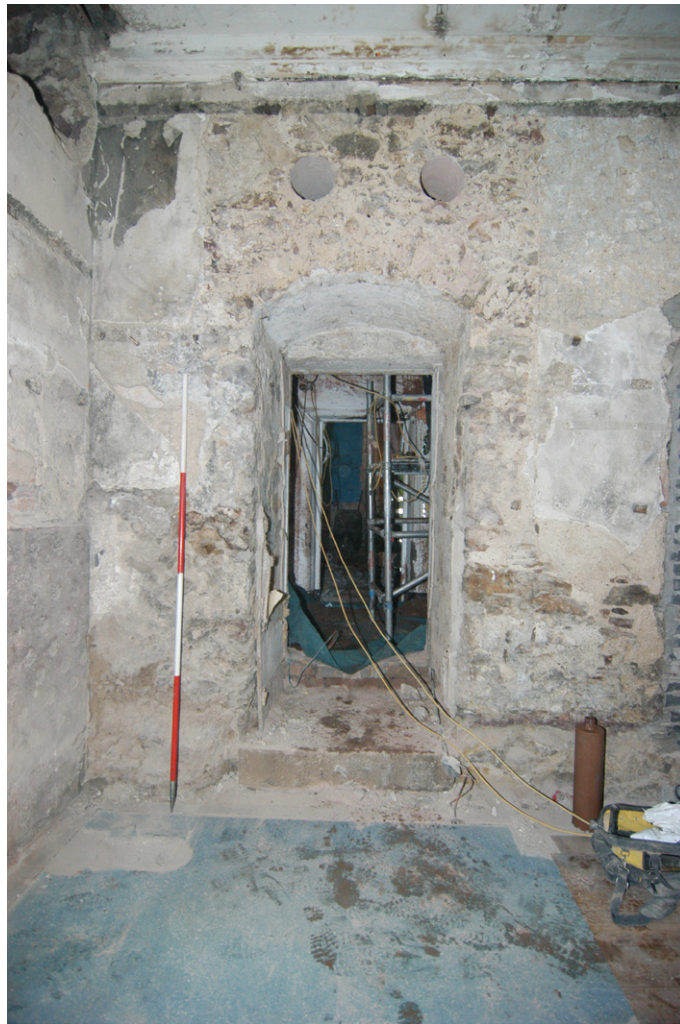
Fig. 5 - An early 16th century arched doorway in Basement Room B02 leading into a former vaulted cellar

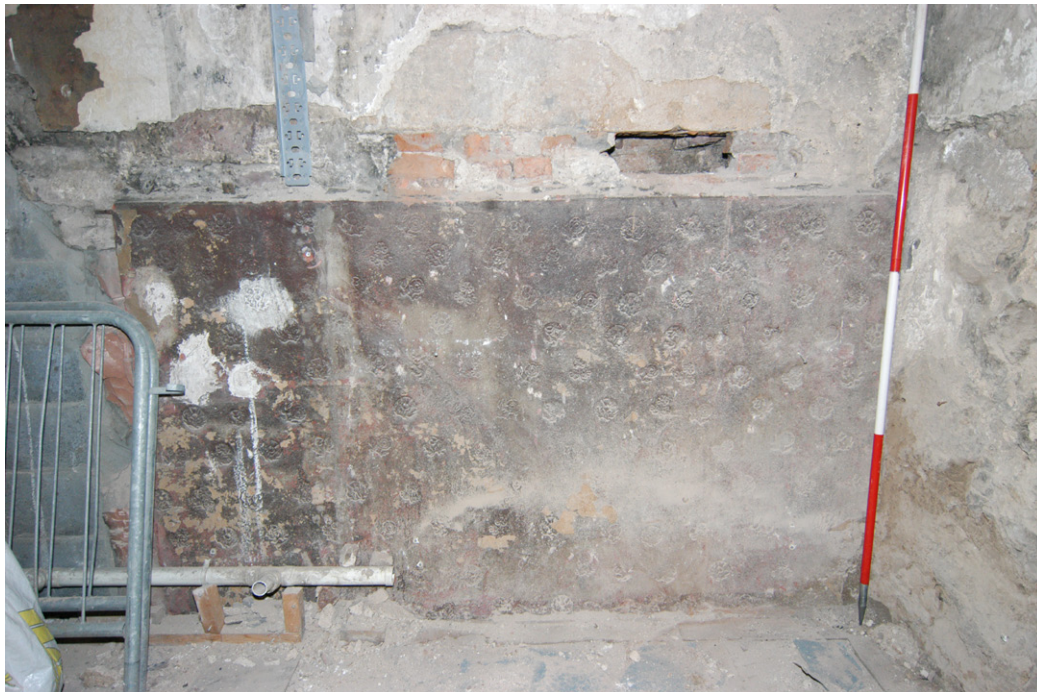
Fig. 6 - A cement panel with butter-press impressions including roses, thistles and shamrocks

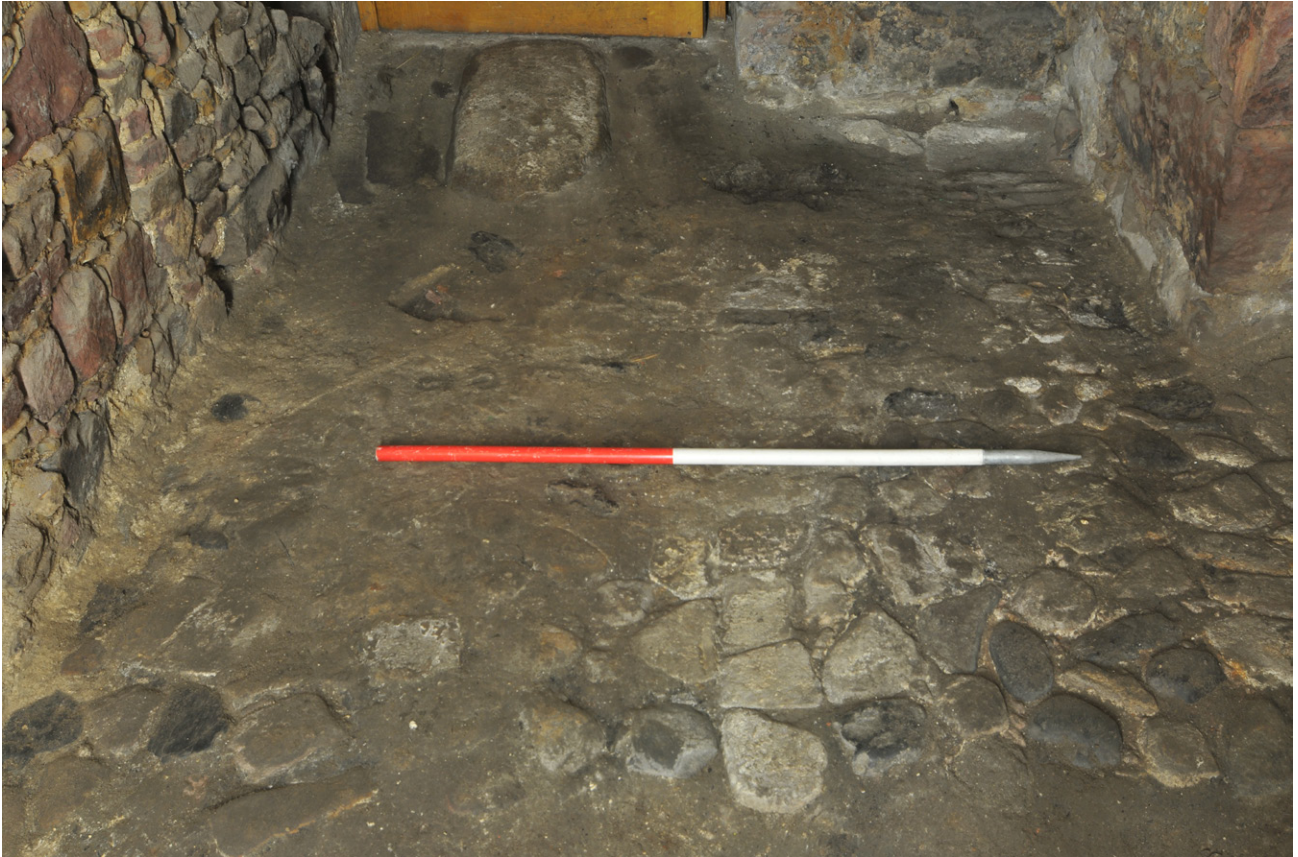
Fig. 7b - A cobble floor (G02/1) recorded in Ground Floor Room G02

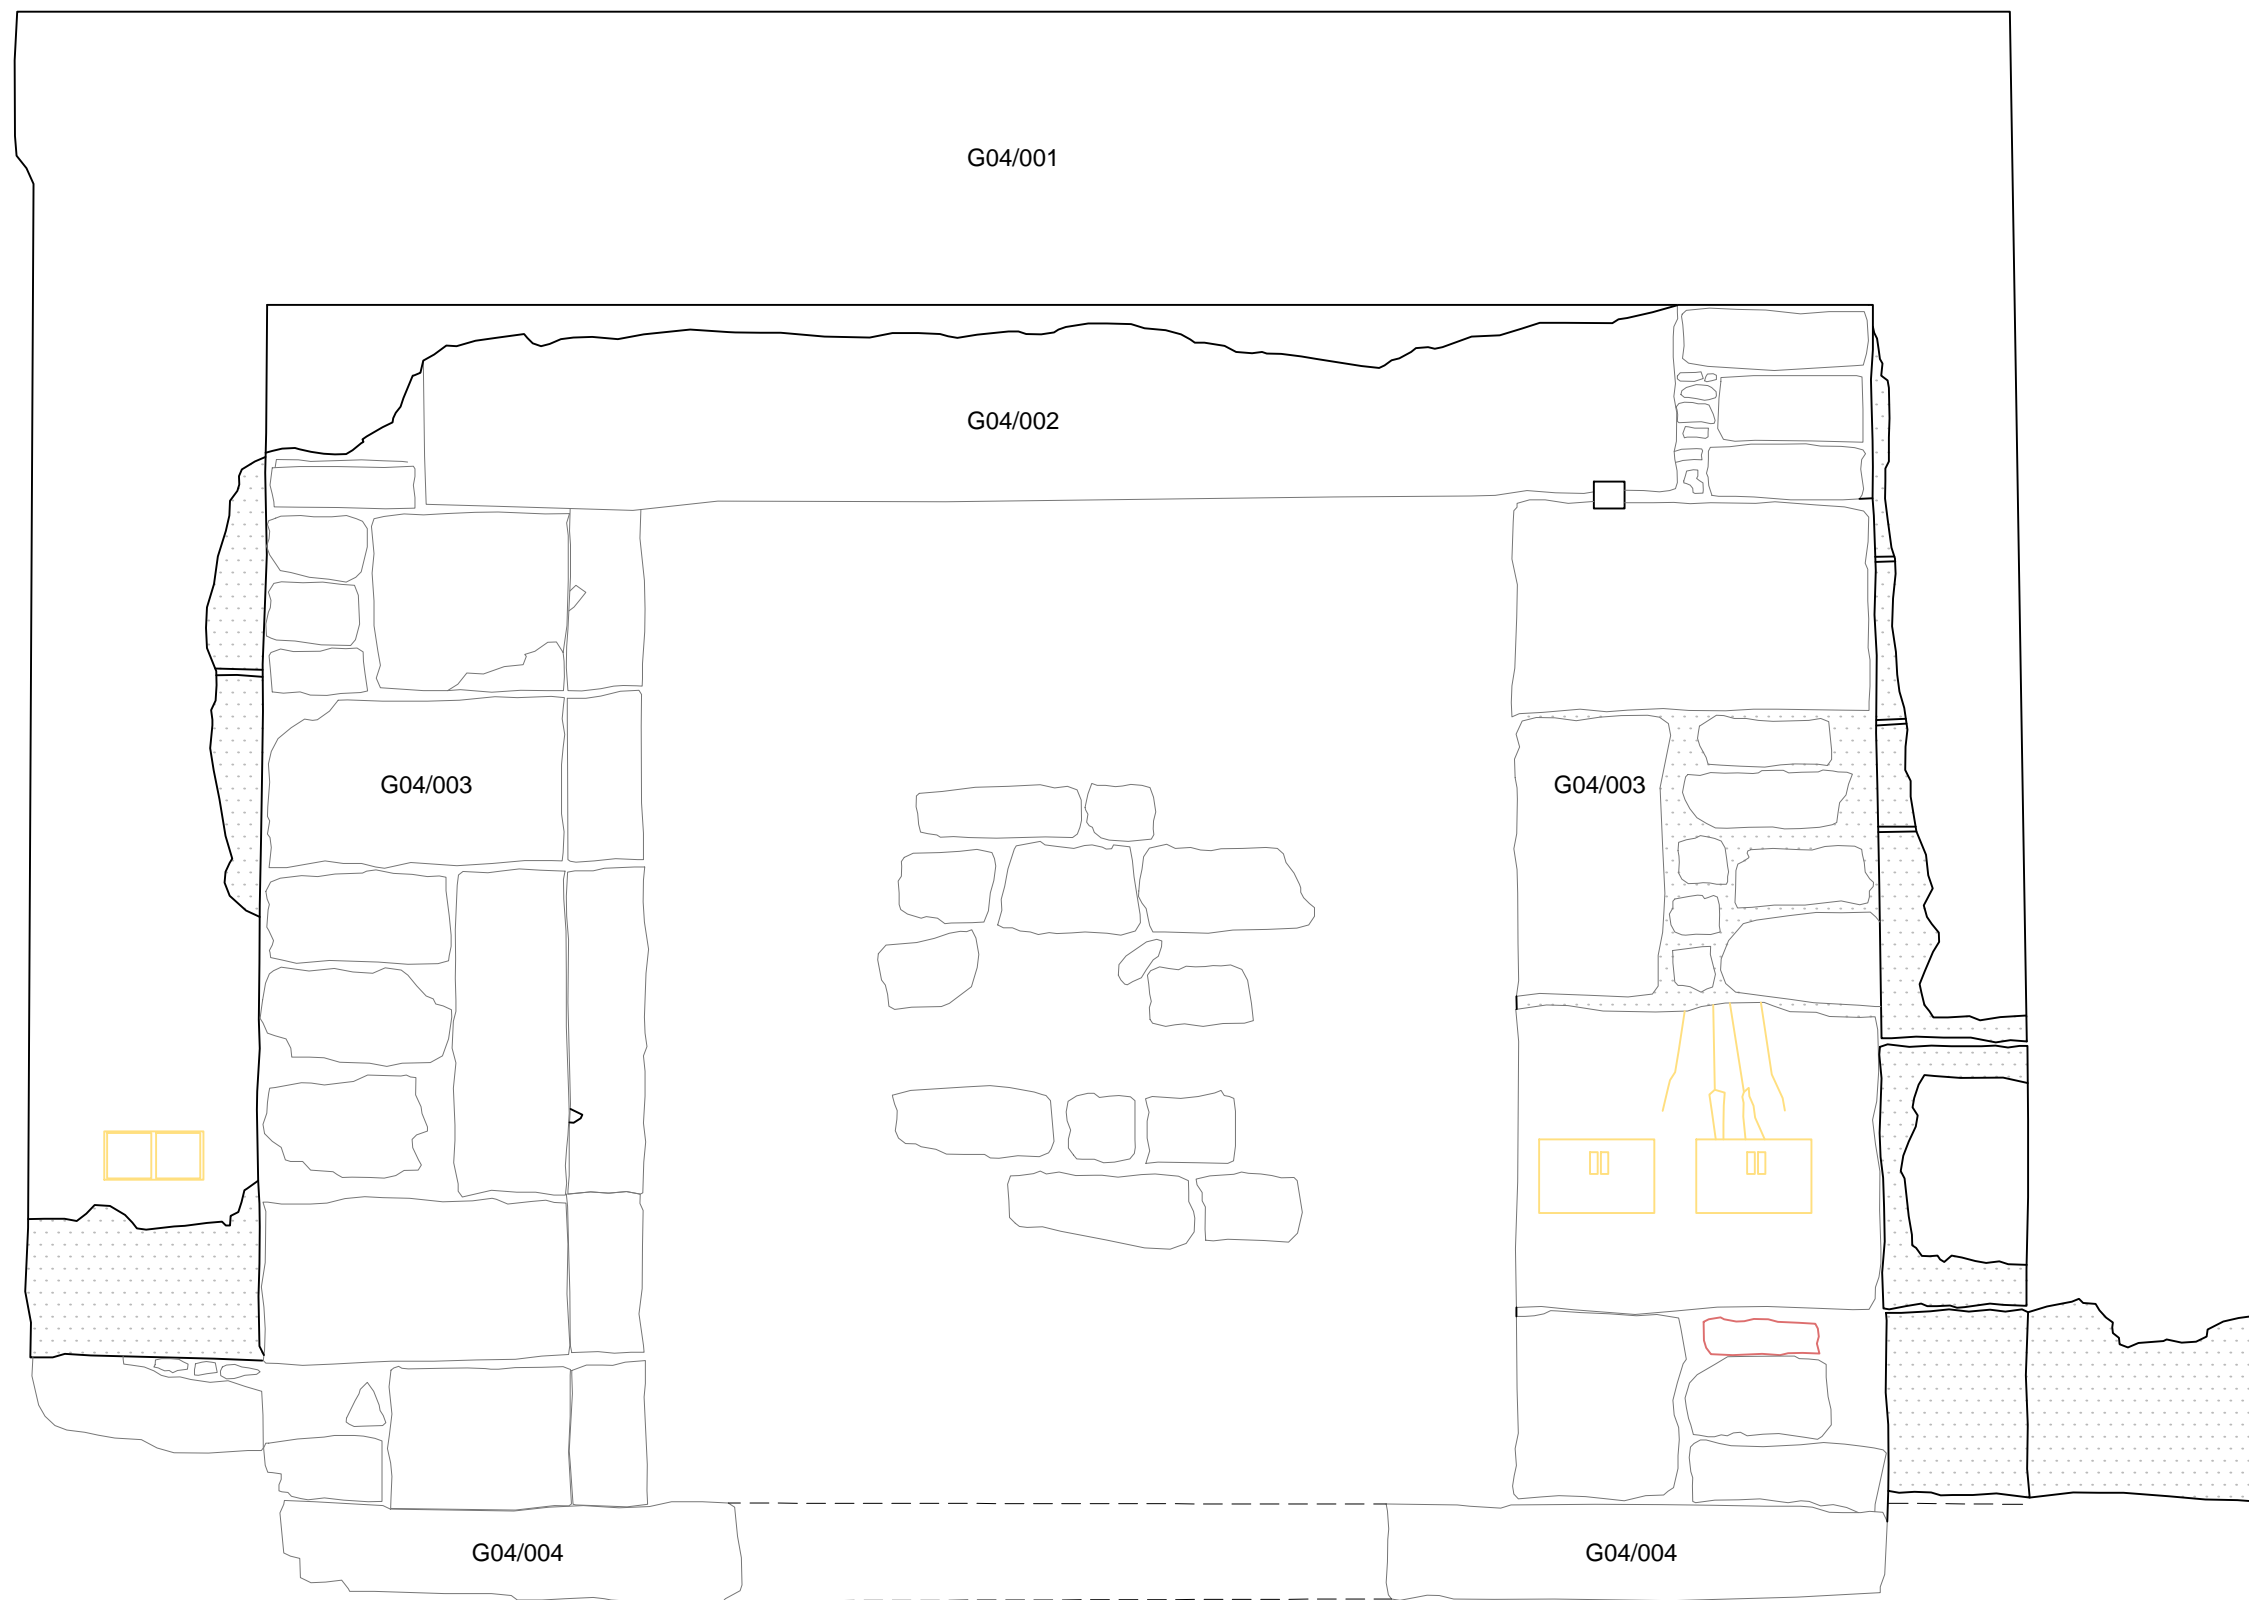
The fireplace (Fig 8) was situated on the west-facing elevation and had been blocked with plaster board in the recent past and two phases are represented. The first fireplace had a large ashlar-built surround (G04/001) measuring 2.62m wide and 1.9m high and was largely covered in green Artex. A lower inserted fireplace had a single slab lintel (G0/002) measuring 1.63m long and 0.22m wide. The surrounds for this fireplace were 0.4m wide and comprised ashlar sandstone and sub-rectangular blocks. The sandstone hearth (G04/004) measured 2.1m x 0.13m and was broken in the middle. The interior left-hand side of the fireplace was splayed and rubble-built with remnants of plaster. The back of the fire was constructed of random rubble.

**Title:**  
A former blocked fireplace in  
Room G04, west-facing  
elevation

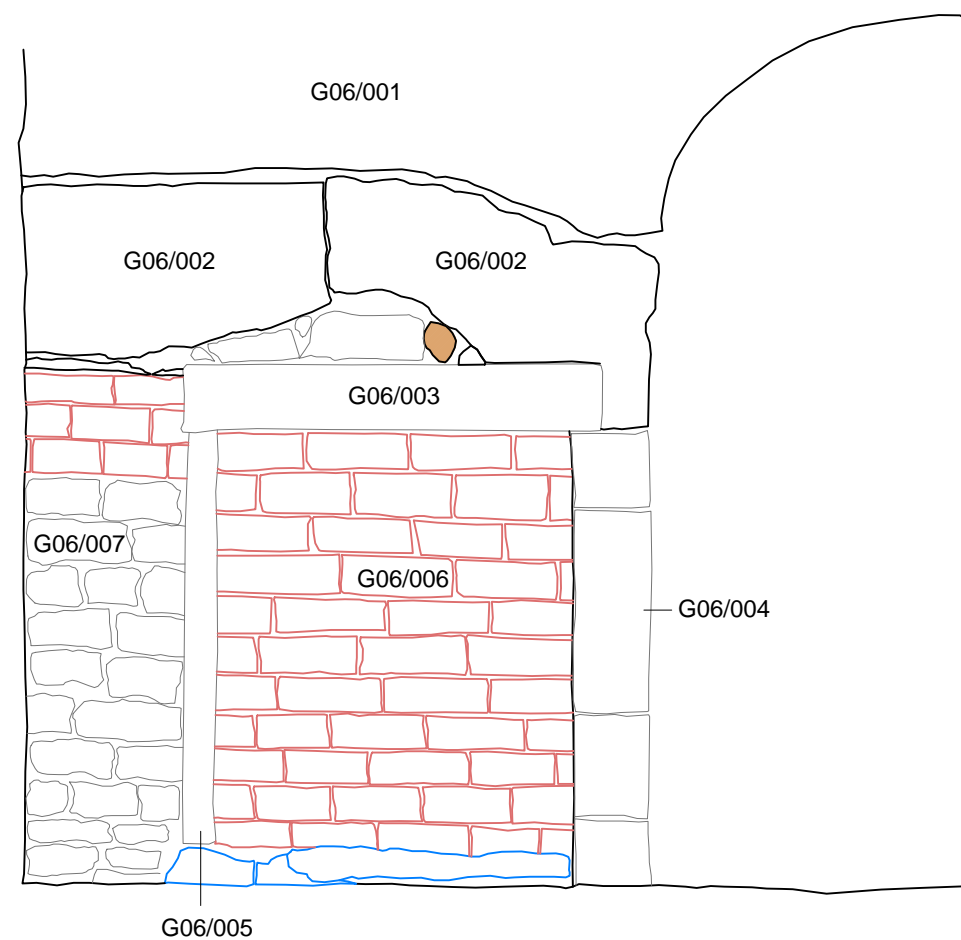
Wall plaster (G06/001) stripping on the internal north-facing elevation revealed a blocked-up fireplace (Fig 9). The fireplace had a large irregular-shaped lintel stone measuring 1.65m x 0.45m that was cracked (G06/002). The lintel of a smaller fireplace (G06/003) was recorded measuring 1.10 by 0.16m and comprised a single block of sandstone. Contemporary with the larger lintel was a series of ashlar blocks (G06/004) on the right hand side of the fireplace. On the left hand side a much thinner single sandstone upright formed the opposite fire surround (G06/005). The fireplace had been blocked with 11 courses of brick (G06/006) laid in stretcher bond. On the east side of the fireplace the wall was built of coursed rubble and brick (G06/007).

Title:  
**A blocked fireplace in Room  
G06, north-facing elevation**

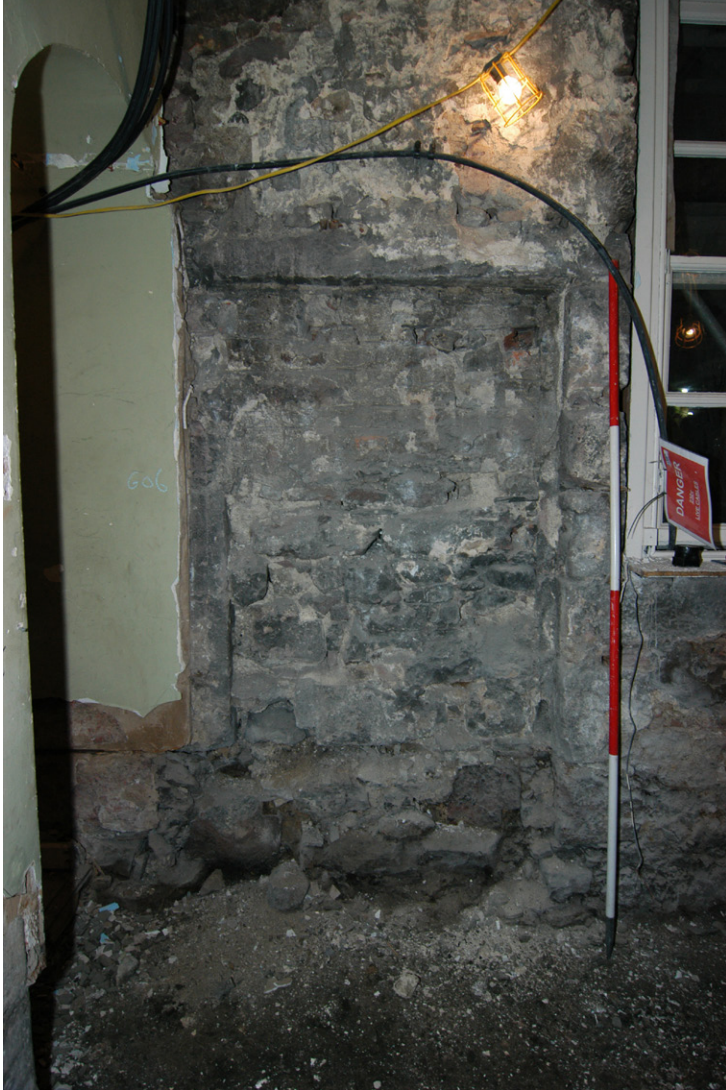
Fig. 10 - A blocked doorway in Room G06 on the east-facing elevation

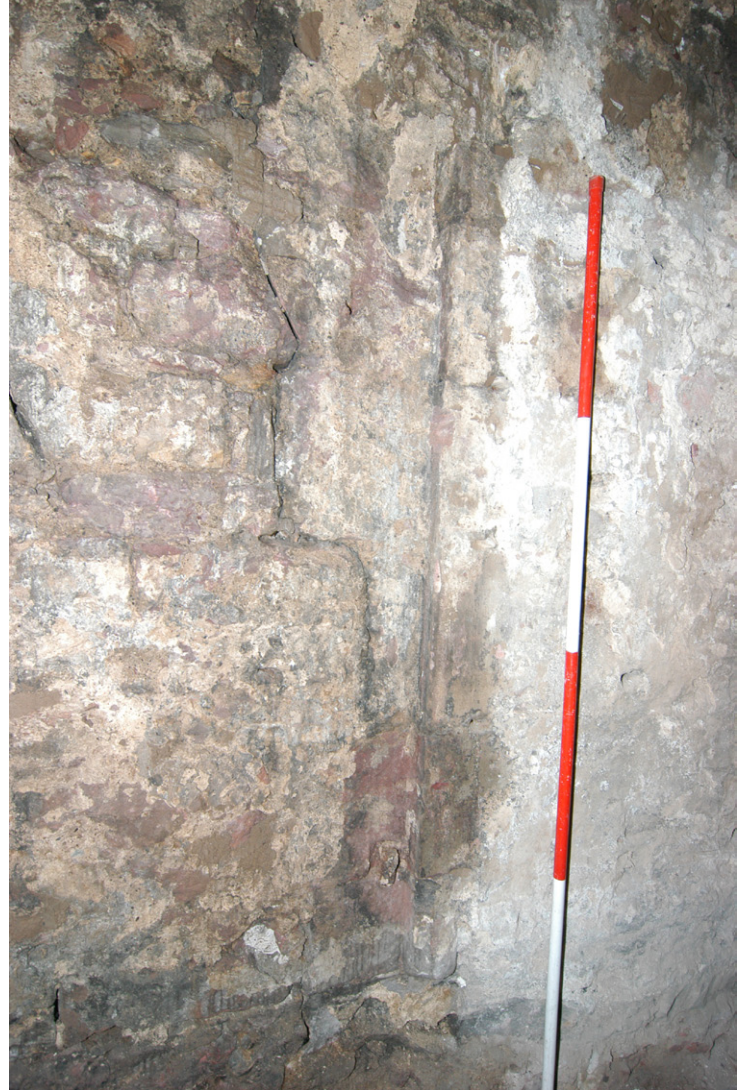
Fig. 11 - The remains of a blocked doorway in Room G06, with an iron door hanger

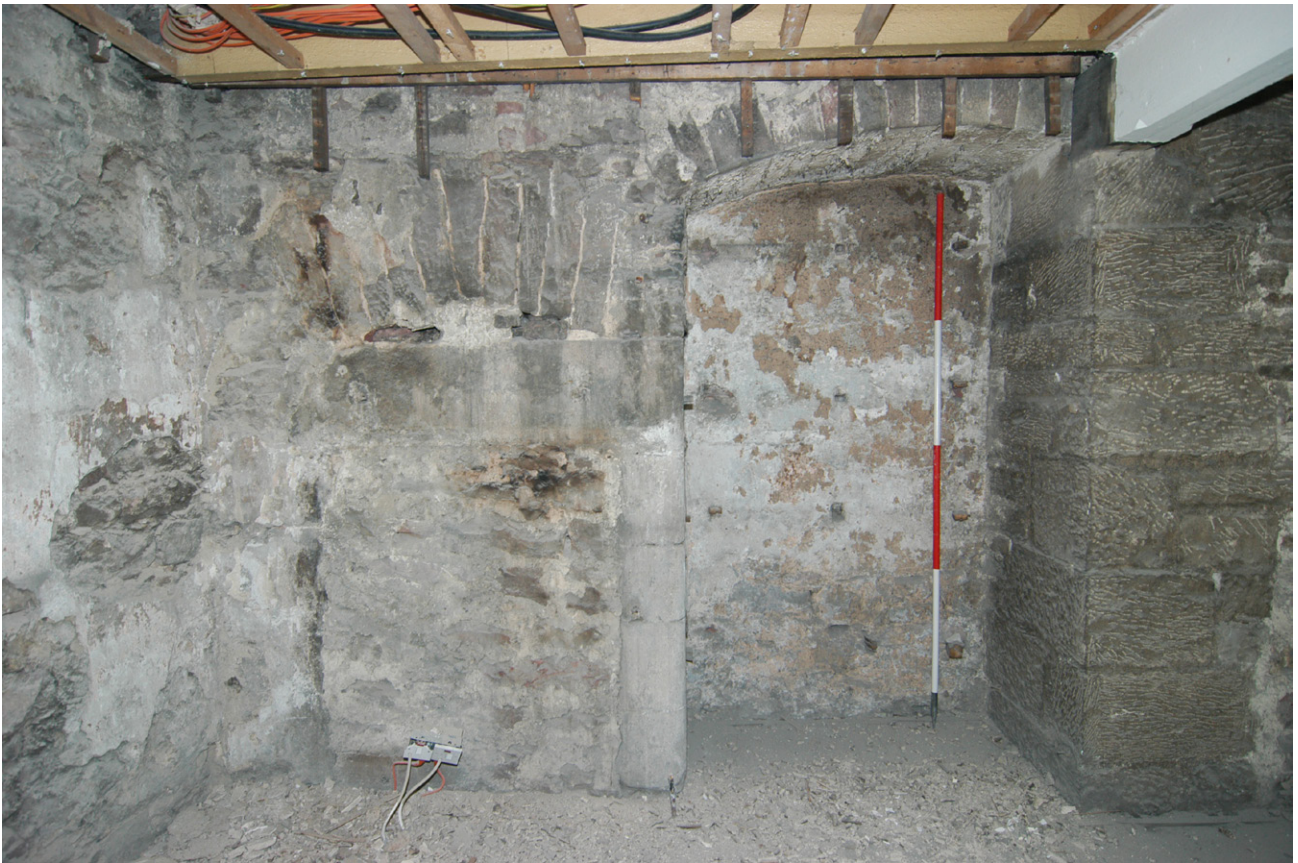
Fig. 12a - A blocked fireplace and press recorded in Room G07 west-facing elevation

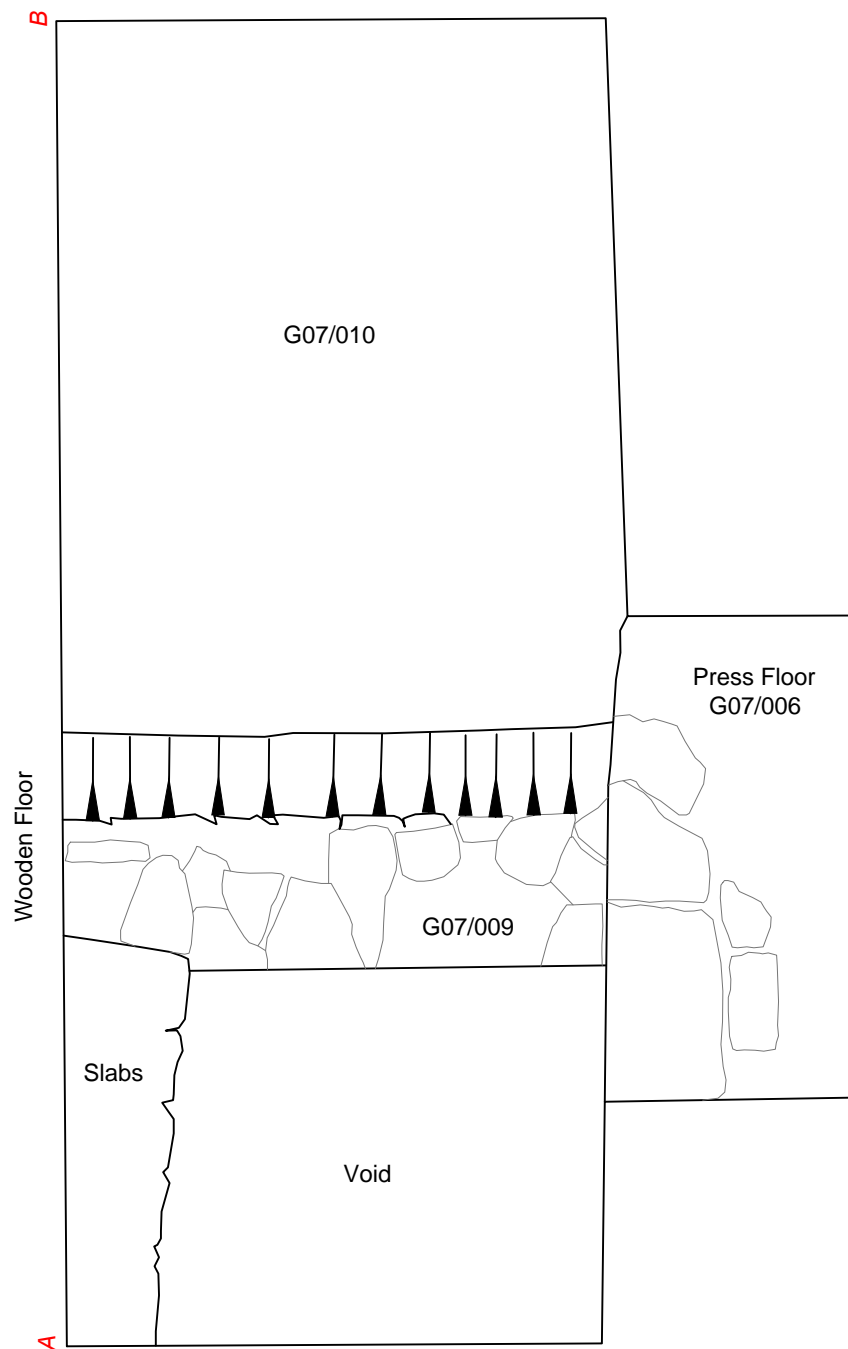
Fig 12b - Lift shaft trench in the floor of Room G07

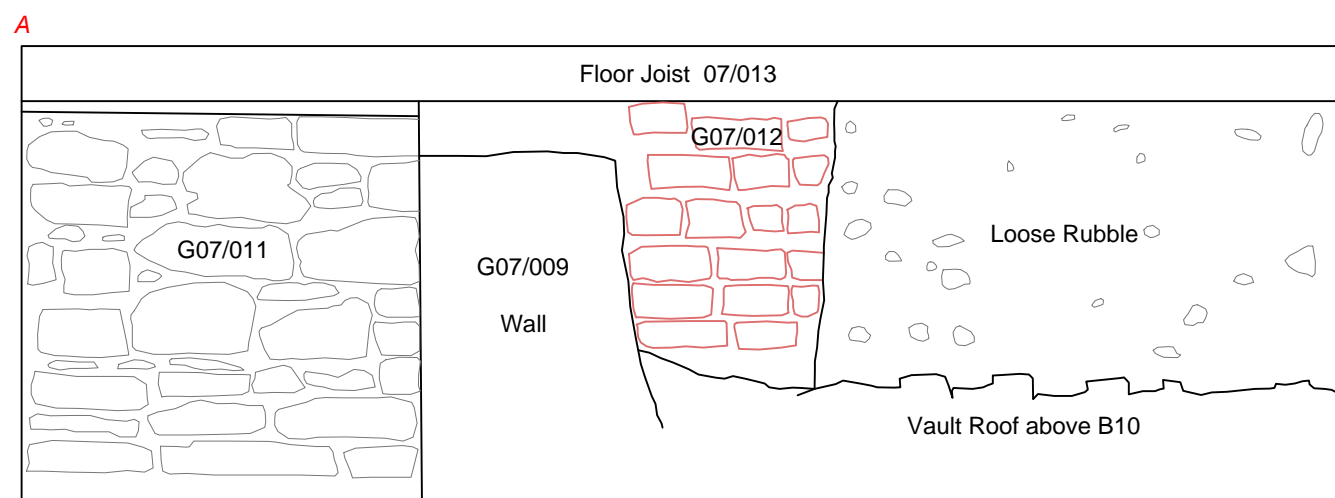
Fig 12c - East-facing section in the lift shaft trench in G07

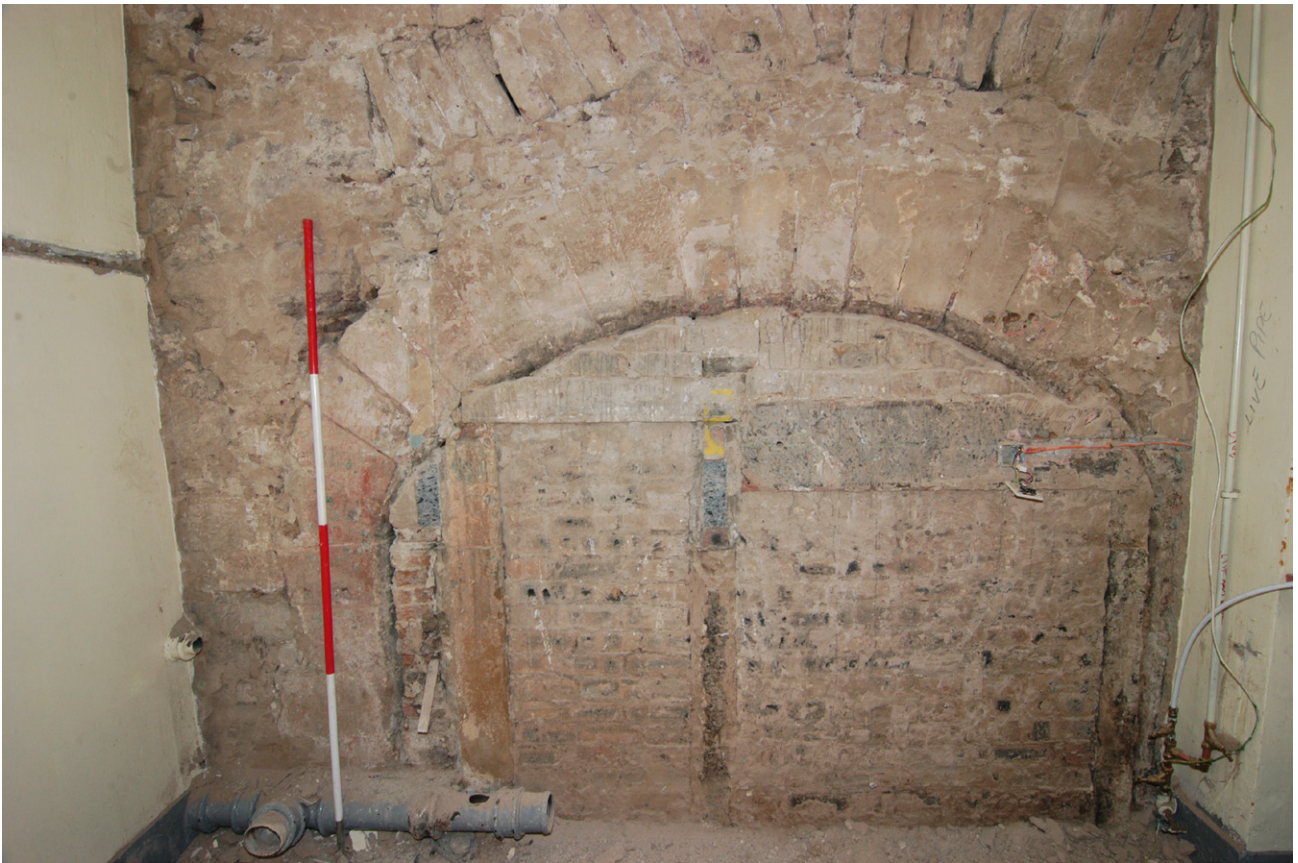
Fig. 13 - A large late 16th kitchen fireplace exposed following the removal of the wall plaster in Room G12, south-facing elevation

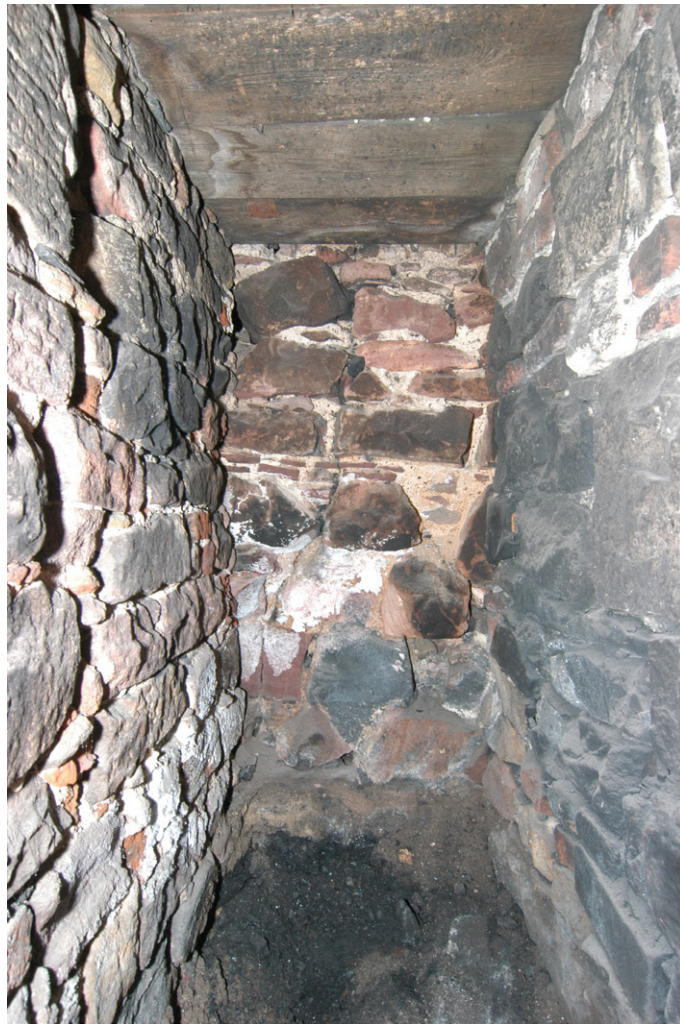
Fig. 14 - Interior of a 19th century coal cupboard in Room G12 after unblocking

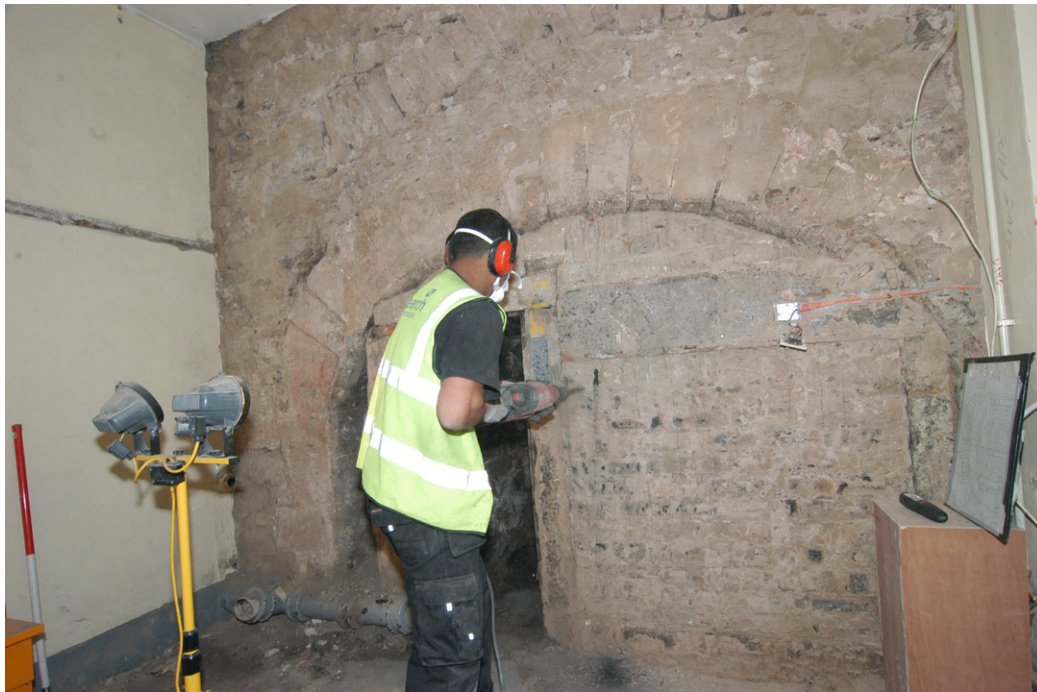
Fig. 15 - Breaking out the blocking work within the inserted 19th century fireplace

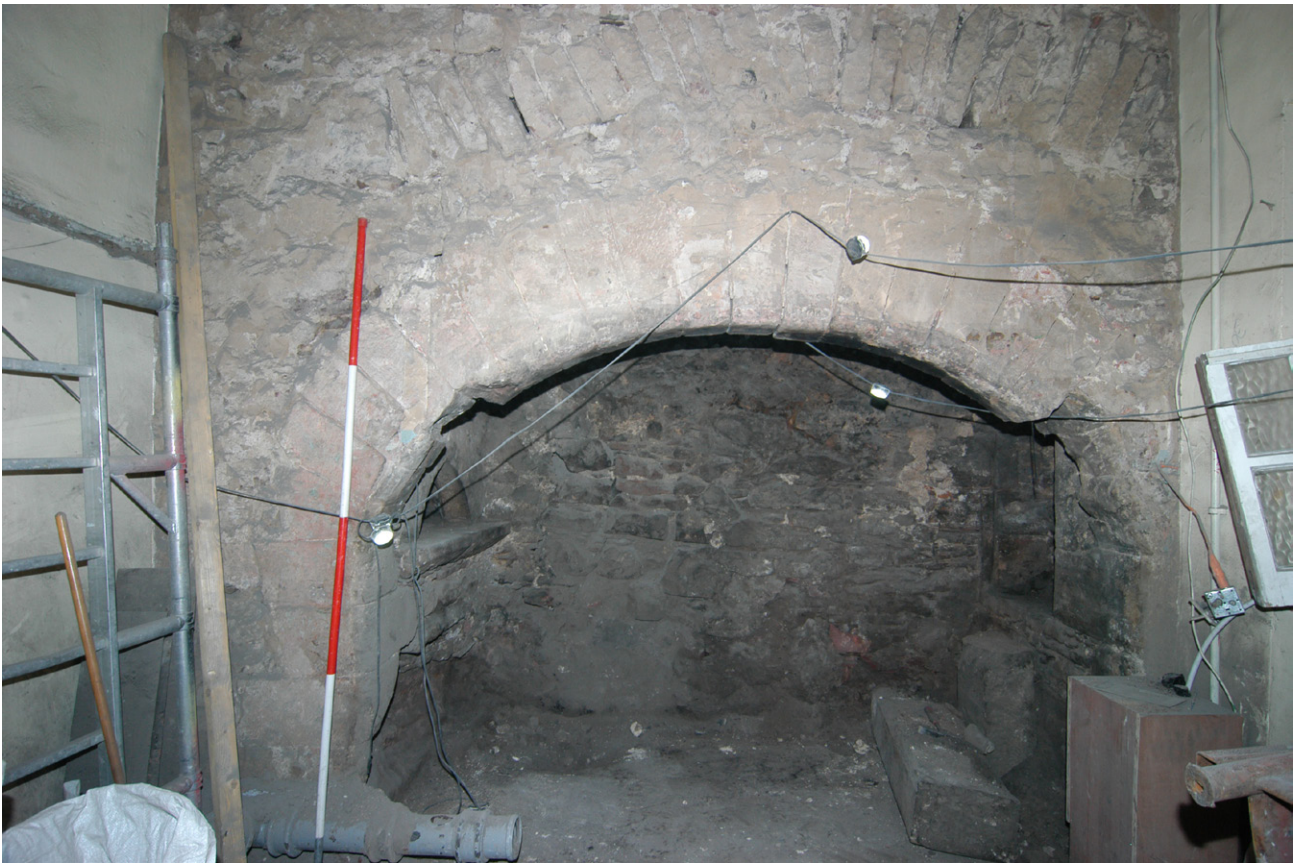
After the coal cupboard and fireplace had been fully recorded these features were broken out to reveal the full extent of the earlier fireplace (G12/004), Fig 16). The fireplace measured 2.5m wide and was 1.8m high. The back of the fireplace was constructed of random rubble and the interior had a flagstone floor. The flue of this fireplace was rectangular in shape with a series of corbelled out stonework. It is presumed that these corbelled out areas added strength to the chimney and provided baffles for the smoke to exit by convection.

Fig. 16 - The kitchen fireplace after the removal of its later insertions

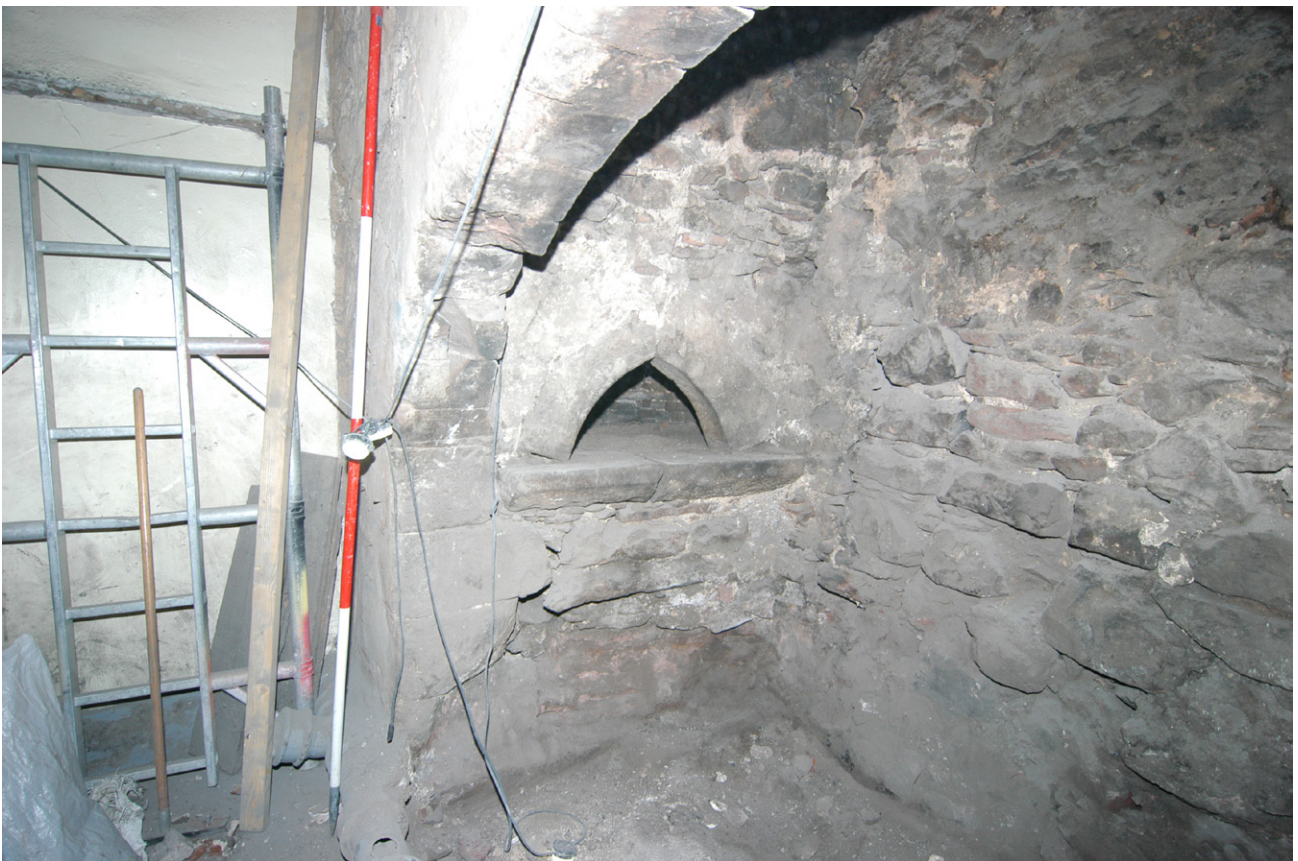
Fig. 17 - The bread oven within the interior of the fireplace

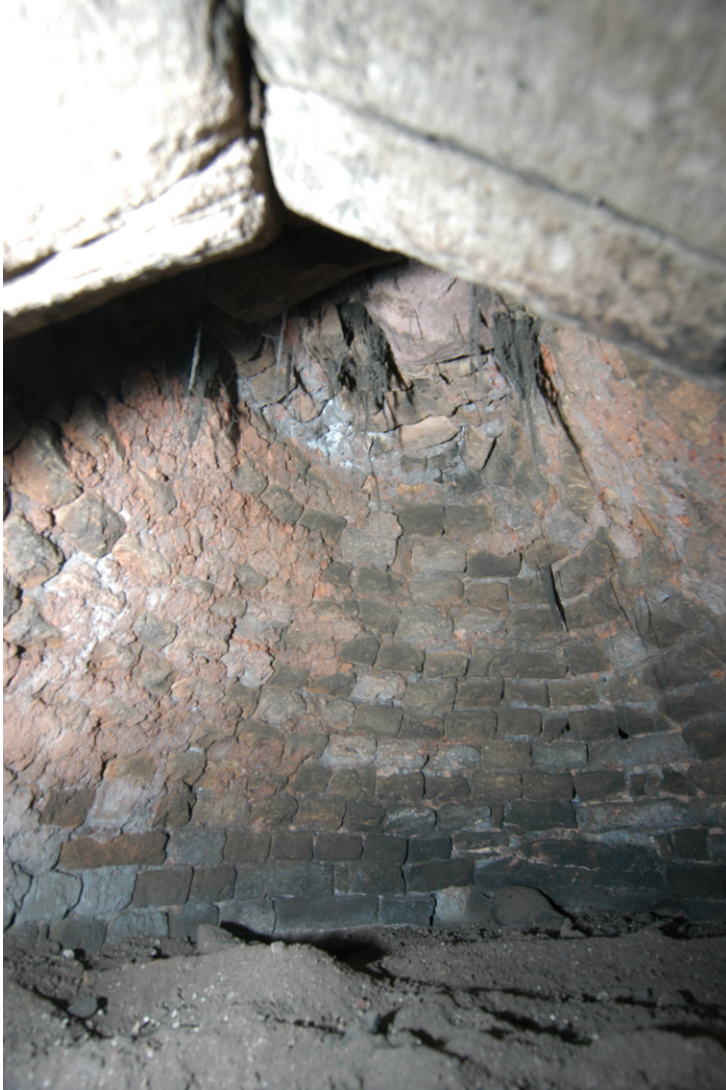
Fig. 18 - The interior of the bread oven
