## Riddle's Court, Lawnmarket, Edinburgh (Phase 2)

Historical Building Survey & Archaeological  
Watching Briefs  
Report No. 3423

**Historical Building Survey Recording and  
Archaeological Watching Briefs**

**Report No. 3423**

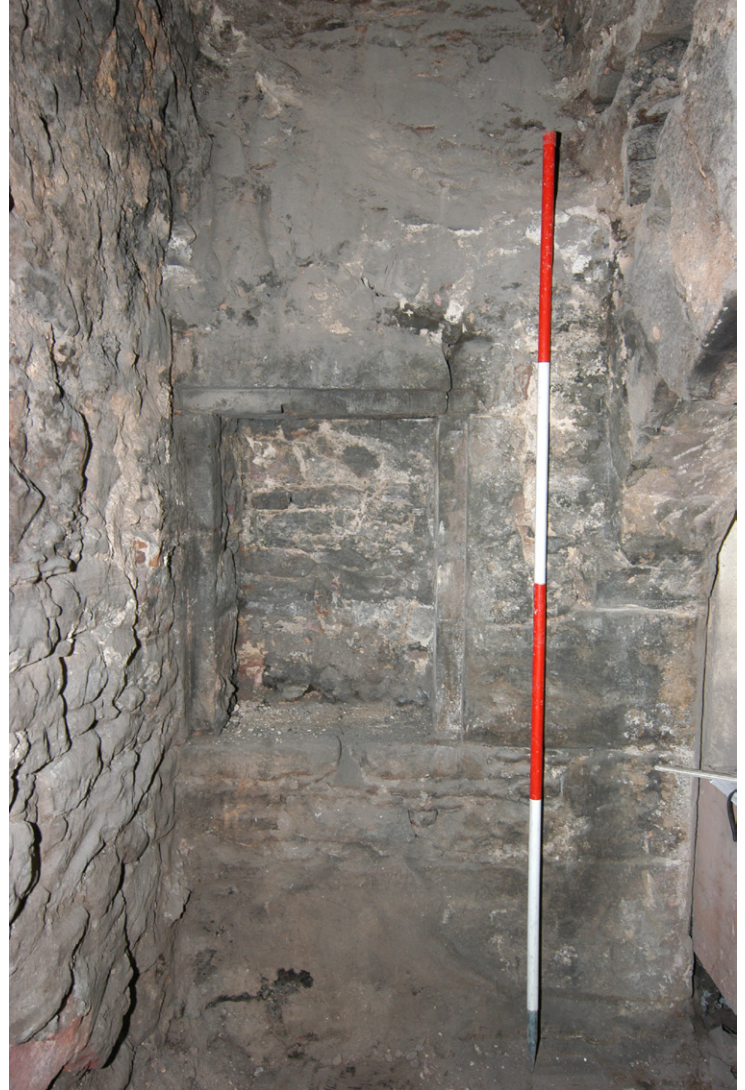
Fig. 19 - The salt press within the kitchen fireplace

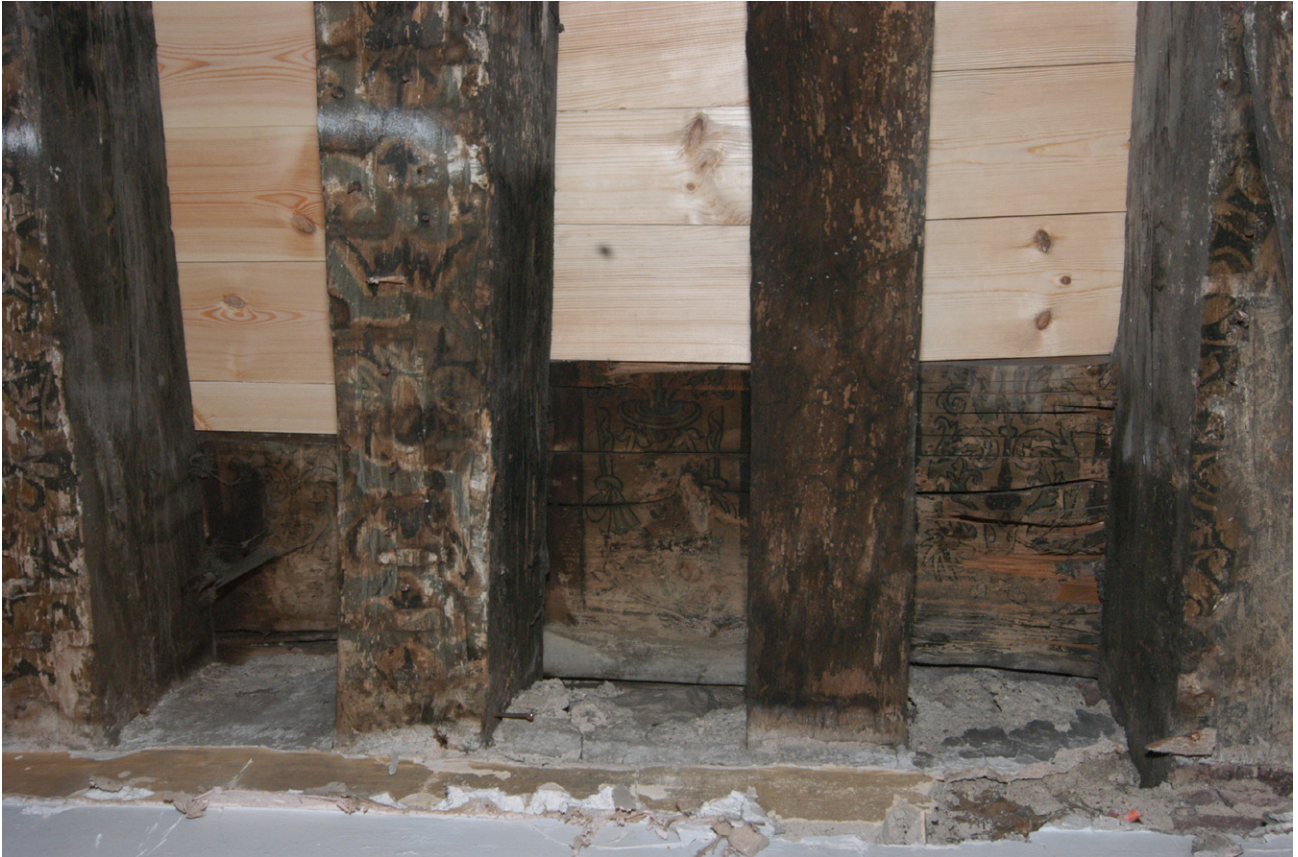
Fig. 20 - The only surviving painted board on the ceiling of Room F03

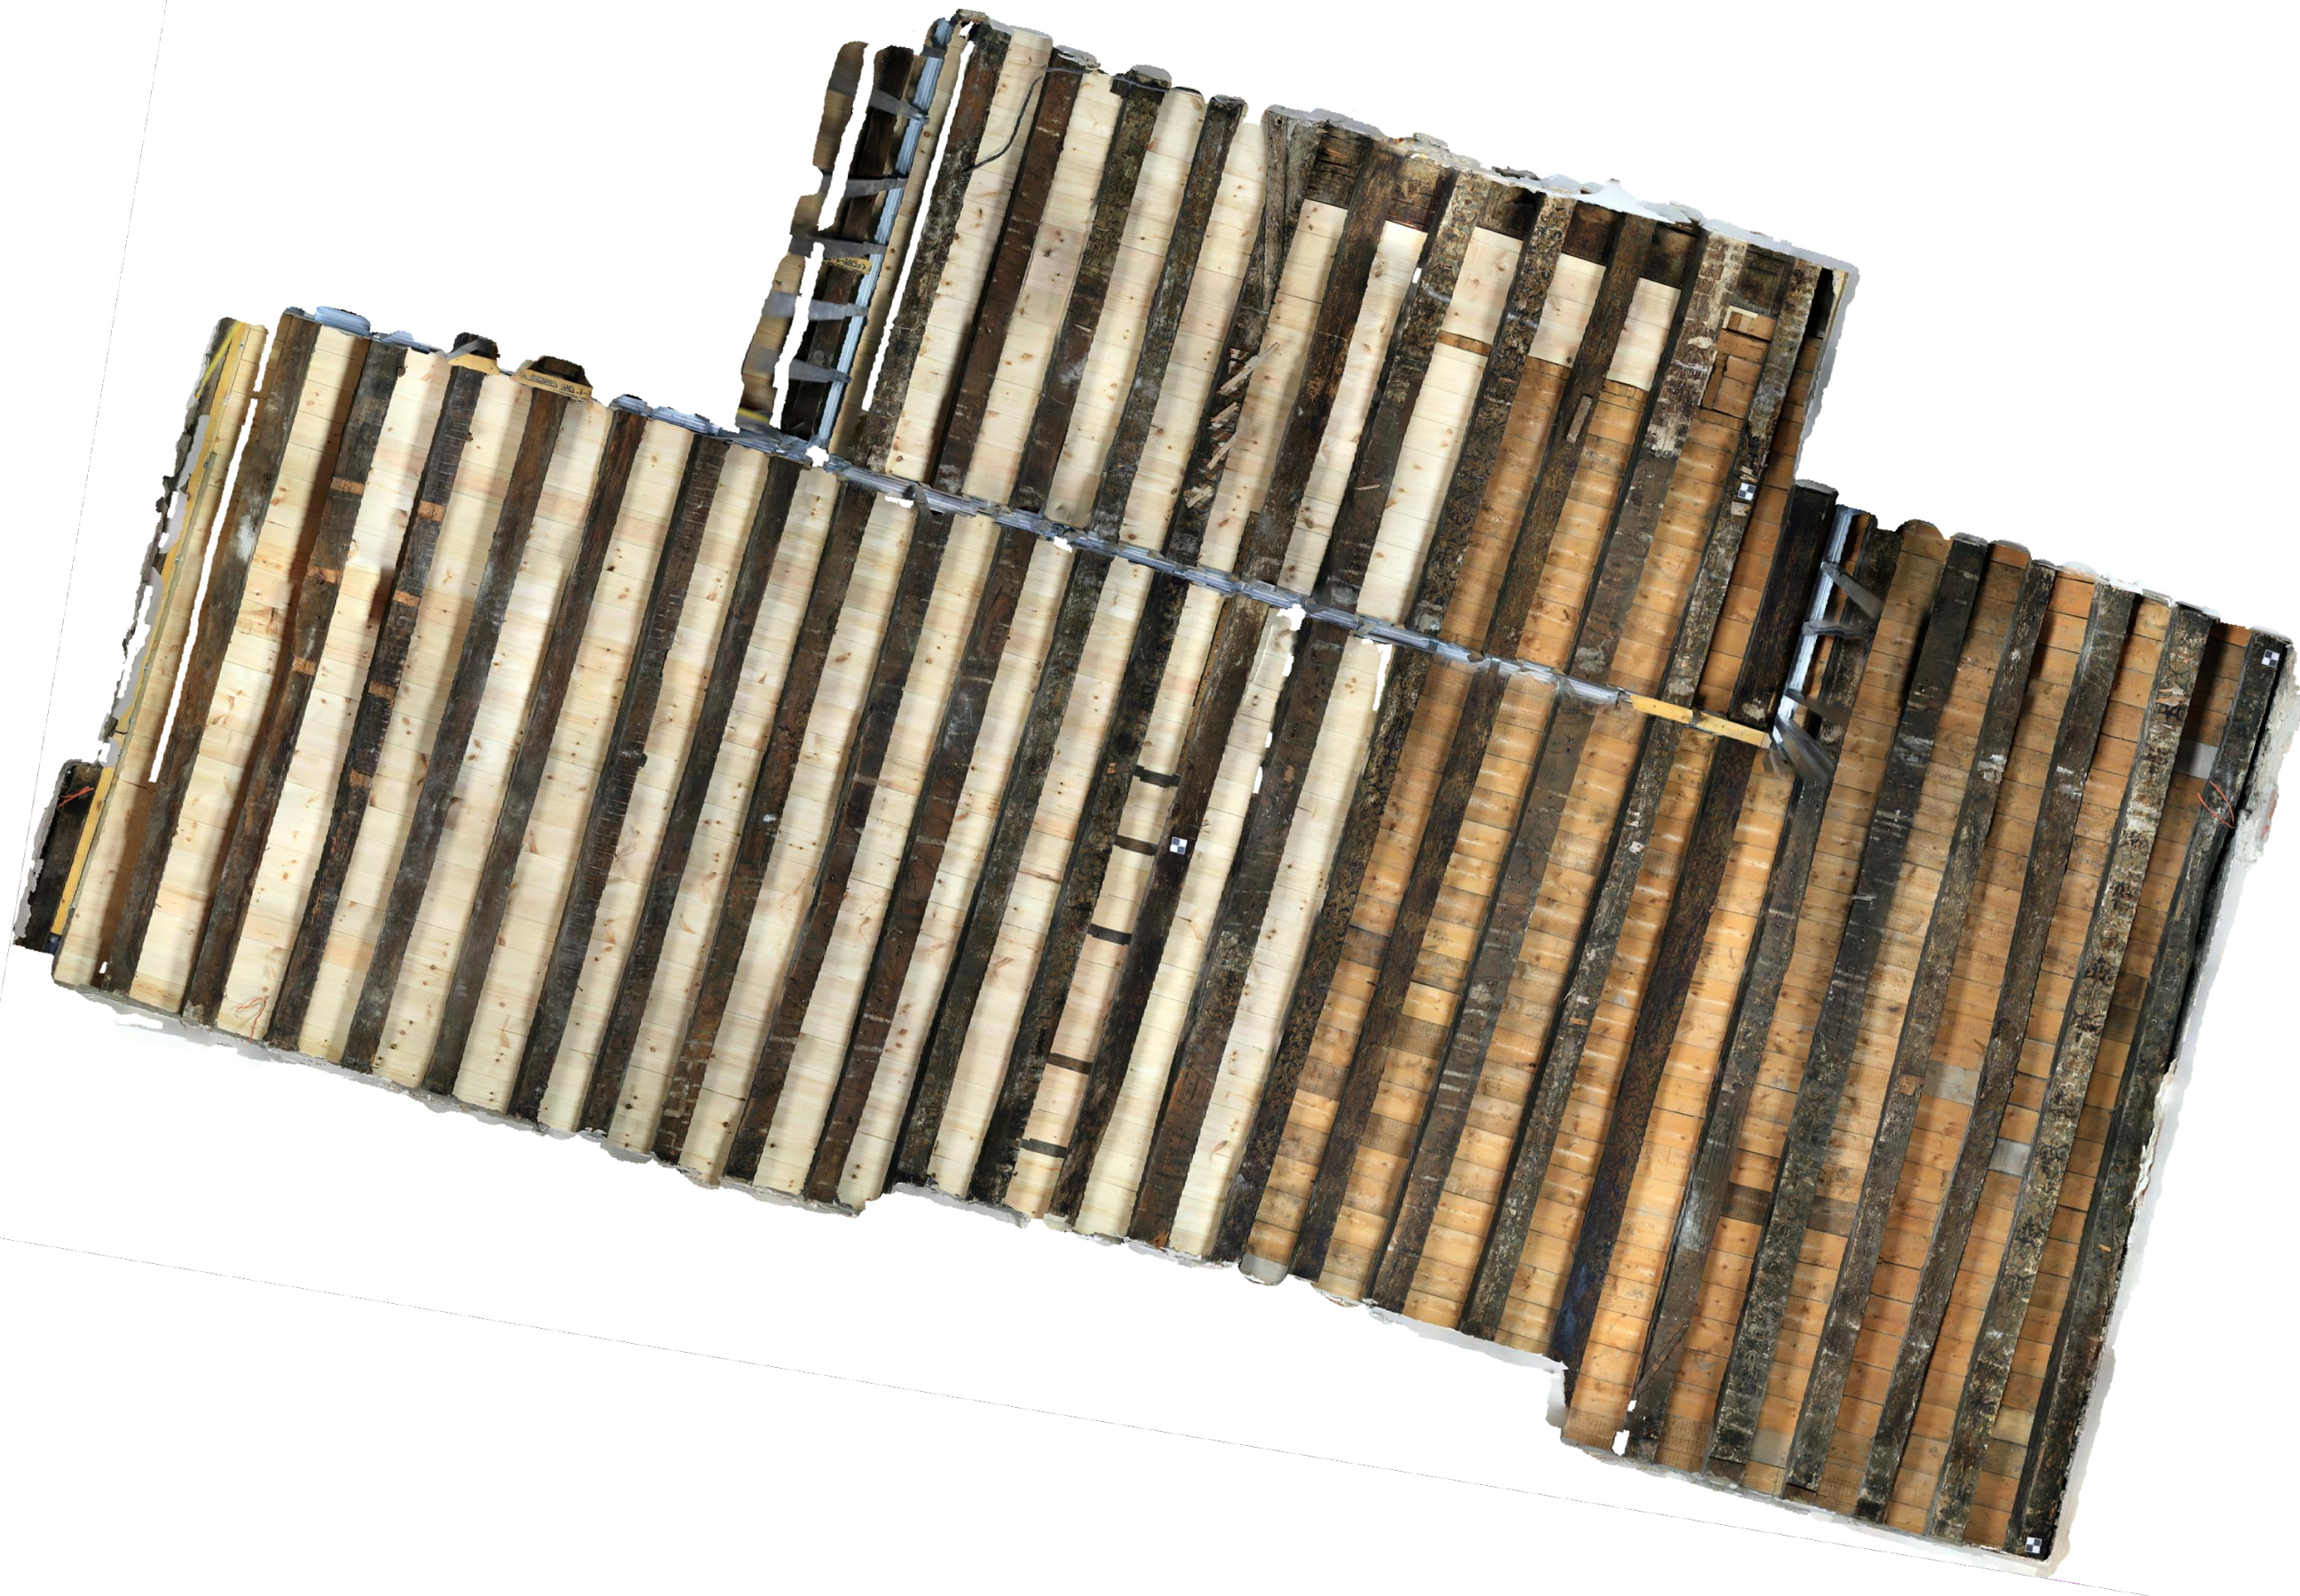
The tempera painted design looks very similar to that found in Room F02. Here the same decorative scheme appears to have been applied (Allardyce and Dundas 2015). Figs 21 & 22 provide colour and negative orthophotographs of the painted ceiling.

Title:  
A colour orthophotograph of the painted beam and board ceiling in Room F03

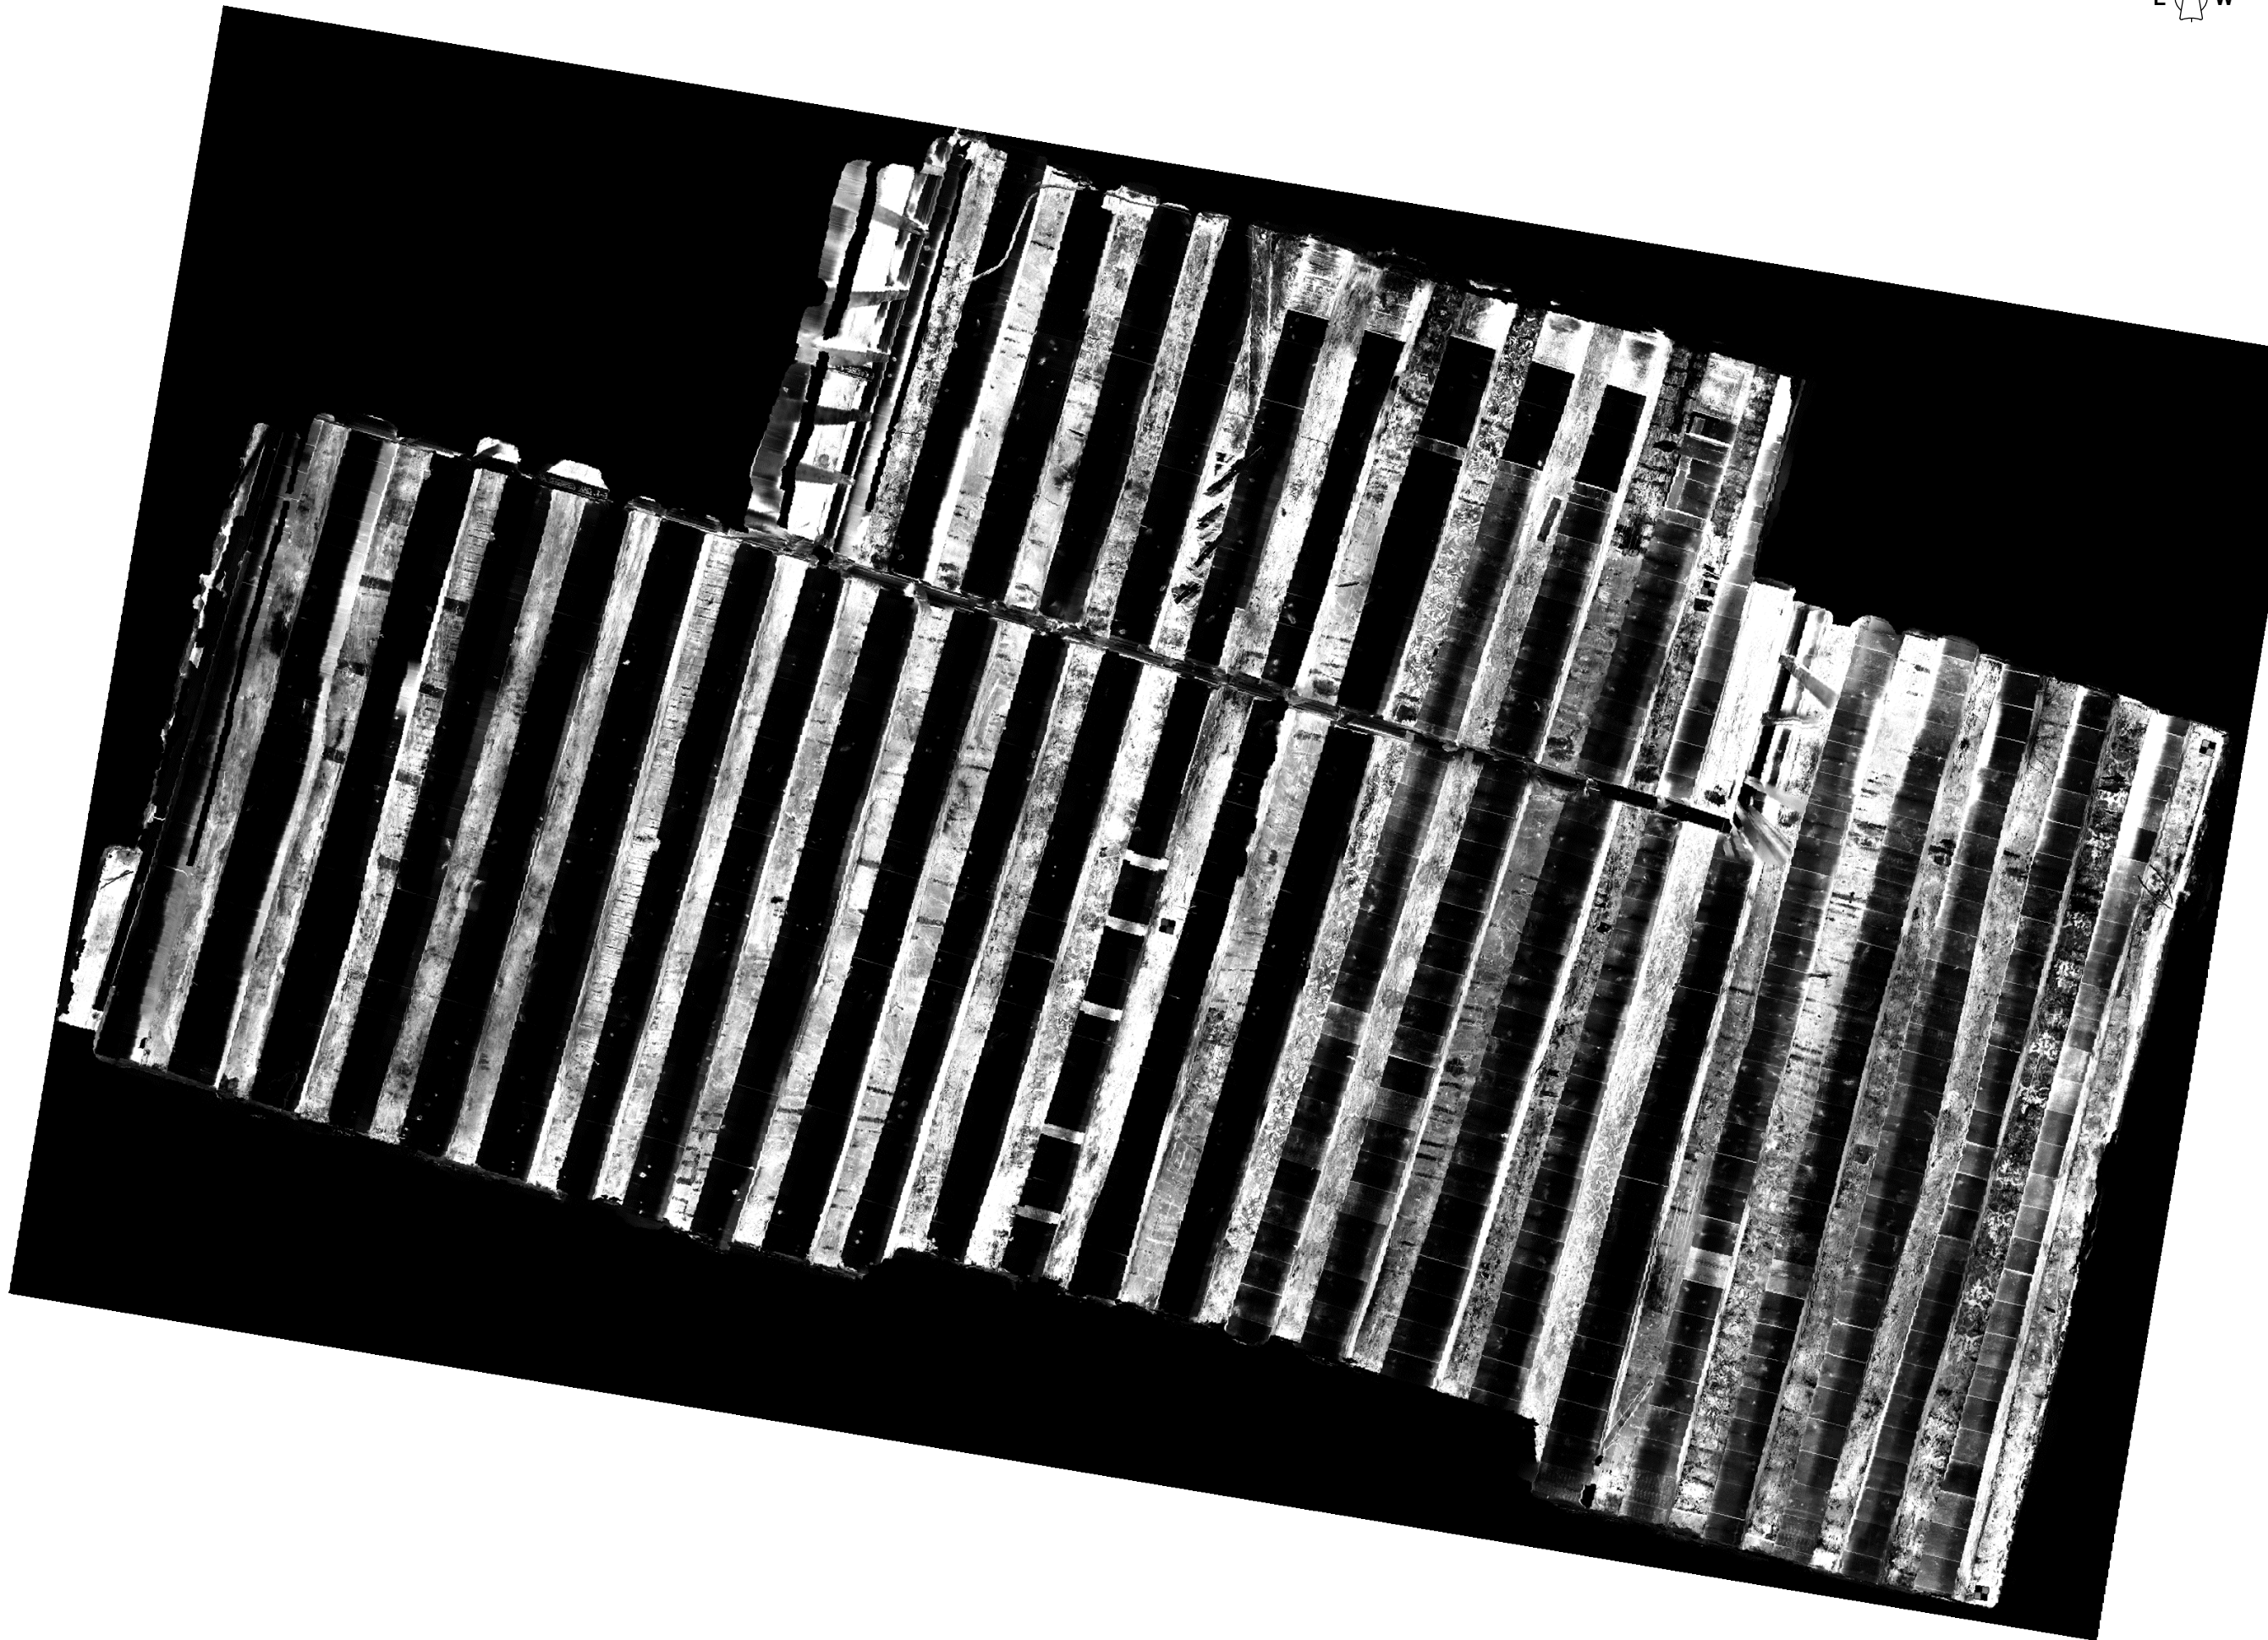
Title:  
A negative orthophotograph of  
the beam and board ceiling in  
Room F03

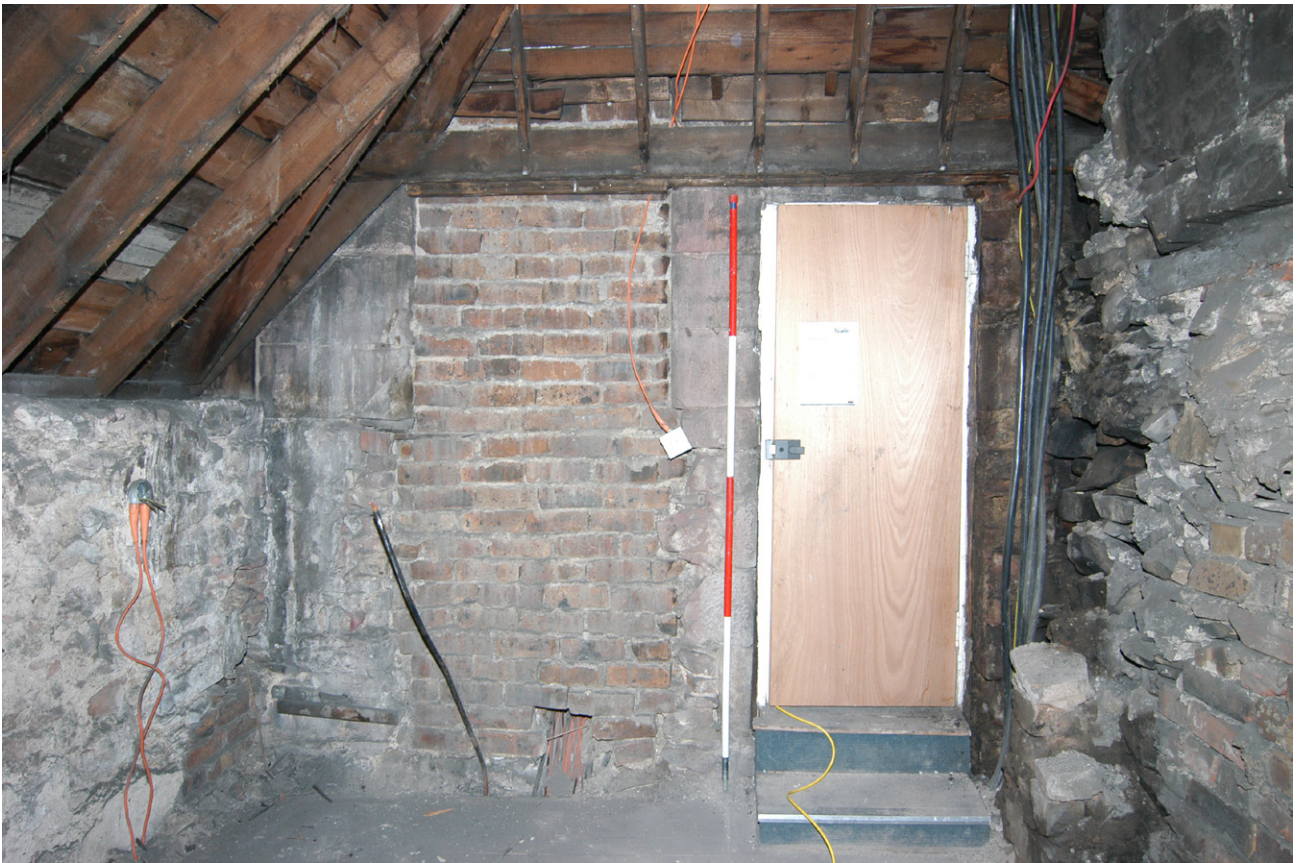
Fig. 24 - A late 16th century blocked doorway in Room F04, south-facing elevation

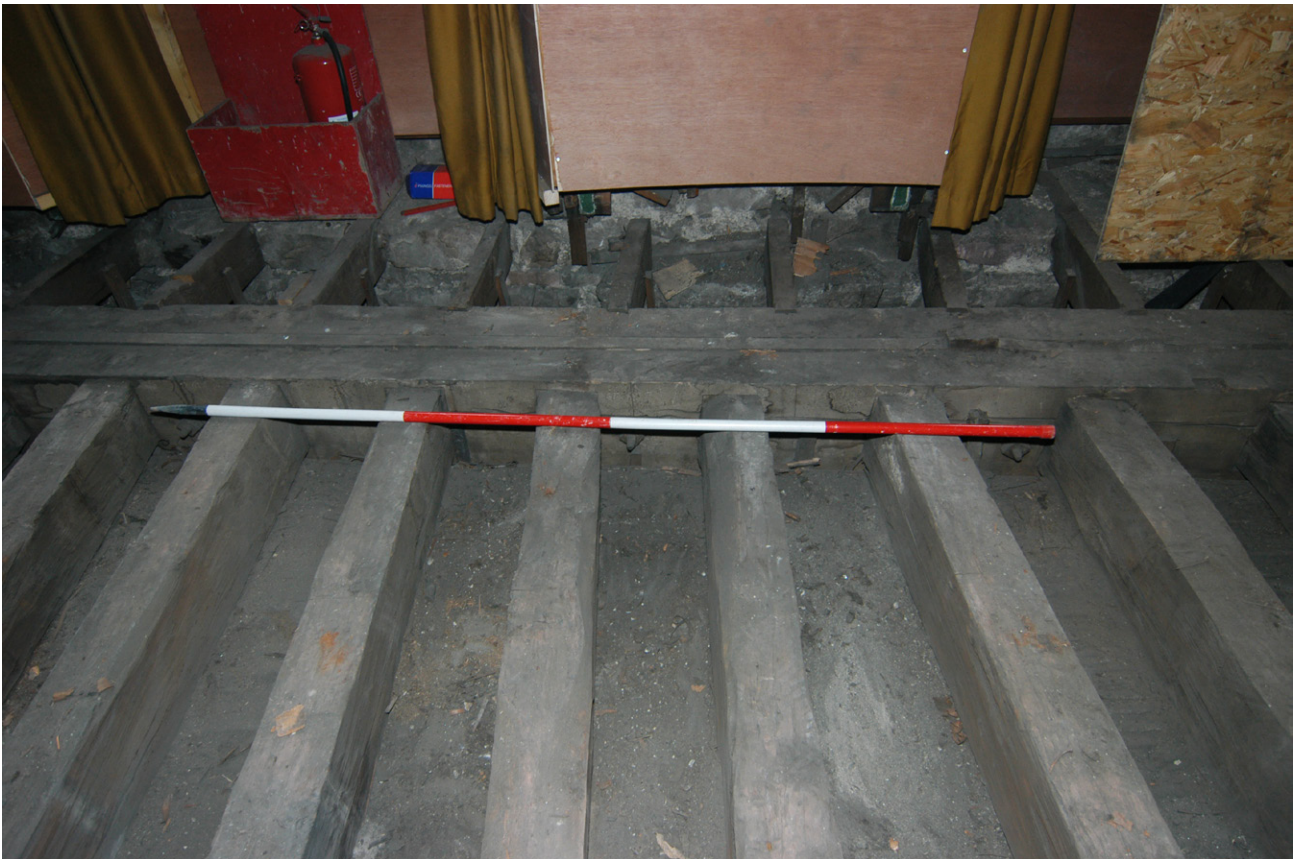
Fig. 25 - The oak floor joists and large flitch beam exposed in Room F09

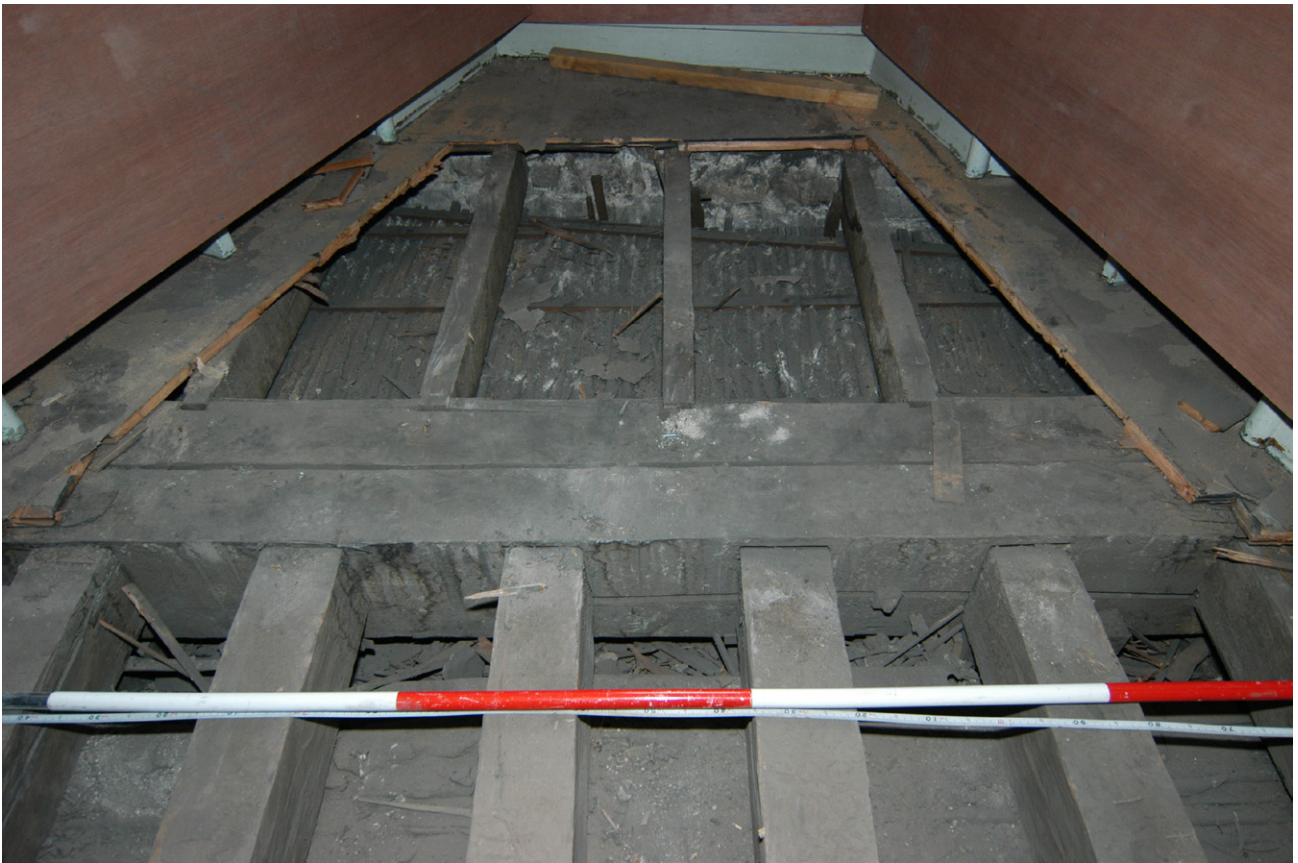
Fig. 26 - Detailed shot of the load-bearing fitch-beam in Room F10

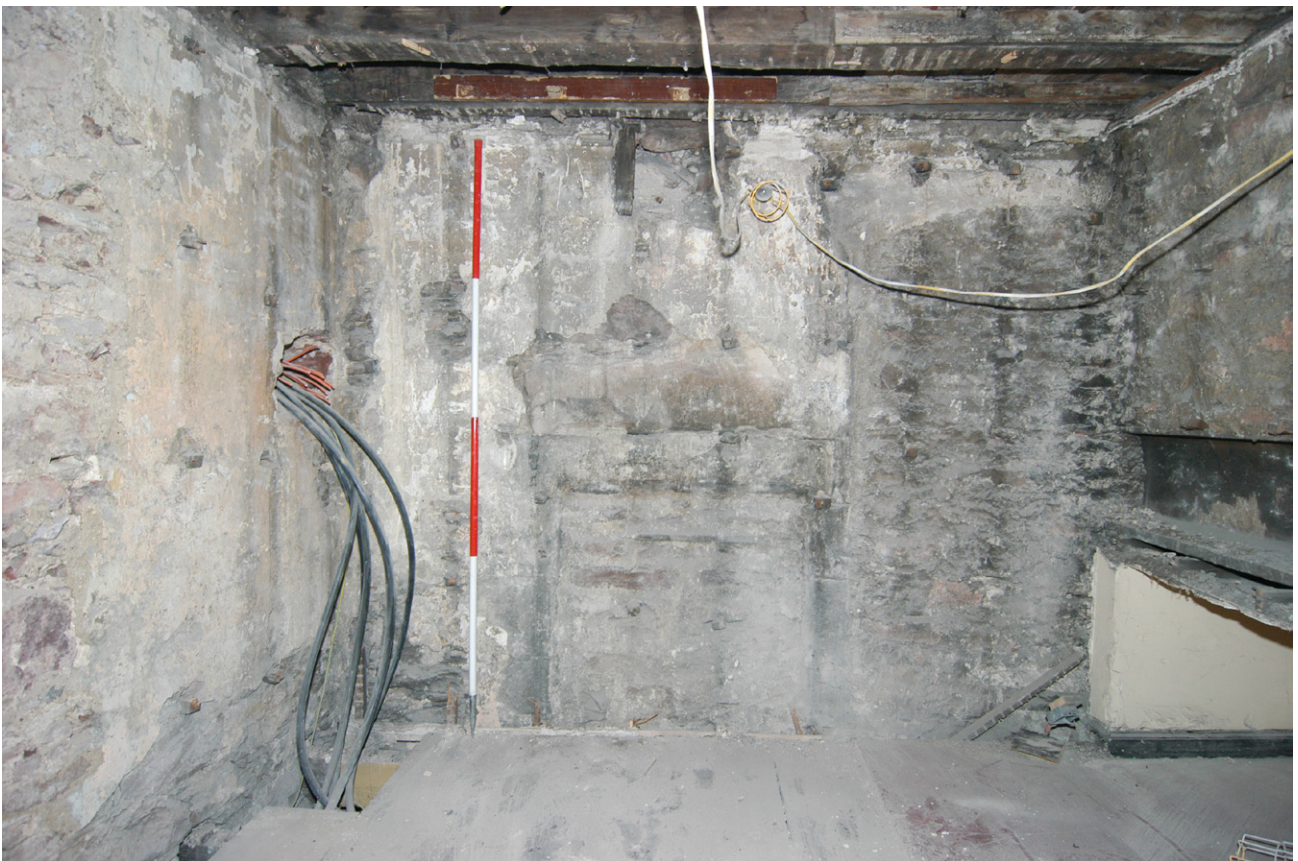
Fig. 27 - The blocked fireplace and press in Room F12, west-facing elevation

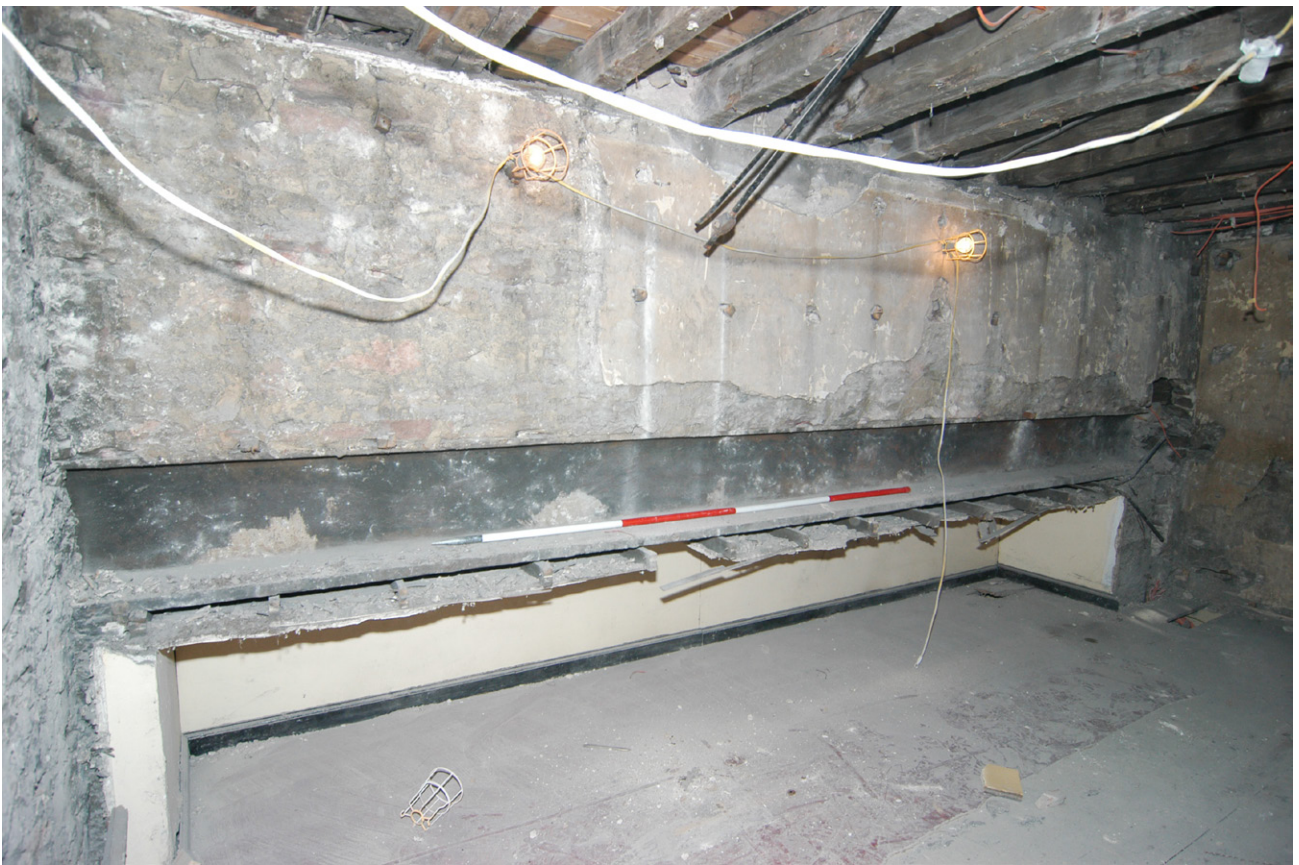
Fig. 28 - One of two 19th century Bressumer beams exposed within Room F12, north-facing elevation

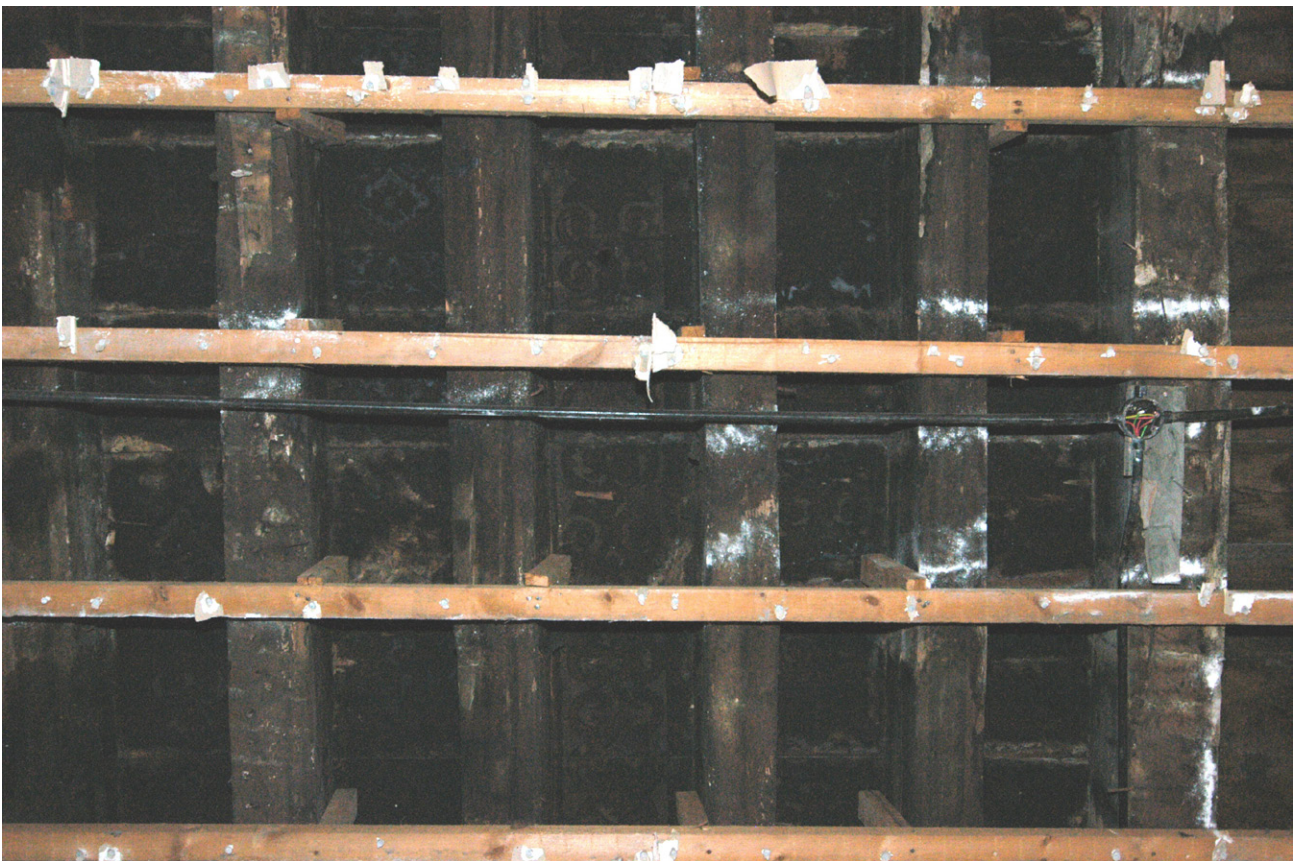
Fig. 29 - Exposed painted beams behind the battens of the modern ceiling in Room S02

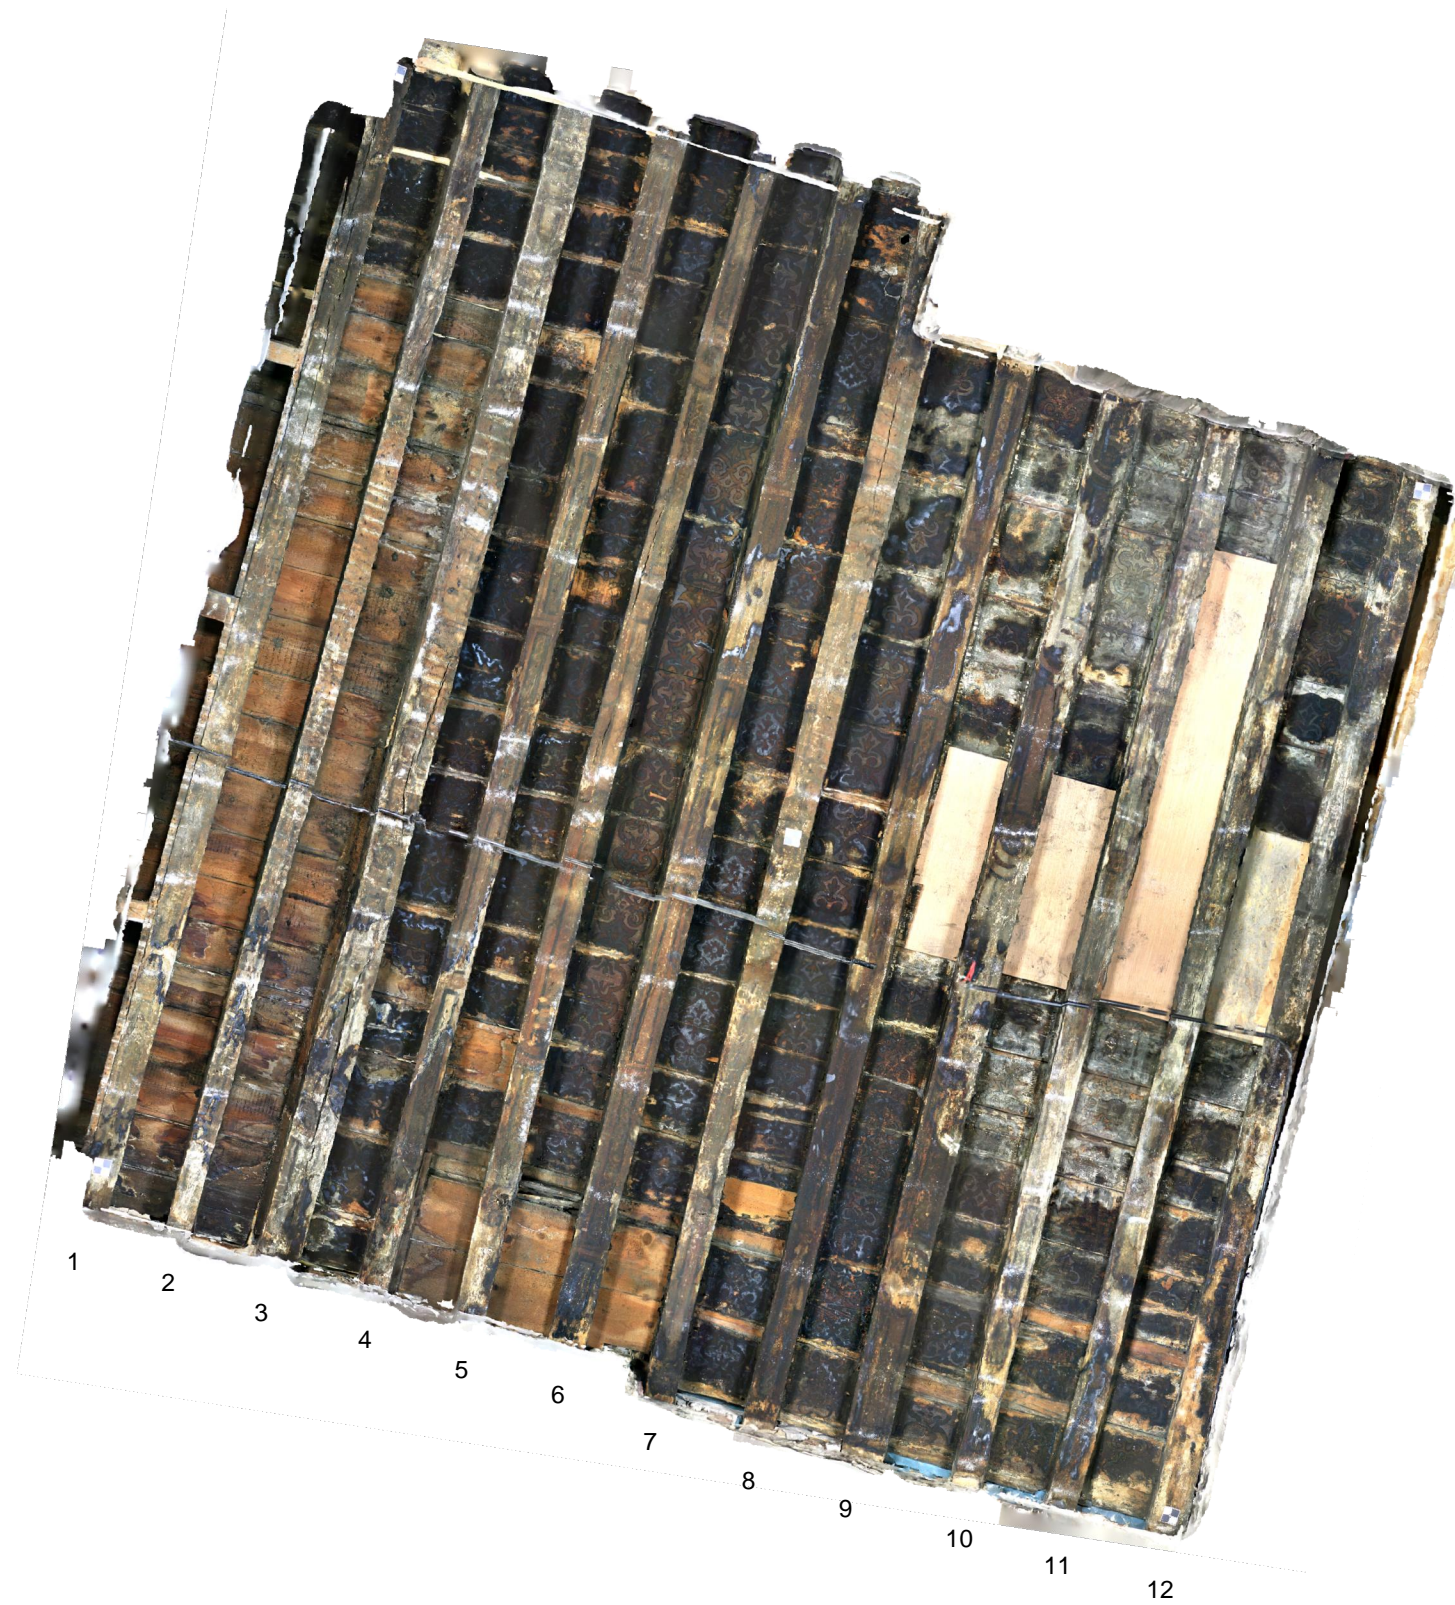
Seventeen painted boards (Fig 30 & 31) were present and these spanned the beams from east to west. Some of the boards had been replaced using modern tongue-and-groove planks and more recently plywood. As this ceiling lie directly under the flat roof of the North Block the paintwork had suffered from the ingress of rainwater and wet and dry rot. The best preserved area where the paintwork has not been blackened is towards the terminus of Beams 9-11. Here the blue/green two-dimensional leafy scrollwork between parallel lines overlay a white background. The leafy style of the paintwork can loosely be described as *Arabesque* according to Bath (2016).

Title:  
A colour orthophotograph of the  
painted beam and board ceiling  
in Room S02

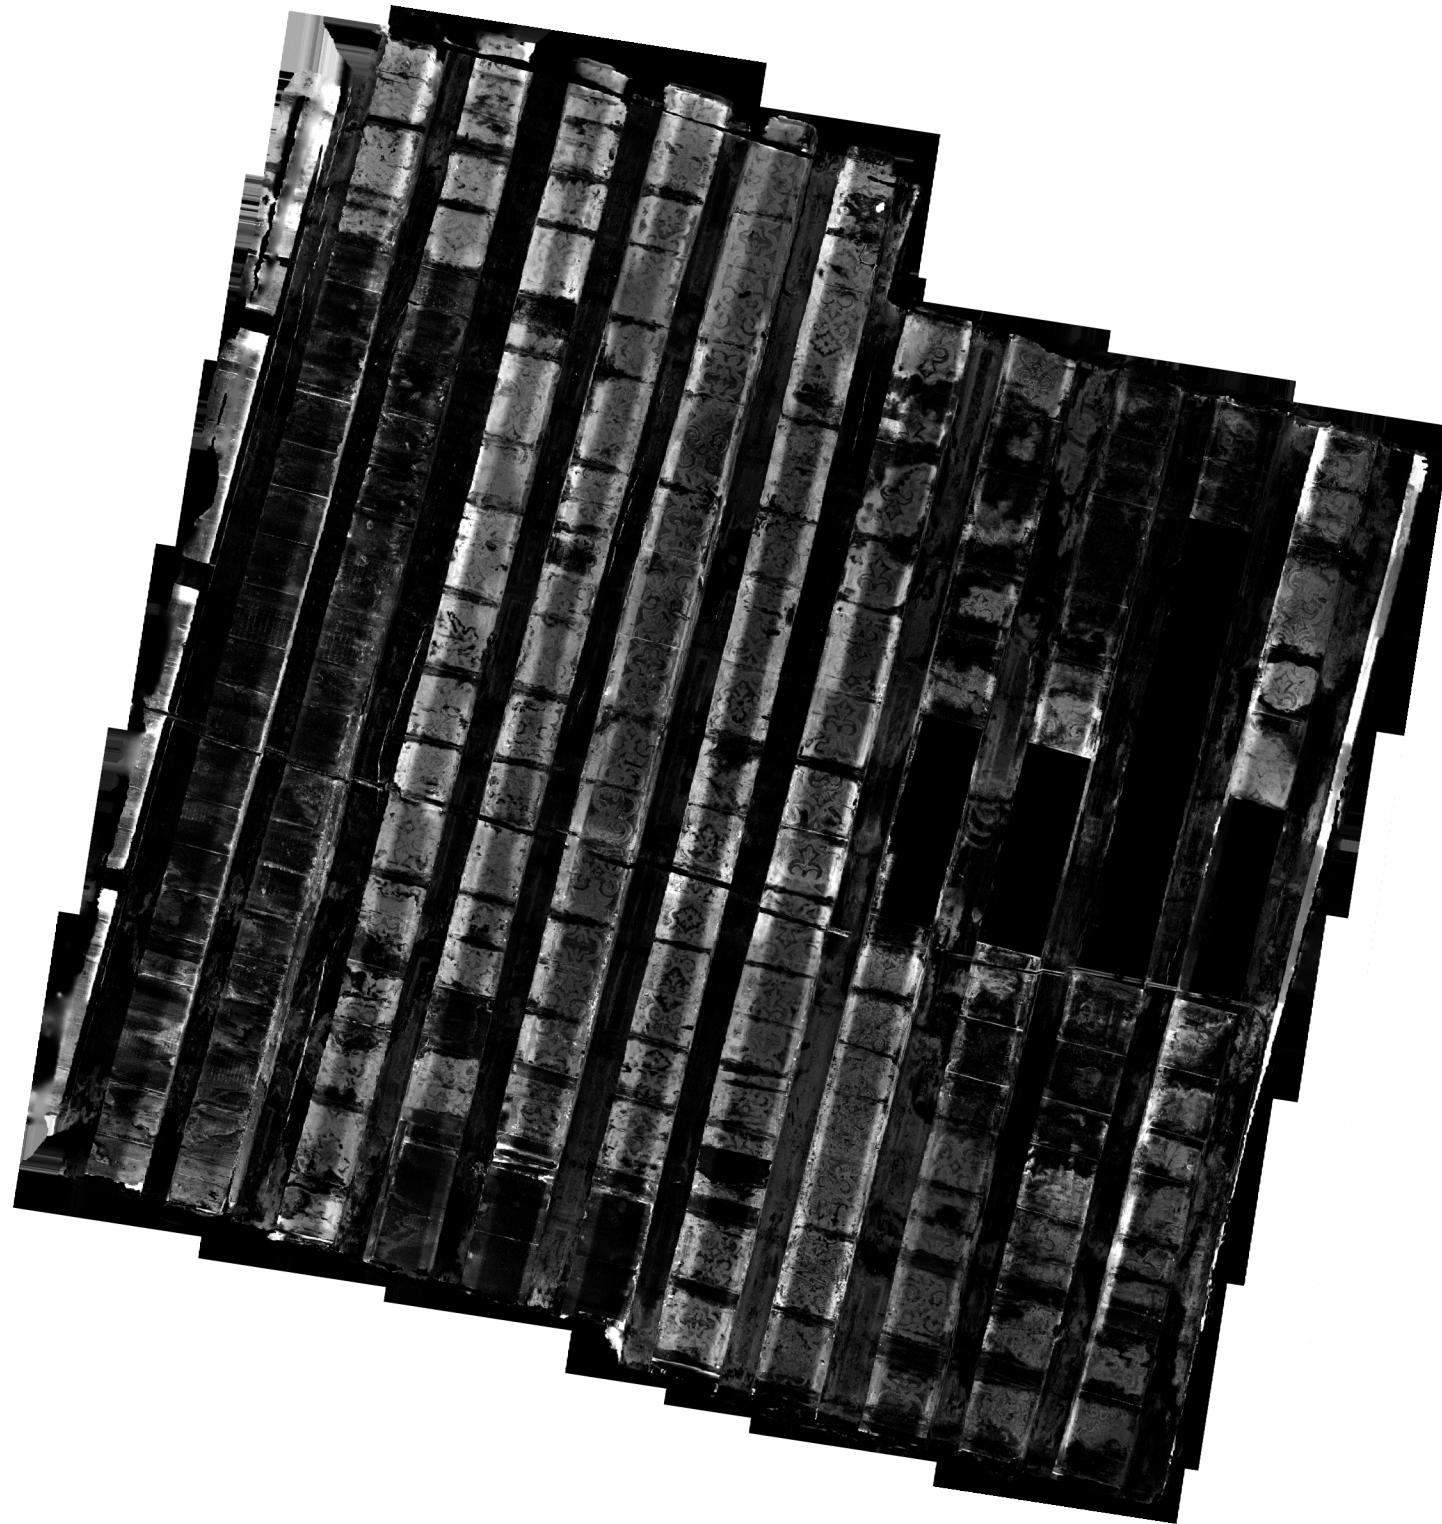
Title:  
A negative orthophotograph of  
the beam and board ceiling in  
Room S02

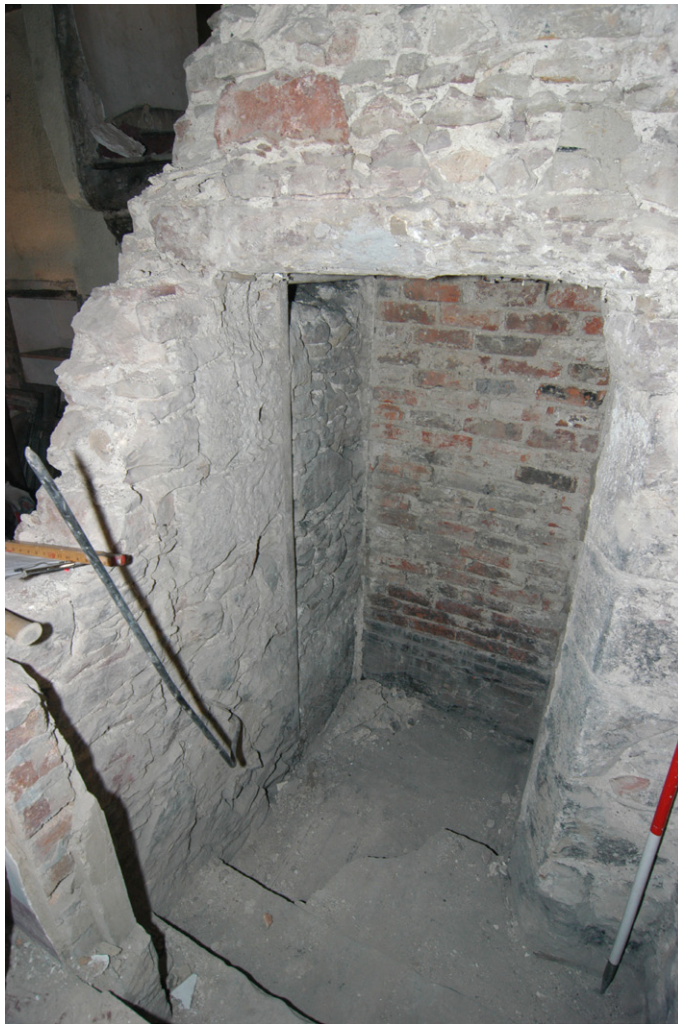
Fig. 32 - An early rubble-blocked doorway in Room S07 with chamfer moulding door surrounds

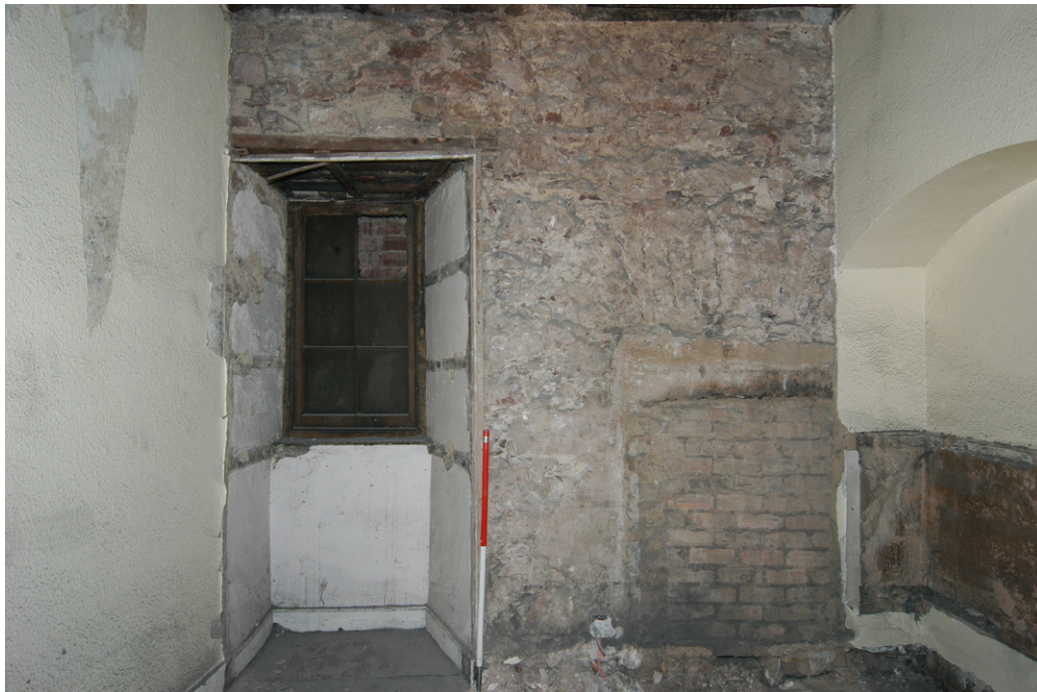
Fig. 33 - Exposed blocked window and fireplace in Room S08
