## Riddle's Court, Lawnmarket, Edinburgh (Phase 2)

Historical Building Survey & Archaeological  
Watching Briefs  
Report No. 3423

**Historical Building Survey Recording and  
Archaeological Watching Briefs**

**Report No. 3423**

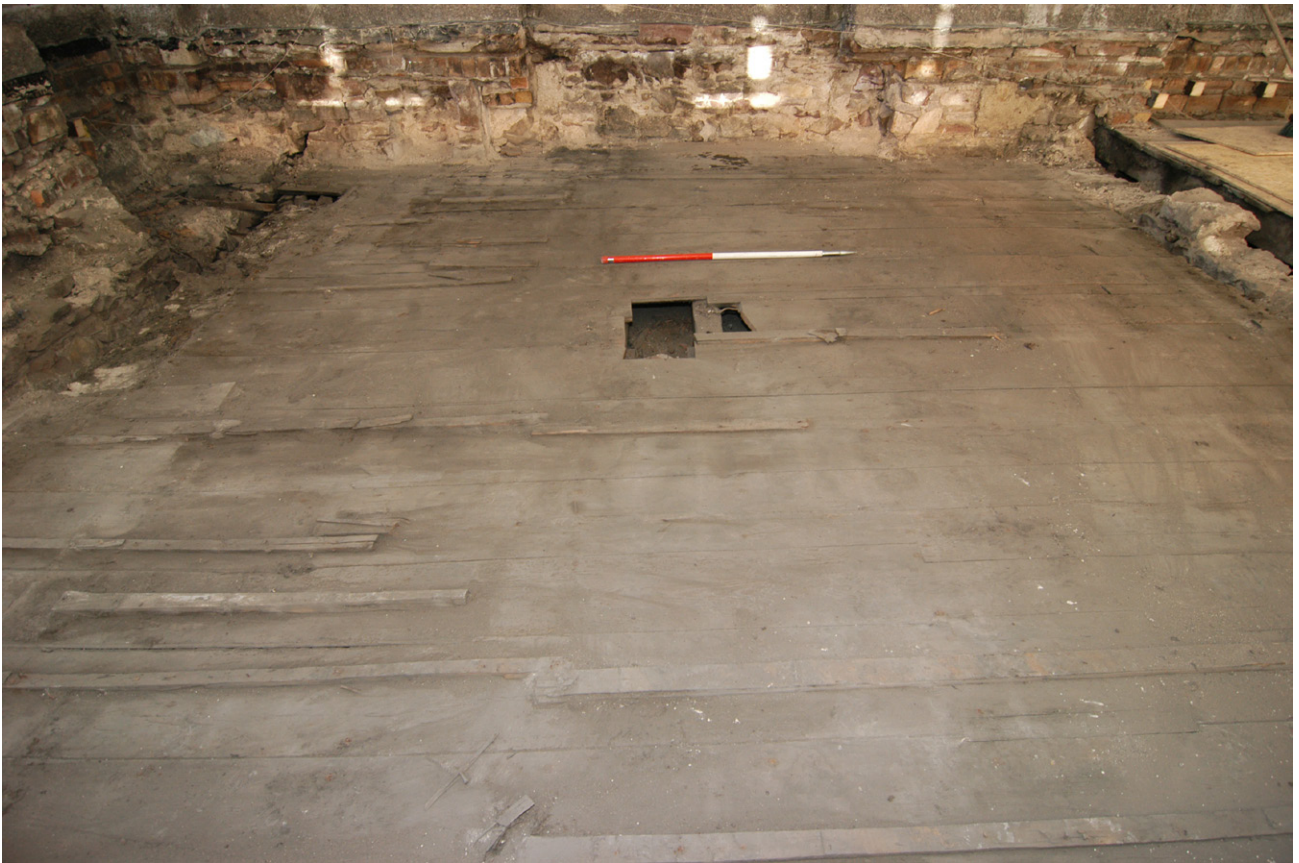
Fig. 34 - The floor boards in situ prior to uplifting on the North Block roof

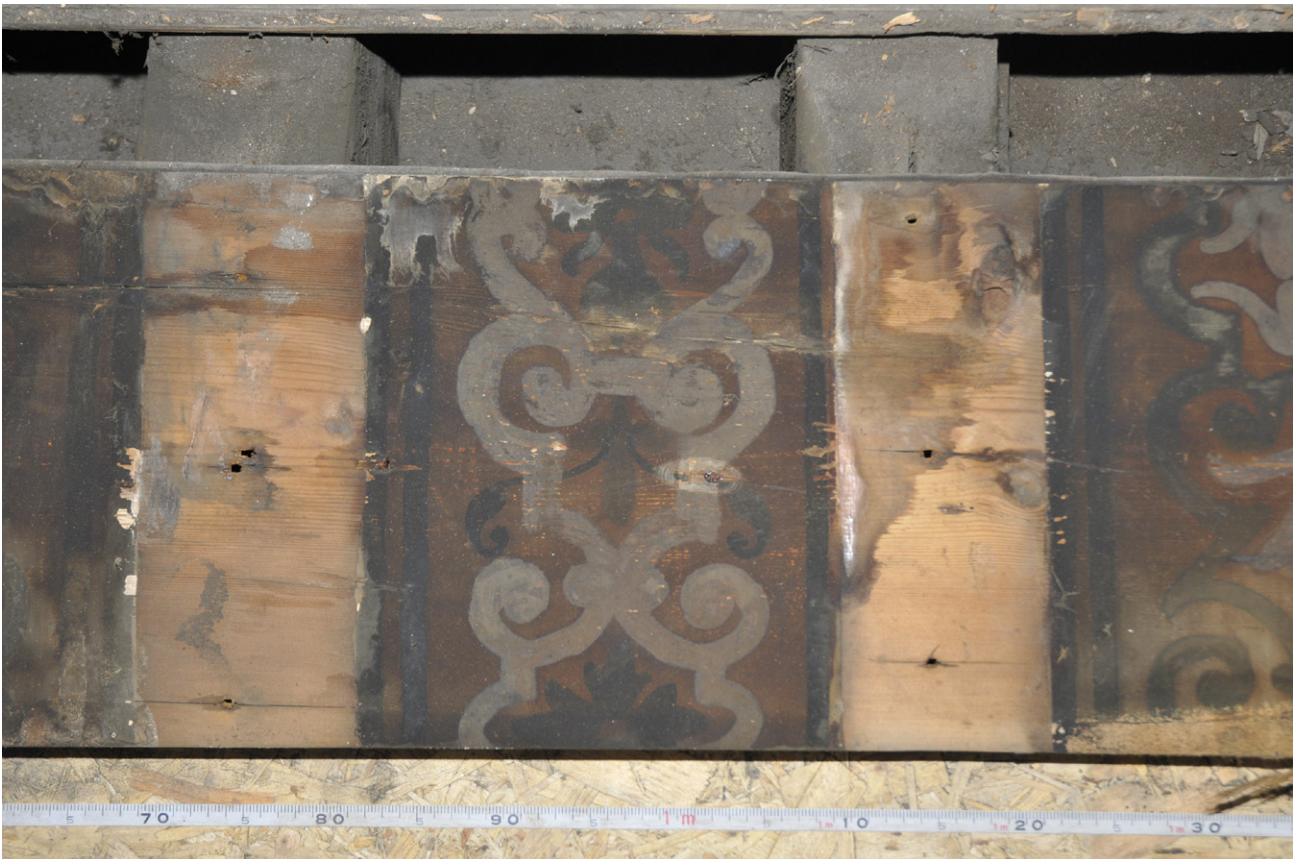
Fig. 35 - Tempra artwork underneath one of the painted boards

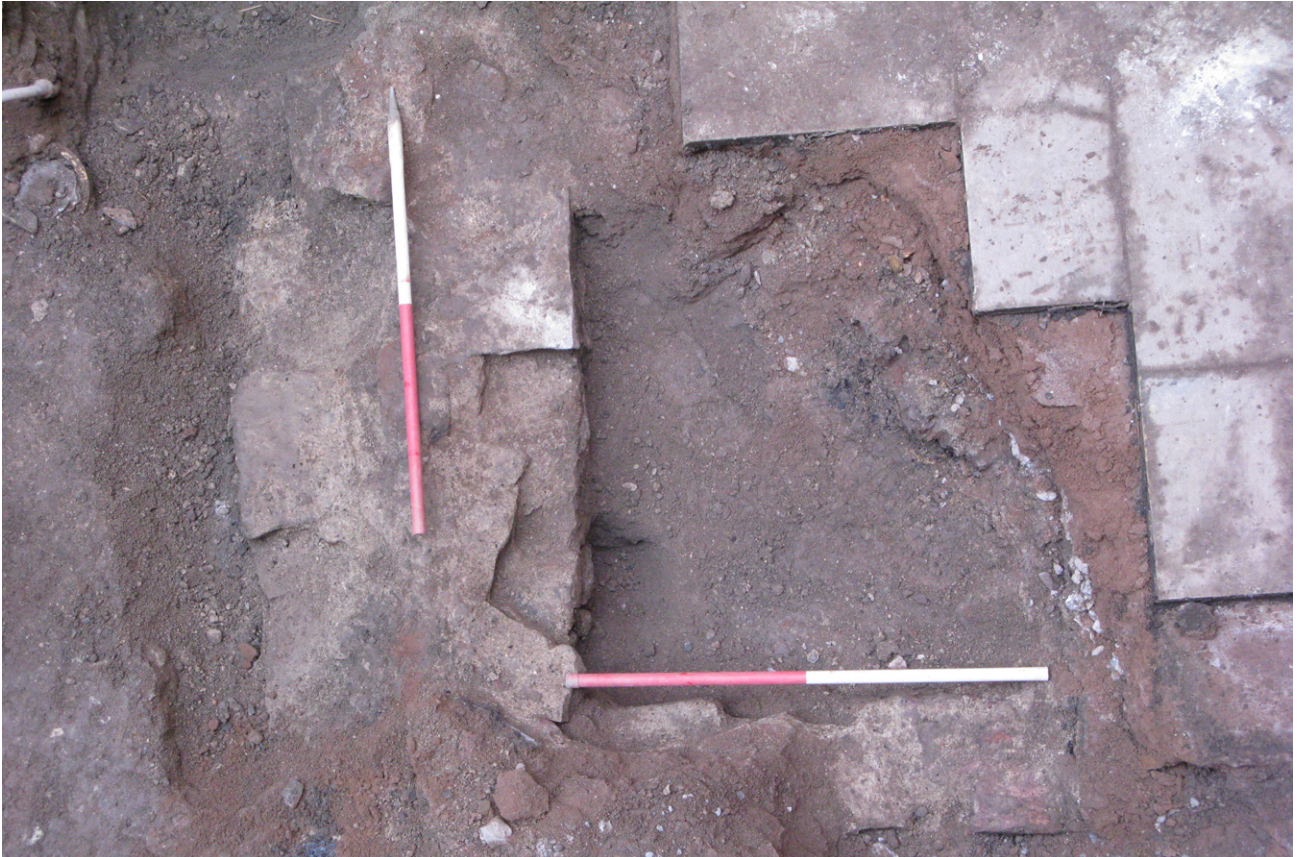
Fig. 44 - External courtyard, the remains of an early wall footing (Context 6)
