50 Nicolson Street, Edinburgh

Report type: Historic Building Survey Report No. 3851

Historic Building Survey

Report No. 3851

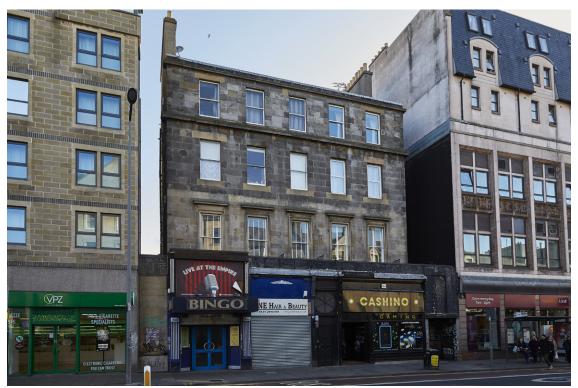
The *Cinema Treasures* website includes a comment on the building and holds historical photographs of the cinema entrance. It mentions that The La Scala Electric Theatre was opened on 31st December 1912 on the site of an earlier New Royal Alhambra Theatre (1862). Ralph Pringle, the proprietor, put on occasional variety acts. The projection box was located at the rear of the stalls seating area, under the balcony. In the 1930s the cinema passed to the Peter Crerer circuit. The Classic Cinema was opened in April 1974 and screened adult films. It closed its balcony, thus reducing its capacity to 294. It then became a bingo hall in the mid-1980s, operated by Premier Empire Bingo (Fig. 4).

Fig. 4 - 50 Nicolson Street frontage showing the main entrance to the former Empire Bingo Hall

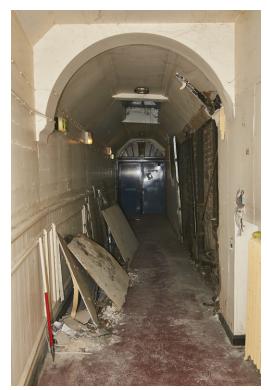
Fig. 5 - Unit 2.2, passage and main fire exit to Nicolson Street

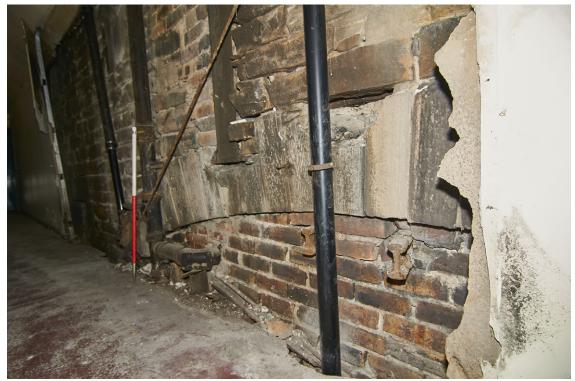
Fig. 6 - Unit 2.1, historic fabric exposed where the cladding had been removed in incorporating a relieving arch blocked with brick and two sections of railway line

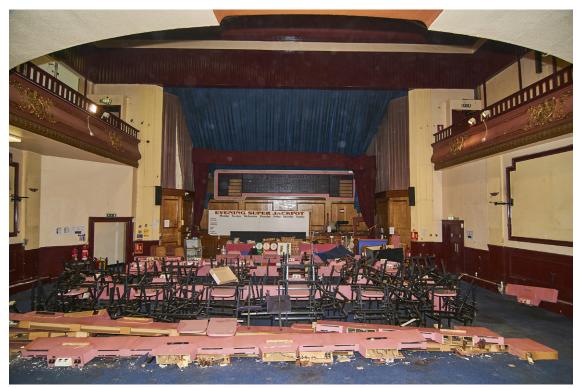
Fig. 7 - Unit 1, general view of the interior of the ground floor Auditorium

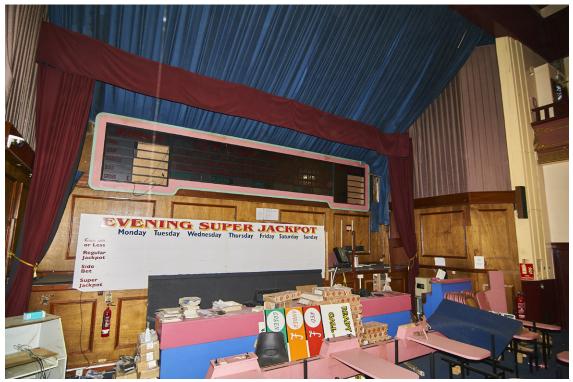
Fig. 8 - Unit 1, general view of the stage and wing walls

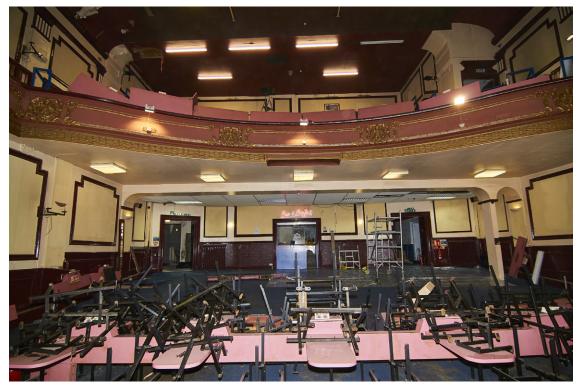
Fig. 9 - Looking up at the first floor balcony

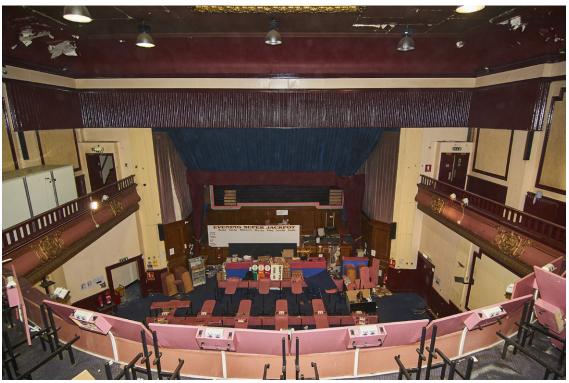
Fig. 10 - Looking down on the auditorium from the balcony

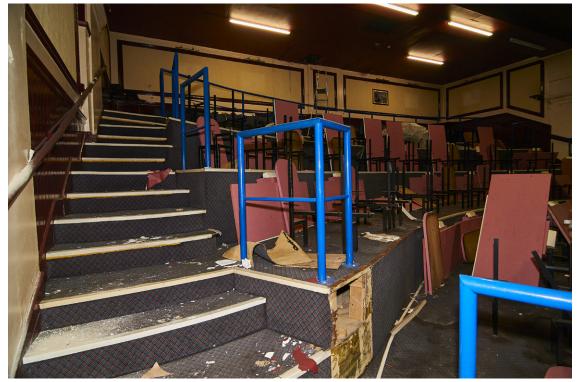
Fig. 11 - Stairs to the rear of the circle floor

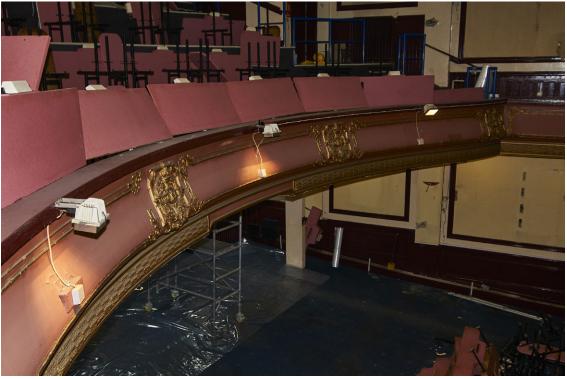
Fig. 12 - Embellished balcony front with heraldic detailing

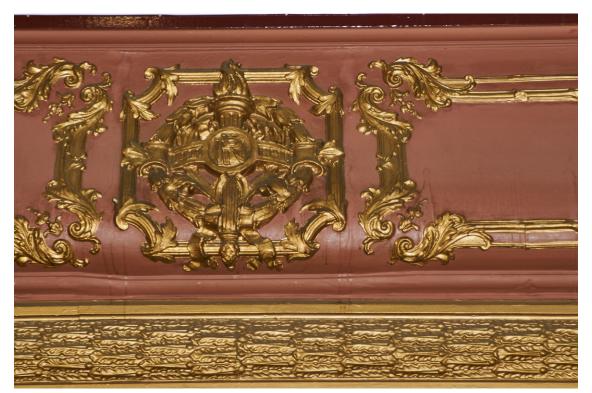
Fig. 13 - Detail of a boss incorporating the initials RP (Royal Princess) and leaf and scroll plasterwork

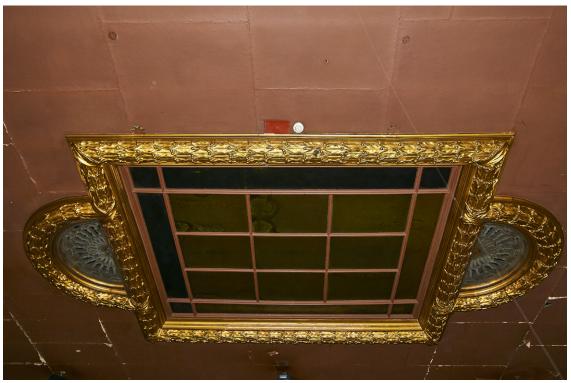
Fig. 14 - Highly ornate gilded ceiling light and semi-circular air vents

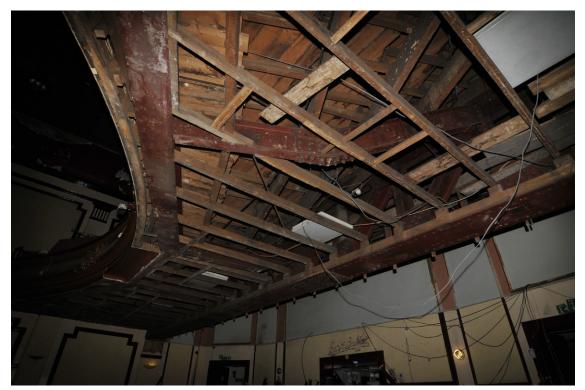
The first floor circle or balcony (Fig. 9) occupied roughly half the area of the auditorium and was split into three seating tiers (Fig. 11). The walls were lined with moulded panels and boxed in stanchions forming palisters that were embellished with fluted capitals that were surmounted by moulded architraves. Original 19th century features included intertwined gold letters R & P representing the initials Royal Princess in the middle of heraldic plaques equally spaced around the balcony front and flanking first floor passages (Fig. 12-13). These were surmounted by long strings of piping that terminated in swags or scrollwork. Following the partial removal of the underside of the balcony, its main superstructure was exposed and seen to comprise a

composite steel Pratt truss with more recent raking joists inserted in the 20th century (Fig. 15).

Fig. 15 - Underside of the first floor balcony with cladding removed exposing a Pratt truss spanning the width of the auditorium with bolted raker girders and original 19th century wooden form work

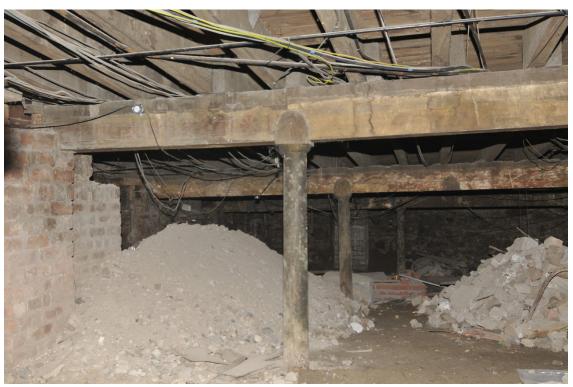
Fig. 16 - Cast iron columns supporting the auditorium floor

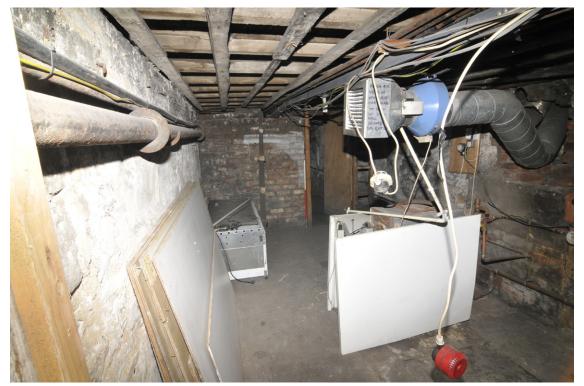
Fig. 17 - Boiler room with services

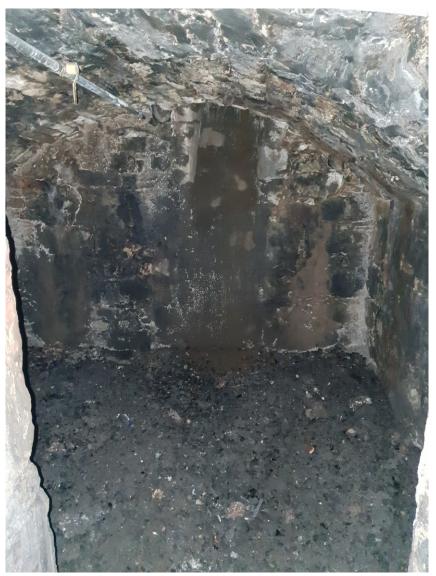
Fig. 18 - Vaulted coal store for a coke fired boiler
