Bonnington Mill, 70-72 Newhaven Road Edinburgh, Historic Building Survey & Architectural Watching Brief

Report type: Data Structure Report
Report No. 3814

**Bonnington Mill,
70-72 Newhaven Road, Edinburgh
Historic Building Recording
&
Architectural Watching Brief**

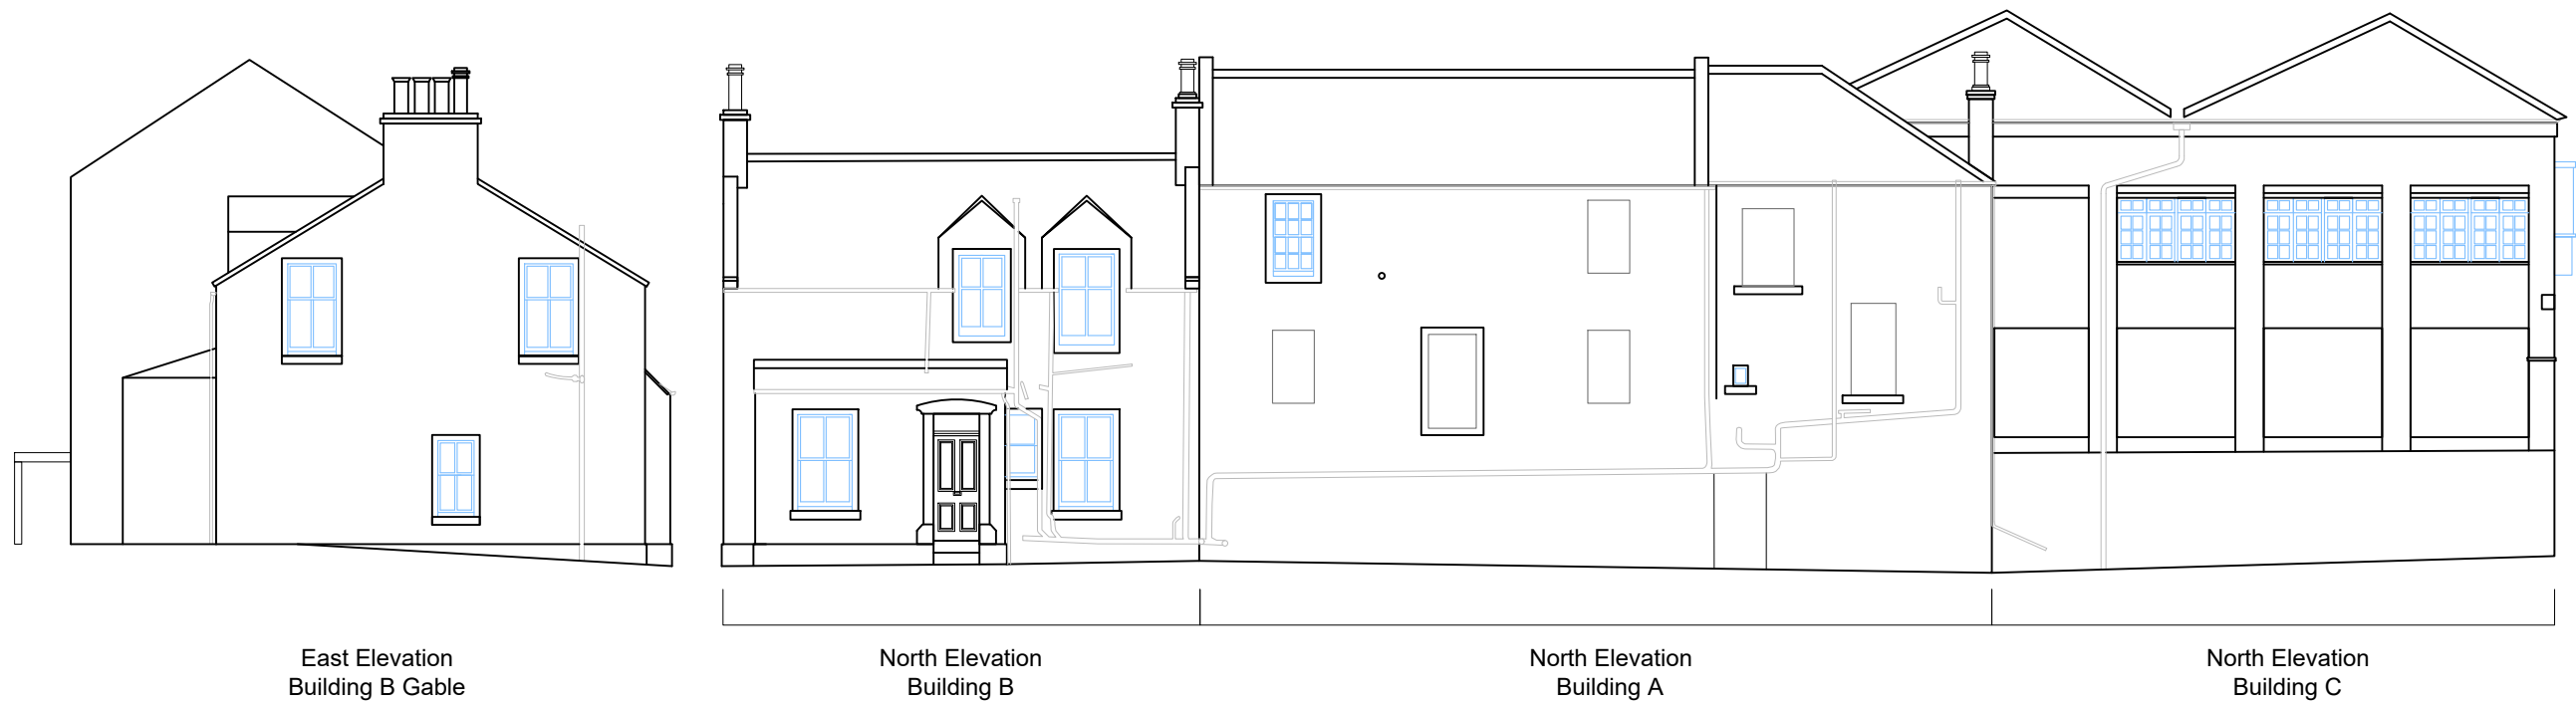
Report.No: 3814	Fig. No: 2a
--------------------	----------------

Building A was a three storey stone-built mill house covered in blue-painted wet-dash render and set back from main street frontage by about 10m at its west end. It contained no ground floor windows on its north-facing elevation. A plank-built door was situated at its west end that led to an undercroft. The first floor windows were all boarded. At first floor level there was four boarded windows and a central doorway that must at one time been accessed by an extra-mural staircase. The second floor had three windows two of which had also been boarded. At the west end of the building a distinct change from a pitched roof to a hipped roof was marked by a stone-built ridge capped with sandstone copings. Both slate roofs shared the same roof line at the ridge. The ridge marked the position of a later extension to the main block of Building A. The footprint of this extension is shown on the 1876 OS map (Fig 39g).

The west-facing gable had a hipped slate roof with a tall chimney stack. The gable wall had two bays one of which was asymmetrical with non-aligned windows. At ground floor level there was a small square opening with a missing window frame. On its right hand side (facing) was a boarded window. The first floor level had two boarded sash-and-case windows and the second floor had smaller sash-and-case windows one of which was only partly boarded.

Building B a former two storey house had been converted into offices. Its external walls had been rendered and painted cream. It had two large sash-and-case windows and a small two-paned toilet window on the ground floor. A central four panelled door with a grilled hall light had moulded stone surrounds and curved lintel. The wall in which the door stood was slightly advanced and had a narrow slate lean-to roof. At first floor level were two dormers with pitched gabled roofs. The windows were sash-and-case. The gable wall adjoining Building B and its gable had a chimney stack. The roof had a lower roofline than Building A. The roof was covered with grey slate.

Building C was last used as a gymnasium that formed a second floor level building and was set back from the long wall of Building A. The main elevation contained three large mullioned casement windows (2 over 6). At eaves level was a brown painted barge board above which were two hipped roofs clad with steel sheeting. The elevation was supported on a series of concrete columns that had been built into a rubble-built boundary wall that was about 4m high at its west end. An underpass was present below Building C. Judging by the contrasting unaltered stonework at the base of the boundary wall it was clear that the top half had been partially rebuilt to accommodate the columns holding up the gymnasium building.

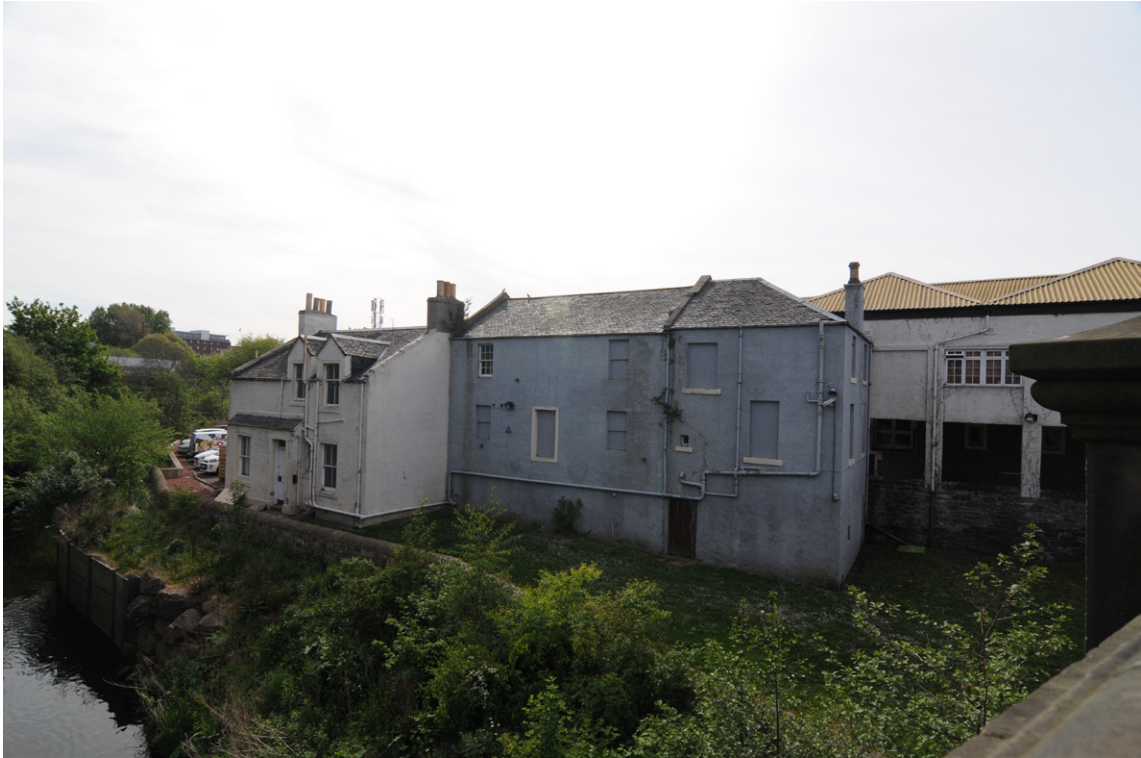
Fig. 4: General shot of the west-facing elevation fronting Newhaven Road (Buildings A-C)

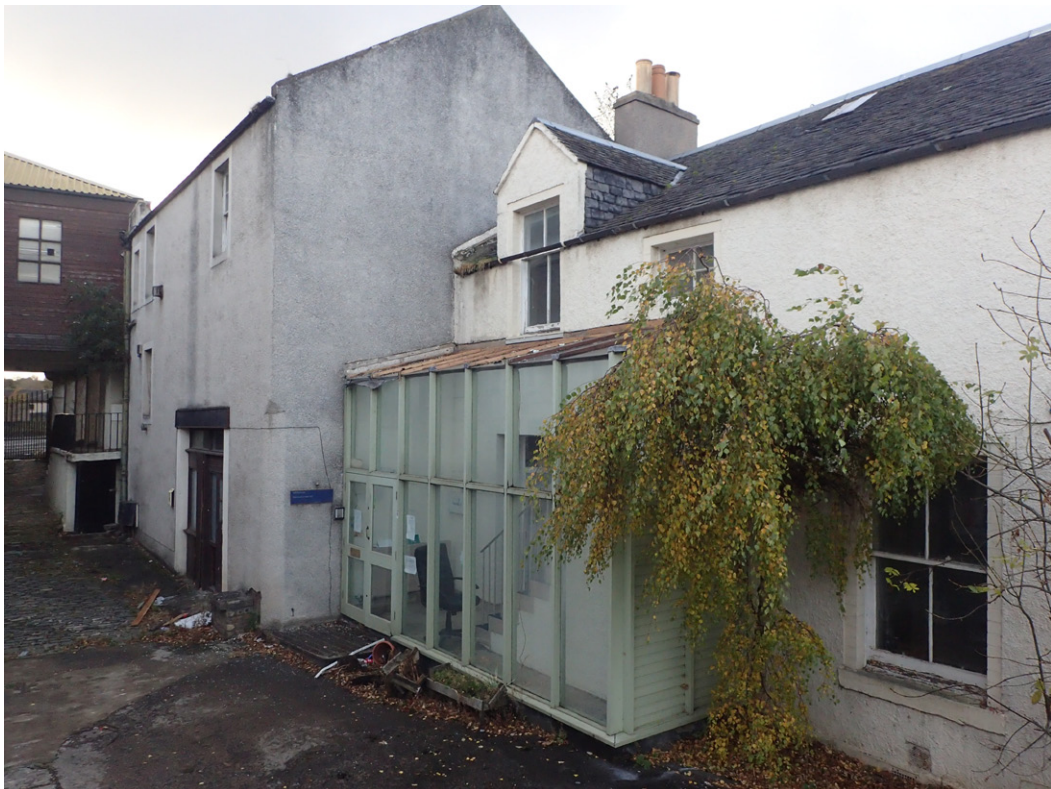
Fig. 5: South-facing elevation overlooking the main courtyard (Buildings C, D and I)

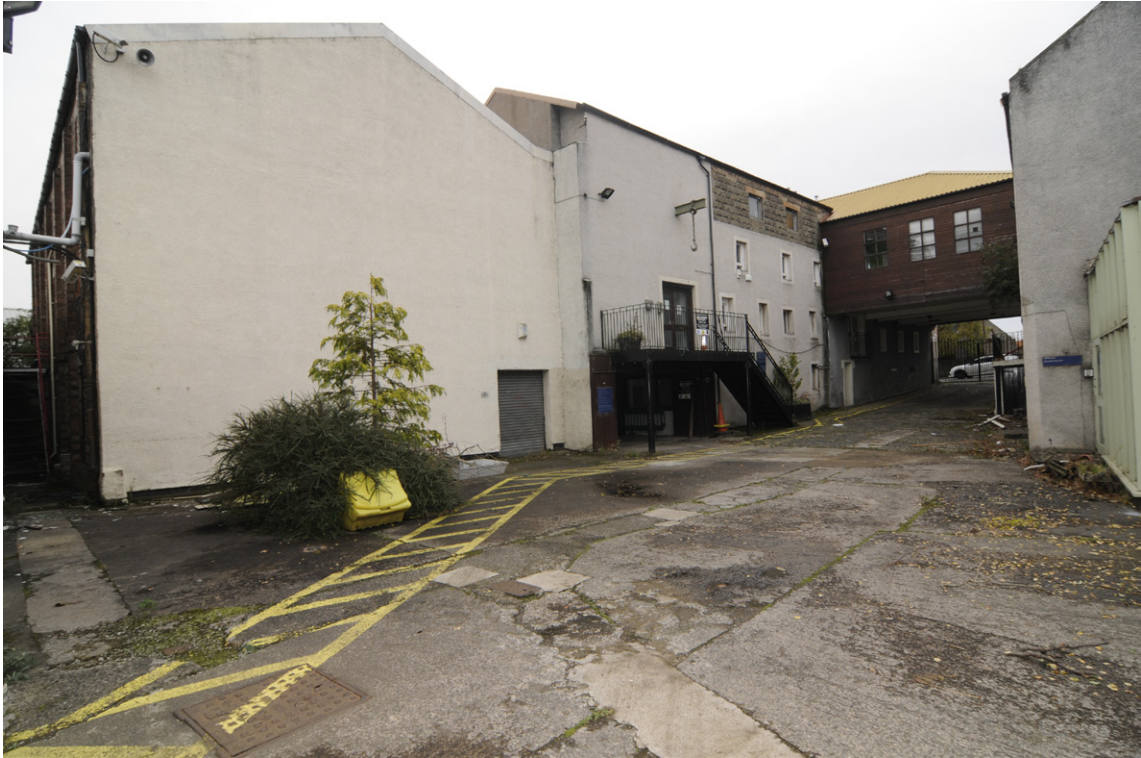
Fig. 6: North-facing elevation overlooking the main courtyard (Buildings A-B)

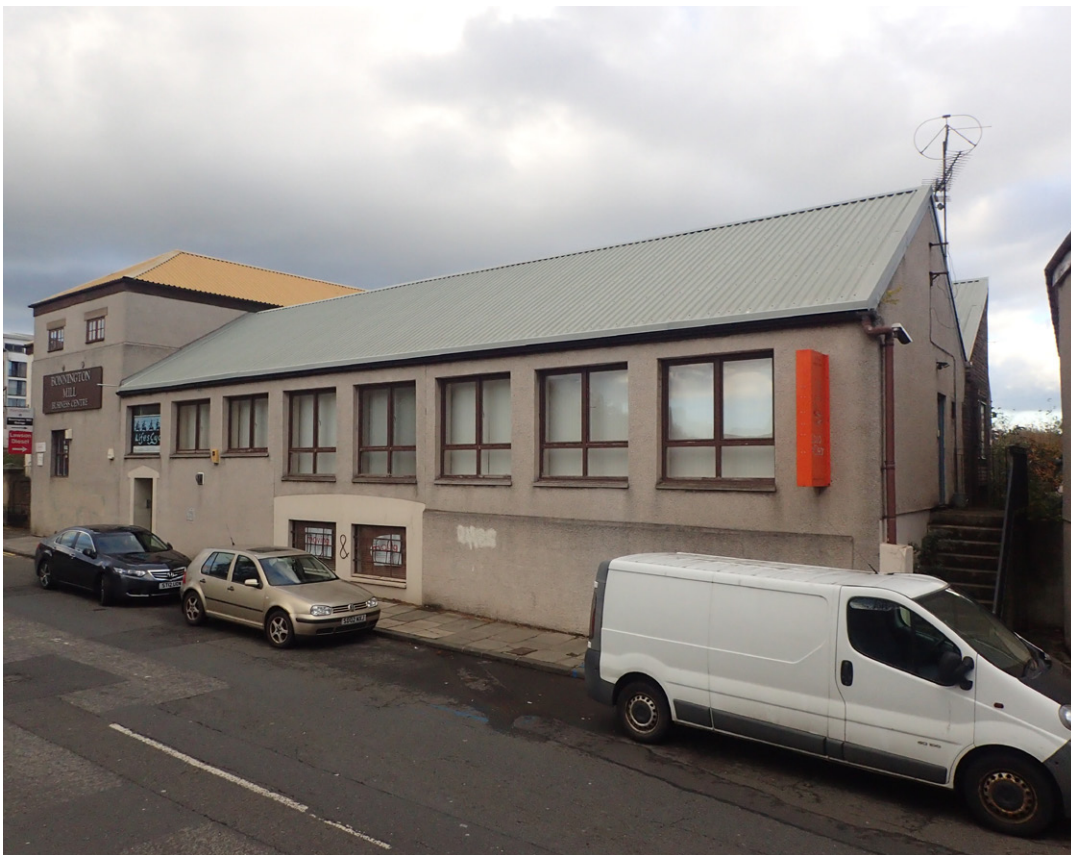
Fig. 7: General shot of the west-facing elevation fronting Newhaven Road (Buildings D-E)

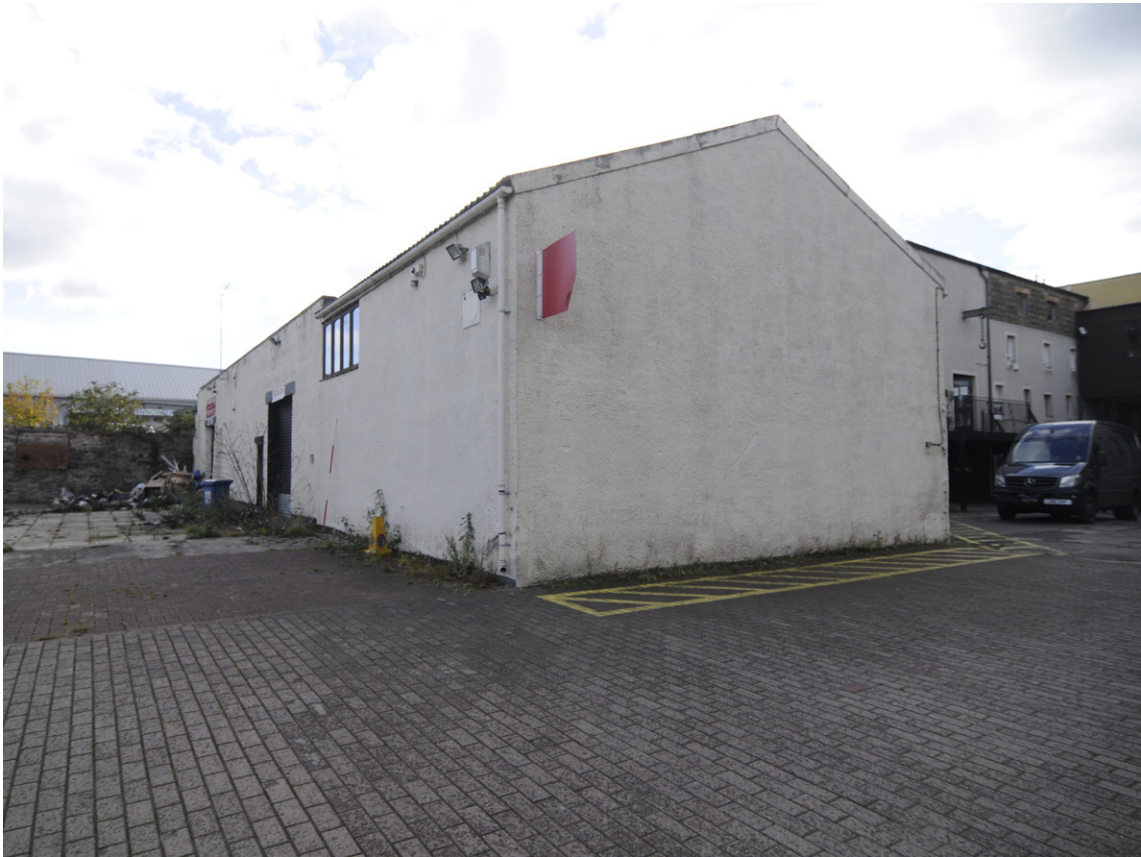
Fig. 8: East-facing elevation and north-facing gable overlooking the carpark (Building J)

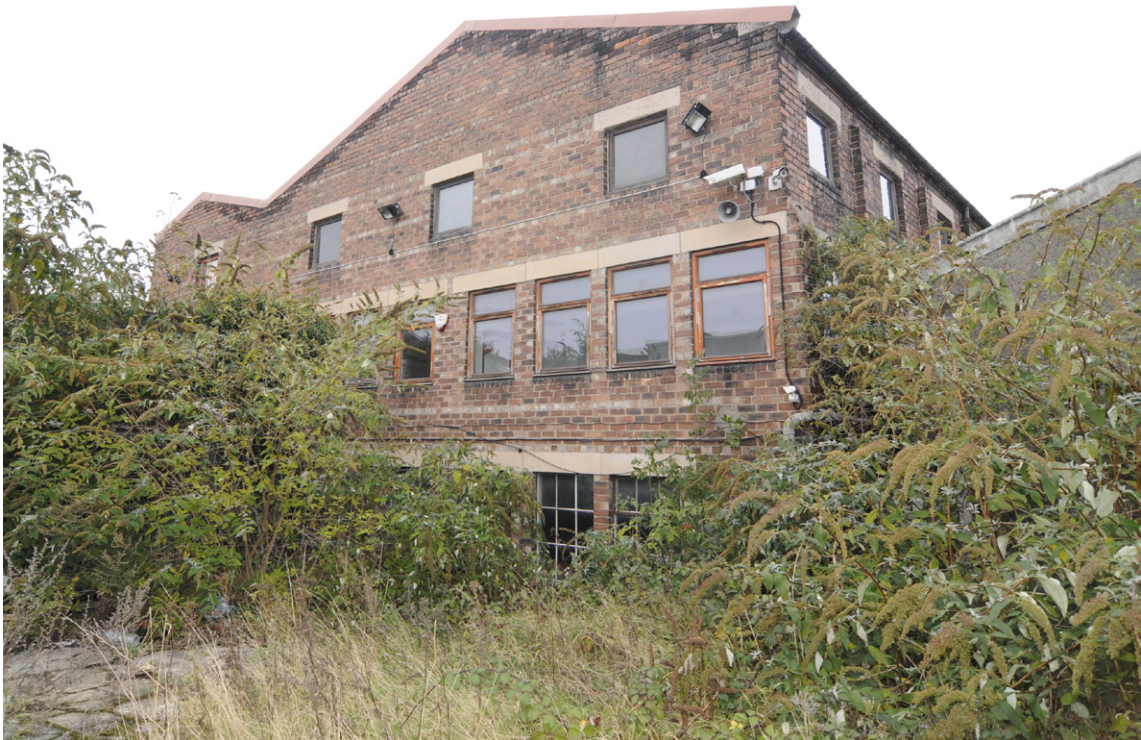
Fig. 9: South-facing elevation overlooking a former lade (Building I)

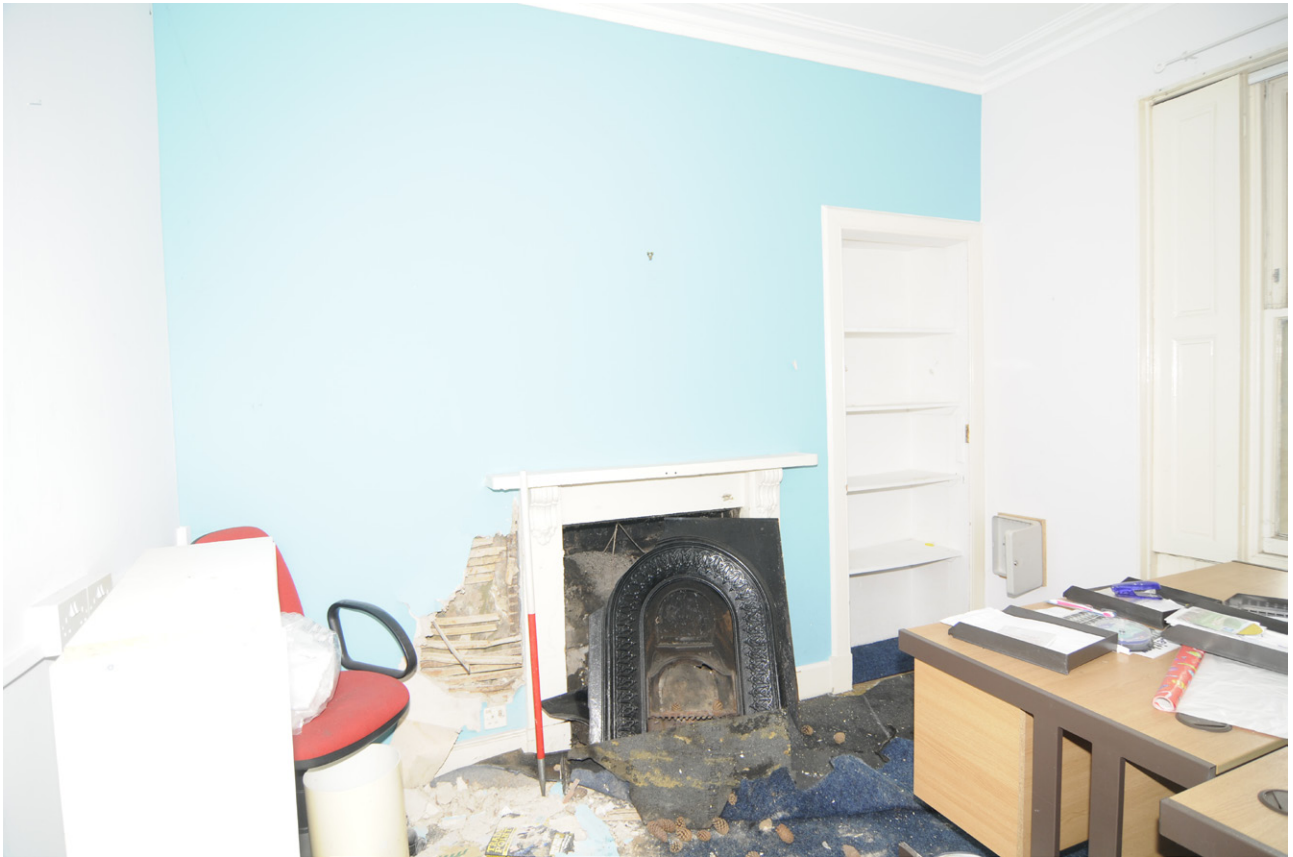
Fig. 10: Interior ground floor office and broken fire place (Building B, Room B3)

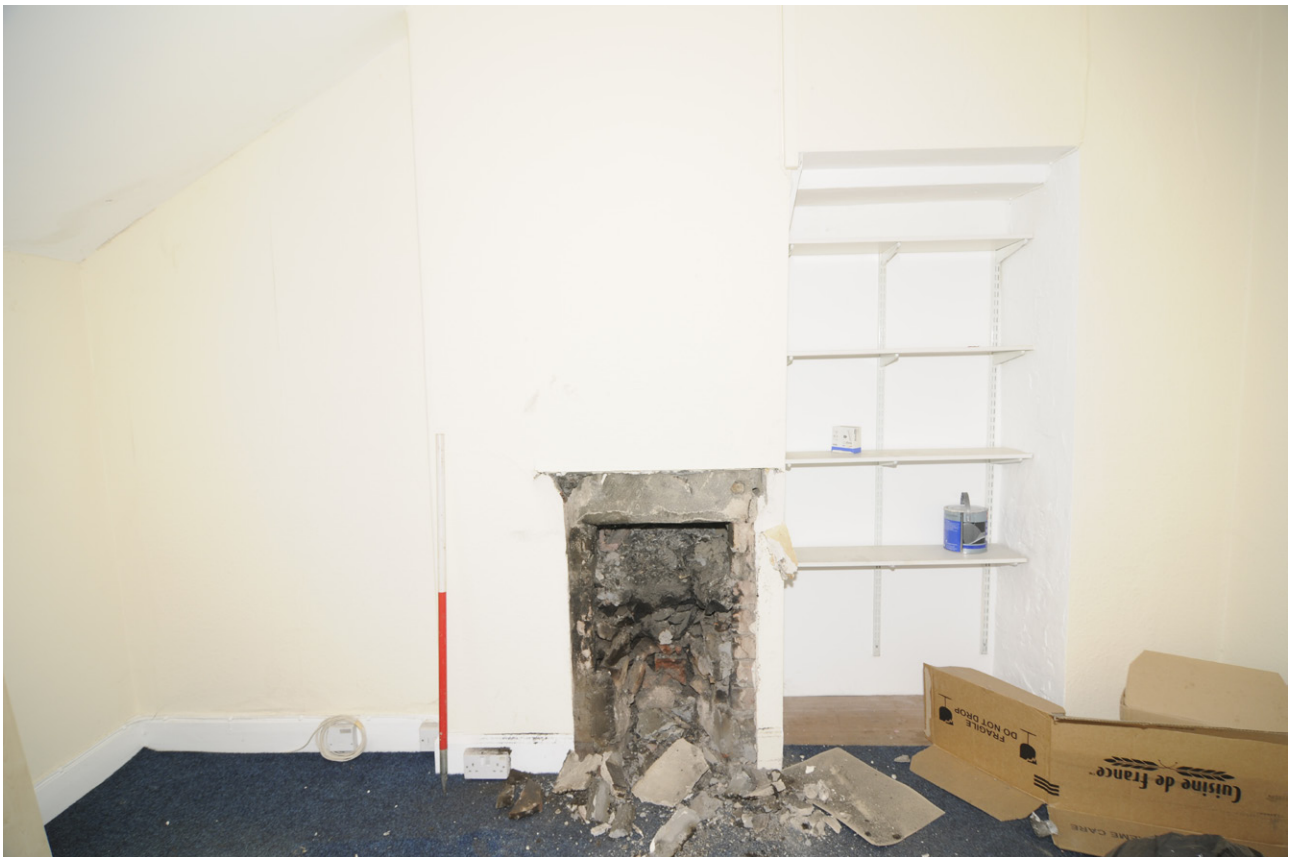
Fig. 11: Interior first floor office with robbed fireplace Building B, Room B12)

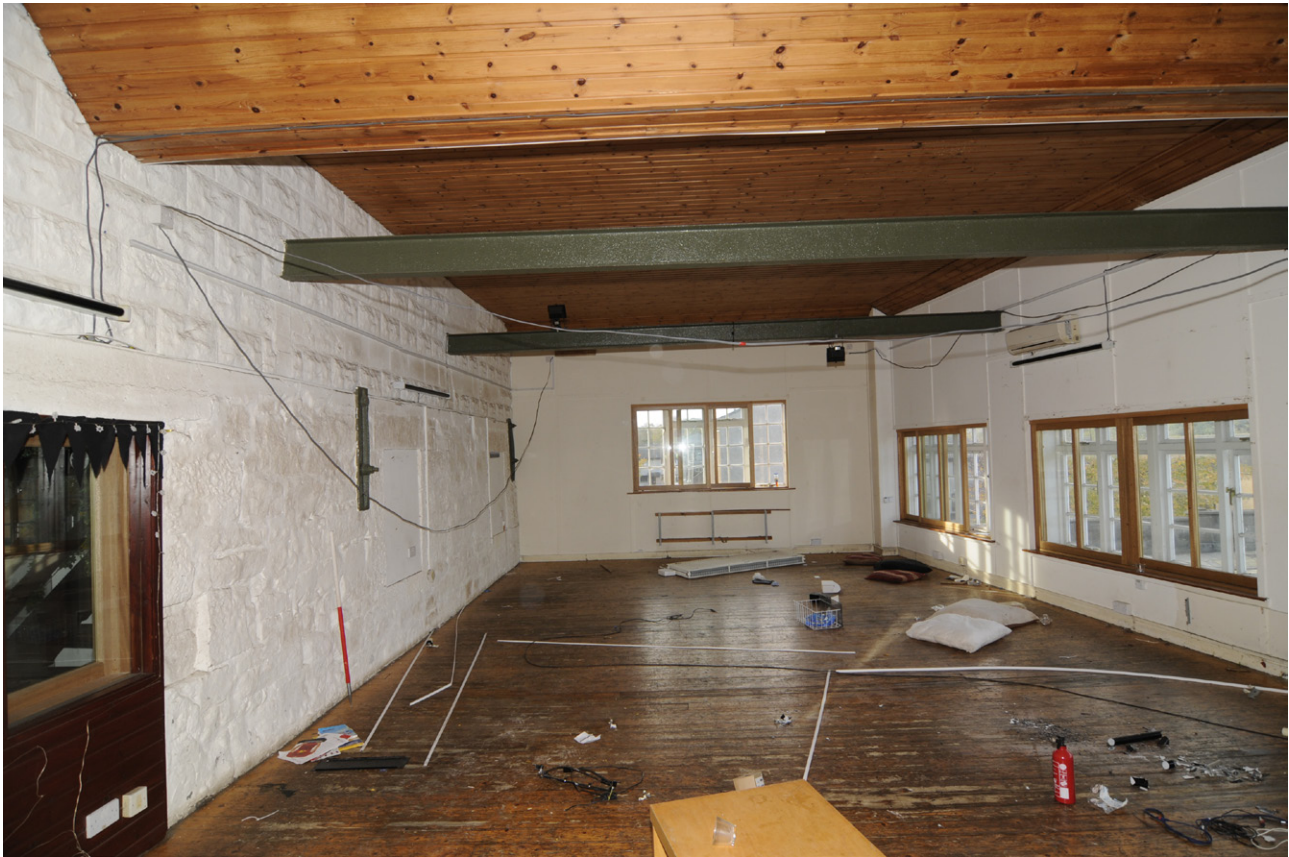
Fig. 12: Interior of Building C the former gymnasium utilizing the outside wall of Building D

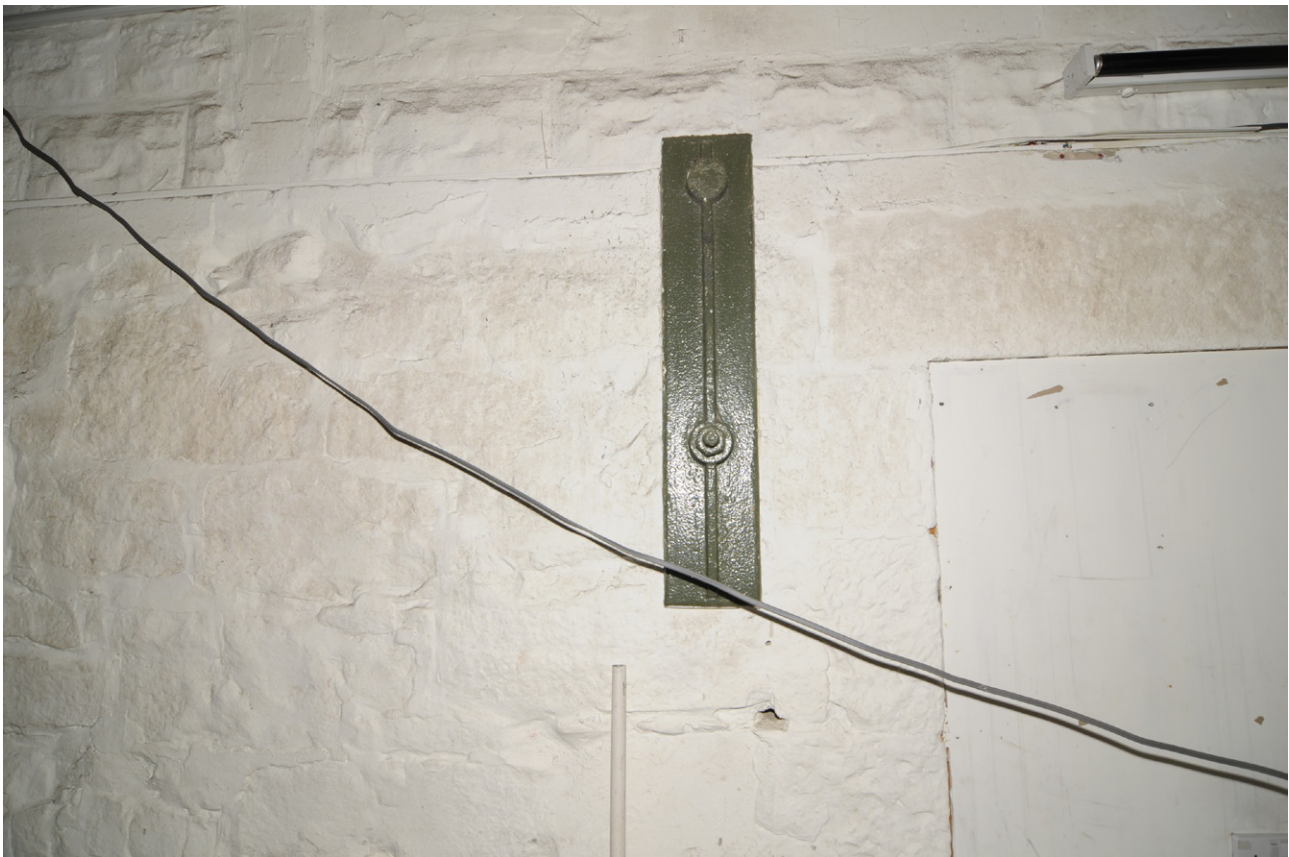
Fig. 13: Detailed shot of one of the tie-plates on a former gable wall of Building D

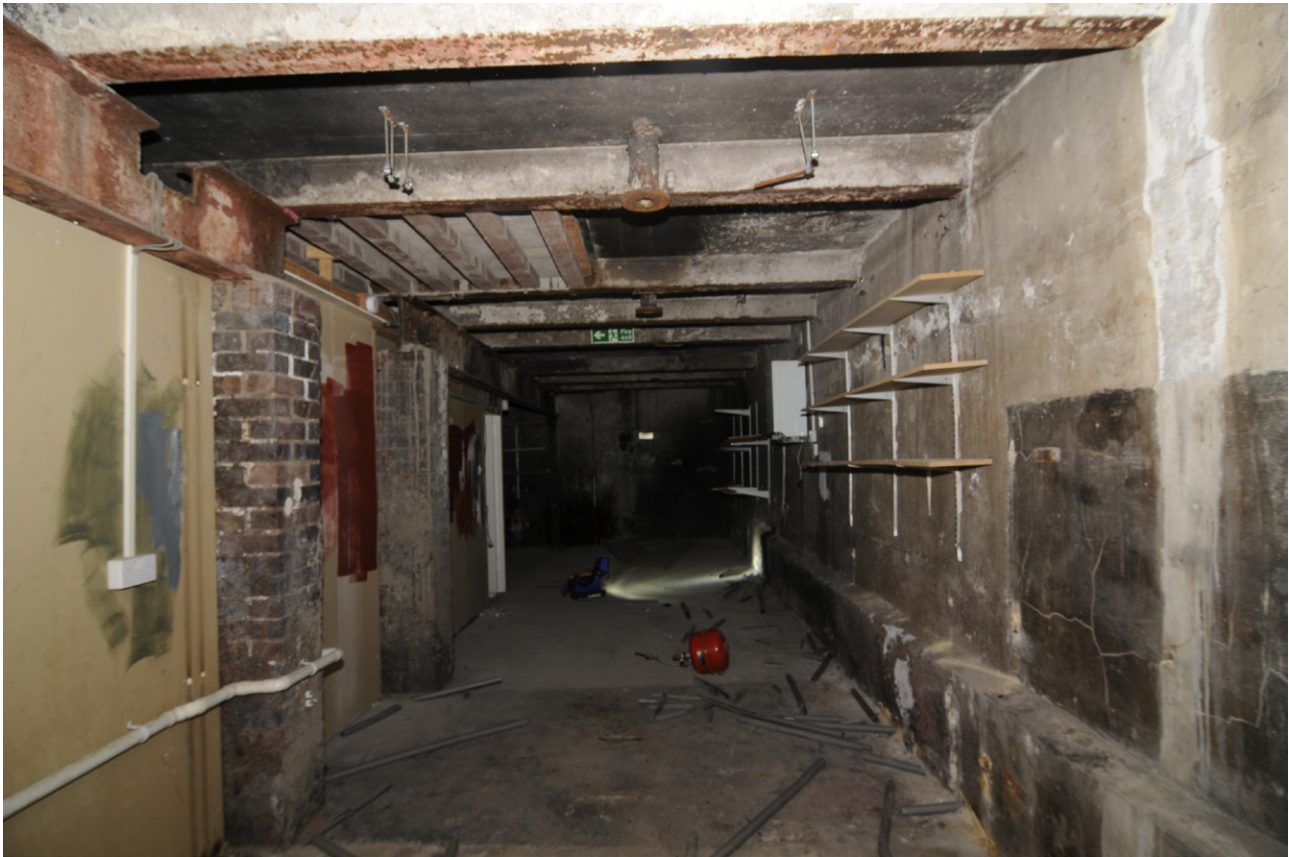
Fig. 14: General shot of the interior of the ground floor in Building D, Room D1

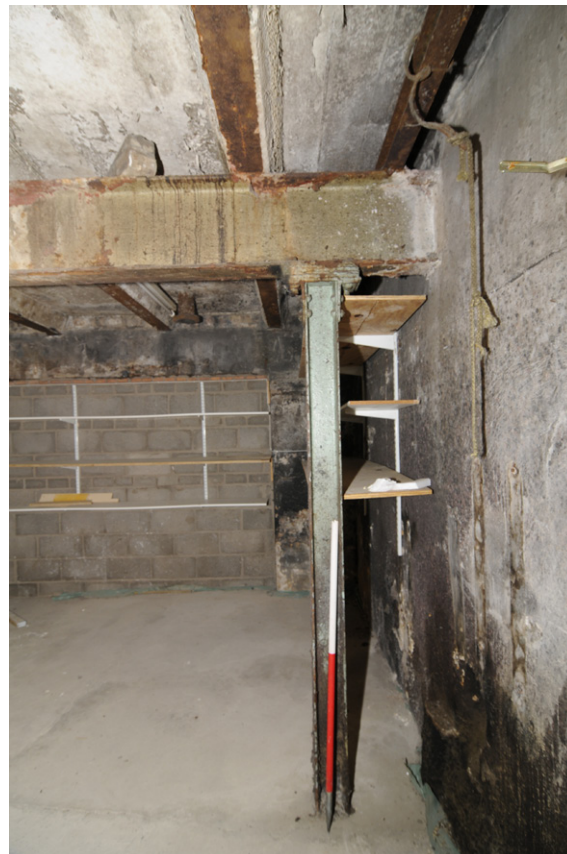
Fig. 15: Part of the load-bearing steel frame at the west end of Building D, D1

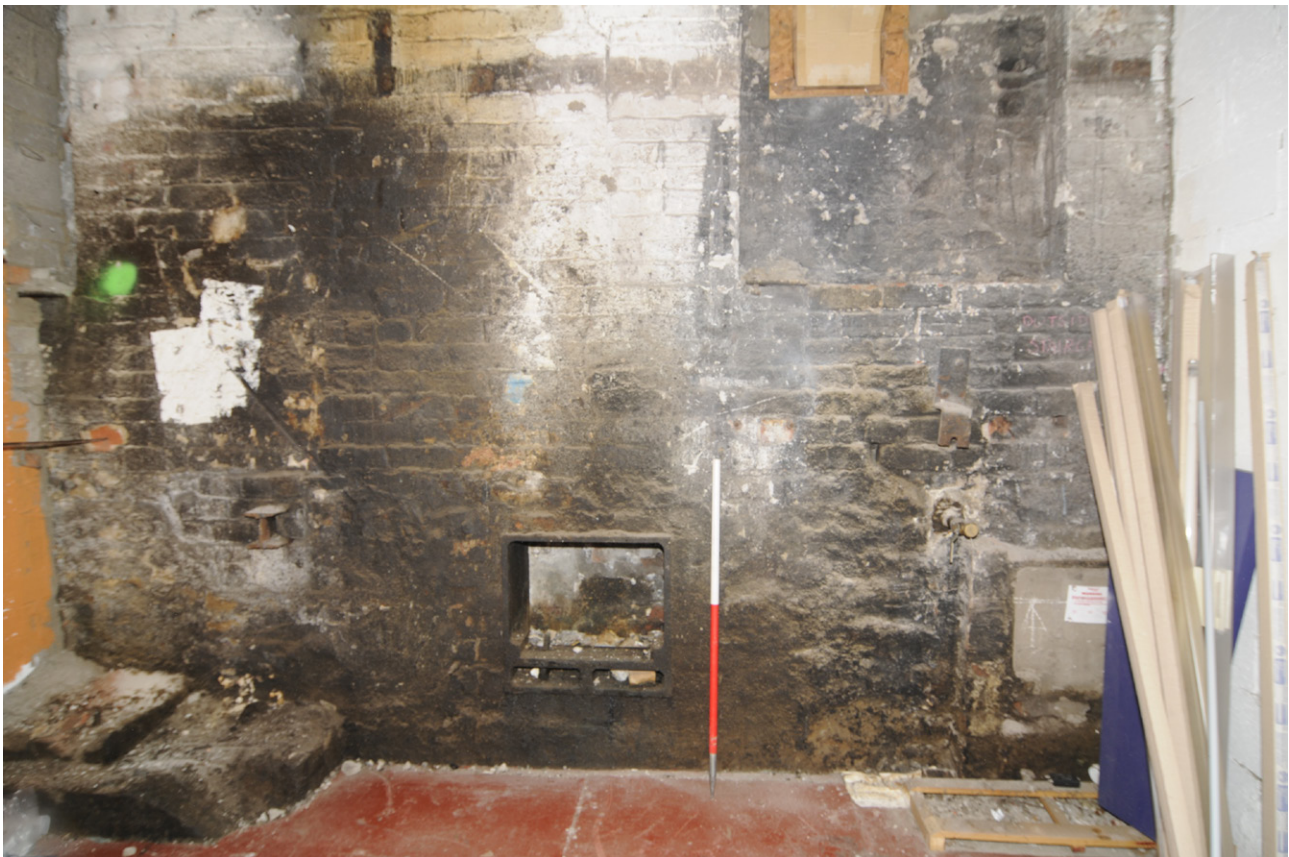
E Figs 3c, 16-17	The interior of Building E had been converted in the recent past into a large suite of offices (E1-E9). The largest being over 13m long (E4). The main corridor (E7) provided access to other ancillary offices (E5-6 and E8-E9). In Room E1 situated on the west wall was a central cast-iron bearing box. The bearing box would have held a brass drive-shaft bearing that was regularly oiled resulting in a heavily oil stained wall immediately above it.	Late 19 th century mill footprint converted to modern offices early 21 st century.
F Figs 3d 18 & 19	The ground floor of Building F contained a plant room with no access. The first floor level comprised an engravers open-plan workshop, kitchen and office (F1-4). Noteworthy features included a blocked doorway on its south wall and a series of steel pillars supporting a large load-bearing steel beam. This room was lit by windows on its north wall overlooking the main and inner courtyard.	Late 19 th century last used as an engravers workshop.

Fig. 16: Central cast-iron bearing box and blocked window on the ground floor of Building E, Room E1

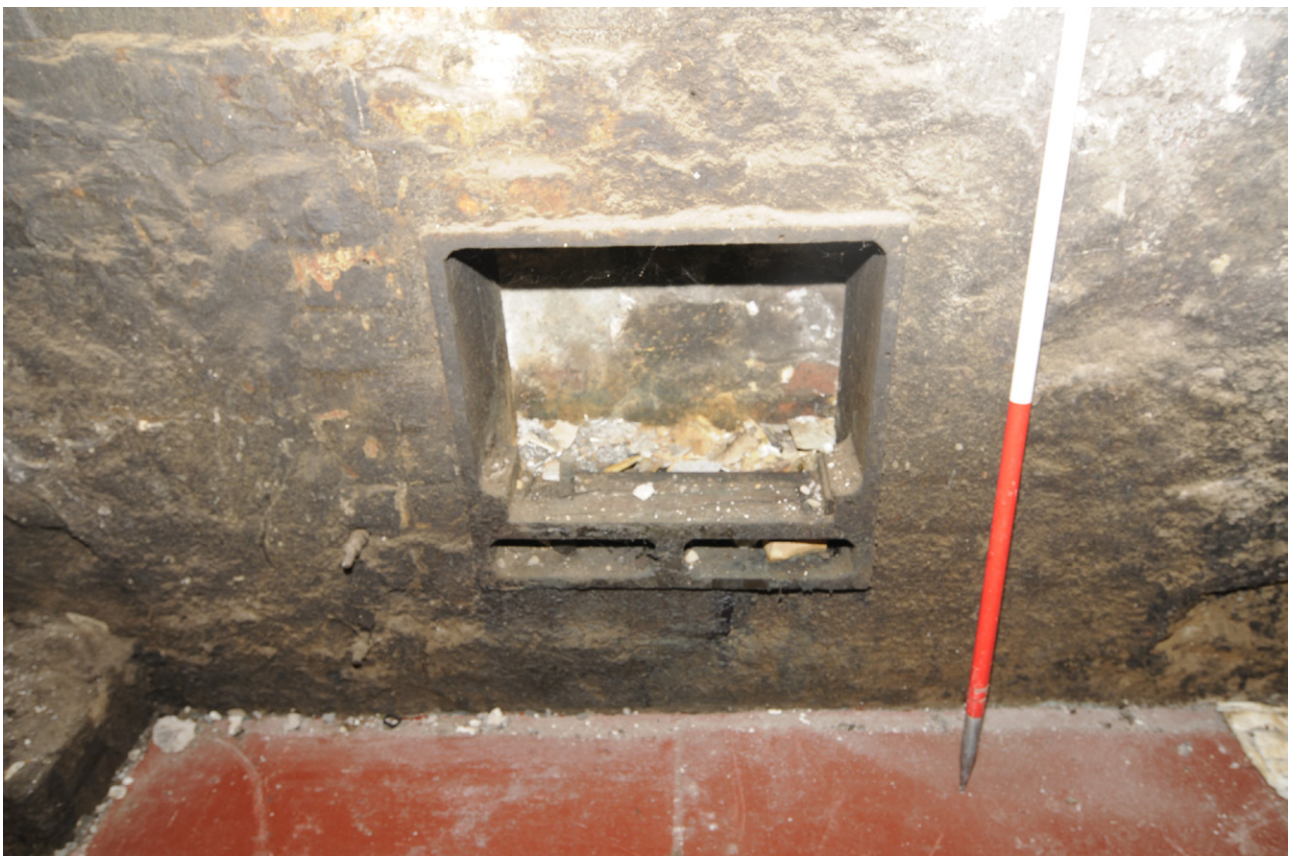
Fig. 17: Detailed shot of the bearing box in Building E1

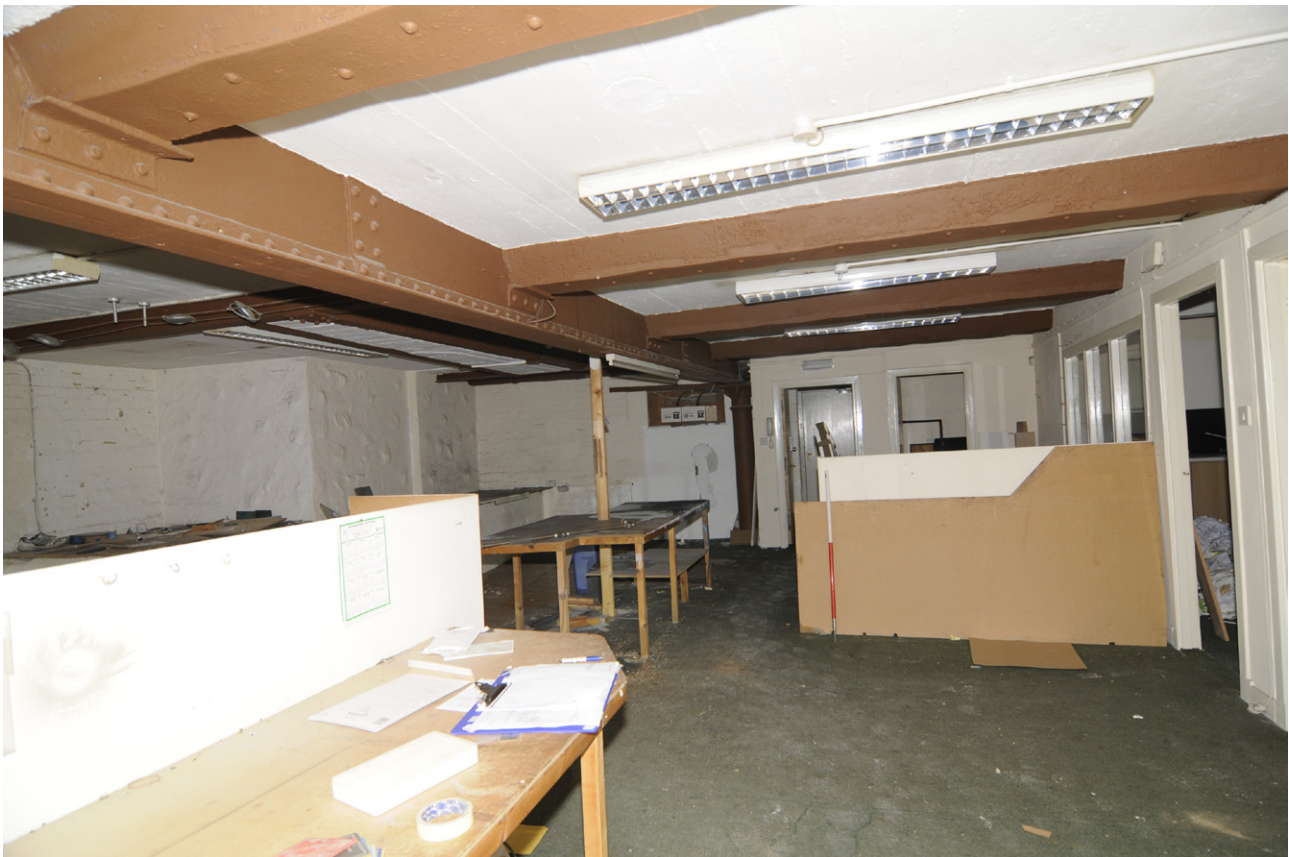
Fig. 18: Open plan workshop and office suite on the first floor of Building F showing riveted steel frame (Room F1)

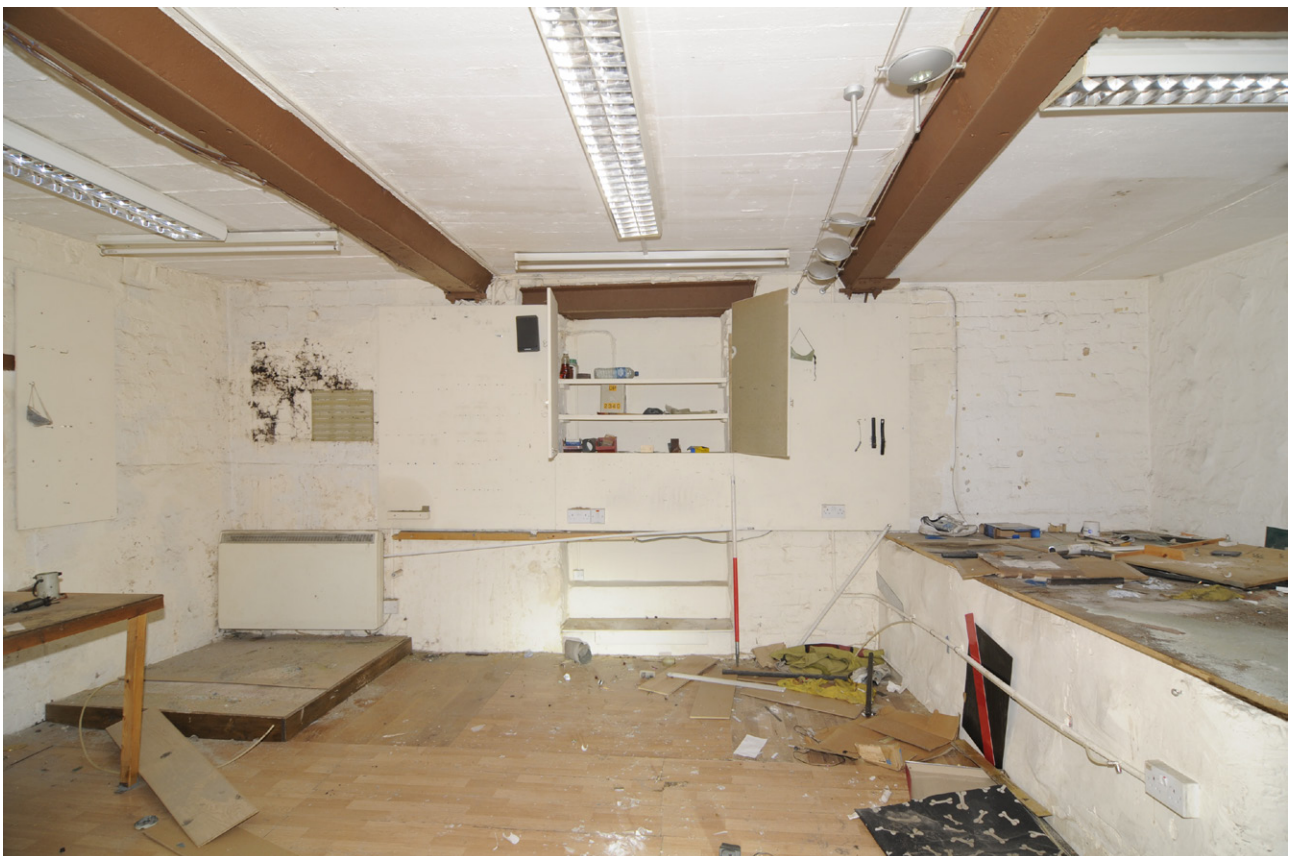
Fig. 19: Earlier blocked doorway on the south wall of the engraving workshop (Building F, Room F1)

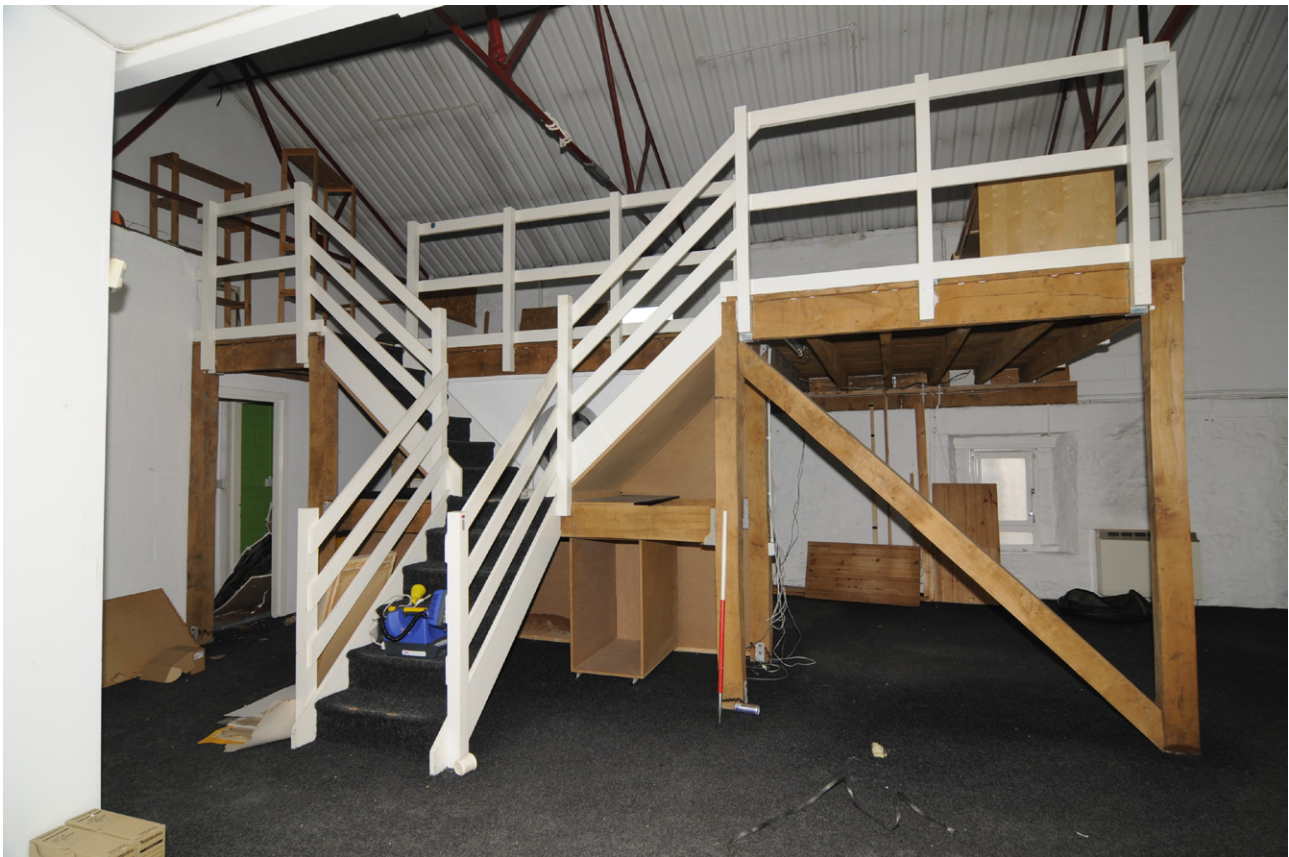
Fig. 22: Timber-framed mezzanine on the second floor in Building H, (Room H1)

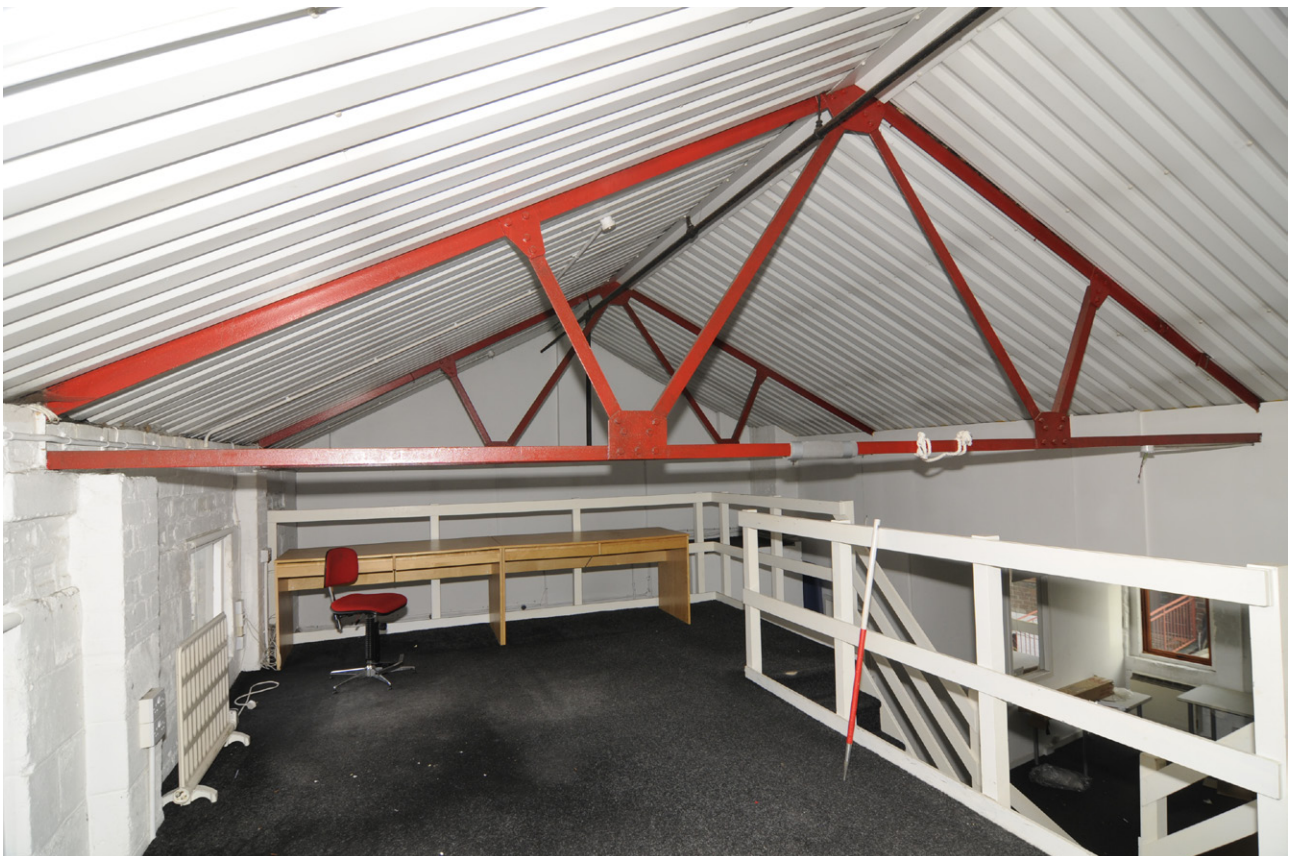
Fig. 23: Composite steel roof truss in Building H (Room H1)

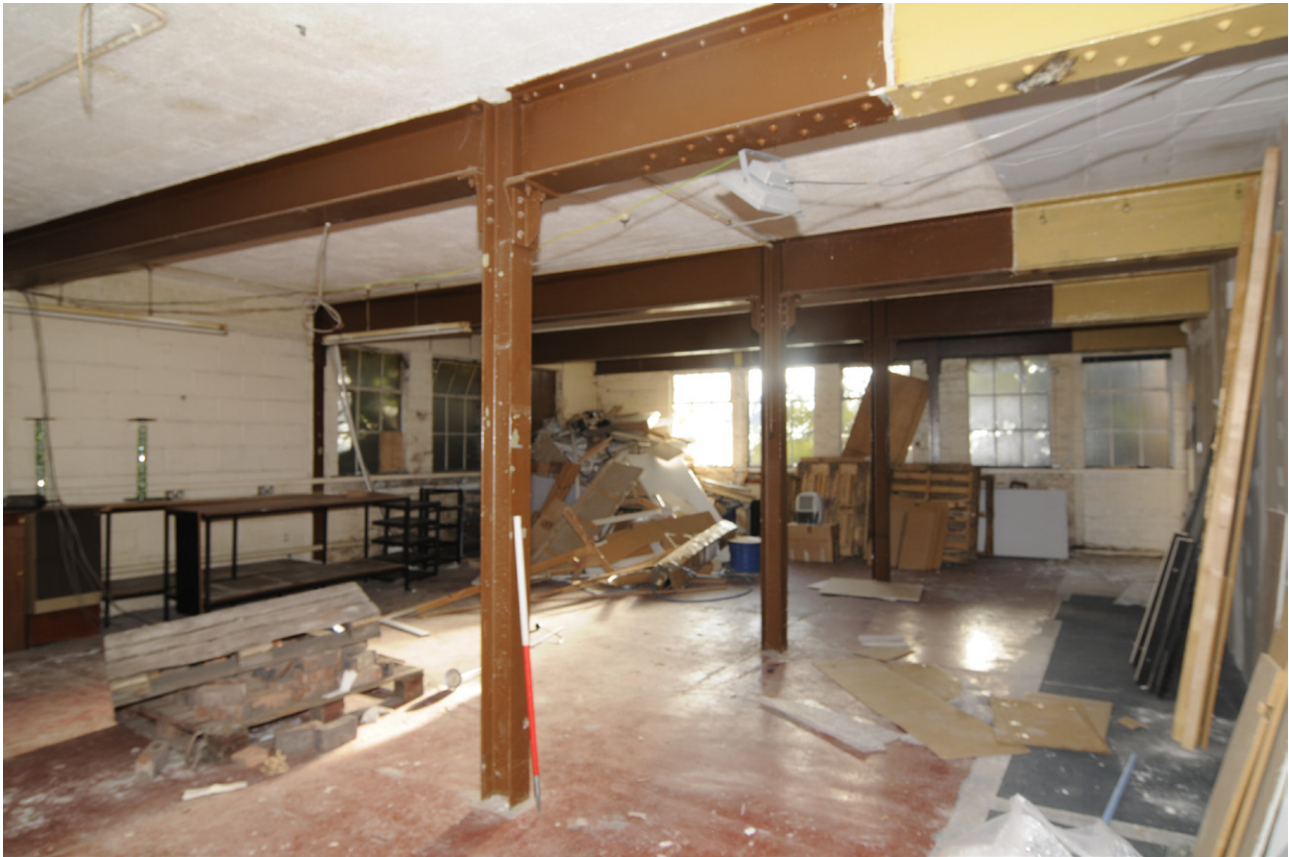
Fig. 24: Ground floor showing load-bearing steel frame Building I, Room I3)
