Bonnington Mill, 70-72 Newhaven Road Edinburgh, Historic Building Survey & Architectural Watching Brief

Report type: Data Structure Report
Report No. 3814

**Bonnington Mill,
70-72 Newhaven Road, Edinburgh
Historic Building Recording
&
Architectural Watching Brief**

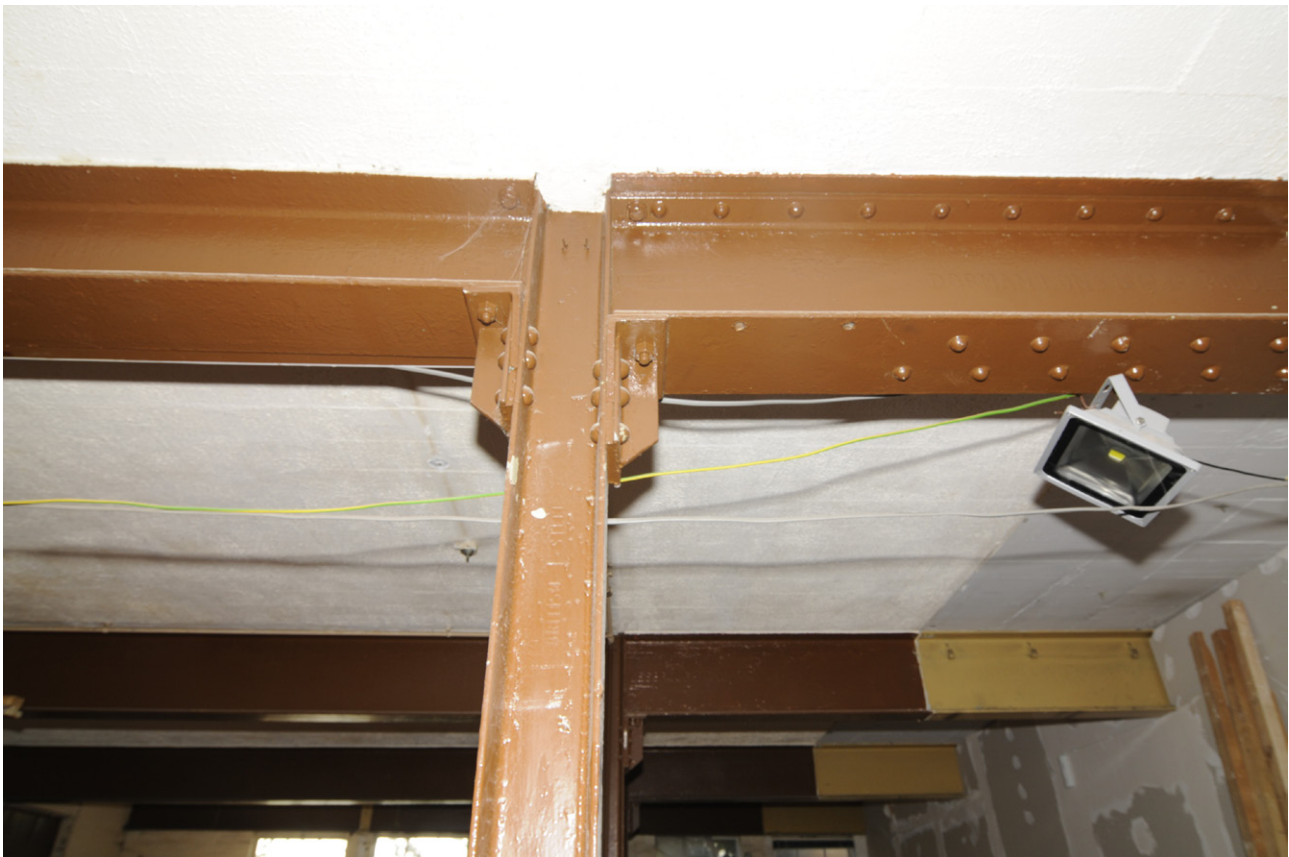
Fig. 25: Detail shot of the I-beams and shoes on the pillar heads that support them (Building I, Room I3)

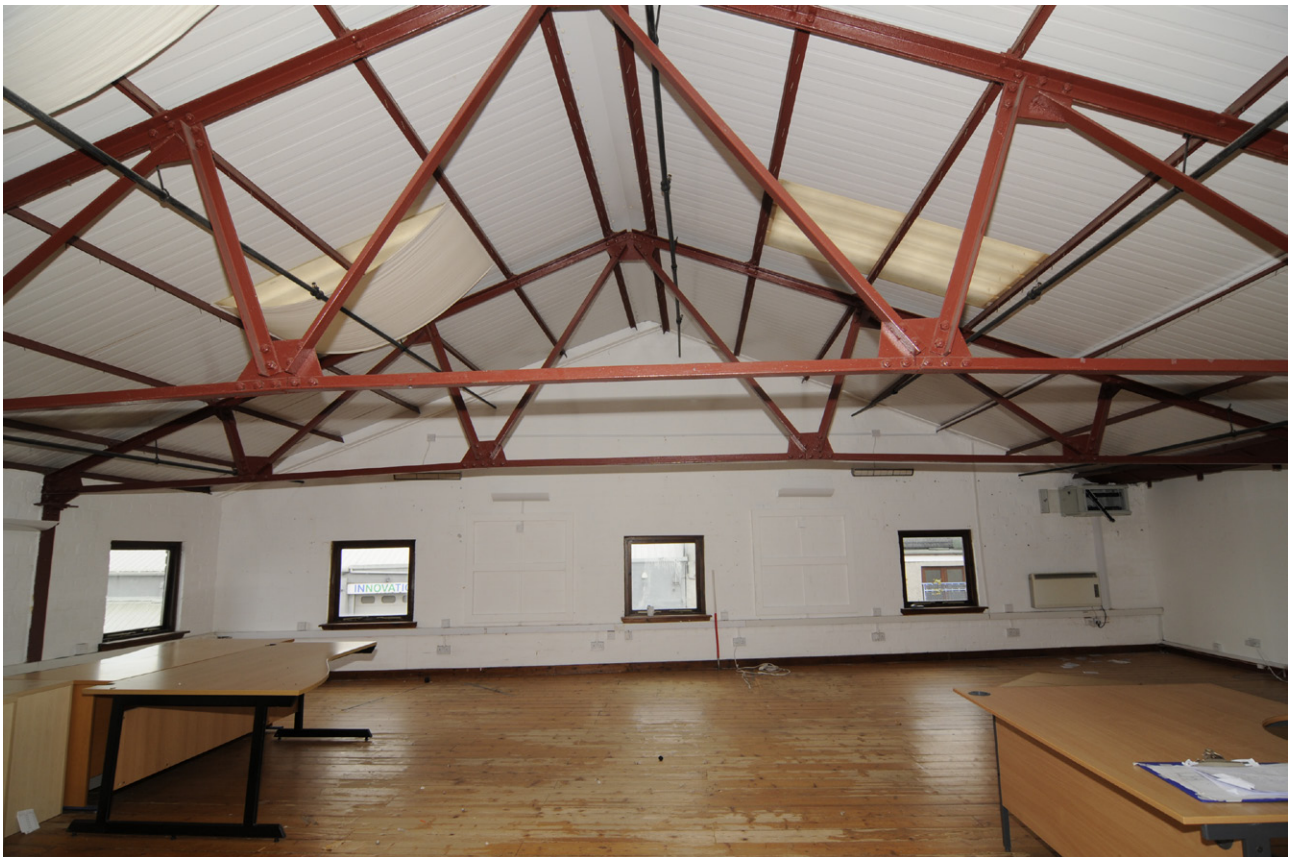
Fig. 27: Second floor of Building I showing composite double-fink wide span joists (Building I Room I20)

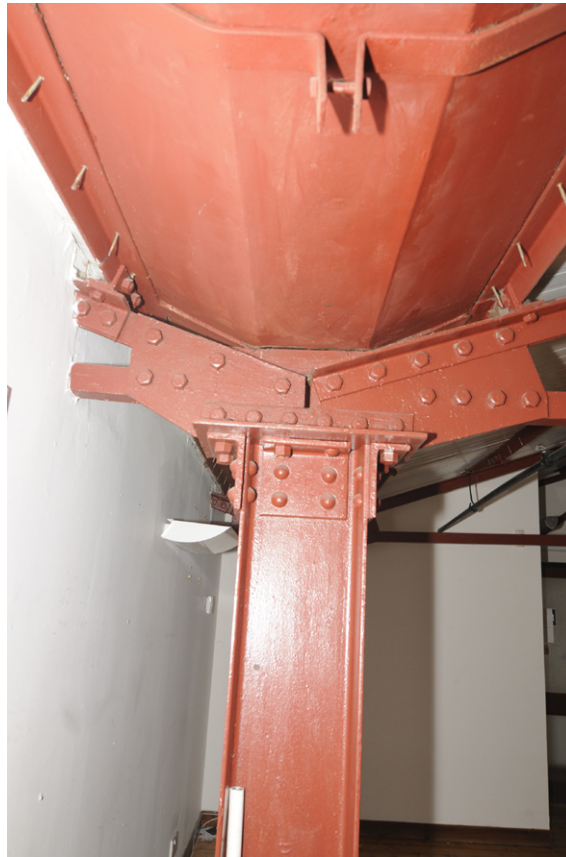
Fig. 28: Load bearing pillar with fish-plates supporting the a steel roof valley (Building I, Room 20)

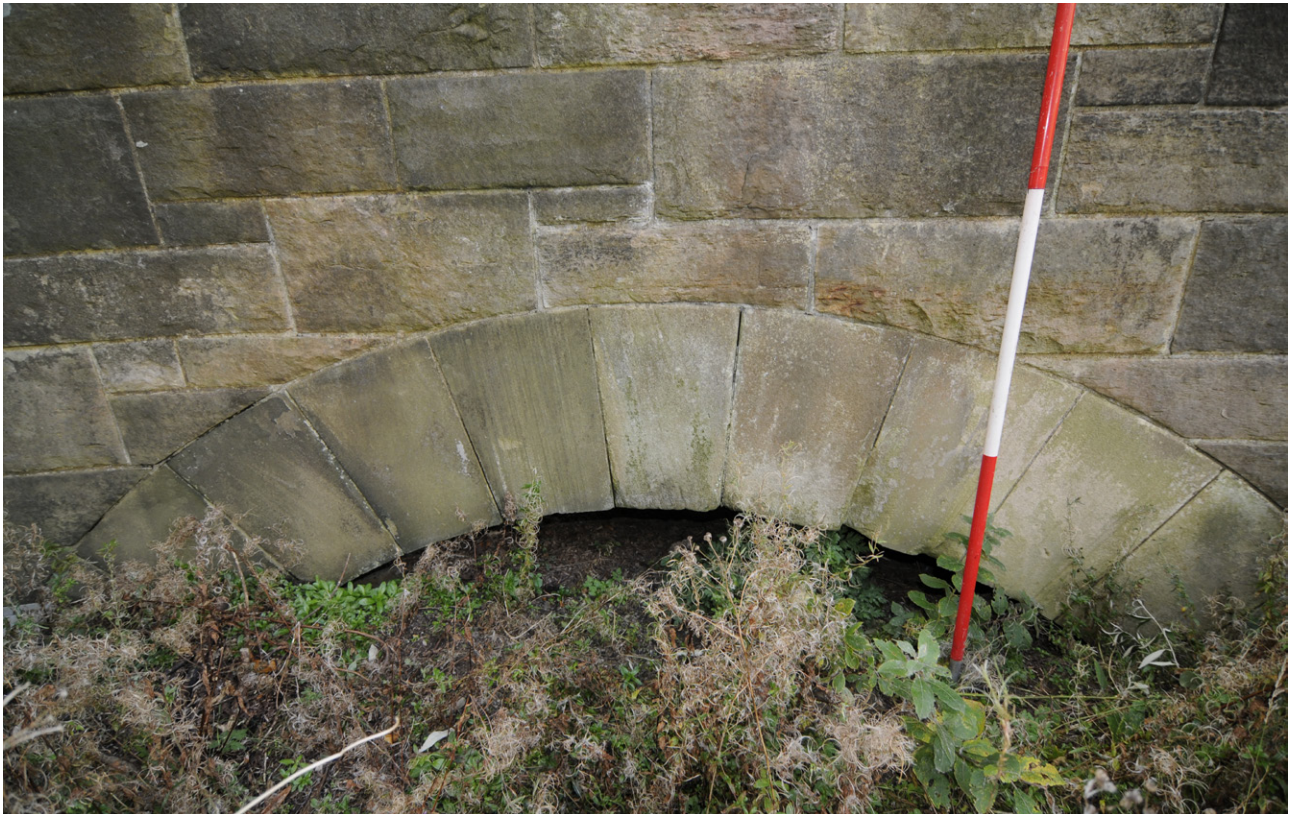
Fig. 32: Detailed shot of the segmented arch of the North Lade

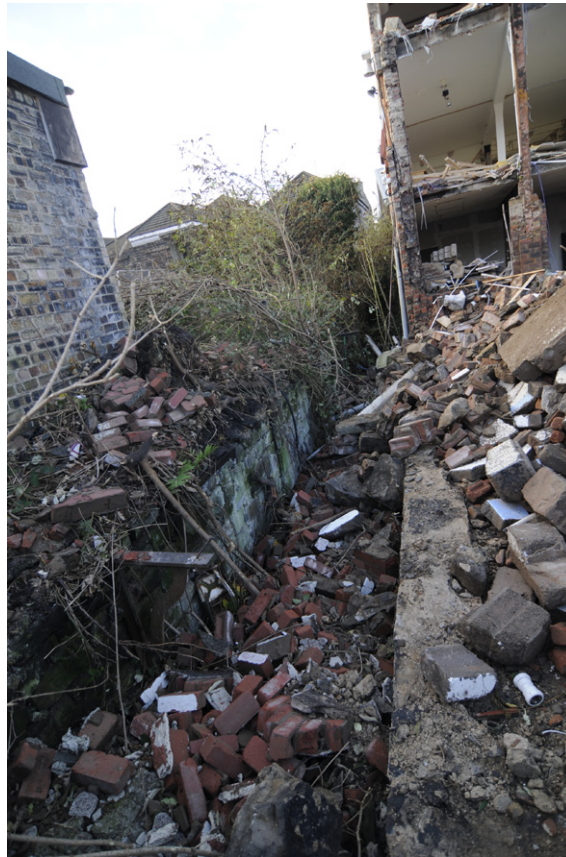
Fig. 34: The South Lade exposed during the demolition

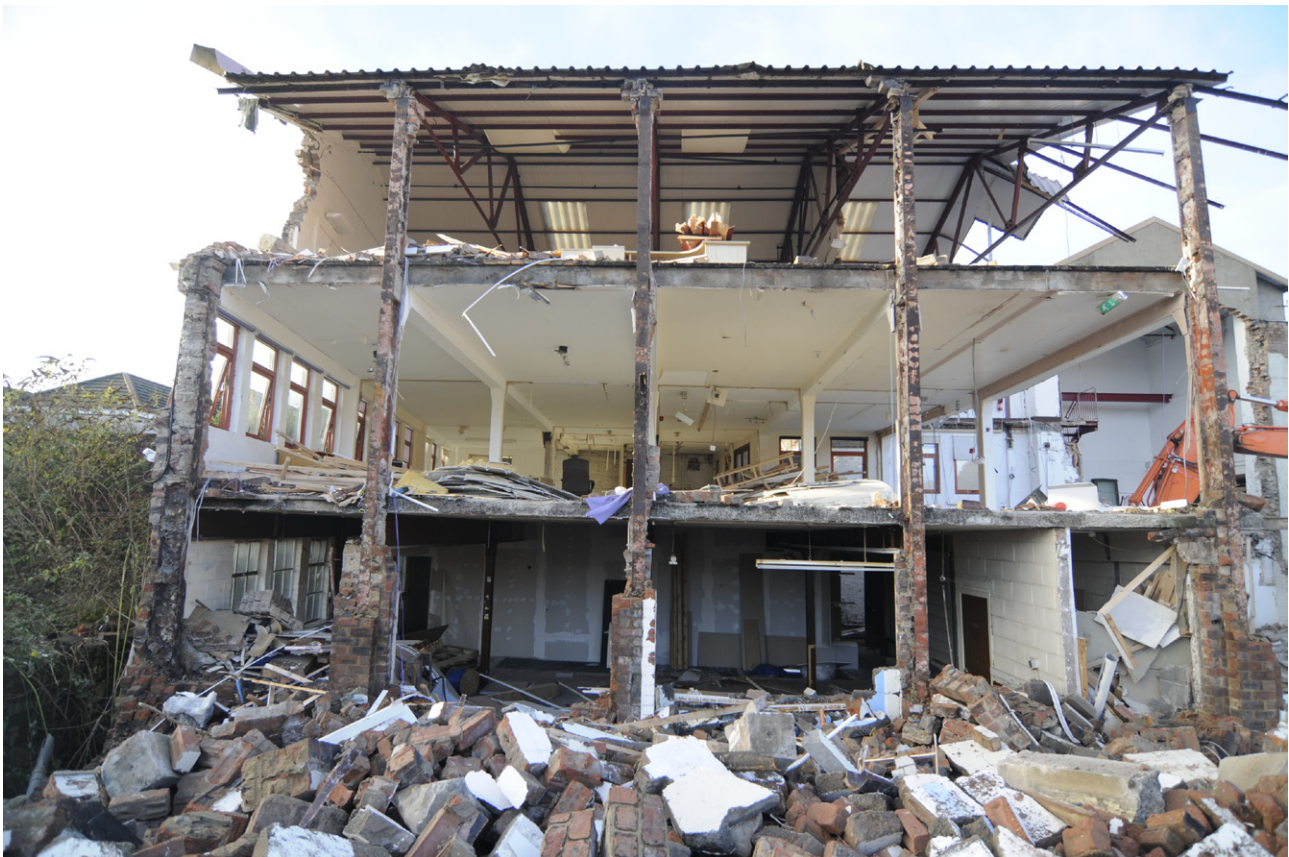
Fig. 35: Building I during demolition showing its exposed steel frame

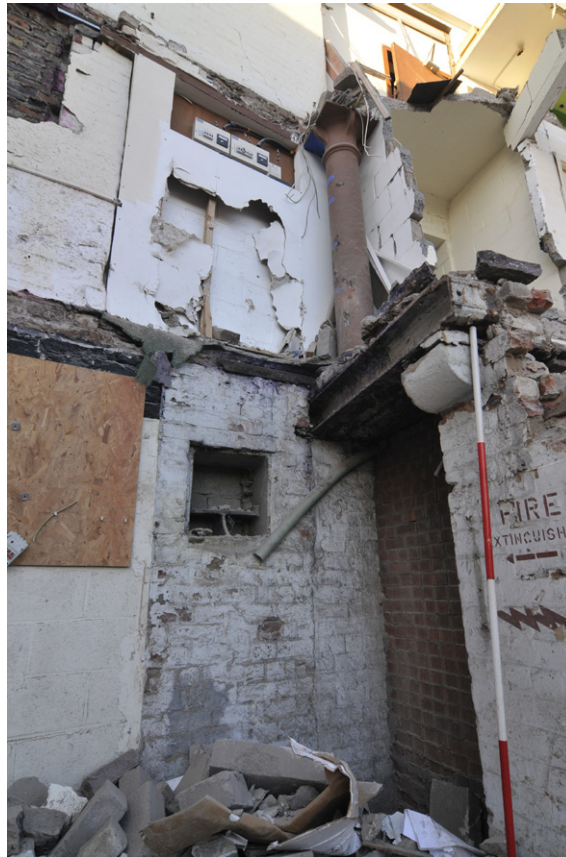
Fig. 36: Exposed cast-iron bearing box and cast-iron column on the floor above (Building F, Room F1)

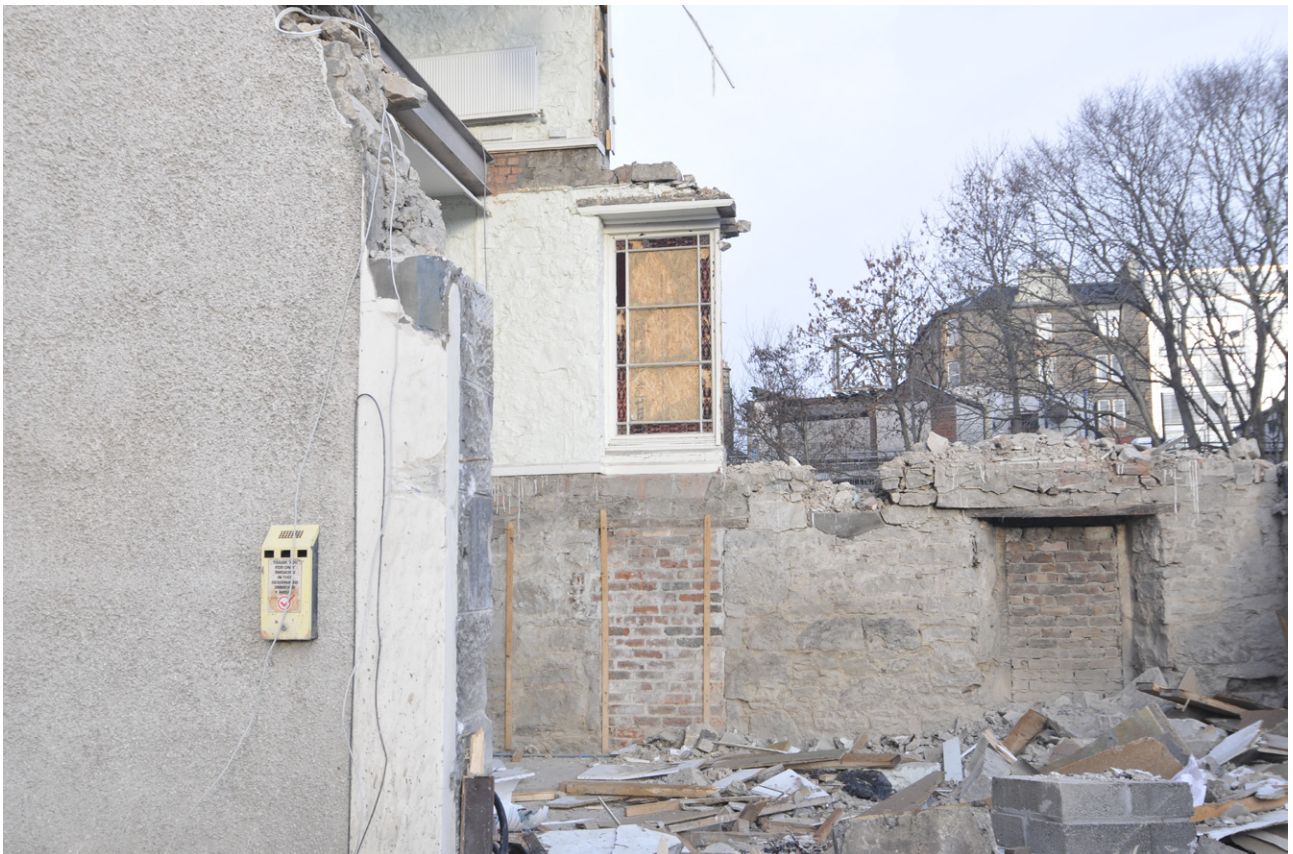
Fig. 37: Blocked ground floor doorways and ornate glazed window on the first floor (Building A, Room A3)

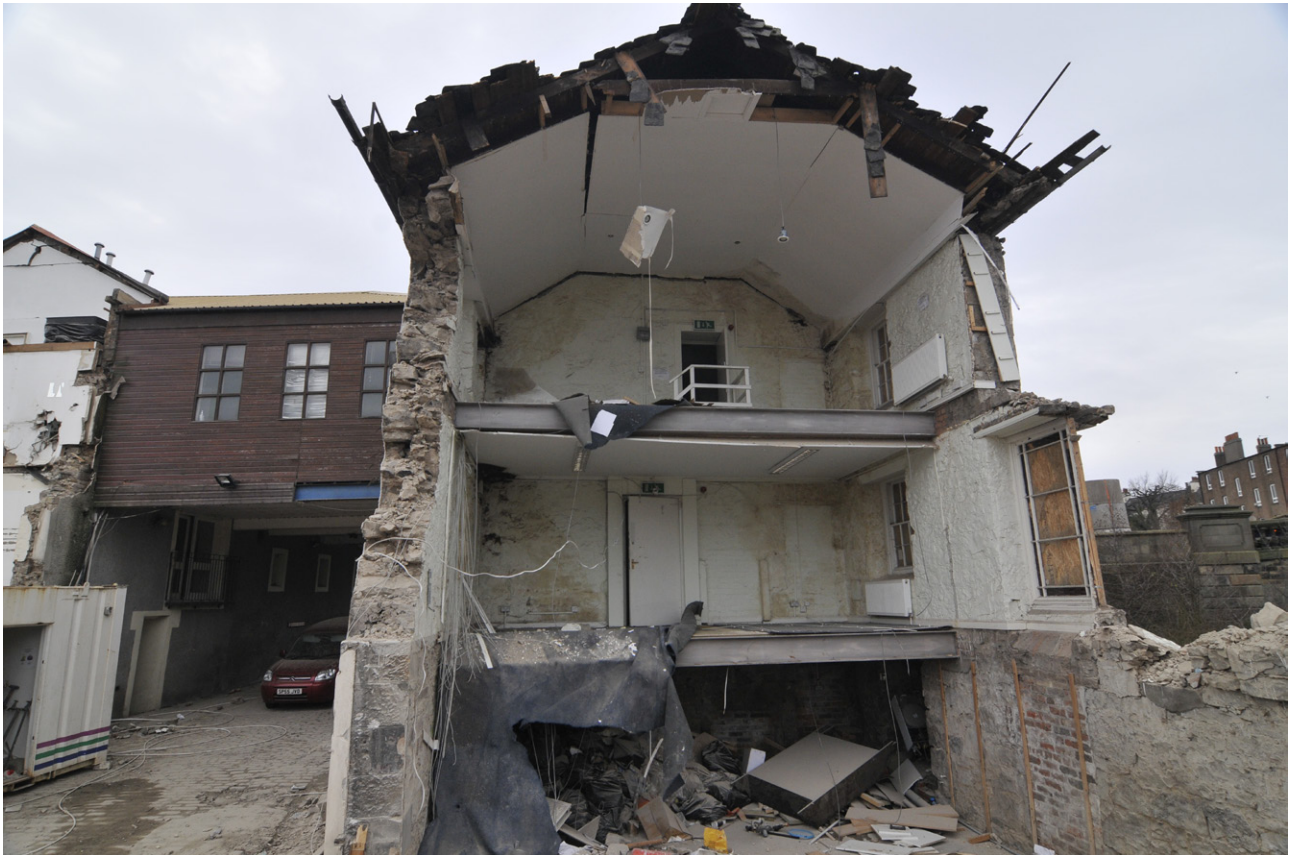
Fig. 38: Section exposed through Building A revealing its gable wall below the pitched roof. Blocked fireplaces and cupboards can be seen to the right of the later inserted doorways
