Milton Farmhouse and Steading, Logiealmond Estate, Perth & Kinross

Standing Building Survey
Report No. 3989

Author	Stuart Mitchell MA ACIfA
Illustrator	Rachel Kershaw MA PCIfA
Approver	Melanie Johnson MA PhD FSA Scot MCIfA
Commissioned by	Logiealmond Estate
Date issued	November 2020
Version	1
OASIS Reference	Cfaarcha1-408219
Planning Application No	20/00693/FLL
Grid Ref	NN 9707 2989

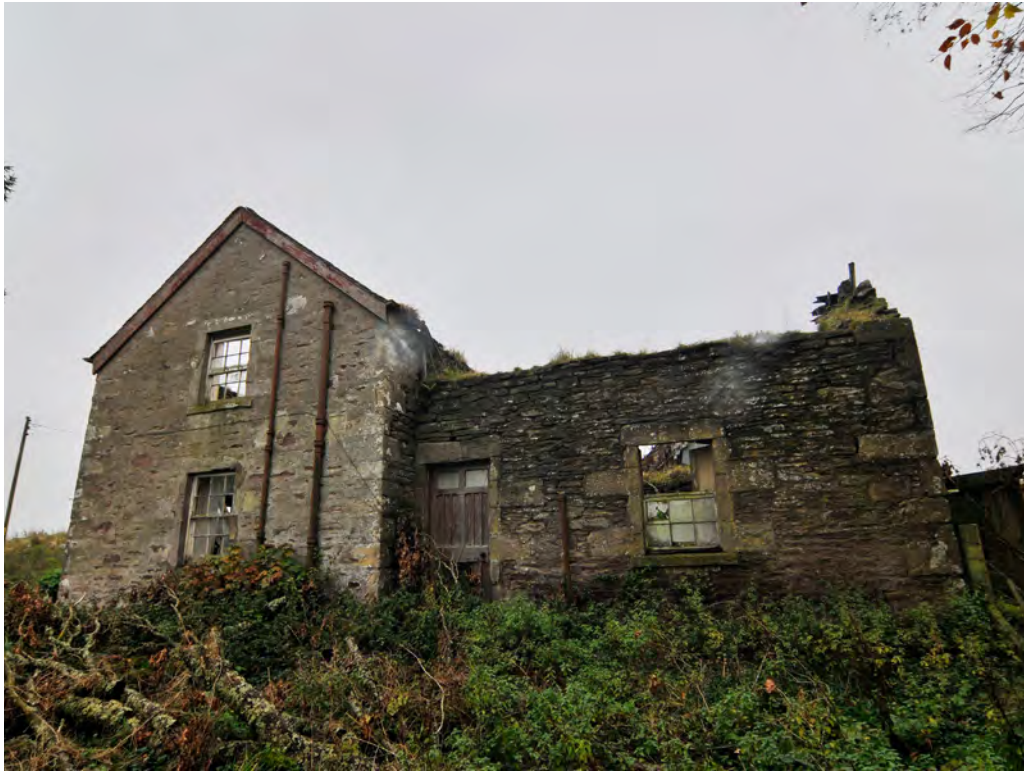
The SE elevation (Fig 5) comprised a pitched gable with random coursed sandstone with long and short dressings. The gable had a central bay with two sash-and-case windows, lighting Unit 2 on the ground floor and a first-floor bedroom. Both windows had advanced sills and straight margins. The gable had been heavily pointed. An outshot wing to the NW side (Unit 4) had been built rather crudely with rough quoins, sills and lintels.

Fig. 5 - The SE elevation of the farmhouse

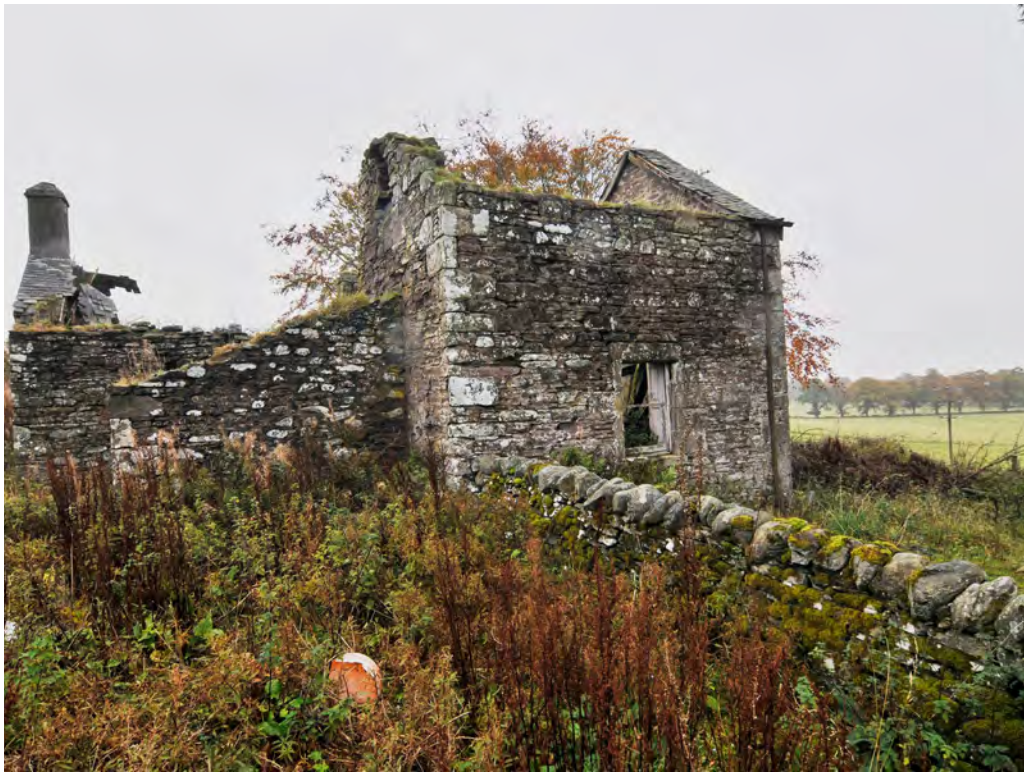
The SW elevation formed the side of the house and was built of random coursed roughhewn blocks with coarse sandstone dressings. Only a single ground floor sash-and-case window frame survived (Fig 6).

Fig. 6 - The SW side elevation of the farmhouse, fabric detail and ground

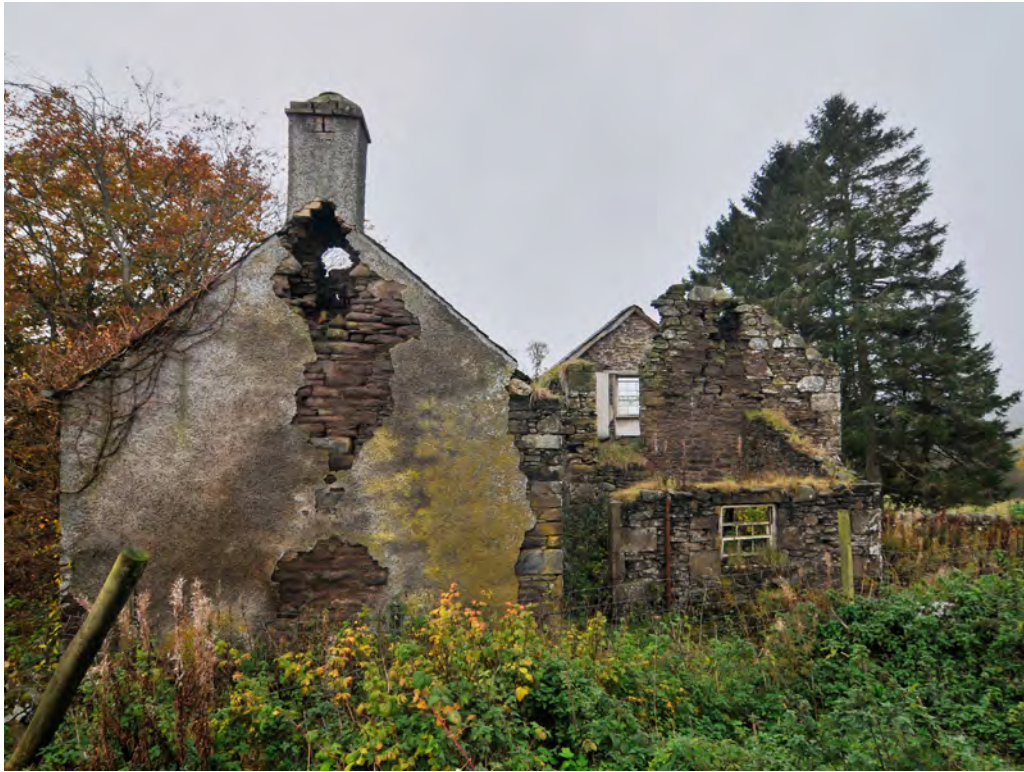
The NW facing elevation featured a pitched gable with a surviving chimney (Fig 7). It was built of rough-coursed hewn blocks that had been harled.

Fig. 7 - The NW rear elevation of the farmhouse with surviving chimney

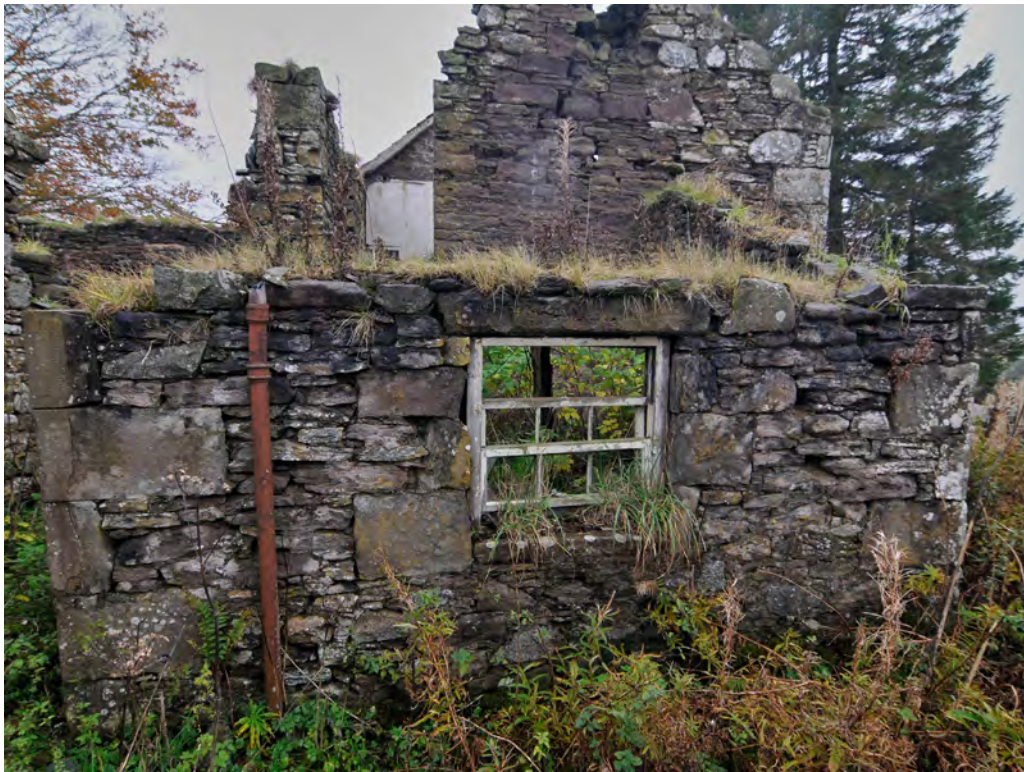
The remains of a lean-to extension (Fig 8) were on the SW side of the NE elevation. It featured an entrance door and a sash-and-case window. It was built of random coursed blocks with large quoins which were keyed into the side of Unit 1. However, it appeared to abut the NW gable of Unit 2, so the sequence of the construction phase was unclear. The NE elevation formed the side of the house and was obscured by dense vegetation. The gable contained a single window and the remains of a wooden barge board (Fig 9).

Fig. 8 - A lean-to extension on the NE elevation, fabric detail

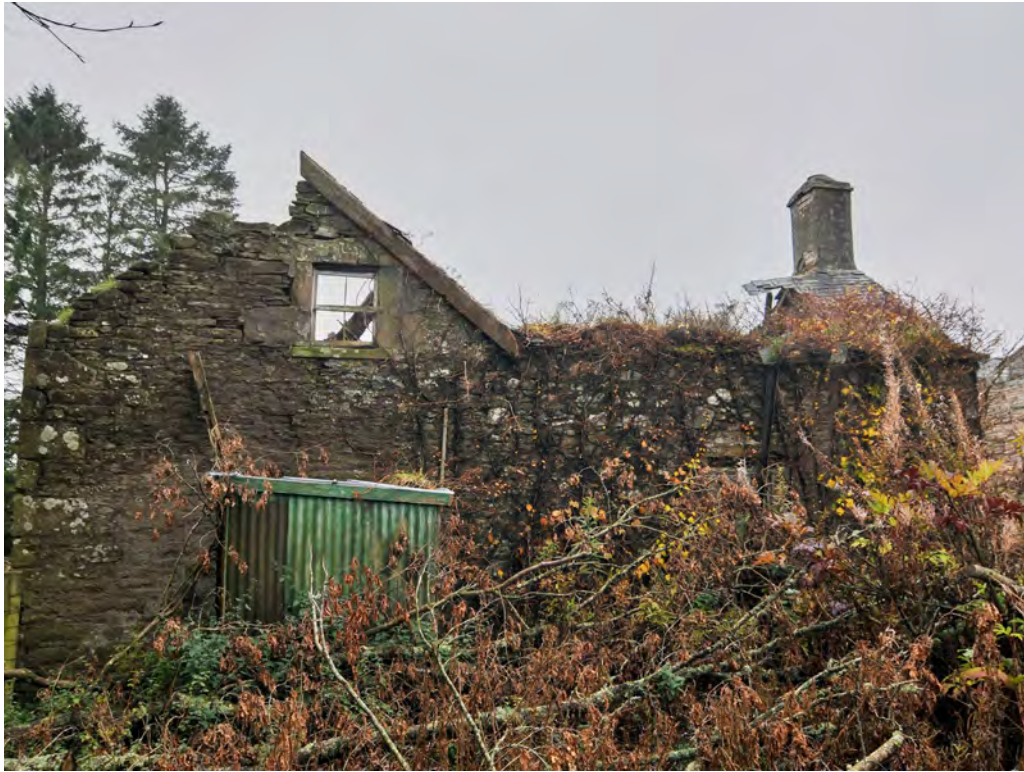
Fig. 9 - The NE side elevation of the farmhouse with part of its gable and window

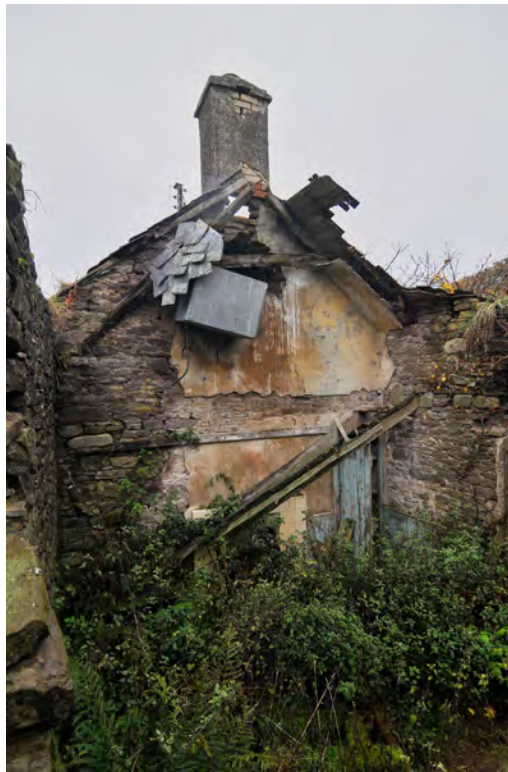
Unit 1 was a small rectangular room. It had the remains of plaster rendering on the NW gable and a tiled fireplace with a timber press at ground level. The NW wall had a small window and a concrete-blocked opening. Whether this was a repair or blocking work for an earlier doorway was unclear. An A-frame rafter immediately above the window suggested the room had a low ceiling.

Fig. 10 - Unit 1 of the farmhouse, with plastered gable and rafter

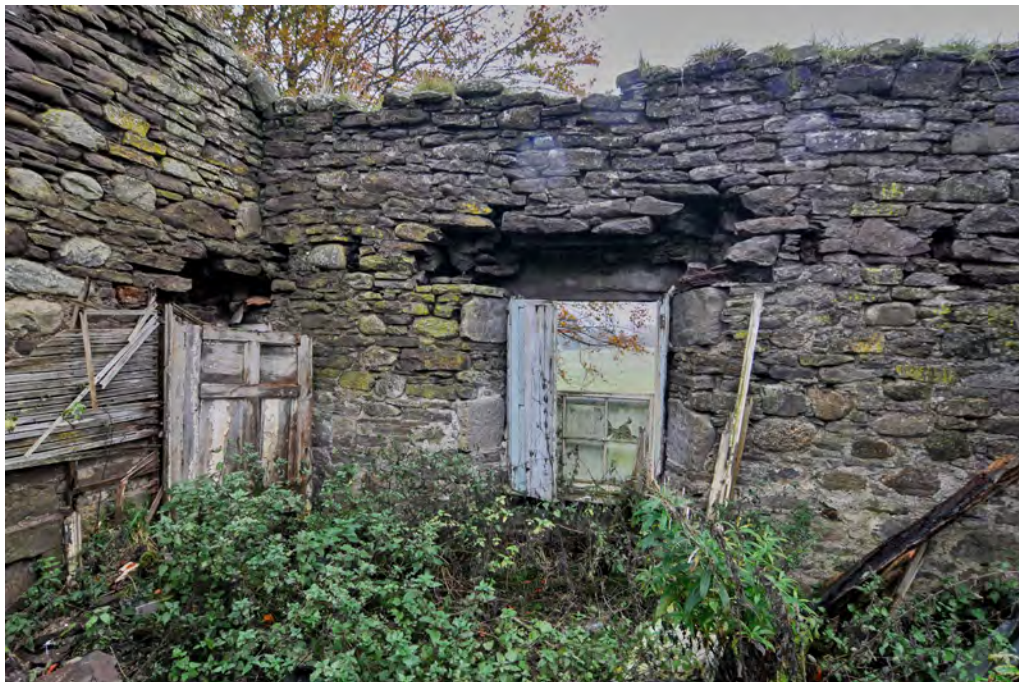
Unit 4 was a rectangular room in a ruinous state. The pitched SE gable had a fireplace on the ground floor. A press and a small square window in the roof apex indicated domestic use of the attic. The SW wall had a window with a splayed reveal and a door which would have opened inwards to the front of the house. Floor-joist sockets mark the position of the missing first floor.

Fig. 12 - Unit 4 interior of the farmhouse with a single splay

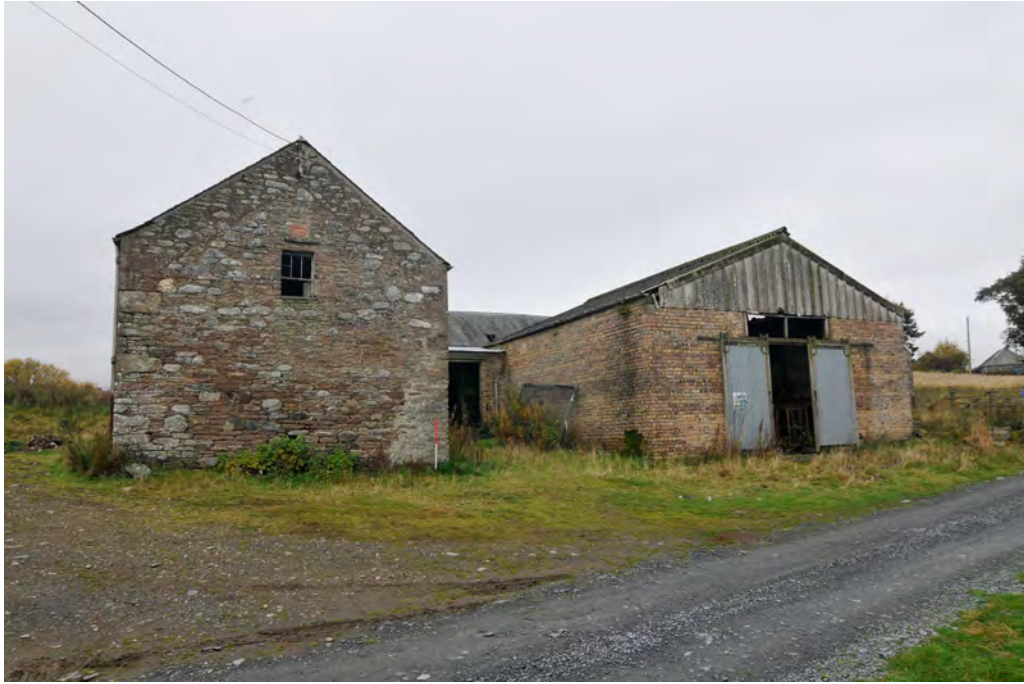
The earliest phase comprised two separate buildings, an L-shaped barn (Units 5-8) and a byre (Unit 9) around an open yard. The second phase comprised the connection of the two original elements which created another small barn (Unit 10) thus forming a 'C' shaped footprint with the yard open to the SE. The final phase comprised the construction of a large brick shed and small lean-to (Units 11 & 12) which occupies most of what was the yard (Fig. 13).

Fig. 13 - Steading exterior with a heightened pitched gable and later brick built shed

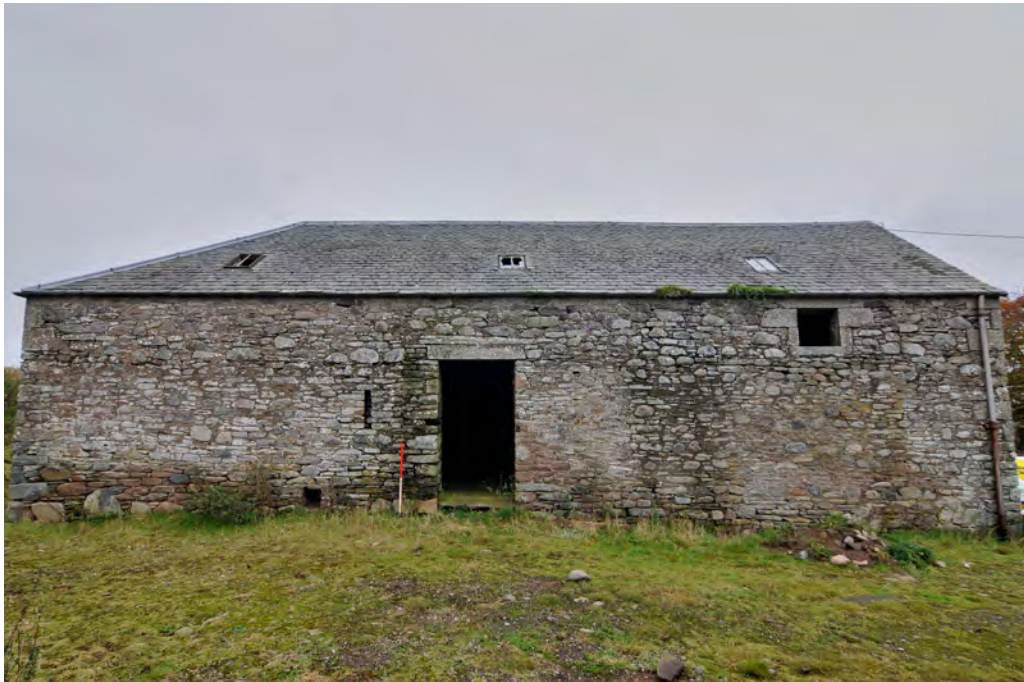
The L-shaped barn was built of random rubble and had roughhewn long and short quoins. It had a pitched gable at its SE end with a single loft level window and small bricked up vent. There was a roof line indicating the building had been heightened (Fig 4e, 4f, 4i and 13). The SW elevation (Fig. 4f) formed the external side of the complex that also had evidence of heightening, representing a major conversion to create a loft (Unit 7). There was a central door into Unit 6 and a small loft window (Fig 14). A slit vent and small square vent or a small animal passage were also incorporated into the build.

Fig. 14 - Steading exterior SW elevation with a central door and small loft widow

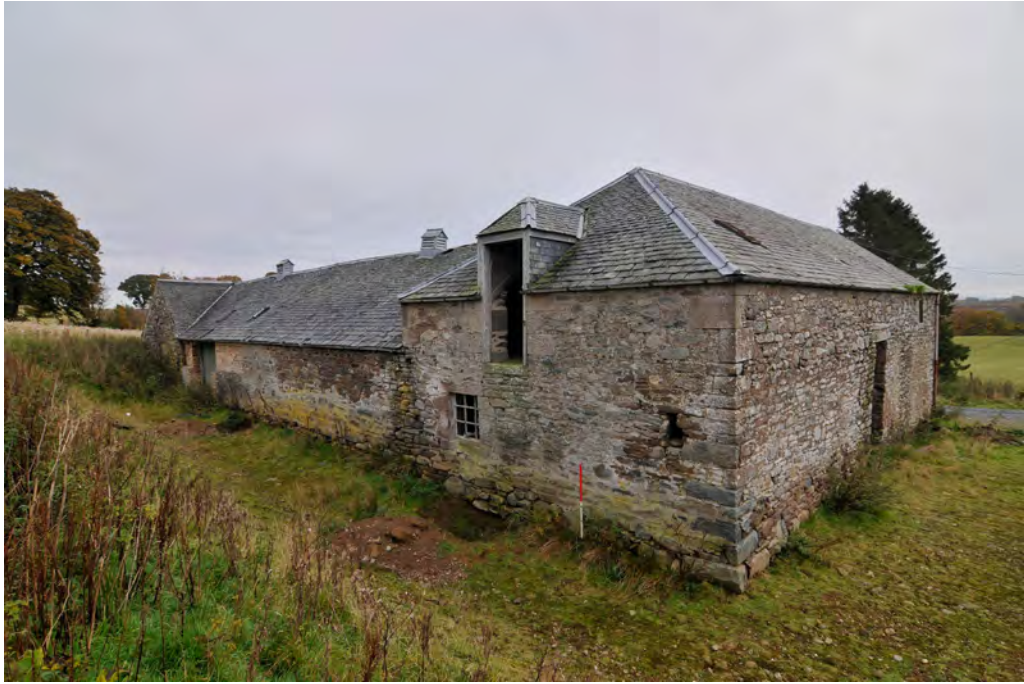
The NW elevation formed the back of the complex. The elevation featured a hipped roof for the main long barn with a dormer forming a pitching door into Unit 6 (Fig 15). The roof was slate and featured later tower vents and rooflights. The elevation also had a square window at ground level. The NW-facing elevation also comprised the pitched gable of the byre (Unit 9).

Fig. 15 - Steading exterior NW elevations with a pitching door at loft level

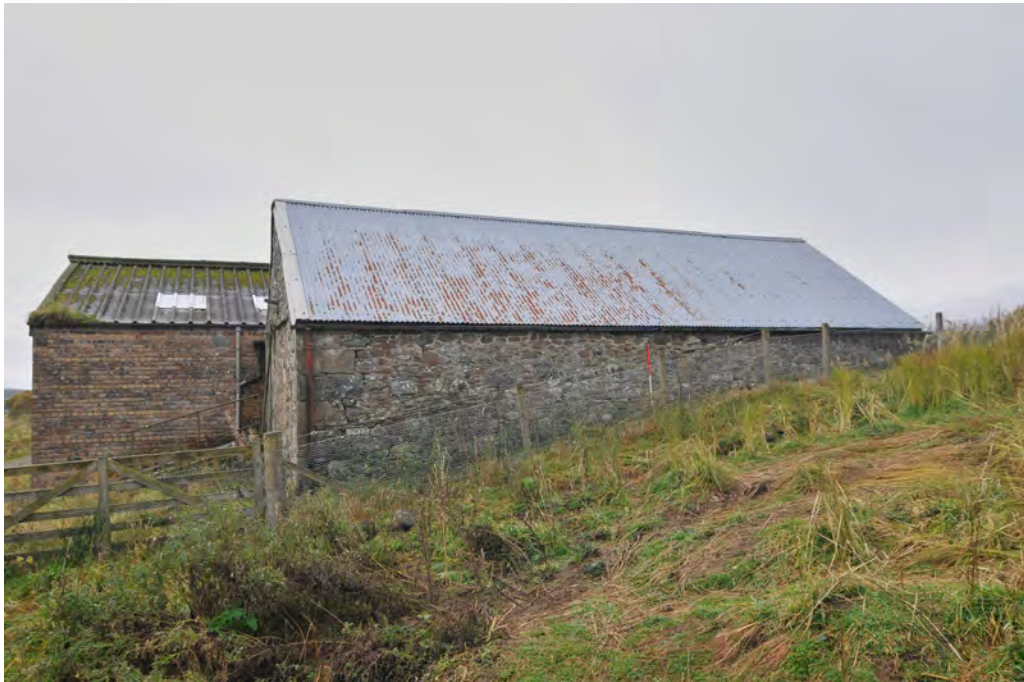
The byre (Unit 9) (Fig 16) was a single long building with a slate covered pitched roof. Its walls were built of random rubble with large rough-hewn quoins. Its SE facing gable had a single door. A shuttered concrete ramp had been added from the doorstep down to the yard. The raggle of a former lean-to survived along with a small square vent that been partly blocked with stone. The byre had been built into the natural slope to its NW and its rear wall was partially buried.

Fig. 16 - Steading exterior, byre wall built into a slope

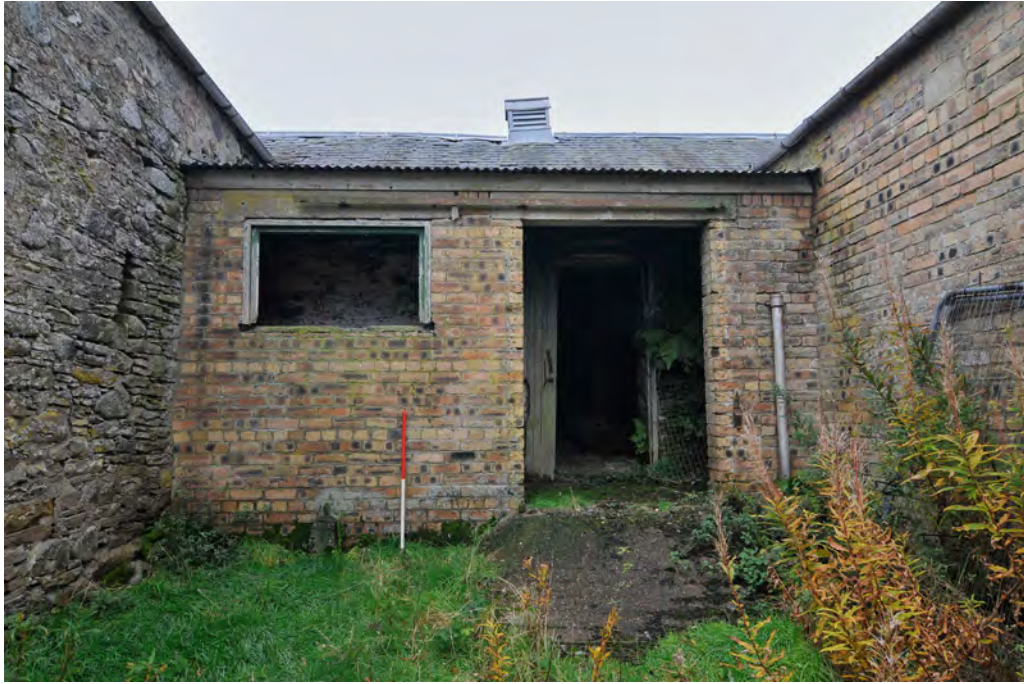
Fig. 17 - Steading exterior with a brick-built lean-to (Unit 12)

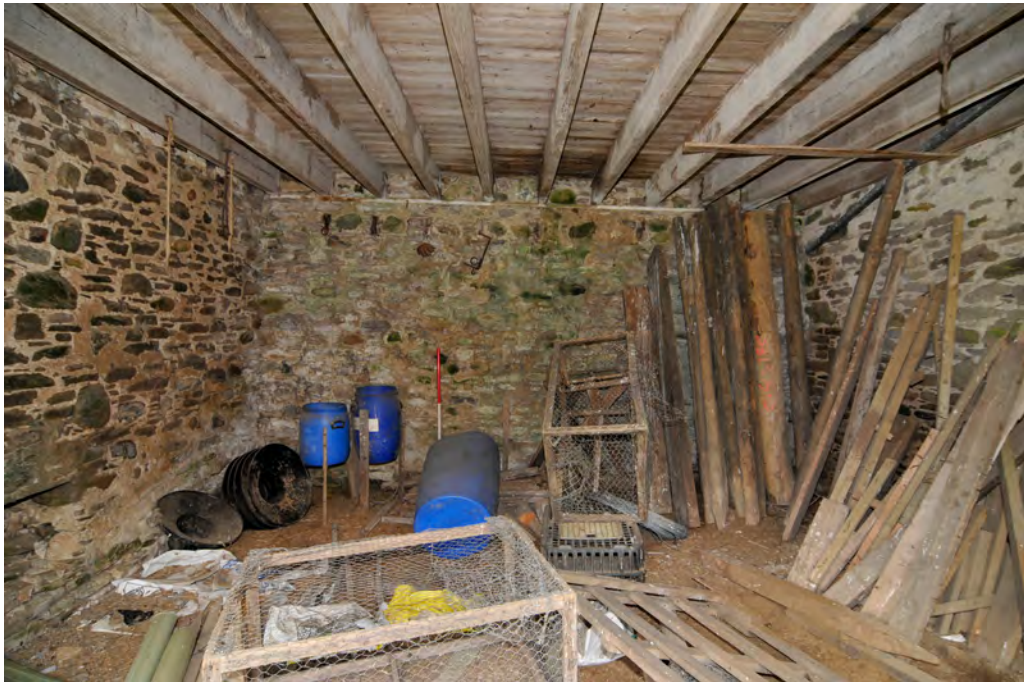
Unit 5 was a square open shed at the SE end of the 'L' shaped barn. It had replacement timber roof joists supporting the floor of the loft (Unit 7). The shed was open to the NW and has a full-width timber lintel supported by a central stone support which was set into a large stone block.

Fig. 18 - Unit 5, interior of the open shed

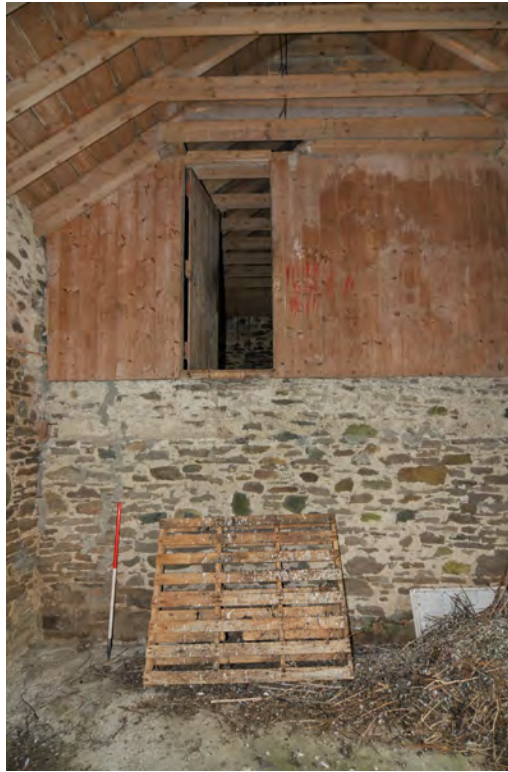
Fig. 19 - Unit 6, partition wall with an opening to the loft Unit 7

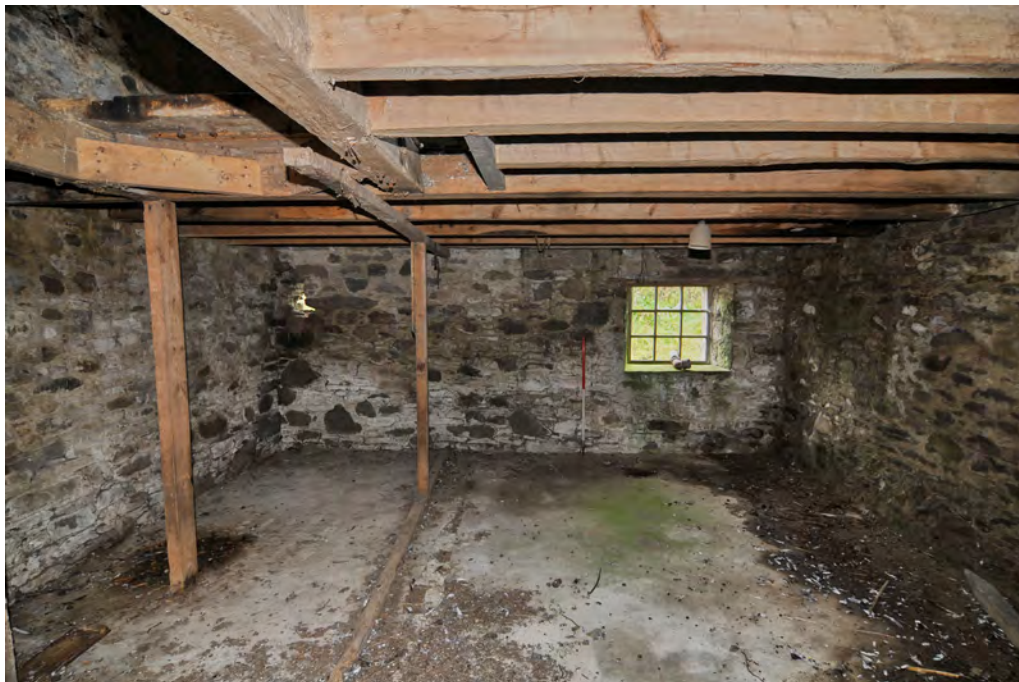
Unit 6 had bare stone walls and was accessed through a door from the SW side of the L-shaped barn. It had a concrete floor and replacement timber-framed roof. It had a timber door connecting it to Unit 12, though this would originally have been open to the former yard. A timber floor (Fig 19) occupied two-thirds of the unit to allow access to the pitching door on the NW elevation. Its SE end had an interior dividing wall that separated it from Unit 7 using tongue and grooved boards with a simple opening giving access to the loft (Unit 7).

Fig. 20 - Unit 6, general interior view with loft joists and window

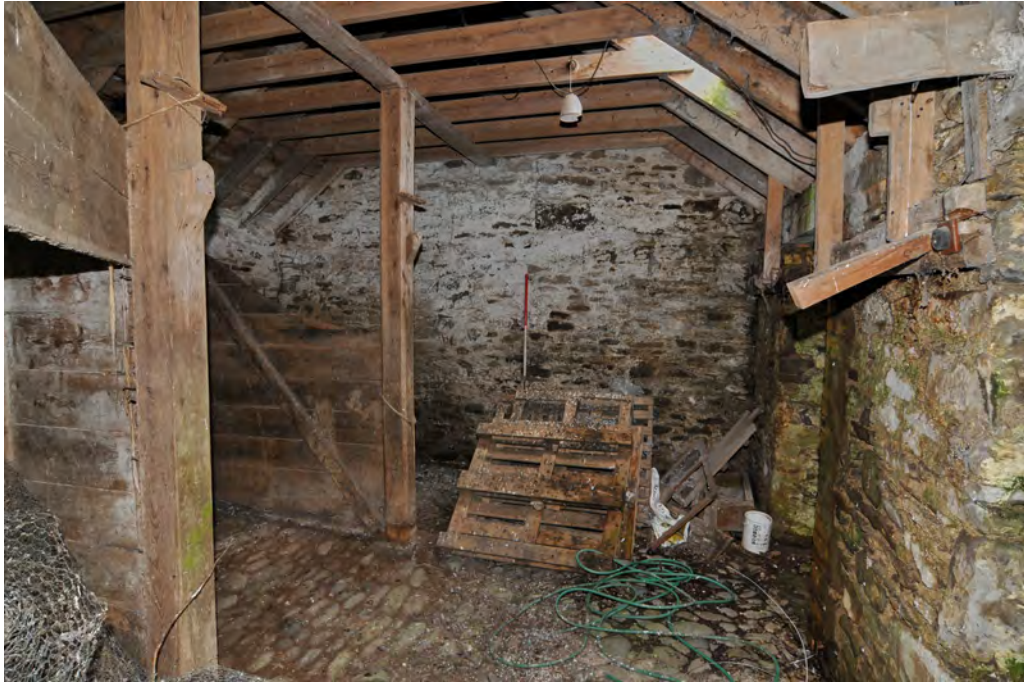
Unit 8 was a rectangular stable with whitewashed walls, a rough cobbled stone floor and a replacement timber roof. It contained timber stalls and feeding troughs. It had two sliding doors opening to the former yard on the SE side of the building.

Fig. 21 - Unit 8, interior of the stable with loose boxes and c

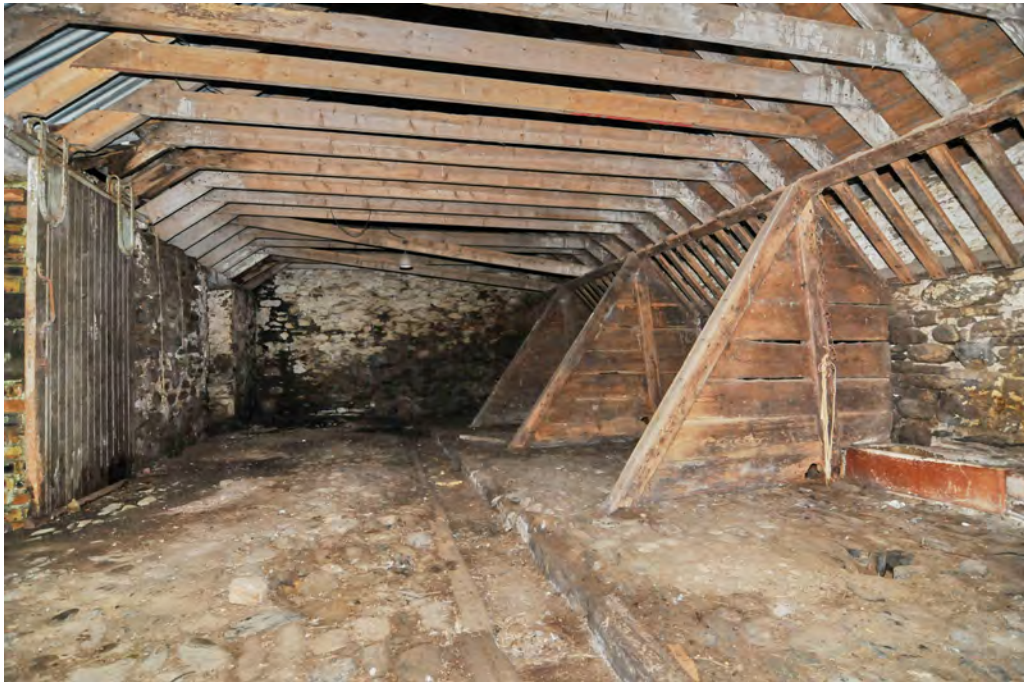
Unit 9 was a separate long byre. It has whitewashed walls and a cobbled floor featuring a central drainage channel, cattle stalls and in situ ceramic "Belfast" feeding troughs. It had a single sliding door on the SE gable and two sliding doors on the SW wall linking it to Unit 11, though this would have originally been an open yard.

Fig. 22 - Unit 9, interior of the byre with feeding stalls, man

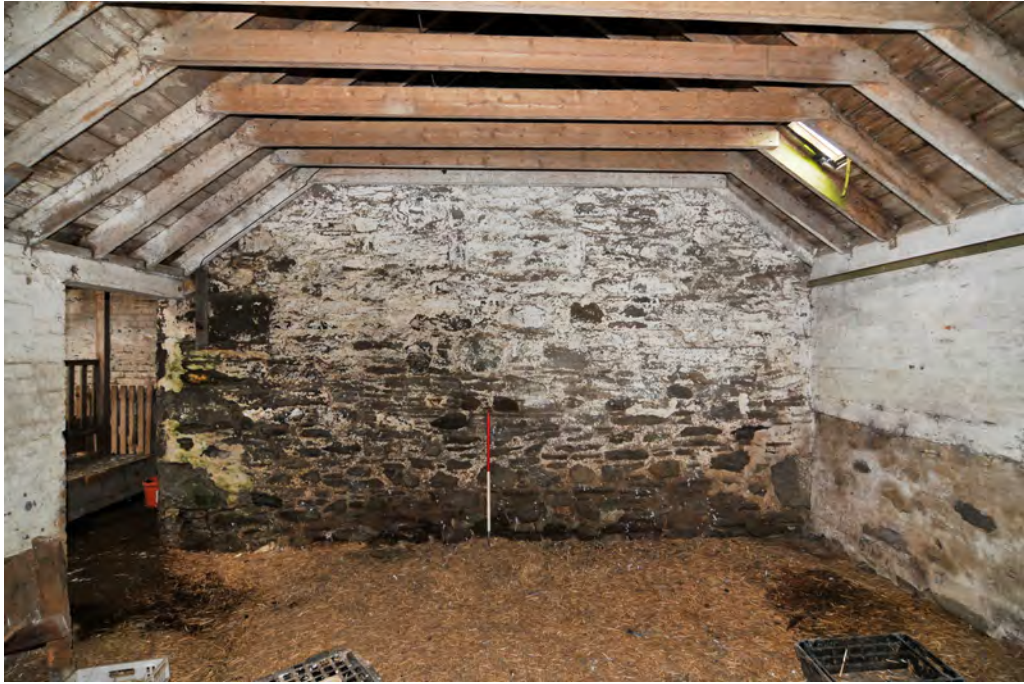
Unit 10 was a square whitewashed shed built between Units 8 and 9. It had brick side walls, a composted floor and a modern timber roof truss. It had a single sliding door connecting it to Unit 11 and a wide sliding door on the NW side which faced out to the back of the steading complex.

Fig. 23 - Unit 10, interior of the barn

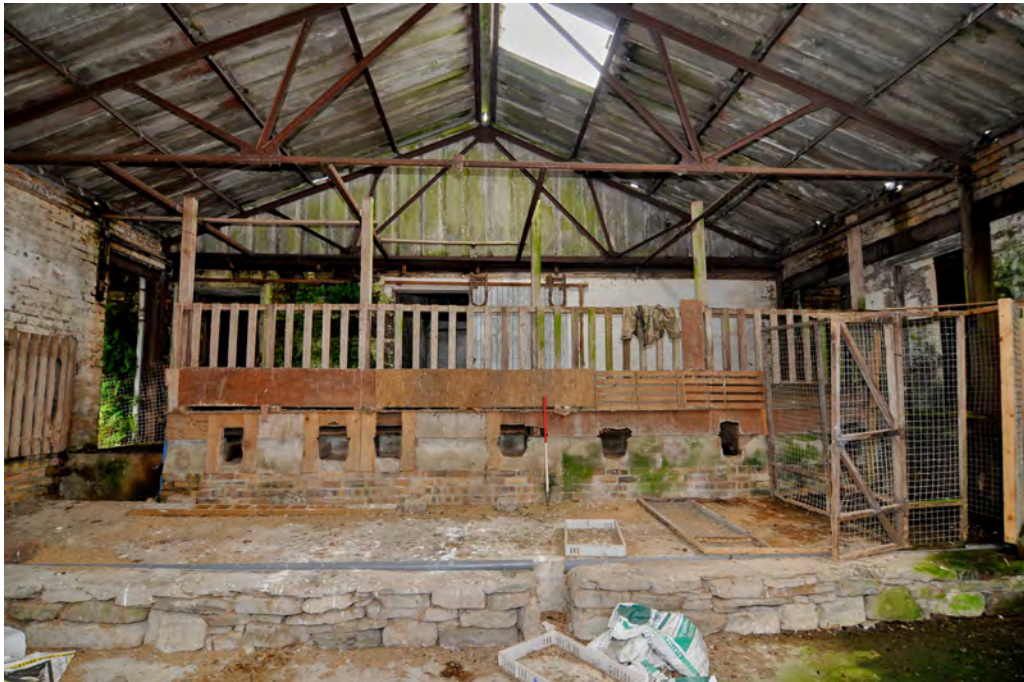
Unit 11 was a large square modern shed. It had a concrete floor and a modern steel roof truss which was covered with broad asbestos sheets. It had a large double sliding door on the

SE-facing gable. The floor was stepped into terraces and had brick and timber structures which may be associated with cattle stalling.

Fig. 24 - Unit 11, interior steel-framed roof and partitioning for cattle stalling

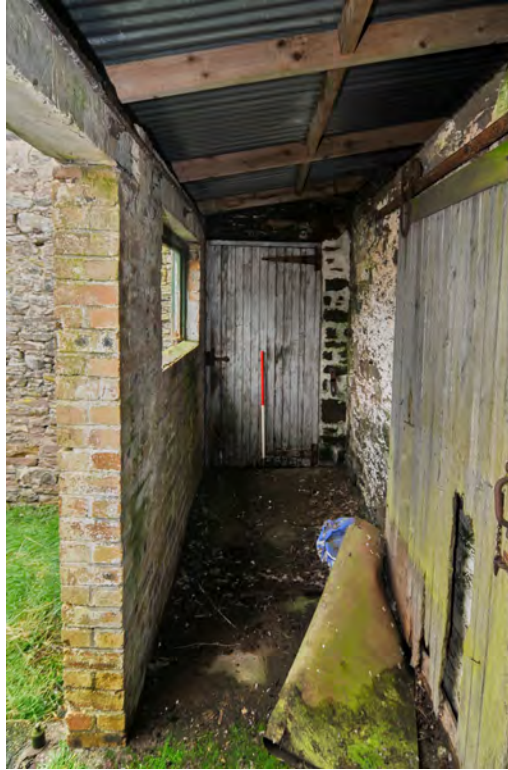
Unit 12 was a small modern lean-to forming a covered passage between Units 6 and 11. It comprised a brick outer wall and timber framed roof supporting modern corrugated zinc sheets. It had a concrete floor and a coarse concrete ramp leading down into the space between Units 5 and 11.

Fig. 25 - Unit 12 small modern brick-built lean-to general view
