August 2008

Commissioned by Gaia Architects

**FULFORD STEADING, MIDLOTHIAN  
STANDING BUILDING SURVEY**

**Report No. 1533**

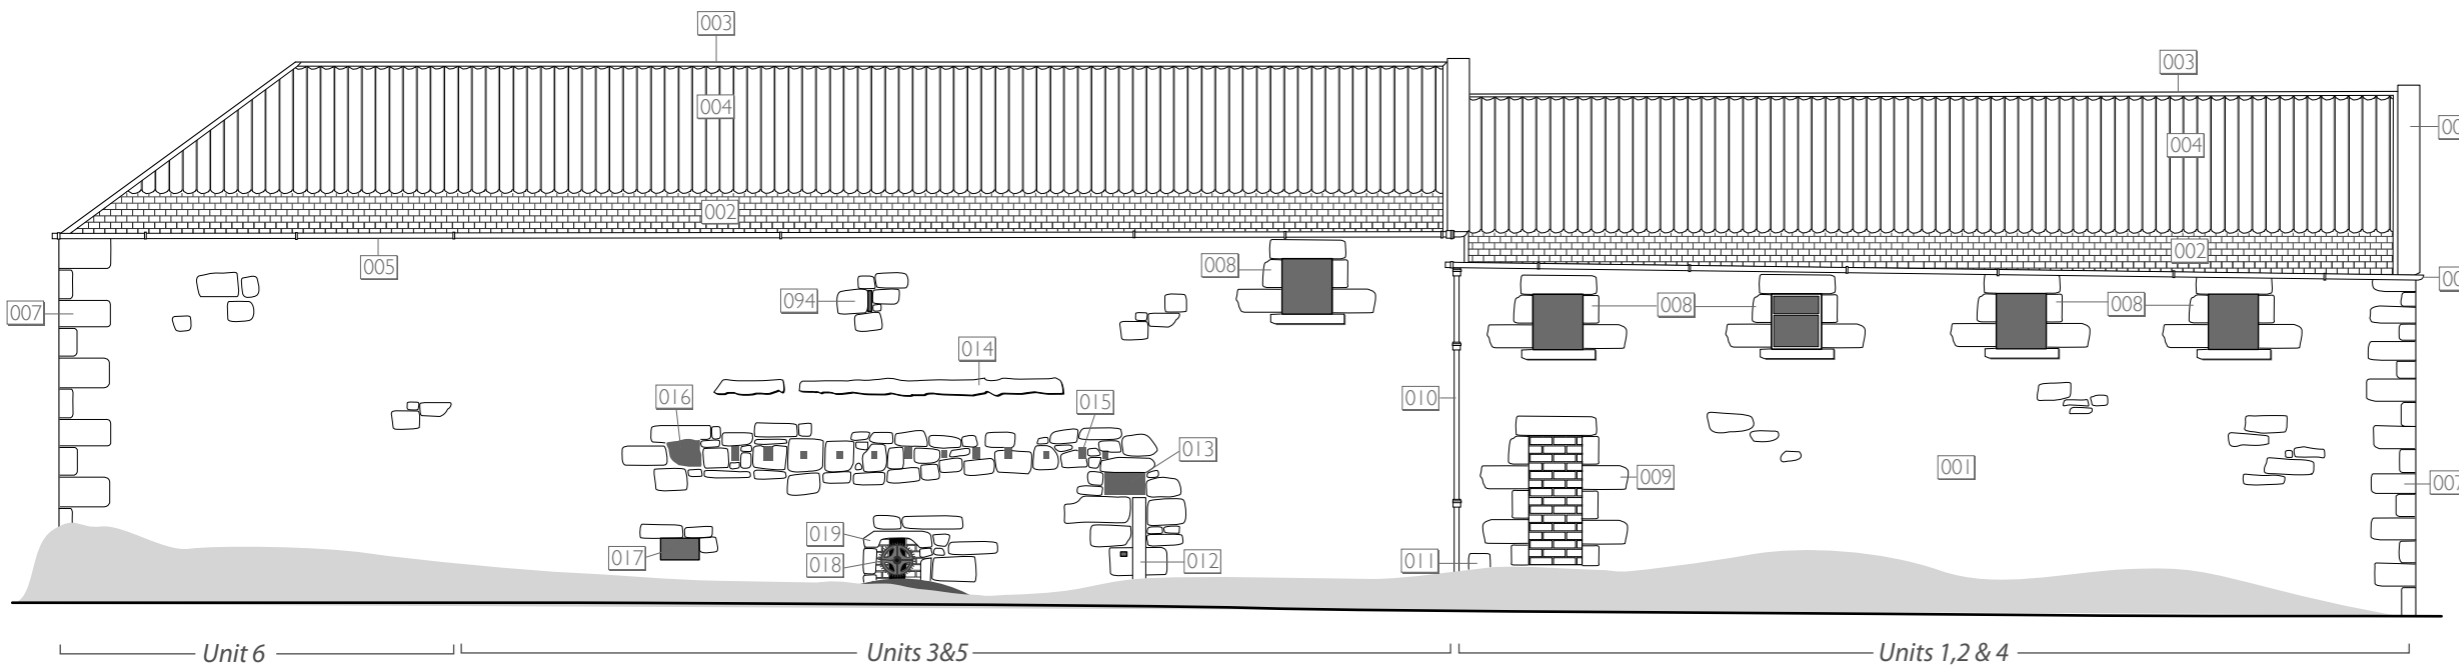
Fig 4 - South Range, South-facing

4.2.1 The fabric (**001**) was built of coursed sandstone blocks with a pale mortar and with droved quoins (**007**). The pitched roof was corrugated iron (**004**) capped with a galvanised roof ridge (**003**). Below this the remains of an earlier slate tile roof (**002**) survived, below which was an iron gutter (**005**). The east gable was finished with sandstone coping stones (**006**).

4.2.2 The elevation has five window openings (**008**) on the eastern half of the first floor, and a single ground floor window blocked by brick (**009**), all with dressed sandstone surrounds. Originally the ground floor window **009** had four vertical iron bars within its opening, only fragments of which survive. A brick blocking (**011**) was noted to the west, between the door and the drainpipe (**010**). A possible blocked slit vent (**094**), with a tree currently growing out of it was situated on the west of the elevation. However no evidence for this slit vent was noted in Unit 5.

4.2.3 The remains of a lean-to arrangement was visible on the western half of the elevation. This consisted of a concrete roof raggle (**014**) below which a series of voids (**013, 016, 017**), probable beam slots (**015**) and edge-set sandstone blocks (**012**) would have enclosed the machinery (**018**) of the large pit-wheel associated with a possible motorised cattle-cake crushing device. The opening for the wheelshaft had been re-modelled at some point in its use, as part of it had been blocked by brick (**019**). This lean-to is probably the remains of the bulge on the western side of the elevation as seen in the early mapping (Figs 2b-e).

4.2.4 No remains of the building on the east of the elevation (see Figs 2b-d) were noted during the survey. The elevation is raised to the west to take account of the slope.

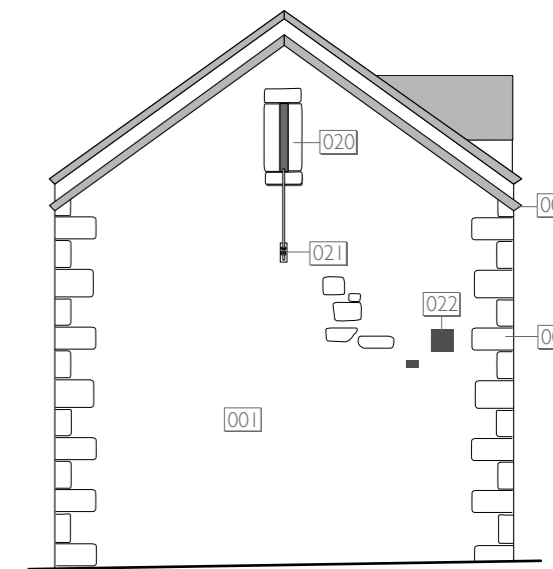
Fig 5 - South Range Gable, East-facing

4.2.5 The east elevation is the gable of the South Range and comprises the same fabric as the south elevation (**001**). A slit vent (**020**) with dressed stone surround occupies the apex of the elevation and had early electrical cable

(021) entering it. Otherwise, apart from a small iron plate (022) to the north of the elevation, the wall is featureless.

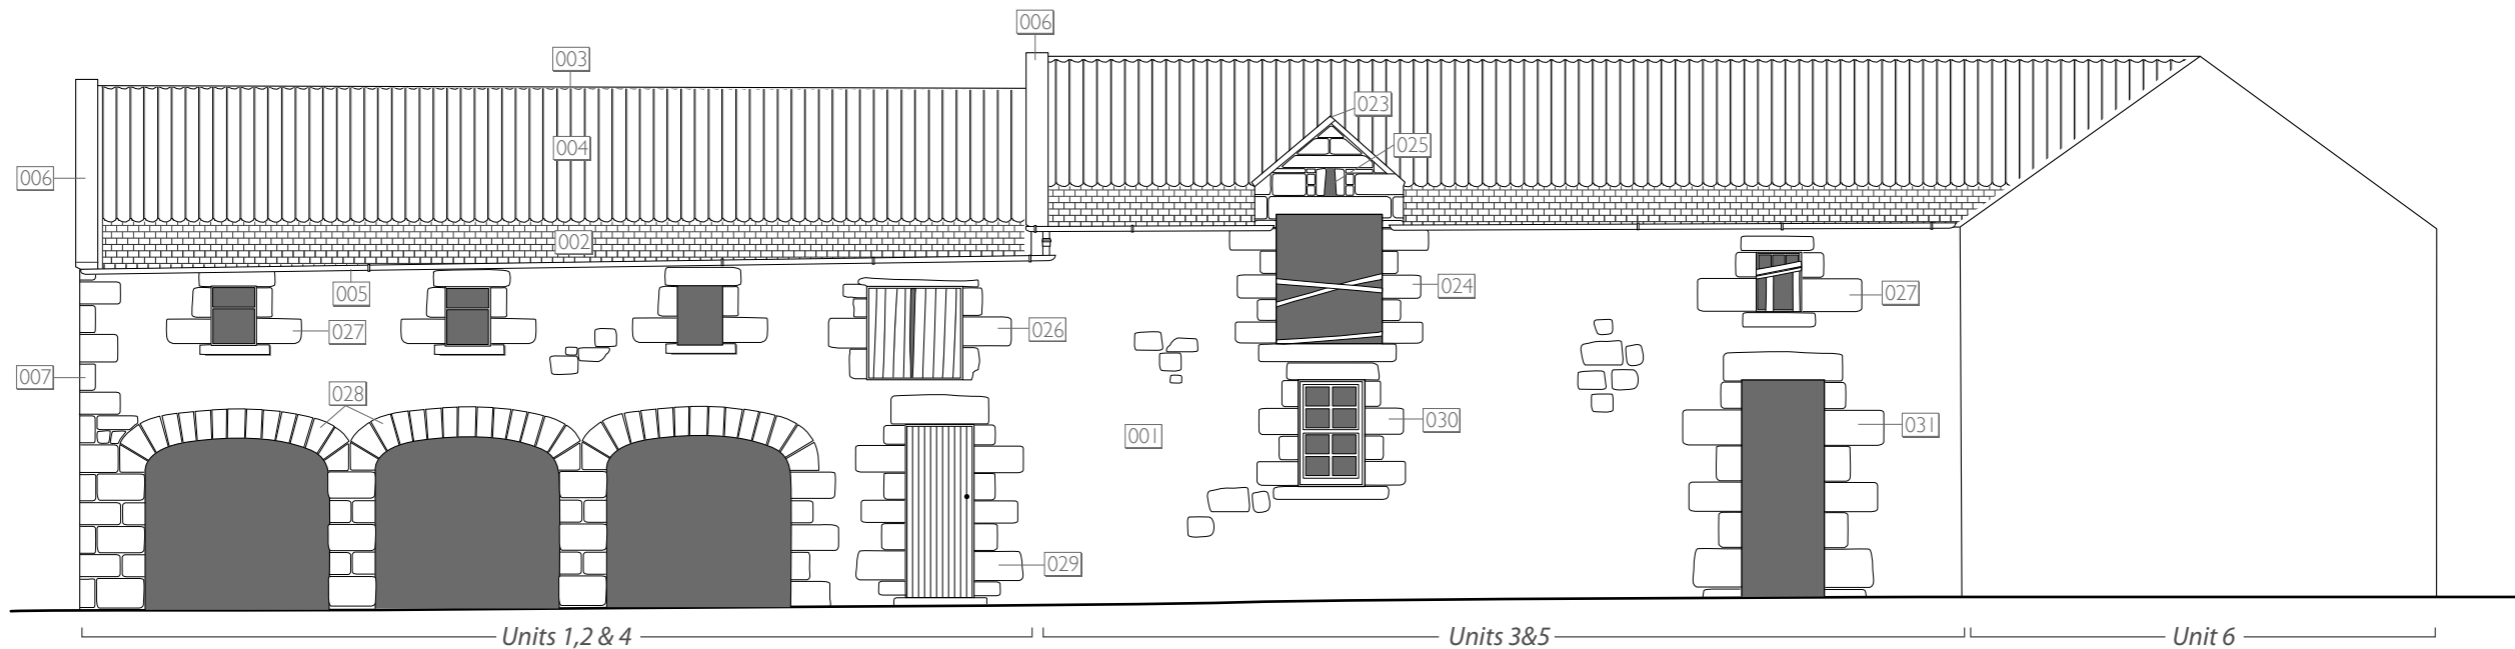
Fig 6 - South Range, North-facing

- 4.2.6 The fabric and roof of the elevation were the same as the south-facing elevation; coursed sandstone blocks with a pale mortar (001) and with droved quoins (007) below a pitched roof of corrugated iron (004) and an earlier slate tile roof (002). There were four window openings (027) on the first floor and a single ground floor window (030), all with dressed sandstone surrounds. A pitching door (026) on the east of the elevation had a double leaved wooden door. A second pitching door (024), further to the west, had been inserted under a dormer roof (023). A small slit vent (025) was present within this dormer. On the ground floor three ashlar segmented arched cart door openings (028), each measuring 2.1m high by 2.4m wide, allowed entry to Unit 1. Unit 2 was accessed via a white softwood door with a dressed stone surround (029). A further door opening at the west of the elevation (031) allowed access to Unit 3. Only the iron brackets survived of the former door in opening (031), and the dressed stone surround would have meant the door had to open inwards. No remains of the small building abutting the west of the elevation on the OS 1907 and 1904 were noted during the survey.

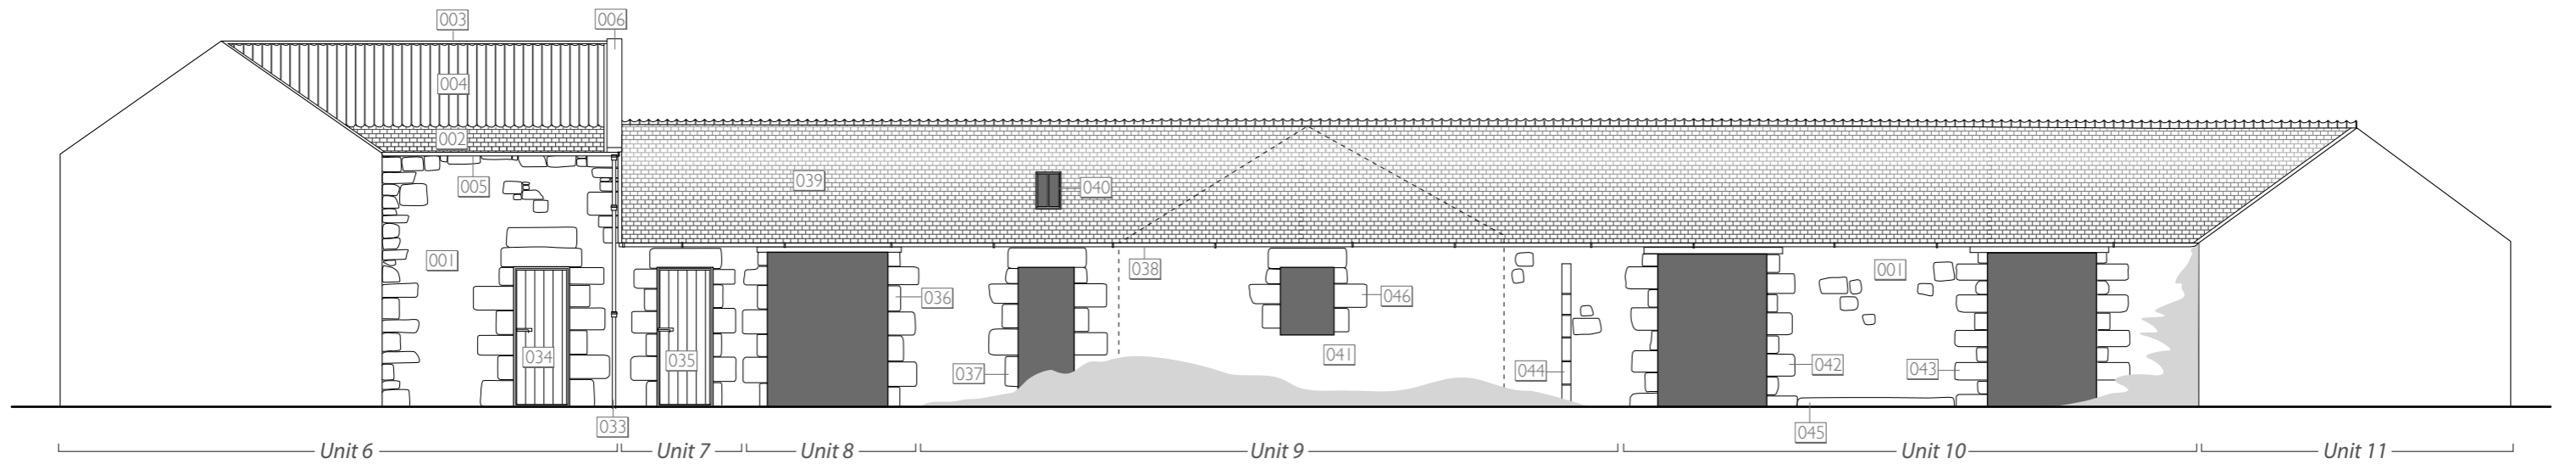
Fig 7 - West Range, East-facing

- 4.2.7 The walls of this elevation are constructed from the same coursed sandstone blocks (001) and droved quoins as the South Range, except where the elevation is masked by the Central Range. Here the fabric (041) is of coursed rubble rather than roughly dressed blocks. A window (046) is present with this rougher fabric. The roof has two elements to it; the southern, higher, end was a continuation of the north elevation of the South Range, whilst the large lower roof was of purple slate tiles (039). A skylight (040) was present in this roof.

- 4.2.8 To the south of the Central Range four doorways opened up on to the southern courtyard. Access to Units 6 and 7 was via softwood plank doors (034) and (035) respectively). The doors into Units 8 and 9 did not survive and access was via door openings (036) and (037). To the north of the Central Range two double door openings (042) and (043) faced the northern courtyard. Both openings allowed access to the divided Unit 10. A concrete dampcourse or pallstane (045) was present at the base of the elevation between door openings (042) and (043). The remains of edge-set sandstone blocks (044) were visible just to the north of the Central Range; it is likely that this feature was related to the similar features on the Central Range. All the doorways had dressed stone surrounds.

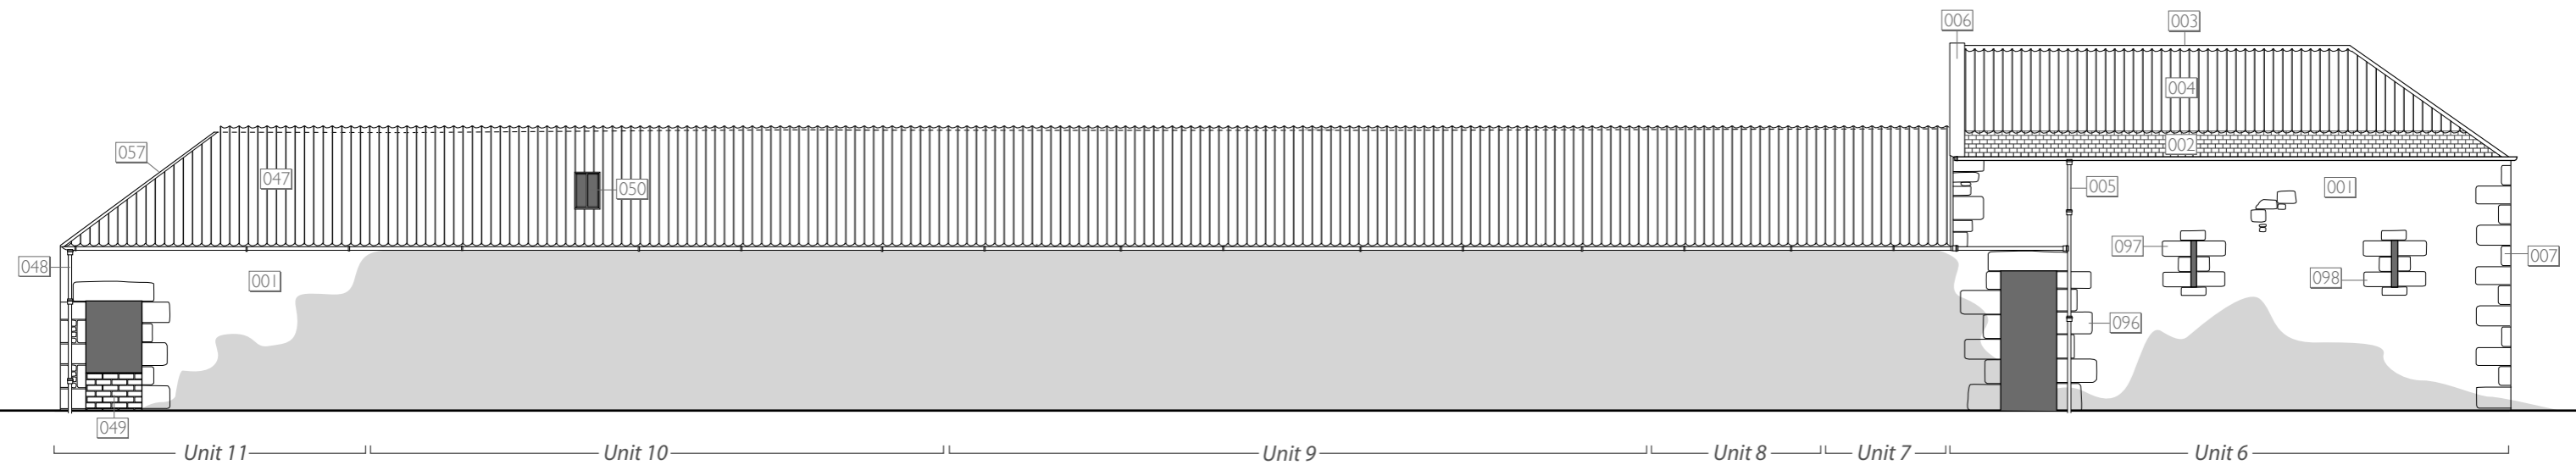
Fig 8 - West Range, West-facing

- 4.2.9 The features on this elevation were largely masked by vegetation, making a thorough survey difficult. In the areas that were visible the fabric of the wall was the same as the South Range with droved quoins (007). In contrast to the east elevation of the range, the roof was of corrugated asbestos sheets (047)

which contained a corrugated plastic skylight (050). To the south of the elevation the higher roof was the continuation of the roof of the South Range. Two slit vents (097) and (098) and a door opening (096) were present on this part of the elevation. The only other visible feature was a door opening (049) leading to Unit 11 on the northern edge of the elevation. The bottom of this doorway had been partially blocked with brick, creating a step on the inside of the Unit.

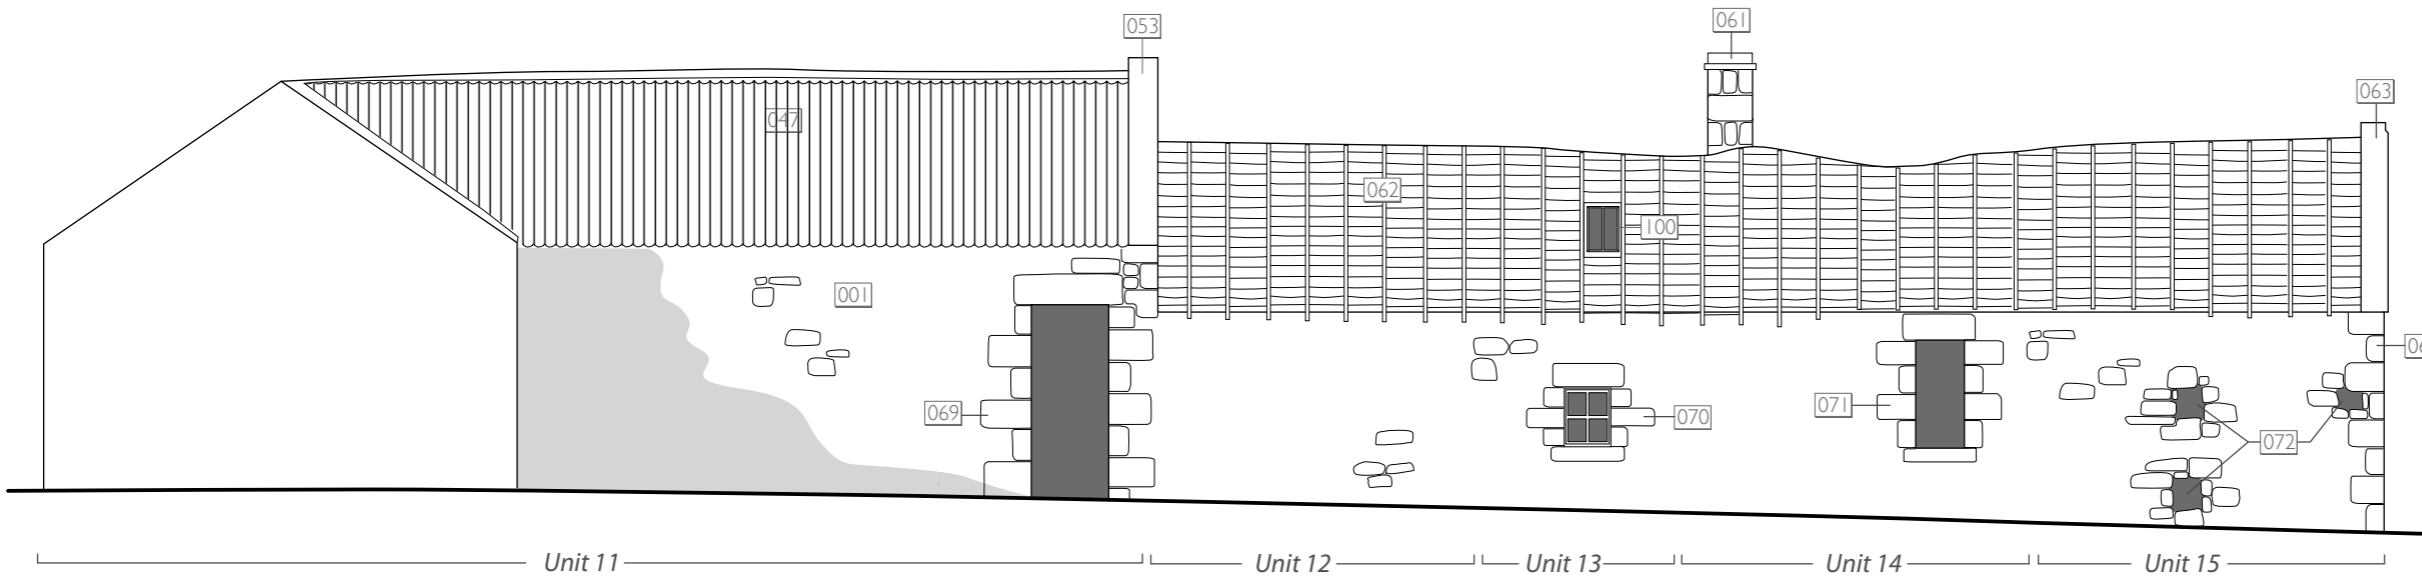
Fig 9 - North Range, South-facing

- 4.2.10 As with all the ranges, this elevation is on two levels to account for the natural slope into which the buildings are constructed. The higher, western end of this elevation was a continuation of the West Range and had the same corrugated asbestos roof (047), which was edged with sandstone coping stones (053). A single door opening (069) was present on the elevation, allowing access to Unit 11. The roof on the lower part of the elevation (062) had collapsed, exposing the wooden roof beams and joists. A skylight (100) was still extant in this roof. A stone chimney-stack (061) was also extant on the lower roof (062). Two stone-lined windows (070) and (071) were also present on the elevation, window (070) still contained its softwood window frame, whilst window (071) contained no frame. Three voids (072) were recorded close to the eastern quoins (064). These voids were probably related to similar voids on the north elevation of the Central Range. Both sets of voids are probably the remains of the small extensions visible on the early maps (Figs. 2b-d) but which were removed by 1972 (Fig. 2e).

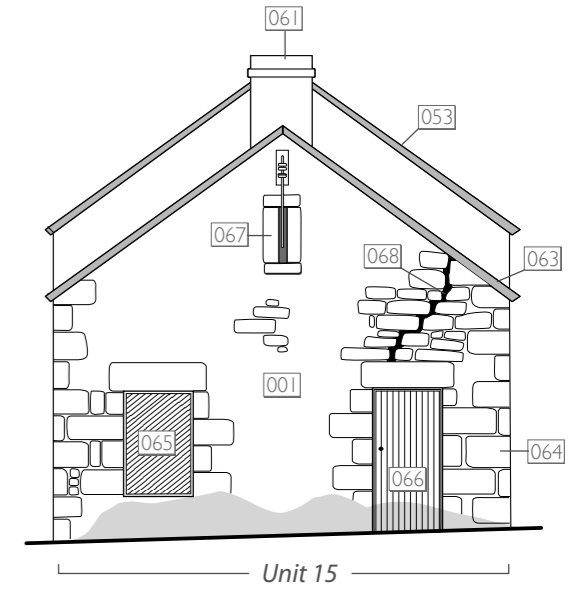
Fig 10 - North Range, East-facing

- 4.2.11 The east elevation is the gable of the North Range and comprises the same fabric as the South Range (001), with quoining (064) and a sandstone coping (063). As with the east gable of the South Range, a slit vent (067) with dressed stone surround occupies the apex of the elevation and had an electrical cable entering it. A plank-built softwood door (066) was present to the north of the gable, above which a structural crack was present (068). To the south of this a boarded-up window (065) is present.

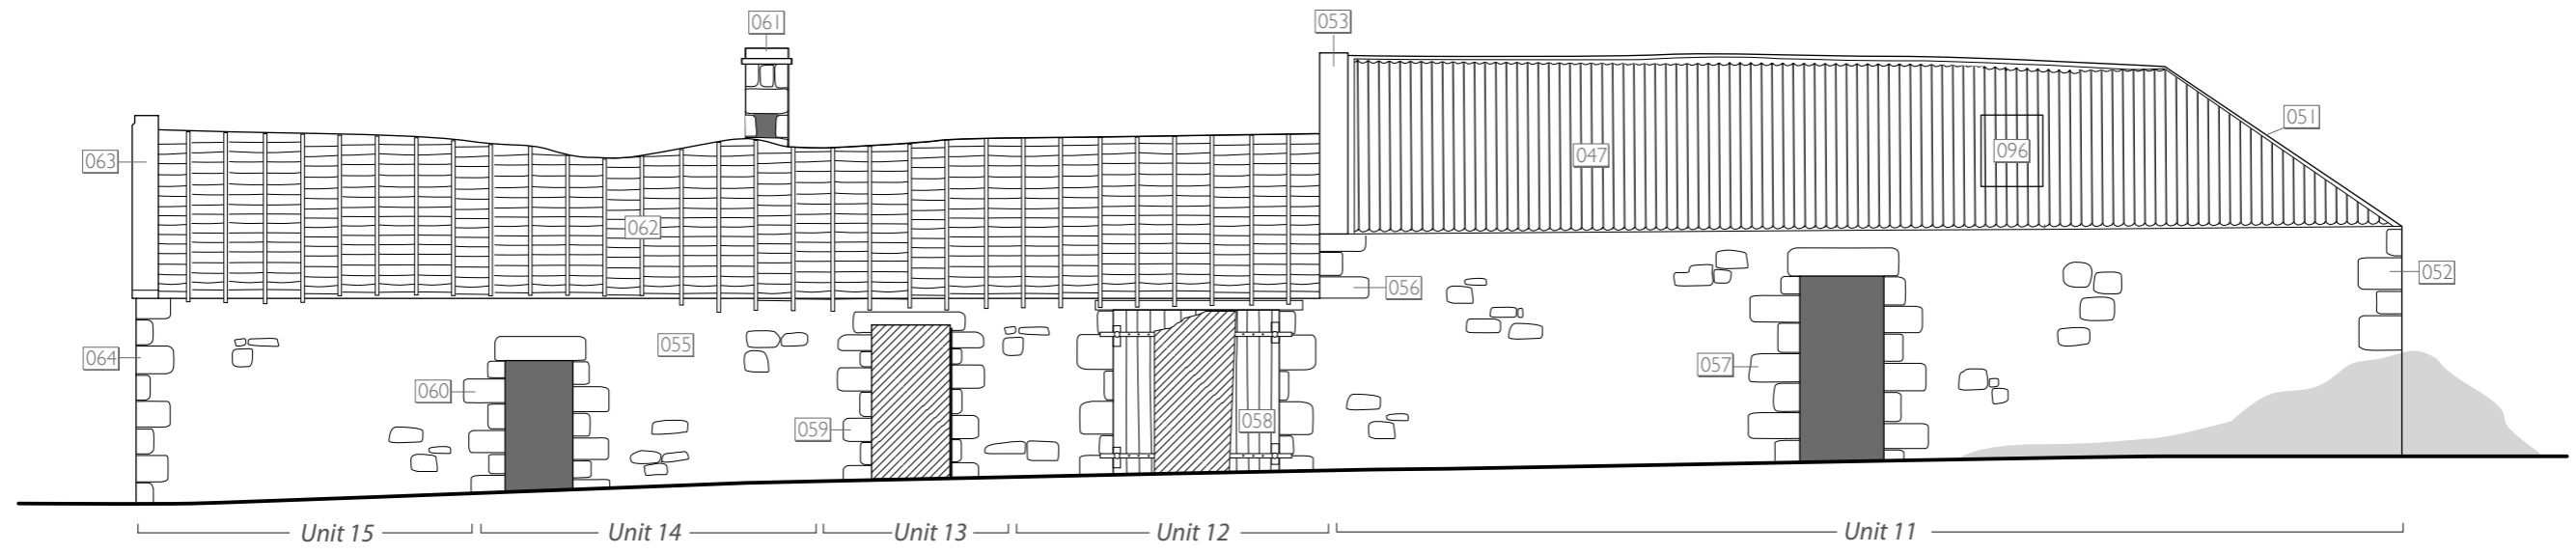
Fig 11 - North Range, North-facing

- 4.2.12 The fabric and the roof of the north elevation are exactly as the south-facing elevation, except for a small area of wall (055) between doorways (060) and (059) which is of coursed rubble and much less dressed than the rest of the Steading's buildings. The elevation contained four doorways (057)-(060), two of which (058 and 059) were boarded up. Fragments of double-leaved plank doors survived in doorway (058). A corrugated plastic skylight (096) was present in the corrugated asbestos roof (047) in the west of the elevation, and there were ceramic coping tiles (051) on the hip.

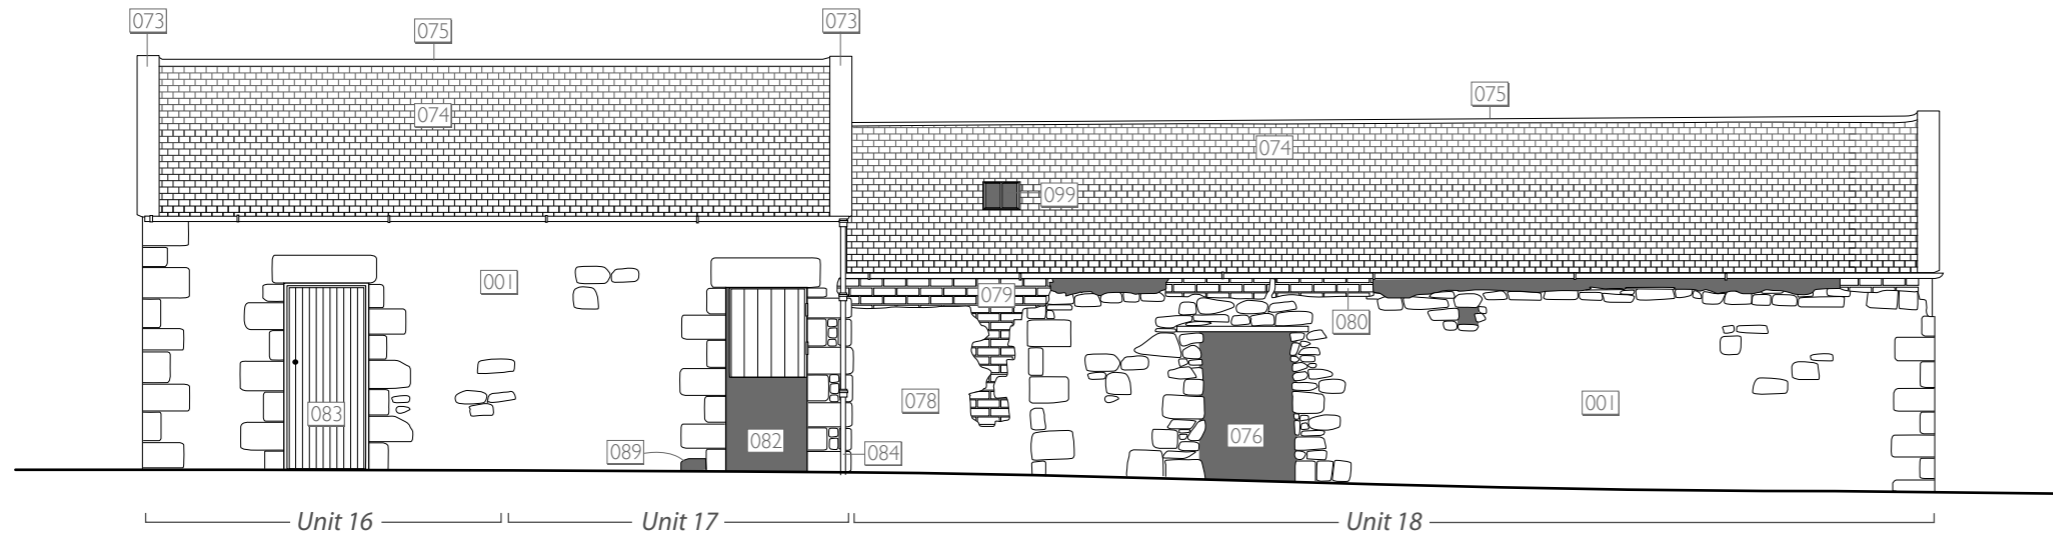
Fig 12 - Central Range, South-facing

- 4.2.13 The Central Range is also built on two levels to account for the slope. The roof (074) was of slate tile and contained a skylight (099). The western part of the elevation contained two doorways. Door (083) was a softwood plank door with iron handle. Doorway (082) contained a two-part softwood plank door, of which only the upper part survived. On the lower eastern part of the elevation a number of modifications had taken place. A doorway (076), with a wooden lintel, had been inserted into the main fabric of the building, whilst a double doorway (078) had been blocked by brick (079). A layer of brick blocking was also present at the wall head (080). These modifications probably relate to the removal of the former small rectangular building, sometime after 1972, which was present on the early mapping (Figs 2b-e).

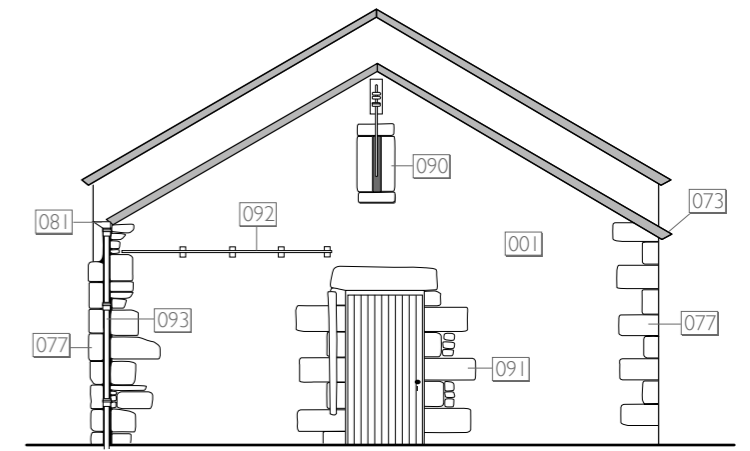
Fig 13 - Central Range, East-facing

- 4.2.14 The east elevation is the gable of the detached Central Range. It was constructed in exactly the same fashion as the gable ends of the North and South Ranges, comprising the same fabric as the South Range, and a slit vent (090) occupying the apex of the elevation with electrical cables entering it. A plank-built softwood door occupied the centre of the gable (091). An iron rail (092) was present to the south of the elevation, but its purpose remains unclear. Iron downpipe (093) had been cut into droved quoins (077), creating a snug channel for the pipes to sit in; this downpipe was fed by the large iron gutter (081).

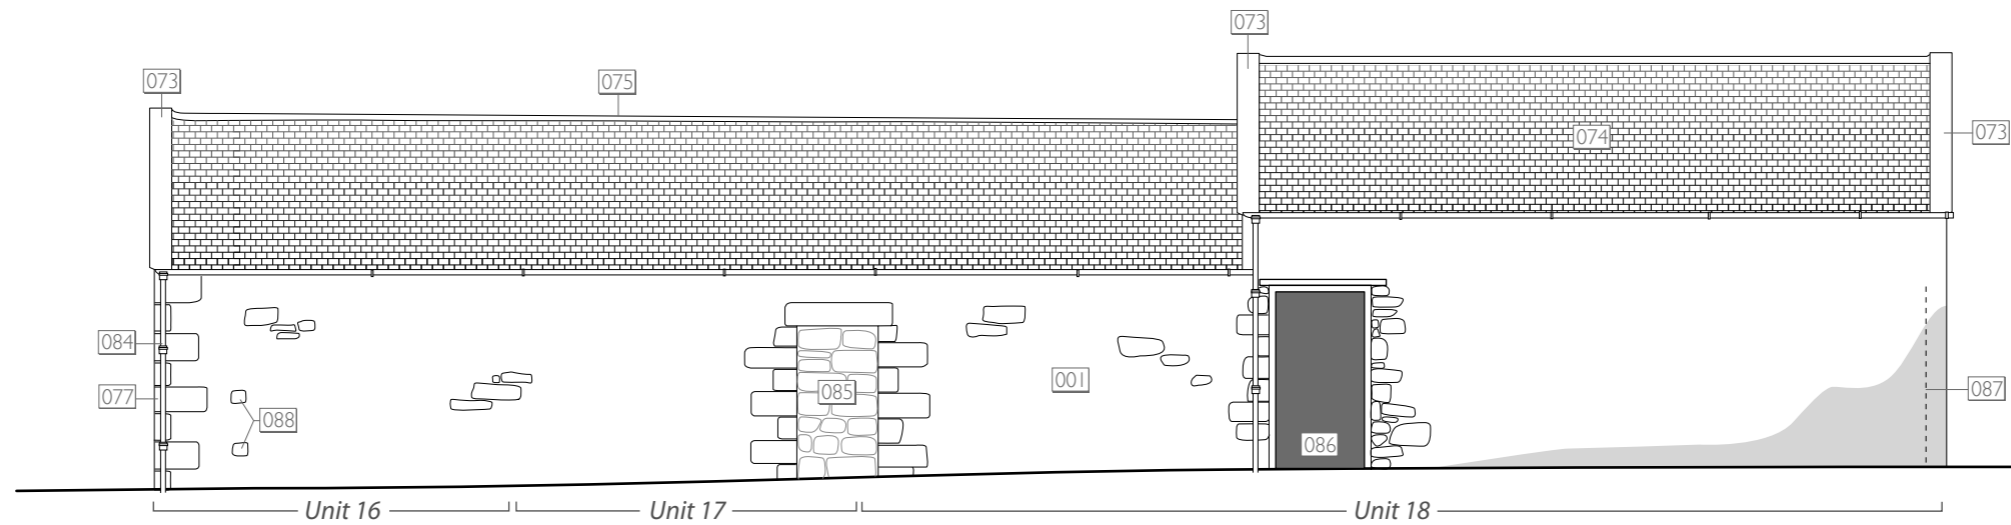
Fig 14 - Central Range, North-facing

- 4.2.15 The north-facing elevation of the Central Range contained two doorways. Doorway (085) had been blocked by dressed sandstone blocks similar to main build (001), which may suggest that this modification took place early in the Steading's development. A doorway (086) had been inserted into the western part of the elevation. This doorway was very similar to doorway 076 on the south-facing elevation of the Central Range. The doorway had a wooden lintel and the gaps in the broken stonework had been filled with brick. Two voids (088) on the eastern end of the elevation probably relate to the removal of the remains of the small extensions visible on the early mapping (Figs 2b-d) but which was removed by 1972 (Fig. 2e). These and similar voids on the south elevation of the North Range probably relate to cattle management.

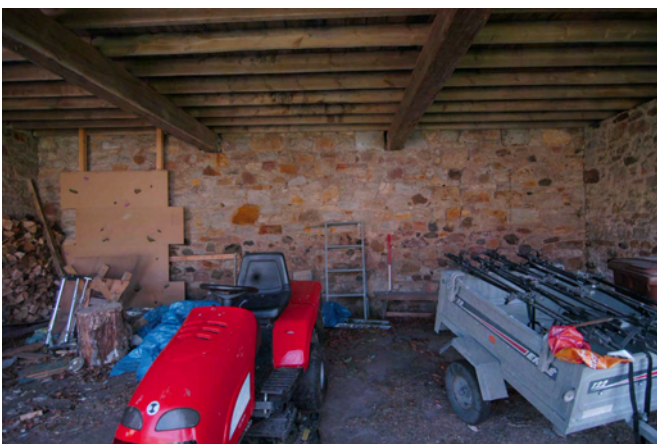
Plate 10 - Unit 1, north-facing elevation

- 4.3.2 This unit is currently used for storage. It is open on the north side where access is provided by three ashlar moulded stone arches. No evidence for any doors was present within these archways. The floor was of rough unfinished concrete and the walls were roughly coursed sandstone rubble. A structural crack was present down the centre of the west wall. This west wall was bonded to the north and south walls but the stones did not overlap. The ceiling was the exposed beams and joists of the floor above. The ceiling joists were in sockets just below the wall head.

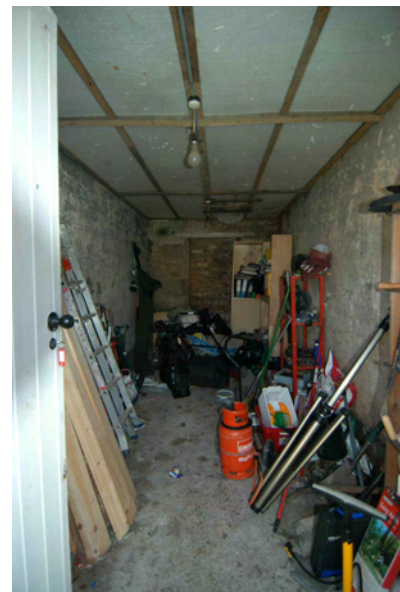
Plate 11 - Unit 2, from the north

- 4.3.3 Unit 2 is currently used as a secure storage area and the ceiling had been recently fitted out with wooden panels for this purpose. The door on the north elevation was a softwood plank door with an iron bakelite handle. The walls were unfinished coursed sandstone rubble and the floor was concrete. A window, blocked by brick, was present in the centre of the south elevation. Both the window and door had wooden lintels behind the exterior dressed stone surrounds.

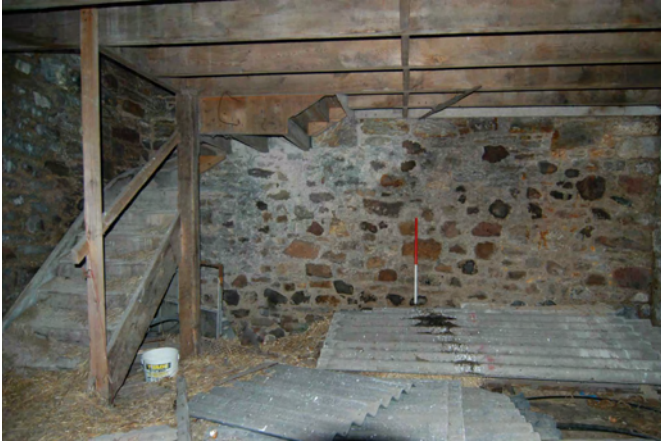
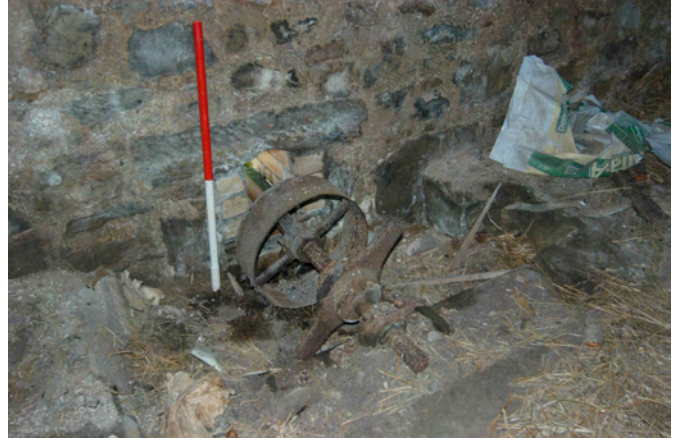
- 4.3.4 This unit contained a pit-wheel (Plate 13) and a belt drive on the southern wall. The remains of the belt-rollers were visible below the ceiling. The pit-wheel driveshaft was exposed at the base of the wall and connected to the pit-wheel belt-drive on the exterior of the South Range. These features are

probably the remains of a motorised cattle-cake crushing device. The floor was concrete and the walls were of coursed sandstone rubble. The ceiling was the exposed beams and joists of the floor above. The unit was lit by an eight-pane softwood window in the north wall and a door opening also on the north wall led to the courtyard. A nine-riser staircase was present in the north-east corner of the unit, leading to the lofts above. A door opening in the west wall led to Unit 11. This door appeared to have been a later insertion as bricks had been used to fill gaps and 'square' the doorway. The door itself was a softwood plank door on iron hinges.

Plate 12 - Unit 3, west-facing elevation

Plate 13 - Unit 3, close-up of machinery, from the north

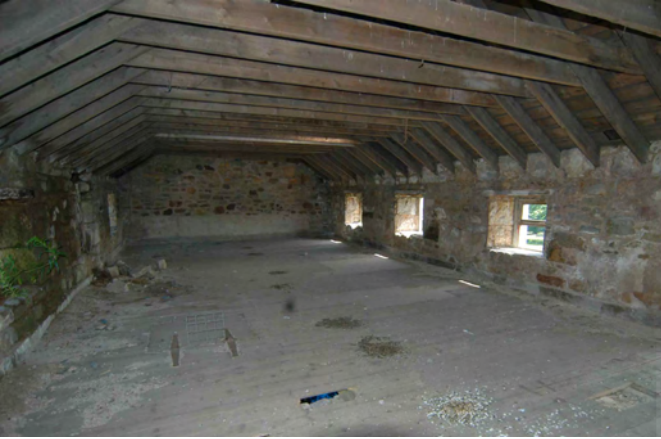
Plate 14 - Unit 4, general shot, from the west

- 4.3.5 The softwood plank floor in this unit was unsafe and so only a cursory survey of this unit was undertaken. The A-frame timber roof sat on the wall head and may have contained the original sarking. The walls were of coursed rubble sandstone. A band of concrete at the foot of the wall may have once held skirting boards. The room was lit by four windows on the southern wall. The windows had splayed ingos and concrete sills. Access to the unit was via the doorway on the east wall at the top of the stairs case in Units 3 and 5. The doorway had a timber frame and iron brackets but the door had been removed. A double leaved, softwood plank, pitching door was present in the north wall.

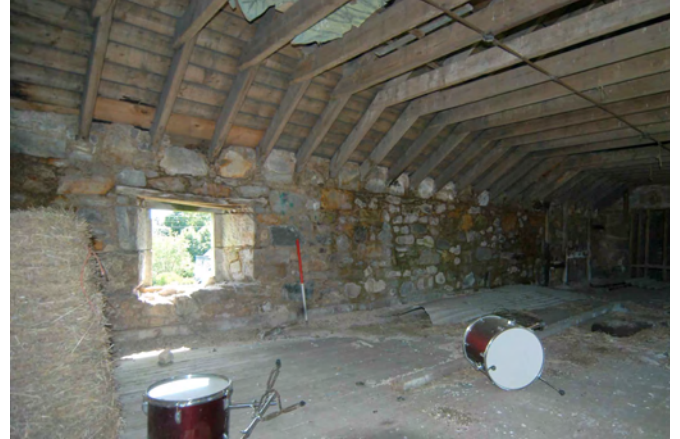
Plate 15 - Unit 5, general shot, from the north-east

- 4.3.6 This unit was very similar to Unit 4, the ceiling, walls and skirting were all the similar. A three-riser stair, at the top of the main stair, led up to the softwood plank floor. The opening for a pitching door was present on the north wall and an opening on the west wall may have been a pitching door into Unit 6. The room was lit by a window on the north wall and a window on the south wall. A gap, with a concrete base, measuring 1.1m high by 0.6m wide, was present in the east wall and led through to Unit 4. This gap appears to have been a later insertion as the stone at its edges appears to have been modified. The stone on the south wall had been rendered whilst the stone on the north wall remained jagged. The purpose of the feature remains unclear.

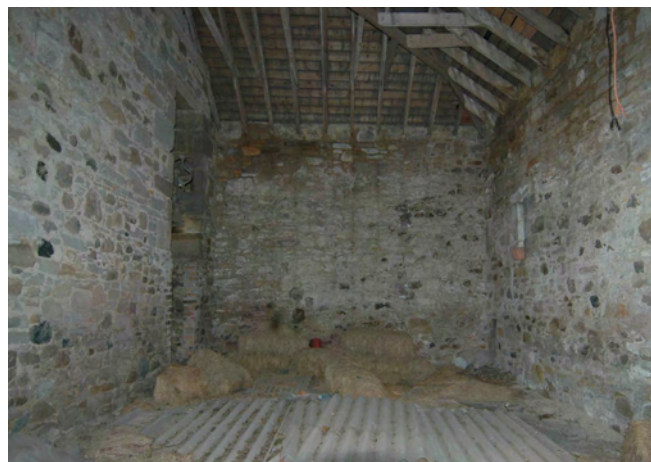
Plate 16 - Unit 6, general shot, from the north

- 4.3.7 This unit was probably most recently used for animal storage. The A-frame timber roof sat on the wall head and may have contained the original sarking. The roof turned to the south-west corner of the building where the South Range joined the West Range. The walls were coursed sandstone rubble and contained two narrow slit vents in the west wall. No evidence for an upper floor was noted and as such the opening from Unit 5 was probably a pitching door. The floor was compact earth. A door opening on the east wall opened up onto the courtyard, whilst a door opposite it on the west wall led to the exterior of the range.

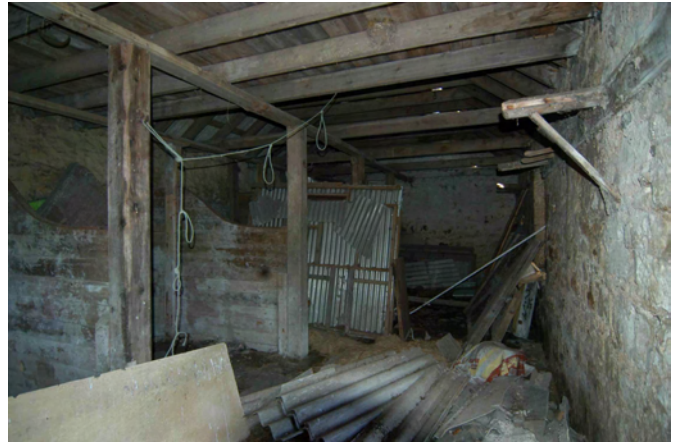
Plate 19 - Unit 9, from the south-east

- 4.3.10 This unit contained a large quantity of broken asbestos corrugated roofing and as such was not fully surveyed. The walls were built of sandstone rubble rendered with whitewashed cement, and the floor was concrete. The ceiling was made of wooden planks with the joists sitting on the wall head. The possible remains of a loft space was present above. Six evenly spaced wooden stalls were present on the west wall and shelves for tack and other equipment were present on the east wall. A window in the east wall looked out onto the Central Range.
