Author	Author: Michael Cressey HND BA MSc PhD MifA FSA Scot
Illustrator	Illustrator: Leeanne Whitelaw BSc MAAIS
Editor	Melanie Johnson MA PhD FSA Scot MifA
Commissioned by	Commissioned by Hackland Dore Architects for Dunedin Canmore Housing Association
Date issued	January 2009
Version	0
OASIS Reference	cfaarchal-53607
Planning Application No	08/03383/FUL
Grid Ref	NT 2332 6910

**St Hilda's Church, 1A Oxbgangs Avenue,  
Edinburgh, Photographic Survey**

**Report No 1590**

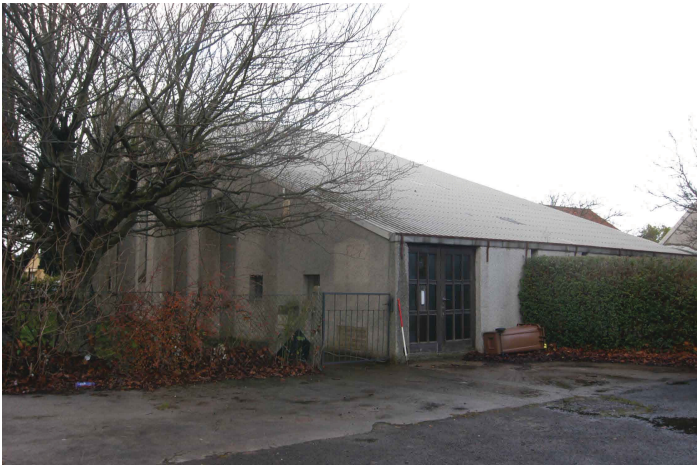
3.1.2 St Hilda's Church is a single storey structure with an asymmetrical pitched zinc alloy roof. The walls are brick-built with a heavy coating of grey pebble-dash render on the exterior. The east elevation incorporates the main entrance doorway and windows that light the baptistery (Plate 1). A commemorative plaque laid by Kenneth Carey, Bishop of Edinburgh on July 25th 1965 is also present on the corner of the south-facing elevation (Plate 2). The south elevation is buttressed with windows lighting the nave (Plate 3 & 7). The north elevation also has buttresses and an outshot building (robe room) with a cat-slide roof. The east-facing elevation incorporates three small windows that light the chapel (Plate 4).

Plate 1 - South-east corner of St Hilda's Church

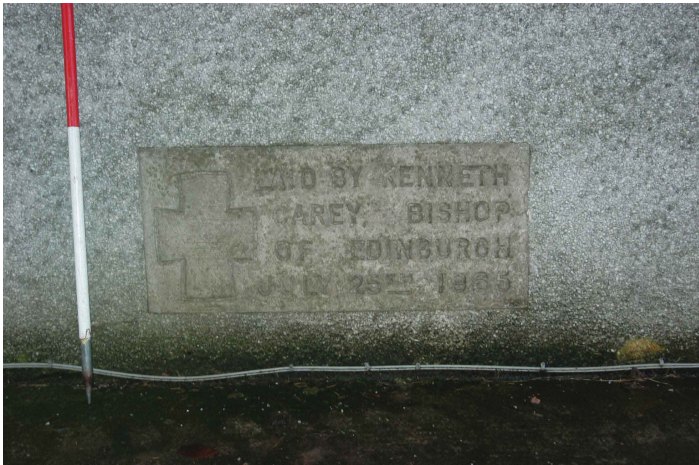
Plate 2 - Commemoration plaque on the south-east corner of the church

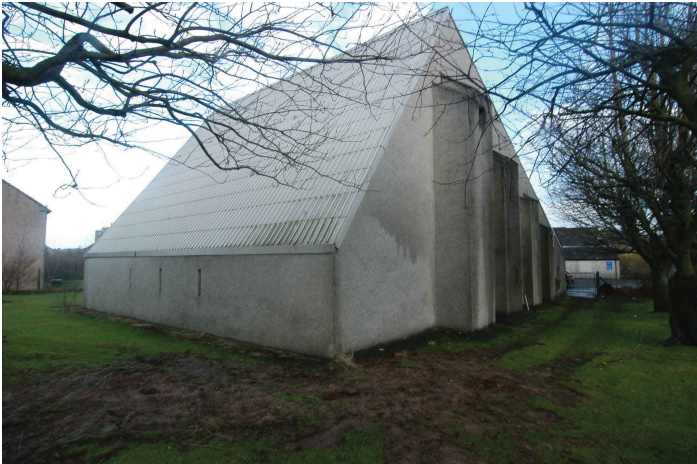
Plate 3 - South-west facing elevation of the church

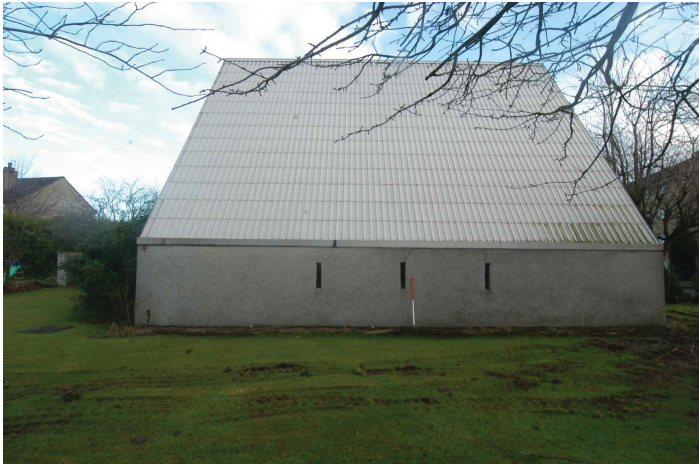
Plate 4 - East-facing elevation of the church

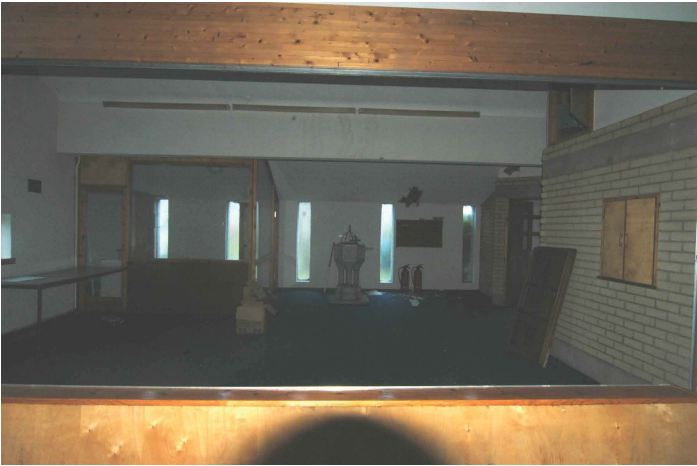
- 3.1.3 The interior of St Hilda's Church is open plan with a sliding door forming a temporary division between the nave and baptistry (Plate 5). The baptistry font is situated at its centre (Plate 6). A doorway on the west elevation of the nave leads to the robe room. On the south wall, a doorway leads to the sacristy where a doorway leads to the chapel. The walls of the nave and chapel have white-painted walls and are lit on the east elevation by lancet windows (Plate 7). Two rows of pews constructed from plywood occupy the nave floor. A brass alter rail enclosed the altar that is raised on a dias at the south end of the nave (Plate 8). The altar is constructed of sandstone blocks (Plate 9). The wall behind the altar has a crucifix and a mural of Christ and his disciples depicted in simple line-form (Plate 10). The chapel is accessed through the sacristy and has plain white-painted walls and a small altar with tabernacle at its south end (Plate 11).

Plate 5 - Interior view of St Hilda's Church baptistry

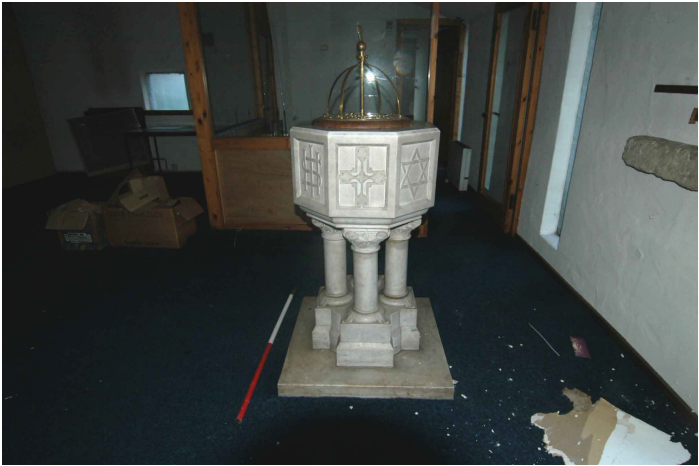
Plate 6 - Close-up of the font

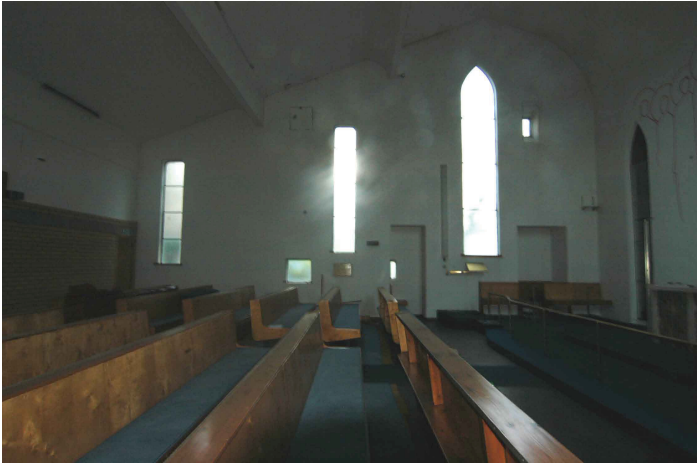
Plate 7 - Window on the nave wall

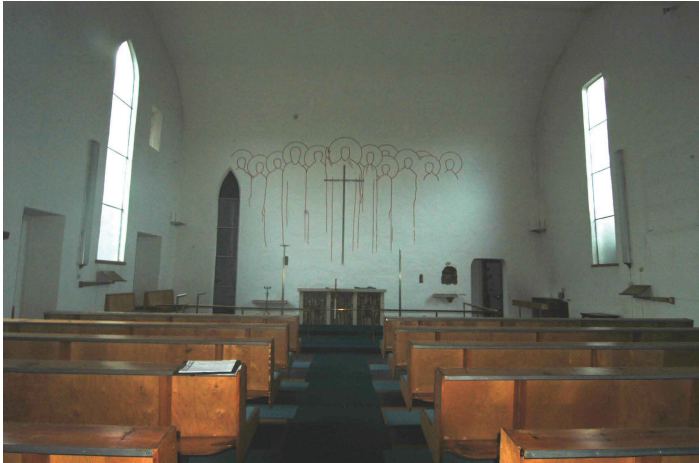
Plate 8 - Nave and altar

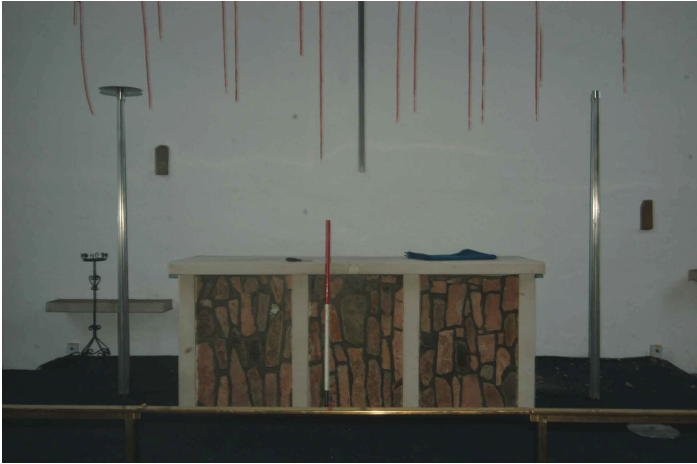
Plate 9 - Altar detail

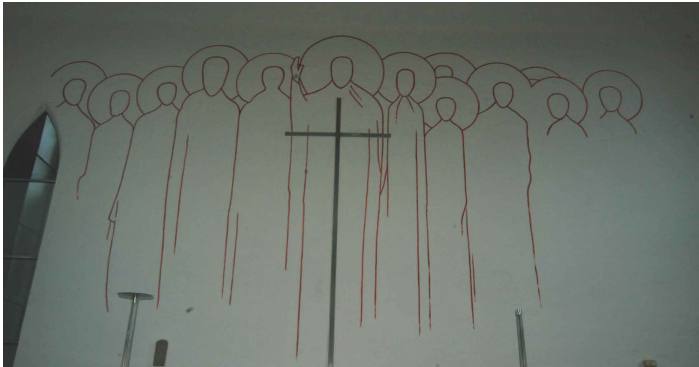
Plate 10 - Mural behind the altar

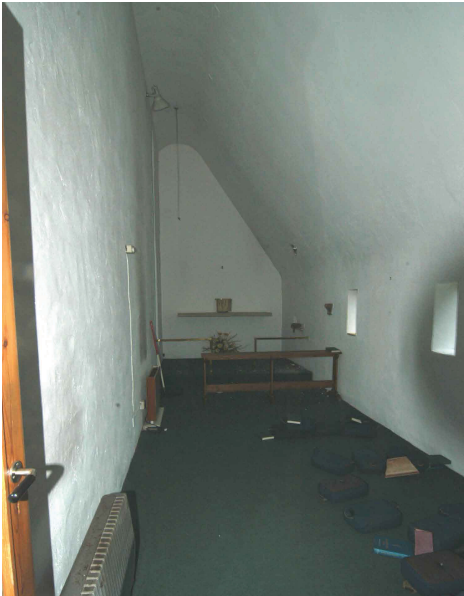
Plate 11 - St Hilda's chapel

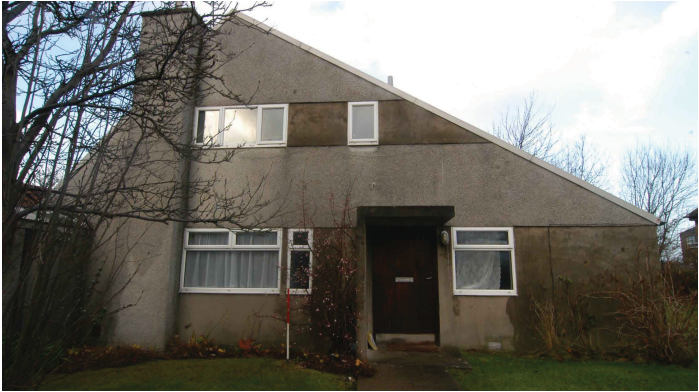
- 3.1.4 The rectory occupies a rectangular layout plan. On the ground floor an L-shaped living and dining room are present at the west end. The kitchen, stairs and hallway occupy the middle part of the ground floor and a study and bedroom are present on the east side of the building. Two bedrooms are present on the first floor. Due to the shape of the asymmetric roof configuration, the east side of the first floor has a large area of loft space used as a storage area. The bathroom leads off the landing and hallway. The two storey rectory has been fully modernized since its construction. There are no 1965 period features present within the building. All the walls are lined with plaster-board and all fixtures and fittings are modern. The main entrance is situated on the south-facing elevation (Plate 12). This elevation also includes an outshot chimney for the living room and bedroom and bathroom windows on the first floor. The east-facing elevation is plain with two windows lighting the study and a bedroom (Plate 13).

Plate 12 - St Hilda's Rectory, South-facing elevation

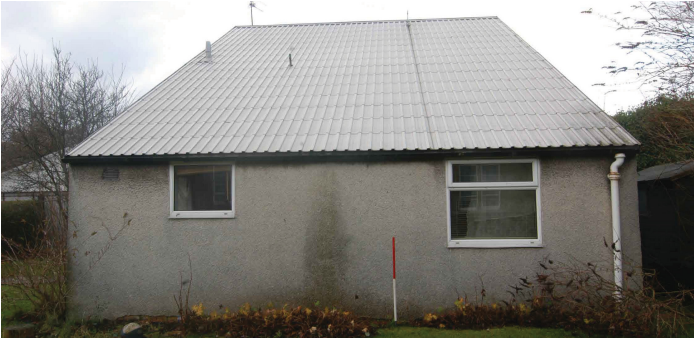
Plate 13 - St Hilda's Rectory, East-facing elevation
