CFA ARCHAEOLOGY LTD

Whin Bank Farm, How Mill, Carlisle: Standing Building Recording

Report No. 1587

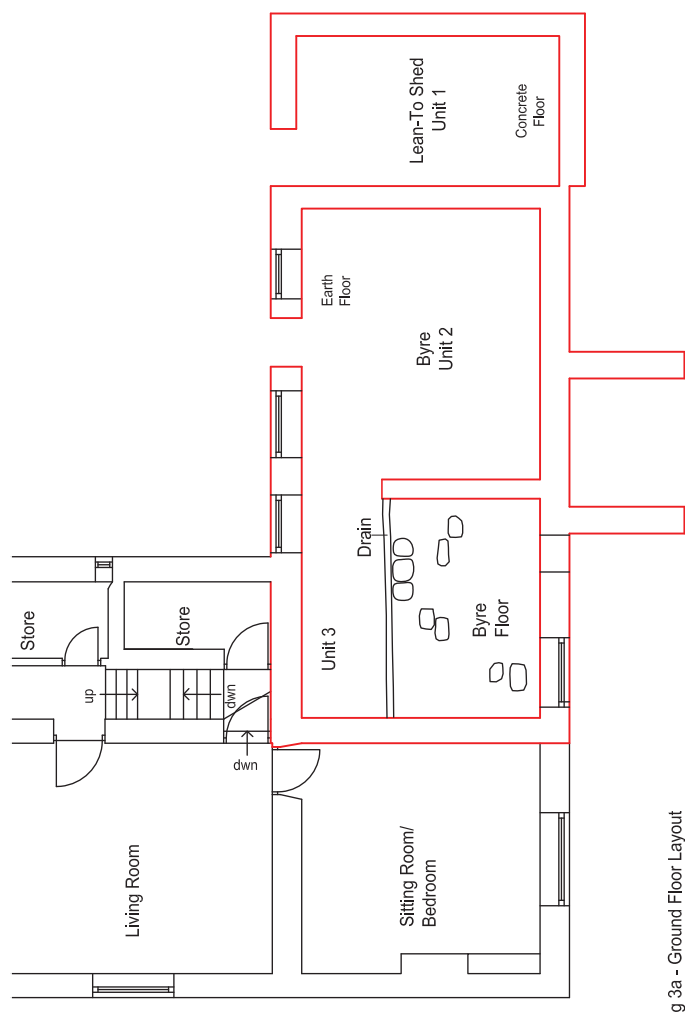
Fig 3a - Ground Floor Layout

Unit 1 is situated on the east gable and accessed by a plank-built door (1.8m x 1.04m) on the north elevation. The walls have been whitewashed. The lower gable wall has two slit vents visible and these are blocked. The corrugated iron roof is carried on timbers resting directly on the wall head. The floor is concrete.

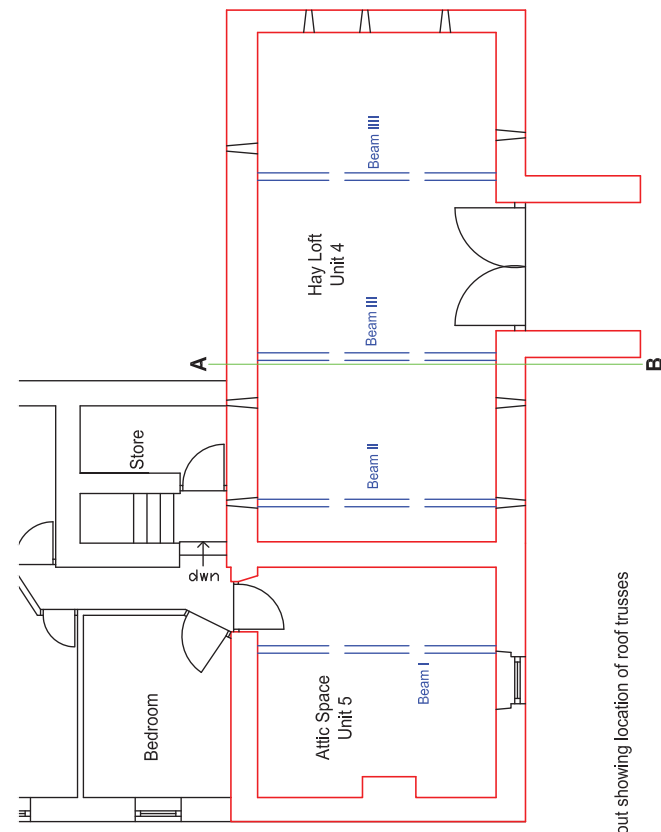
Fig 3b - First Floor Layout showing location of roof trusses

Approximately 5m above the barn's first floor is a second level with a wooden floor measuring 4.9m x 4.3m. The partition wall between the farmhouse and the first floor loft contains a blocked feature, and is possibly a small doorway into the farmhouse. A wooden lintel is present above the blocking work. On top of what is now a farmhouse bedroom is a floor which allows access behind the first A-frame cruck of the barn roof. At the rear of the floor space is the west gable wall which has a brick-built chimney breast. To the right of the chimney breast is a small brick-blocked opening measuring c. 0.4m by 0.25m. It is assumed that this was a small window.

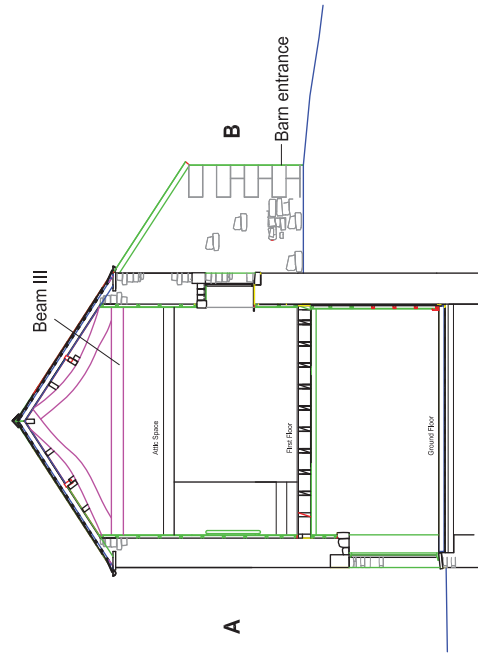
Fig 3c - Section (A-B) through Barn showing A-Frame roof trusses

The barn roof incorporates four oak A-frame crucks with wide timber blades that are united by scarf-joints cut on the left-hand side blade. The ridge-beam is trenched into the top of the right-hand cruck blade. The common rafters comprise both original oak timbers and modern replacements and are nailed to the ridge beam. The through-purlins sit in trenches cut into the cruck blades. Timber packers sit between the blades and the common rafters. Between the purlins and the top of the crucks are a series of oak pegs which continue on all four A-frames. The pegs appear to be from an earlier phase of roof construction that incorporated a different configuration of purlin, in all probability associated with a thatched roof.

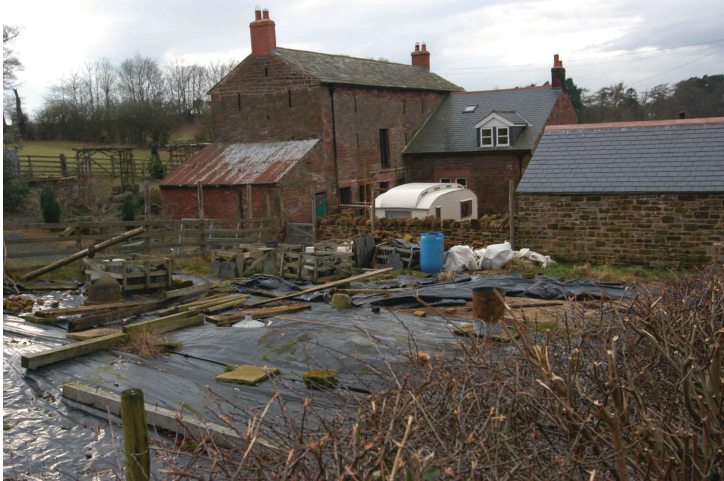
The barn occupies a rectangular footprint and is on the east side of the farmhouse (Plate 1). A shed (Unit 1) has been added to the east gable and has a corrugated iron roof. The barn has two units (Units 2-3 byres) on the ground floor which are entered from doorways on the north elevation. The first floor entrance is a large bay opening on the south elevation. The first floor comprises the hay loft (Unit 4) and at the east end there is a second floor in the attic space (Unit 5). The structure is a typical bank-barn built into the side of a hill.

Plate 1 - Whin Bank Farm, general setting

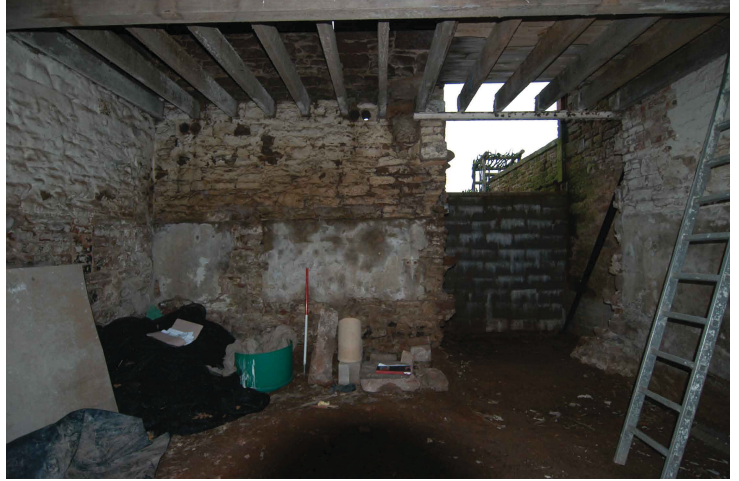
Unit 2 is a former byre with whitewashed rubble walls, and a cement render covering the lower portion of the walls. On the north elevation, the main doorway has a stone lintel on the outside; on the inside of the wall, an original timber lintel is present. The walls are 0.5m thick. The floor has been removed but it was probably originally stone setts with a central drain, as is the case in the adjoining byre (Unit 2). The south elevation wall has been slapped through and removed. The walls (0.5m thick) are exposed and comprise a double skin arrangement with rubble core. A large void extends below the south door

opening which has truncated a partition wall and exposed an I-beam that carries the loft floor.

Plate 2 - Unit 2, former byre looking south

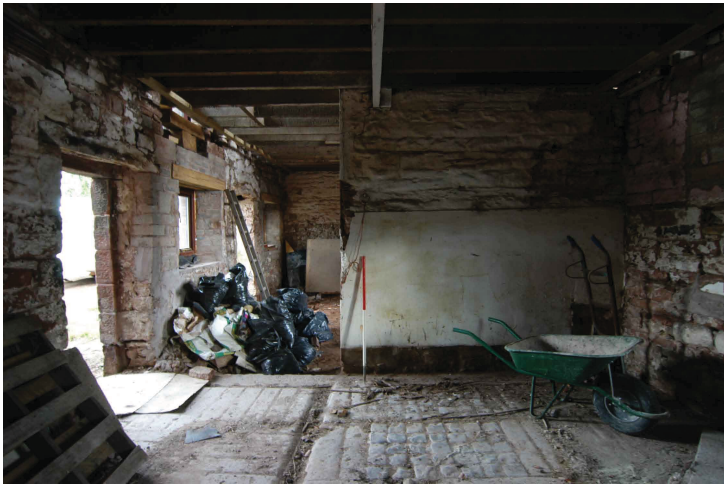
Unit 3 is accessed by a door on the north-facing elevation and has whitewashed walls and a stone floor with central drain. A window on the south elevation is a recent insert. The floor-joists are exposed throughout the length of the unit.

Plate 3 - Unit 3, former byre looking east

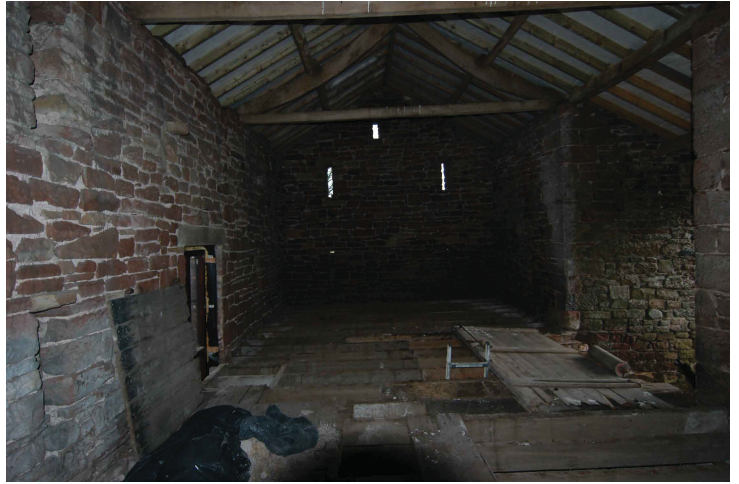
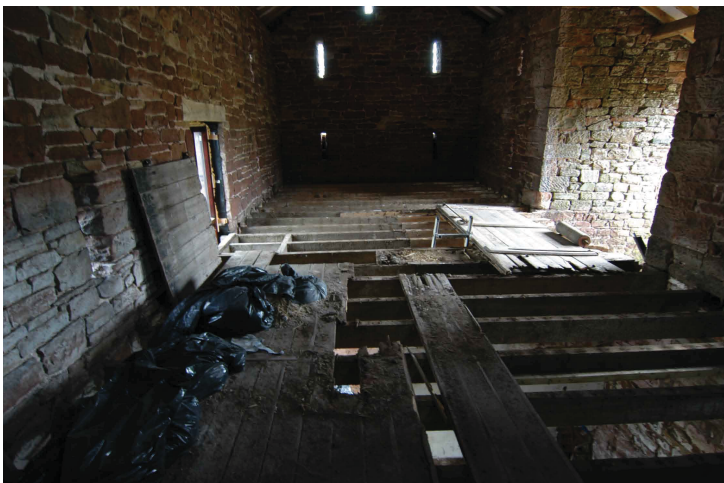
The barn's principal entrance is on the south elevation and is centrally placed. The floor-joists are all in situ but the plank floor has been removed, albeit for a small section, at the west end. The floor planking ran east to west. Directly opposite the main bay opening was another door now converted into a window. This door may have been a loft door accessed via a set of wooden stairs (forestair) or it may have been a pitching door, conveniently placed for large carts to load fodder directly into the barn floor. The barn is open to the roof and its coursed sandstone fabric is exposed throughout. The gable is pierced by three slit vents. A further six slit pierce the walls on either side of the main barn doorway.

Plate 4 - Interior of the barn looking east

Plate 5 - Interior of the barn from the attic space

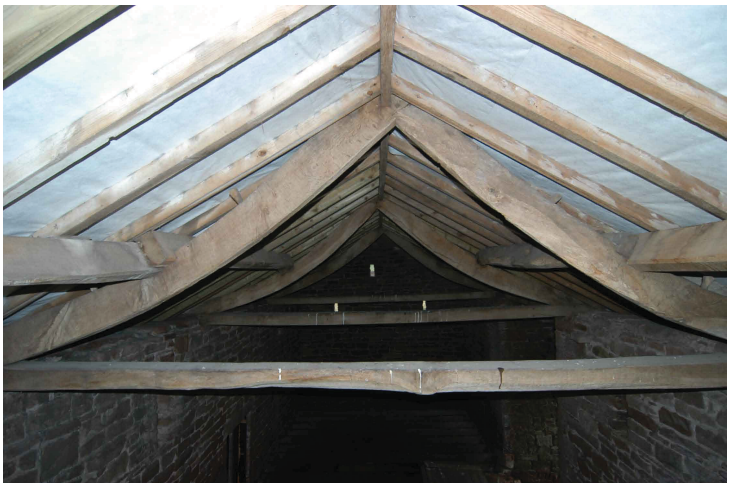
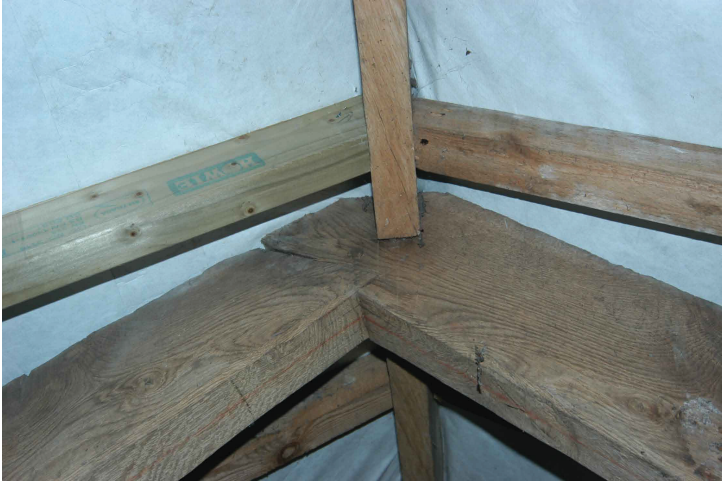
Each set of crucks is numbered (I-III) on the blade and on the tie-beam. The numbers are on the right hand side of the crucks looking east. The presence of numbers on cruck-framed roof members is not uncommon and demonstrates they were constructed in kit-form in a carpenter's workshop. Importantly the numbers show that the trusses are all contemporary in terms of construction. However it is possible that the timbers were re-numbered following modification from an earlier roof. There is evidence to suggest that this occurred in some Cumbrian buildings at the end of the 18th and early 19th century buildings (Bruntskill 2002) which would fit well with the age of the barn at Whin Bank Farm.

Plate 6 - A-frame cruck's, looking east

Plate 7 - Scarfe-joined cruck blades and new common rafters

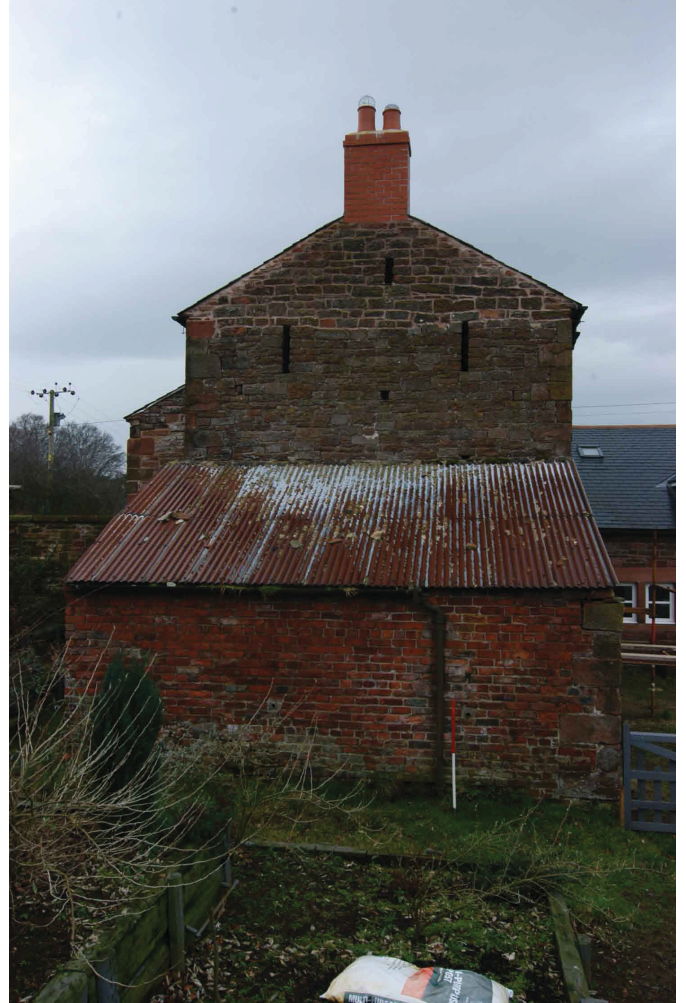
The east-facing elevation incorporates the gable of the barn and the brick-built shed (Unit 1). The gable measures 5m wide and the corrugated pent-roof of the brick-built lean-to shed (Unit 1) occupies about a third of the gable. The fabric of the main build comprises coursed sandstone. Three slit vents occupy the centre of wall with another higher up at the apex. A smaller square opening is present below the two lower slit vents. The gable has ashlar quoins. The upper part of the gable has been rebuilt to accommodate the new chimney stack.

Plate 9 - East-facing gable with brick-built lean-to shed

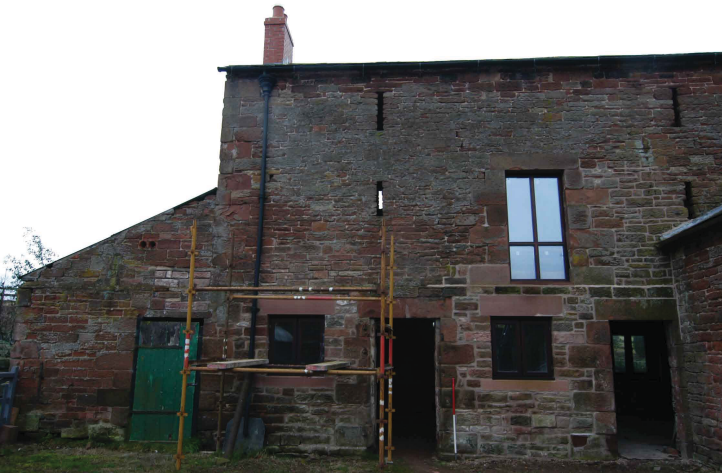
The North elevation of the barn measures 10m from the east gable to the corner of the farmhouse. Unit 1, a lean-to shed has been constructed against the east gable. The building is constructed of coursed sandstone with red sandstone quoins. A plank-built door has dressed surrounds. A small window above the door has been blocked. The shed has a corrugated iron pent roof.

The north elevation of the barn includes the north entrance to the farmhouse. This building has an asymmetric roof which masks about one third of the barn's exterior. On the ground floor two doorways provide entry into Units 2 and 3, the former byres. A new window has been inserted in between the doors. The doors have long and short surrounds and sandstone lintels. Two windows have been inserted recently and are enlargements of existing smaller windows.

On the first floor, a new four-paned window has been inserted into an earlier loft pitching door. The former doorway is flanked by rectangular slit vents. Two more are hidden behind the dormer of the farmhouse.

New cast-iron rain goods have been added at the east end of the elevation. The roof is covered with slates that are graded in size with smaller near the ridge and larger near the eaves. A brick-built chimney stack has been added to the east end of the barn.

Plate 8 - North-facing elevation of the barn (west end)

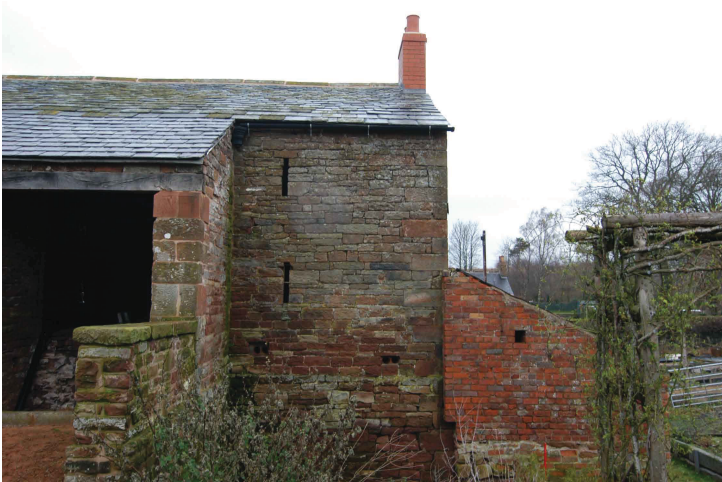
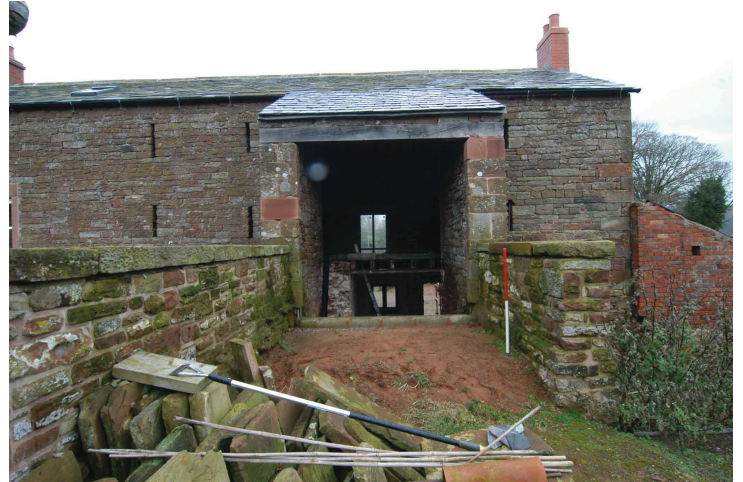
The south elevation measures 12.4m long. The principal feature on this elevation is the large bay opening into the barns first floor. At the east end at ground level is the rear wall of the brick lean-to shed. The shed abuts the corner of the gable rather crudely. Earth is exposed below the foundation courses. On the east end of the barn two slit vents occupy the first floor level of the wall. A large bay opening measuring 2.4m wide is flanked by two parapet walls which flank a ramp up to the doorway. The walls are topped by sandstone copings and are about 1m high. A timber beam above the doorway supports a cat-slide roof. On the west side of the doorway there are four more slit vents.

Plate 10 - South-facing elevation of the barn

Plate 11 - South-facing elevation with large bay doorway

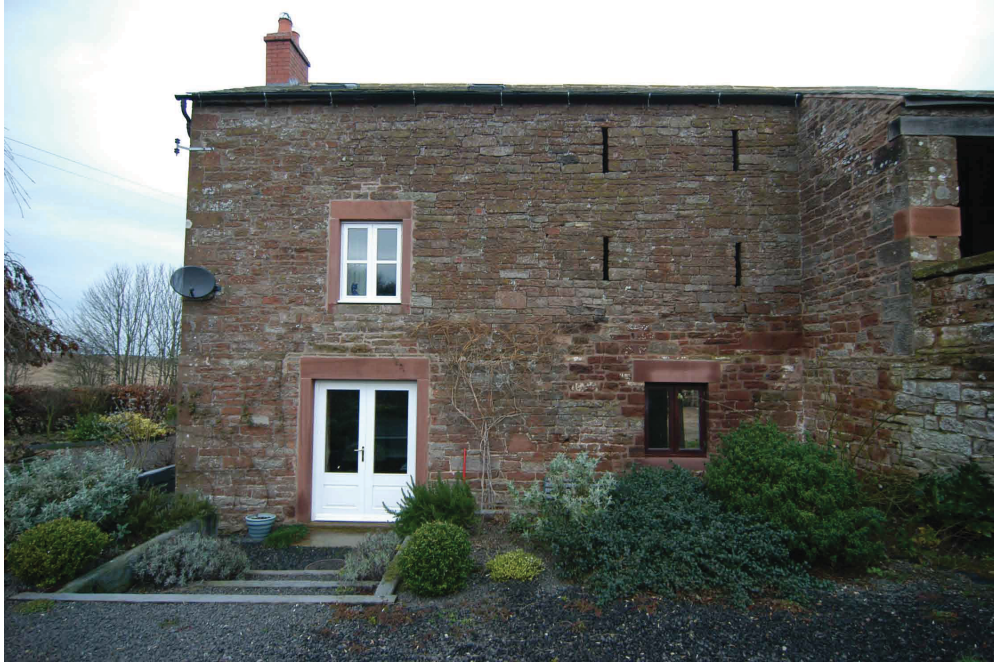
The west end of the barn incorporates the farmhouse (Plate 12). A window is present on the ground floor and lights Unit 3, the former byre. A large doorway to the farmhouse is surmounted by a 4-paned window. These features have raised margins.

Plate 12 - South-facing elevation, west end, showing slit vents and farmhouse

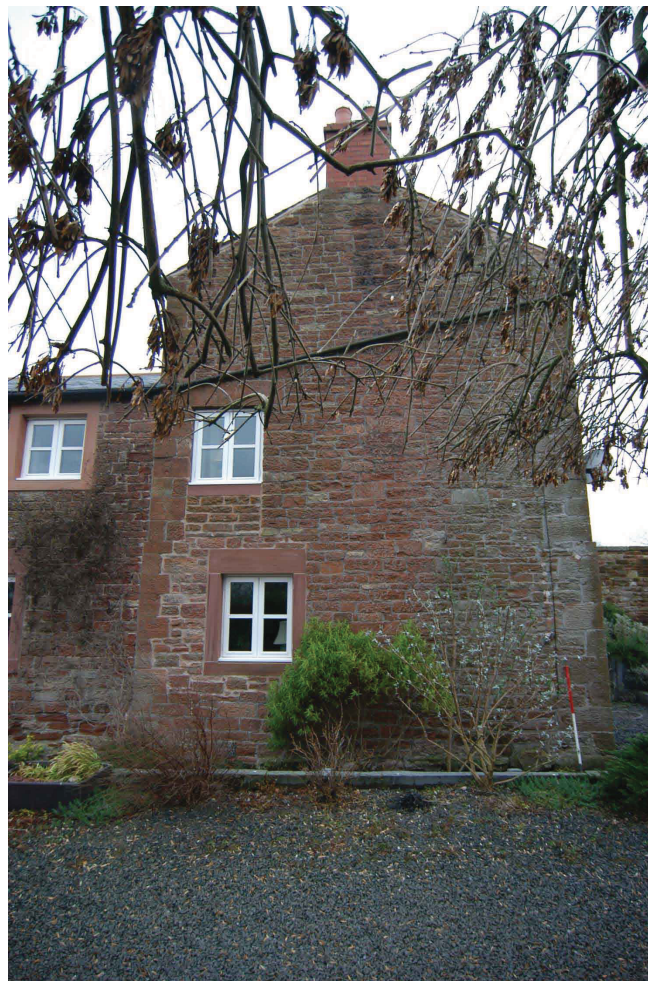
The west elevation incorporates the farmhouse gable and has two four-paned windows and a central chimney stack. The first floor window appears to have been secondary within a larger window opening. Ashlar quoins frame the gable. The adjoining building on the north side of the main block rests with some conformity against the ashlar quoins of the gable.

Plate 13 - West-facing gable and attached Farmhouse
