FRIARDYKES STEADING, CRYSTAL RIG, SCOTTISH BORDERS, STANDING BUILDING SURVEY

Report No. 1654

Author	Mike Cressey HND BA MSc PhD FSA Scot MifA
Illustrator	Leeanne Whitelaw MA MAAIS
Editor	Sue Anderson BA MPhil PGDip MifA FSA Scot
Commissioned by	Natural Power Consultants Ltd
Date issued	August 2009
Version	0
OASIS Reference	cfaarcha1-60179
Grid Refs	NT 6618 6805

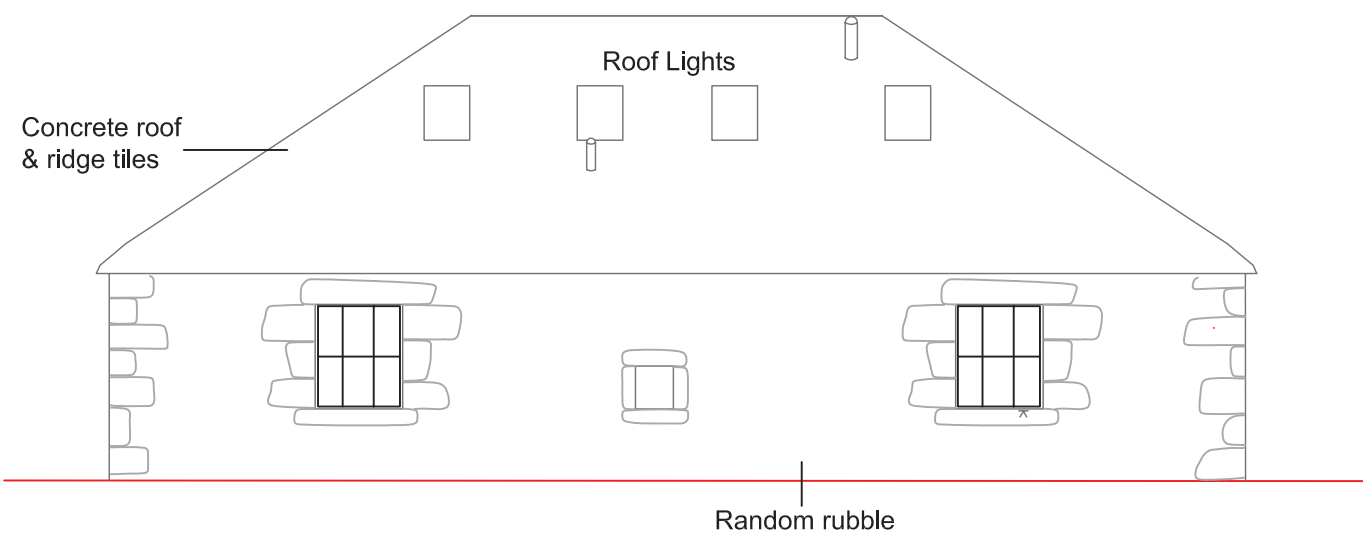
Fig. 3a - North-facing elevation

3.2.1 The north-facing elevation measures 12.2m long and 2.3m high and is constructed of random rubble build with stugged quoins and window dressings. A foundation/levelling course measures 0.2m high and consists of sub-angular stones. Two sash-and-case windows (6 over 6) measure 1.1m x 0.9m and a small (0.4m x 0.3m) blind window (bathroom) is present in the middle of the elevation. The surrounds around the windows are all droved. The pined roof is covered with modern cement tiles. The rain goods are plastic.

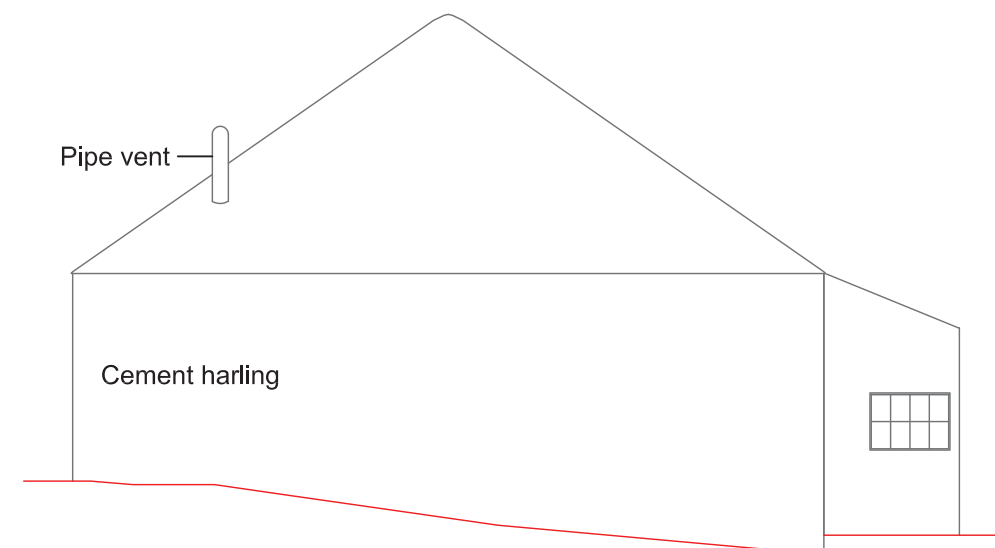
Fig. 3b - West-facing elevation

3.2.2 The west-facing elevation measures 7.9m long and 2.3m high and is featureless. The elevation has been rendered with concrete and marked out to represent block work. Where the harling has been removed at the corners, quoins and random rubble are exposed, thus confirming the same construction materials as used on the north-facing elevation.

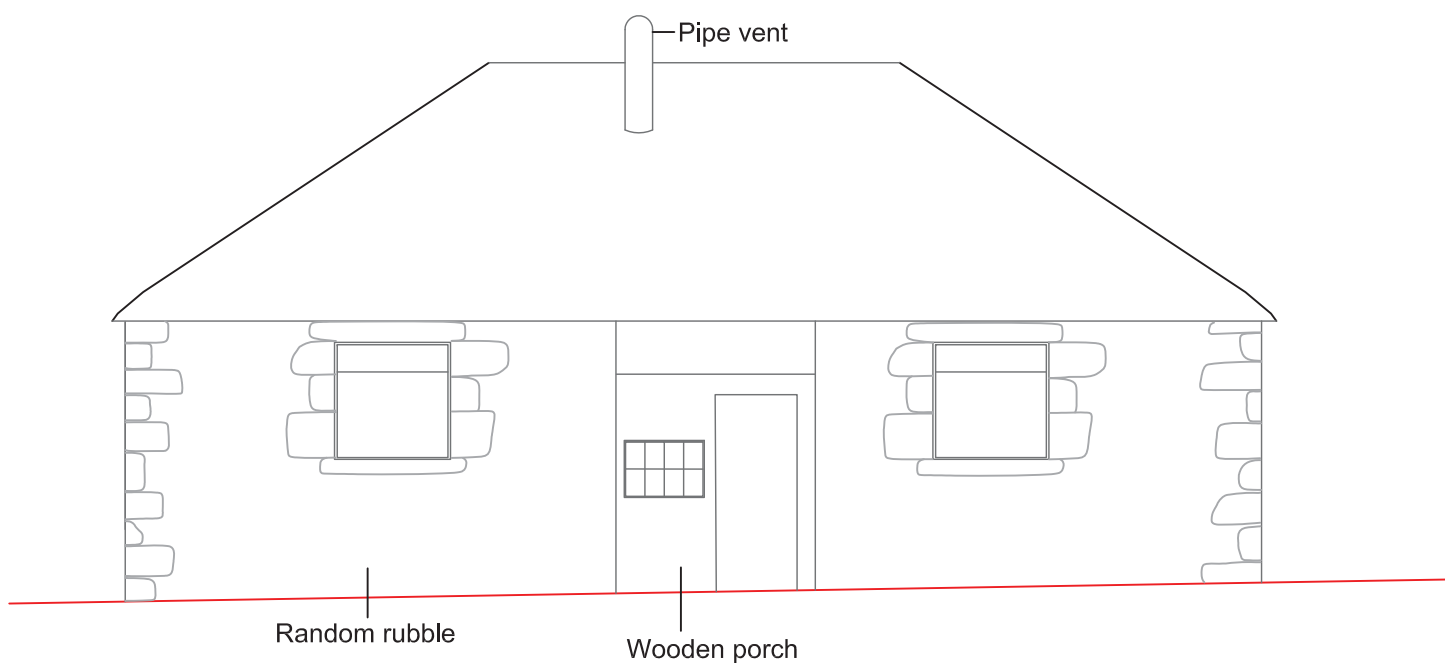
Fig. 3c - South-facing elevation

3.2.3 The south-facing elevation measures 12.3m long and 3m high and incorporates two modern PVC double-glazed windows measuring 1.2m x 1.2m. The stone window surrounds are all droved. A central doorway is sheltered by a timber-built porch. The porch is lit by three 8-paned windows and has a panelled door. The main door to the building has a frosted single

pane with lower panel. The door surrounds are dressed sandstone. The roof is covered with concrete tiles and the rain goods are plastic.

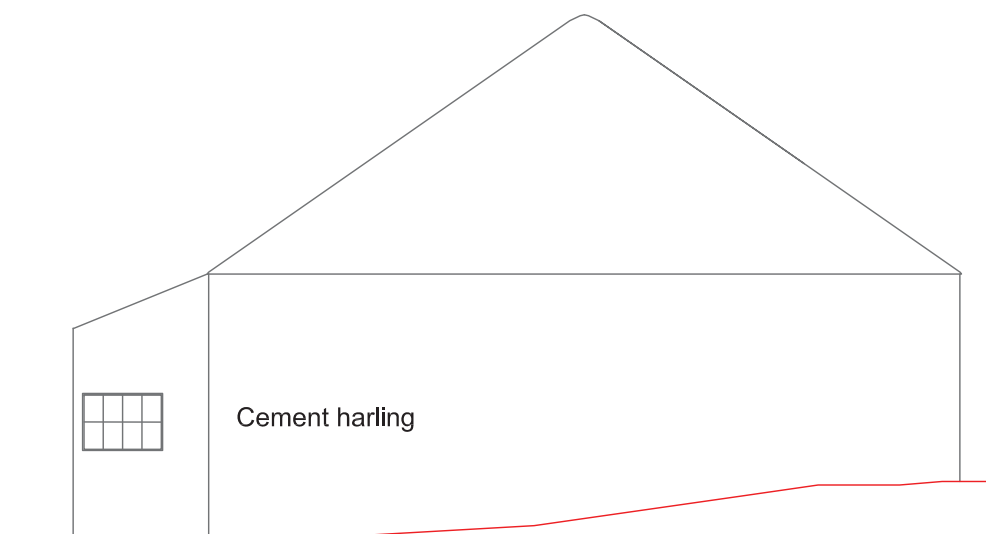
Fig. 3d - East-facing elevation

- 3.2.4 The east-facing elevation measures 7.9m long and 2.3m high and is featureless. The elevation has been rendered with cement. Where the harling has been removed at the corner, quoins and random rubble are exposed.

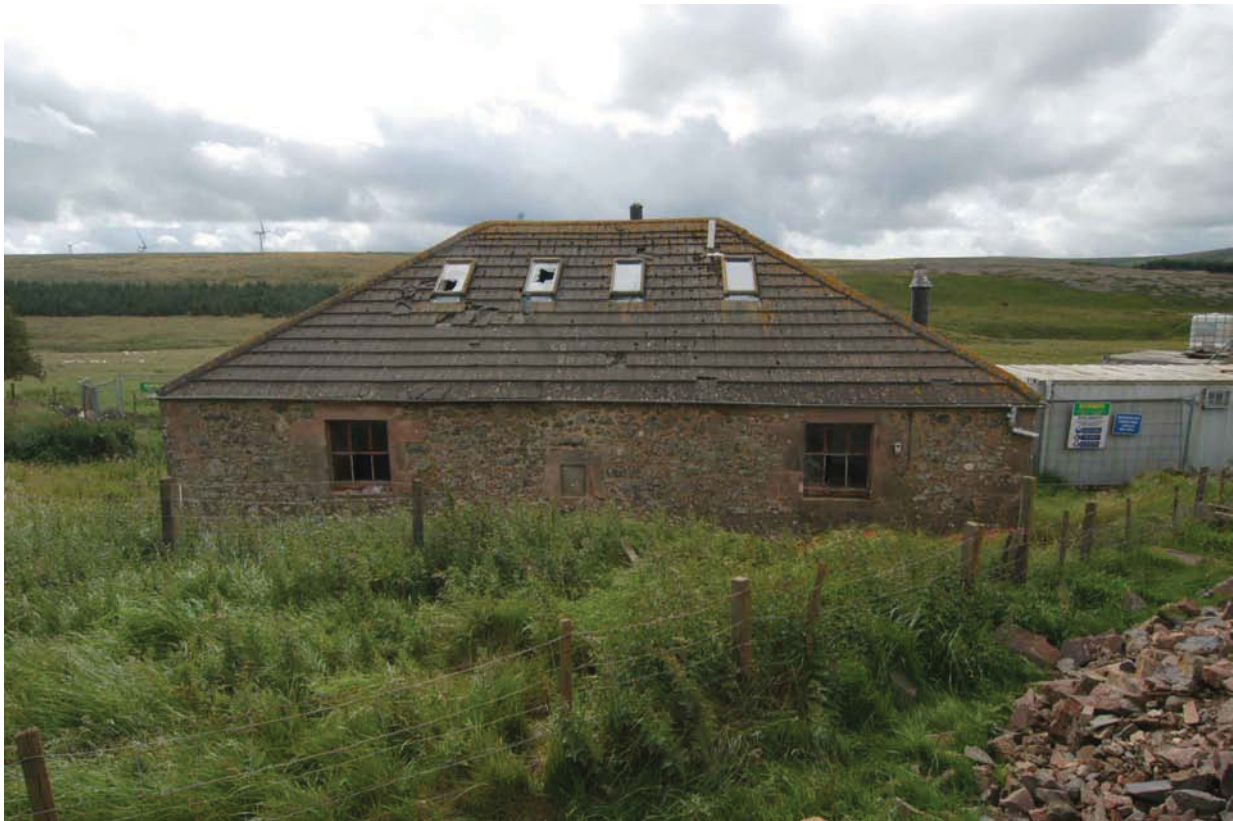
Plate 1 - General view of the cottage from the north

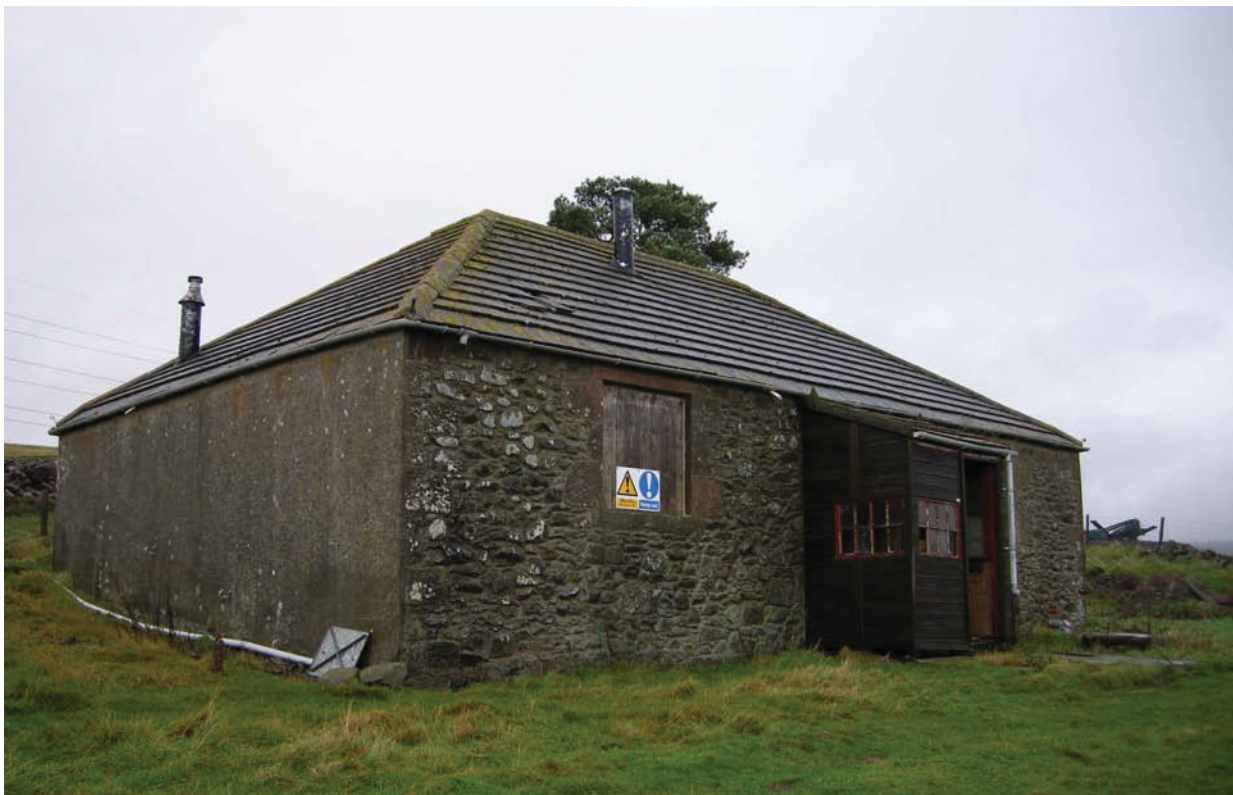
Plate 2 - General view of the cottage from the southwest

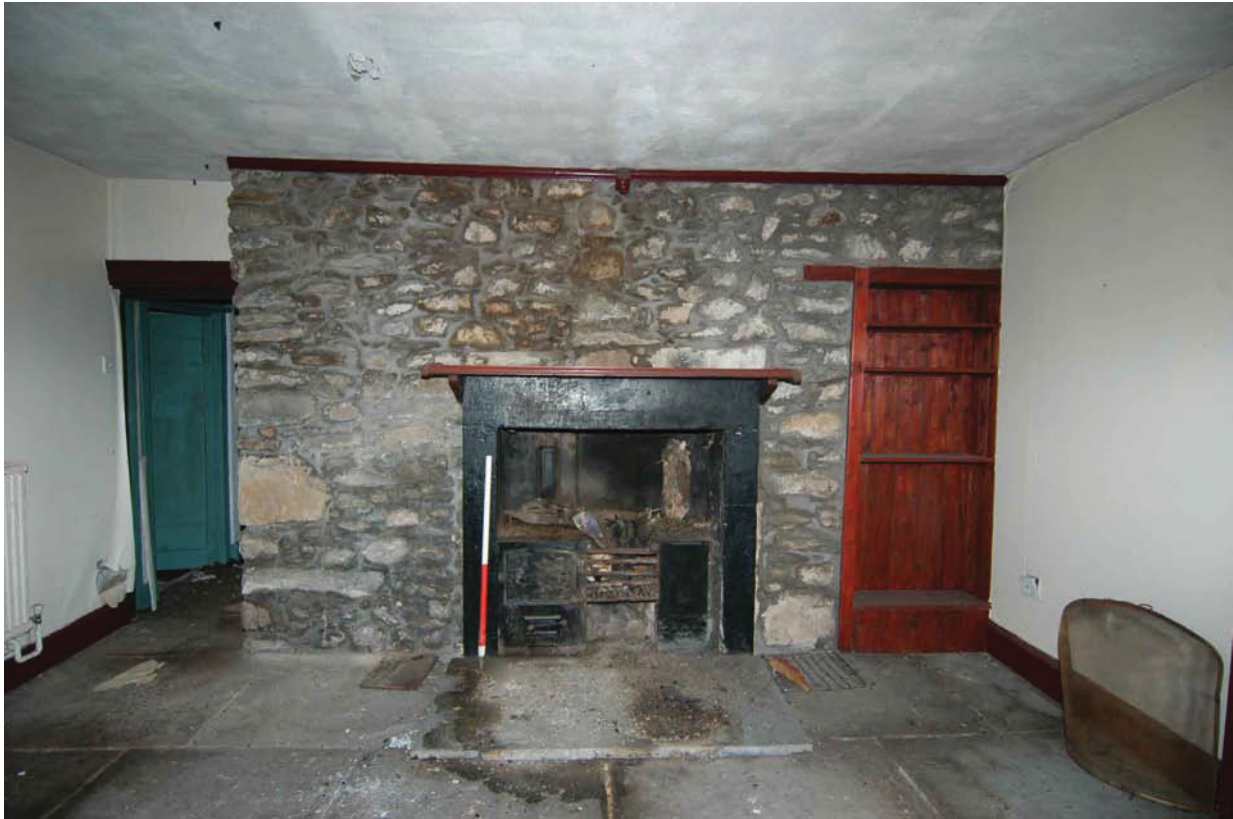
- 3.3.1 This unit is lit by two windows on the south-facing elevation which have tongue-and-grooved surrounds with splayed ingos. The principal feature on the east-facing elevation is a large cast-iron range with a modern softwood mantelpiece set below an exposed rubble-built wall that has been refaced and heavily pointed. The floor is flagstone of varying sizes and appears to be an original feature. The west-facing wall is featureless. The north-facing wall incorporates a door into Unit 2, the boiler room. The door itself is plank-built with a simple latch. The walls and ceilings throughout are covered with plasterboard fixed on stud-work. The skirting-boards are soft-wood with no moulding.

4.4 The range in the living room probably dates to the 1930s and has been inserted into an earlier range opening. During the 1980s the cottage was completely refurbished and had a new roof installed. The staircase appears to date from this major phase and is kit-form. The position of the earlier staircase may have been in what is now the bathroom. The PVC windows are an obvious insertion. There is no evidence to suggest that the openings for these windows are not original and as they are south-facing they would attract more light, these being larger than the north-facing windows. The building was re-wired during the renovation as the sockets are all modern. The bedrooms have been created from the available roof space and were clad throughout with plaster board. The porch is a 20th-century addition.

Plate 3 - Room 1 living room range, formerly the kitchen

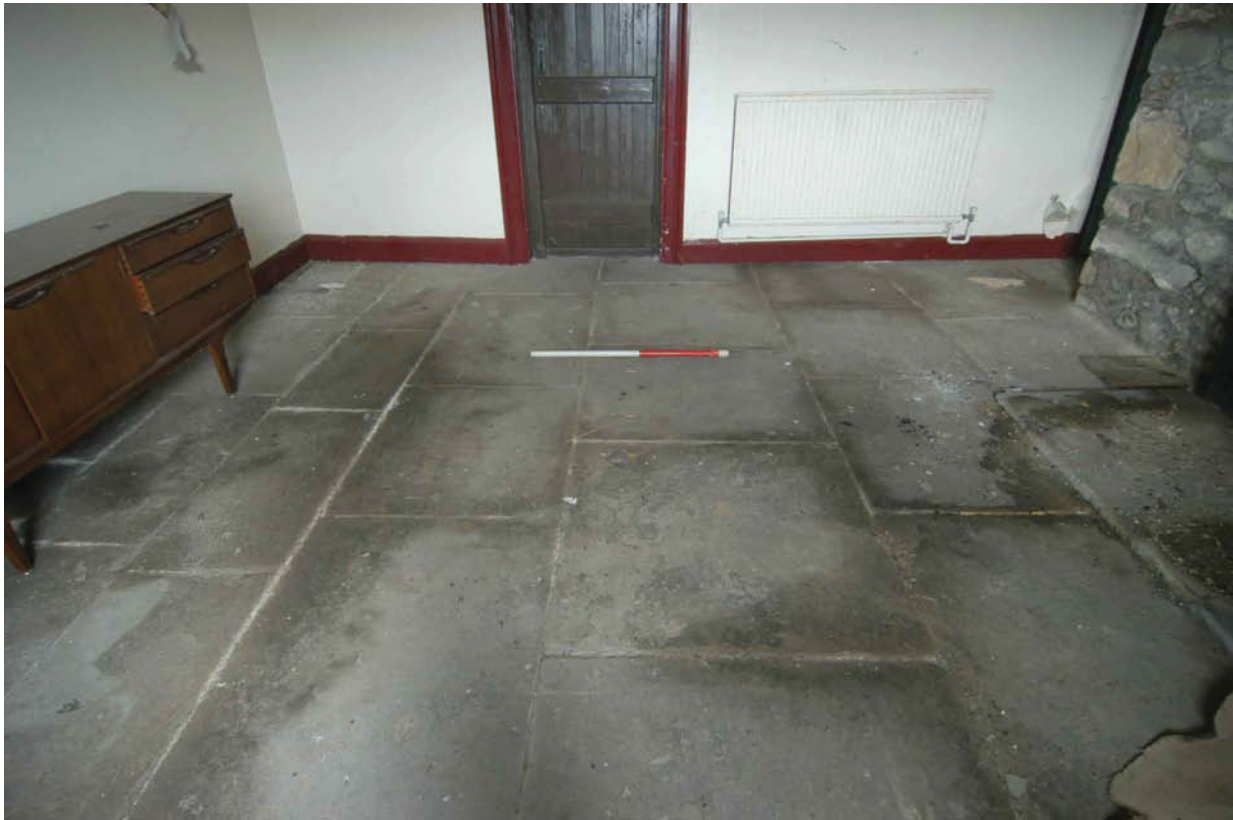
4.3 The main rubble-built core block of the cottage is probably early 19th century and has dressed quoins and window surrounds. During this period the cottage probably had a dormer roof. The fireplace and the flagstone floor in what is now the living room (Unit 1) appear to date to this phase. The flagstone floor continues into Unit 2, the boiler room, which earlier may have served as a pantry. The fire-place below the stair-case appears to be contemporary with this first phase and its presence strongly suggests that the present kitchen, was then either a bedroom or a parlour.

Plate 4 - Room 1, flagstone floor

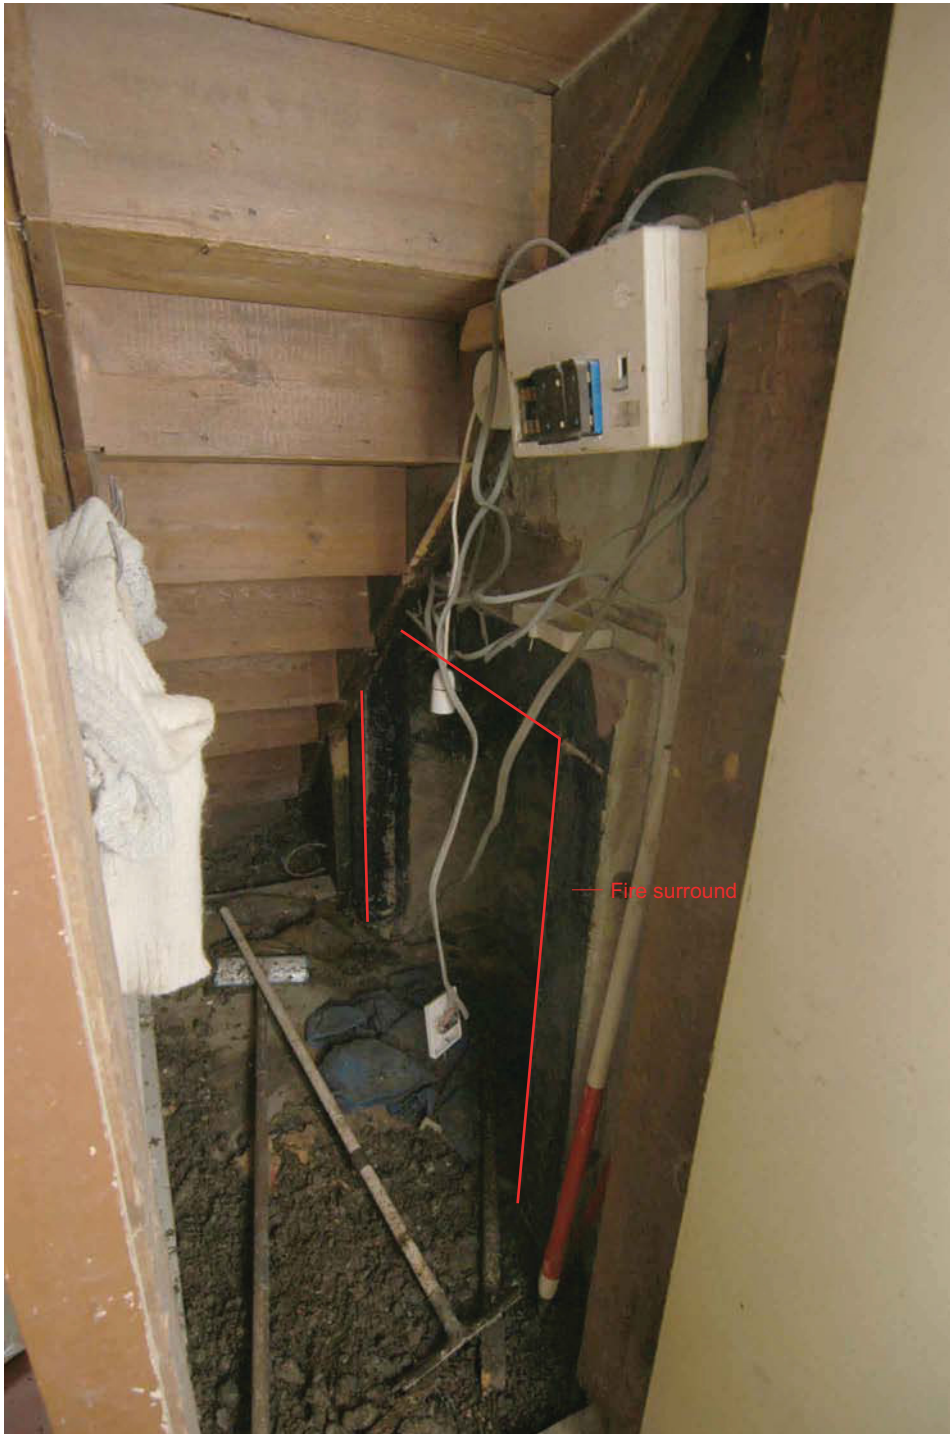
- 3.3.5 The kitchen is lit on the north-facing elevation by a PVC window. A stainless-steel sink unit occupies the wall. On the west-facing elevation modern kitchen units are present either side of a gas cooker with *New World Forty Two* logo.
- 3.3.6 On the west-facing elevation there is a very narrow staircase with a cupboard below. The staircase has 11 treads and is constructed of red-painted tongue-and-grooved planks with barley-twist balustrades. A plank-built cupboard door is present below the stair. Within the cupboard space situated on the west-facing elevation is a fire-place (Plate 5). The fire-place is stone-built and c 1m high and 0.9m high and it projects of the wall by about 0.1m. The wall surrounding the fireplace contains original lath and plaster. The south-facing elevation of the kitchen is featureless.

Plate 5 - Room 5 fireplace below the staircase
