July 2008

Commissioned by East Lothian Council

**Town House, Dunbar
Historic Standing Building Survey**

Report No. 1430

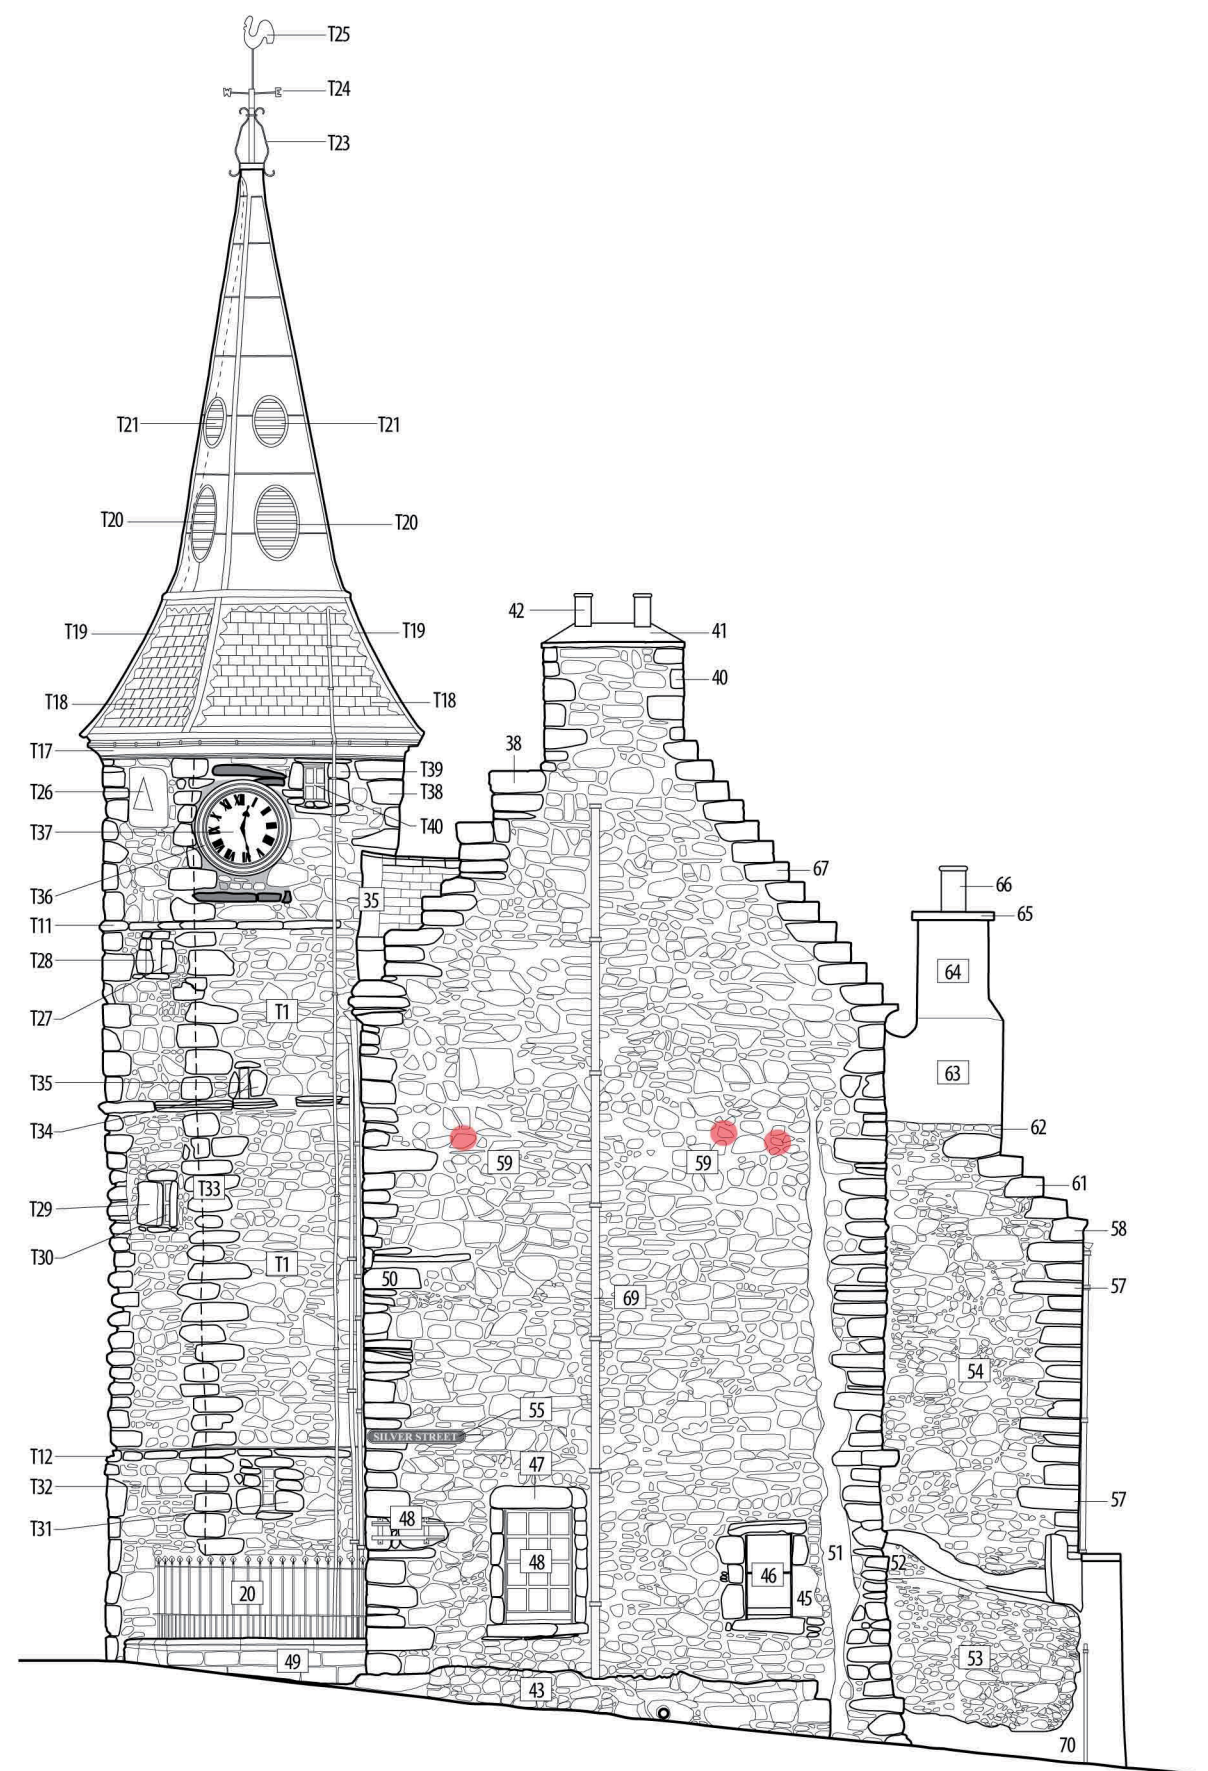
6a - South Facing Elevation

- 2.4.1 Three individual pieces of timber were found within the stonework of the south elevation (samples 1-3, positions are shown in red Fig 6a). The methodology employed in this programme of work is provided in Section 6.

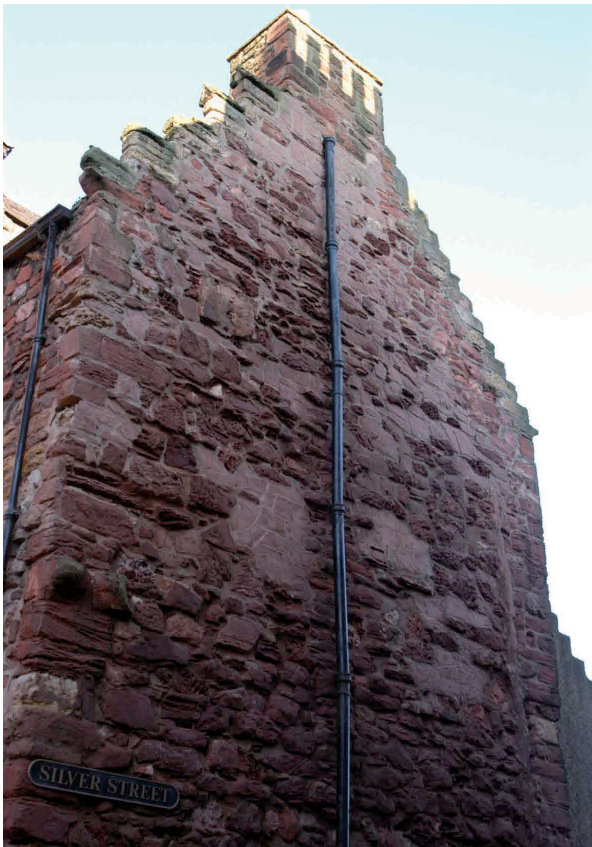
Plate 4 - South elevation, gable showing repair work

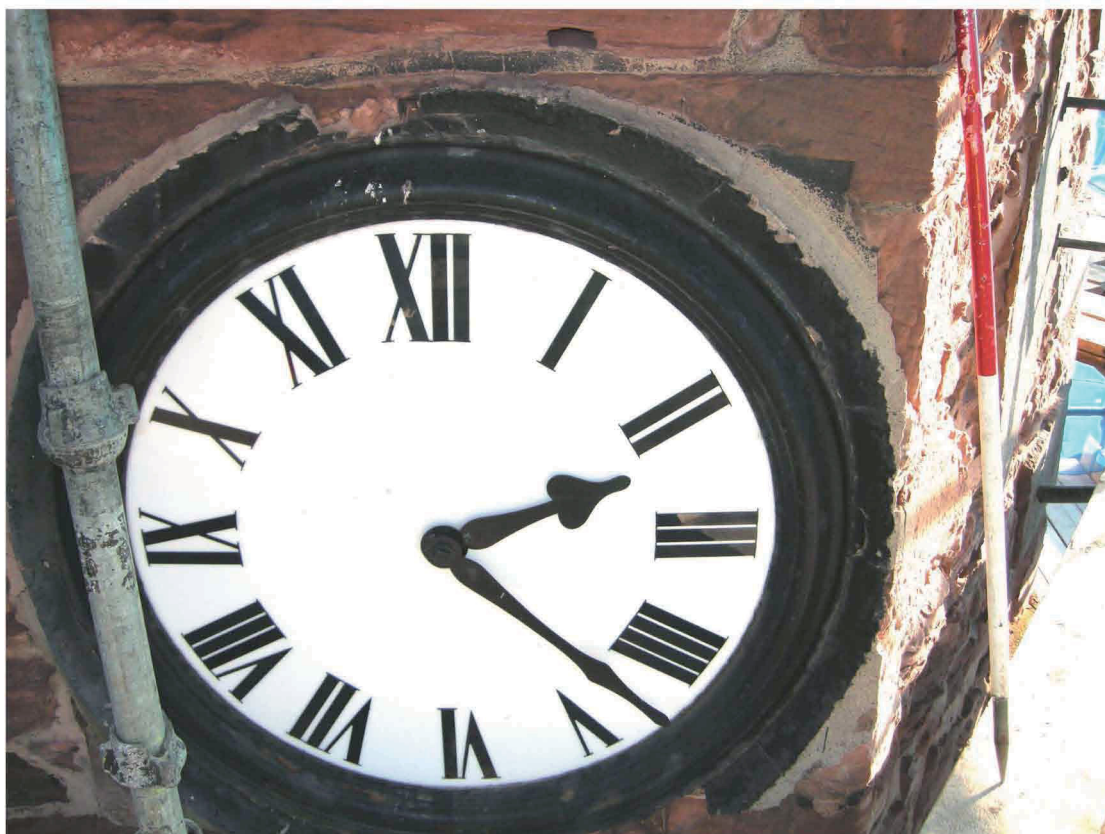
Plate 9 - North-facing elevation, clock face and cast-iron surround sat within an earlier clock surround

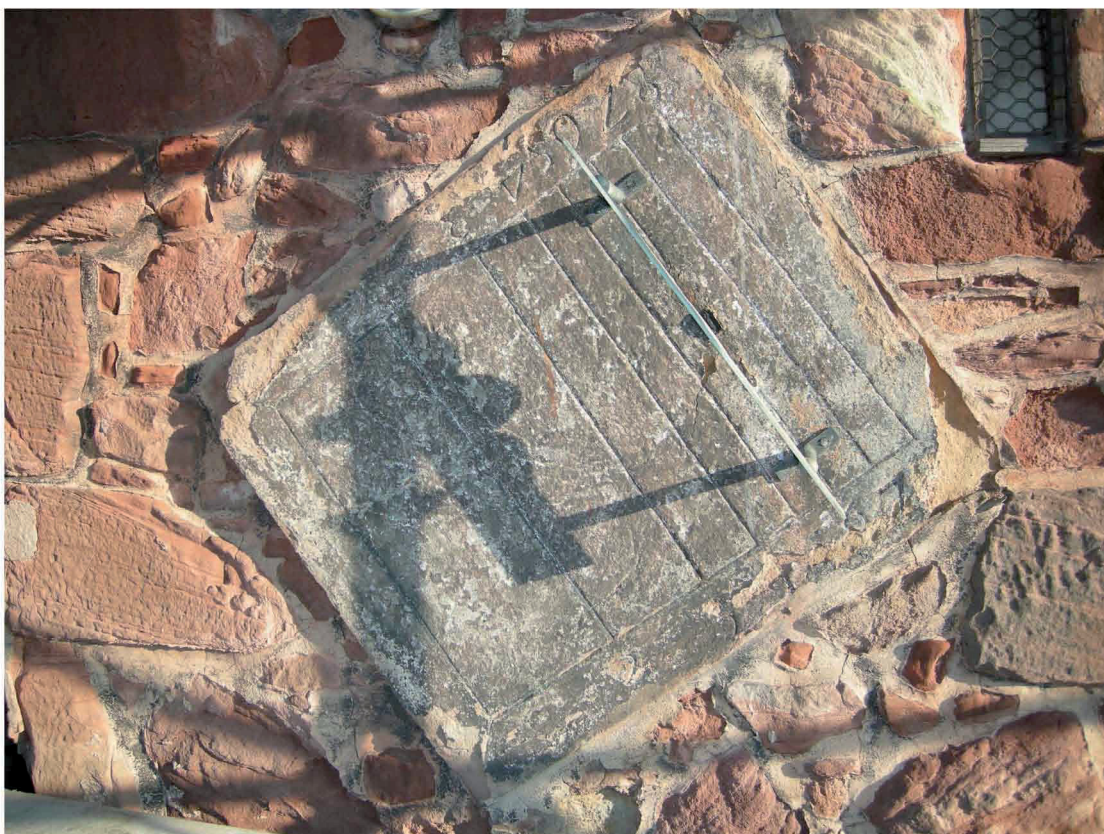
- 5.3.2 Two stone sundials (Plate 10-11) with copper and iron gnomons (T16 and T26) face north-west and south-west respectively. The north-west facing dial is the smaller of the two; it measures 0.80m by 0.60m and consists of a single slab of sandstone 0.06m thick. The copper gnomon is a replacement for an earlier iron blade of which only the impression of its hold-fasts survive. A border has been incised around the edge of the stone and vertical lines have corresponding numbers at each end (numbers 2-8). The top 3-8 numbers are upside down whilst the bottom set of numbers are correct. This appears to have been an error when the numbers were carved. The present copper gnomon is held in place by copper screws and appears to be of 19th- or 20th-century date.

Plate 10 - West-facing elevation, tower sundial, T16

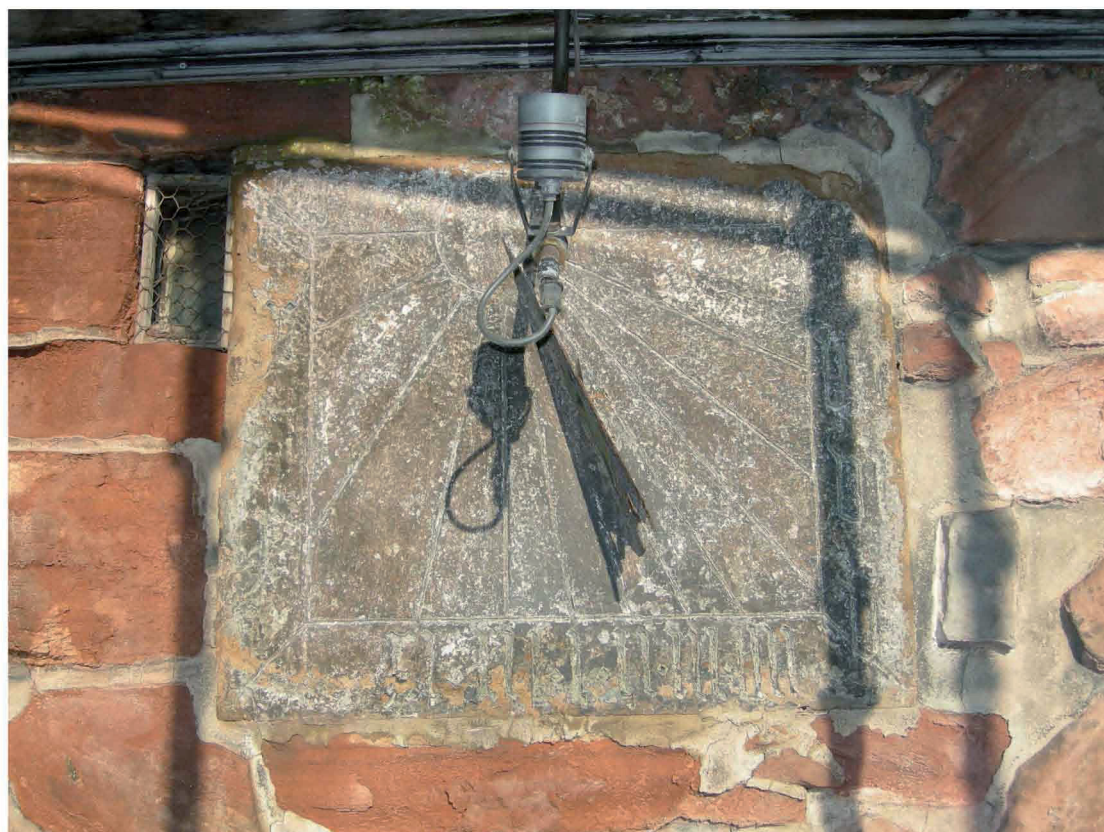
- 5.3.3 Measuring 0.90m by 0.76m the south-west facing dial has weathered badly. The numerals at the bottom and right hand side are eroding. The gnomon is iron and has been repaired using two copper plates. This feature has residues of gilding present on its surface. In the top left corner an incised circle is connected to radial lines pointing to the numerals. Its face was painted black, of which there are several layers. Presumably the face was painted so that the shadow cast by the dial could be read more easily, although it is difficult to see how the numbers could be seen from the ground.

Plate 11 - West-facing elevation, tower sundial, T17

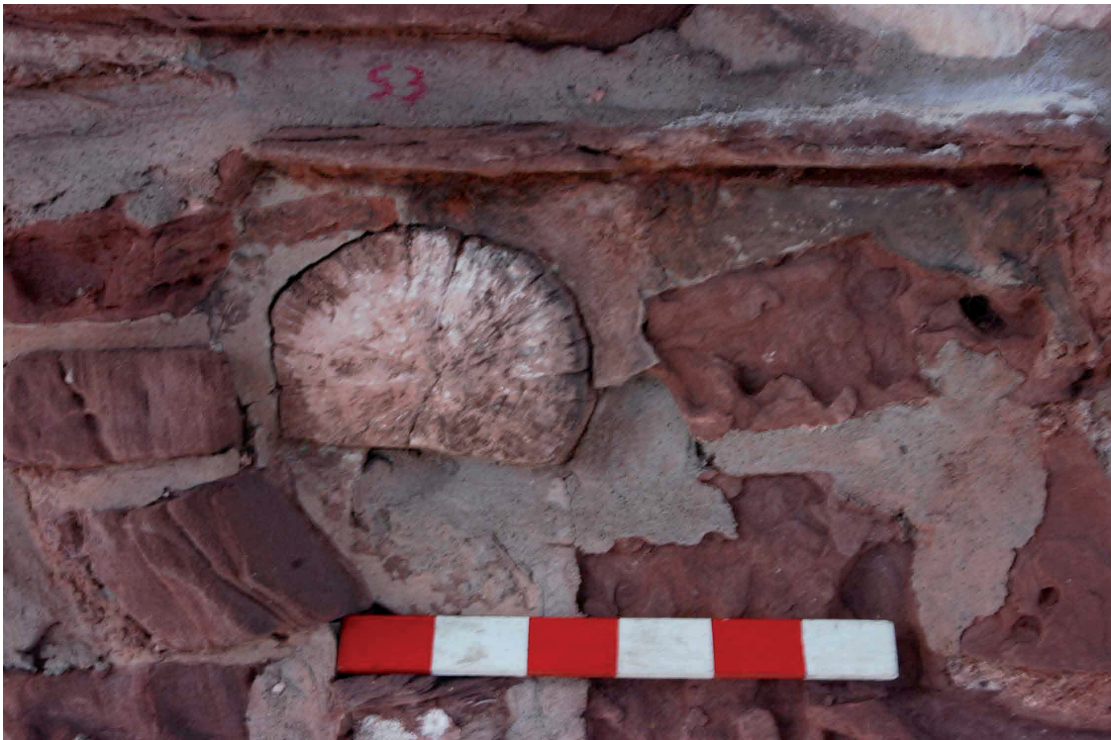
- 6.1 Three oak joists (Fig 6, Plate 13) retrieved from the south gable wall were submitted for dendrochronological analysis. The timbers were all squared heart baulks, the pith being present on all of them. The outer surfaces were heavily decayed and no sapwood had survived. However, on DTH3 the curvature of the outer surface indicates that this is on, or very near, the heartwood/sapwood boundary (h/s).
- 6.2 The surfaces were finely sanded to enhance the ring-pattern. The ring-pattern was measured using *Dendro for Windows* (Tyers 1999).
- 6.3 All three timbers produced relatively long, sensitive ring-patterns (Table 5).

Plate 13 - Dendrochronology sample S3 shown before sampling
