John Gray Centre, 52-54 High Street Haddington, East Lothian

Historic Building Recording & Archaeological Watching Brief Report No. 1942

CFA ARCHAEOLOGY LTD

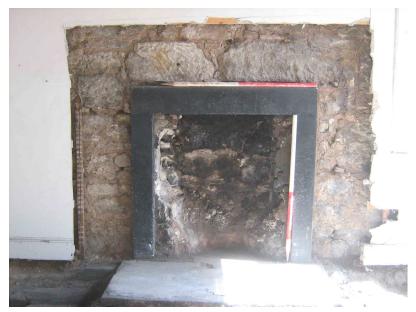
Fireplaces were recorded in Unit 25 on the ground floor (Figs. 2-3) and in Unit 38 on the first floor (Figs. 2, 4). Both are 19th-century in date. Figures 3 and 4 show the fireplaces after the removal of their surrounds. Formed from cast-iron, these were horse-shoe shaped and had a rope motif on their edges.

Fig. 3 - Fireplace in Unit 25 after removal of horseshoe surround

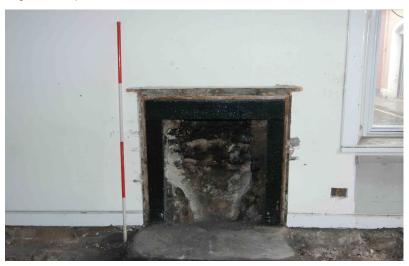
Fig. 4 - Fireplace in Unit 38 after removal of horseshoe surround

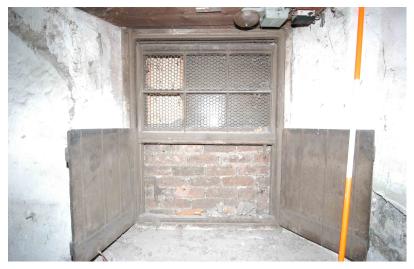
Following the removal of an internal staircase (Unit 19, Fig. 2), a mid-19th-century blocked window (Fig. 5) was also recorded. The window consisted of a modern 6-pane sash upper frame over a wooden shutter lower element. The window had been blocked using modern frogged bricks.

Fig. 5 - Blocked window in Unit 19 after removal of the staircase

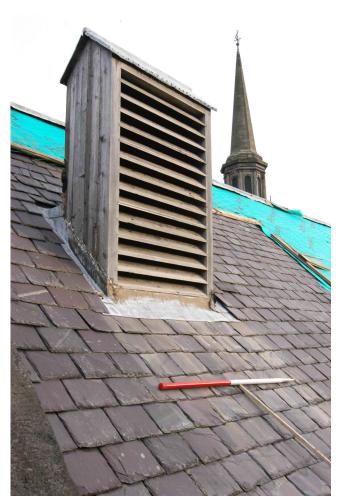
Scaffolding allowed access to the roof and this facilitated the recording of a wooden roof vent (Fig. 6) in the south-facing elevation. The structure had a height of c.1.3m and basal dimensions of c.0.75m by c.0.5m. Wooden louvres were fitted in the southern elevation.

Fig. 6 - Roof vent on the south-facing roof elevation

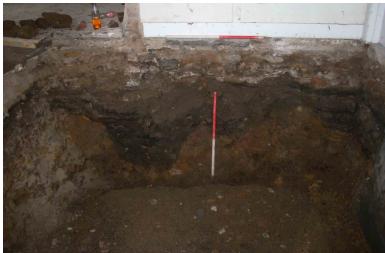
A pit measuring 6m by 3m in plan and 1.5m deep was excavated to accommodate the base of the lift mechanism on the ground floor in 52 High Street (Fig. 2). This revealed that natural subsoil was cut by a possible pit feature (029) which appeared in the south-facing section (Fig. 7). This had a width of 1.3m and a depth of 0.6m. It was filled with alternating bands of dark soil and sooty material (030). No finds were recovered. Deposits similar to the fill of the pit extended to the west (into the east-facing section). Two other possible features (031, 033) were recorded to the east of pit 029. Both were shallower and contained similar fills (032, 034).

Fig. 7 - Base of lift-shaft

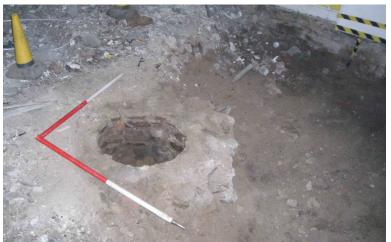
A well in Unit 47 was also recorded during a reduction in floor levels (Fig. 2). Circular at ground level, it had an internal diameter of 0.5m (Fig. 8) with a stone lining (001). Although access was not possible, an internal view (Fig. 9) shows that it widens and becomes more square with depth as far as the current water level, which was at a depth of c.2.4m from the surface. From this point a narrower sub-circular shaft was visible (003, Fig. 9). A modern metal pipe (002, Fig. 9) had been inserted into this well and may have been used to suck out water as required.

Fig. 8 - General view of the well

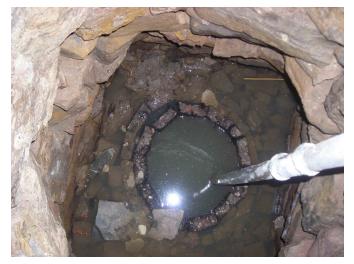
Fig. 9 - Vertical view into the well

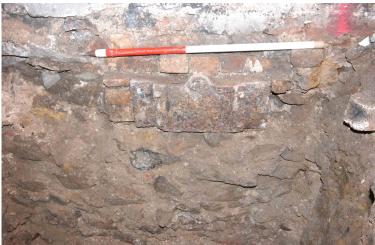
What may be the backing plate for a flue (044) was recorded set into an internal spine wall between Units 1 and 2 (Figs. 2, 10). Made of iron, this measured 0.6m by 0.3m. Four flange bolts held a cover and a hole had been formed in a rounded lobe in the upper edge. This may have been intended for lifting the cover. This feature may, along with the roof vent, be part of a system dating to the late 19th or early 20th century and may be associated with air circulation and/or the dissipation of explosive gasses in the Grain Store.

Fig. 10 - Iron cover for probable vent

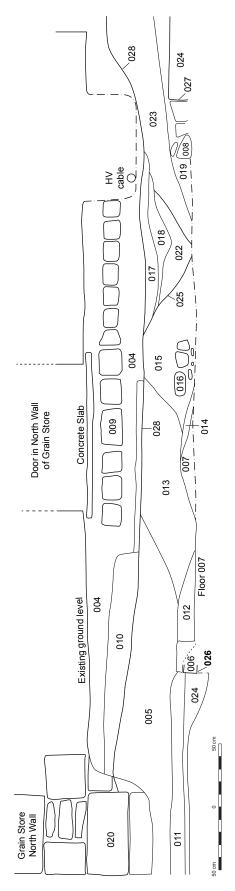
In the base of the trench, at a depth of 0.7m, two north/south aligned mortared walls (006, 008, Figs. 2, 10-11) were recorded. These were 4m apart. Both were cut (026, 027) into natural orange silty gravels (024). Wall 006 was 0.25m wide and 0.25m high. Wall 008 was 0.45m wide and 0.15m high. A deposit of grey-black highly micaceous silt (007) was present between these walls and this possible floor deposit contained iron slag, a nail and what may be iron plate with two sherds of 19th/20th-century stoneware pottery adhering to it.

Fig. 11 - North-facing section in utility trench to north of Grain Store

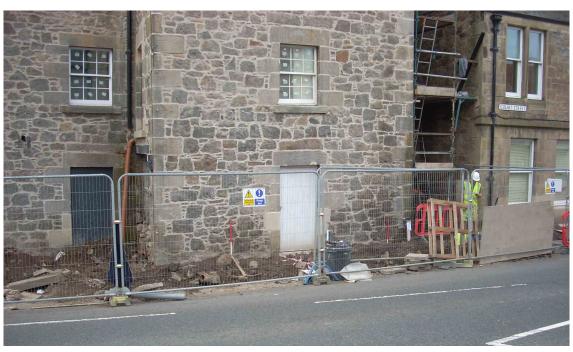
Fig. 12 - General view of the utility trench to the north of the Grain Store. The ranging rods mark the location of the walls 006, 008.
