Standing Building Survey & Archaeological recording at Old House Point, Nr Cairnryan, **Dumfries & Galloway**

Report No. 1731

CFA ARCHAEOLOGY LTD

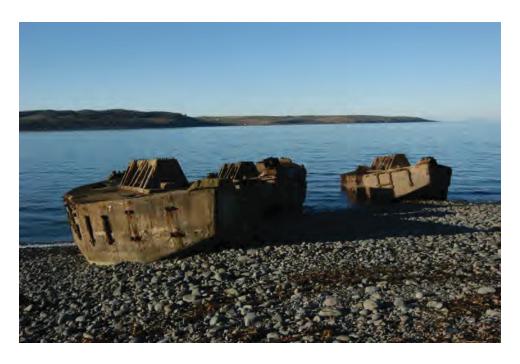
- 5.2.1 The remains of six concrete Beetle Craft are situated at the low water mark and are exposed at mean low water mark during ordinary spring tides during calm weather. Four of the craft are grouped together on the shoreline (Plate 11). This group included the single Beetle accessible at low tide which was subject to detailed survey. The other two craft are situated approximately 50m to the south, and are capsized and submerged hulks only exposed during low spring tides (Plate 12). All are in a very poor condition. The surveyed Beetle had been stripped of much of its iron deck fittings; however, these were still present on the most inaccessible Beetle, affording a visual and photographic appraisal from a distance.

Plate 11 - Four on the six Mulberry Harbour Beetle Craft exposed during low tide

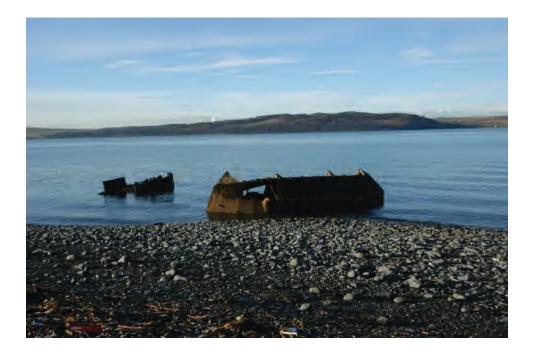
Plate 12 - Two capsized Beetle Craft

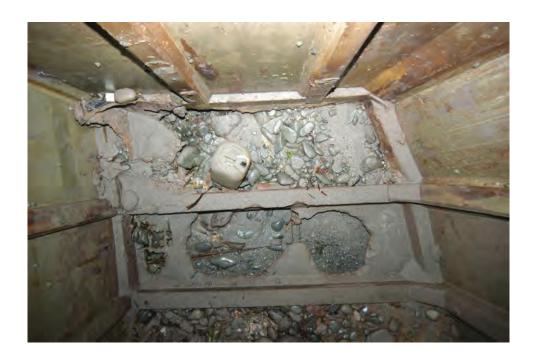
Plate 13 - View of internal bulkheads and floor

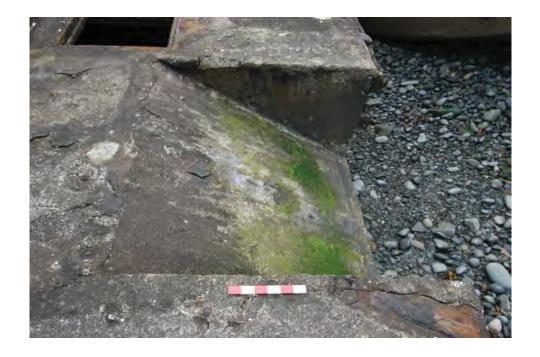
Plate 14 - Beetle Craft ramp detail

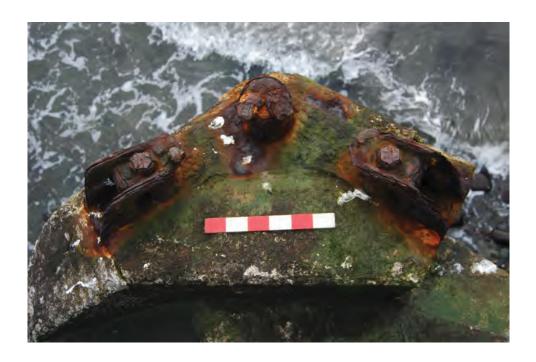
Plate 15 - Capston fittings detail on bow of Beetle Craft, 115

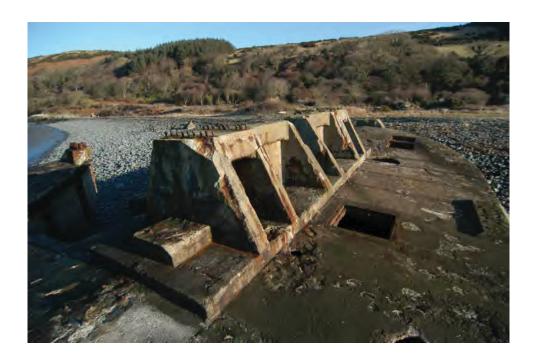
Plate 16 -Superstructure on deck of Beetle Craft, 110,111,112,114

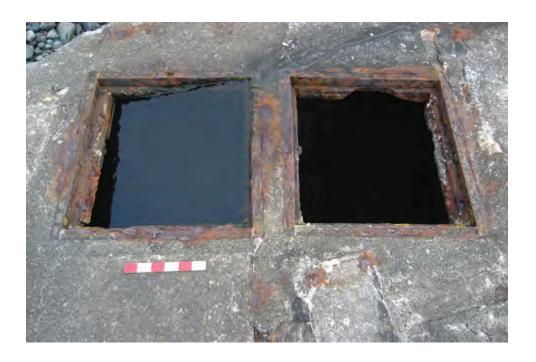
Plate 17 - Paired hatches, 103

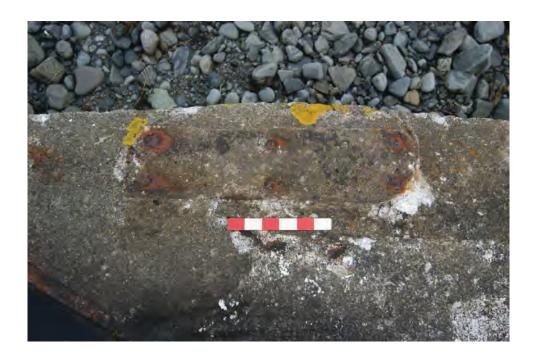
Plate 18 - Double capston mounting plate, 105

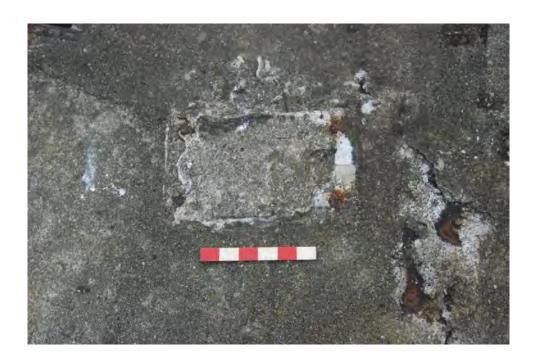
Plate 19 - Fixing plate, 104

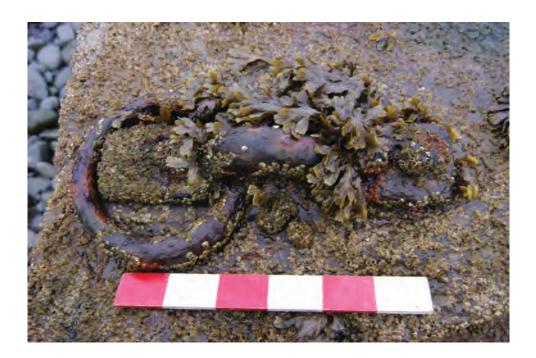
- 5.2.7 The robbed remains of 8 ring anchor brackets (107) were located in pairs at each corner of the deck. A single ring bracket is also present between the ramps (113) and visible on other craft but missing from the surveyed Beetle. The brackets were iron and measured 340mm by 82mm and were held by four hex-head bolts. An intact bracket and ring (Plate 20) survives on an adjacent craft; the bracket has a stapled arch holding the ring, which measures 210mm in diameter.

Plate 20 - Ring and holding plate, 107

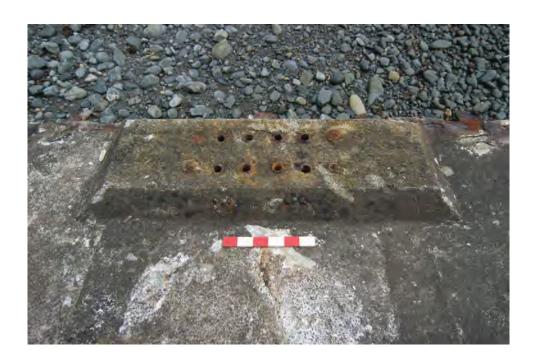
Plate 21 - Central mount, 108

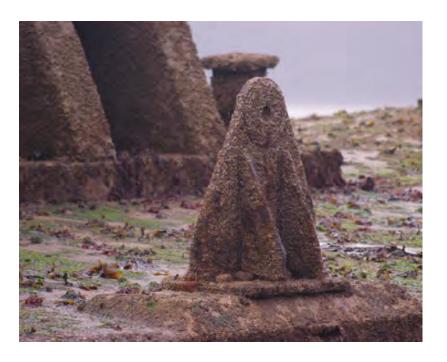
Plate 22 - Surviving central fitting on 108

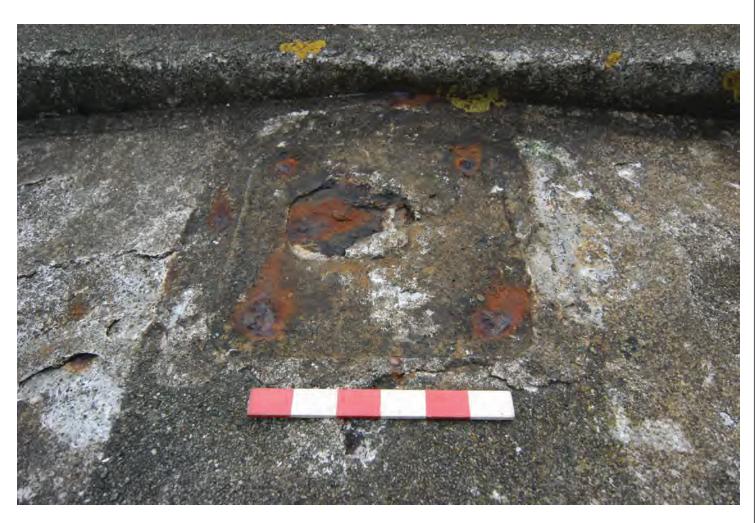
Plate 23 - Square capston plate, 109

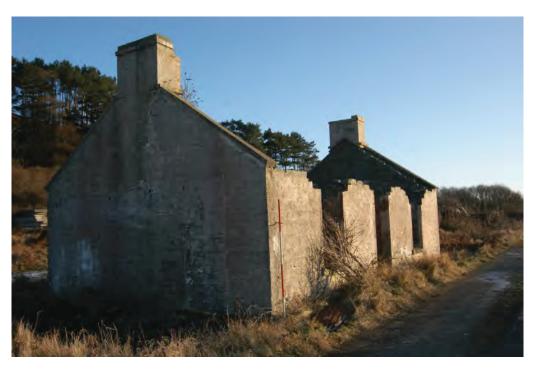
Plate 24 - Feature 4, North and West facing elevation of the cottage

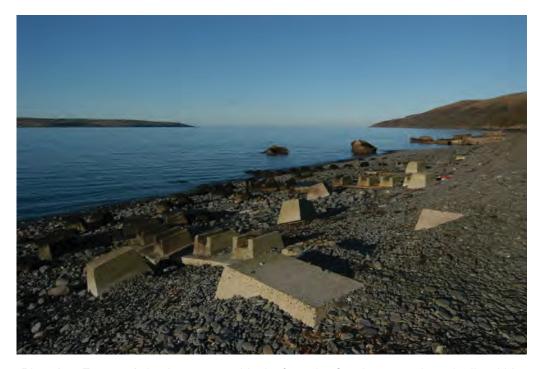
Plate 25 - Feature 2, in situ concrete blocks from the Spud pontoon launch slip within the inter-tidal zone

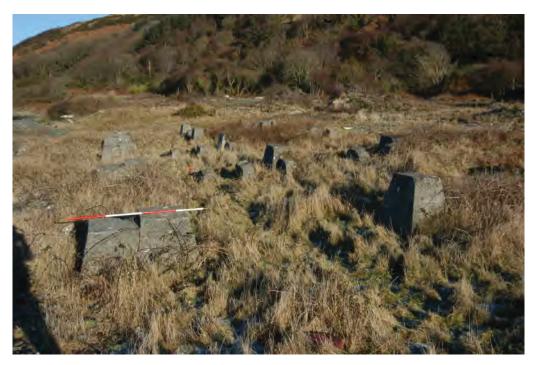
Plate 26 - Feature 2, in situ concrete blocks that supported the Spud pontoon during fabrication

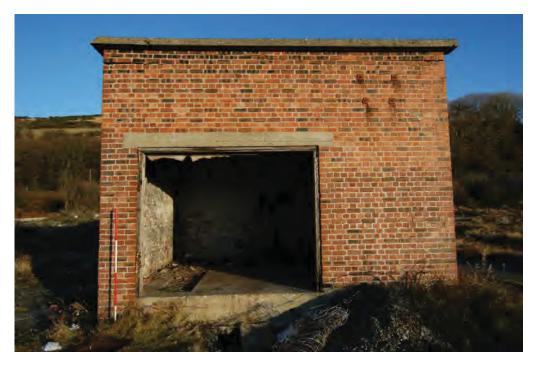
Plate 27 - Feature 3, West facing elevation of the brick built transformer block

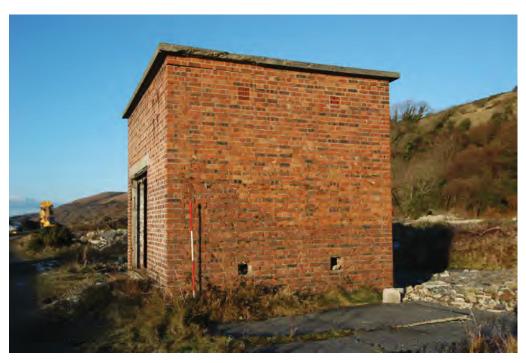
Plate 28 - Feature 3, South West facing elevation of the brick built transformer block

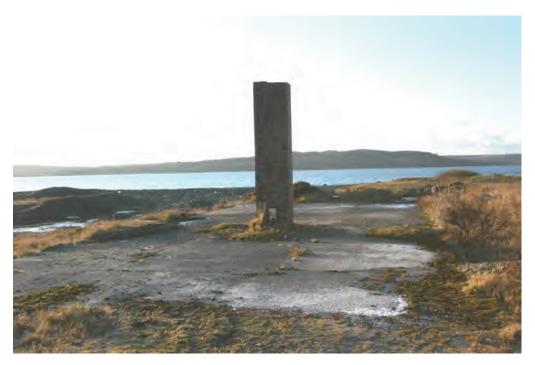
Plate 29 - Feature 7, the former mess-hut chimney and floor

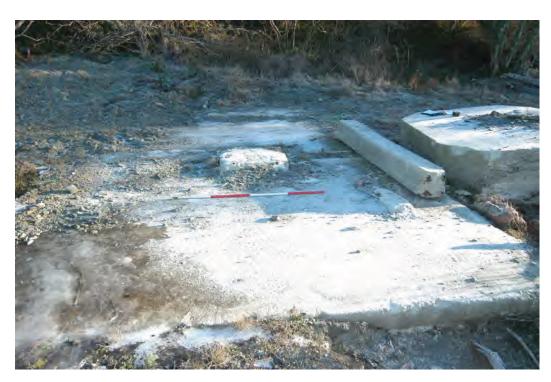
Plate 30 - Feature 12, building foundations and engine plinth

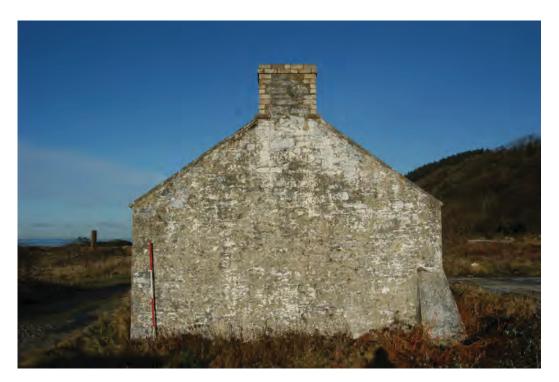
- External south-facing elevation (Plate 31)
- 5.5.6 The south elevation forms a pitched gable 5.65m wide and 4.5m high. It is rendered and whitewashed with stone ridge copings (4/9). The chimney stack (4/10) is stone built with brick repairs to the margins. Feature 4/1, a re-used ?trigonometry point, forms a buttress on the right hand side of the gable.

Plate 31- Feature 7, South facing elevation of of the cottage

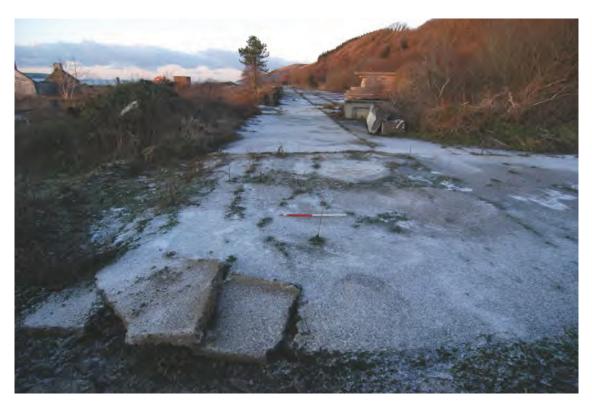
Plate 32 - Feature 9, concrete casting bed looking north

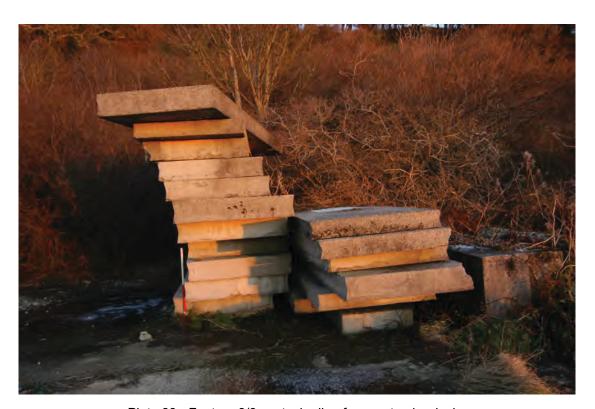
Plate 33 - Feature 9/3, a stock-pile of concrete pier decks

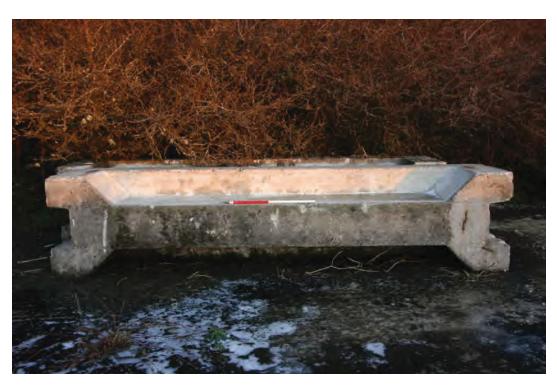
Plate 34 - Feature 9/4, a pair of concrete pier stanchions

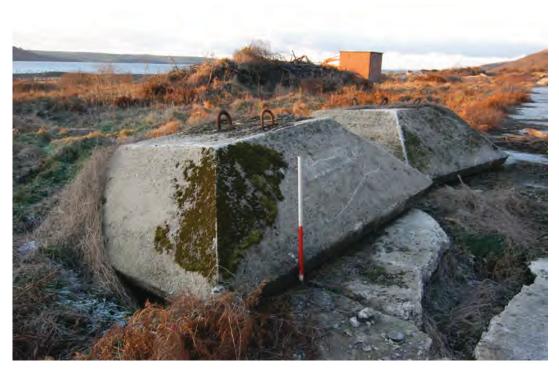
Plate 35 - Feature 8/4, a pair of concrete anchor blocks

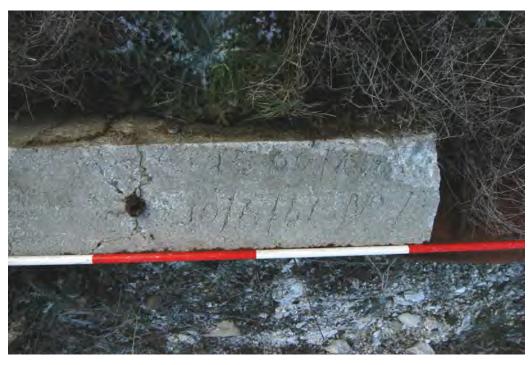
Plate 36 - Feature 10, discarded pier pile with the inscription 1500/1600 10/6/41 No.1

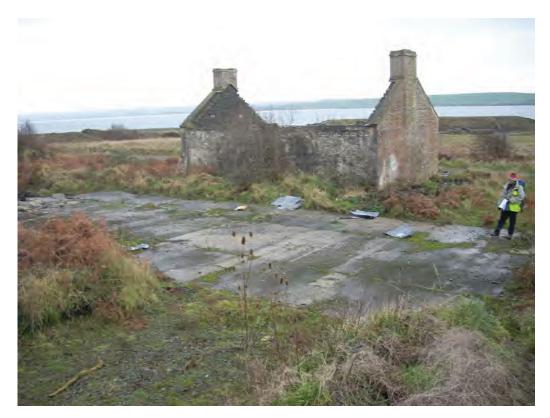
Plate 37 - Feature 20, concrete building foundations

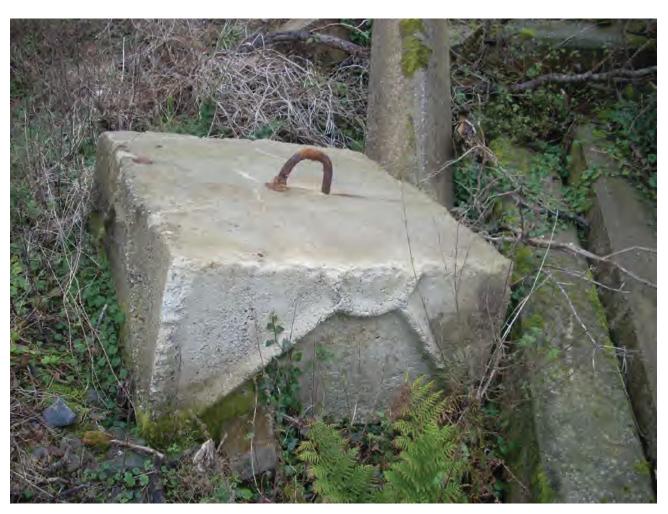
Plate 38 - Feature 22, concrete ballast block
