Mill Wynd, East Linton Historic Building Appraisal

Report No. 1821

**Mill Wynd, East Linton
Historic Building Appraisal
Report No. 1821**

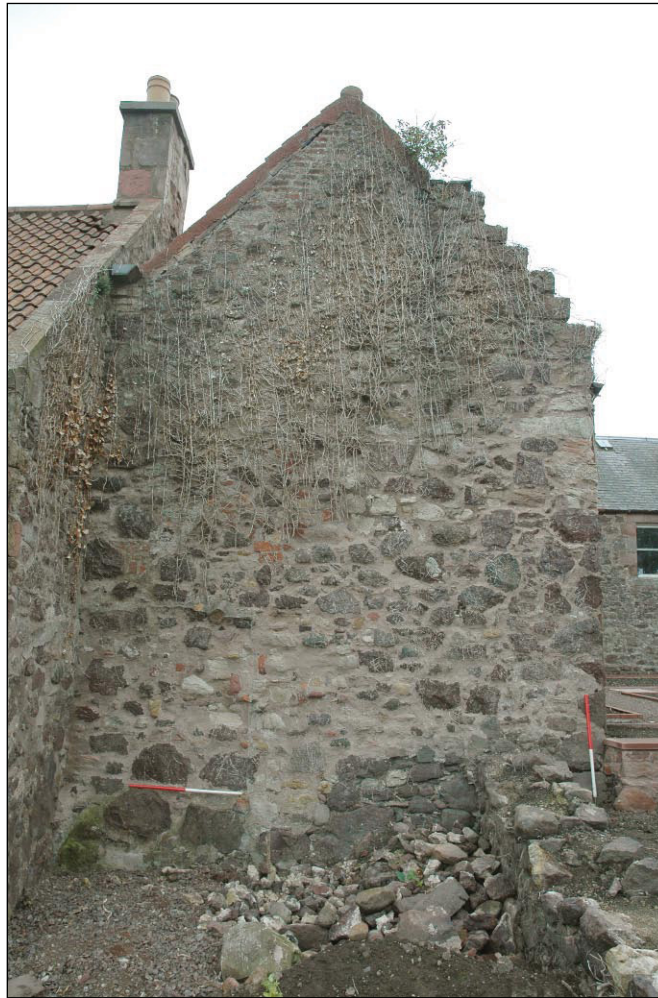
Context No.	Description	Summary	Dimensions (m)	Photo No.
14	Main build (Plate 1)	Random rubble coursed, mortar bonded and founded on large boulders.	4.7 x 8 (max)	15
15	Stepped roof on north side of roof (Plates 1 & 2)	Stepped sandstone skews leading to chimney (13)		16
16	Brick and stone repair to south side of gable end (Plates 1 & 2)	The upper section of the north side, the south side, and the apex of the roof takes the form of a standard pitched roof, not crow stepped like the lower part of the north side of the roof. This change in construction technique appears to be a later alteration as the new section has been built up with random rubble and bricks. .		15, 16, 19
17	Lean-to raggie (Plate 1)	Mortar raggie of former lean-to visible on lower left side of wall, and visible on wall of adjoining cottage.	1.6 x 2.3	17, 18
18	Garden wall (Plate 1)	Foundations of sandstone rubble wall in poor condition	4.5 x 0.6	15, 19

3.2.4 The east elevation forms the gable end and forms a corner with the gable of the cottage at No. 3. The former lean-to was probably a temporary structure. There has been some significant alteration of this gable end as only part of the original crow stepped gable (15) survives, the rest having been remodelled at some point, possibly in the recent past, to remove the steps.

Plate 1:
Eastern elevation gable

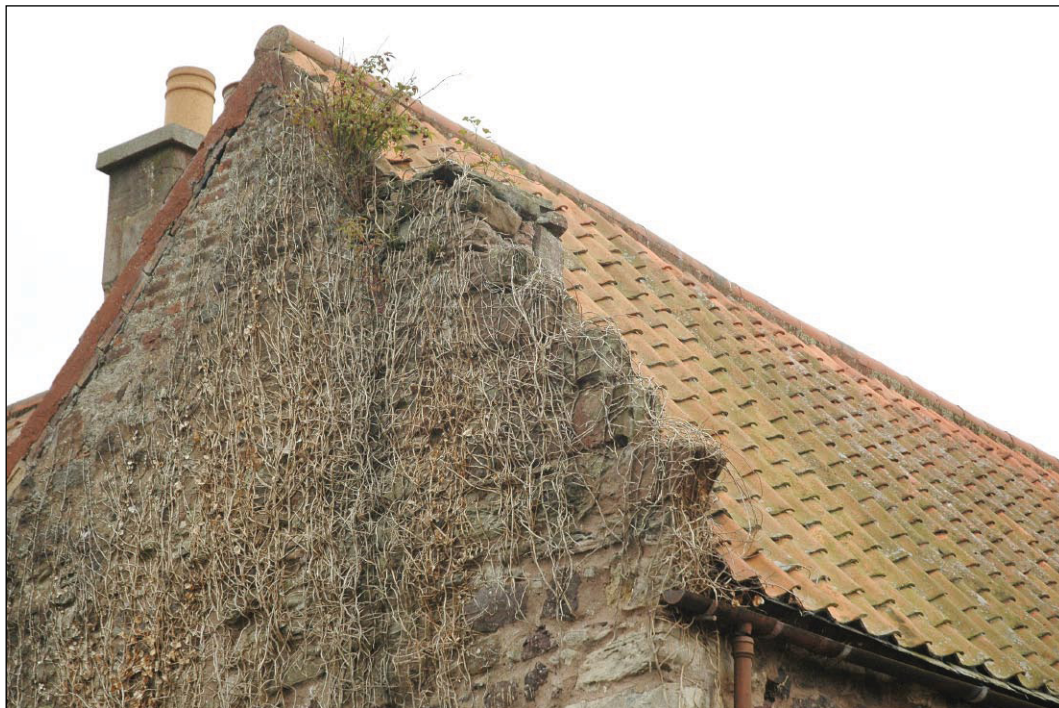
Plate 2: Detail of crow-step gable

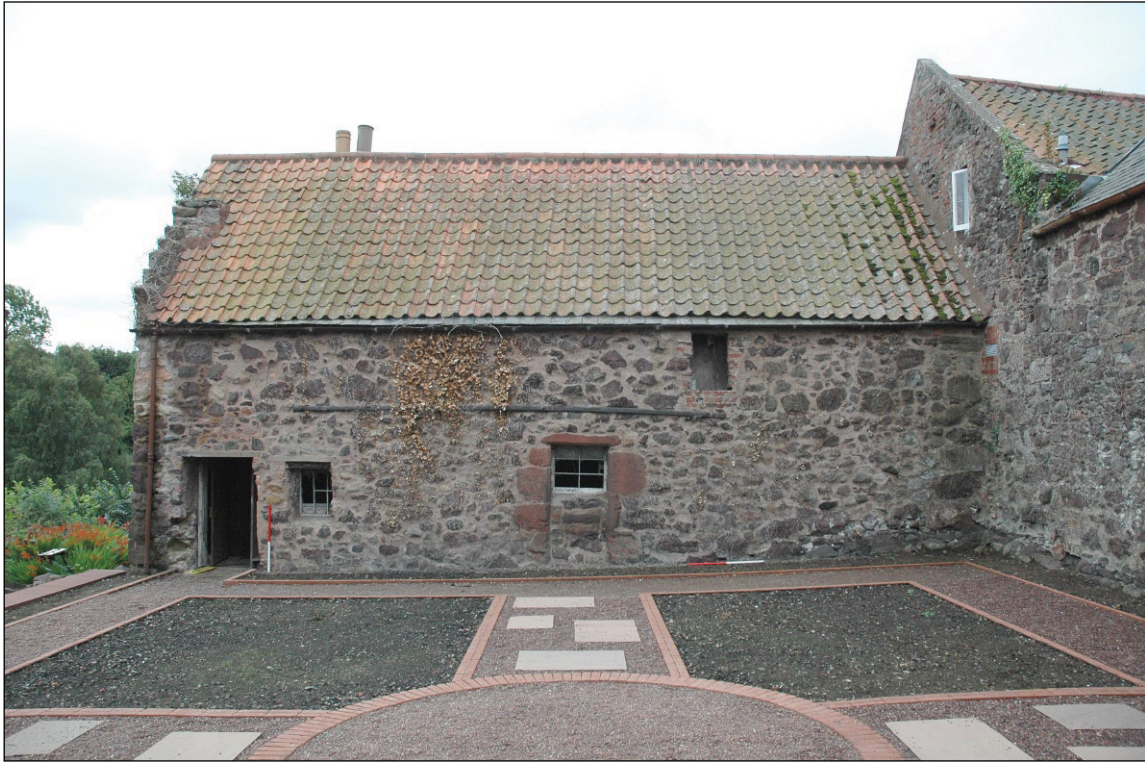
Context No.	Description	Summary	Dimensions (m)	Photo No.
7	Main build (Plate 3)	Random rubble coursed local dark red and grey sandstone, mortar bonded. Founded on large rough boulders at the base with roughly hewn quoins at its east end.	12.5 x 6.5 (max)	9
8	Doorway at east end of elevation (Plate 4)	Surround in poor condition, edges partly eroded or damaged and repaired with mortar, cement and brick. Replacement concrete lintel.	1 x 1.65	10-11,
9	Window at ground floor level (Plate 4)	Angled surround with remains of a timber framed 6 pane window. Replacement concrete lintel	0.65 x 0.9	10-11
10	Partially blocked doorway in	Red sandstone quoins which are chamfered, and red sandstone lintel. Lower half blocked with mortared	0.76 x 1.65	12

3.2.3 The north elevation forms the back of the building and faces onto the garden. It forms a right angle with the house at No. 4, and appears to abut it although brick repairs to the east facing elevation of No. 4 and extensive filleting and repointing make this relationship unclear. The wall has a marked outward lean which is supported by the tie-bar (12). The entrance door (8) located to the east is most likely a later addition, as is the small square window (9) to the right of the doorway. The partially blocked central doorway (10) is probably the original entrance to the barn. The small window (11) under the eaves at the top of the wall would have been a loft window.

Plate 3: Northern external elevation

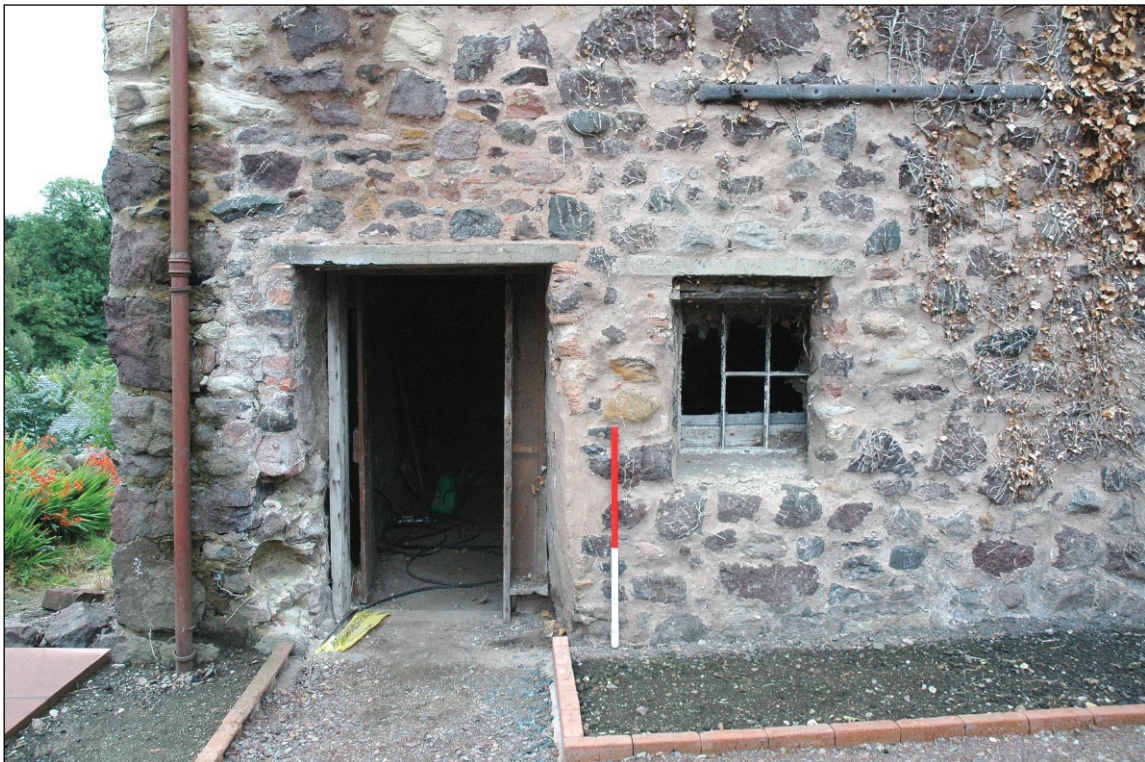
Plate 4: Detail of door and window on northern elevation

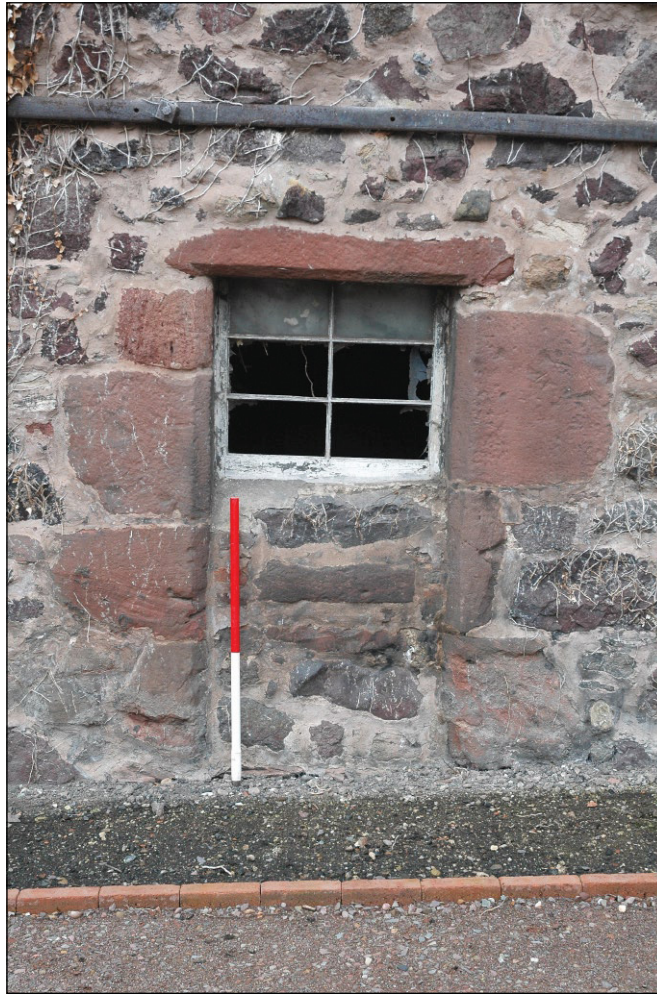
the middle of elevation (Plate 5)	sandstone. Upper half fitted with 6-paned timber framed window		
11	Window at loft level (Plate 6)	Brick framed with concrete lintel.	0.5 x 0.8	13
12	Iron tie bar (Plates 3-6)	Runs most of the length of elevation, fixed with square-headed bolts	6.5 long	9, 10, 12, 13

Plate 5:
Detail of blocked door on
northern elevation

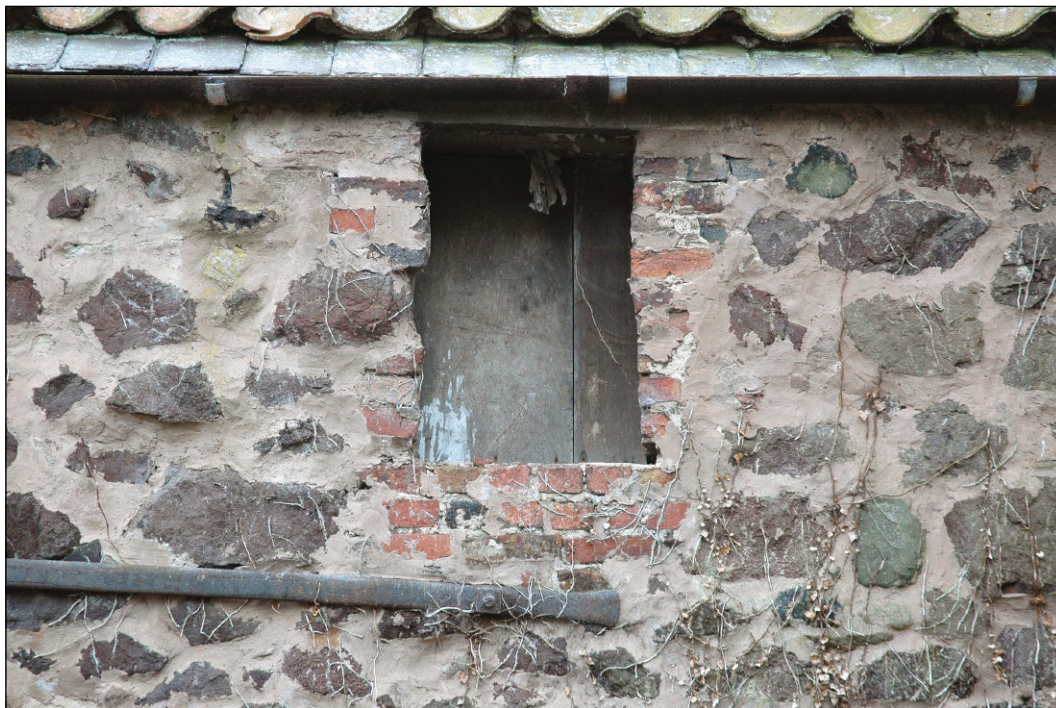
Plate 6: Detail of upper window on northern elevation

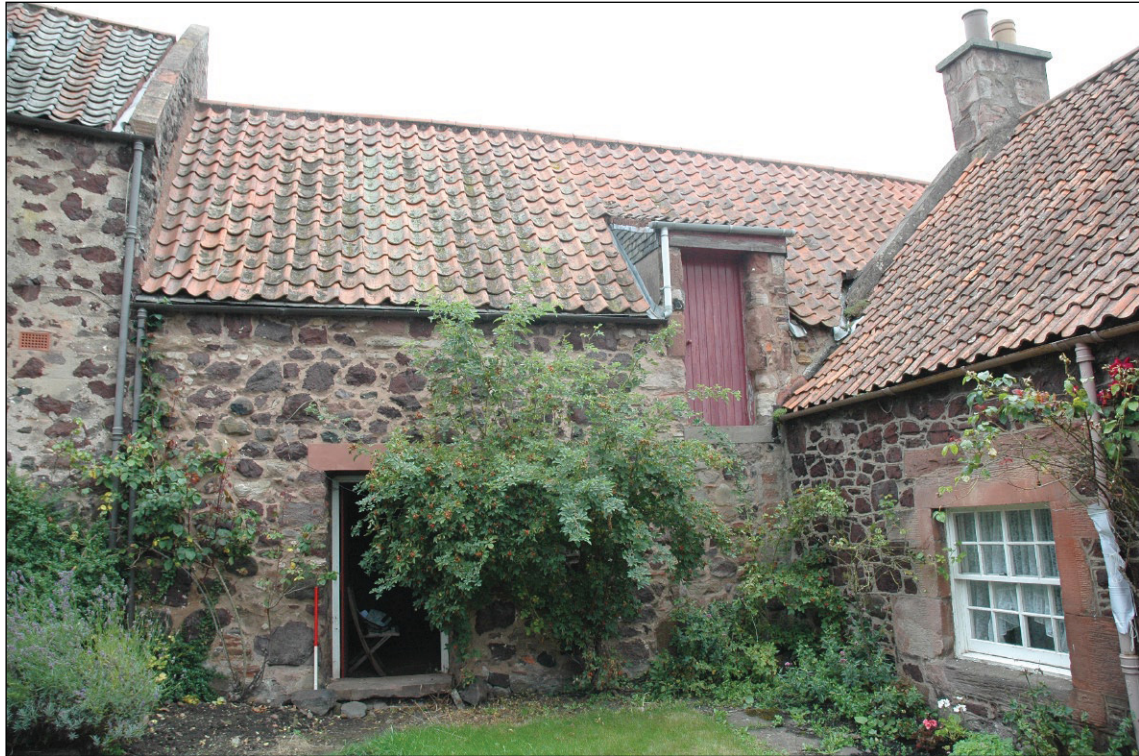
Context No.	Description	Summary	Dimensions (m)	Photo No.
1	Main build (Plate 7)	Random rubble coursed local dark red and grey sandstone, mortar bonded and repointed	6.3 x 6.5 (max)	1-3
2	Doorway (Plate 8)	Framed by rough-hewn quoins, detached red sandstone threshold and more recent replacement red sandstone lintel. Door is tongue and groove and set in a timber frame.	1.2 x 1.9	4
3	Pitching door (Plate 9)	Set under a cat-slide roof. Rough red sandstone quoins and a replacement cement sill. Door is tongue and groove and set in a timber frame.	1 x 1.8	5-6
4	Blocked doorway	Faintly traceable below the pitching door (3), blocked with mortared sandstone rubble and repointed. Hidden behind large climbing rosebush. Internally this is numbered as (27).	1 x 1.9	1-3
5	Iron tie-bolts	Two visible square headed bolts, one fixing an iron bracket.		7-8

3.2.2 The south elevation forms the front of the building and extends from the house at No. 4 Mill Wynd. The blocked doorway (4) is likely to be an original entrance. The current main door (2) may be a later addition.

Plate 7: Southern external elevation

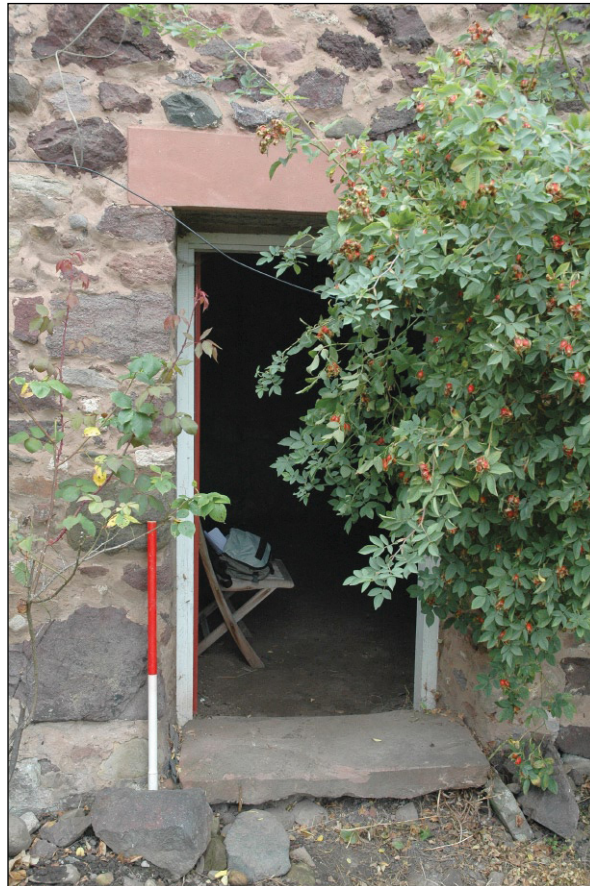
Plate 8:
Detail of doorway on
southern elevation

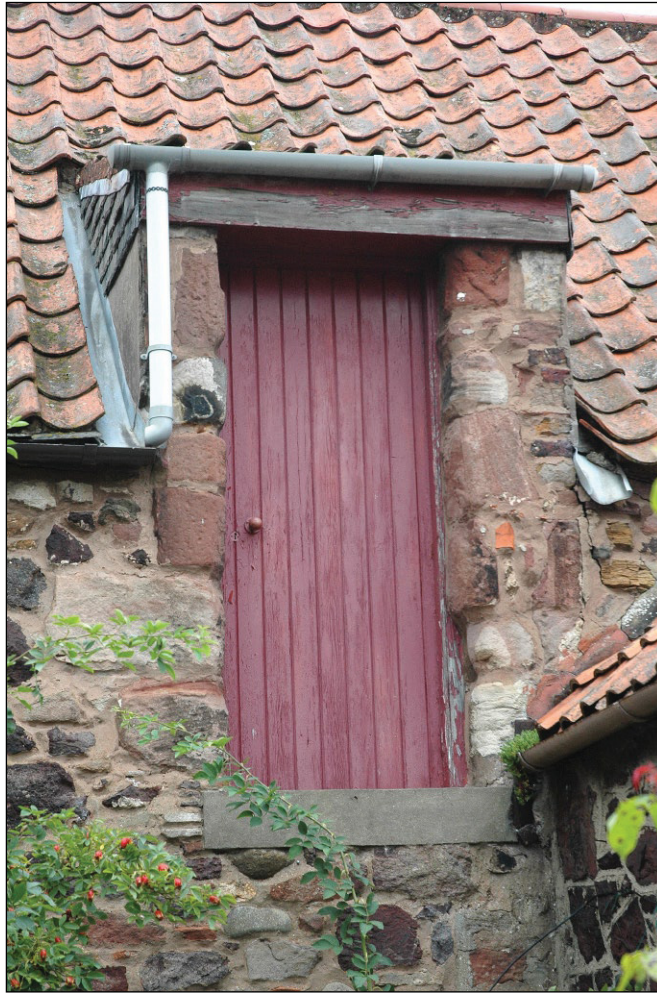
Plate 9:
Detail of upper doorway
on southern elevation

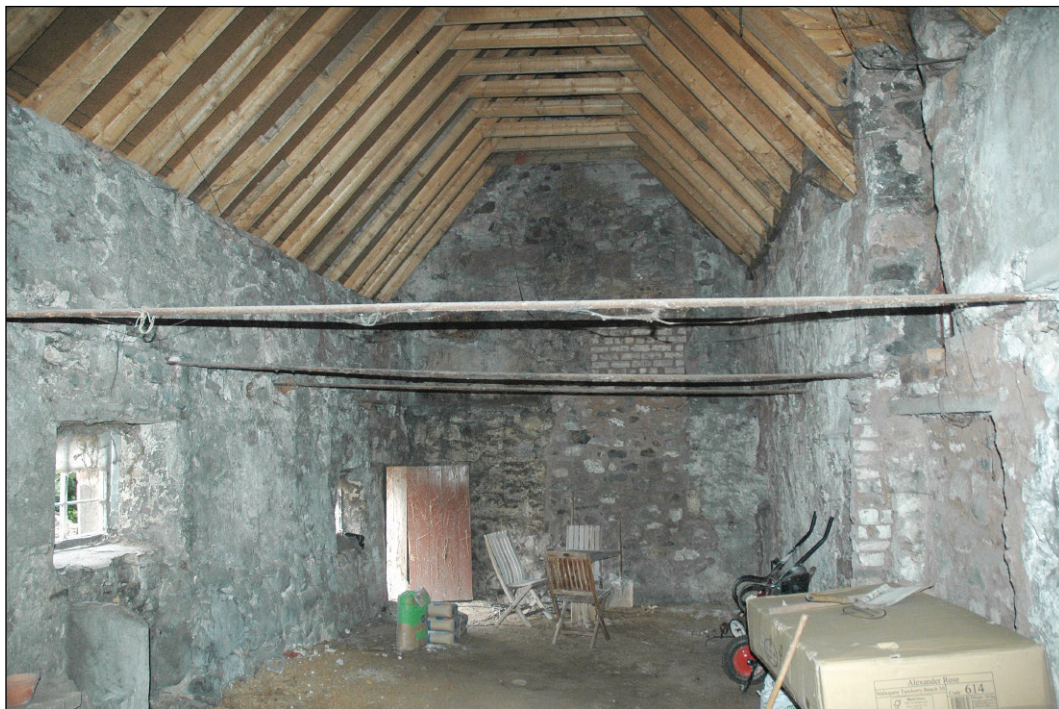
3.2.6 The interior comprises a single room with a beaten earth floor and a replacement timber A-frame roof. Three iron tie rods cross the building at c. mid-height, attached to the exterior tie bolts and bar. The floor has a square concrete surface (40) at its west end. A timber batten and stone block (42) set in a 'T' are set centrally in the floor.

Plate 10: General internal view of eastern elevation

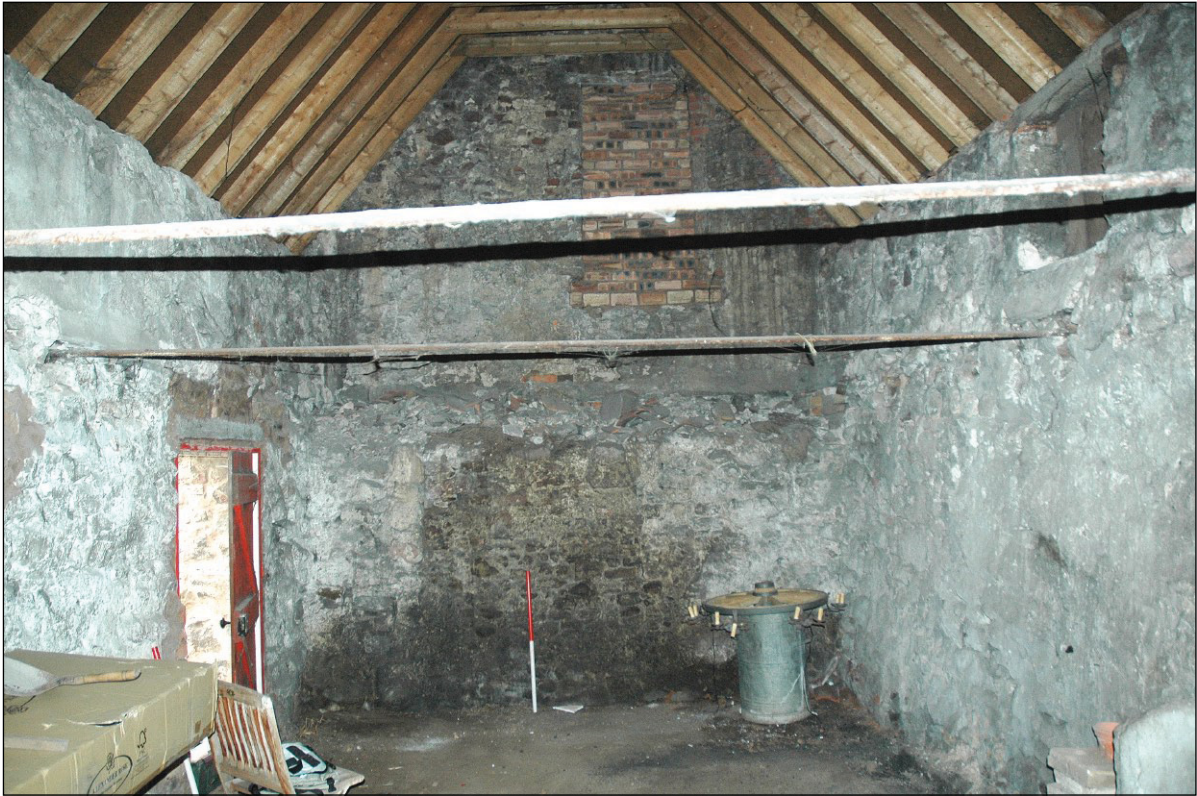
Context No.	Description	Summary	Dimensions (m)	Photo No.
34	Elevated later wall of No 4 Mill Wynd	Random rubble coursed sandstone and white washed. This is the gable wall of No. 4 which has been built on to the back of the original barn wall		29-33
35	Main build	This is the main wall of the barn which has been reduced to loft floor level during the construction of No 4 Mill Wynd.	2.1 high	29-33
36	Blocked Door	Blocked opening off centre in the gable wall to the height of the loft floor.	1.1 x 2.1m	36-38,
37	Blocked window or door	Set high on the wall within the former loft space. Has a replacement brick sill and is blocked with bricks.		53

3.2.9 The west elevation adjoins the side of the cottage at 4 Mill Wynd. The gable wall of the barn (35) appears to have been demolished to the level of the loft floor and the gable wall of No. 4 (34) appears to then have been built on to the back of it. A tall bricked up window or door (37) is present within the gable wall of No. 4 and would have connected No. 4 with the loft of the barn but not at floor level. It would be unusual for this feature to be a window if the proposed phasing is correct and it is more likely to be a connecting door that was served by a short set of wooden steps. A blocked opening is present just off centre on the gable wall of the barn (35). This is likely to be an original door and the block work survives at least to the top of the surviving gable of the barn.

Plate 11: Western internal elevation

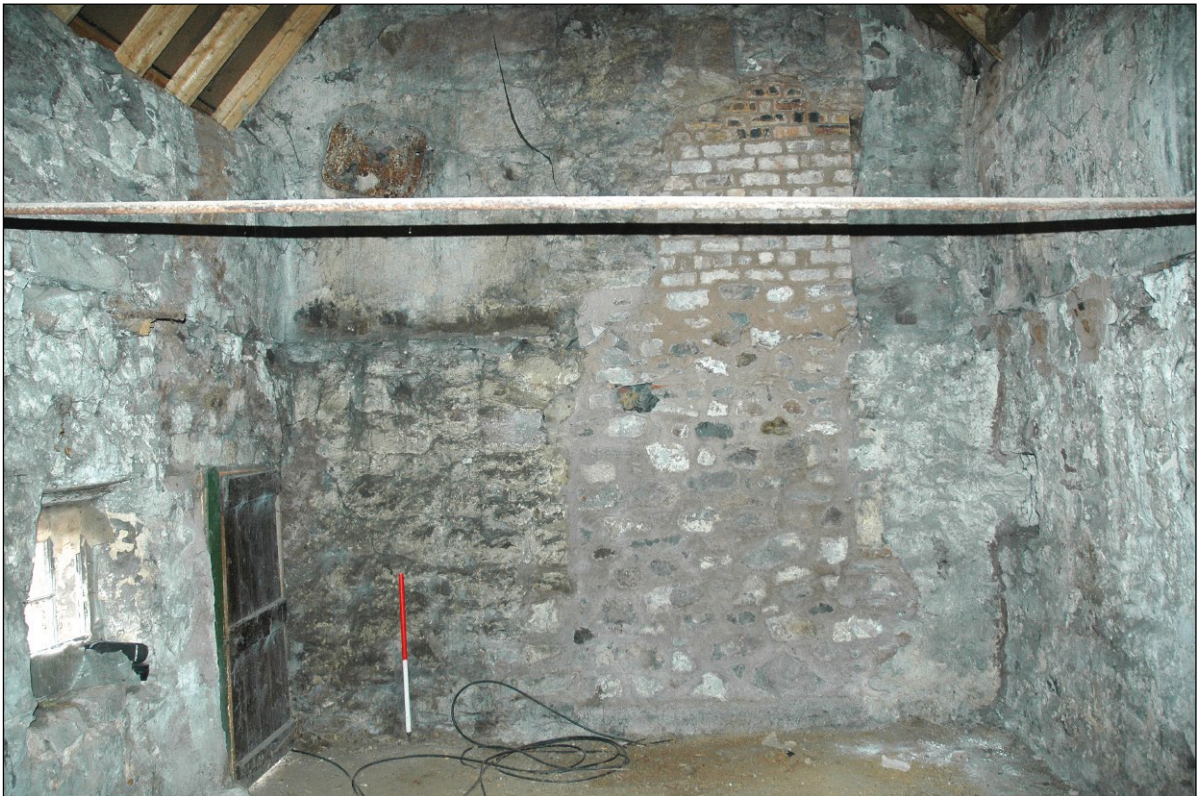
Context No.	Description	Summary	Dimensions (m)	Photo No.
19	Main build	Random rubble coursed sandstone thinly rendered and whitewashed.		21-26
20	Blocked fireplace	Situated in the centre of the wall, blocked with mortar bonded rubble and tile and repointed with cement.	1.3 x 2	21-26
21	Chimney breast	Stands above the fireplace (20). Merges with main build of wall and partly rendered and whitewashed. Partly built from brick and stands proud of the wall, may be a repair.		21-26, 42, 62
22	Cement Fillet	Cement fillet marks the loft floor level, with render and whitewash above.		21-26
23	Iron tie plate	Large rectangular iron tie plate fixed to wall beneath chimney exit. May be a reinforcing plate following a repair.		21-26, 41

3.2.7 The east elevation comprises the interior gable at the east end of the barn. Evidence of the level of the upper floor is clearly visible (22). The ground floor fireplace (20) and chimney breast above (21) show signs of extensive rebuilding and repair.

Plate 12: Eastern internal elevation

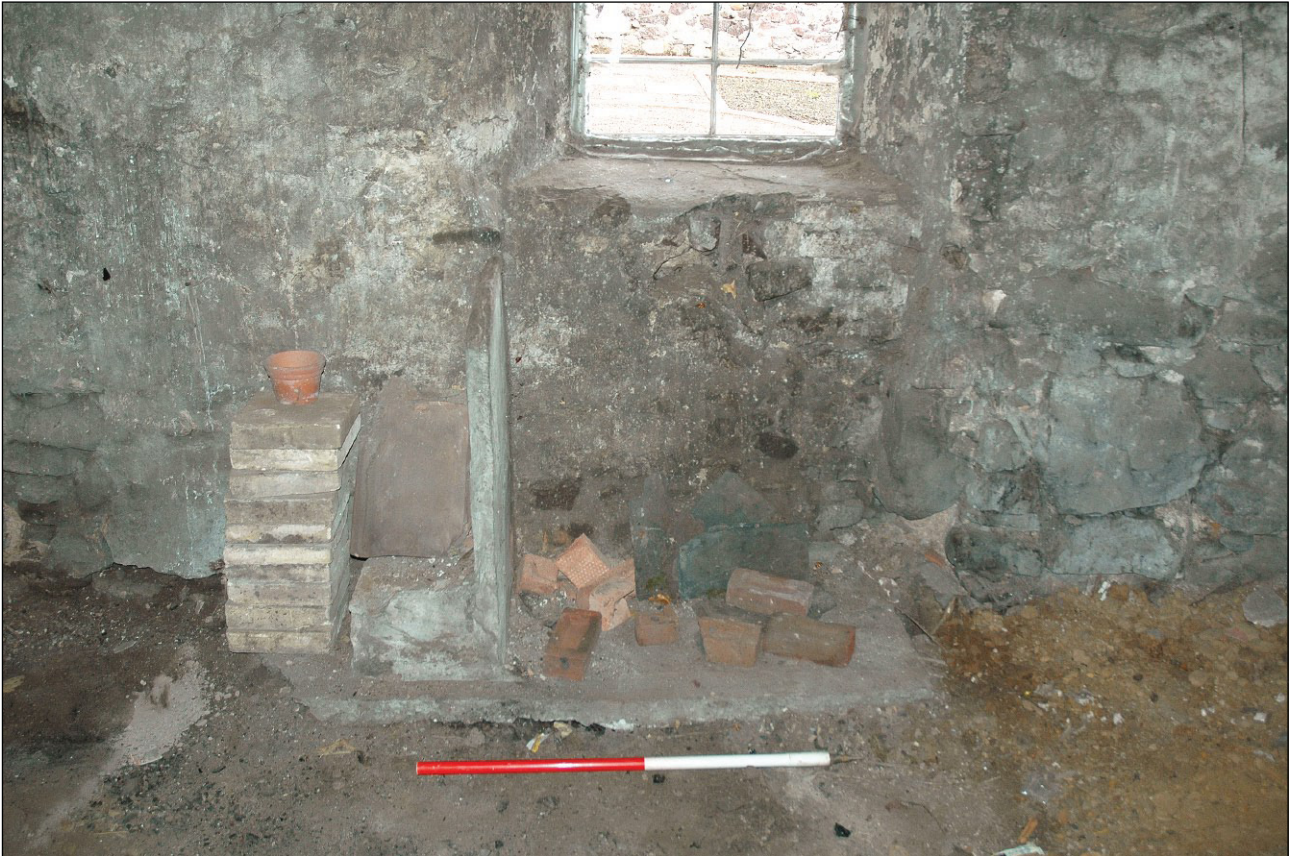
Context No.	Description	Summary	Dimensions (m)	Photo No.
38	Main build	Random rubble coursed sandstone incorporating joist slots parallel to those in the south elevation.		33-40
39	Stone screen	Upstanding sandstone slab at blocked entrance (10).	1.7 long x 0.47deep x 0.9 high	57-59
45	Joist slots	Series of joist slots along length of wall. A fillet of concrete runs along the top of these showing the level of the loft floor	0.55 apart	60
46	Concrete floor	Patch of concrete floor above earth floor. Presumably later floor surface only surviving due to presence of stone screen		57-59

3.2.10 The north elevation is the rear of the barn. Evidence of the upper loft floor is evidenced by the presence of joist slots in the wall. The upstanding stone slab (39) which is located beside the blocked entrance (10) forms a screen of unknown date or use. The concrete floor is presumably a surviving remnant of a late floor covering for at least part of the barn.

Plate 13: Detail of concrete floor and stone partition on northern internal elevation

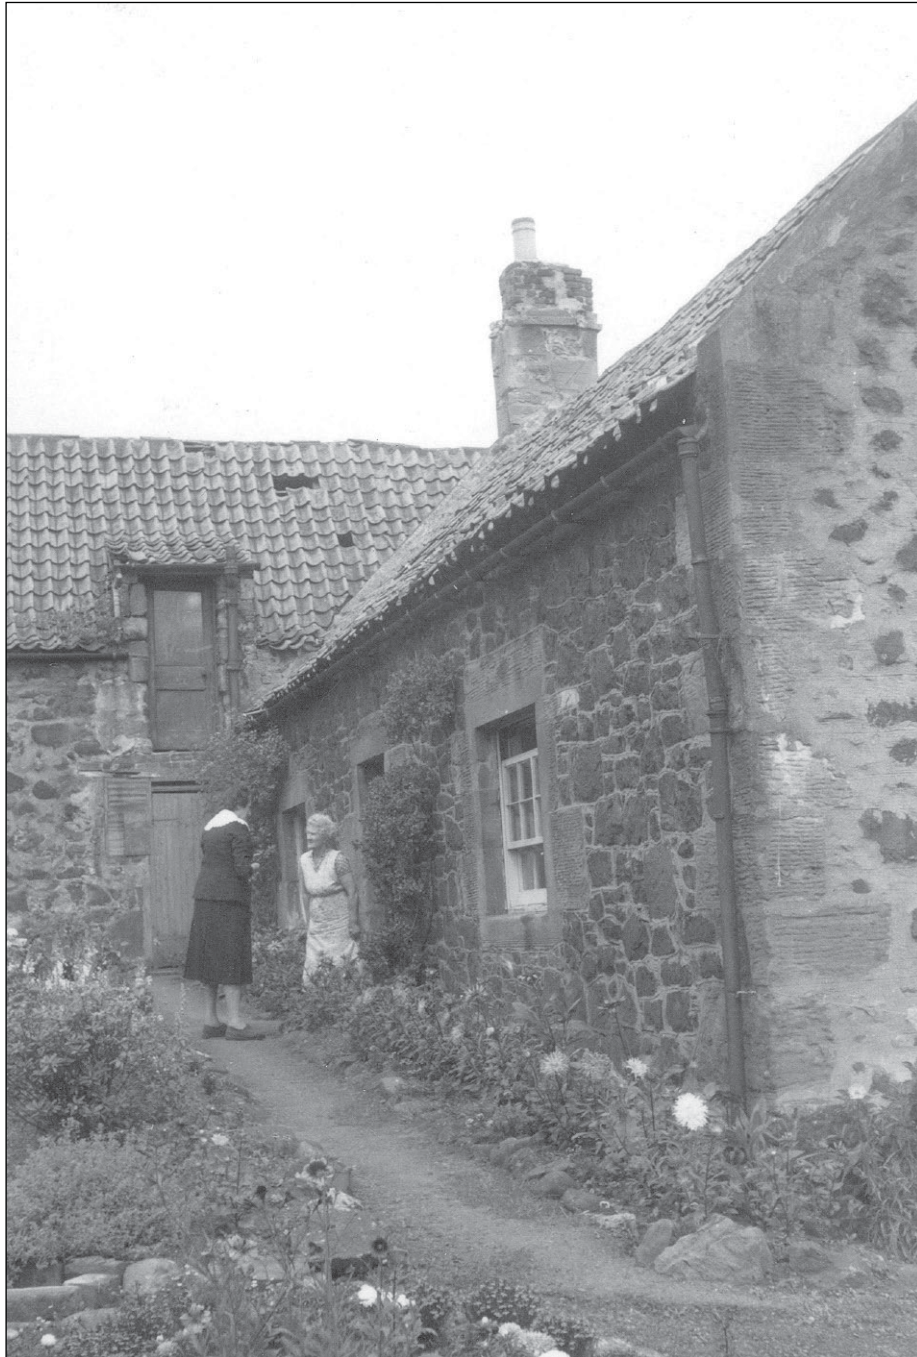
- 3.1.4 The clients supplied two historical photographs of the site which show the barn. One (Plate 14) post-dates the active use of the byre as an agricultural building. It shows that a doorway once existed directly below the pitching door. The other one is an older photograph and shows a posed scene of agricultural labourers and two horse and carts loaded with sacks outside the byre; an external wooden staircase leads up to the pitching door from the side (Plate 15).

Plate 14: Archive photograph showing southern external elevation.
Courtesy of property owners

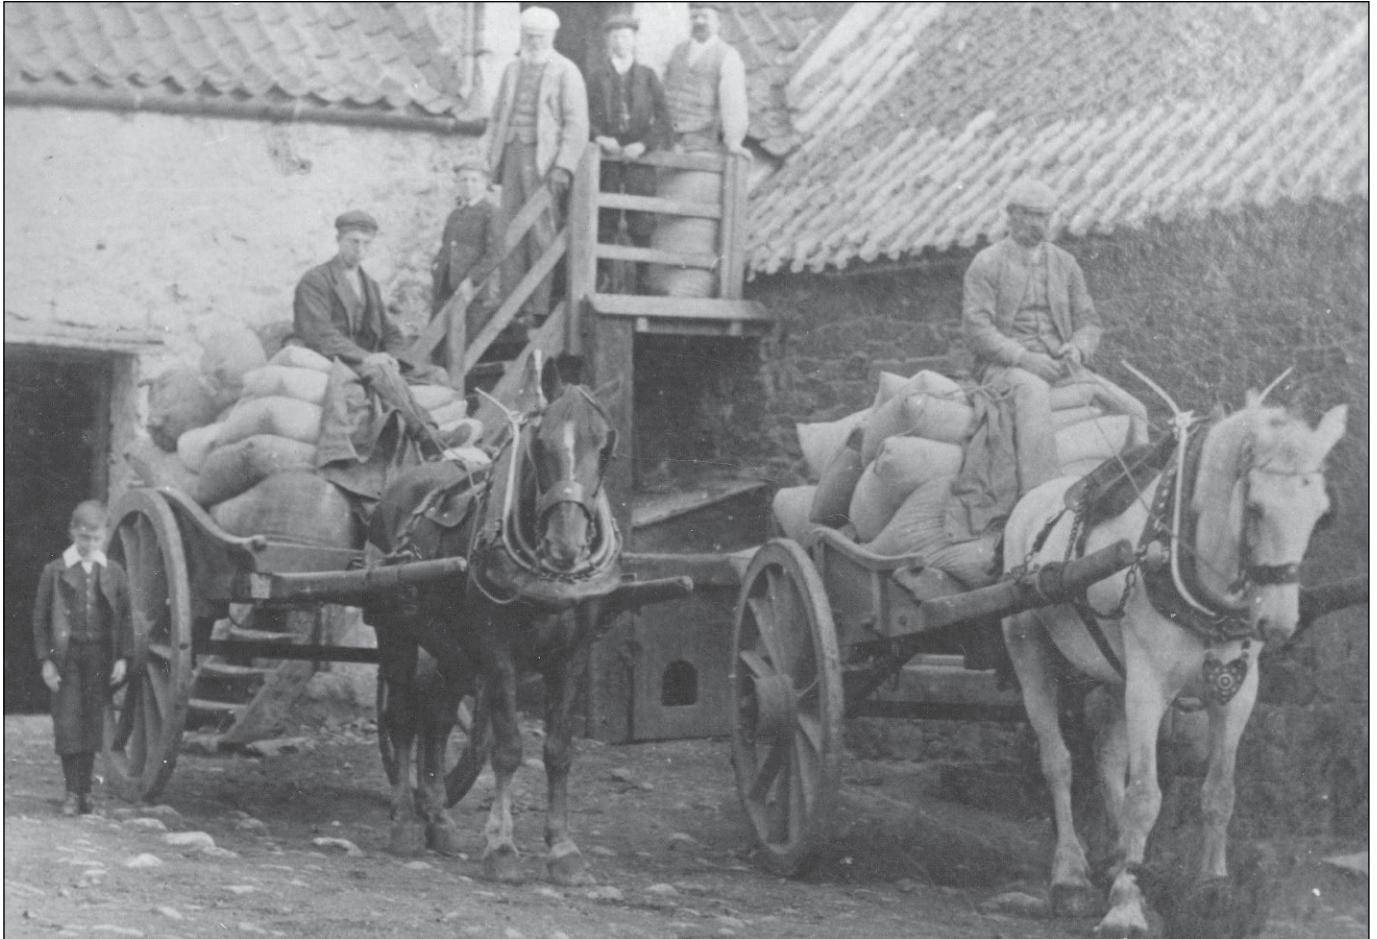
Plate 15: Archive photograph showing southern external elevation.
Courtesy of property owners
