Haggerston Dovecote, Ancroft, Northumberland Archaeological Watching Brief

Report No. 1822

Author	Stuart Mitchell MA AIfA
Illustrator	Graeme Carruthers MA MAAI&S and Shelly Werner
	BSc MPhil PhD
Editor	Melanie Johnson MA PhD FSA Scot MIfA
Commissioned by	Robin Kent Ltd on behalf of Marshall Leisure Ltd
Date issued	September 2011
Version	3
OASIS Reference	cfaarcha1-83194
Planning Application No	-
Grid Ref	NU 0352 4359

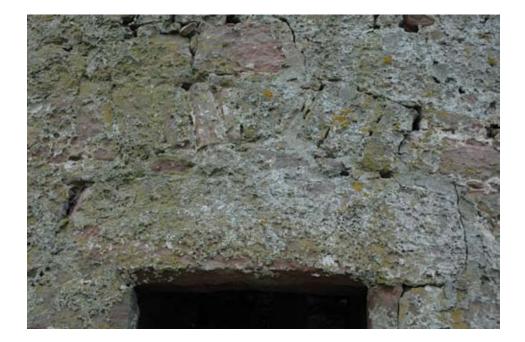
Fig. 7 Relieving arch and lintel detail, main entrance

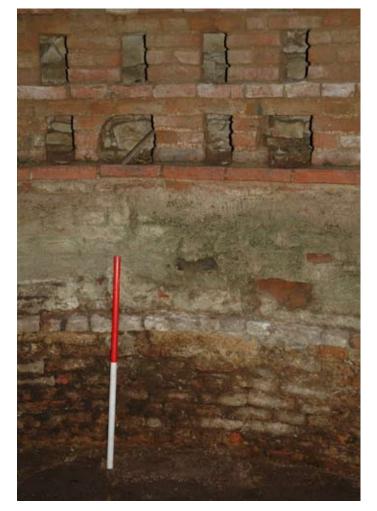
- 3.1.3 The interior has occasional rough pointing but is unrendered. It has been lined with fired clay bricks forming a 360mm thick foundation wall and nest boxes (2) for doves, although two sections of this have collapsed. The nest box construction comprises a 1280mm high foundation incorporating two rat courses (Fig. 8), and up to fifteen storeys of nest boxes. The lower foundation walls have been rendered, and the date '1824' is etched into the render close to the entry door (Fig. 9).

Fig. 8 Nest boxes

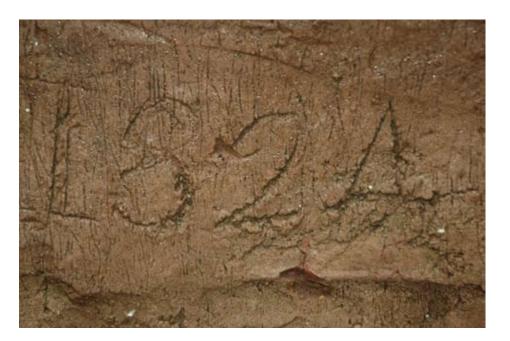
Fig.9 '1824' graffiti

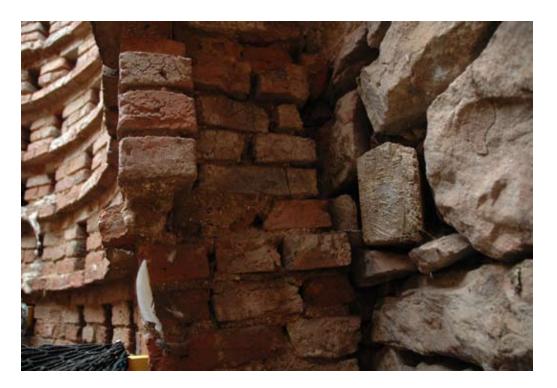
- 3.1.4 The potence (3) survives in situ and is described in full below.
- 3.1.5 A single timber stub (4) is visible in the internal wall face, fixed into a socket and sawn off at an angle flush with the wall (Fig. 10). The timber measures 160mm square and is 3100mm above the floor. Its substantial size, fixing and angle would suggest that it is a floor joist for a phase of use predating the construction of the nest boxes in the interior.

Fig. 10 Joist stub and section of brick nest boxes

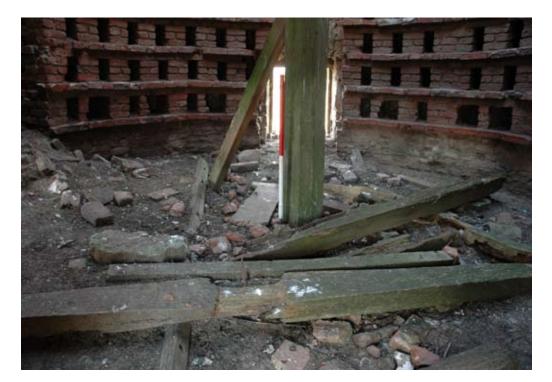
- 3.1.6 Prior to the watching brief, the lower 1m of the interior was filled with accumulated compost (9) from bird droppings and included large quantities of fallen bricks and structural timber (7) (Fig. 11).

Fig. 11 - Fallen timbers prior to clearance

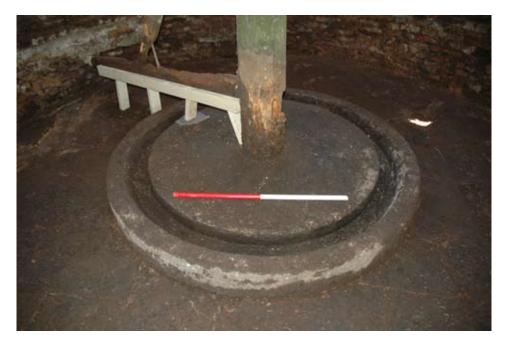
- 3.2.2 The locations of all fallen timbers were recorded in plan prior to their removal (Fig. 16).
- 3.2.3 The potence (3) survives as a largely free-standing timber arbre built in two halves, scarfed together at roughly mid height. The topmost part of the potence has rotted thus it is unclear how this was formed. The arbre is mainly octagonal in section, being a square-sided post with chamfered edges. It is four-sided at the scarf, and tapers towards to the top. It has a surviving doublearmed gallows pole fixed at roughly mid height under the scarf, fixed by a dovetail and dowel pinned. A second gallows pole would have been fixed but had fallen off, although it was recovered from the floor during clearance. A single timber arm extends from near the base of the arbre. The arm is supported by a diagonal brace which is fixed to the arbre by an angled mortice and tenon joint and pinned with a dowel. Carpenter's marks (Fig. 14) on the brace and arbre indicate that the components were prefabricated off site. The brace and arm are reinforced with an iron pin and the remains of a metal stub protrudes from beneath the arm. This stub is probably the remains of a wheel fixing.

Fig. 12 Potence and base

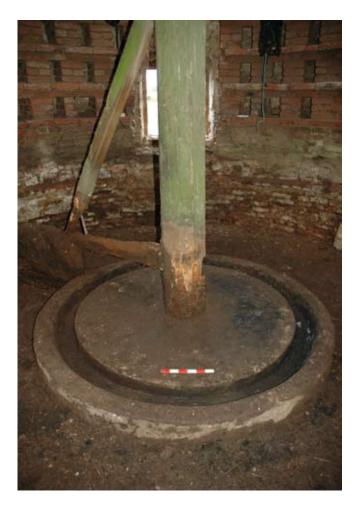
- 3.2.4 The arbre is set into a bearing in a substantial aggregate base (5) which is centrally situated on the floor of the dovecote (Fig. 13). The base measures 2.1m in diameter and 0.21m thick. It has a 105mm deep and 160mm wide groove which runs around its surface at 115mm inside its circumference. The groove has a sloping profile at the outside and is vertical on the inside. It is likely that the groove acted as a wheel guide for the revolving potence.

Fig. 13 Potence and base

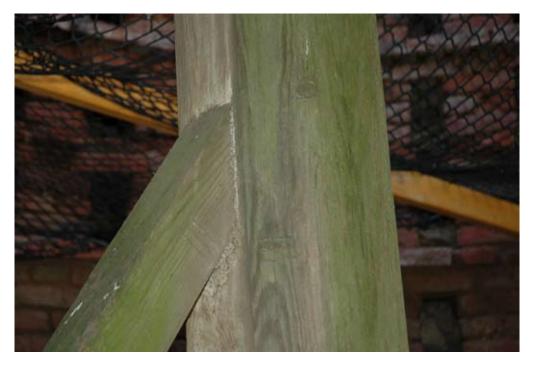
Fig.14 Dowel pin and carpenter's marks

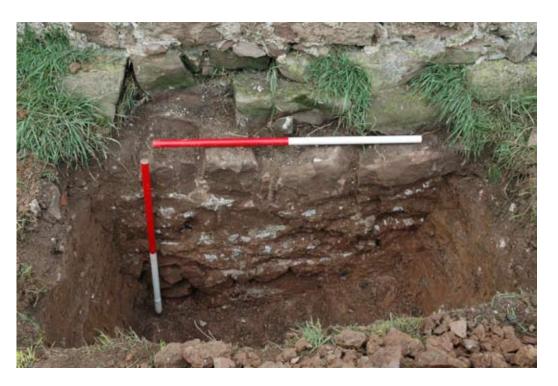
3.3.2 Trench 1 was excavated to a depth of 1m beneath ground level (Fig. 18). The topsoil (001) was c.0.15m thick and overlay smooth stiff pinkish natural clay subsoil (000). The sub-surface foundations of the building (8) formed a scarcement of c.200mm. The foundation continued as a mortar bonded rubble-

coursed sandstone wall. No gap or infill between the wall and foundation cut was noted, the wall being built directly against the vertical cut into the natural (000). The base of the foundation was not reached in this trench.

Fig. 17 - Trench 1 showing partial excavation of foundations

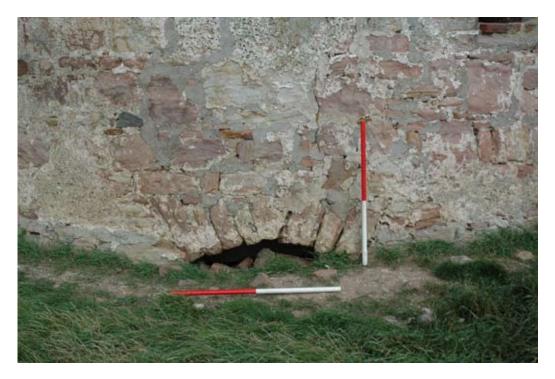
Fig. 18 - Relieving arch above subterranean blocked doorway prior to trench excavation

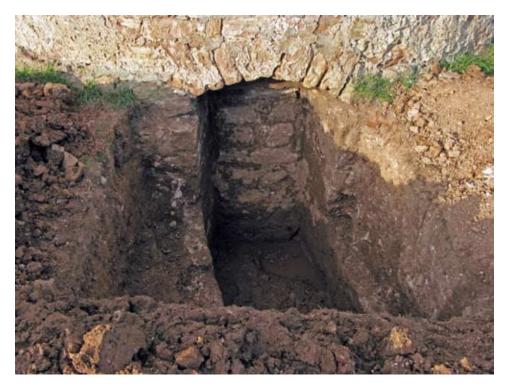
- 3.3.5 The blocked doorway (10) is 1.05m wide and comprises a flared entrance formed by rough quoins. The build is identical to that of the ground floor doorways including a relieving arch built over a large lintel (Fig. 19). It differs in orientation however; whereas the ground floor doorways are set for their doors to open inwards, the basement entrance is set for a door to open outwards. Both sides of the doorway have rebates forming door checks, and a cast iron hook for a door hinge survives on the right hand side (Fig. 20). The stub of a second hook has been sheared off flush with the stone. The doorway is blocked with mortared sandstone with a timber batten fixed across the base (Fig. 21), thus it is unclear whether the interior has been infilled or left empty. What is clear however is that the doorway and deep foundations confirm the existence of a basement.

Fig. 19 Basement door

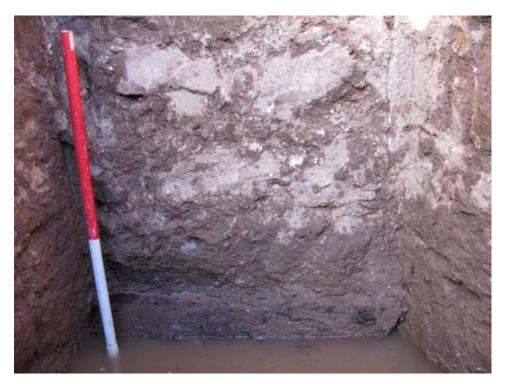
Fig. 20 Detail of basement door blocking showing the door check and hinge-hook

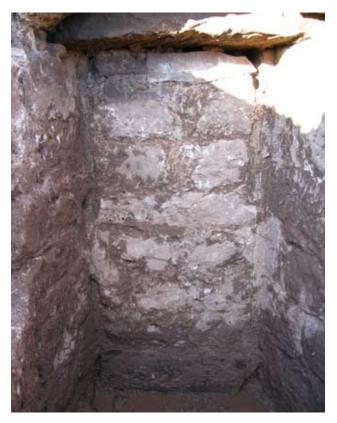
Fig. 21 Detail of basement door blocking

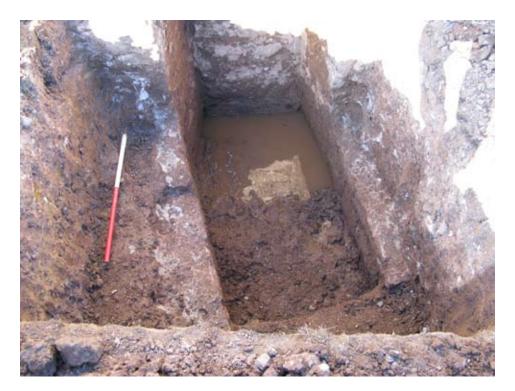
- 3.3.6 Two low walls (Fig. 22-23) were revealed running southwards from the base of the doorway. They are aligned parallel to each other and form a 1m wide approach to the basement. The approach is set at a slightly off-perpendicular angle to the doorway. The walls are built of mortar bonded sandstone blocks, laid in a single skin abutting a cut into the natural (000). The cut (003) and the walls extend to the south beyond the edge of the trench. The walls survive to a maximum height of 0.75m but have been reduced in height, evidenced by the presence of loose mortar on their tops. A small fragmented area of hard standing (13) survives between the walls. It is c.0.05m thick and comprises compacted gravel. The remains of the hard standing abut the base of a wall and represent a running surface for access to the basement. It is set directly on the surface of the cut into the natural subsoil (000), which slopes downwards slightly towards the basement door. This suggests that access to the basement was via a shallow ramp rather than steps, or that the ground level had been lowered across the whole of the southern side of the dovecote.

Fig. 22 Retaining walls and basement door

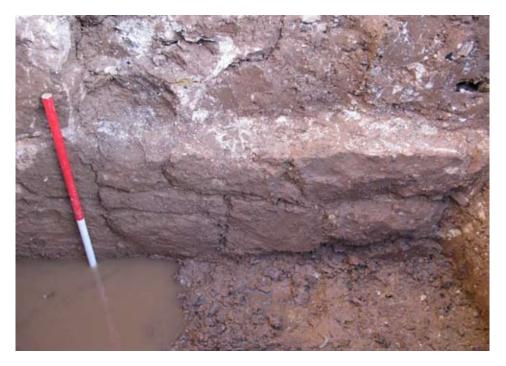
Fig. 23 Retaining wall elevation

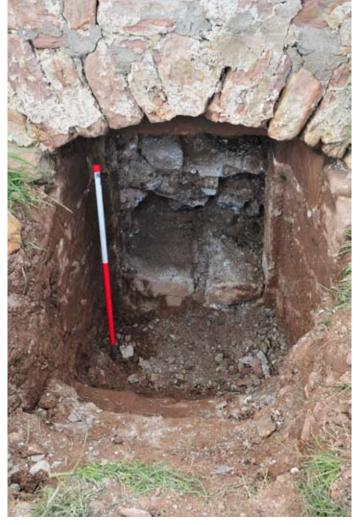
- 3.4.1 Approximately 1m in height of blockwork was removed from the top of the doorway revealed in Trench 2 in order to investigate the interior of the basement. This amounted to four courses of blockwork. Additionally, c.600mm of the interior rubble fill was removed (Fig. 26). This was deemed sufficient to satisfy the requirements of the structural engineer and allowed the measurement of the foundation wall thickness.

Fig. 26 Basement doorway showing blocking work removed

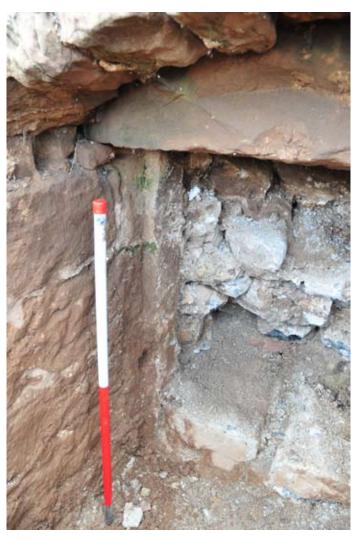
- 3.4.2 Once the upper four courses of the blockwork were removed, the form of the doorframe was visible (Fig. 25 b, 27). The checks forming the door are tooled from the blocks forming the door entrance and have right angle rabbets on the outside edge and 45° chamfers on the inside edge. The chamfers are level with the inside curve of the basement foundation wall. The foundation wall is c.950mm thick.

Fig. 27 Detail of door frame

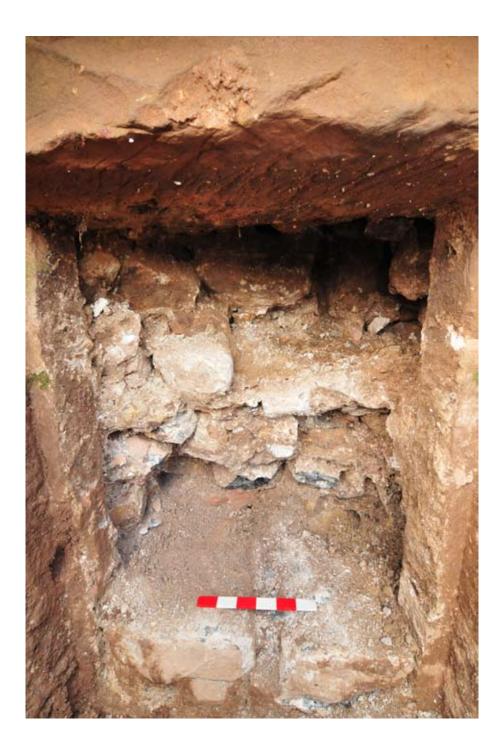
- 3.4.3 The removal of part of the blockwork revealed that while the outer faces of the blocking stones were dressed and shaped, their unseen backs were rough and undressed. The interior of the basement appeared to be filled with rough stone rubble. The rubble infill is tightly packed and contains mortar bonding within the voids, forming a very solid and stable interior fill (Fig. 28). While only c.600mm of infill was removed, it seems likely that the inside is filled in a like manner.

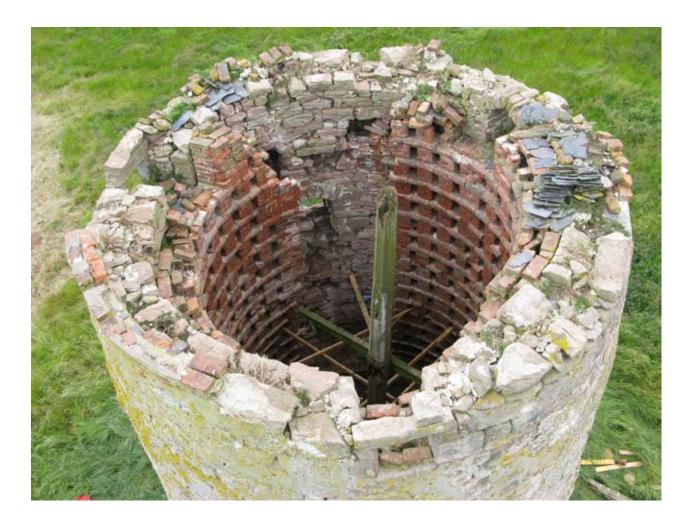
- 3.5.1 A 3D laser scan of the building and a photographic survey using a telescopic pole were undertaken to provide detailed information on the building. The point cloud data was used to create sections through the building and interior and exterior elevations, with the elevations 'rolled out' to account for the curvature of the building (Figs. 29-31).
- 3.5.2 The photographic survey of the wallhead was successful in providing previously unseen details of the wallhead (Fig. 32).
