Dalgig Farm, New Cumnock, East Ayrshire Level 3 Standing Building Survey

> **Data Structure Report** No. 1865

Author	Stuart Mitchell MA AIfA
Illustrator	Graeme Carruthers MA MAAIS PIFA
Editor	Mike Cressey HND BA MSc PhD FSA Scot MIfA
Commissioned by	Kier Mining Ltd
Date issued	March 2011
Version	0
OASIS Reference	cfaarcha1-94193
Planning Application No	06/0538/FL
Grid Ref	NS 5577 1295

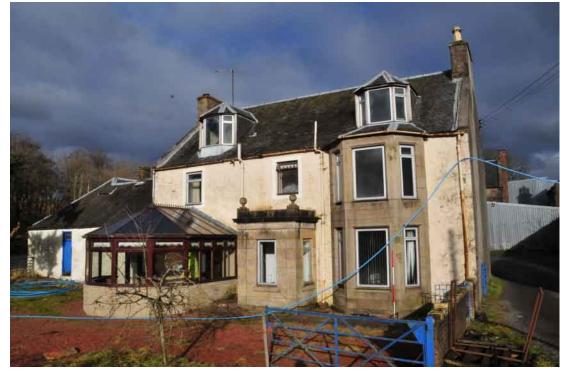
This forms the front elevation (101) of the house. It comprises two storeys and is built of sandstone with large quoins at each corner. The façade is rendered and whitewashed. A two storey bay (102) is set at the right hand side of the façade. It is unrendered and is ashlar built with fine decorative stugging and fine droved margins. The bay terminates at the same height as the wall head and accommodates two bay windows, one on each floor. The windows are modern aluminium framed double glazed units.

Fig. 9 Building 1 from the south

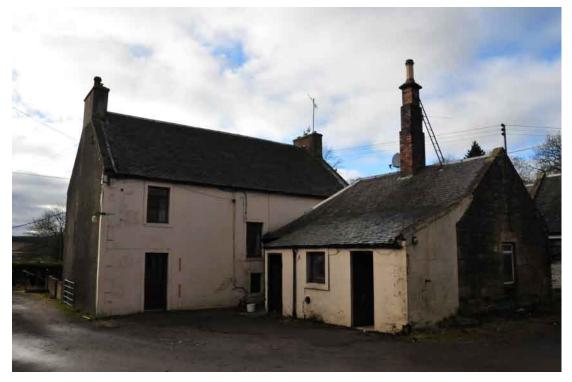
The NE-facing elevation forms the back of the farmhouse and features an extension. The main build (116) of the wall is thinly rendered and whitewashed and features long and short corner quoins. An entrance doorway (117) is situated to the left hand side and is fitted with a timber door with a single opaque glass window. A single window sits at ground floor level (118).

Fig. 10 Building 1 from the east

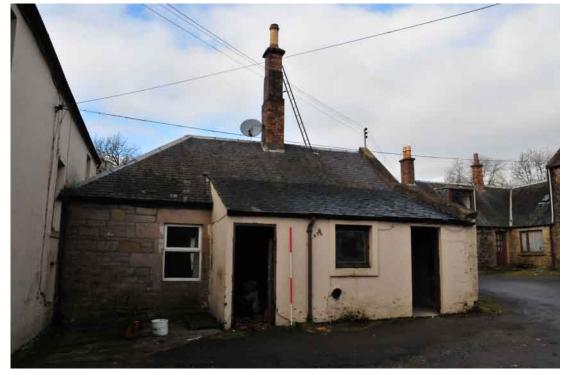
The extension abuts the NE-facing (rear) elevation of the farmhouse and is rectangular in plan with its own later extension on its SE-elevation. The walls (125, 128, 131) are built of random coursed stugged sandstone blocks with large quoins at the corners and decorative raised pointing.

Fig. 11 Building 1 rear extension from the south east

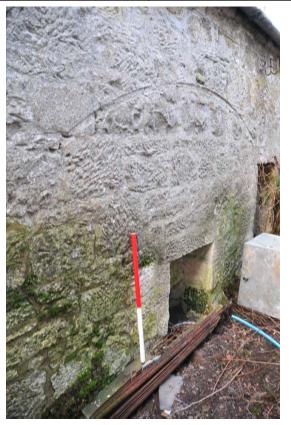
To the left of the door are features indicative of the earlier use of this building as a mill. A wheel scar (416) is located worn into the surface of the wall, indicating a wheel of c. 3.7m diameter. A blocked recess (418) is partially visible at the point central to the radius of the wheel scar, indicating that it was an axle bearing prior to being blocked up. A second blocked recess (419) is set to the right of the axle bearing recess. It is unclear what this represents, though it may have been an inspection or servicing window. A bearing box (417) with an in situ girder and bearing is set into the wall to the left of the axle bearing recess.

Fig. 23 Building 4, water wheel rim wheel scar and axle box

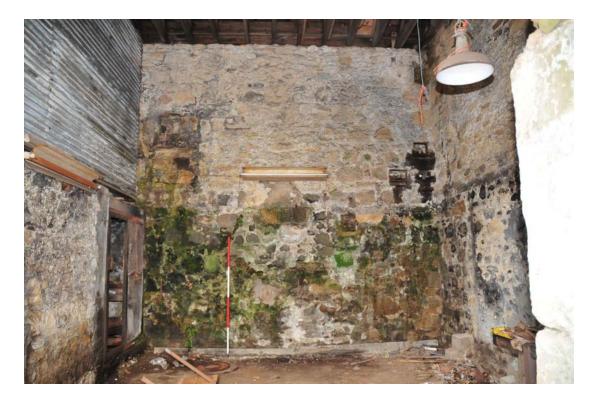
The SW (Fig 24) and NW-facing elevations contain a number of recesses (432, 433, 434) which are most likely the remains of bearing boxes for the wheel and belt-driven mill machinery. Most prominent is a large rough repair (435) roughly in the centre of the wall which probably marks the position of the wheel axle. Joist stubs (431) are visible along the SW and NE-facing elevations indicating the earlier presence of a first floor. No trace of a fireplace associated with the chimney on the SE-facing exterior elevation was visible on the NW-facing elevation. The remains of a probable

Fig. 24 Building 4 interior, south-west facing elevation and oil stained walls

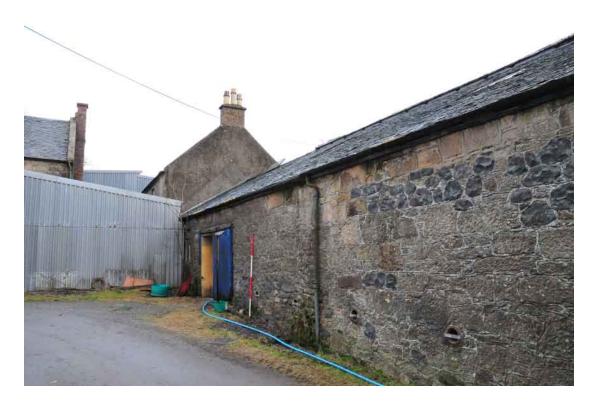
The SW-facing elevation forms a pitched gable (501). It is harled to c.50mm of the edges of the wall, exposing the quoins. The stain of a previous pitched roof (502) is visible lower down on the gable. The wall heads are capped with large sandstone skews. A rectangular section brick chimney stack (503) is set at the apex of the pitch.

Fig. 28 Building 6 exterior showing the pitched roof stain on gable of Building 5

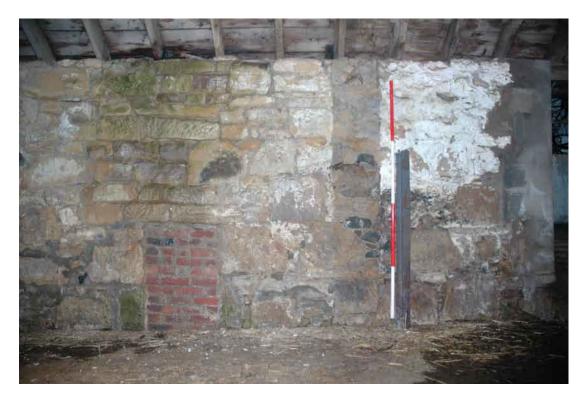
The interior walls have been whitewashed although much of this has faded or worn off. Unpainted marks (716, 717) on the NW and SE-facing elevations indicate the prior existence of an interior dividing wall (Fig 36). This would have been built of timber, indicated by the presence of wooden dooks set into the unpainted margins.

Fig. 36 Building 7 interior detail of blocked hatch and partition mark
