**Archaeological Building Recording at the  
Former Denton Works, Chaplin Road, Normacot  
Stoke-on-Trent  
Staffordshire  
NGR SJ 91945 42585**

**Planning Ref.: SOT/48329**

**Report No. 305**

**November 2010**

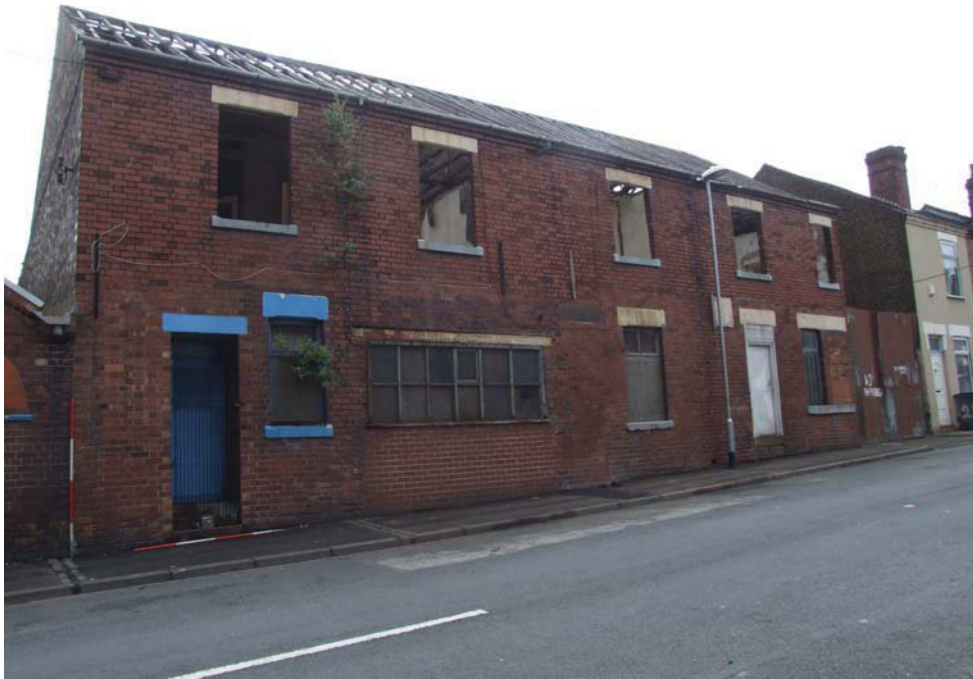
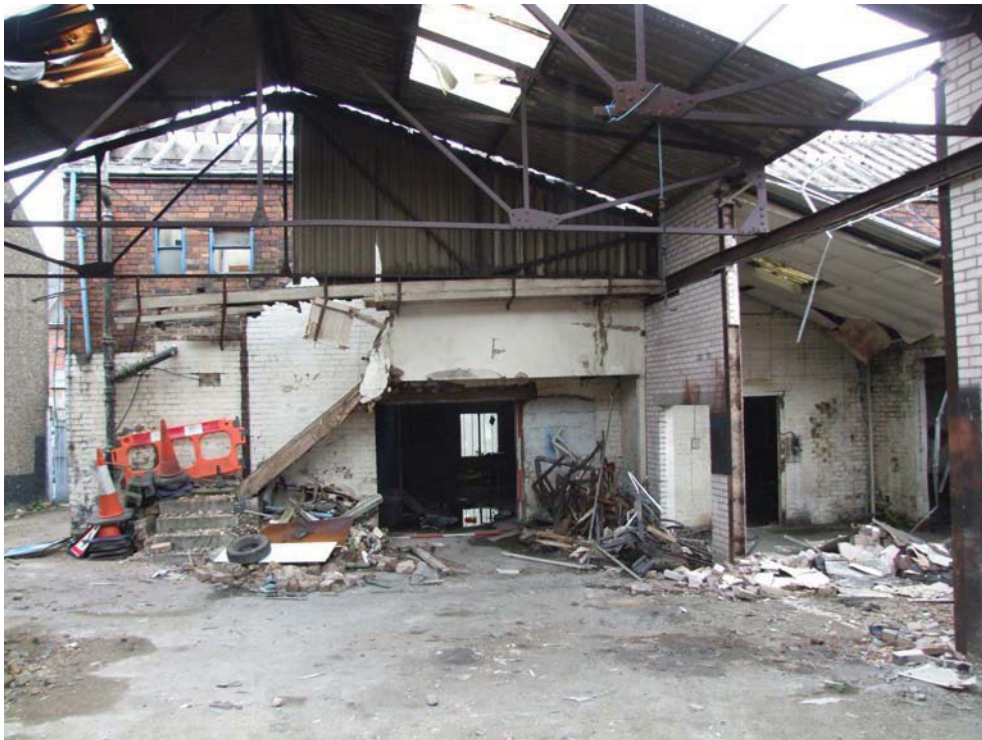
**5.2.1** Building A was a red-brick, two-storey structure built in Flemish bond with a projecting course at the eaves. The roofing material had been removed by the time of survey but the wooden purlins, rafters and ridge piece remained. The original windows and doors on the western elevation had stone lintels and sills with a chamfered detail at the lip. This elevation was arranged in four bays, suggesting that the building had originally been a row of four separate terraced properties. The northernmost bay had a door and a window on the ground floor with a window on the first floor above. The next bay to the south had probably followed this pattern, but the ground floor openings had been replaced by a rectangular window with steel lintel extending for the full width of the bay. The third bay to the south was identical to the northernmost bay, and the southernmost bay was slightly larger with a double window on the ground floor and two windows on the first floor. The width of each bay and the groupings of doors and windows were very similar to existing nearby houses, suggesting that building A had originally been a continuation of the terraces on Rothesay Road. The original segmental-arched doors on the rear (east) elevation of the building had been bricked-up. Original

windows with segmental-arched heads also remained on the first floor of this elevation and on the ground floor of the south elevation.

**PLATE 1**

Building A west elevation, Rothesay Road.

**PLATE 2**

Building A east elevation from courtyard.

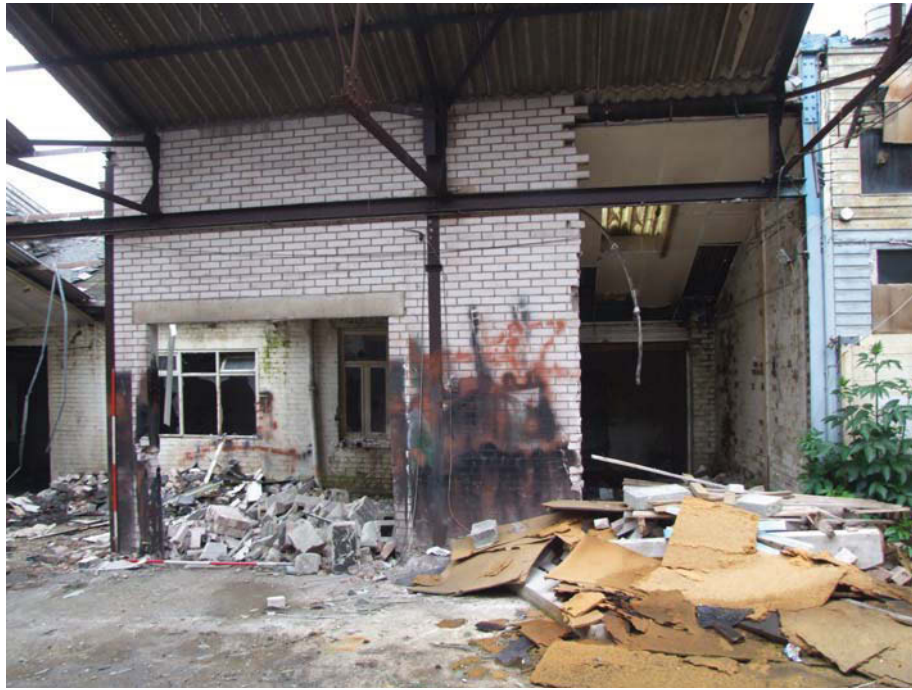
**PLATE 3**

**5.3.1** Building B was a single-storey construction extending eastwards from the rear elevation of building A at its northern end. The building consisted of two phases of construction, both post-dating building A. The earlier phase, represented by B100 and part of B102, was constructed with red-brick in a stretcher bond, although this had been painted white in its conversion to an internal space. The roof of this phase of building B was a single slope covered with red clay tiles and forming a V with the roof over the later

part of building B to the south. The wooden-framed casement window in the south wall of room B100 had a concrete lintel and may have been a later insertion. Access to building C had formerly been via a door in the north wall of room B102, but this had been blocked with breeze-blocks by the time of survey. The change from the older section to the newer section of building B was indicated in B102 by the ramped floor at the southern end of the room.

Building B south elevation from courtyard.

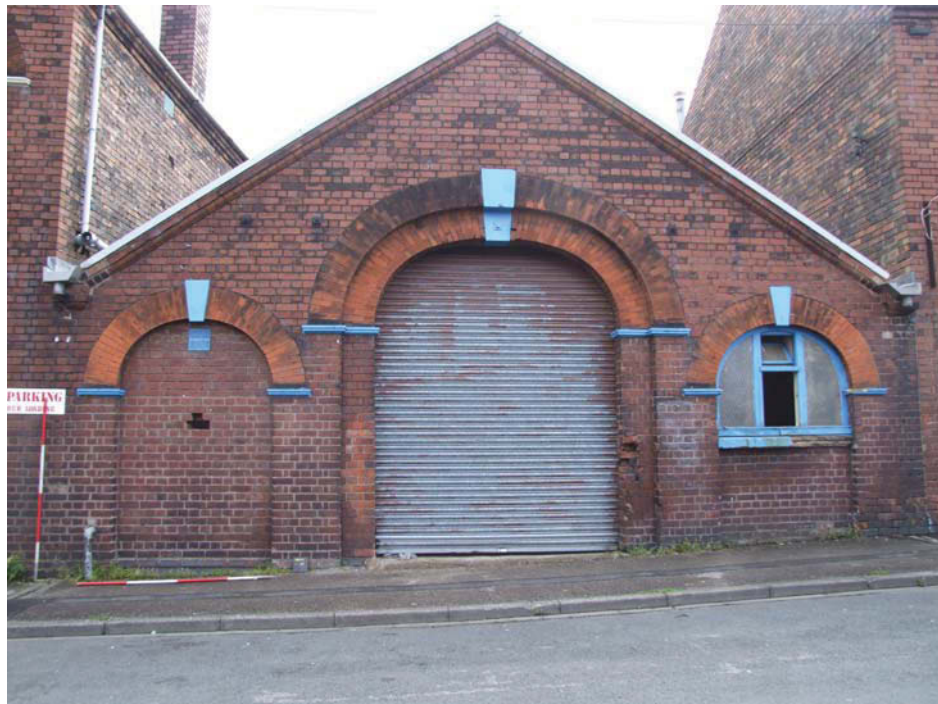
**PLATE 4**

**5.4.1** Building C was a single-storey building on Rothesay Road located between building F and buildings A and B. Building F was a two-storey building on the corner of Rothesay Road and Chaplin Road. The buildings were constructed in red-brick English bond with moulded brickwork at the eaves. Both had roofs pitched north-south; building F was covered with grey clay tiles and building C with corrugated metal sheets, probably a later replacement. The buildings had similar architectural details. Both had elliptical arches, with keystones and moulded brickwork at the imposts, above recessed windows and doors on the Rothesay Road elevations. These details were repeated on the first floor of the Chaplin Road elevation of building F in the central pedimented bay. These similarities, coupled with the OS map evidence (Figs. 4 and 5) suggest that buildings C and F were built at the same time; they appear to have been built by 1912.

**5.4.2** Building C was principally accessed via a central doorway in the west (Rothesay Road) elevation, closed with a metal roller-shutter door. The apertures to either side had been blocked, the one to the south side of the doorway partially with a window remaining in the top half. Internally the building enclosed just one large room, C100, lit by skylights in the roof. Both the historical maps (Figs. 6 and 7) and recent aerial

photographs suggest building C had been extended at its eastern end, but evidence for this was not obvious within the room. Blocked doors along both the north and south walls showed that the building had formerly been accessible from both buildings F and B. A pulley-driven lift mechanism at the east end of the room extended through the roof to a loading point on the first-floor bridge from building G. These internal features suggest that the building had an industrial function.

Building C west elevation, Rothesay Road.

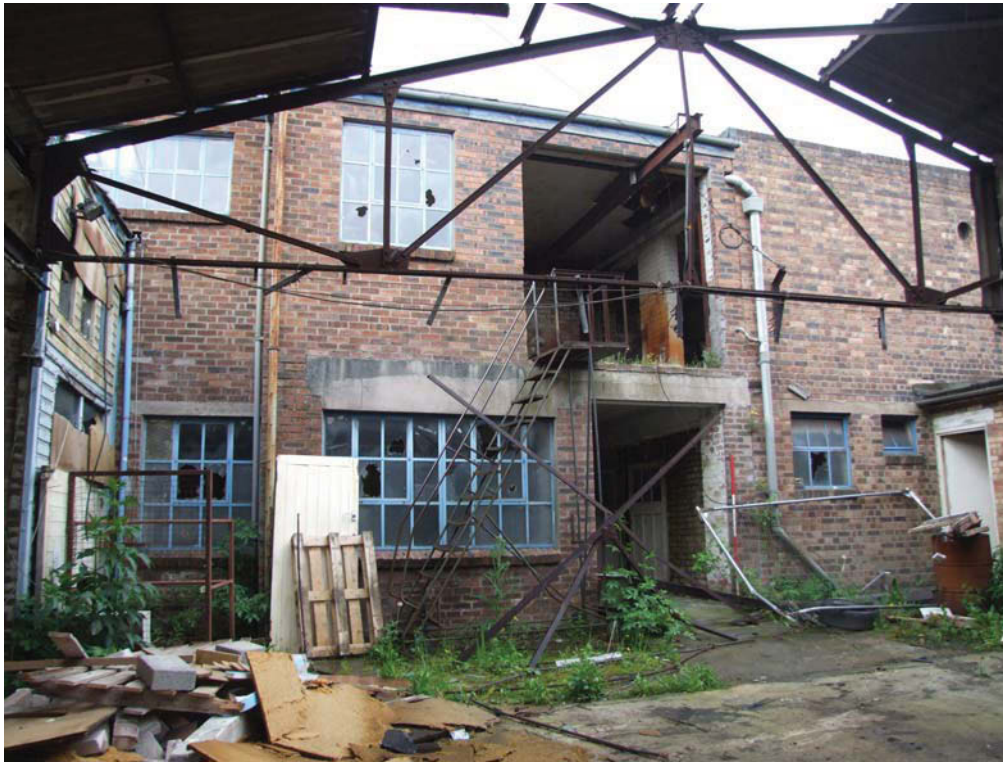
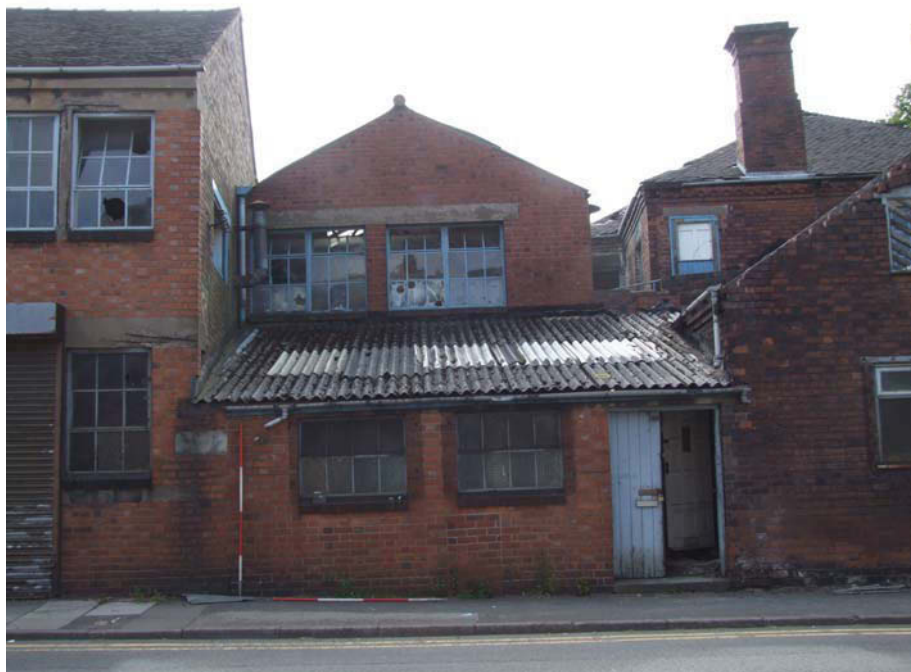
Building H was a 19th-century industrial building that first appeared on the OS map of 1900 (Fig. 3). Historical map evidence shows that part of building D was added between 1937-1950, in-filling the space between buildings G and H (Figs. 6 and 7). The remainder was built post-1950. Building H was a two-storey, red-brick building constructed in Flemish bond. It had a plain clay-tiled roof pitched west-east with a single central chimney. The façade of the east elevation had been substantially remodelled and incorporated concrete eaves, lintels, string course and ground floor sill course, and metal-framed windows with hopper-lights. This frontage included an entrance into room H103 and two metal roller-shutter doors giving access to rooms H100 and H101. The central light of the southernmost window at first-floor level had been removed and the space enlarged to create a doorway. External signage confirmed the most recent use of the building as a manufactory for windows and conservatories. Building D included two-storey red-brick buildings to the north and east of building H, constructed in several phases, and single-storey additions to both the south and north of building H containing rooms D100, D105 and D108. To the north of building H the single-storey building featuring room D100 and the two-storey block containing rooms D101 and D200 were constructed in Flemish bond. The northern section of the two-storey block to the west of building H containing rooms D103 and D203 was constructed in stretcher bond. The southern section of this block containing rooms D104, D106 and D202 was constructed in English bond. The windows in the east wall of room D103 had brick sills of a type generally used for external windows suggesting that it had previously been an external wall and, therefore, that the section of building D containing rooms D102, D107 and D203 represented an earlier phase of construction.

**PLATE 5**

Building D west elevation from courtyard.

**PLATE 6**

Building D east elevation, Upper Normacot Road.

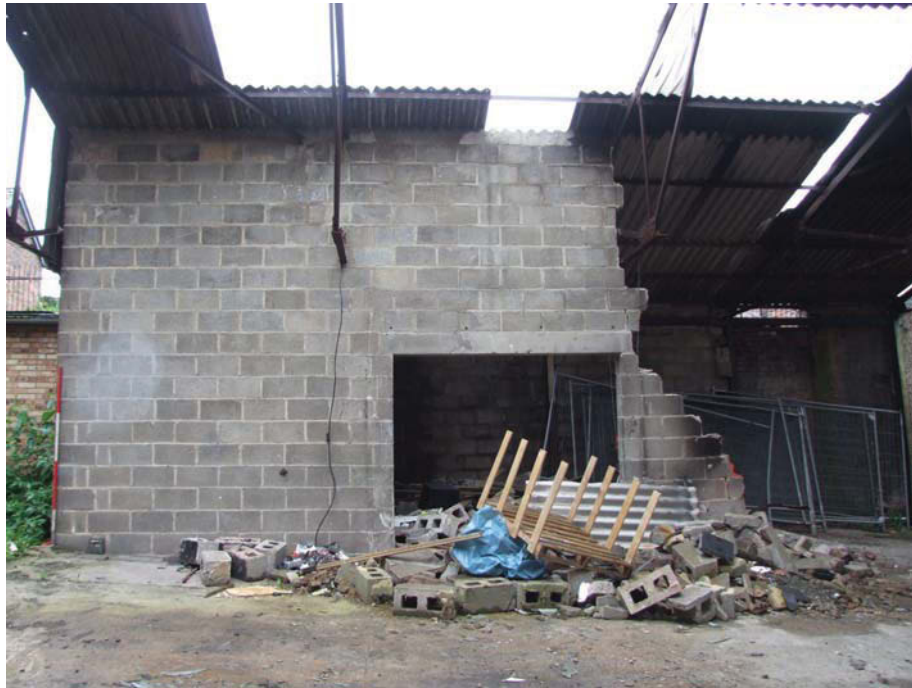
**PLATE 7**

Building E was located against the south wall of the courtyard area between buildings A, B and D that had formerly been roofed over. By the time of the survey part of the roof had been removed, and the west wall and part of the north wall of building E had been demolished. The building consisted of a single room constructed in breeze block with a concrete floor and corrugated metal sheet roof. It was single storey with an open doorway located in the north wall. The north wall was apparently constructed around the metal roof structure, suggesting that it post-dated the construction of the roof. It seems likely, therefore, that building E was a late 20<sup>th</sup>-century insertion beneath the existing courtyard roof. No features survived to indicate what the building was used for.

Building E north elevation from courtyard.

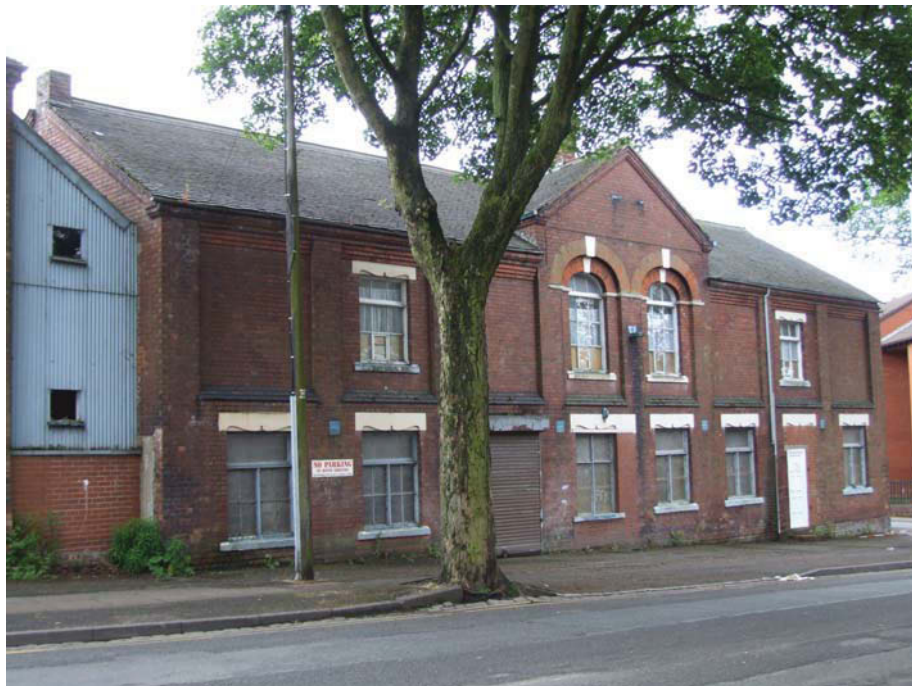
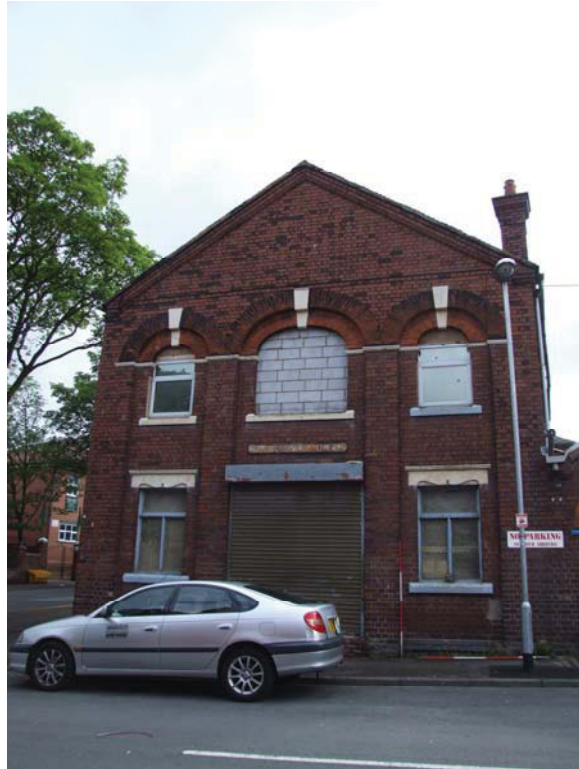
**5.4.3** Building F had metal roller-shutter doors on both the Chaplin Road and Rothesay Road elevations, and a single ground floor doorway had also been inserted into the Chaplin Road elevation replacing a former window.

**PLATE 8**

Building F north elevation, Chaplin Road.

**PLATE 9**

Building F east elevation, Rothesay Road.

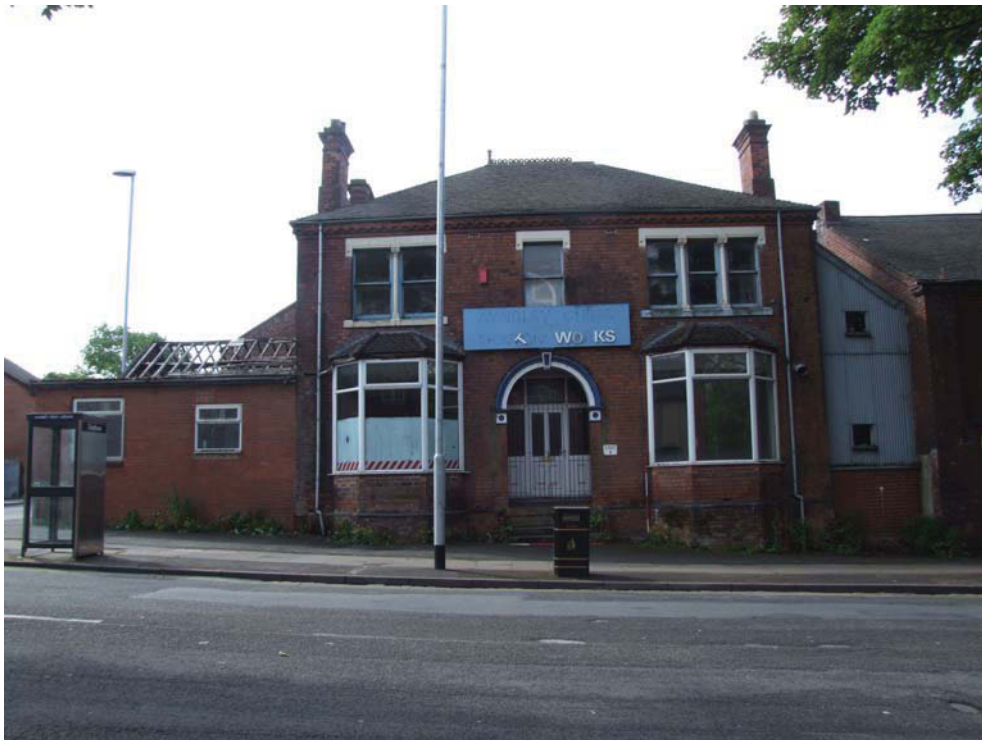
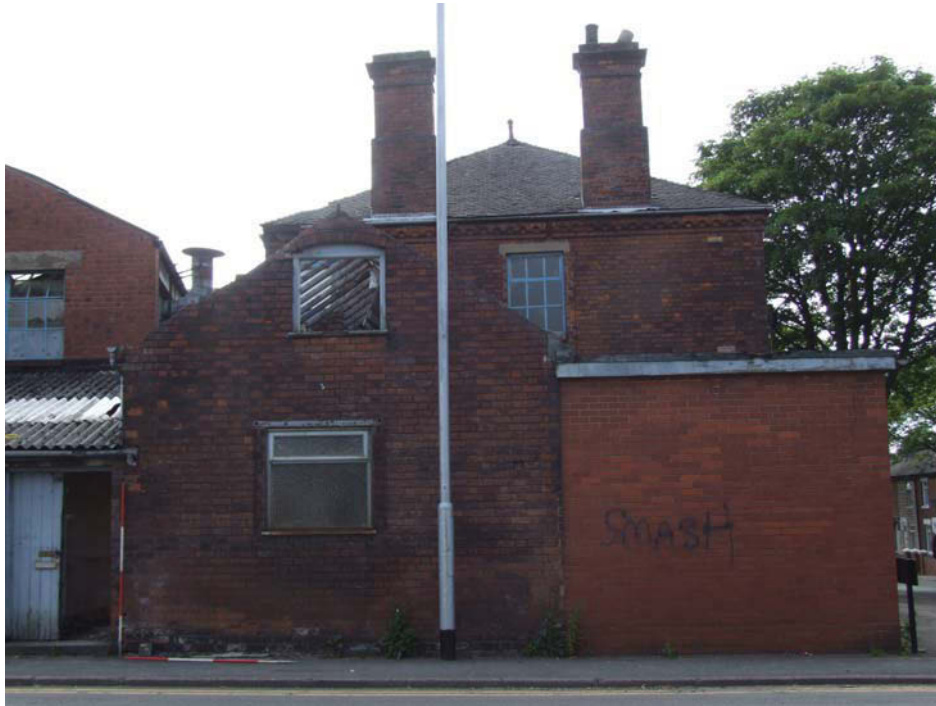
Building G consisted mainly of a large former domestic house that first appears on the OS map of 1900 (Fig. 3). It comprised a two-storey, red-brick building constructed in Flemish bond with decorative moulded brick dentilation at the eaves. It had a course of chamfered blue bricks at plinth level. The roof was hipped and covered with plain clay tiles; it had decorative clay ridge tiles with a single surviving finial. The building had four chimneys. The north elevation included a central ground floor entrance accessed by a flight of four steps. The door was a modern uPVC replacement recessed within an elliptical-arched porch with moulded detailing, keystone and imposts. Bay windows with tiled roofs were located to either side of the entrance at ground floor level. There were three first-floor windows in the north elevation all of which had original vertical sliding sashes with wooden frames, moulded lintels and stone sills. Those above the bay windows had decorative columnar mullions. Also included in the description of building G is a single-storey red-brick building located in the north-east corner of the site. This was built in two phases with the part containing room G108 constructed in stretcher bond with a roof pitched north-south and including an attic-level gable window. The area containing rooms G109 and G110 was constructed in Flemish bond and had a flat roof. OS map evidence suggests that the area containing room G108 was built by 1900 (Fig. 3) whereas the area containing rooms G109 and G110 was constructed between 1937 and 1950 (Figs. 6 and 7).

**PLATE 10**

Building G north elevation, Chaplin Road.

**PLATE 11**

Building G east elevation, Upper Normacot Road.

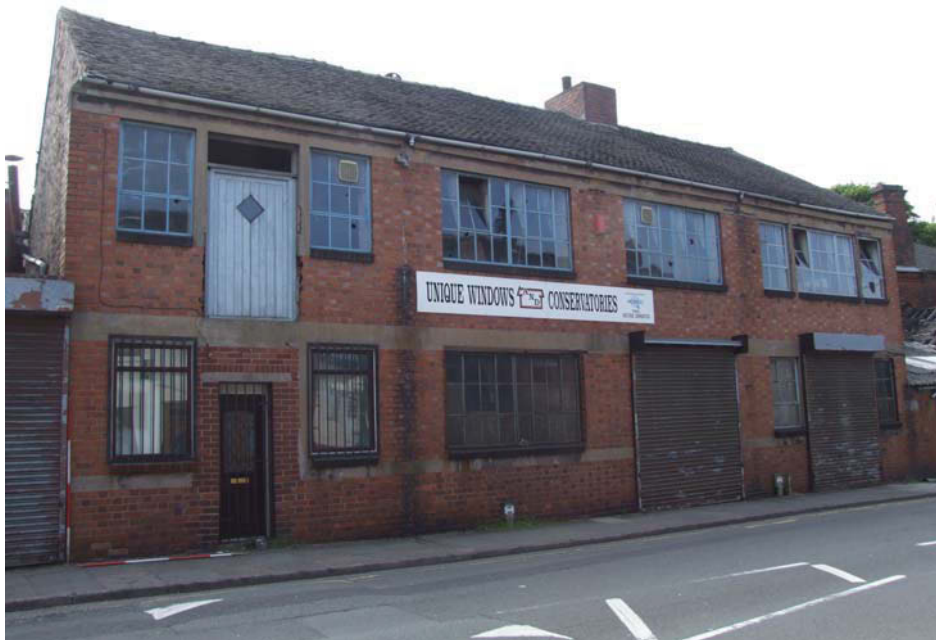
**PLATE 12**

Building H east elevation, Upper Normacot Road.

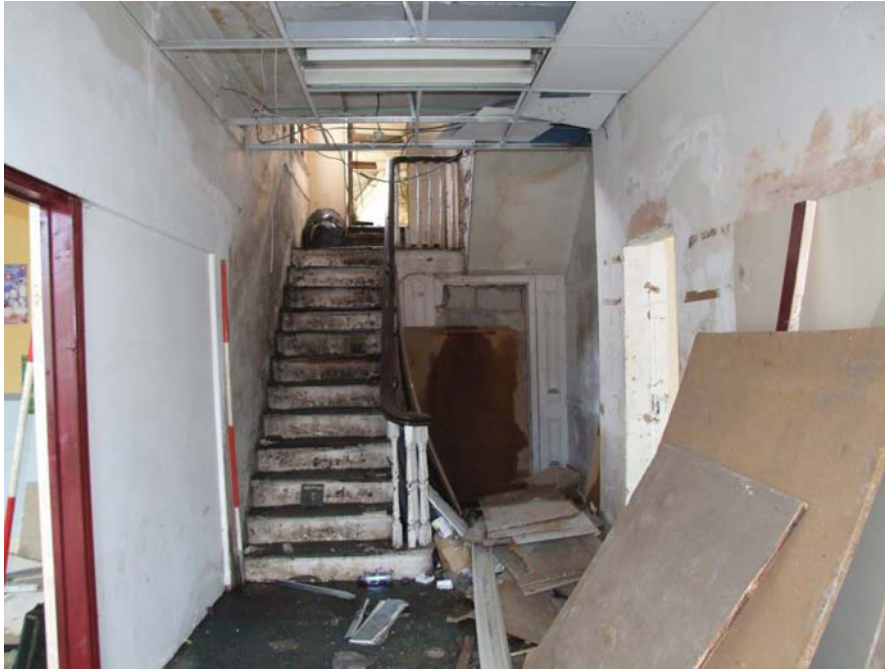
**PLATE 13**

Building G, room G100 entrance hall looking south showing original staircase, blocked cellar door and altered doorway to room G101.

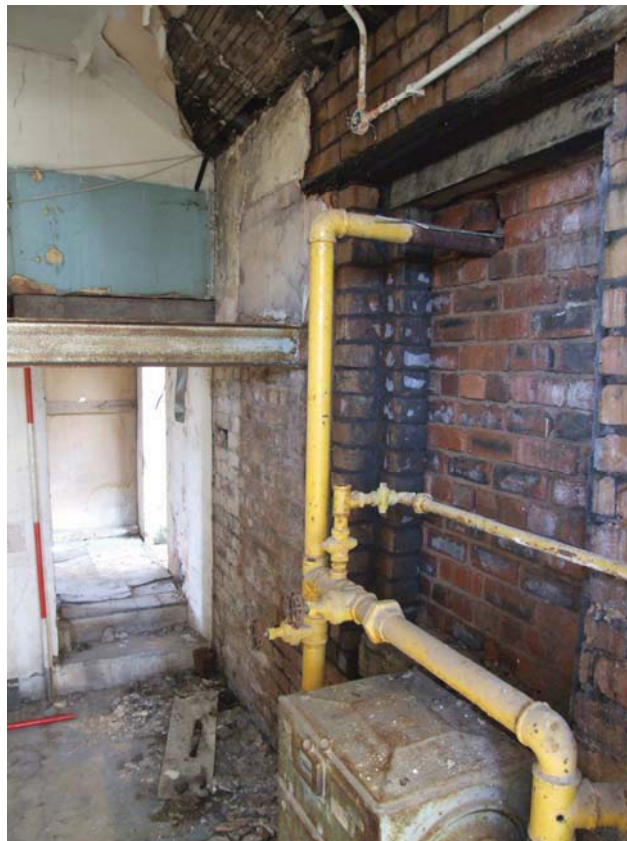
**PLATE 14**

Building G room G205 looking north with pump and associated pipework.

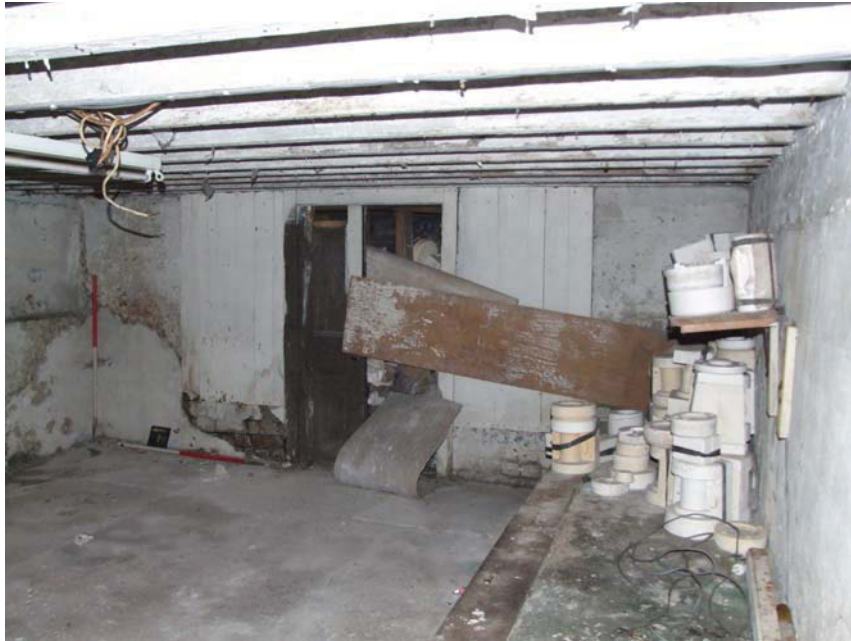
**PLATE 15**

Building G cellar room G002 looking north showing cupboard below bay window, shelf along east wall and pottery moulds.

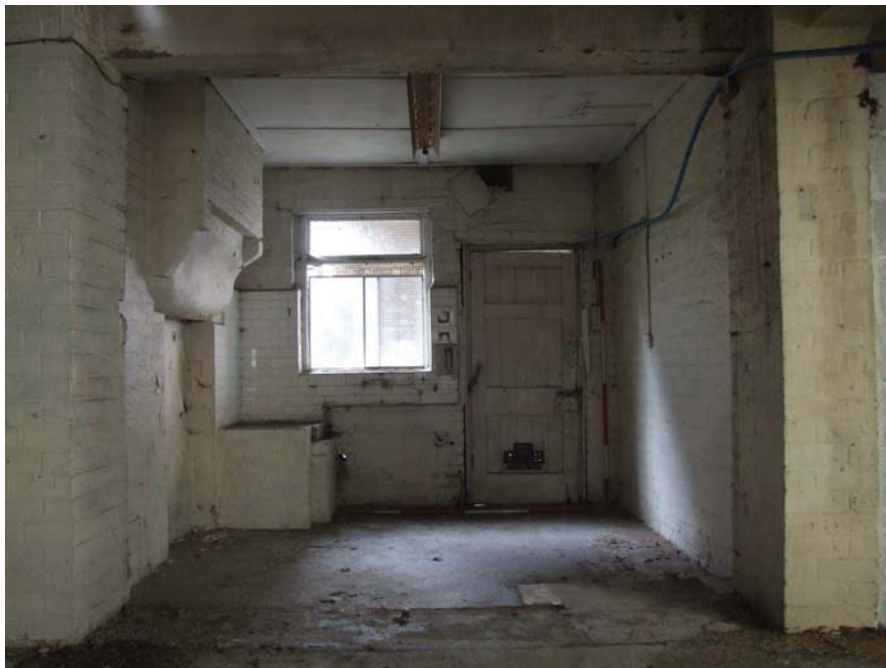
**PLATE 16**

Building G room G106 looking east showing remains of original fireplace and copper.
