Recovery report detailing the excavation of a historic aircraft crash site:

Armstrong Whitworth Whitley BD381

Crashed 6th of May 1943

Near Dewshill Farm, Shotts

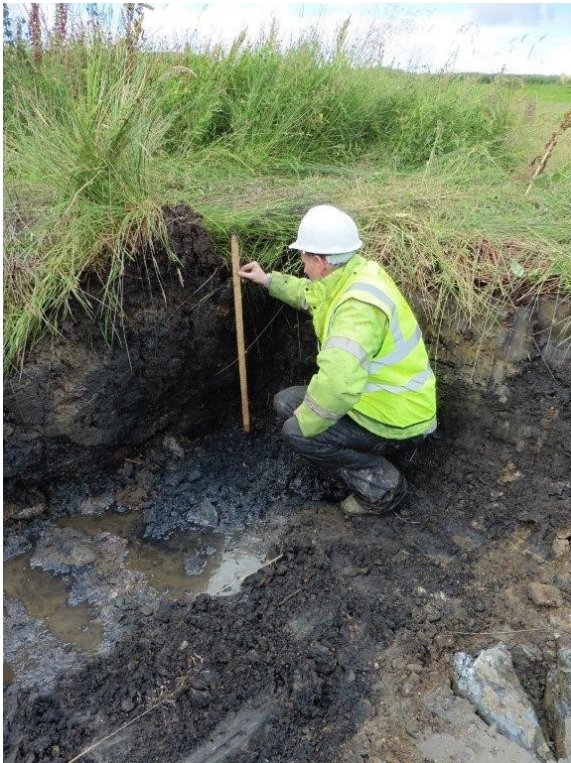
A few molten pieces of alloy and small fragments were found until , at a depth of 90cm , a large burnt area containing a concentration of metal fragments were found:

Figure 10, Burnt area at 90cm. (Stevie Spink)

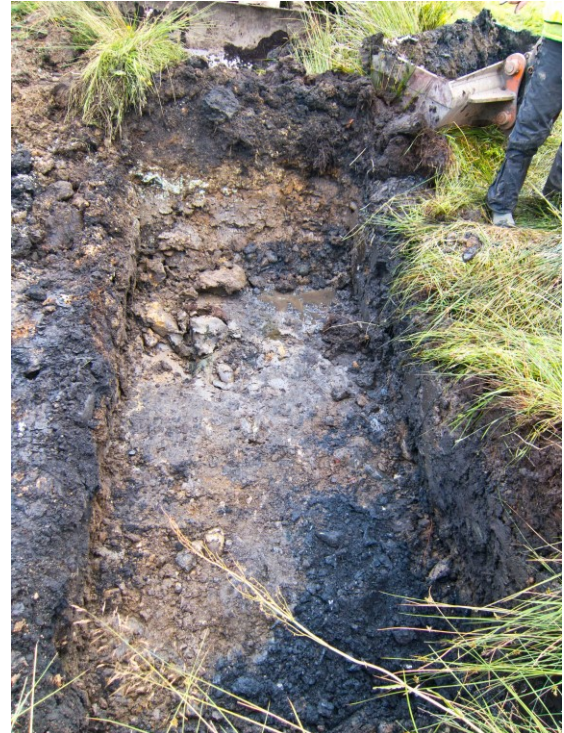
Figure 11, Looking south along trench. (Ken Law)

The trench was widened and taken down to 90cm over a three metre area where hand digging commenced.

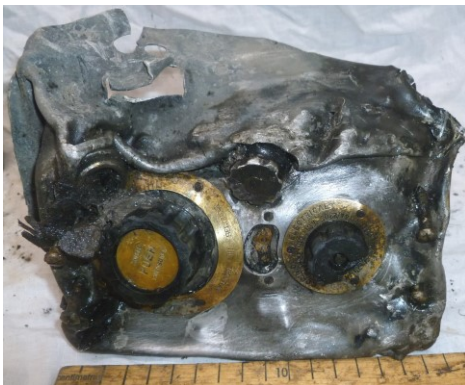
Figure 12, Camera control unit

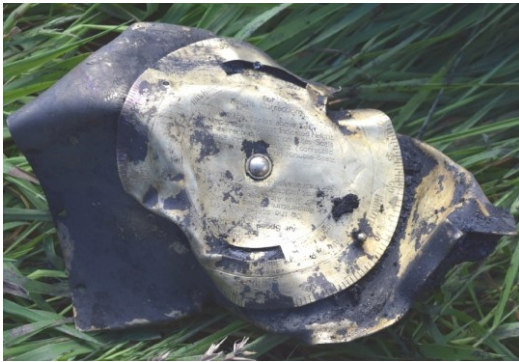
Figure 14, Navigational computer. (Mark Shelden) Figure 15, Undamaged computer.

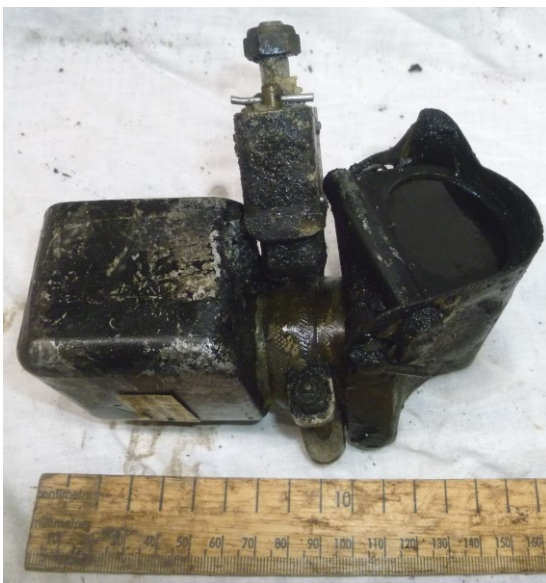
Figure 16, Reflector gun sight

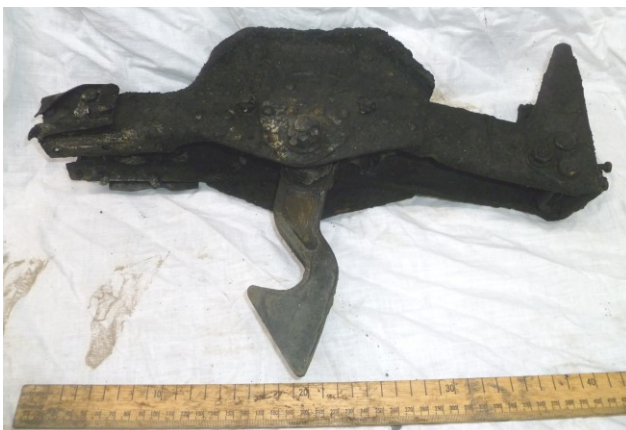
Figure 18, Undercarriage lock

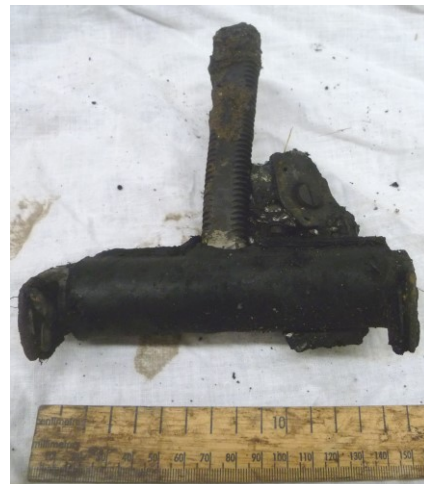
Figure 19, Rudder pedal

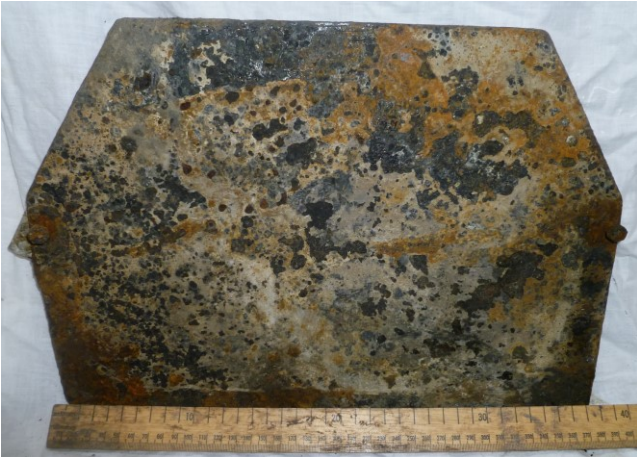
Figure 20, Armour plate from seat.

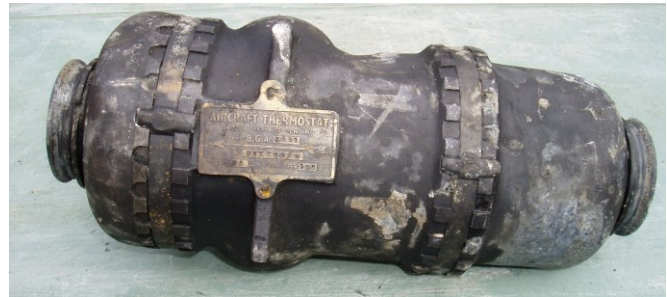
Figure 21, Thermostat. (Mark Evans)
