**Historic building recording at  
Frogs Hall Farm,  
Bambers Green Road,  
Takeley, Essex, CM22 6PE**

**November 2019**

**CAT Report 1540**  
April 2020

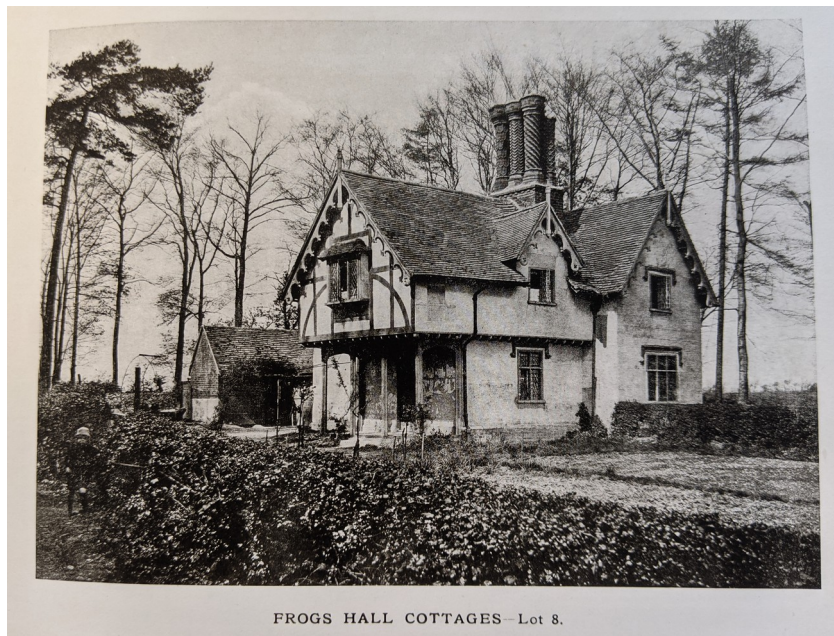
**Photograph 1** Eastern and southern elevations of the house, taken from the 1921 sales catalogue. Note the original windows, chimney and faux timber-framing on the suspended section of the upper storey. Taken from ERO Sale-A57. Photograph taken facing north-west.

Even though the interior of the building has no surviving features that corroborate the Arts and Crafts style, the exterior of the building, particularly before the modern additions (Photograph 1), is enough to very clearly show that the structure was at the forefront of architectural fashion in the late Victorian period.

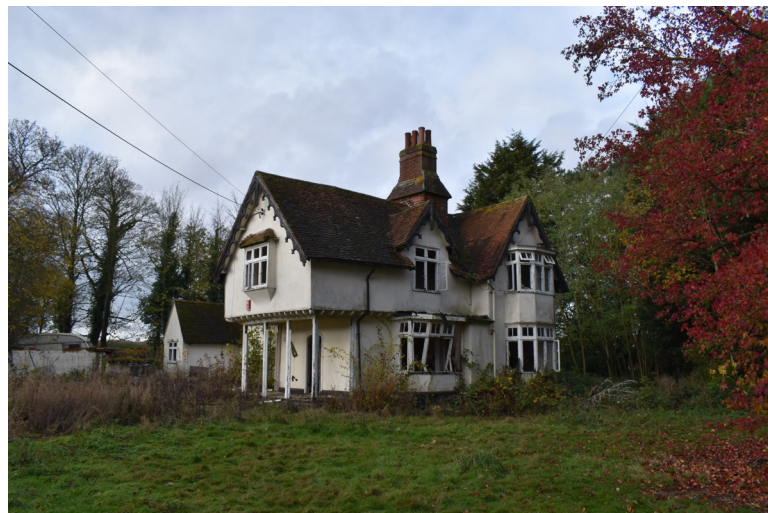
**Photograph 2** Modern eastern and southern elevations, showing bay-window extensions, replacement windows and altered chimney. Photograph taken facing north-west.

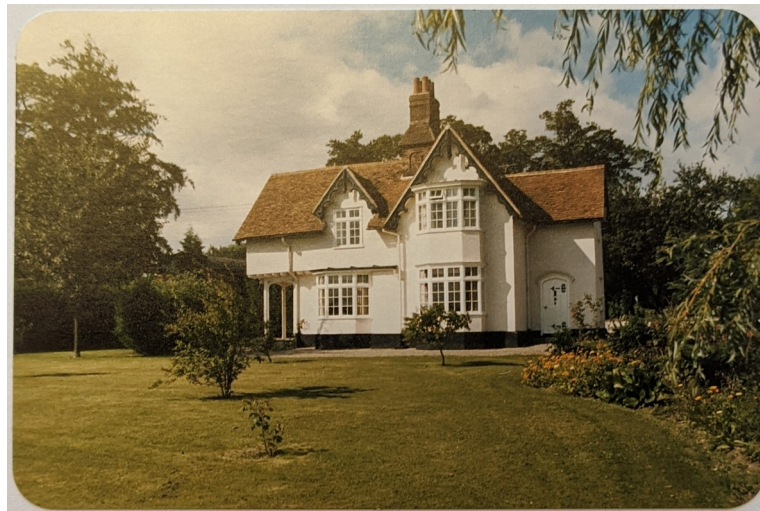
**Photograph 3** East elevation of the house, taken from 1986 sales catalogue ERO SALE-D1321.

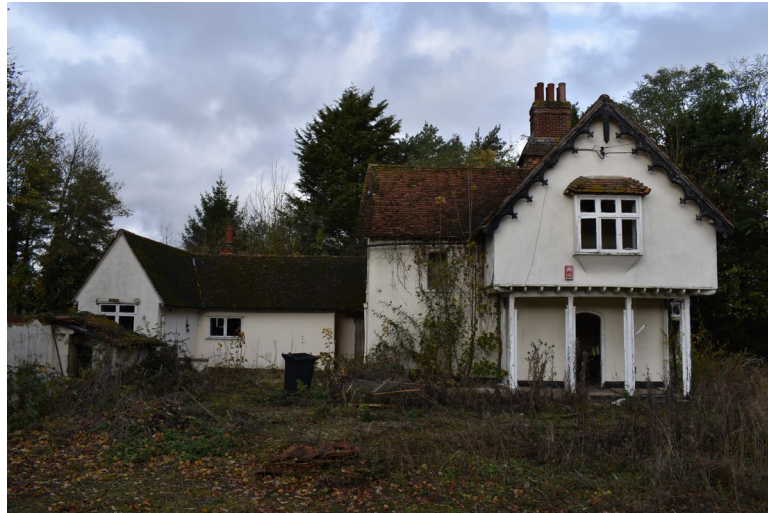
The main, two-storey ranges of the house are timber-framed and covered in lath and plaster, and supported on a largely obscured and painted over brick-plinth laid in an irregular Flemish-bond. In contrast, the single-storey ranges on the western side of the house are brick-built (again laid in Flemish-bond and with dimensions of 220 x 110 x 55mm) and rendered over (Photograph 4). All of the building's various roof pitches are covered in peg-tiles, and each range has a gabled roof.

**Photograph 4** Southern elevation of building. Photograph taken facing north.

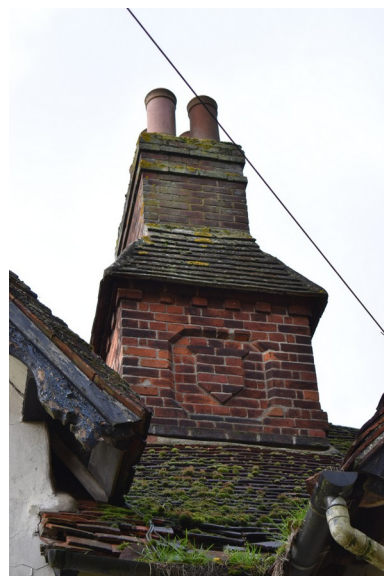
**Photograph 5** East side of chimney-stack, showing shield emblem. Photograph taken facing north-west.

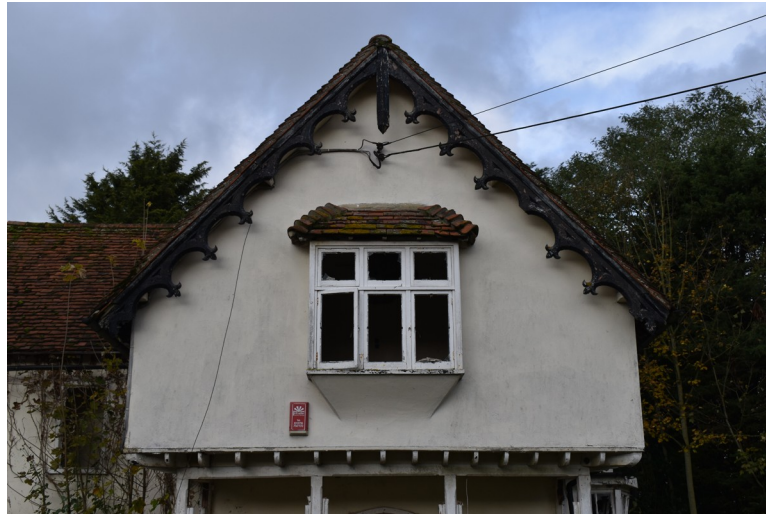
storey range has damaged decorative bargeboards with a *fleurs-de-lys* pattern (Photograph 6).

**Photograph 6** Detail of south gable-end, showing decorative bargeboards. Photograph taken facing north.

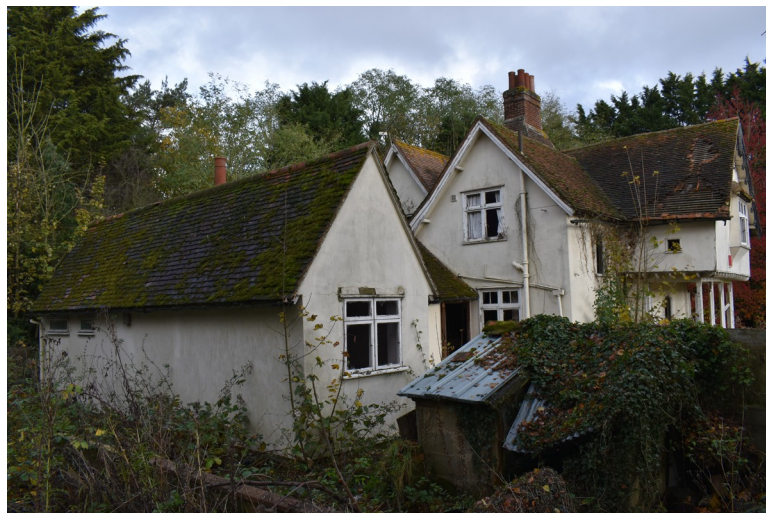
The western elevation of the house (Fig 5) has two single-light awning windows on the single-storey range and three four-light awning and casement windows on the west facing gable-ends of the two-storey ranges (Photograph 7). Also present on this elevation is a small single-light fixed window on the building's projecting upper storey (Photograph 7).

**Photograph 7** Western elevation of building. Photograph taken facing north-east.

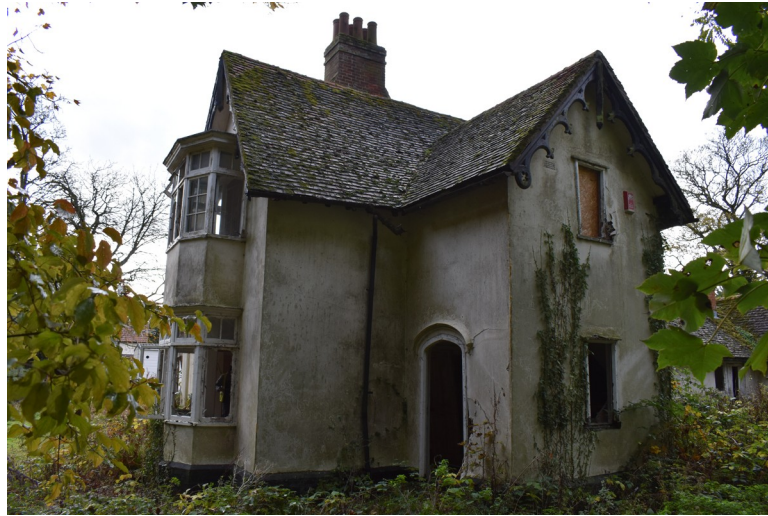
remaining (Photograph 8). This northern facing gable of the two-storey range has damaged decorative bargeboards containing *fleurs-de-lys* patterns (Photograph 8). A six-light casement/awning window survives on this elevation to the west of the north-facing gable (Fig 6).

**Photograph 8** North elevation of two-storey ranges. Photograph taken facing south-west.

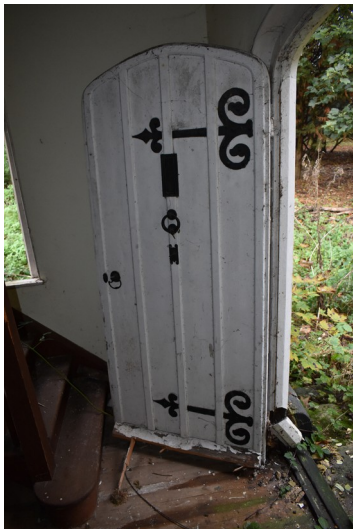
**Photograph 9** Exterior door on eastern elevation, with ornate hinges. Photograph taken facing north.

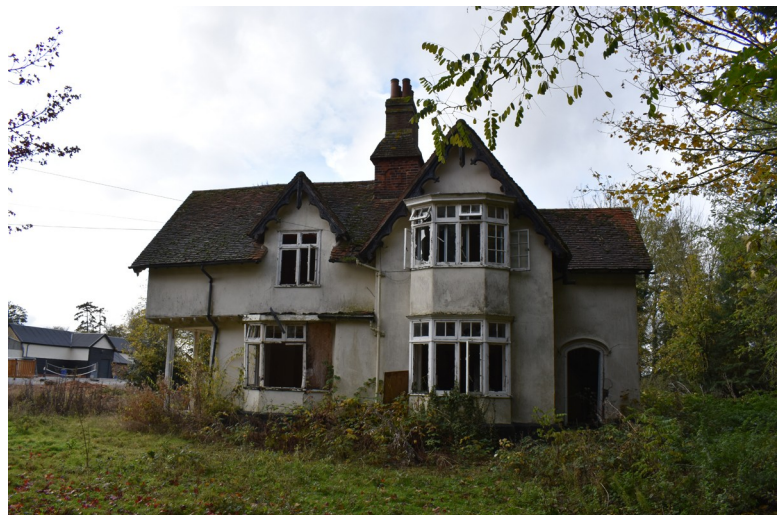
The eastern elevation of the house (Fig 7) has a surviving vertical-planked door with applied fillets and ornate hinges (Photograph 10). Also present on this elevation is a projecting large bay and oriel window extension, containing 18-light awning and casement windows on both the ground and first-floors (Photograph 9). A smaller bay window extension, on only the ground-floor, is also present on the southern half of this elevation, as is a four-light awning/casement window within a dormer and front-facing gable.

**Photograph 10** Eastern elevation of building. Photograph taken facing west.

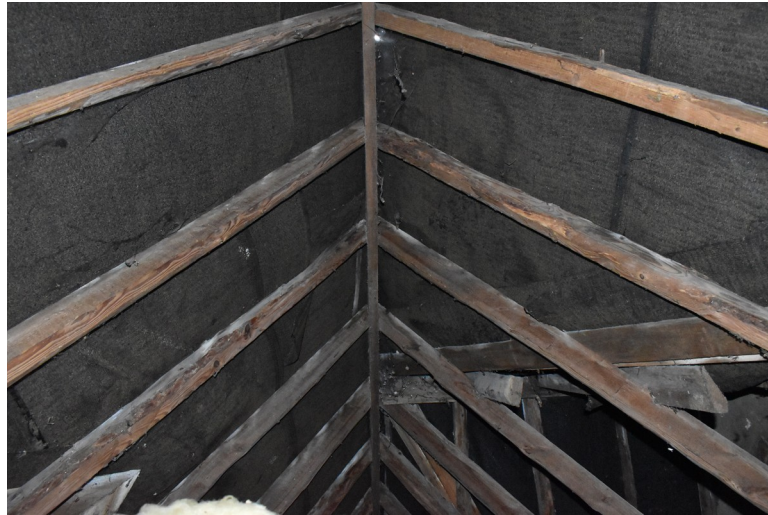
Where the roof of the building could be observed through loft hatches it was shown to be constructed of modern machine-cut timber, with rafters meeting at a ridge-board at the roof's apex, supported by occasional upper collars (Photograph 11).

**Photograph 11** Roof structure of two-storey range. Photograph taken facing east.

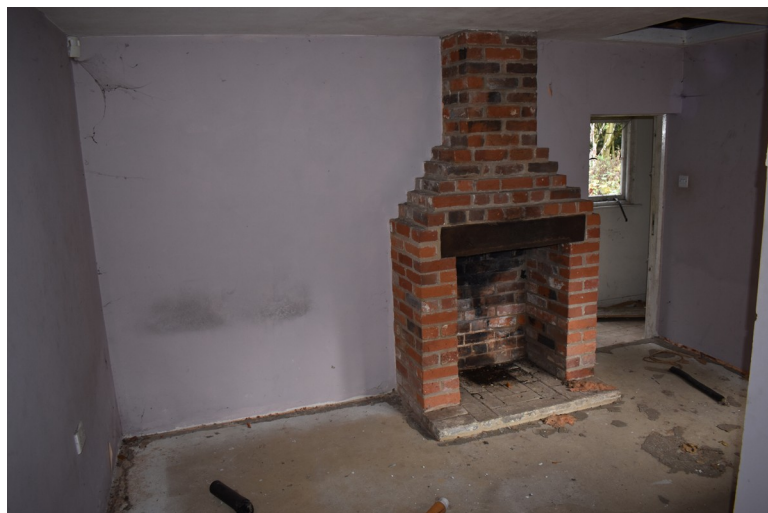
**Photograph 12** Interior of room 3, showing rebuilt fireplace. Photograph taken facing north-east.

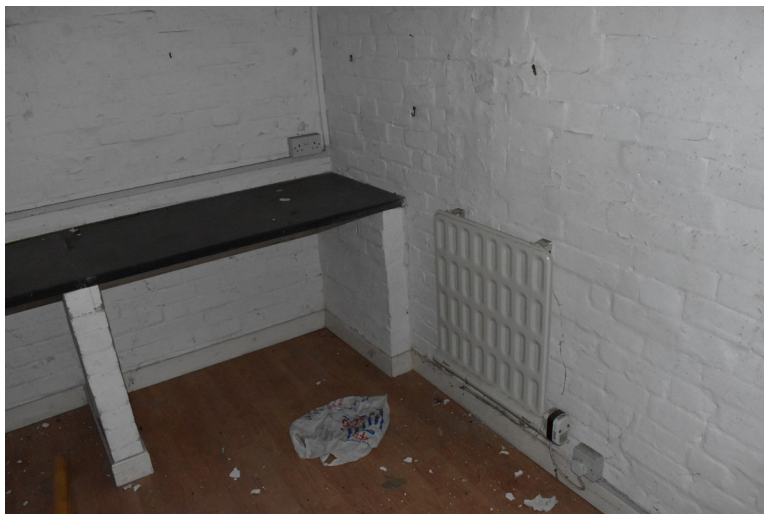
This room is within the single-storey range and contains shelves and counter-tops, with a lino floor (Photograph 13). Additionally, although the brickwork is painted over, it appears that there is a blocked entranceway on the western wall. This entranceway presumably dates from when the building was divided into two dwellings.

**Photograph 13** Interior of room 4, showing rebuilt brickwork indicating possible doorway in brickwork to right. Photograph taken facing south-west.

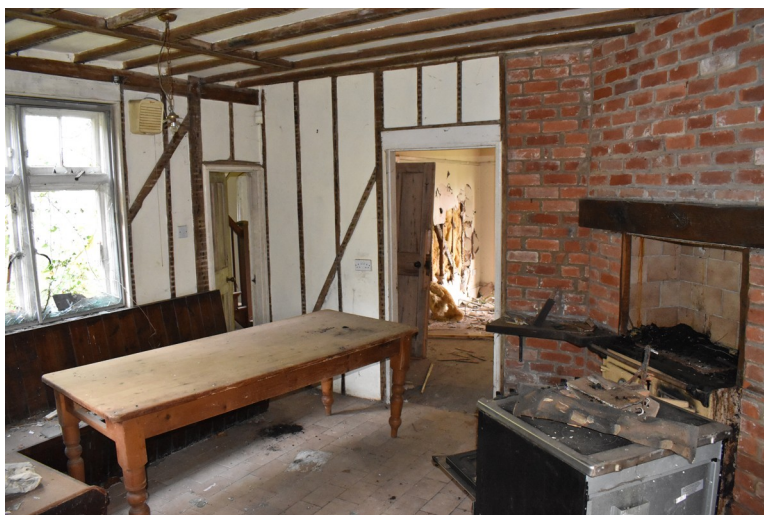
**Photograph 14** Interior of room 6, showing timber-framing and rebuilt fireplace. Photograph taken facing north-west.

This room is the current kitchen of the building. It has large amounts of timber-framing visible on its walls, alongside a tiled floor and a partially-blocked brick fireplace in its south-east corner (Photograph 14). The brickwork of this fireplace is laid in stretcher-bond, with measurements of 215mm x 120mm x 60mm, and appears to have been at least partially rebuilt, as it now surrounds an Aga and the flue has been blocked. The rebuilding of the fireplace and insertion of the Aga both probably date from the building's renovation in the 1980s (see historical background above). The majority of the visible timbers appear to be part of the fabric of the building and not later additions. A large beam visible in the ceiling, and supported by two arched braces, was (judging from mortices on its underside) originally supported by studwork which has since been removed (Photograph 15). Also present on east face of this beam are what appear to be Baltic shipping marks.

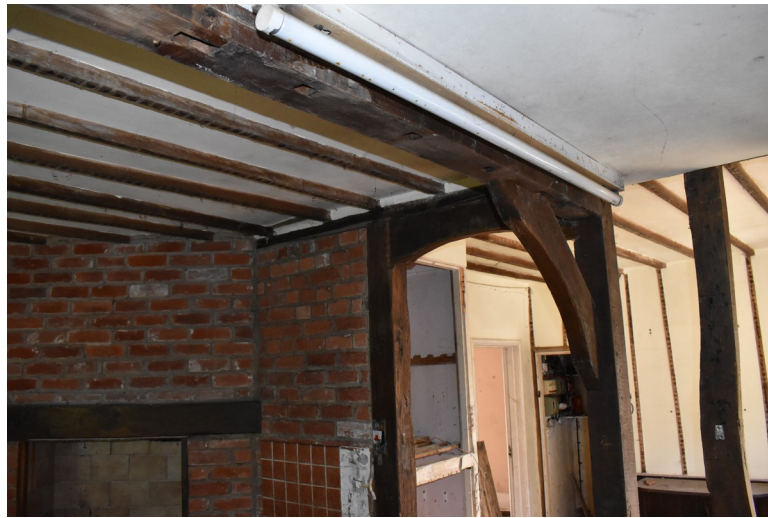
**Photograph 15** Underside of beam in ceiling of room 6, showing empty mortices. Photograph taken facing south-east.

The possible Baltic shipping marks observed in room 6 (pg 14) are commonly observed on timber-framed buildings of this period. The importing of timber into Britain from the Baltic began in the 17th century, but increased dramatically during the 19th (Vandenabeele et al 2016). The decline of local oak and other hardwood timbers in Britain was mainly due to an increase in shipbuilding and the economic pressures and needs of the Industrial Revolution. Because suitable trees take a significant time to mature, in densely populated countries like Britain land could usually be far more profitably used for farming rather than producing timber. The production of timber was a much more viable industry in the more sparsely populated countries around the Baltic Sea.

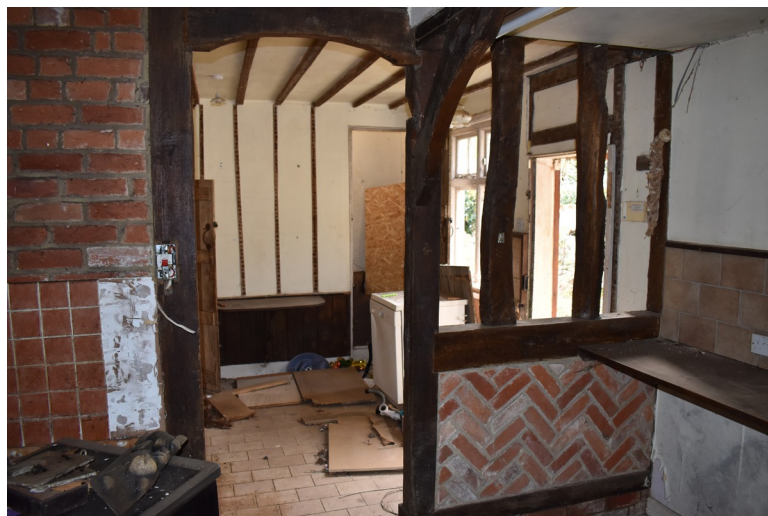
Between this room and room 9 to the south is a studwork division supported on a high plinth constructed of brick laid in a herringbone pattern (Photograph 16). Although the beam in the ceiling above this studwork appears original, the current studs seem to be later additions; they are oversized compared to the mortices and are larger than the studs elsewhere in the room (Photograph 16). The raised herringbone plinth must have been added at the same time. Like the addition of the brickwork and Aga, this division was probably added to the building during its renovation in the 1980s.

**Photograph 16** Herringbone brick plinth and studwork between rooms 6 and 9. Photograph taken facing south.

This studwork is presumably in the location of an original division within the building from when it was two dwellings.

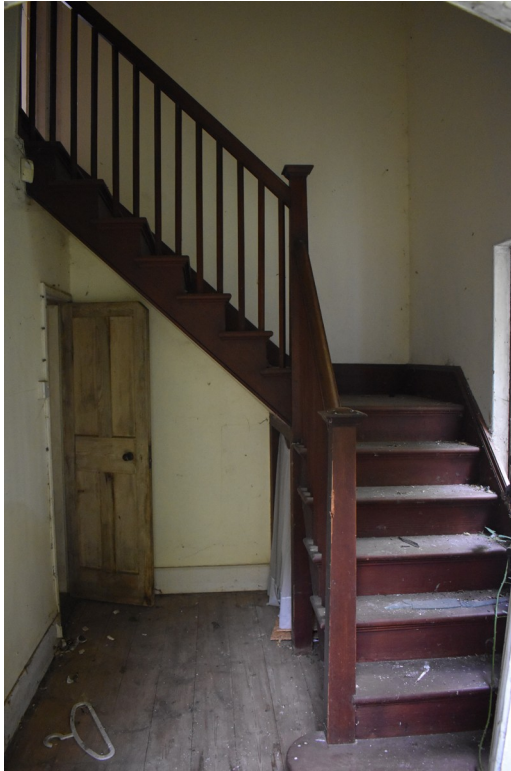
**Photograph 17** Interior of room 7, showing staircase and door leading to room 6. Photograph taken facing west.

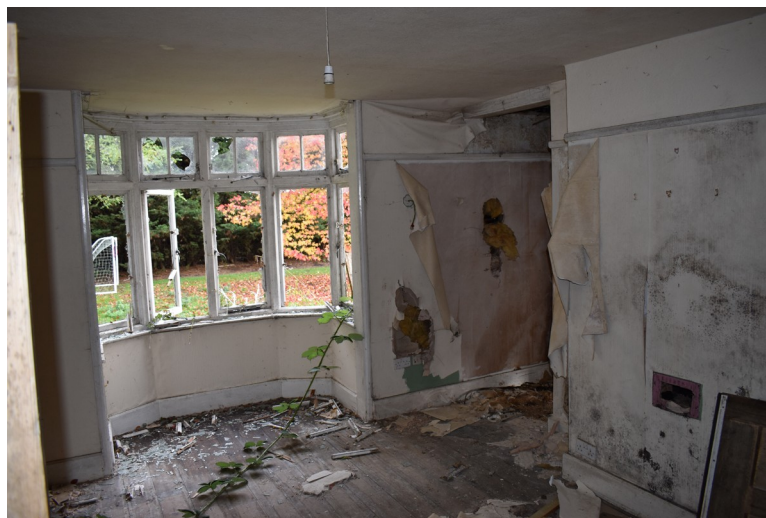
**Photograph 18** Interior of room 9, showing bay window extension and blocked fireplace. Photograph taken facing south-east.

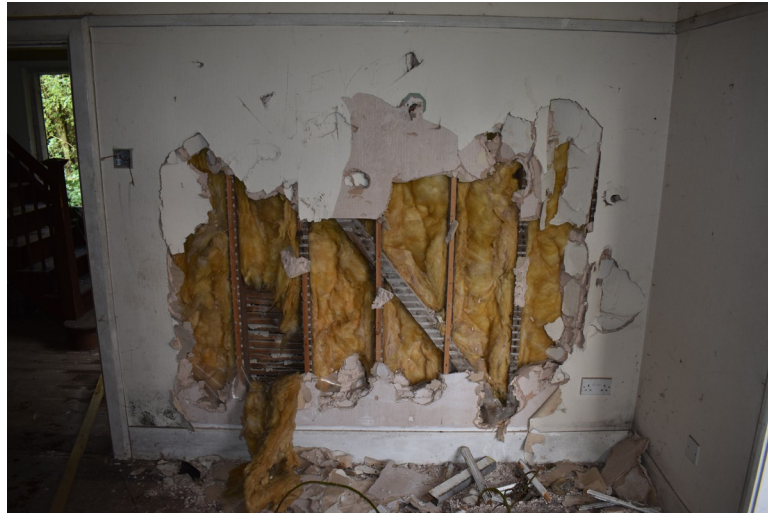
The northern wall of this room has had a section of the plaster removed, exposing the timber-frame (Photograph 19). The thin, machine-cut studs and through-bracing appear identical in size and spacing to those exposed in room 6 (see above).

**Photograph 19** Exposed section of timber-framing in room 9.  
Photograph taken facing north.

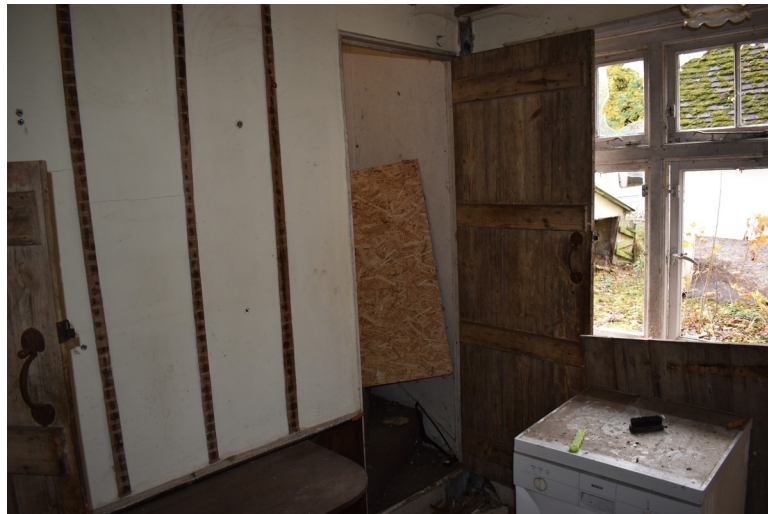
This room, much like the adjacent room 6 to the north, contains a large amount of exposed timber-frame, as well as a tiled floor (Photograph 20). The southern half of the room is occupied by a staircase up to the first-floor. Beneath the stairs is a cupboard. Both the staircase and cupboard are accessed via vertical-plank doors (Photograph 20).

**Photograph 20** Interior of room 9, showing doorway accessing staircase. Photograph taken facing south-west.

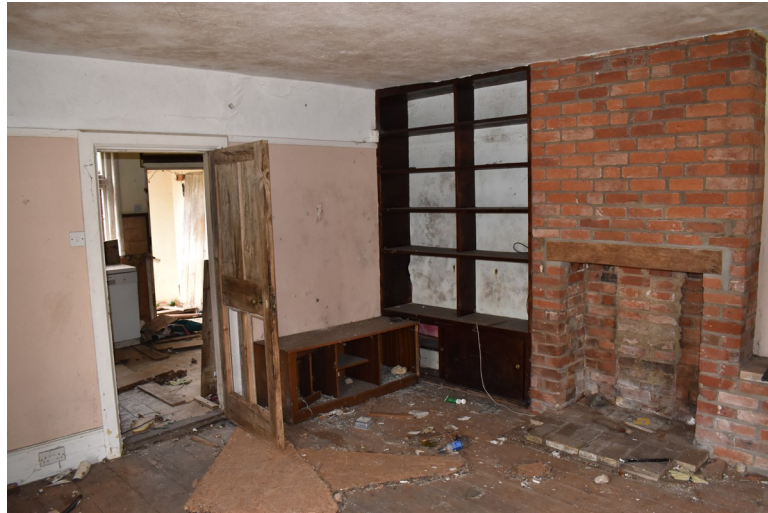
**Photograph 21** Interior of room 10, showing rebuilt fireplace and inserted shelving. Photograph taken facing north-west.

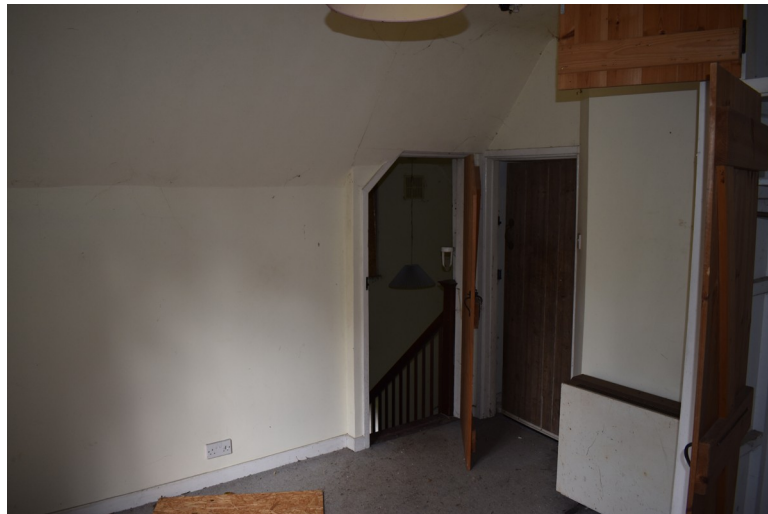
This room has a carpeted floor and is access via doorways from rooms 7, 12 and 14. All of these doorways contain vertical-planked doors, the ones leading to rooms 7 and 14 are very clearly modern replacements, whereas the one leading to room 12 appears original (Photograph 22).

**Photograph 22** Interior of room 11, showing doorways to room 7 (to left) and room 12 (to right). Photograph taken facing north-east.

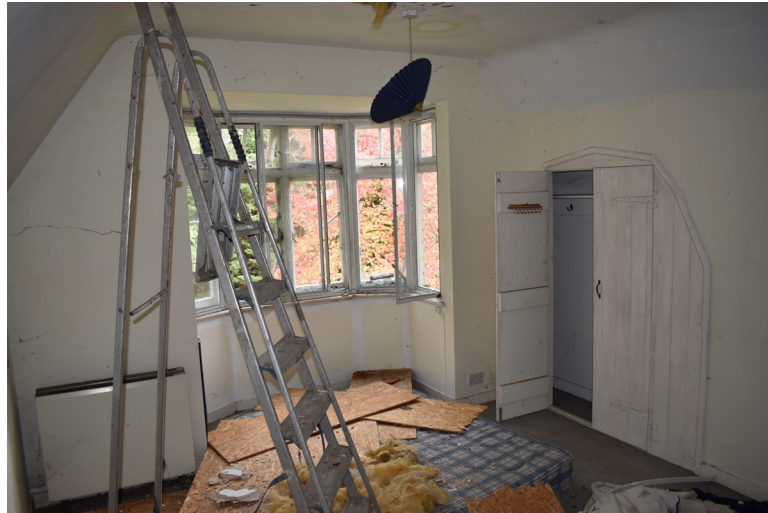
Like the room immediately below on the ground-floor (room 8), this room has been extended by the construction of an oriel window on its eastern wall (Photograph 23). The fireplace on the southern wall has been totally blocked and in-filled on either side by cupboards with vertical-planked doors (Photograph 23).

**Photograph 23** Interior of room 12, showing oriel window extension and inserted cupboard to right. Photograph taken facing south-east.

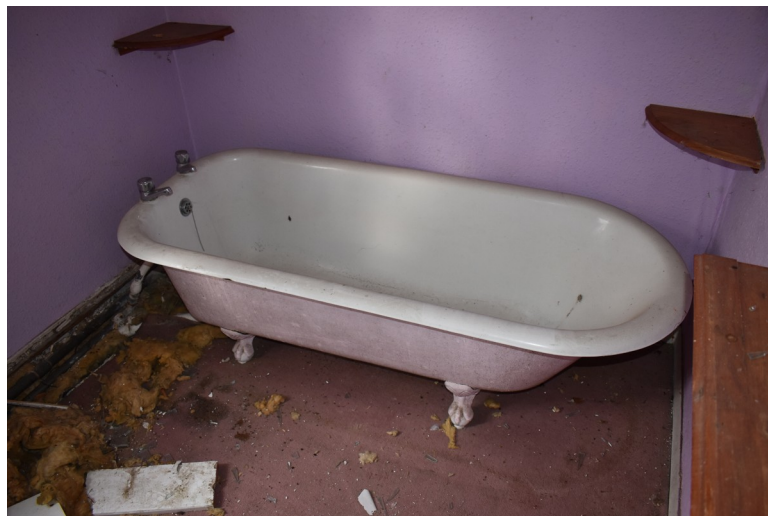
This room is currently outfitted as a bathroom, and is dominated by a large cast iron free-standing bath in its northern half, presumably the same one as mentioned in the 1986 sales catalogue (Photograph 24). The vertical-planked door to room 14 is modern, and indeed the entire dividing wall between rooms 13 and 14 is probably a later insertion (Fig 3).

**Photograph 24** Interior of room 13, showing cast-iron bathtub. Photograph taken facing north.

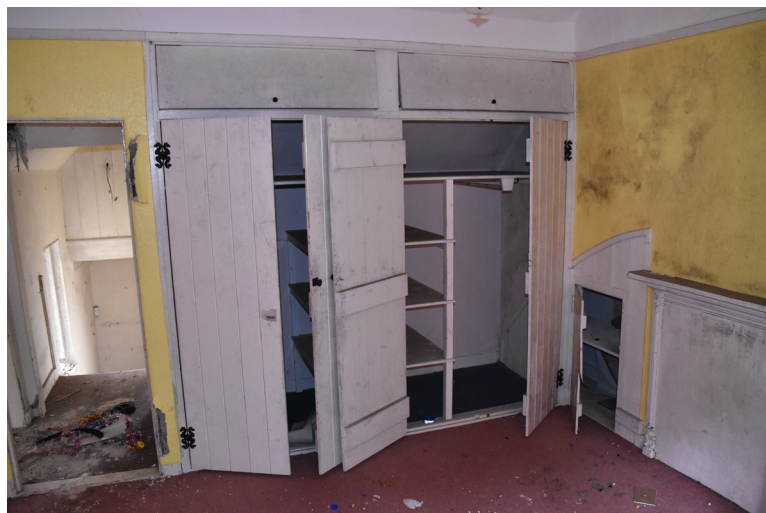
This room contains several inserted cupboards with vertical-planked doors, both on the western wall and also surrounding the fireplace (Photograph 25). The cupboards on the western wall seem to be a later addition than the ones on either side of the fireplace, as they partially obscured some wooden panels associated with the latter.

**Photograph 25** Interior of room 15, showing inserted cupboards. Photograph taken facing north-west.

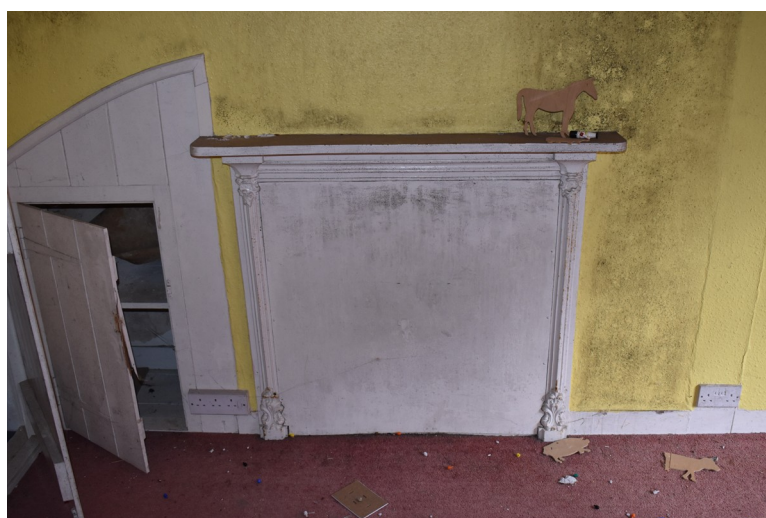
**Photograph 26** Detail of blocked fireplace in room 15. Photograph taken facing north.

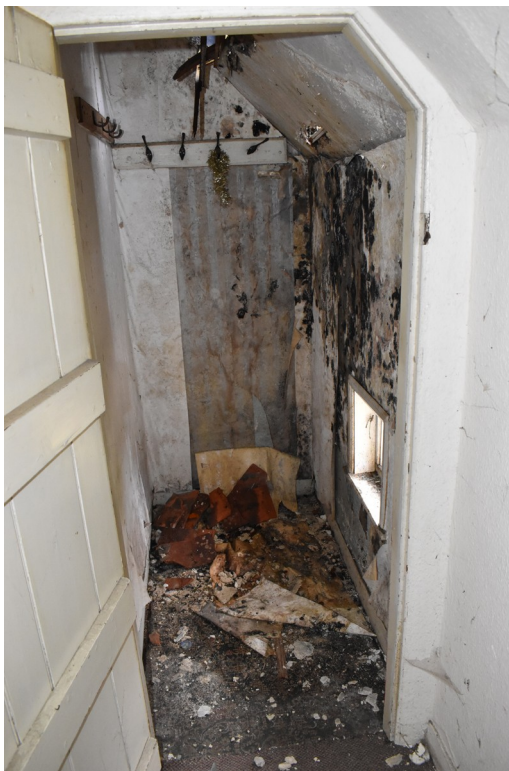
This room is part of the suspended section of the first-floor, over the veranda at the south end of the building (Fig 3). It is a small, walk-in, cupboard with hooks on its southern wall. This room has suffered significant damage as the roof above it has partially collapsed, resulting in severe water damage particularly to its western wall (Photograph 27). The dividing wall between this room and room 17 is probably a later addition.

**Photograph 27** Interior of room 16, showing water damage due to hole in roof. Photograph taken facing south.

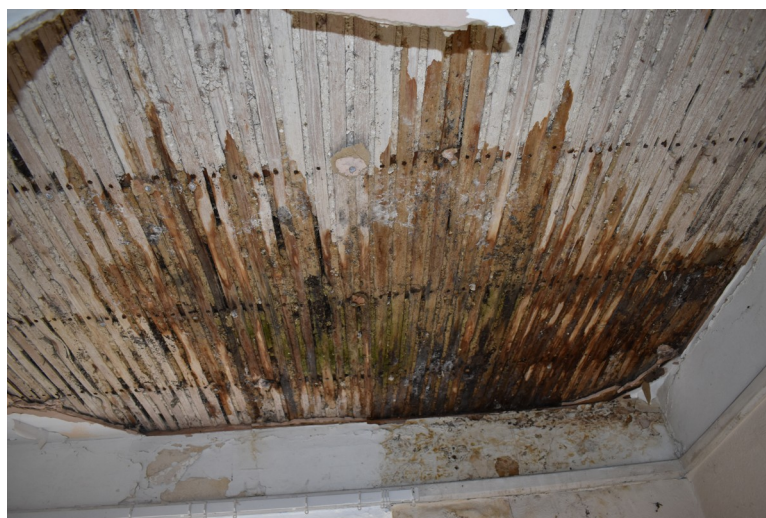
**Photograph 28** Roof of room 17, showing exposed lath and plaster. Photograph taken facing south.
