**Historic building recording at
Princes Halfyards,
Stebbing Road, Felsted,
Essex CM6 3LG**

**report prepared by
Mark Baister**

CAT project ref.: 2020/07n
NGR: TL 68245 22072 (c)
Planning reference: UTT/19/1235/FUL
ECC code: PHFL20
OASIS project id: colchest3-400269

CAT Report 1601
October 2020

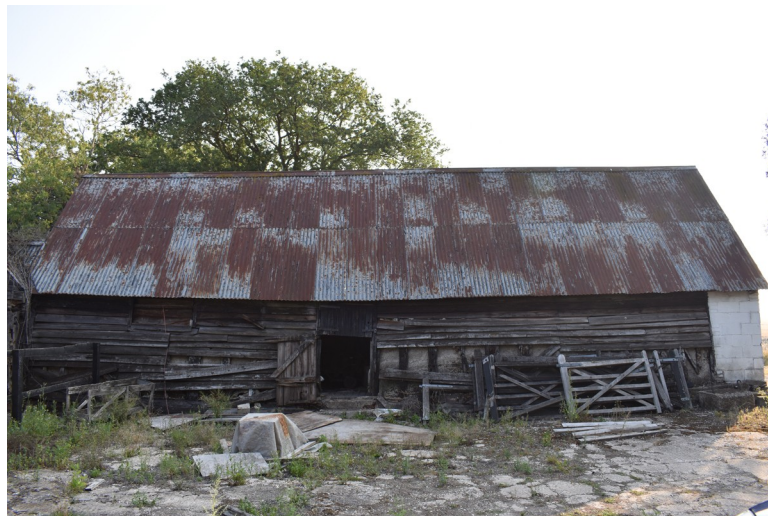
The outbuilding is a single-storey timber-framed structure, covered in traditional weatherboarding. It is supported on a largely-obscured brick plinth, laid in mixed English-bond and made of shallow-frogged bricks, measuring 220mm x 110mm x 60mm in size. The roof of the outbuilding is covered in panels of corrugated tin, laid on a steep pitch (Photograph 1).

Photograph 1 South-west elevation of outbuilding, bays 2 and 3. Photograph taken facing north-east.

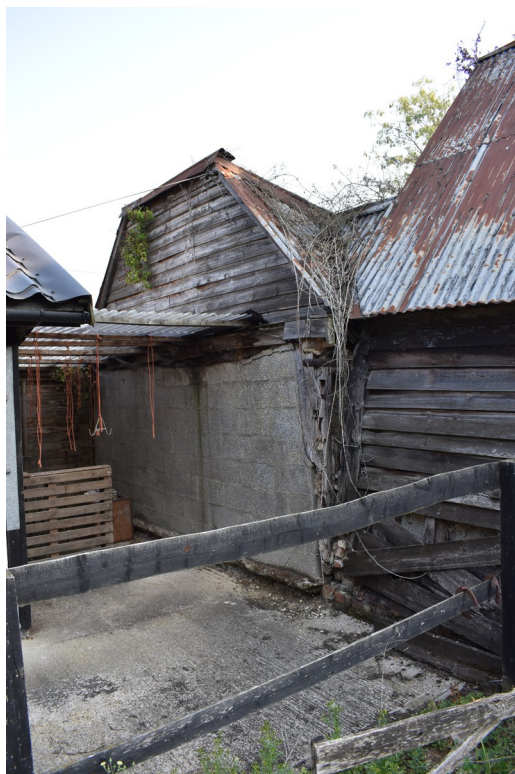
Photograph 2 South-west elevation of outbuilding, bay 1, showing concrete block infilling. Photograph taken facing north.

The structure is in significant disrepair and has been the subject of at least one phase of rebuilding, with the south-east gable-end having been almost completely replaced with concrete blocks and brickwork (Photograph 3). In addition, the south-west elevation of the building's northern bay (where originally it would have joined with the since demolished range; see above) has been in-filled, again with concrete blocks (Photograph 2).

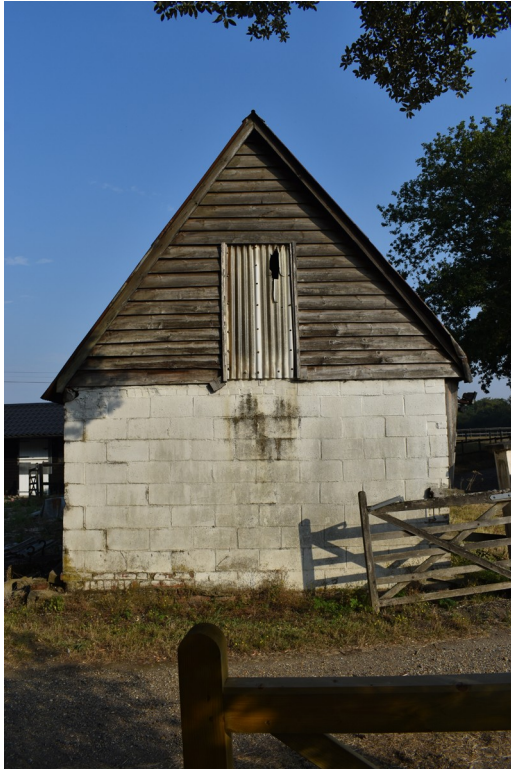
Photograph 3 South-east elevation of the outbuilding. Photograph taken facing north-west.

The lower register of the south-east elevation of the outbuilding is entirely constructed of concrete blocks and brickwork, and in the weatherboarded gable is a window opening covered in corrugated plastic (Photograph 3).

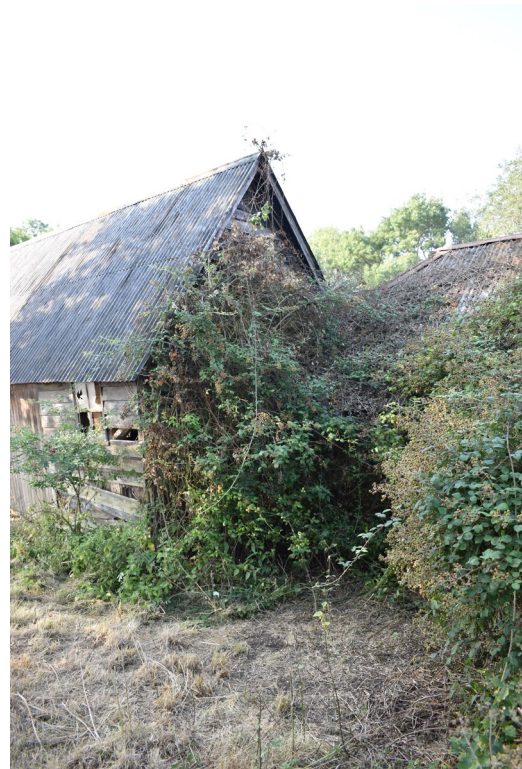
Photograph 4 North-west elevation of outbuilding, showing overgrowth. Photograph taken facing south.

The north-west elevation of the outbuilding is largely obscured by overgrowth, but appears to be featureless (Photograph 4; Fig 5).

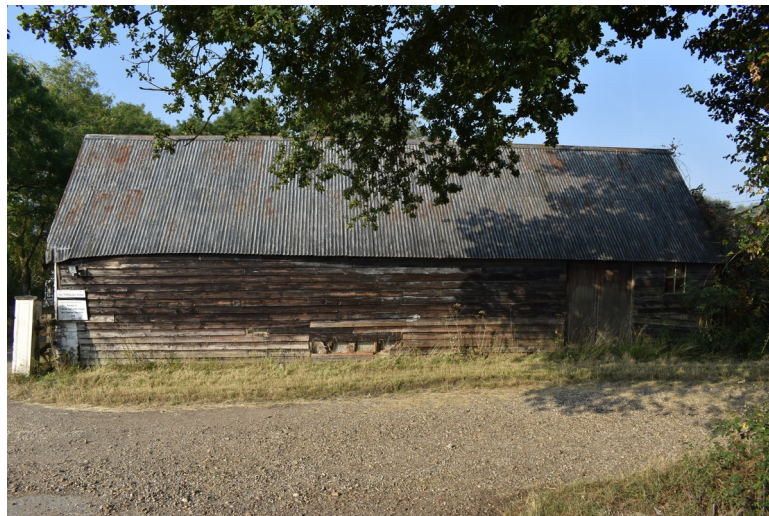
Photograph 5 North-east elevation of the outbuilding. Photograph taken facing west.

The north-east elevation of the outbuilding (Photograph 5) has an entrance filled with a vertically-planked double door, adjacent to a small inserted four-light window (which is boarded up internally).

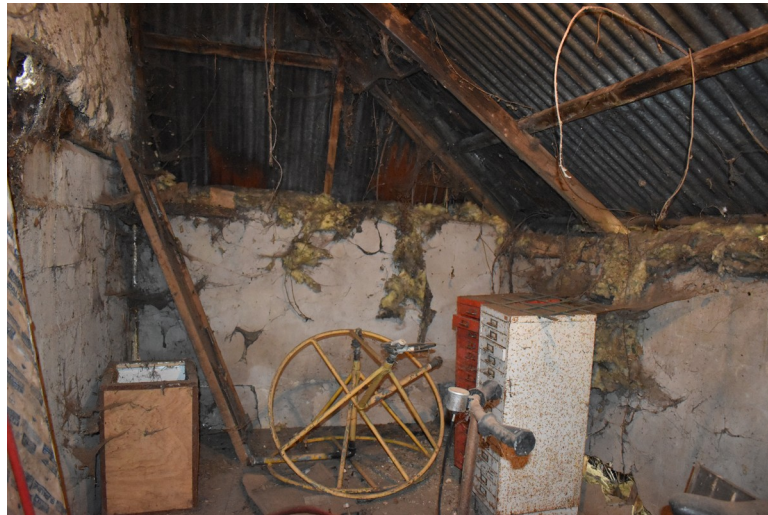
The northern bay (bay 1) is all that remains of the north-east/south-west aligned structure visible on earlier mapping (see above). It measures 4.7m in length and its roof is mostly a single pitch, partially hipped to the south and north, constructed entirely of modern machine-cut timber (Photograph 6). The timber-frame of this bay (below the roof) is obscured by render and concrete additions, but in small sections where it is visible it appears to be constructed of hand-sawn timber (Photograph 7). The floor of this bay is concrete.

Photograph 6 Interior of bay 1. Photograph taken facing north-west.

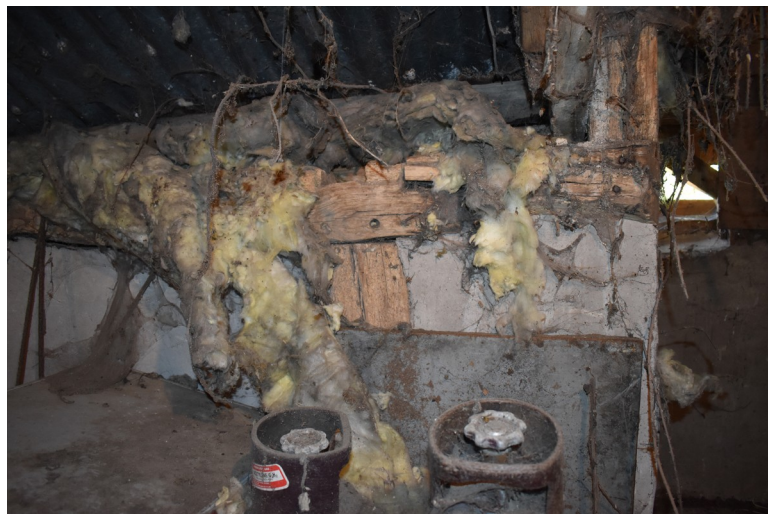
Photograph 7 Detail of small section of exposed ?hand-sawn timber in bay 1. Photograph taken facing north-east.

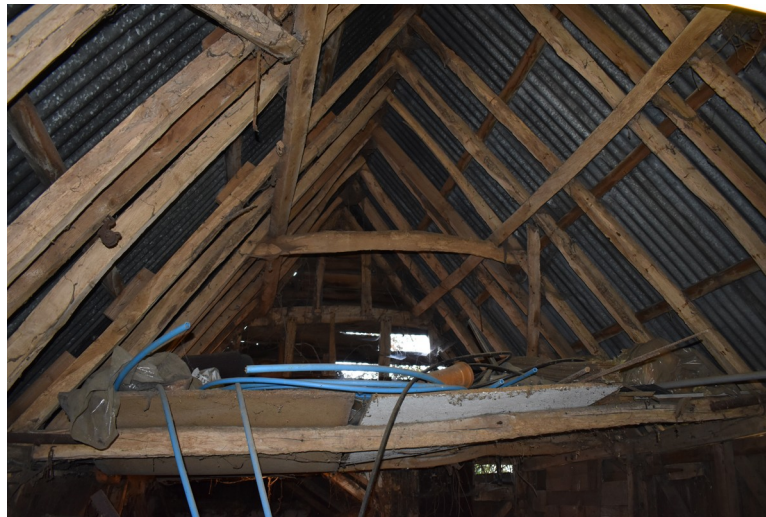
Bay 2's timber-frame, including the roof, is entirely hand-sawn and pegged-together, although it is sawn in a very rudimentary fashion. Many timbers (particularly the rafters) are quite sinuous, and several timbers still have patches and strips of bark (Photograph 9).

Photograph 9 Interior of bay 2, showing roof structure and suspended floor. Photograph taken facing north-west.

The roof of bay 2 consists of pairs of rafters meeting at the apex of the roof (there is no ridge-board). These rafters are supported by wind-braces and a single purlin on each roof pitch, which is clasped by, in this bay, three collars (Photograph 9).

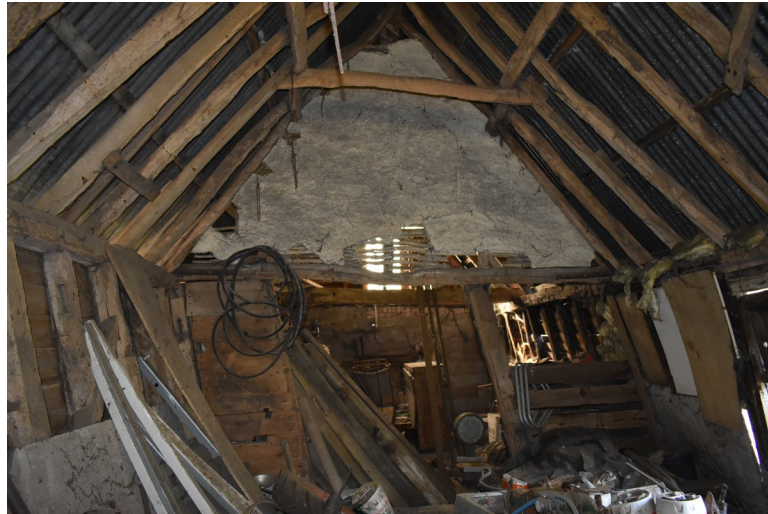
Photograph 10 Interior of bay 2, showing bay division between bays 2 and 3. Photograph taken facing south-east.

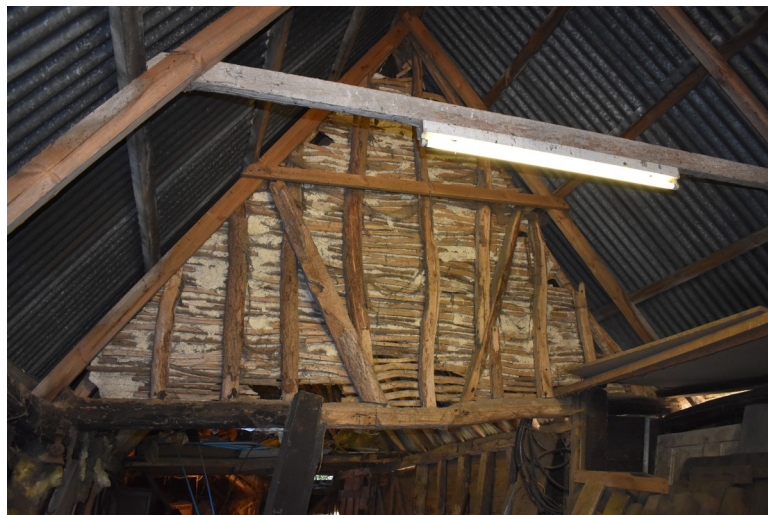
The tie-beam between bays 2 and 3 is not supported by any bracing, and appears to never have been (there are no empty mortices on its underside). Instead it is supported by metal braces at each end (Photograph 10). Rising from the tie-beam are two hand-sawn inclined-struts, along with 8 studs, all rising to the rafters (Photograph 11). The northern side of this arrangement is covered in lath and plaster, while the southern side

is exposed (Photograph 11). Below this tie-beam are several modern machine-cut timbers forming a partial division and entrance between bays 2 and 3.

Photograph 11 Interior of bay 3, showing division between bays 2 and 3. Photograph taken facing north.

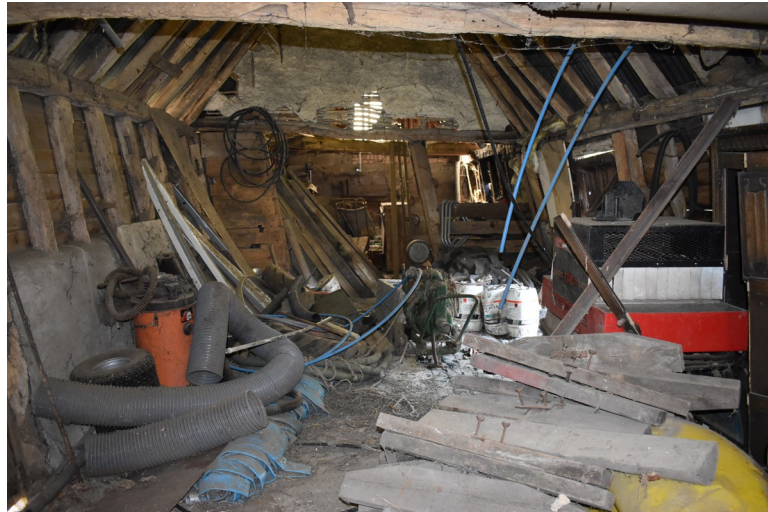
The lower-half of the timber-frame in bay 2, including the sill-beam, is obscured by concrete (Photograph 12). The visible frame comprises studs supported by through-bracing. The two doors into the structure lead into this bay (on the north-east and south-west elevations) and examination of the wall-plate above both of these shows that neither are original entrances into the building; they both have empty mortices above indicating that studs have been removed in order to insert the doors.

Photograph 12 Interior of bay 2. Photograph taken facing south-east.

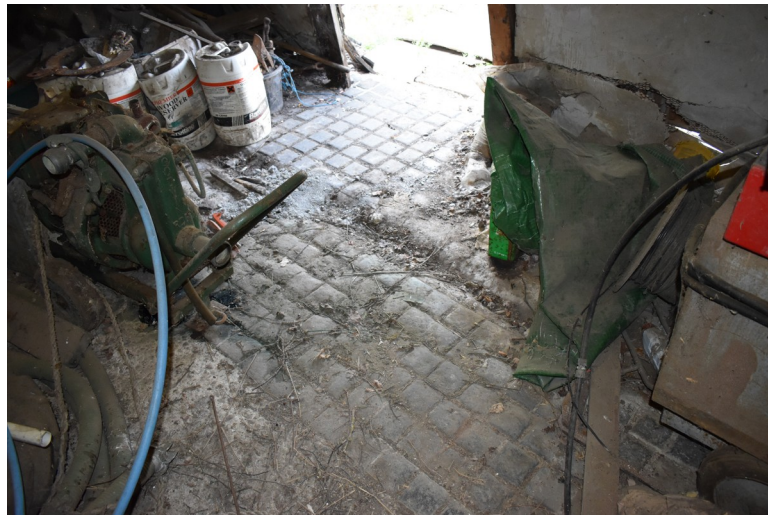
The floor of bay 2 is concrete, with the exception of a section of square-cobbled floor in front of the door on the south-west elevation (Photograph 13). This section of flooring also includes a drainage gully.

Photograph 13 Detail of surviving cobbled floor and drainage run in bay 2. Photograph taken facing south.

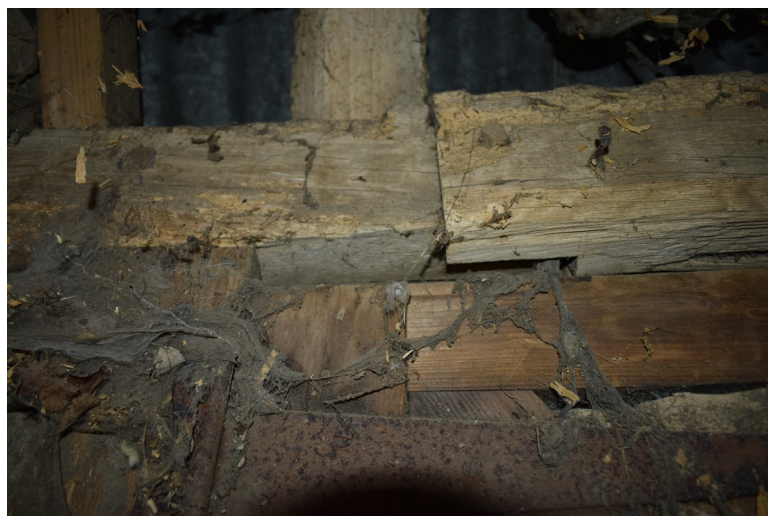
Photograph 14 Detail of face-halved scarf in bay 2, above double-doors on north-east elevation. Photograph taken facing north-east.

Two scarf joints were observed on the wall-plates of this bay. One is above the double-door on the north-east elevation and, although partially obscured, appears to be a face-halved and bladed scarf with two edge-pegs (Photograph 14). The other scarf joint is just to the north of the tie-beam separating bays 2 and 3, and is a much more rudimentary edge-halved scarf with square abutments (Fig 2).

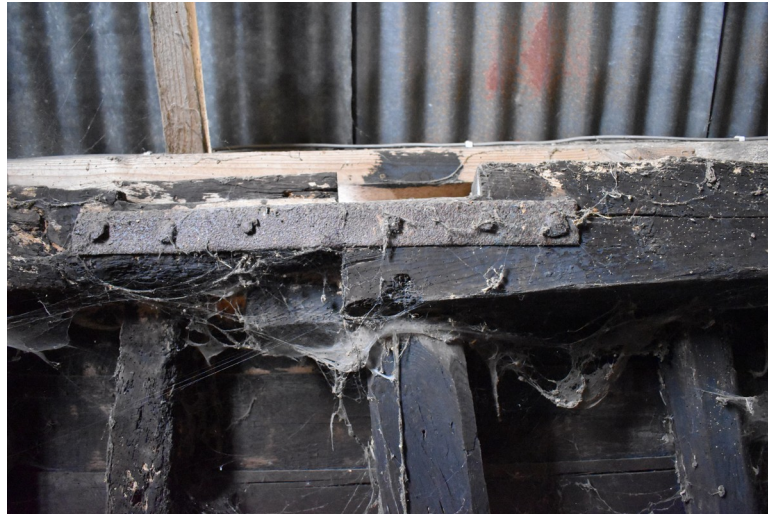
As described above, the southern end of bay 3 is constructed of concrete blocks and brickwork, with machine-cut timbers above forming the gable (with a window opening covered in corrugated plastic; Photograph 15). The concrete blocks and brickwork have a wall-plate sitting on them, and on both the north-east and south-west elevations

it is joined to the wall-plate of the timber-frame proper by extremely rudimentary face-halved scarfs, heavily supported by metal straps (Photograph 17).

Photograph 17 Detail of rudimentary scarf joint supported by metal strap in bay 3, connecting wall-plate to rebuilt gable-end. Photograph taken facing south-west.
