**Historic building recording  
of Maldon Wycke Barn,  
Spital Road, Maldon,  
Essex, CM9 6SQ**

**April 2021**

**CAT Report 1675**  
May 2021

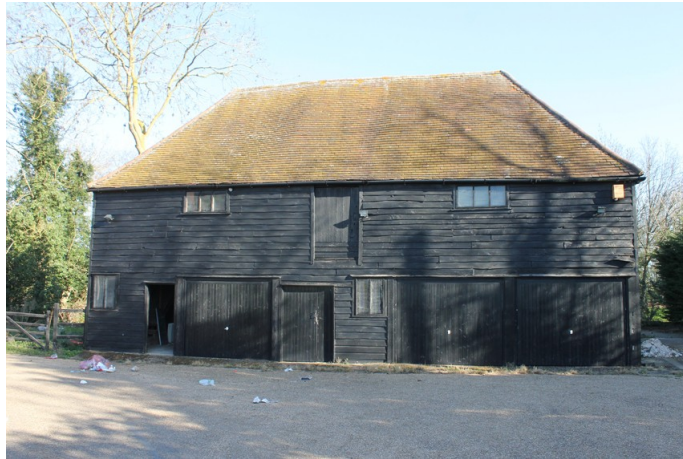
The southern elevation of the building has two vertically-planked doors at the ground-floor level, along with three garage doors (Photograph 1). Also present on the ground-floor are two fixed two-light windows (Photograph 1). All of these features are modern additions.

**Photograph 1** Southern elevation of building.  
Photograph taken facing north.

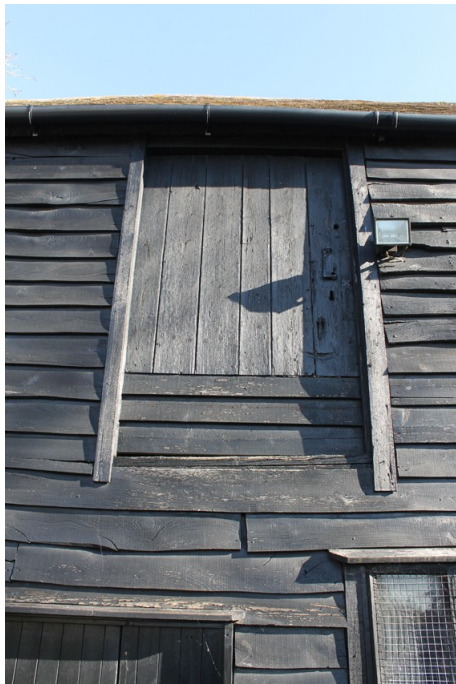
**Photograph 2** Detail of pitching-door on southern elevation. Photograph taken facing north.

The first-floor on this elevation has another two modern fixed windows, this time of three-lights. In the centre of the first-floor of this elevation is a vertical-planked pitching-door (Photograph 2).

All the current external features appear to be modern additions, with the exception of the pitching-door on the southern elevation, which is probably original to the second-storey granary (pg 12).

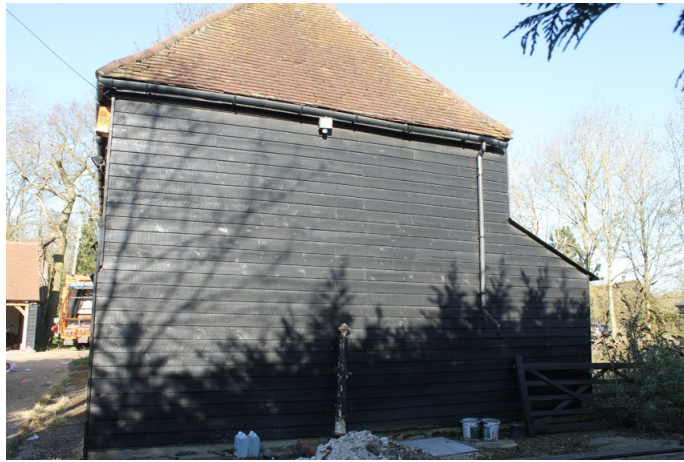
The eastern elevation of the building is featureless (Photograph 3).

**Photograph 3** Eastern elevation of building. Photograph taken facing west.

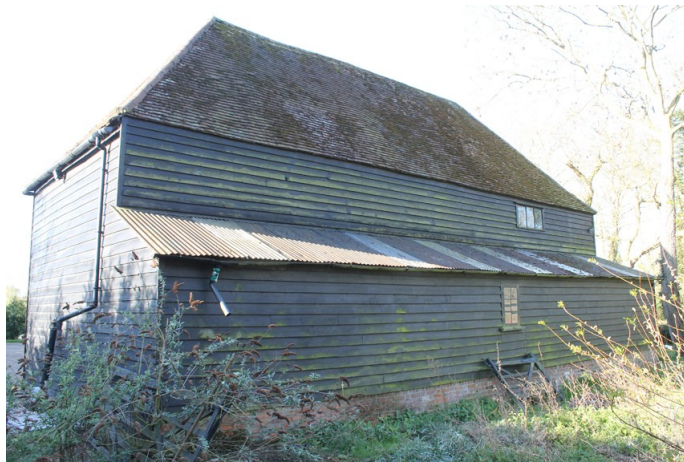
The northern elevation has a modern six-light fixed window on the ground-floor lean-to, and a modern three-light fixed window on the first-floor (Photograph 4). The brick plinth on this elevation consists of six courses, laid in Flemish bond and with brick measurements of 225 x 105 x 65mm (Photograph 4).

**Photograph 4** Northern elevation of building, show lean-to supported on brick plinth. Photograph taken facing south-west.

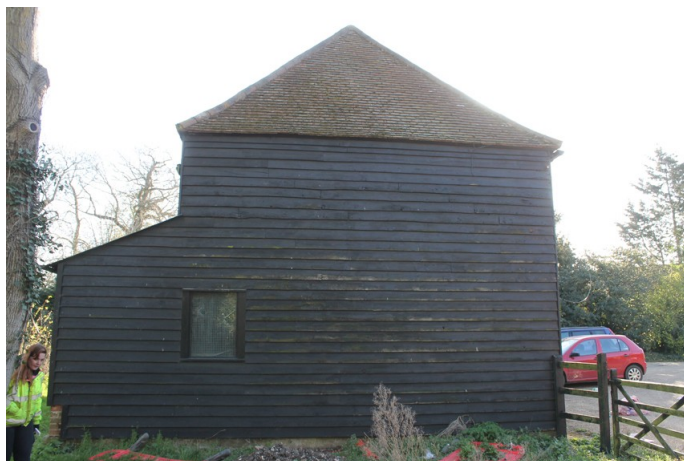
The western elevation contains a blocked modern fixed single-light window (Photograph 5).

**Photograph 5** Western elevation of building. Photograph taken facing east.

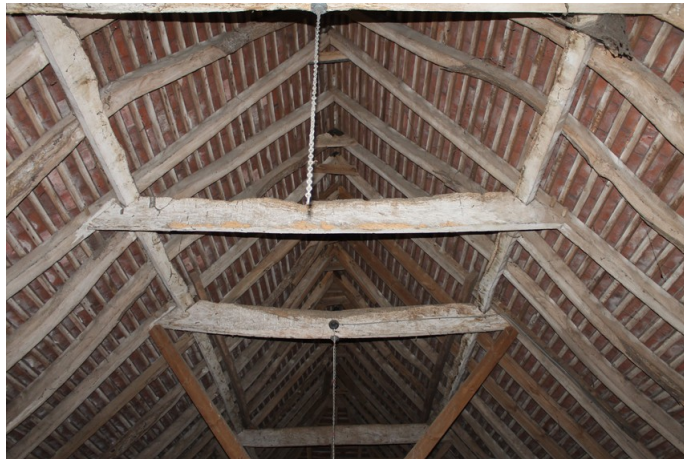
**Photograph 6** Detail of roof, showing hand-sawn collars, rafters and purlins. Photograph taken facing east.

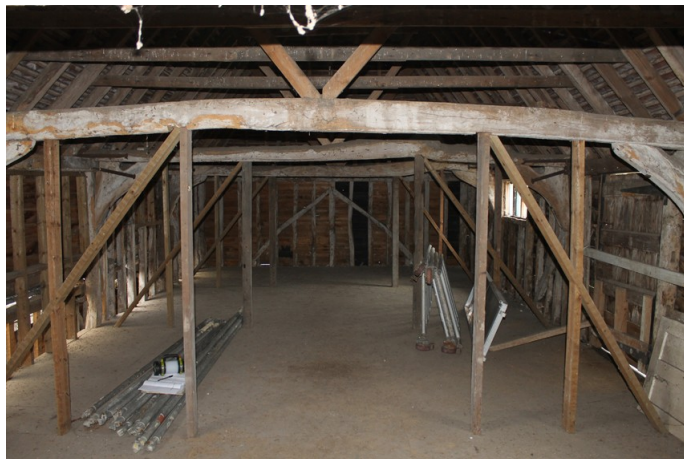
The building has a hipped roof, which structurally consists of pairs of rafters meeting at the roof's apex, where they are pegged together (there is no ridge-board). These rafters are supported by a single clasped purlin on each roof pitch, as well as collars at bay and some mid-bay intervals (Photograph 6). The tie-beams separating the building's bays are hand-sawn, with some being quite sinuous. They are supported at both ends by knee braces. Several of the tie-beams have inclined struts rising from them to further support the roof, but these are all machine-cut and clearly later additions to the frame (Photograph 6). Beneath each of the tie-beams are several more modern timbers, providing further support (Photograph 7).

**Photograph 7** First-floor, showing tie-beams and machine-cut timbers. Photograph taken facing east.

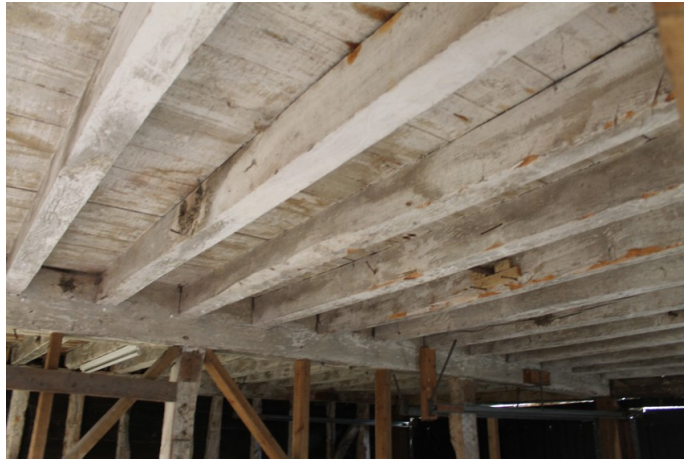
The majority of the remaining timber-frame consists of hand-sawn timber, pegged together and supported with through-bracing (although in several locations there are later, modern, machine-cut additions or repairs, most prominently in bays 1, 2 and 3: see below). Each bay has a girding-beam separating the lower and upper register, which interrupt the principal and corner-posts. Jointed into these girding-beams and the principal-posts below are a series of binding-beams crossing the width of the building, positioned at bay intervals (Photograph 8). These binding-beams supports joists aligned east-west across the building, which in turn support the first-floor (Photograph 8).

**Photograph 8** Floor joists above bay 3, showing binding-beam between bays 3 and 4. Photograph taken facing south-east.

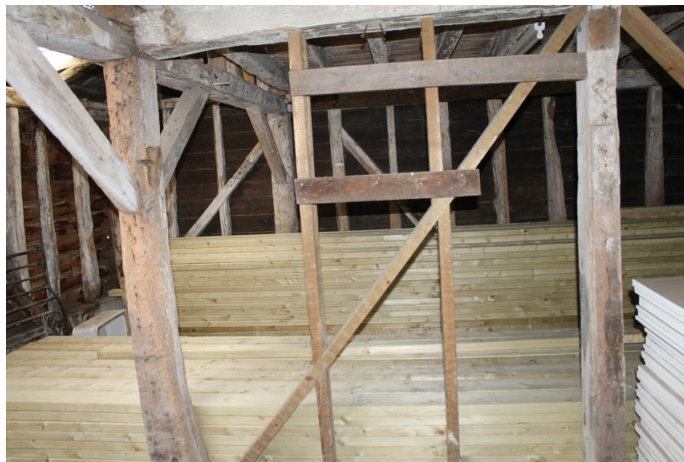
**Photograph 9** Detail of original posts and modern additions supporting binding-beam between bays 3 and 4. Photograph taken facing east.

The binding-beams between each bay are further supported by two hand-sawn studs (Photograph 9). Several modern machine-cut studs and braces have also been added beneath the binding-beams to provide additional support (Photograph 9). In addition, all of the studs beneath the binding-beams, whether original or modern, are jointed to modern machine-cut sill-beams supported on a concrete plinths.

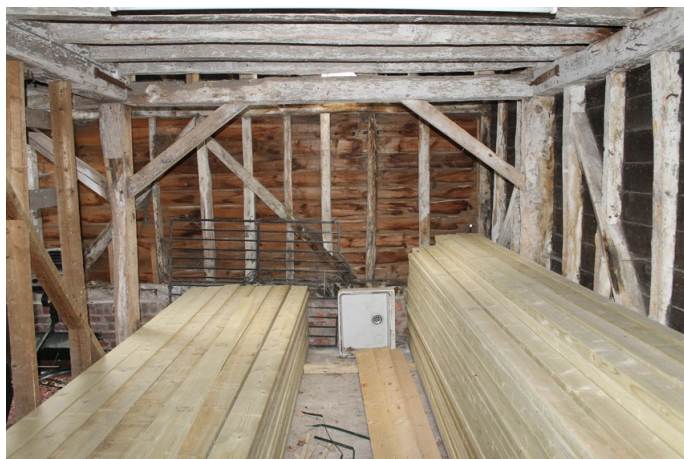
**Photograph 10** Northern elevation of bay 5, showing open lower register leading into lean-to and bracing supporting girding-beam. Photograph taken facing north.

The lower register of each bay's northern elevation is open, with bracing supporting the girding-beams above (Photograph 10). Some of these braces are original and have chiselled carpenter's marks on their northern sides (Fig 2), mirroring ones on the principal-posts on this elevation (see bay descriptions below).

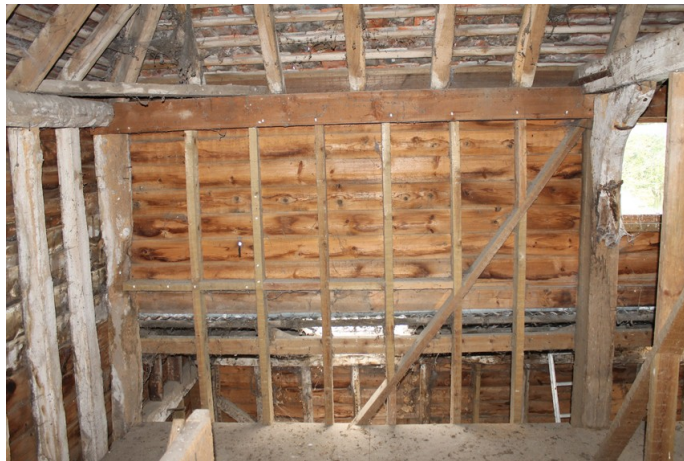
The entirety of bay 1 has been rebuilt and is constructed of machine-cut modern timber, nailed together. This includes the girding-beam on the northern elevation, its associated principal-posts, the binding-beam between bays 1 and 2, the joists supporting the first-floor, and the wall-plate (Photograph 11). Additionally, the roof above bay 1, including the western hip of the building, has also been rebuilt with machine-cut timber (Photograph 12). The only exception to this is the upper-register on the western and southern elevation, which are both constructed of, presumably re-used, nailed together hand-sawn timber (Photograph 13). Also present within bay 1 is a modern staircase connecting the ground and first-floors, constructed of machine-cut timber (Photograph 14).

**Photograph 11** Northern elevation of bay 1 on first-floor, showing modern studs and wall-plate. Photograph taken facing north.

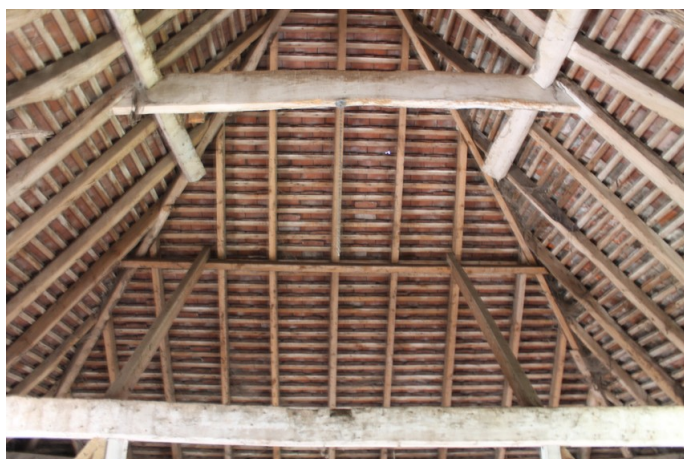
**Photograph 12** Detail of roof hip above bay 1, entirely constructed of machine-cut timber.

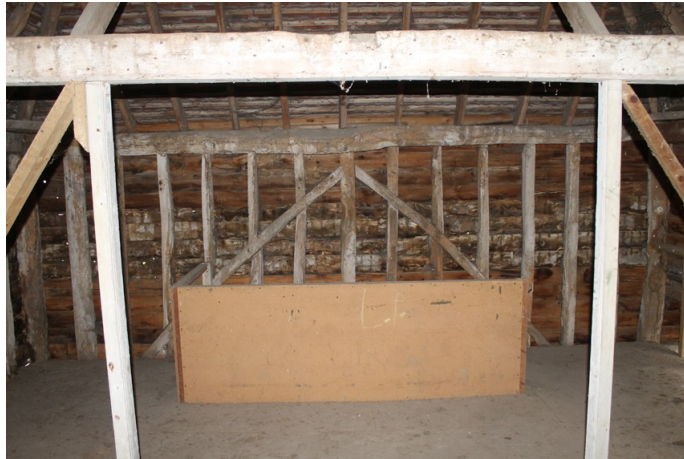
**Photograph 13** Detail of western elevation of bay 1, showing re-used hand-sawn timber. Photograph taken facing west.

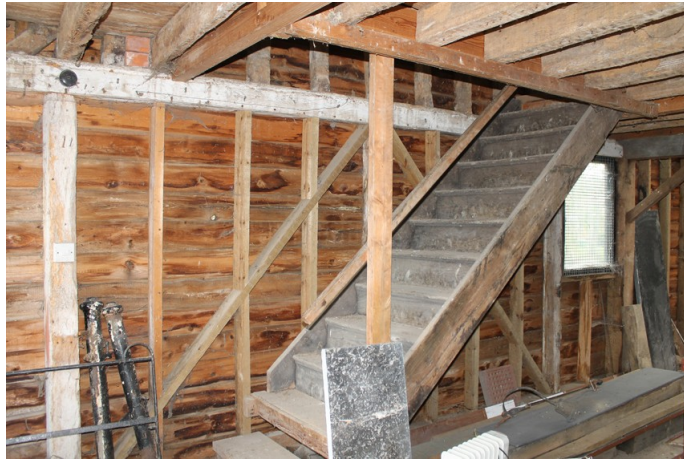
**Photograph 14** Inserted staircase in bay 1. Photograph taken facing north-west.

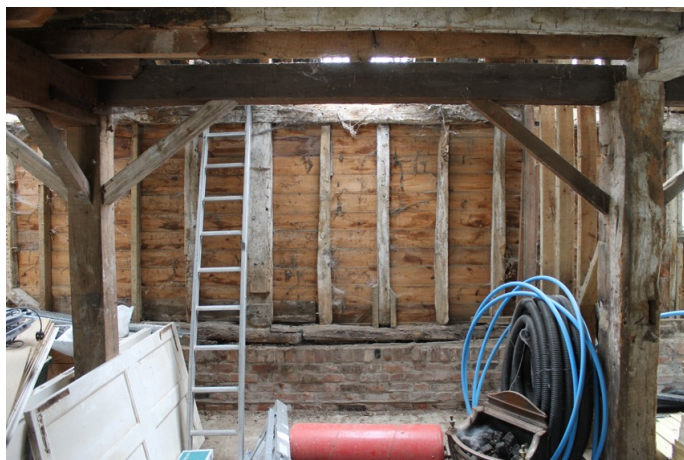
**Photograph 15** Northern elevation of bay 2 on the ground-floor, showing modern girding-beam and braces. Photograph taken facing north.

Bay 2 also contains a substantial amount of modern timber. The northern girding-beam is a modern addition (Photograph 15), as is some first-floor stud-work to the south and north, and the northern wall-plate. The northern principal-post supporting the binding-beam between bays 2 and 3 is hand-sawn but has clearly been re-used, and was originally a binding-beam, judging from the mortices on its east and west sides (Photograph 16). The southern elevation of the ground-floor is dominated by an inserted vertical-planked garage door. On the first-floor there is an inserted modern window on the southern elevation (Photograph 17).

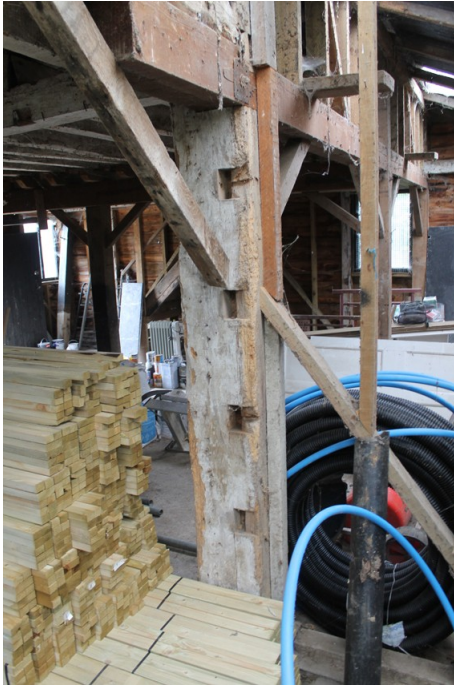
**Photograph 16** Detail of re-used northern principal-post between bays 2 and 3, showing mortices. Photograph taken facing south-west.

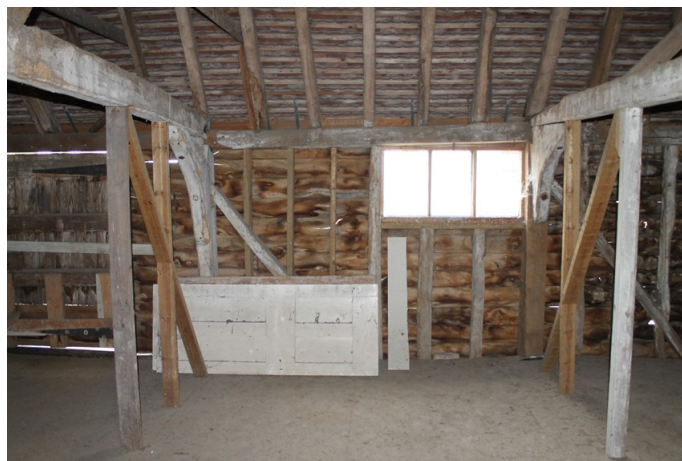
The southern wall-plate of bay 2 contains a rudimentary edge-halved scarf joint (Photograph 17) joining it to the modern replacement southern wall-plate of bay 3 (see below). Additionally, the purlin on the northern roof pitch in this elevation contains a splayed scarf joint.

**Photograph 17** Southern elevation of bay 2 on first-floor, showing modern studs, window and scarf joint. Photograph taken facing south.

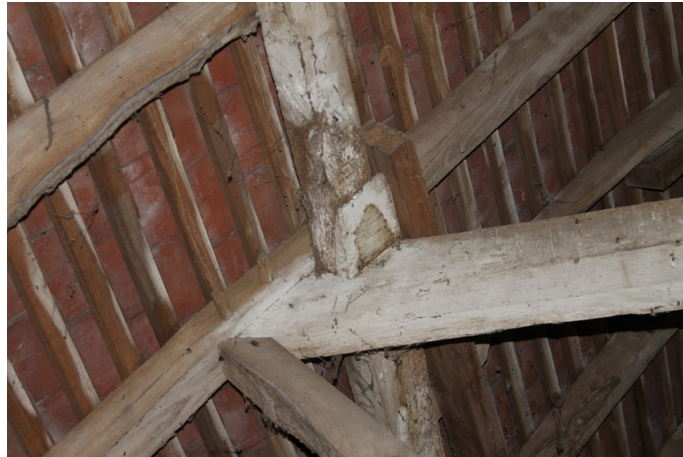
The collar between bays 2 and 3 has a chiselled 'll' carpenter's mark on its northern end, corresponding to one on the rafter (Photograph 18). The binding-beam between these two bays has evidence of re-use, in the form of empty mortices on its eastern face.

**Photograph 18** Detail of carpenter's mark 'II' on collar and rafter between bays 2 and 3. Photograph taken facing north-east.

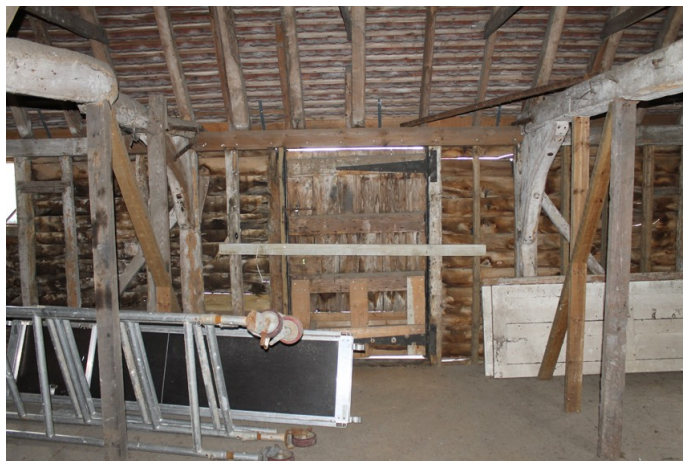
**Photograph 19** Southern elevation of bay 3 on first-floor, showing modern studs and original pitching-door. Photograph taken facing south.

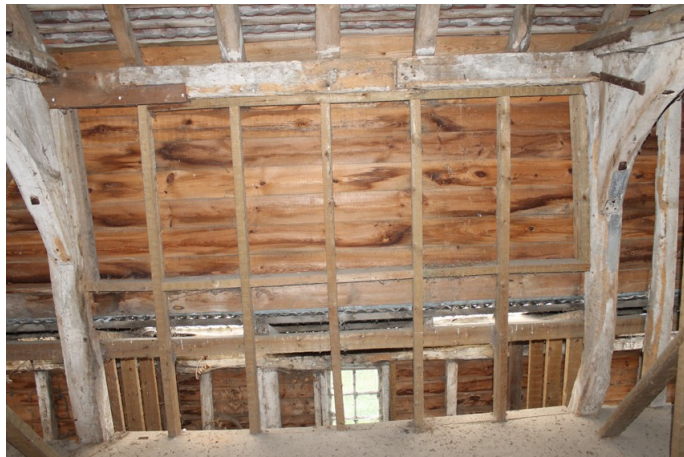
**Photograph 20** Northern elevation of first-floor of bay 3, showing wall-plate and scarf joints. Photograph taken facing north.

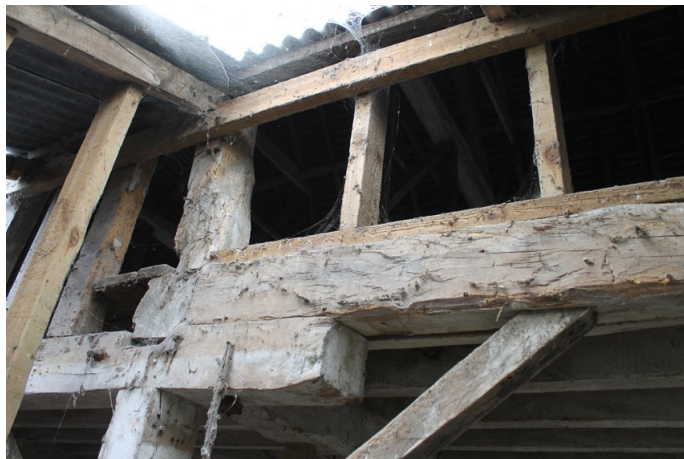
Bay 3 is the central bay of the structure and is slightly wider than the rest (Fig 2). On its southern elevation at the ground-floor level is an inserted door and fixed window. The southern wall-plate in this bay is made of modern machine-cut timber, and the majority of stud-work on the first-floor is modern. The exception to this is the stud-work surrounding the first-floor pitching door on the southern elevation, which appears hand-sawn and original, like the door itself (Photograph 19). The northern wall-plate consists of three pieces of timber, two original and one modern (Photograph 20). The modern and original timbers are joined by a rudimentary edge-halved scarf joint, while the two original timbers are joined by a face-halved and bladed scarf joint with two edge-pegs (and three reinforcing nails added subsequently). The tie-beam between bays 3 and 4 has been reinforced at either end by metal braces. The northern girding-beam in this bay is hand-sawn, but is supported on the girding-beams of the adjacent bays, suggesting it is re-used (Photograph 21).

**Photograph 21** Detail of girding-beam of bay 3 sitting on top of bay 4's girding-beam. Photograph taken facing south-east.

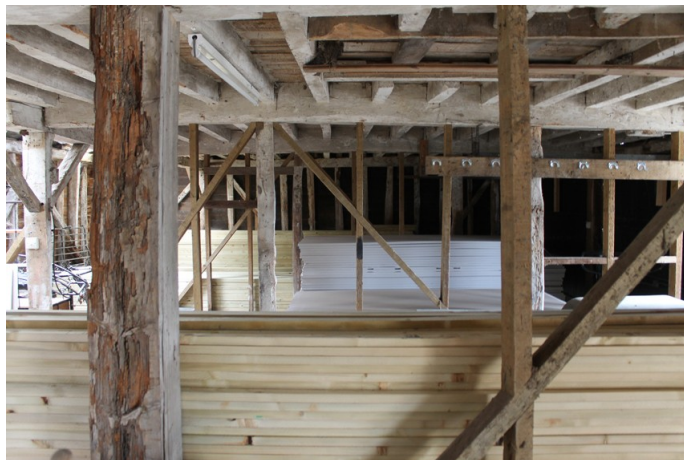
In the centre of bay 3 in the ceiling of the ground-floor is an opening in the joists (that has since been filled). This seems to indicate the location of an original trapdoor providing access into the first-floor (Photograph 22).

**Photograph 22** Ground-floor of building. Trapdoor in bay 3 visible to top right of frame. Photograph taken facing east.

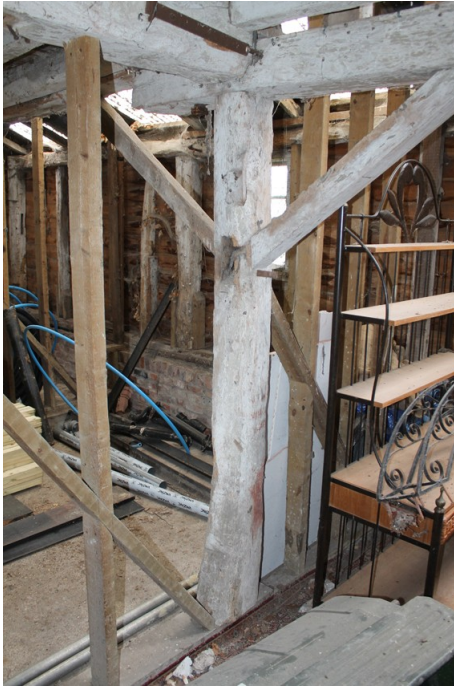
**Photograph 23** Detail of principal-post between bays 3 and 4, showing empty mortice on southern face. Photograph taken facing north-west.

The principal-post on the northern elevation between bays 3 and 4 has two carpenter's marks on its northern face. There is a 'I' on its eastern side, corresponding with the brace going into bay 4, and a 'λ' on its western side (Fig 2). Present on the southern face of this post is an empty mortice that would probably have been in use before the building's extension (Photograph 23).

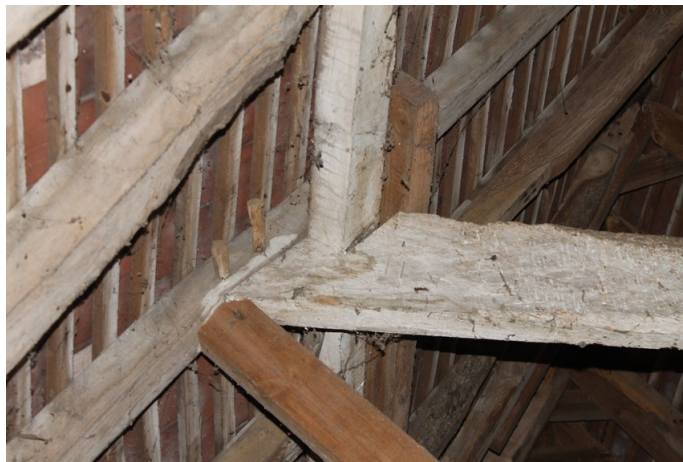
The collar between bays 3 and 4 also has carpenter's marks. On its western face at the northern end is a 'I' with a corresponding mark on the rafter. On the eastern face of the collar, at the southern end, is a 'II', but with no corresponding mark on the rafter (Photograph 24).

**Photograph 24** Carpenter's mark 'II' on southern end of collar between bays 3 and 4. Photograph taken facing south-west.

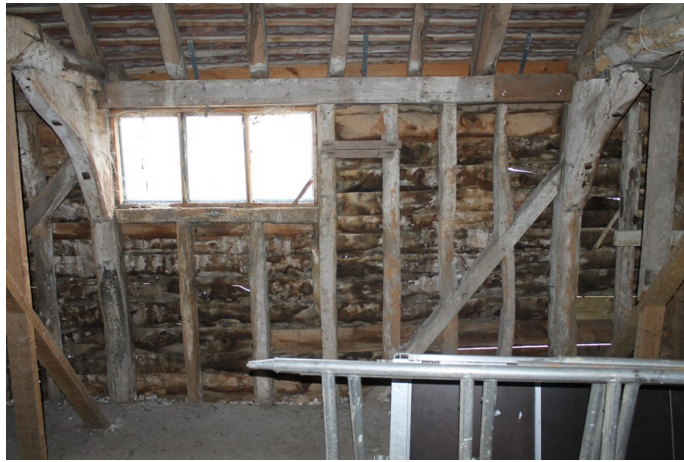
Bay 4 is largely constructed of hand-sawn, original, timber. It does, however, contain an inserted garage door on its southern elevation (Fig 4). A rudimentary modern edge-halved scarf joint on the southern elevation joins a modern machine-cut timber to an original hand-sawn one to form the wall-plate (Photograph 25). Also present on the southern elevation at the first-floor level is a modern fixed window. The northern elevation at this level also contains a modern window opening, but it has since been weatherboarded over (Photograph 26).

**Photograph 25** Southern elevation of bay 4 on first-floor, showing inserted window and scarf joint on wall-plate. Photograph taken facing south.

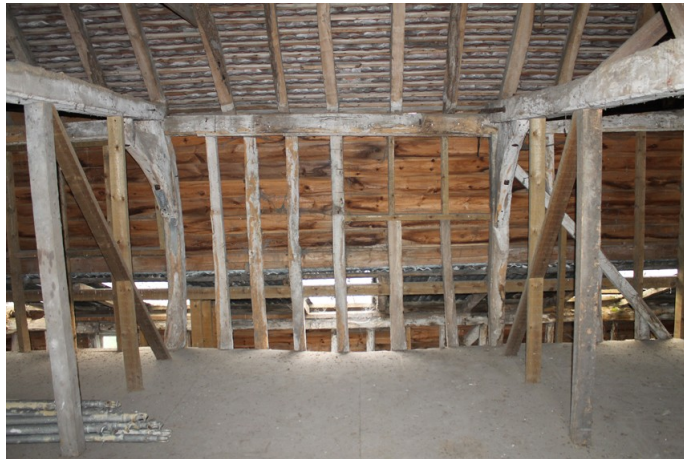
**Photograph 26** Northern elevation of bay 4, showing inserted, and subsequently blocked, window opening. Photograph taken facing north.

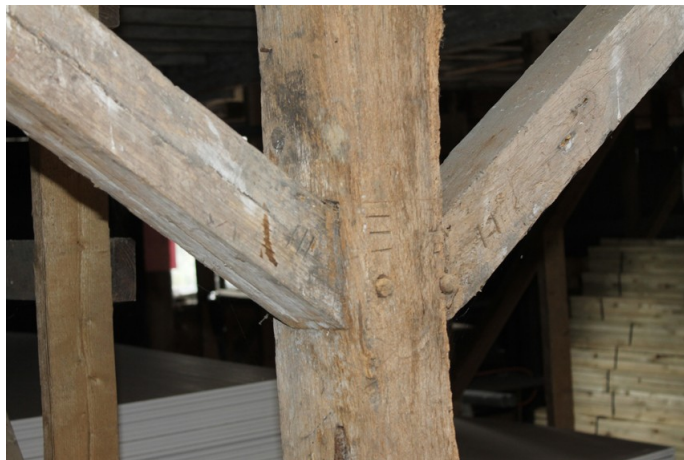
**Photograph 27** Detail of northern principal-post between bays 4 and 5, showing carpenter's marks 'II' and 'III'. Photograph taken facing south-west.

The principal-post between bays 4 and 5, on the northern elevation, has two more carpenter's marks on its northern face (Photograph 27). To the west is a 'II' and to the east is a 'III', both of which are mirrored by identical marks on their corresponding braces. On the southern face of this post is another empty mortice, which, like the one on the post between bays 3 and 4, would probably have been in use before the building's extension (Photograph 28).

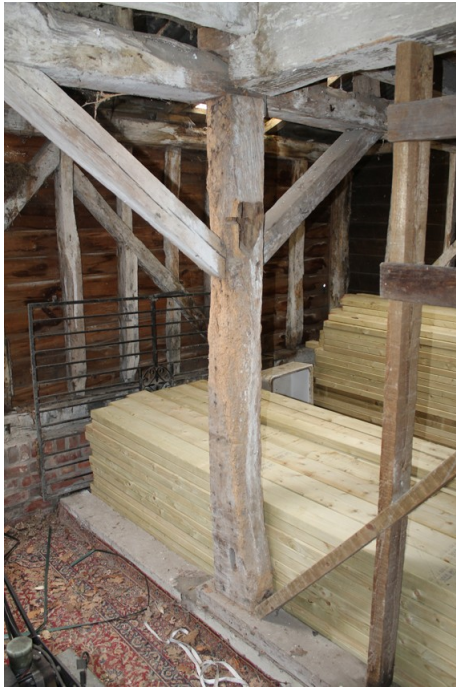
**Photograph 28** Detail of northern principal-post between bays 4 and 5, showing mortice on southern face. Photograph taken facing north-east.

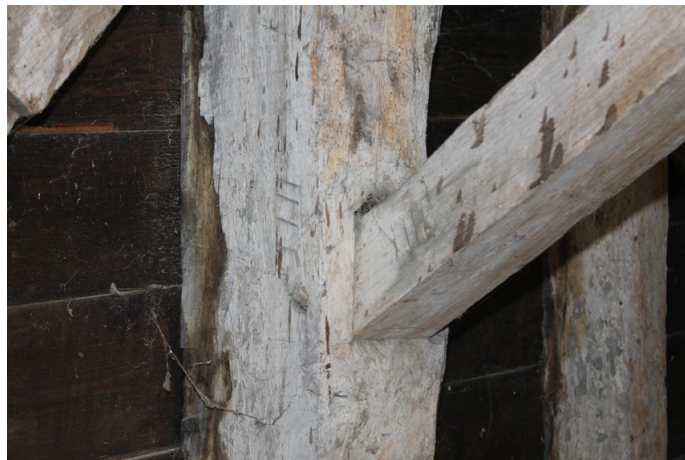
Bay 5 also contains a higher percentage of hand-sawn timber than the western bays. Aside from the inserted garage door on the southern elevation and some replacement studs on the first-floor, the bay is entirely constructed of hand-sawn timber. On the north side of the north-east corner post is the carpenter's mark 'IIII', which is replicated on the brace supporting the northern girding-beam (Photograph 29).

**Photograph 29** Detail of north-east corner-post of building, showing carpenter's mark 'IIII' on post and brace. Photograph taken facing south-east.

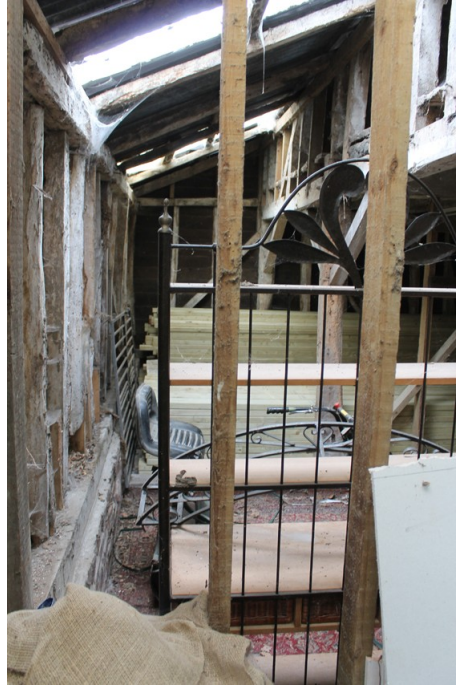
The lean-to projecting from the north of the building has a roof entirely constructed of machine-cut modern timber (Photograph 30). The eastern and western ends of the lean-to are similarly constructed. The northern elevation, however, although containing some machine-cut timber, is largely constructed of hand-sawn timbers, nailed together and with little in the way of jointing (Photograph 30). These hand-sawn timbers have several empty mortices and are clearly re-used, possibly from an earlier phase of the building.

**Photograph 30** Interior of lean-to, with re-used hand-sawn studs to left of frame. Photograph taken facing east.
