# Historic building recording of 61-63 New London Road, Chelmsford, Essex, CM2 0ND

**CAT project ref.: 2022/02k**

Planning reference: 21/02529/FUL & 21/02530/LBC

**CAT Report 1799**

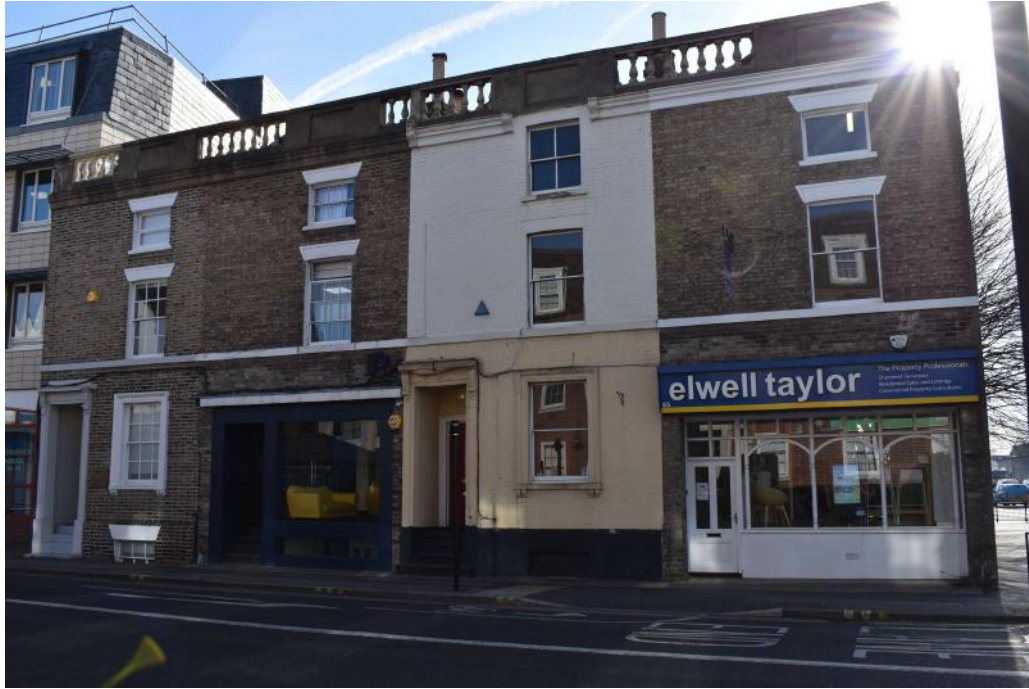
**Photograph 1** North-west elevations of no 61 and 63. Photograph taken facing east.

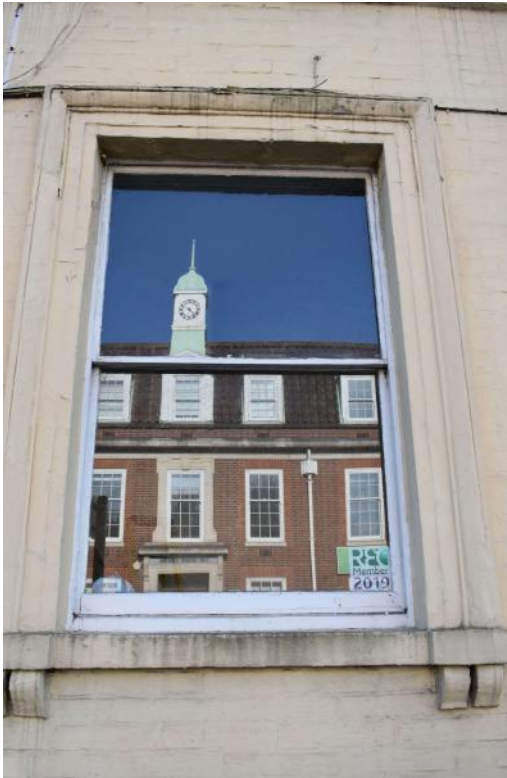
arched lintels, while the ground floor window has a stucco architrave surround. The second floor window is a larger replacement window, with an imitation flat-arched lintel, that interrupts the corncicing.

**Photograph 2** Detail of window on north-west elevation of no 63 (ground floor). Photograph taken facing north-west.

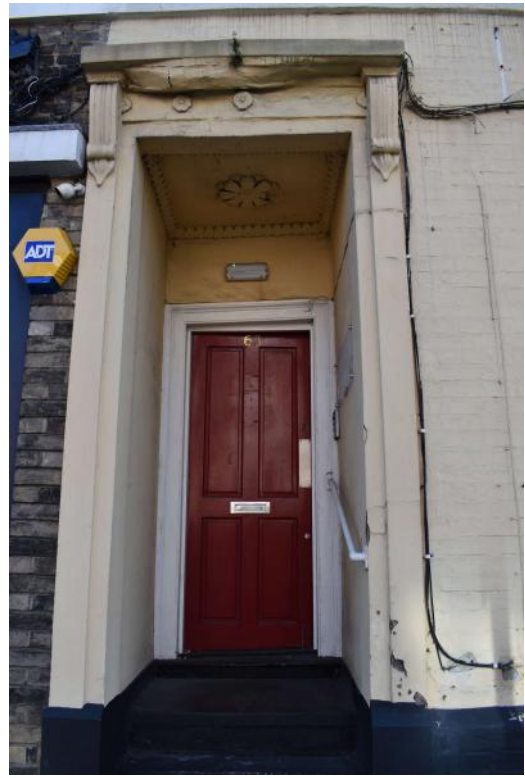
**Photograph 3** Detail of entrance to no 63. Photograph taken facing south-east.

There is an original doorway on the ground floor of no 63, with a recessed porch and a small staircase. It has an original decorative stone surround and a decorative plaster ceiling. The door is a replacement and the plastered area above the door may have once contained rectangular fanlight.

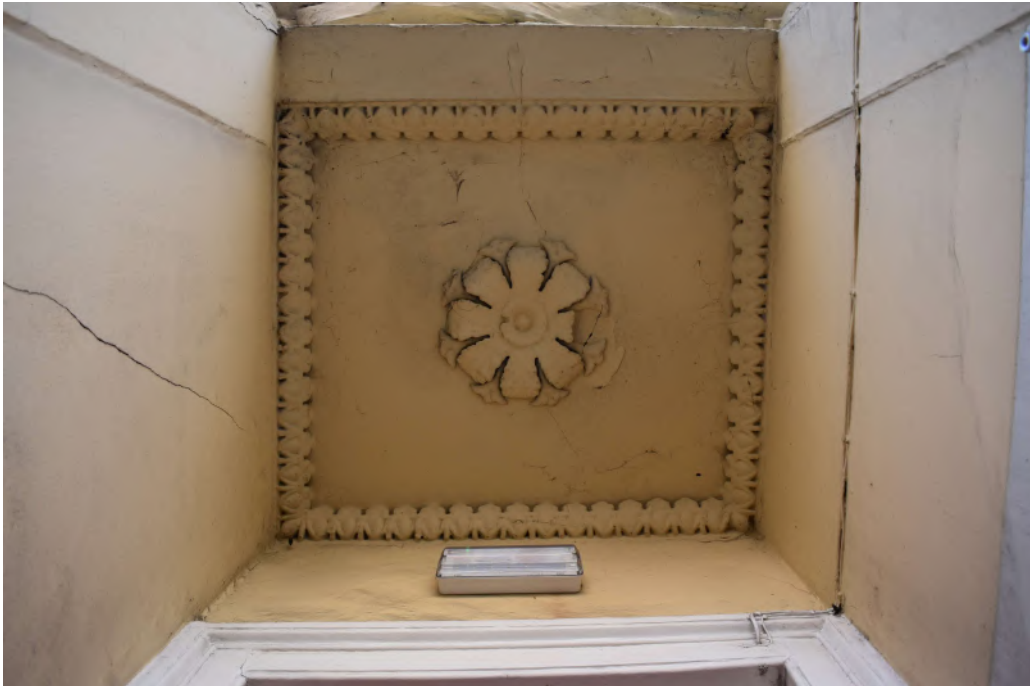
**Photograph 4** Detail of original plaster decorative ceiling in entrance way of no 63.

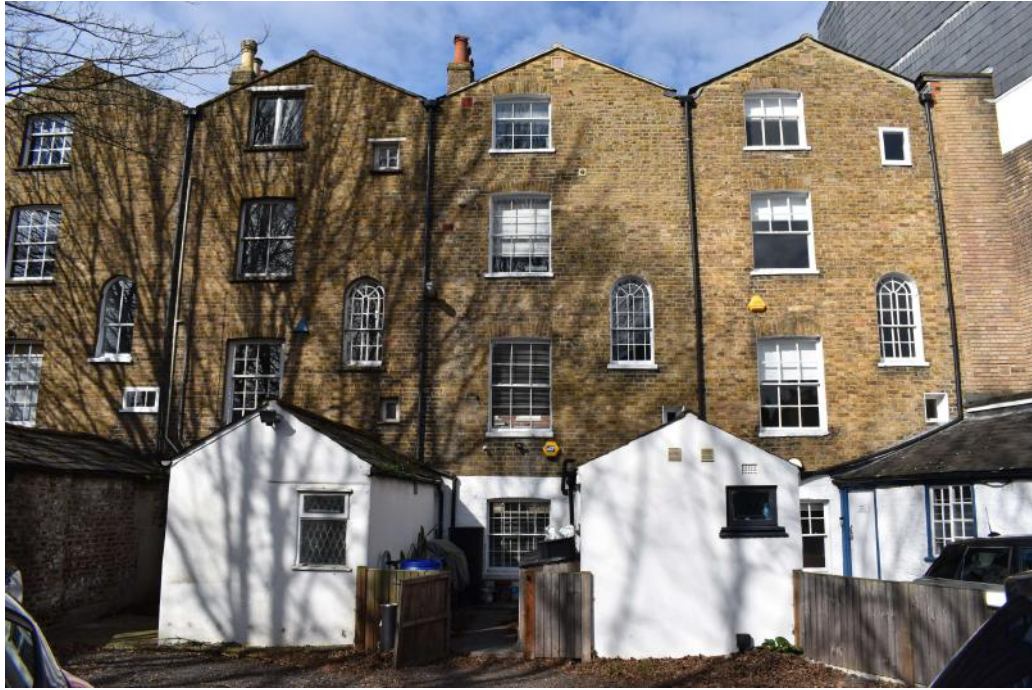
**Photograph 5** South-east elevation of nos 61 and 63. Photograph taken facing north-west.

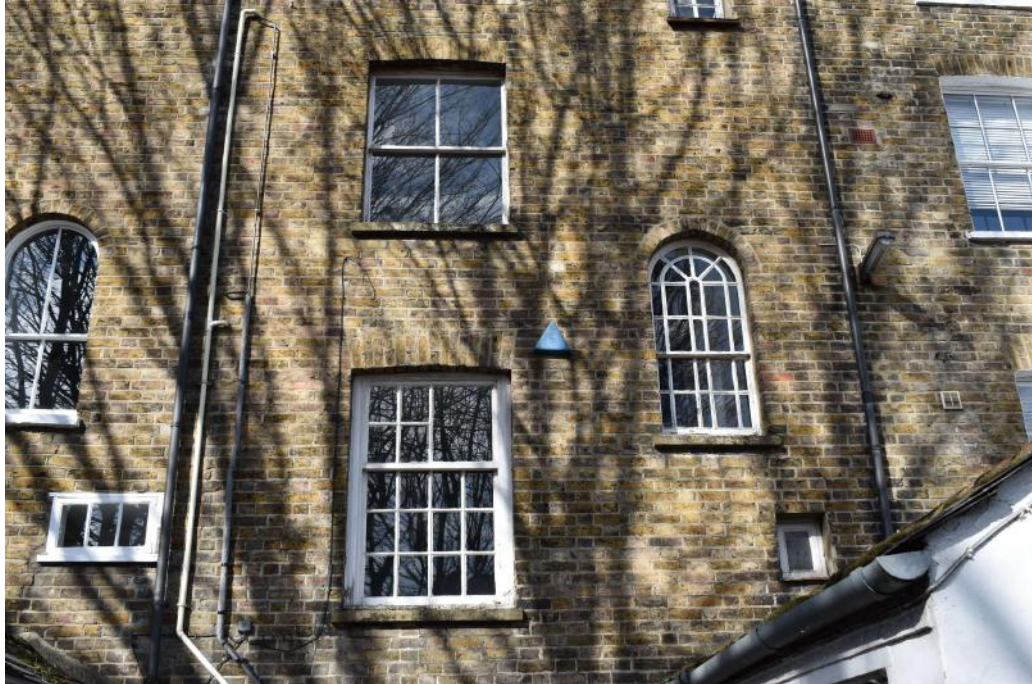
The ground floor and first floor windows have segmented brick arches and are 17-light and four-light, respectively. The window located between the ground and first floor is a round-headed 28-light sash-window with a brick arch. The small window at the bottom of the ground floor is a single-light awning window with no lintel and a red tile sill. At the basement level, the wall has been rendered and painted white. The window is a two-light awning replacement window.

**Photograph 6** Detail of windows on south-east elevation (ground and first floor of no 63). Photograph taken facing north-west.

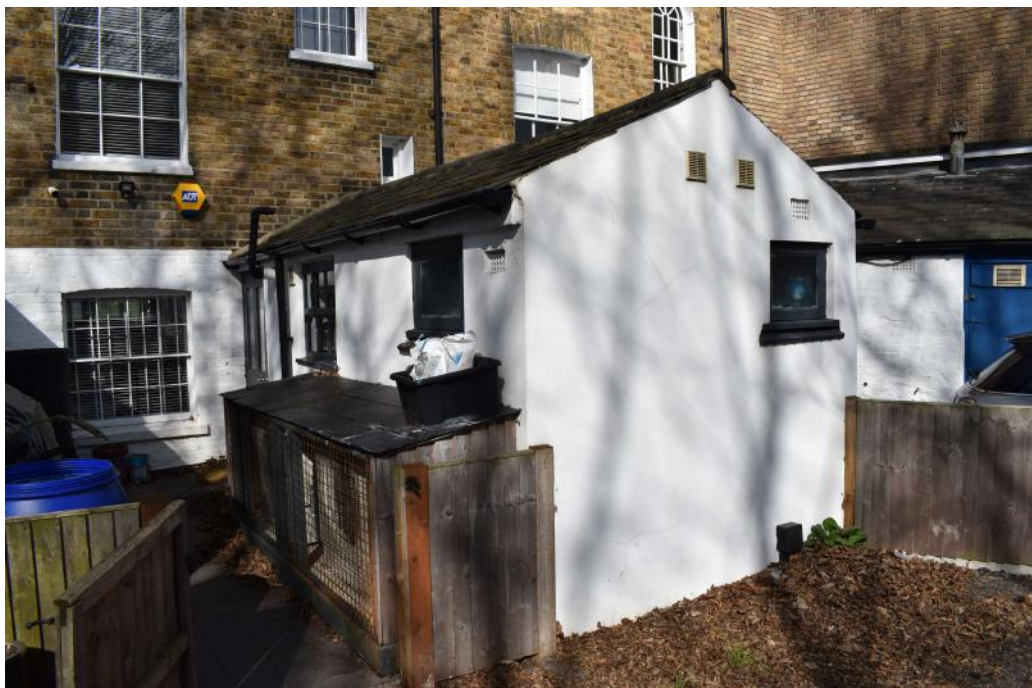
**Photograph 7** South-east and south-west elevations of no 61. Photograph taken facing north.

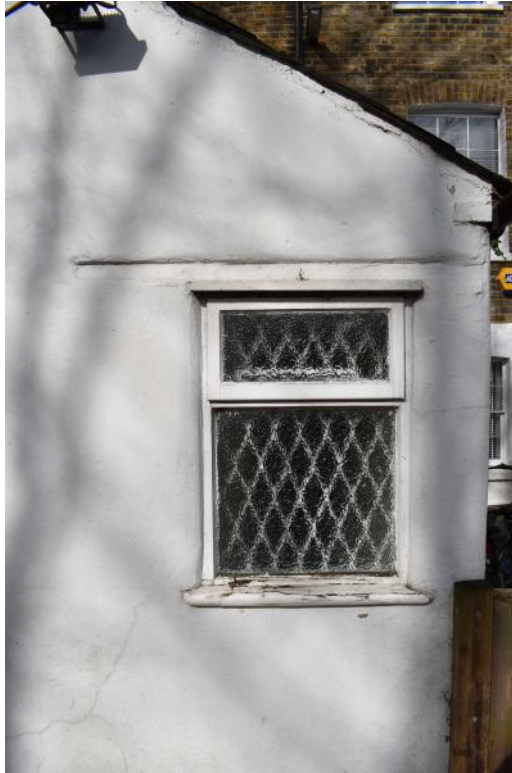
**Photograph 8** Detail of window on south-east elevation (ground floor of no 63). Photograph taken facing north-west.

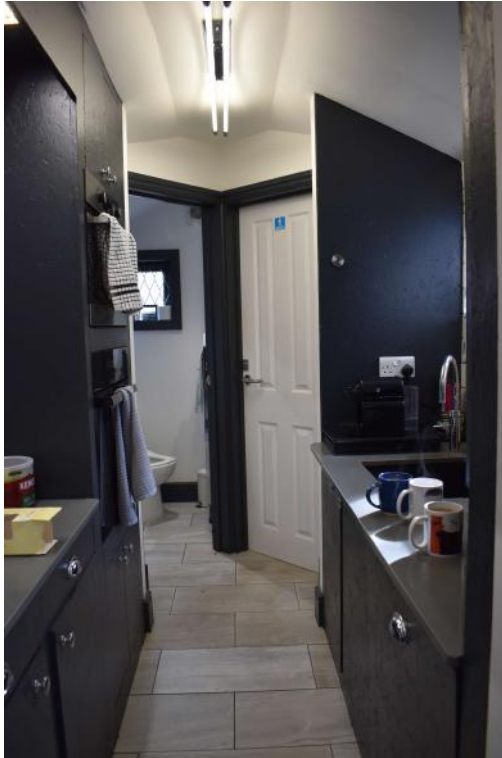
**Photograph 9** Interior of room 1 (basement of no 61). Photograph taken facing south-east.

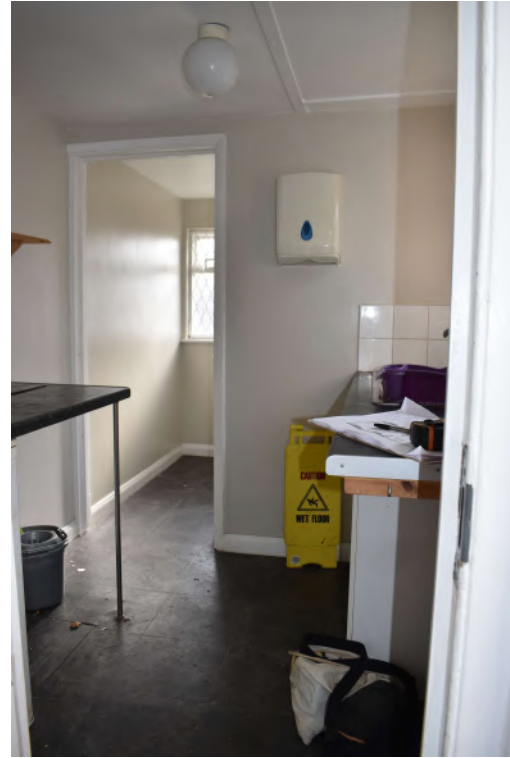
**Photograph 10** Interior shot room 4 (basement of no 63). Photograph taken facing south-east.

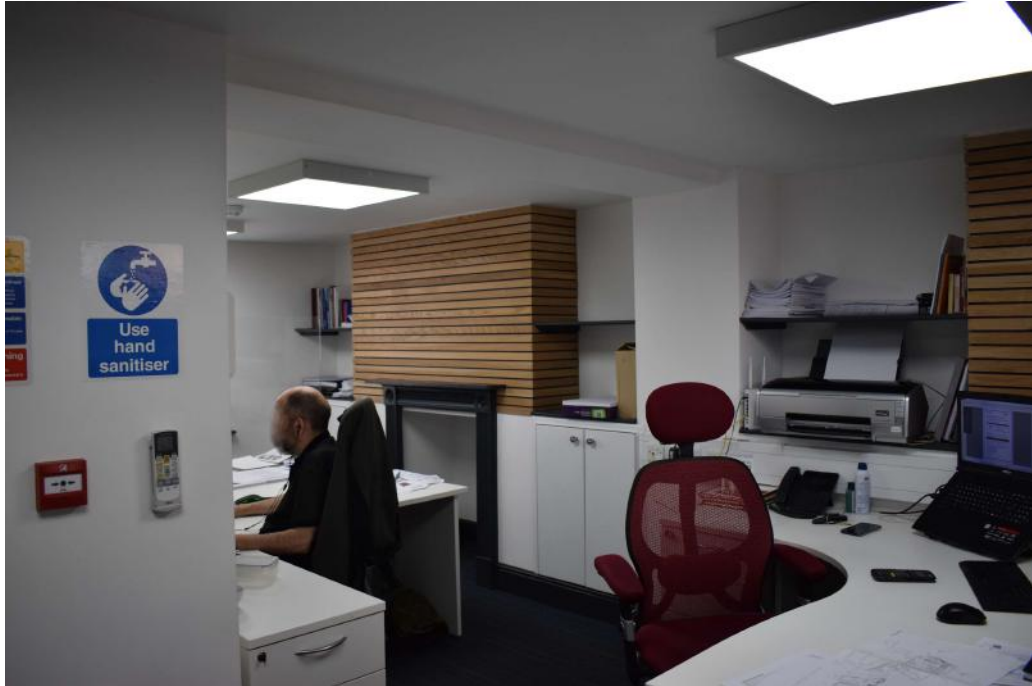
**Photograph 11** Interior shot of room 2 (basement of no 61). Photograph taken facing south.

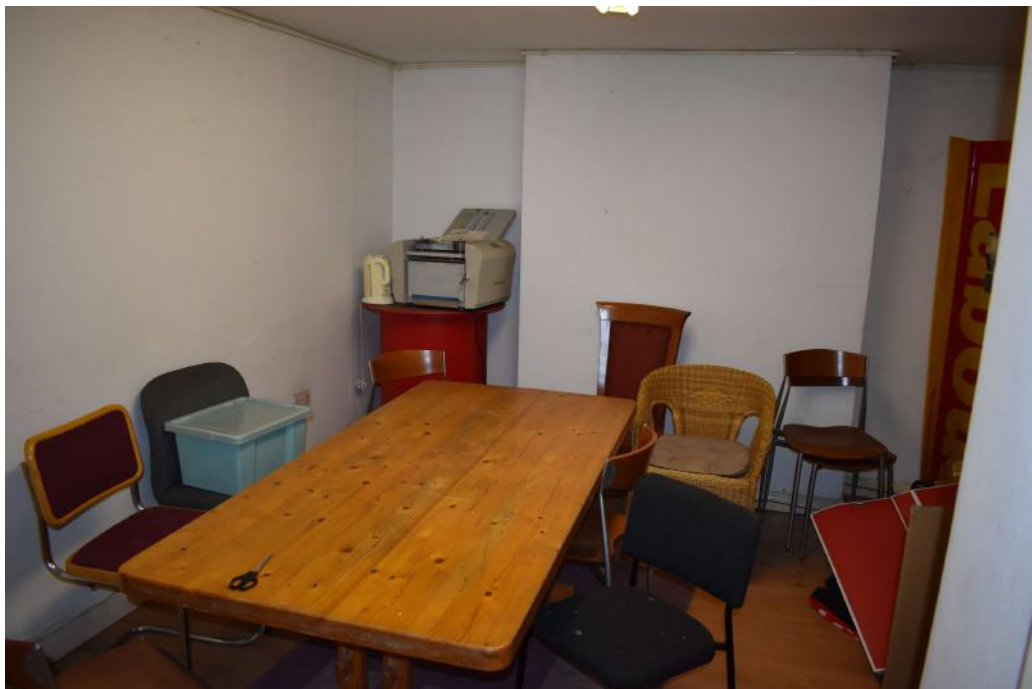
**Photograph 12** Interior shot of room 7 (basement of no 63). Photograph taken facing south-west.

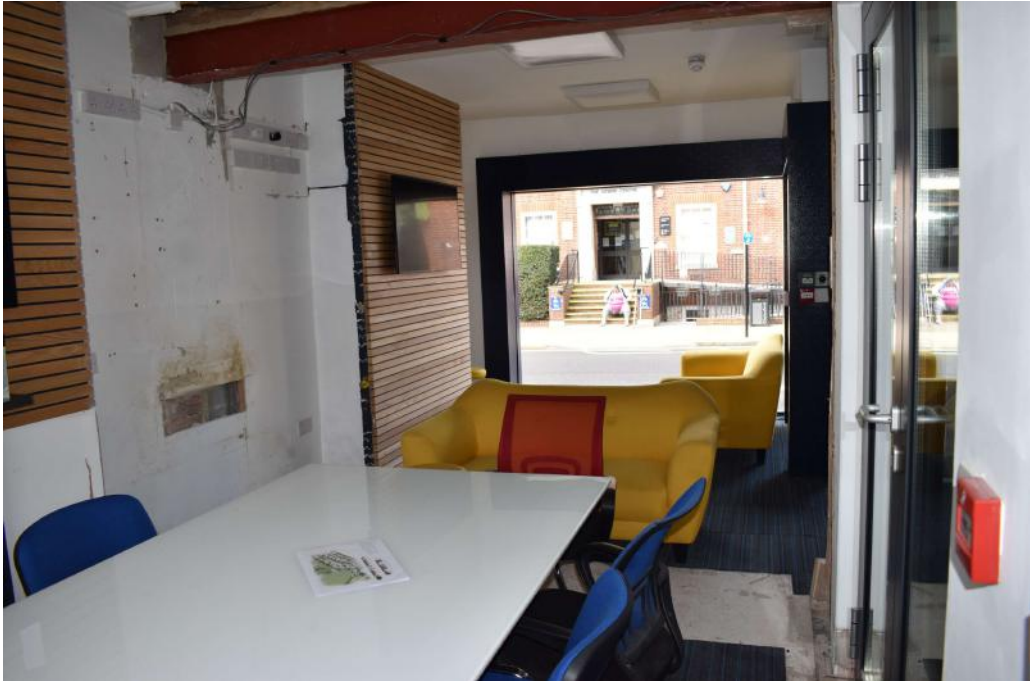
**Photograph 13** Interior of room 8 (ground floor of no 61). Photograph taken facing north-west.

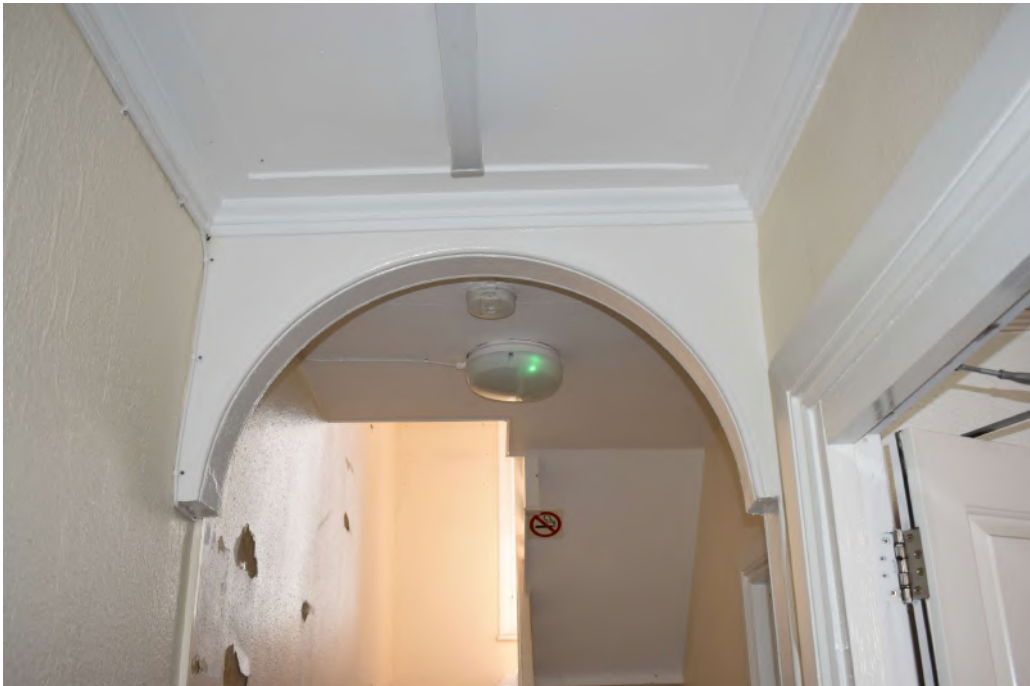
**Photograph 14** Detail of original timber arch in room 11 (ground floor of no 63). Photograph taken facing south-east.

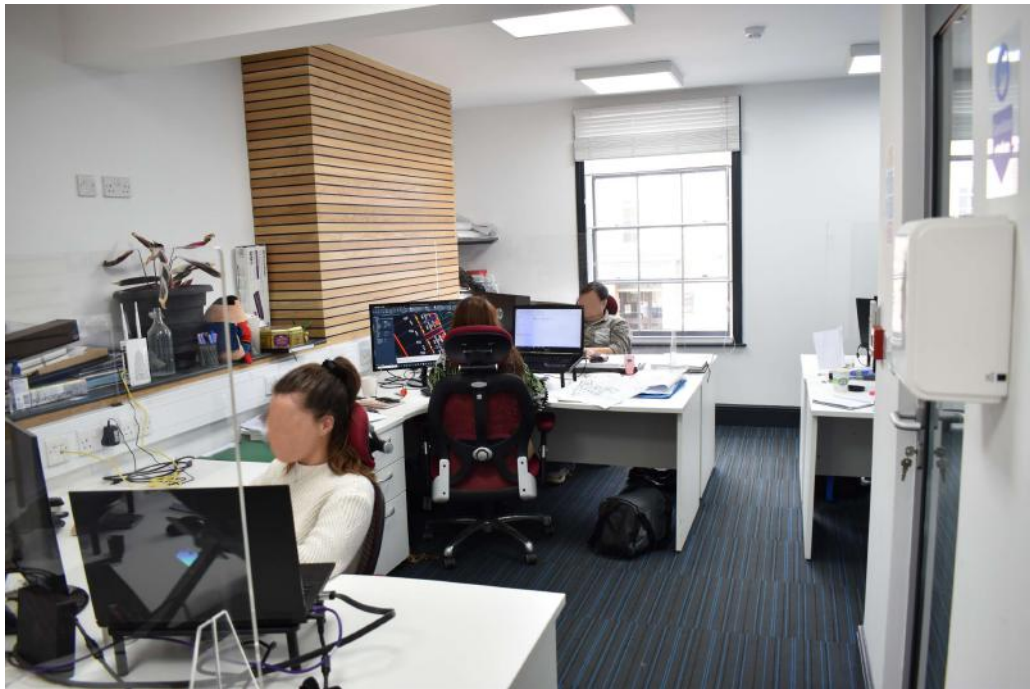
**Photograph 15** Interior of room 14 (first floor of no 61). Photograph taken facing north-west.

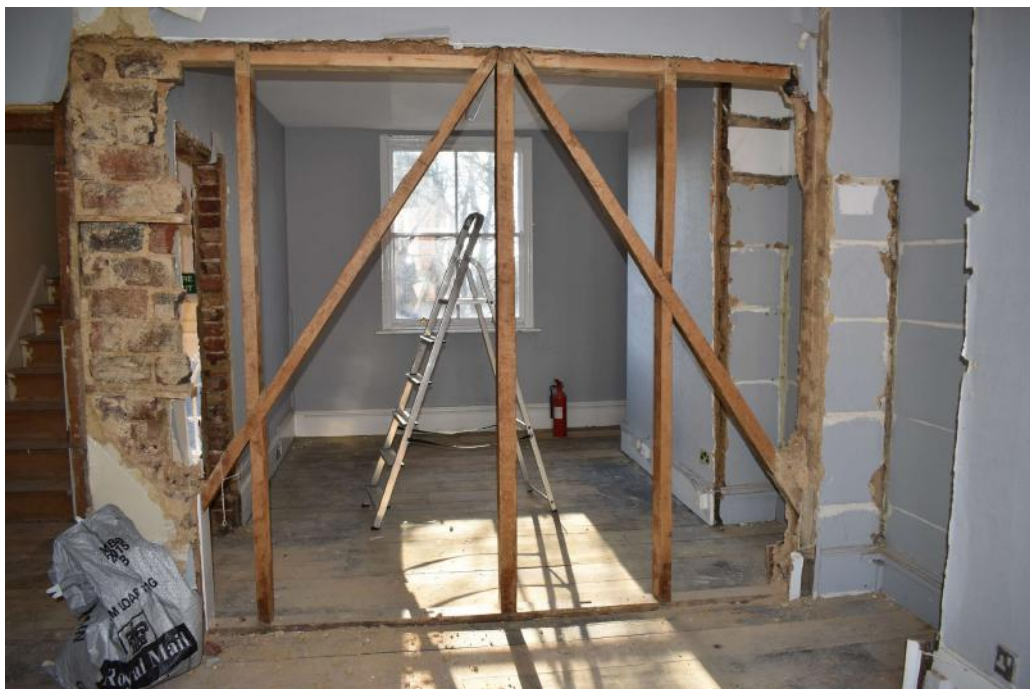
Removal of the plaster board on the wall between rooms 16 and 17 in no 63 has revealed a timber frame beneath. The wall has a middle post with a stud and diagonal through-brace either side. Carpenters marks are present in the form of 'I' and 'II' on the braces and stud. Baltic timber marks were also observed on both studs. Further removal of plaster, this time around the frame of the doorway between rooms 15 and 17, has exposed the wooden pegs used to peg the timber door frame together. The timber used in the stud wall and the door frame is machine-cut.

**Photograph 16** Detail of stud wall between room 16 and 17 (1st floor of no 63). Photograph taken facing south-east.

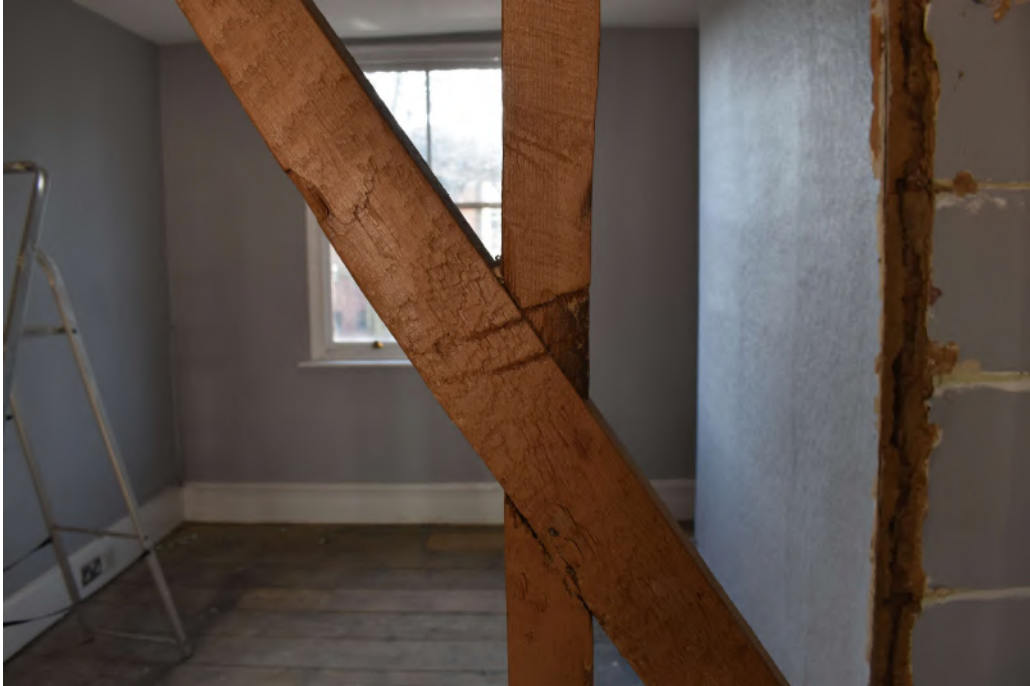
**Photograph 17** Detail of carpenters marks 'II' on stud and brace of stud wall of room 16 and 17 (1st floor of no 63). Photograph taken facing south-east.

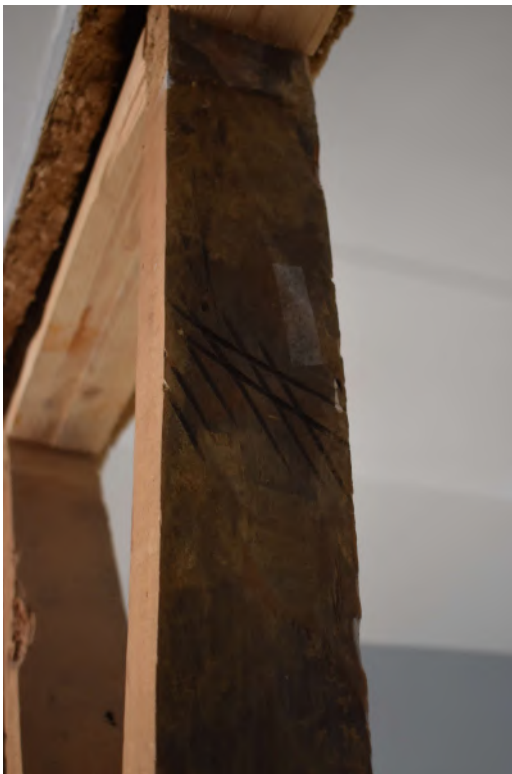
**Photograph 18** Detail of Baltic Timber marks in stud wall of room 16 and 17 (1st floor of no 63). Photograph taken facing east.

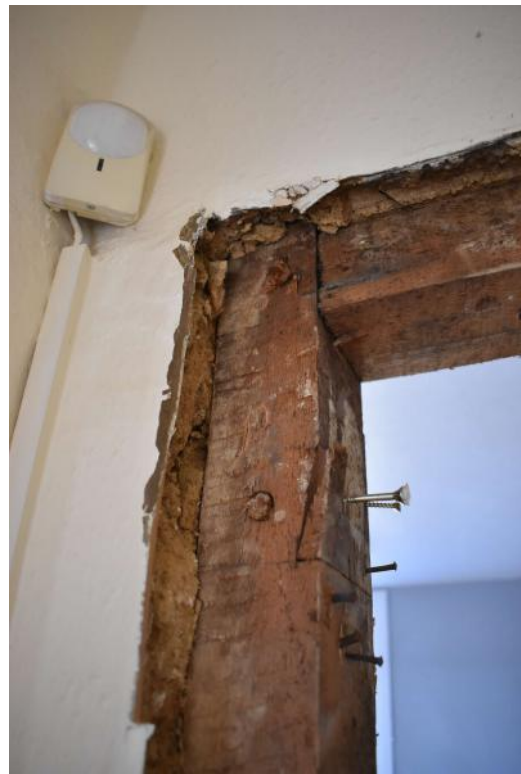
**Photograph 19** Detail of timber pegs in doorway in room 17 (1st floor of no 63). Photograph taken facing south-east.

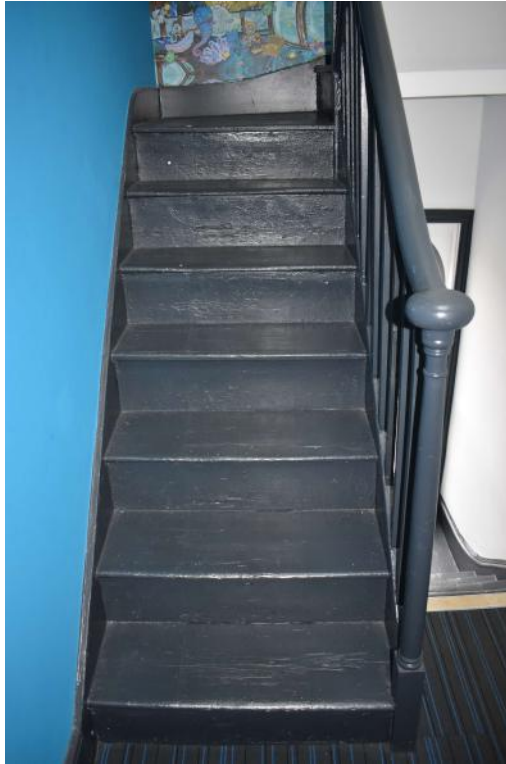
**Photograph 20** Detail of stairs in room 13 (first floor of no 61). Photograph taken facing south-east.

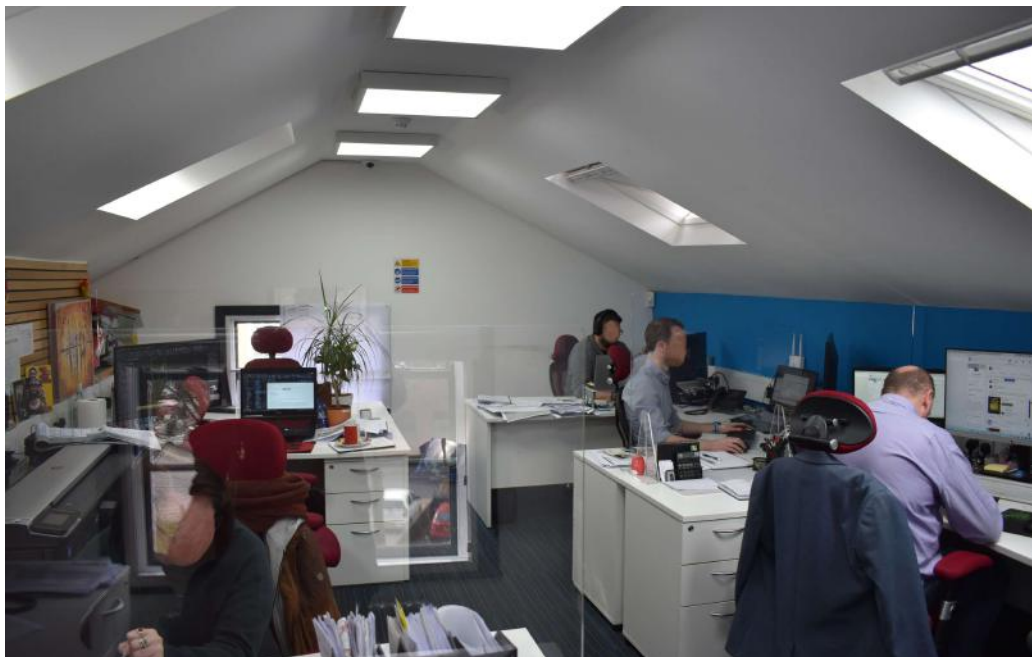
**Photograph 21** Interior of room 18 (second floor of no 61). Photograph taken facing south.

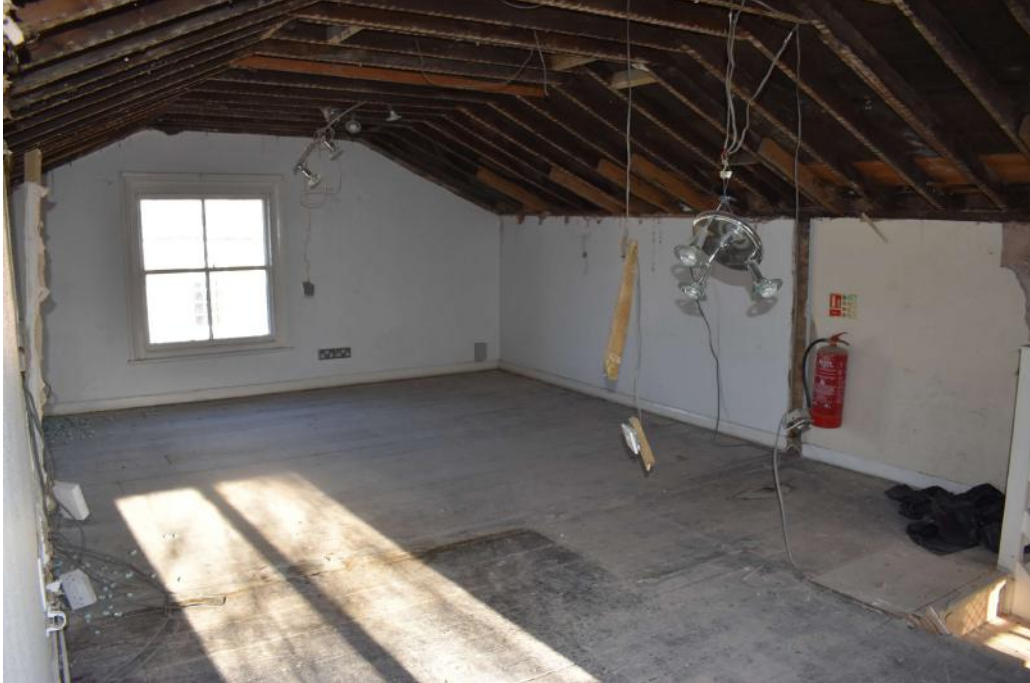
evidence in no 63 that the attic was originally split into three rooms with the same layout as the floors below. The attic would have been the same in no 61.

**Photograph 22** Interior shot of room 19 (2nd floor of no 63). Photograph taken facing north.
