# Report on archaeological investigations in the Braxted folly at Braxted Park Estate, Great Braxted, Essex.

**January 2011**

**report prepared by  
Adam Wightman**

**CAT Report 555**  
January 2011

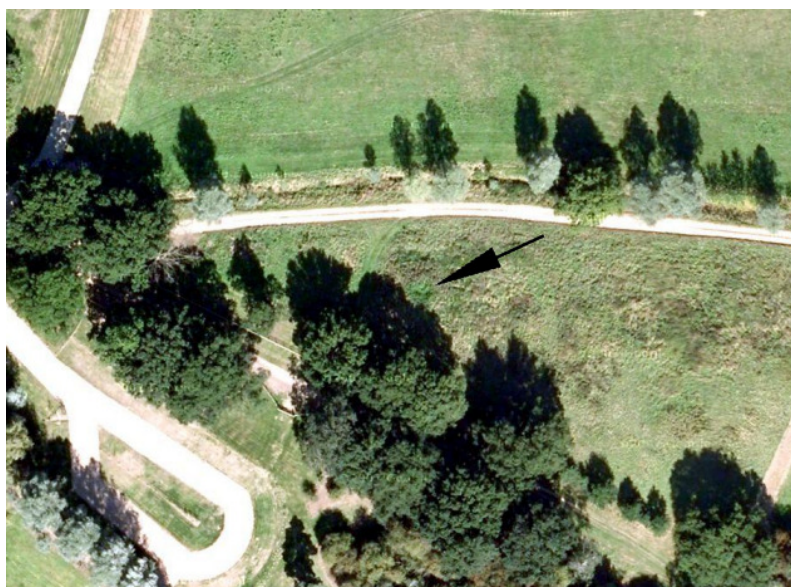
Also of note is the presence of a structure to the south-east of the main house labelled as an ice house on the 25" Ordnance Survey map of 1897. This 'ice house' is considerably closer to the main house than the structure under investigation, whilst also being in close proximity to the lakes to the east of the main driveway. No evidence on the ground survives of any structure in this area today. However, a circular patch of bright green grass is visible on Google Earth in this location which could indicate the backfilled cavity of an ice house. The presence of an ice house here would negate the need for the structure under investigation to be used for that purpose (Wells & Derrick 2009, 37).

**Plate 1: Circular patch of bright green grass which could indicate the backfilled cavity of an ice house.**

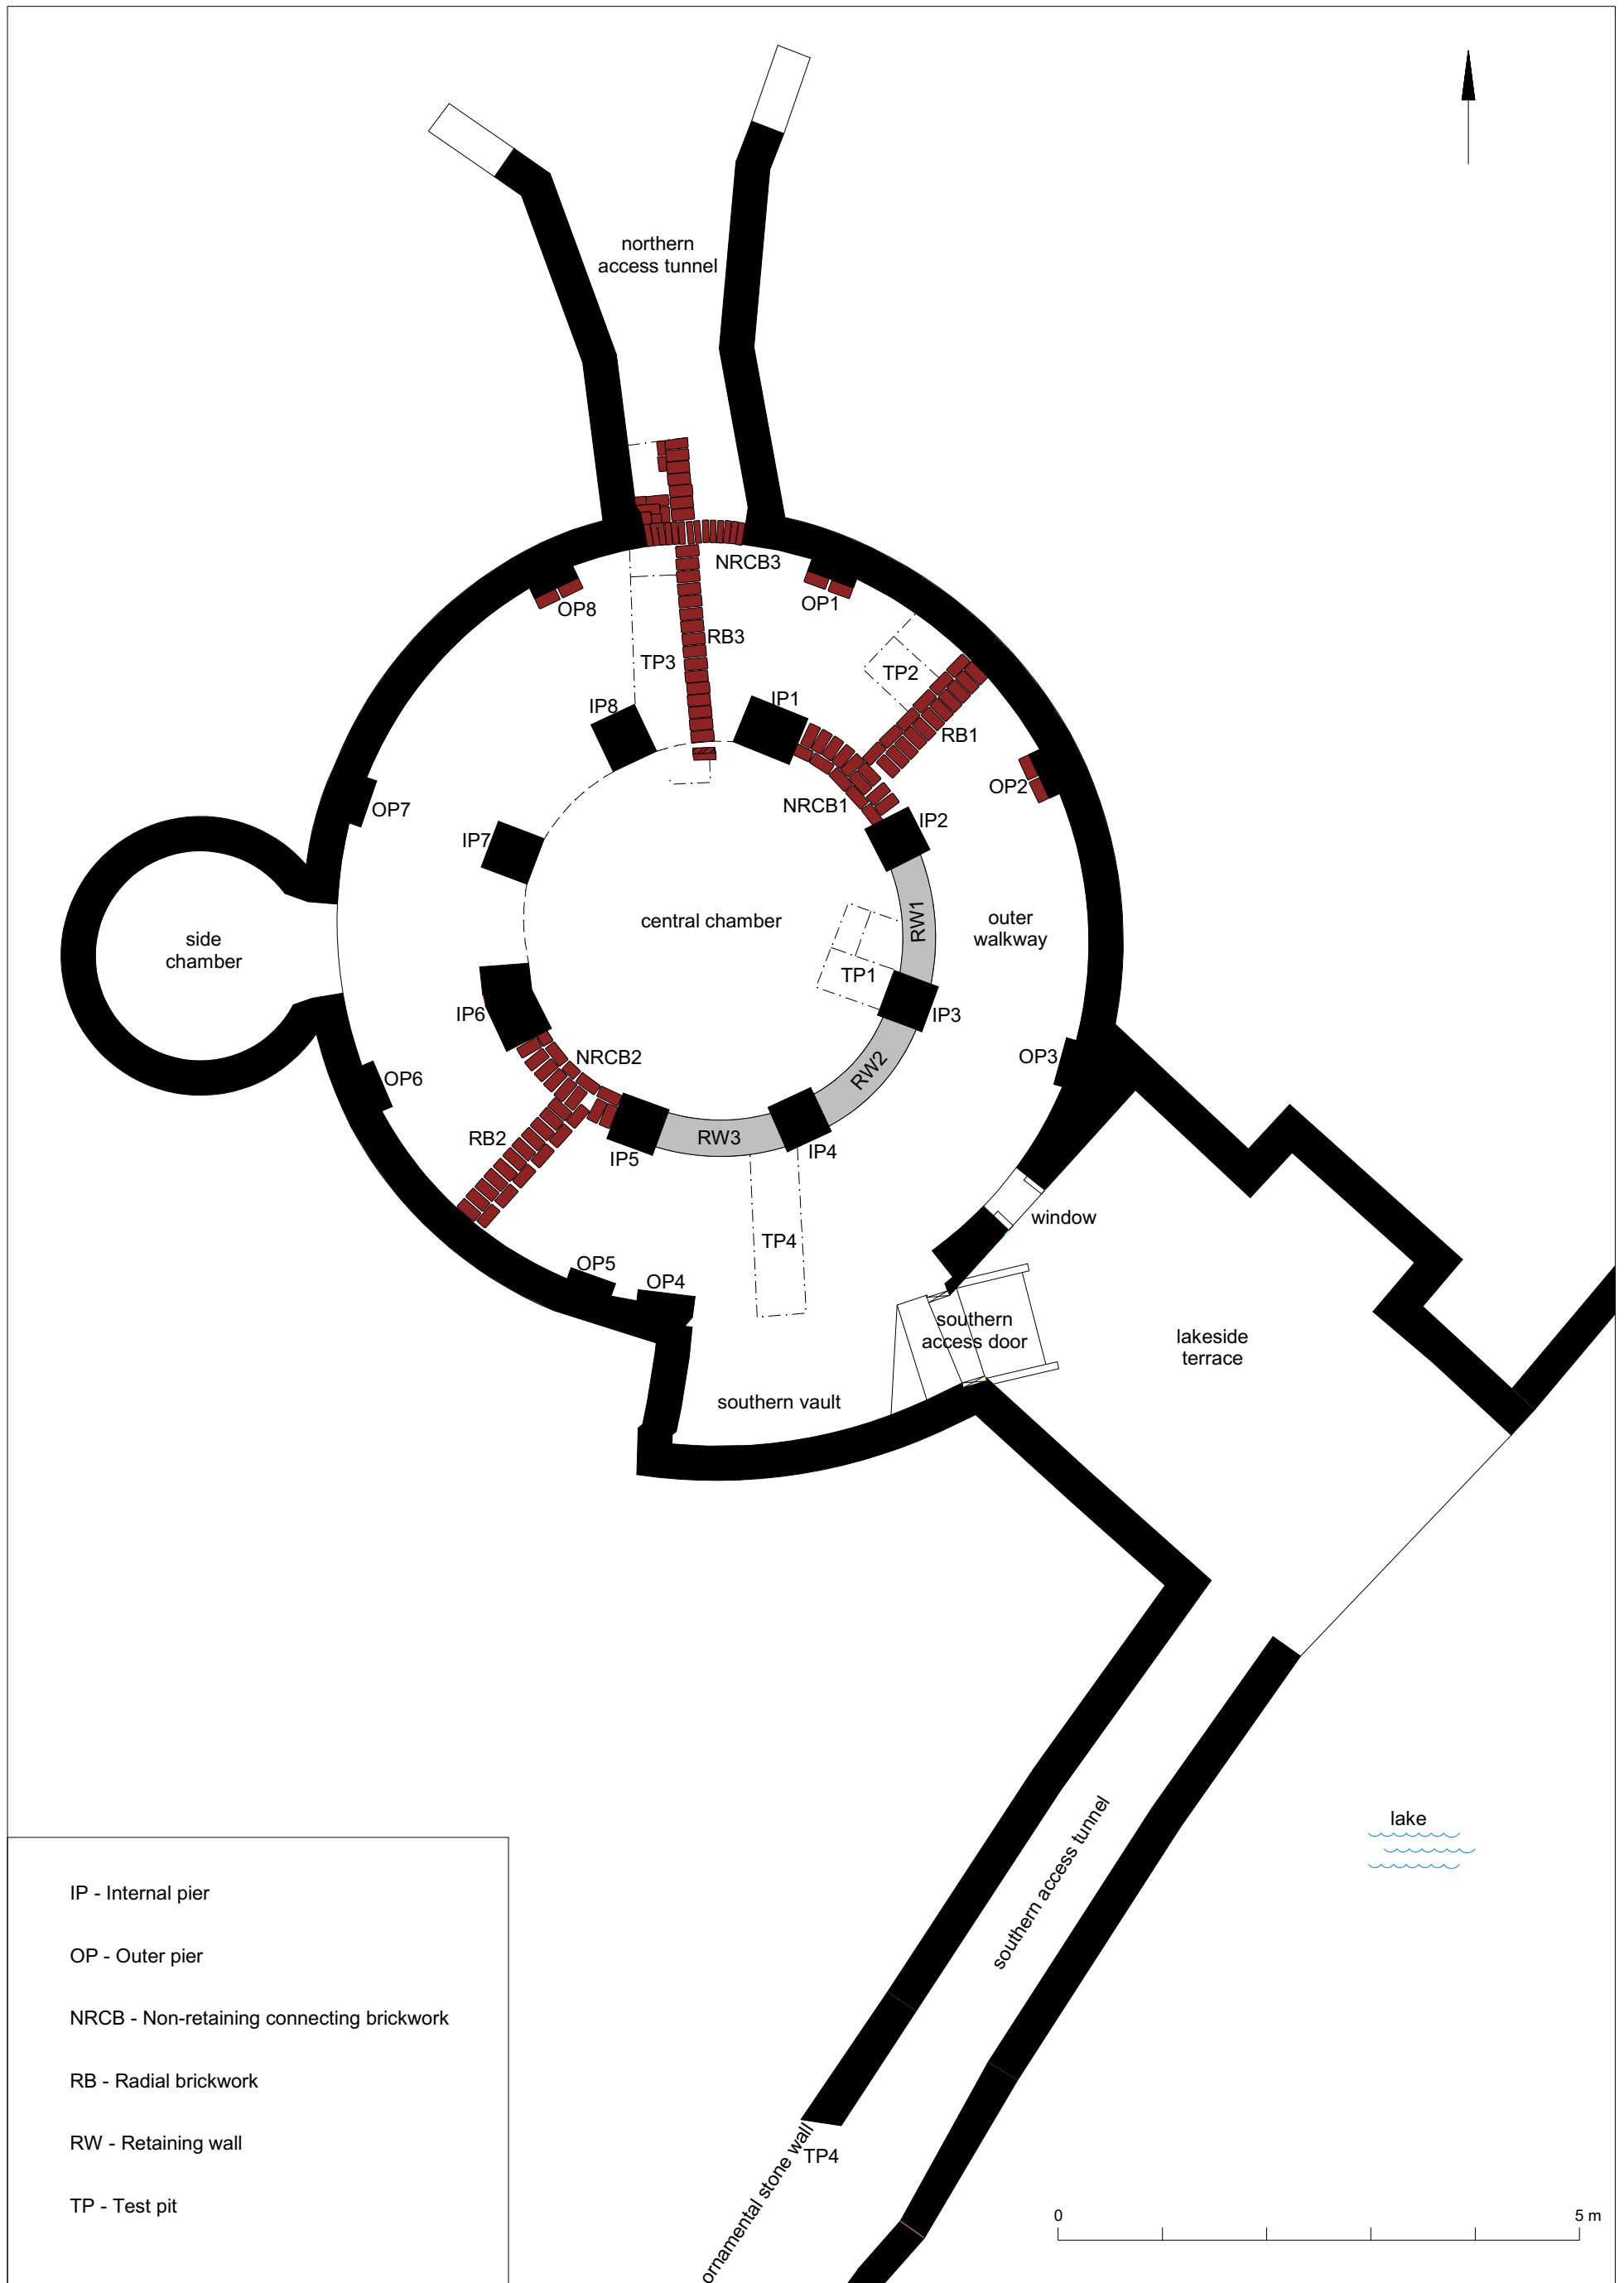
Fig 2 The layout of the structure.

Work within the structure took place in two phases. This section combines the findings of both of these phases. For a plan of the layout of the structure with the abbreviations used for different structural features, consult Figure 2.

Test-pit 1 was located against RW1 Revetment Wall 1) and IP3 (Internal Pier 3) (Fig 2). The size of the test-pit decreased as depth increased due to the solidity of the clay encountered. The layer of probable limewash (L1) was only 4mm thick and directly overlay the compacted clay layer L2, which contained loose soil and brick fragments (Fig 7). Beneath L2 was a layer of clay with frequent brick and mortar fragments with a dense lens of mortar at the top of the layer (L3). Underlying L3, another clay layer very similar in character to L2 was uncovered (L4). L4 sealed the dark yellow/brown natural clay (L5). Upon discovery of the natural clay, it became clear that the two clay layers previously encountered (L2 and L4) were redeposited natural clay with loose soil and brick fragments incorporated. It is possible that L4 is the backfill material in the foundation cut for the revetment wall, although the presence of brick fragments in the clay at some distance from the wall suggests that L4 was more widespread. All of the deposits within the structure were very dry, in particular where the redeposited clay met the brickwork due to the absorption of moisture from the clay into the bricks. Excavation of TP1 ceased when the lowest course of bricks in the revetment wall was encountered. This roughly corresponded with the bottom of L4 and the top of the natural clay L5 on which the lowest course of bricks was situated (Fig 7).

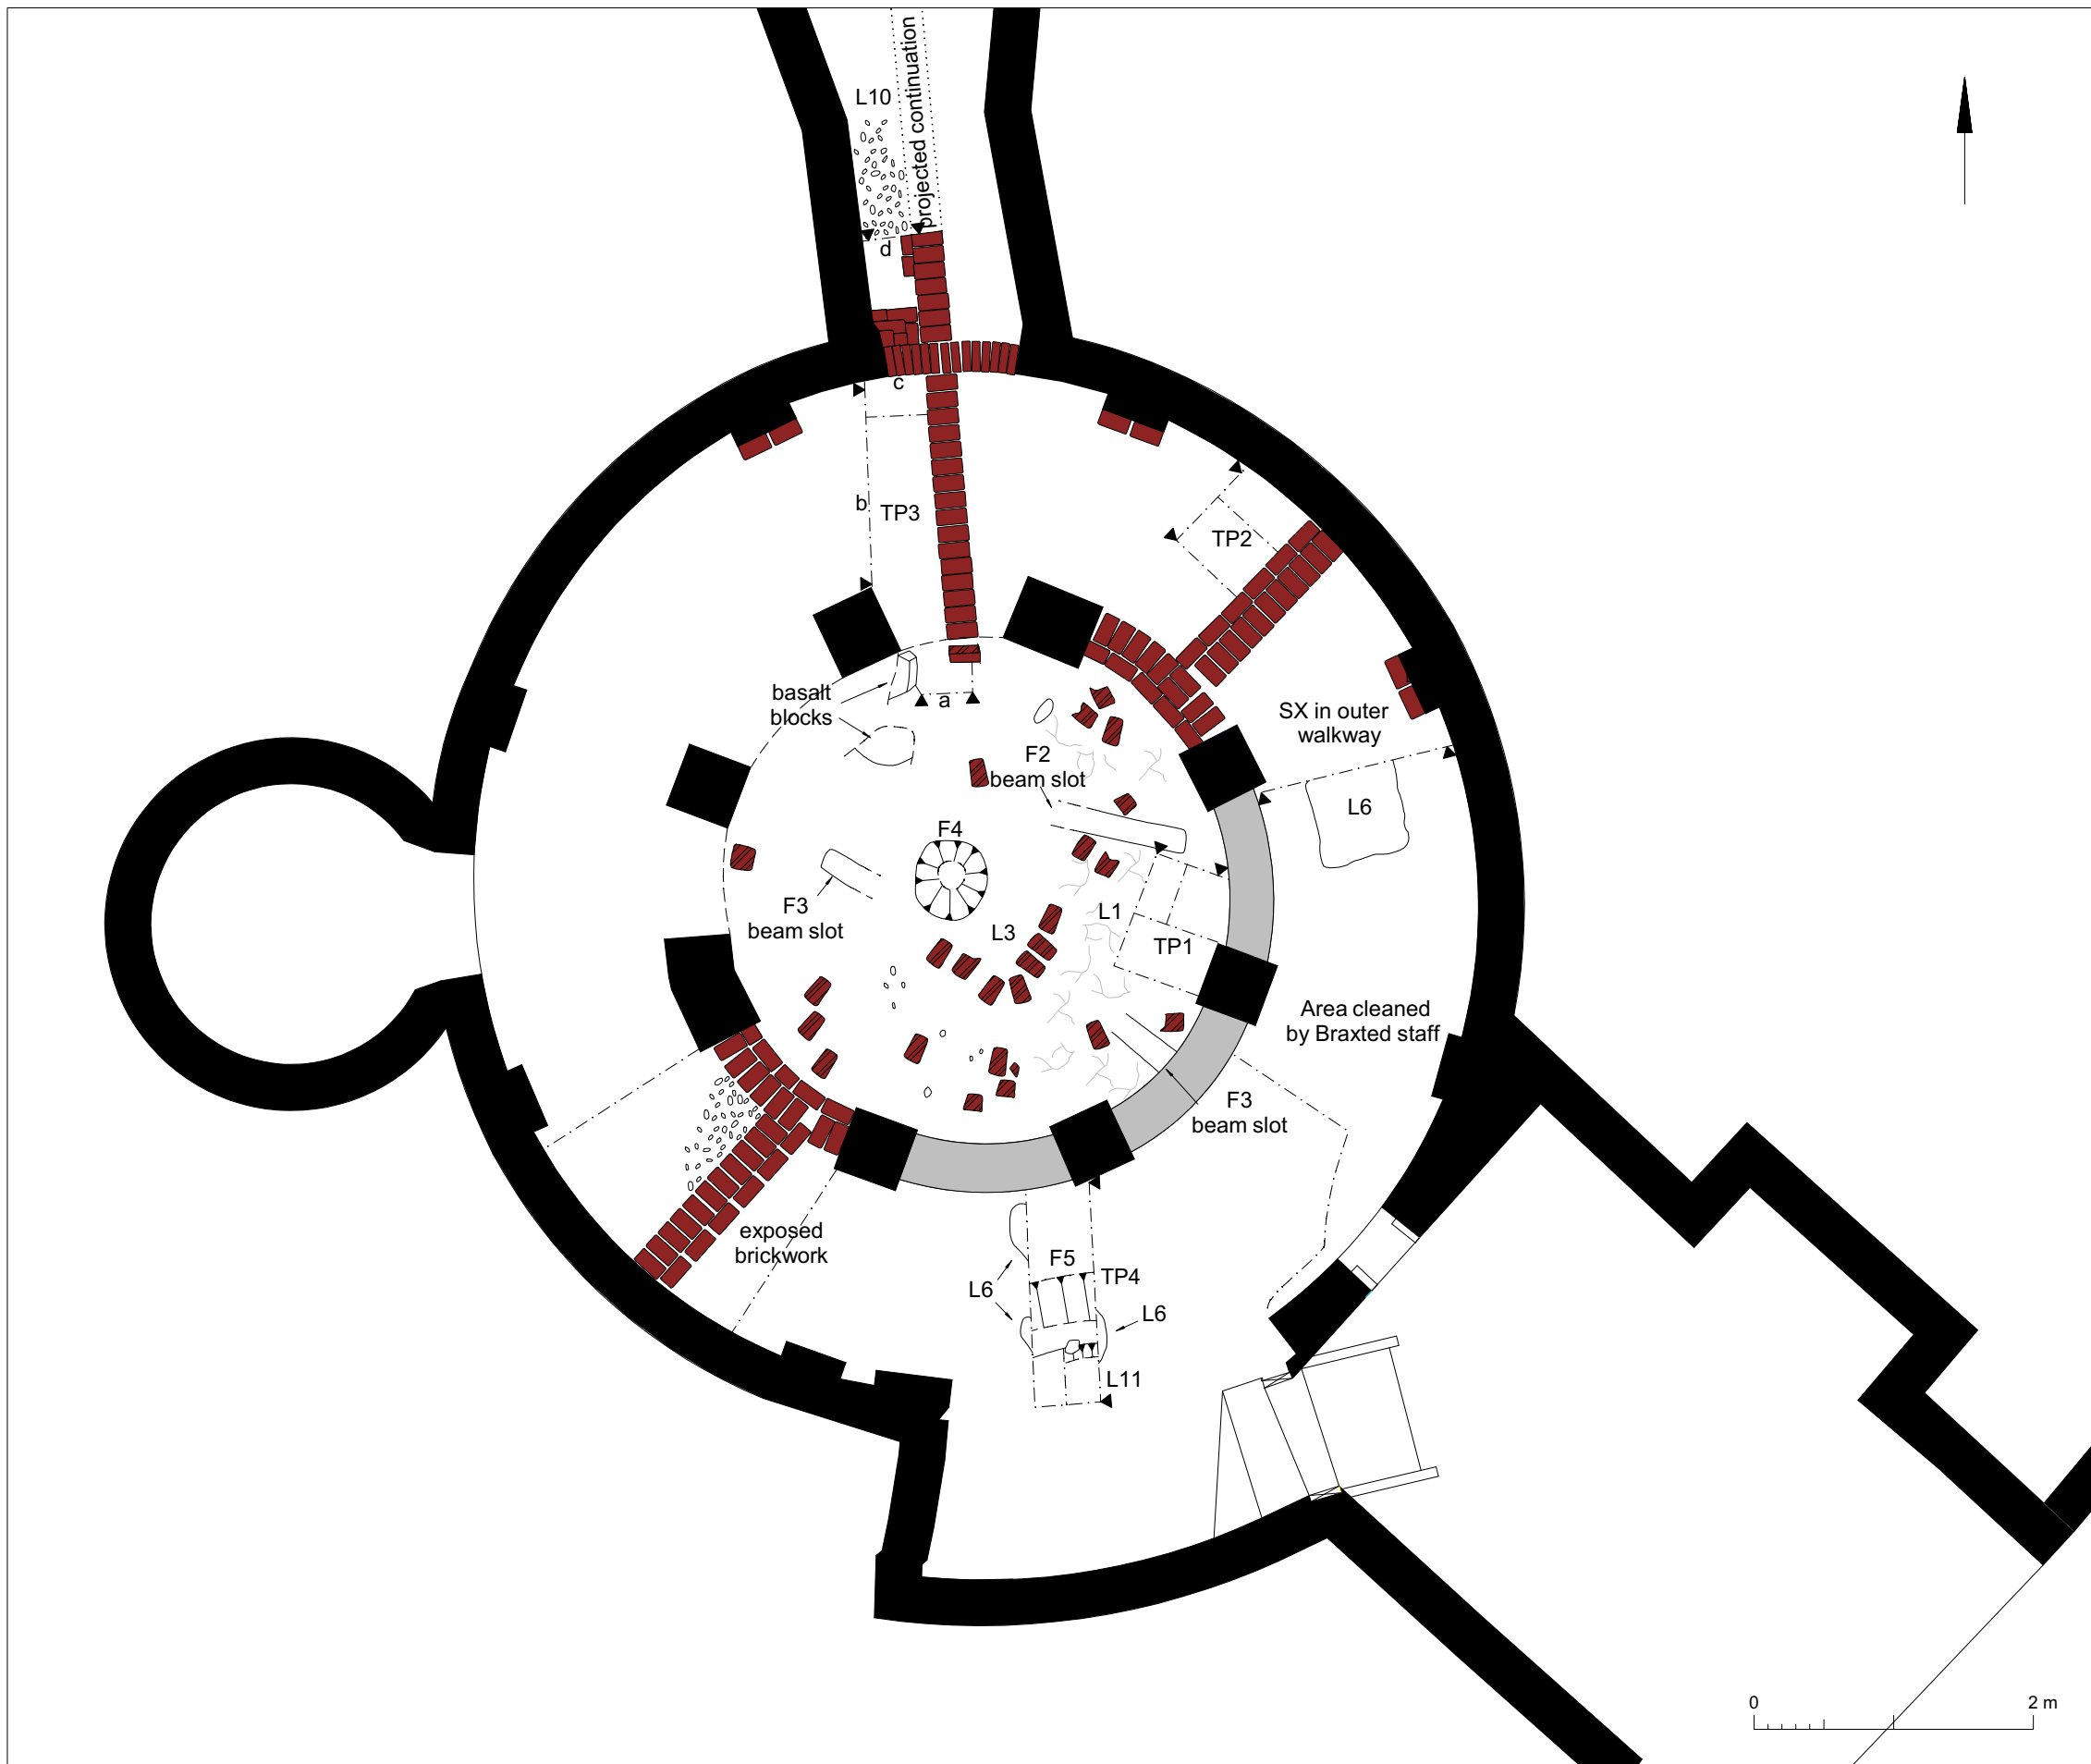
Fig 3 Results.

approximately 200mm of L8 had been removed. Further down the slope, near to IP2 where numerous burrow entrances were located, a section was recorded across the walkway (Fig 3). A thin layer of L8 overlay the limewash (L6), which sealed redeposited clay (L7; Fig 7). L7 was thick in this area, probably because it had been used to create a gradual slope from the high point behind IP3 down towards the northern entranceway as no evidence for any steps in the structure was observed.

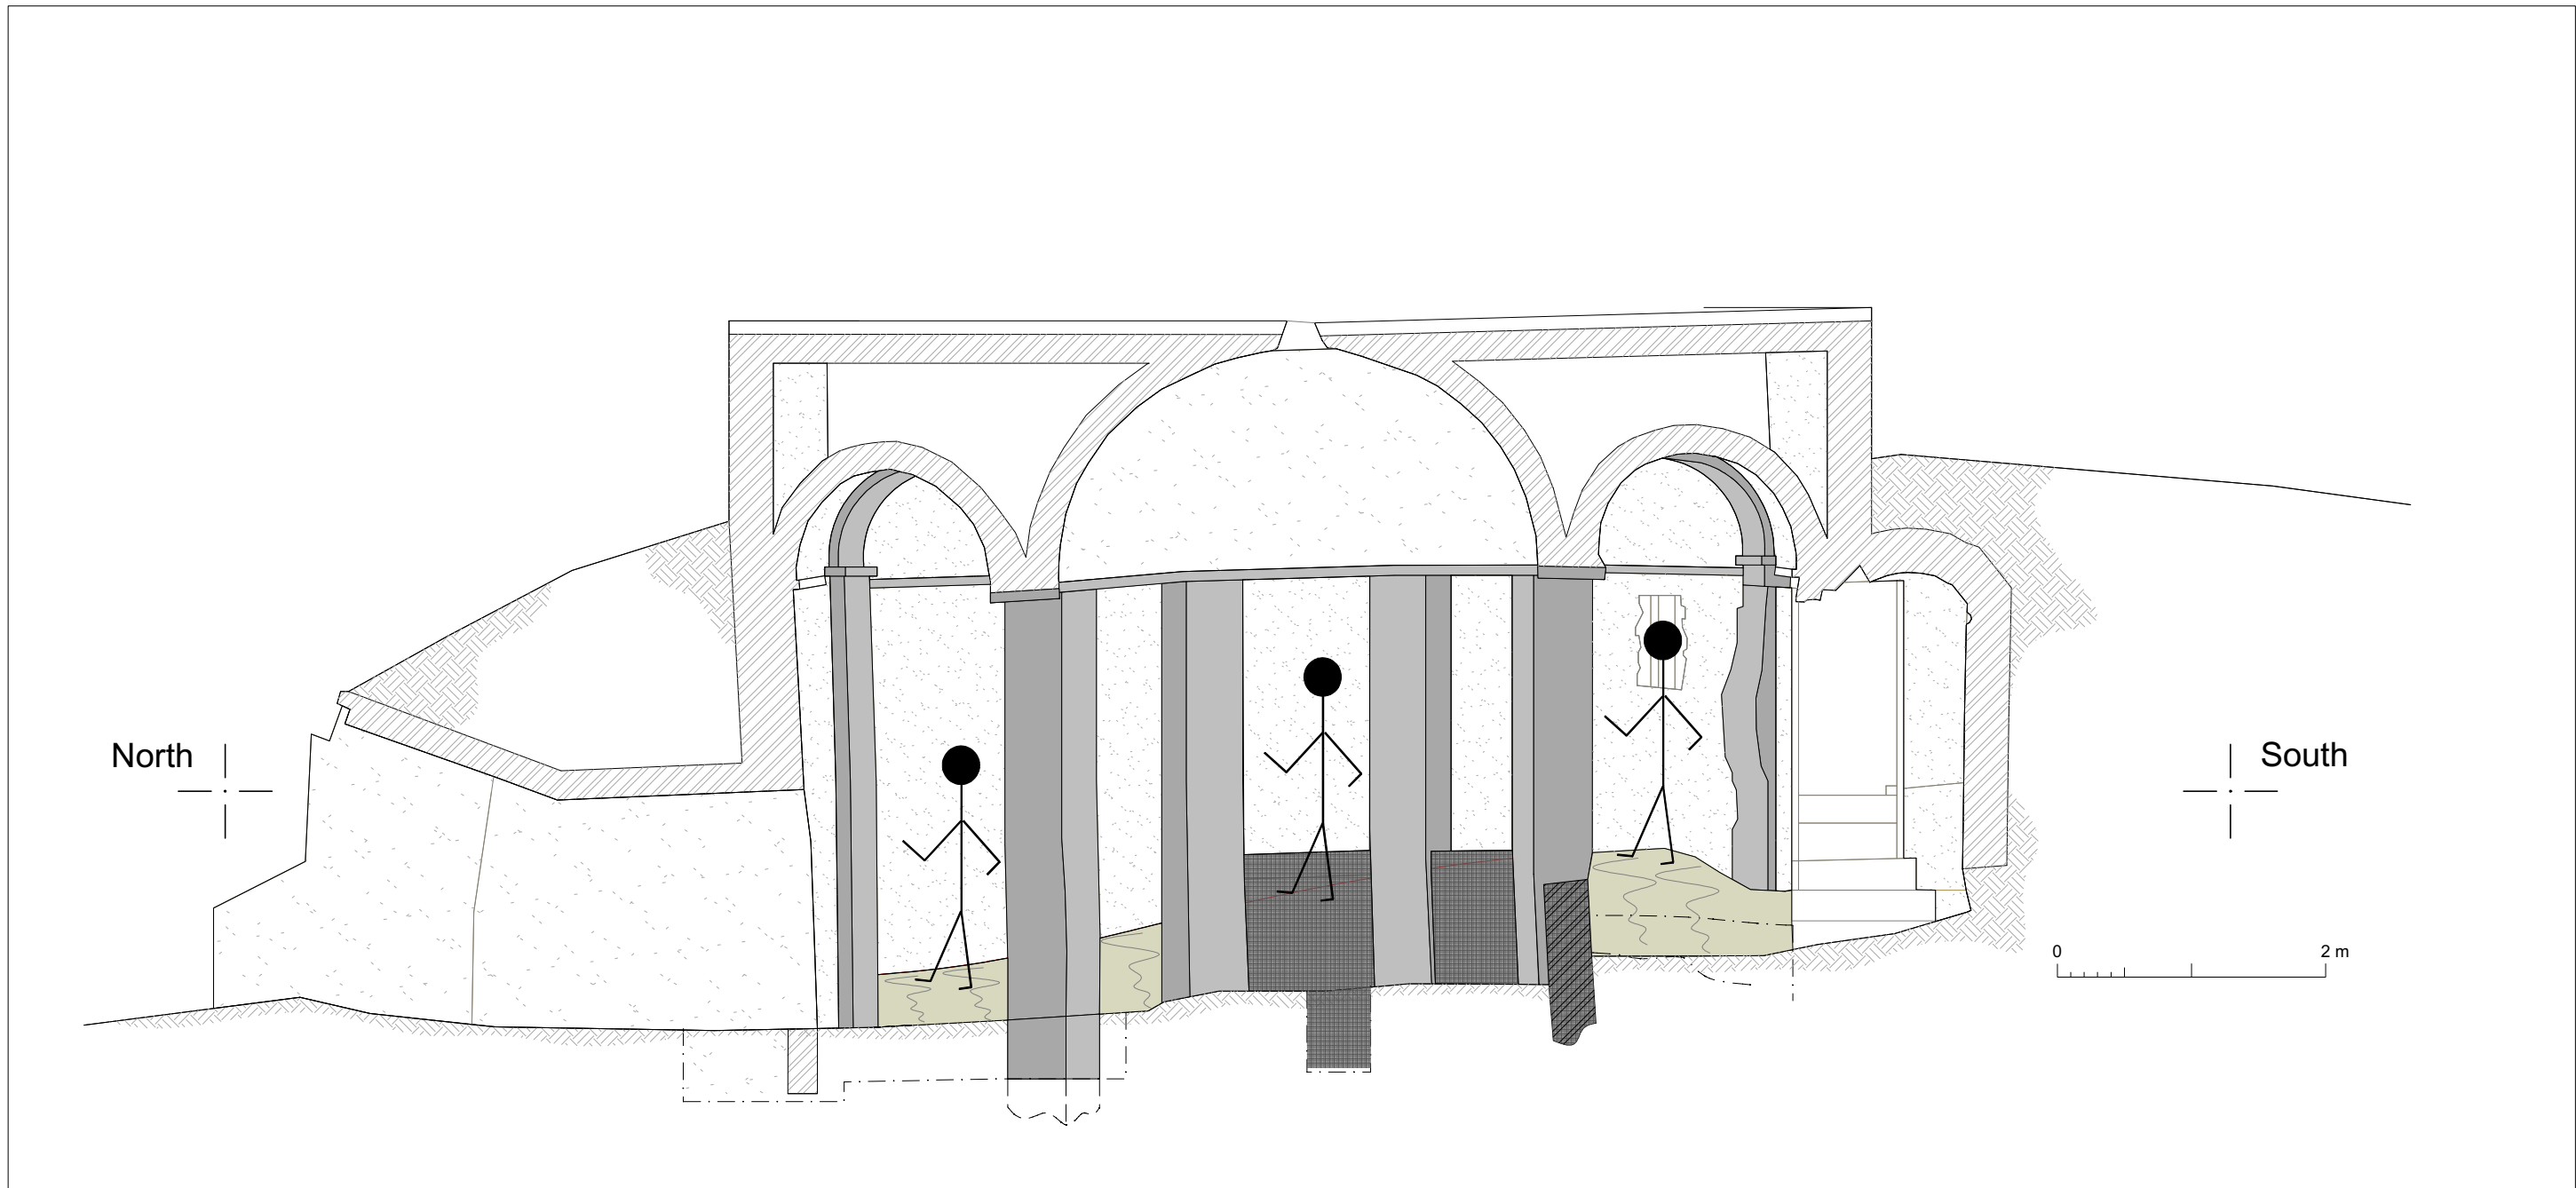
Fig 6 Section showing the slope in the outer walkway based on the height of the redeposited clay (L7).

ascertained. However, it was distinguishable from the overlying layers by the absence of brick and mortar and its greater solidity. The only place in the outer walkway where redeposited clay does not overlie the natural clay is at the highest point within the structure, behind RW2 in the south-east. Instead of removing a considerable quantity of soil and clay from this area and then using bricks to build up the height of the wall, this section of the outer wall has been constructed on higher ground than that to the north-west. Consequently, the outer walkway in the south-east is notably higher than to the north-west. This can be seen by comparing the height of the redeposited clay L7 and the natural clay L5 in TP3 and TP4 (Fig 5). Revetment walls were constructed between four of the inner piers in the south-east so that the central chamber could be made level (Figs 2 & 5). The desire to construct a level surface in the central chamber is indicated by the comparable heights at which the natural clay (L5) was encountered in TP1 and TP3 (28.58m AOD and 28.55m AOD respectively; Fig 5). Redeposited clay was used to grade the slope between the higher and lower areas of the outer walkway to create a ramp (Fig 6).

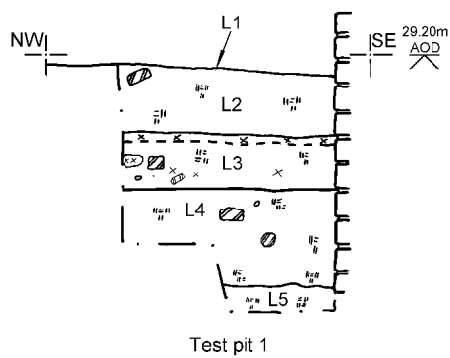
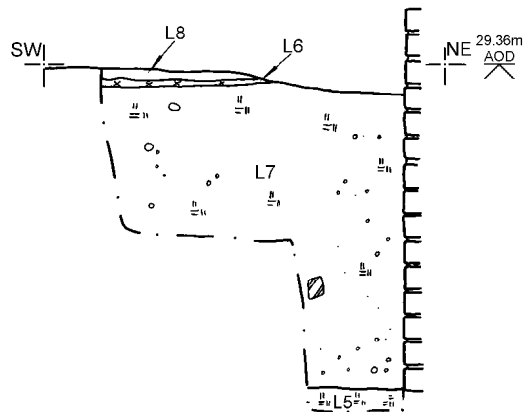
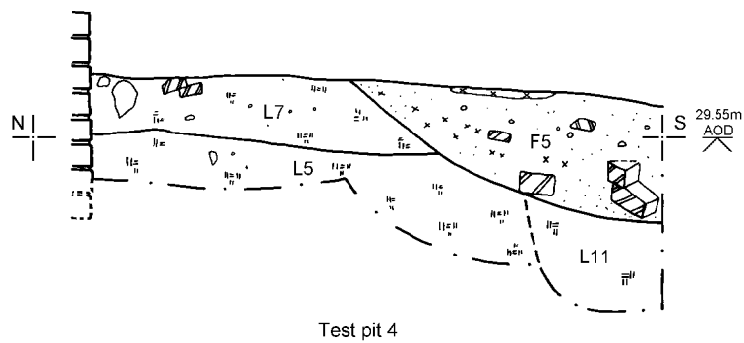
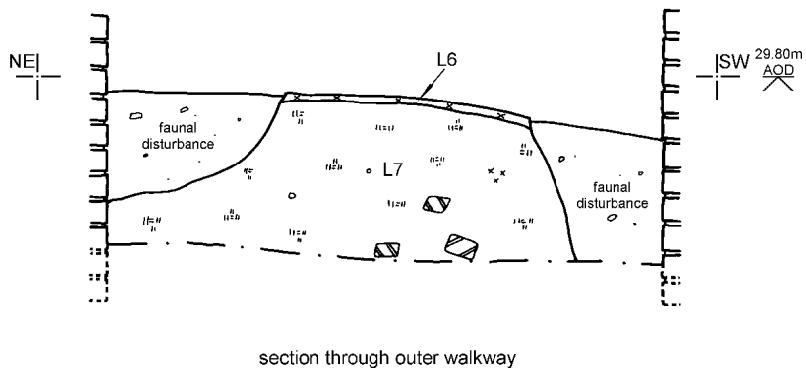
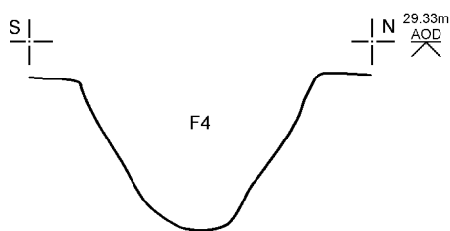
Fig 7 Sections.

Only a thin layer of loose sediment (L8) overlay the redeposited natural clay (L7) in TP4. L7 was notably thin in TP4, with undisturbed natural clay (L5) uncovered 200mm below the existing ground-level (Fig 7), notably higher than it had been identified elsewhere in the structure. A feature containing dense mortar and frequent brick fragments (F5) was cut through L7 and L5 in the southern end of TP4. The feature may be associated with the addition on the lakeside terrace. At the southern end of TP4, the natural clay was softer, darker, and moist (L11; Fig 3). The clay was homogeneous, contained no inclusions, and had an ephemeral edge with the solid natural clay L5. This may have resulted from a natural water-carrying feature such as a stream once flowing across the site where the structure stands today.

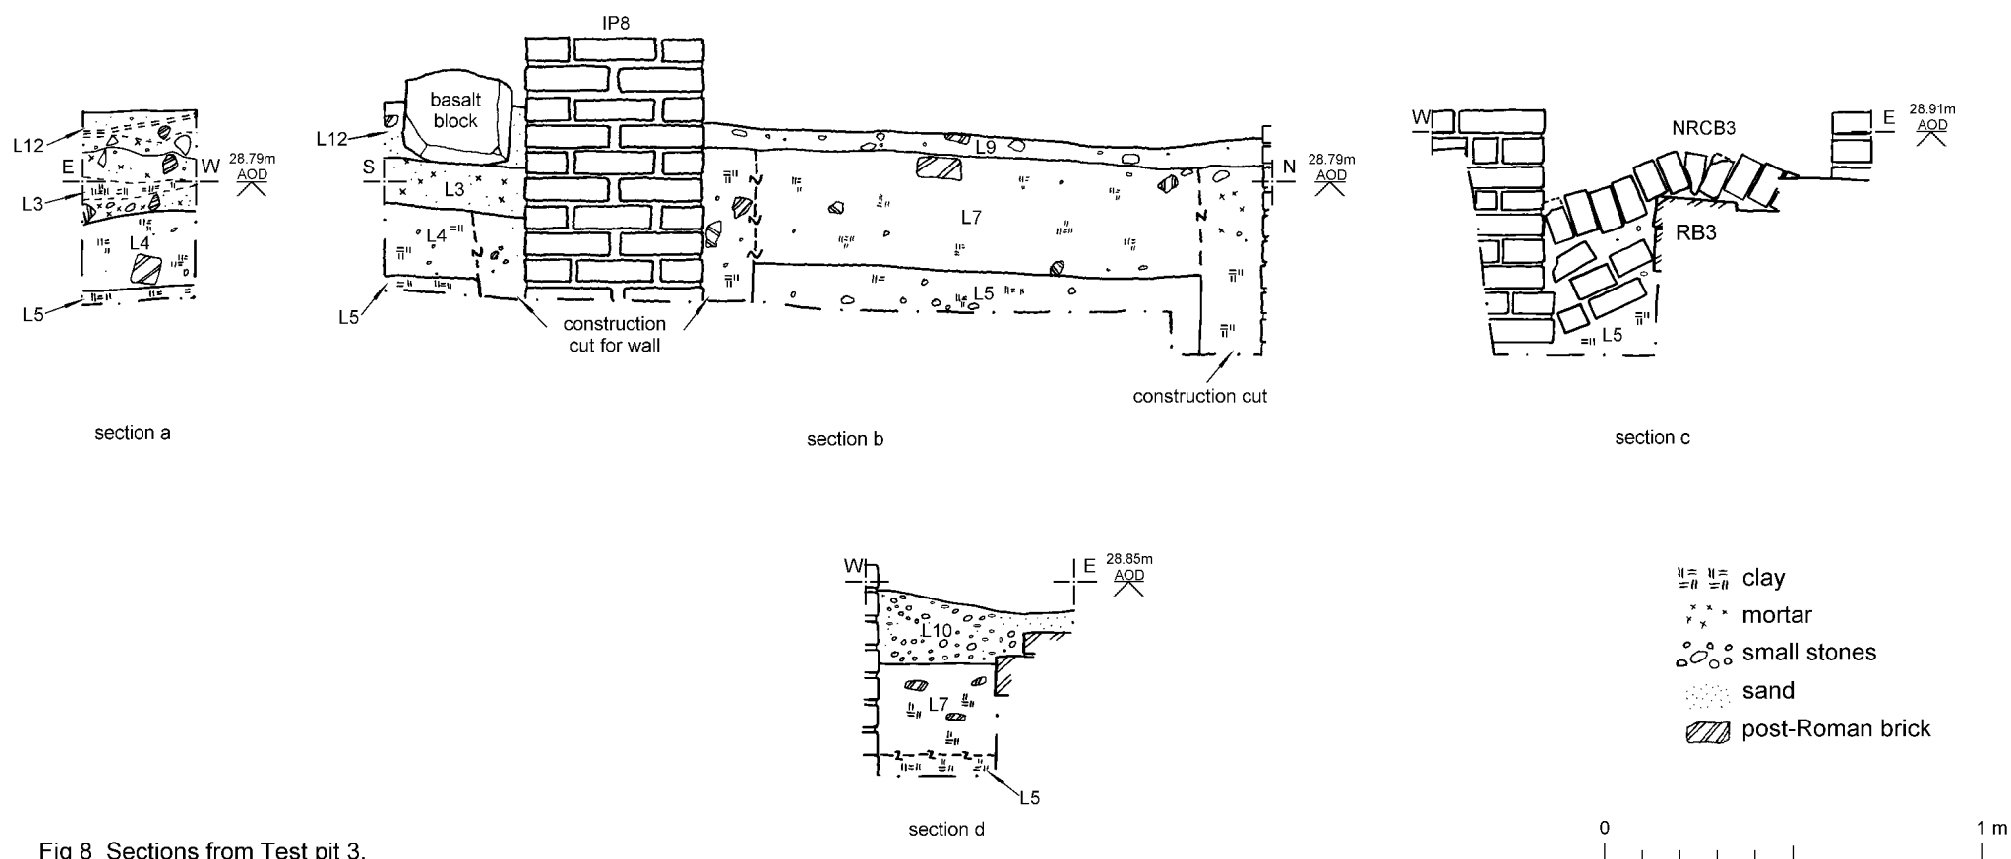
Fig 8 Sections from Test pit 3.

Excavation in the central chamber in TP3 identified dense deposits of brick and mortar interspersed with clay (L12 and L3; Fig 8a/b). The uppermost layer (L12) had rare brick fragments and frequent mortar (including a notable mortar lens) set in a clay matrix. Also incorporated in L12 was a large basalt block (Fig 8b). Other basalt blocks were observed in the demolition layer as well as lying on the surface in the south-western area of the outer walkway. The redeposited clay layer with rare brick fragments identified in TP1 (L4) was also identified beneath L3. In conjunction with the findings from TP1, the identification of L4 at some distance from the cut for IP8 suggests that the layer probably exists throughout the central chamber as opposed to being backfill material in a wall foundation cut. Excavation continued until the natural clay L5 was reached. The lowest course of the internal brick pier (IP8) was not reached and the cut for the pier was observed in the natural clay.

In TP3, the uppermost layer was a sandy silt with occasional stones 60mm thick (L9; Fig 8b). L9 covered a mortared brickwork structure only two courses deep (RB3). The upper course was constructed of a single line of bricks laid flat and side by side. The lower course was a double row of bricks laid lengthways and on their sides. RB3 was overlaid by one course of bricks laid flat and side by side in the entrance to the northern access tunnel (NRCB3; Fig 2). Further subsided brickwork courses beneath appeared to abut RB3 (Fig 8c). RB3 continued into the northern access tunnel and beyond the limit of our excavation. It appeared to end without abutting anything where it met the central chamber (Fig 2). To the west of RB3 in the outer walkway, L9 overlay compacted redeposited clay L7 (Fig 8b). The natural clay L5 was identified below L7. The lowest course of bricks in the external wall was identified below the level of the natural clay within a wall foundation cut which had been backfilled with redeposited clay identical to L7 (Fig 8b). In the northern entrance tunnel, a relatively thick layer of gravel in a sandy silt matrix (L10) overlay the redeposited clay (L7; Fig 8d). The gravel was compacted into the clay forming a metallised surface. The gravel partially covered RB3, and it is assumed that this was present across the whole northern access tunnel which was otherwise covered in loose sediment and debris.
